FINAL REPORT

NASA CR 71163

AN EXPERIMENTAL EFFORT TO IMPROVE THE

NIMBUS HIGH RESOLUTION INFRARED RADIOMETER

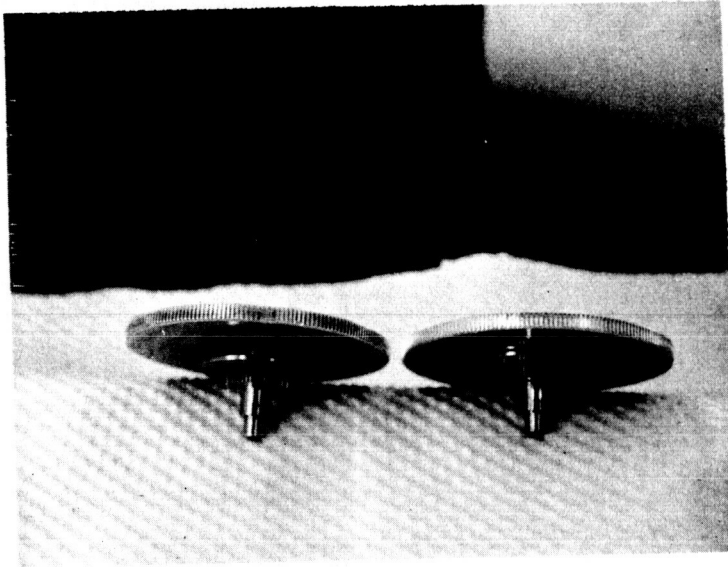
FIGURE 1

The failure was caused by longitudinal separation of the large aluminum gear from its shaft flange. This separation caused it to become disengaged from the motor pinion, allowing the mirror to "run free". See Figure 1 for a comparison of the defective gear (left) and a good gear (right).

None.   The test was shorted and the unit returned to ITTIL for repairs.

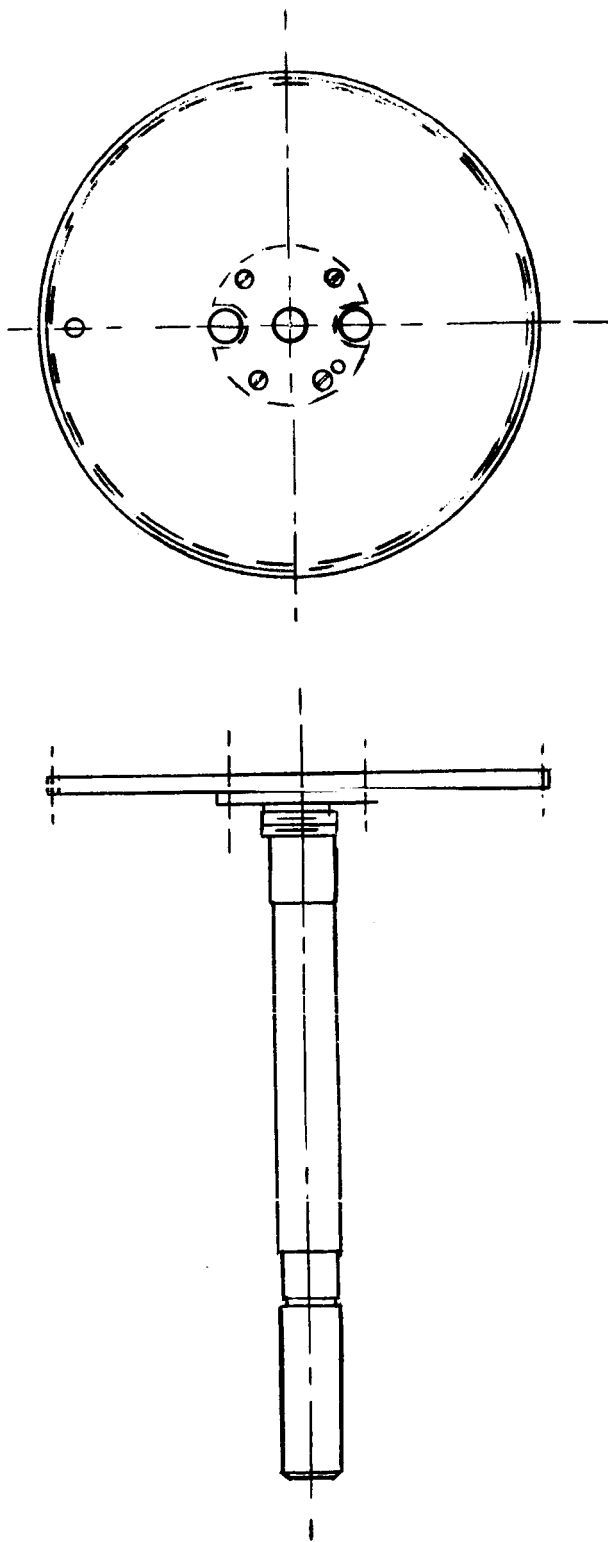
Figure 1    Scan Gear Assembly

It was generally agreed that the present design using a number 6 press fit for gear attachment was inadequate.  A discussion brought out a number of various "fixes" that could be instituted on these and all future gear assemblies.  The accepted methods for attaching gears on the three assemblies are illustrated in figure 1, 2 and 3.
