FABRICATION AND TEST
OF INORGANIC/ORGANIC SEPARATORS

by J. S. Smatko

STANFORD RESEARCH INSTITUTE
333 Ravenswood Avenue
Menlo Park, California 94025

1. Report No. NASA CR-134646	2. Government Accession No.	3. Recipient's Catalog No.
4. Title and Subtitle Fabrication and Test of Inorganic/Organic Separators		5. Report Date February 1974
		6. Performing Organization Code
7. Author(s) Joseph S. Smatko		8. Performing Organization Report No.
		10. Work Unit No.
9. Performing Organization Name and Address Stanford Research Institute 333 Ravenswood Avenue Menlo Park, California 94025		11. Contract or Grant No. NAS 3-17344
		13. Type of Report and Period Covered Final Nov 1972-Jan 1974
12. Sponsoring Agency Name and Address NASA-Lewis Research Center 21000 Brookpark Road, Cleveland, Ohio 44135		14. Sponsoring Agency Code

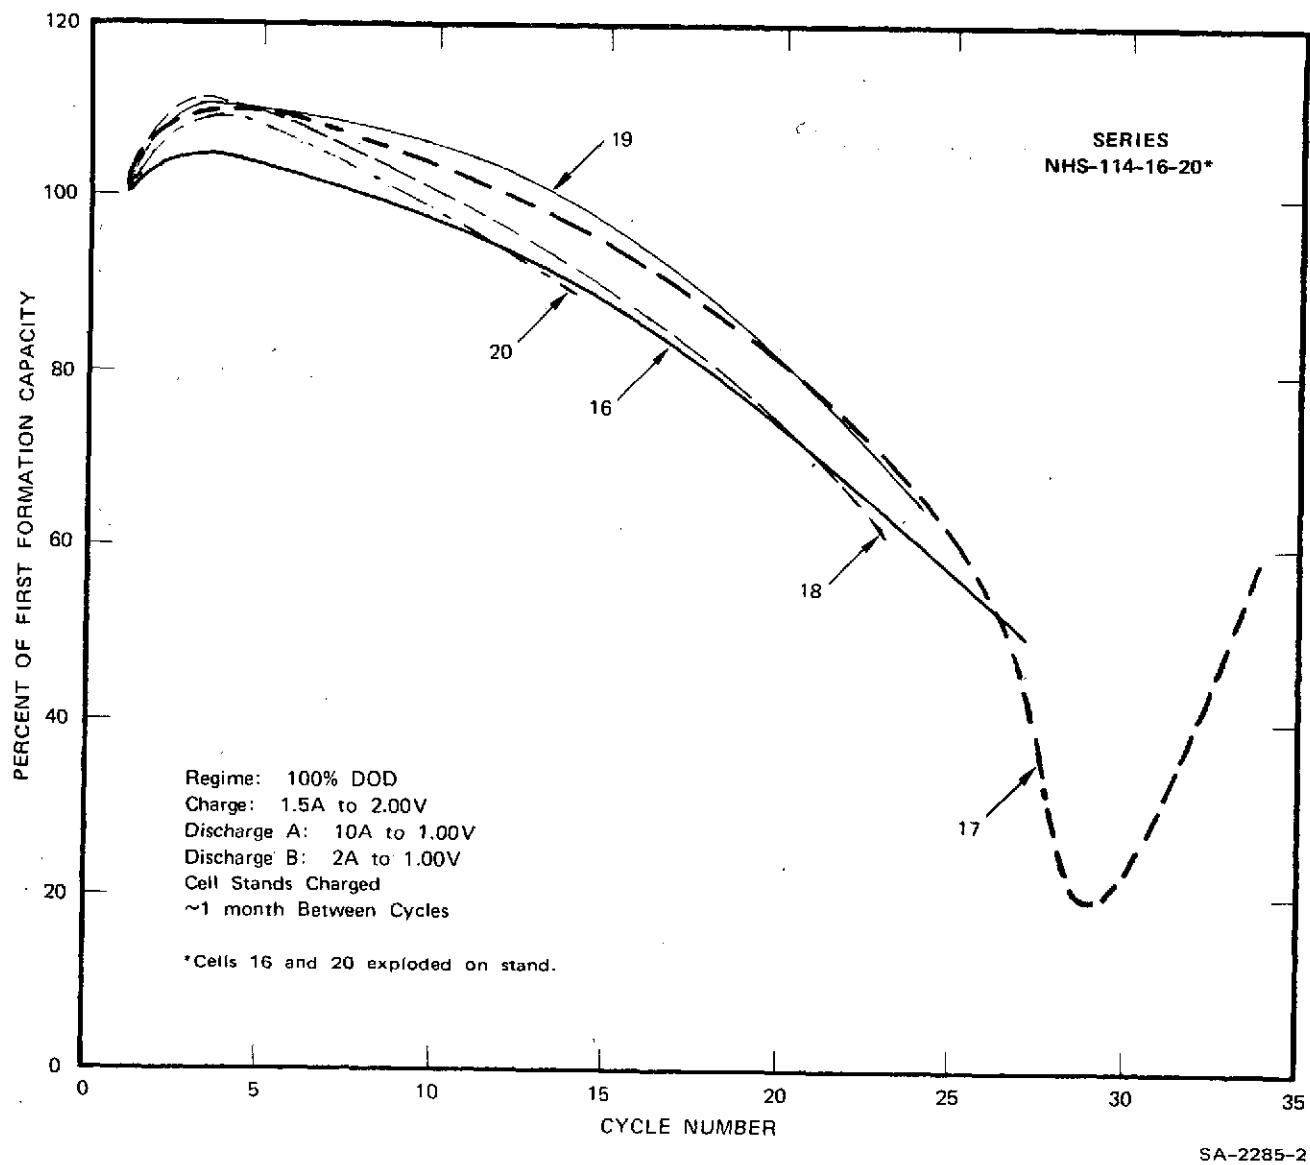
FIGURE 1   OUTPUT CAPACITY RETENTION WITH CYCLE LIFE

The cells of the plate-lock group were broken down into subgroups that correspond to the factors examined. These subgroups and the results obtained in cycling these cells are shown in Table 7. The capacity loss during cell operation is shown in Figures 1 to 4 as the percentage of first formation capacity versus cycle number. No group was clearly superior to any other, although the B and C subgroups tended to have higher capacity retention, at least for the first 15 (approximately) cycles. At 50% of the formation capacities of surviving cells in the B and C subgroups had an average of 27 and 30 cycles, respectively, compared to surviving cells of subgroups A and D which had 26 and 24 cycles, respectively. At 70% of the formation capacity, surviving cells of the B and C subgroups had 22 cycles each, compared to surviving cells of subgroups A and D which had 20 and 18 cycles, respectively. The reasons for variation in formation capacity are not clear. One must exercise caution in interpreting small-number statistics, especially in this case where curve smoothing methods were employed.

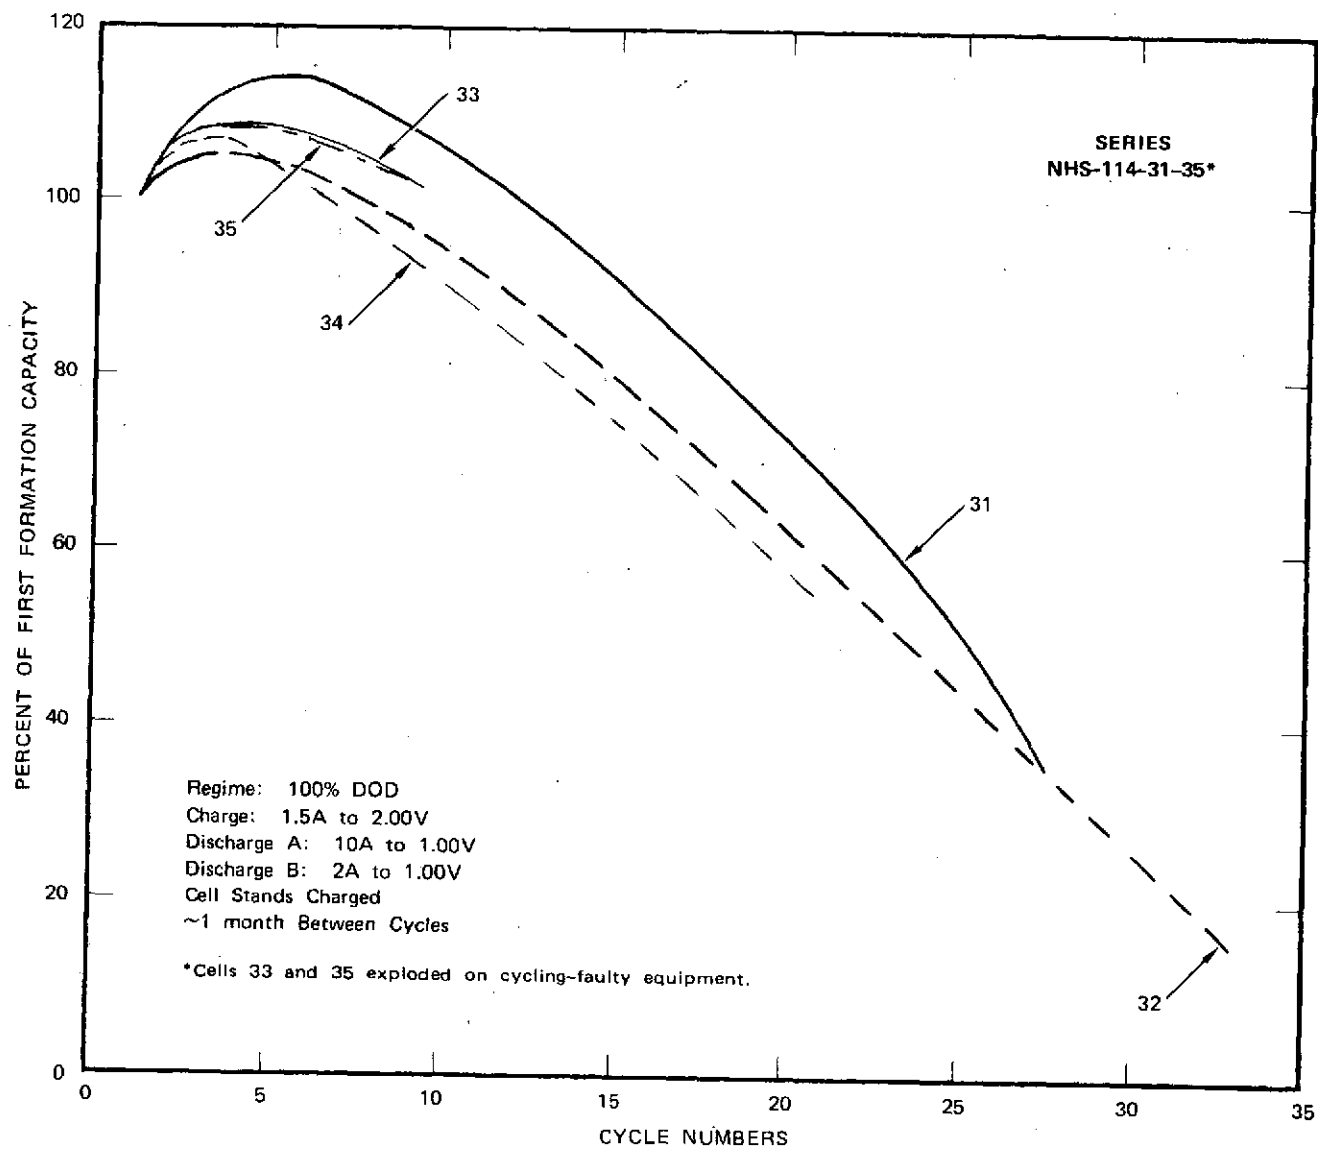
FIGURE 4   OUTPUT CAPACITY RETENTION WITH CYCLE LIFE

Regime: 100% DOD
Charge: 1.5A to 2.00V
Discharge A: 10A to 1.00V
Discharge B: 2A to 1.00V
Cell Stands Charged
~1 month Between Cycles

*Cells 33 and 35 exploded on cycling-faulty equipment.

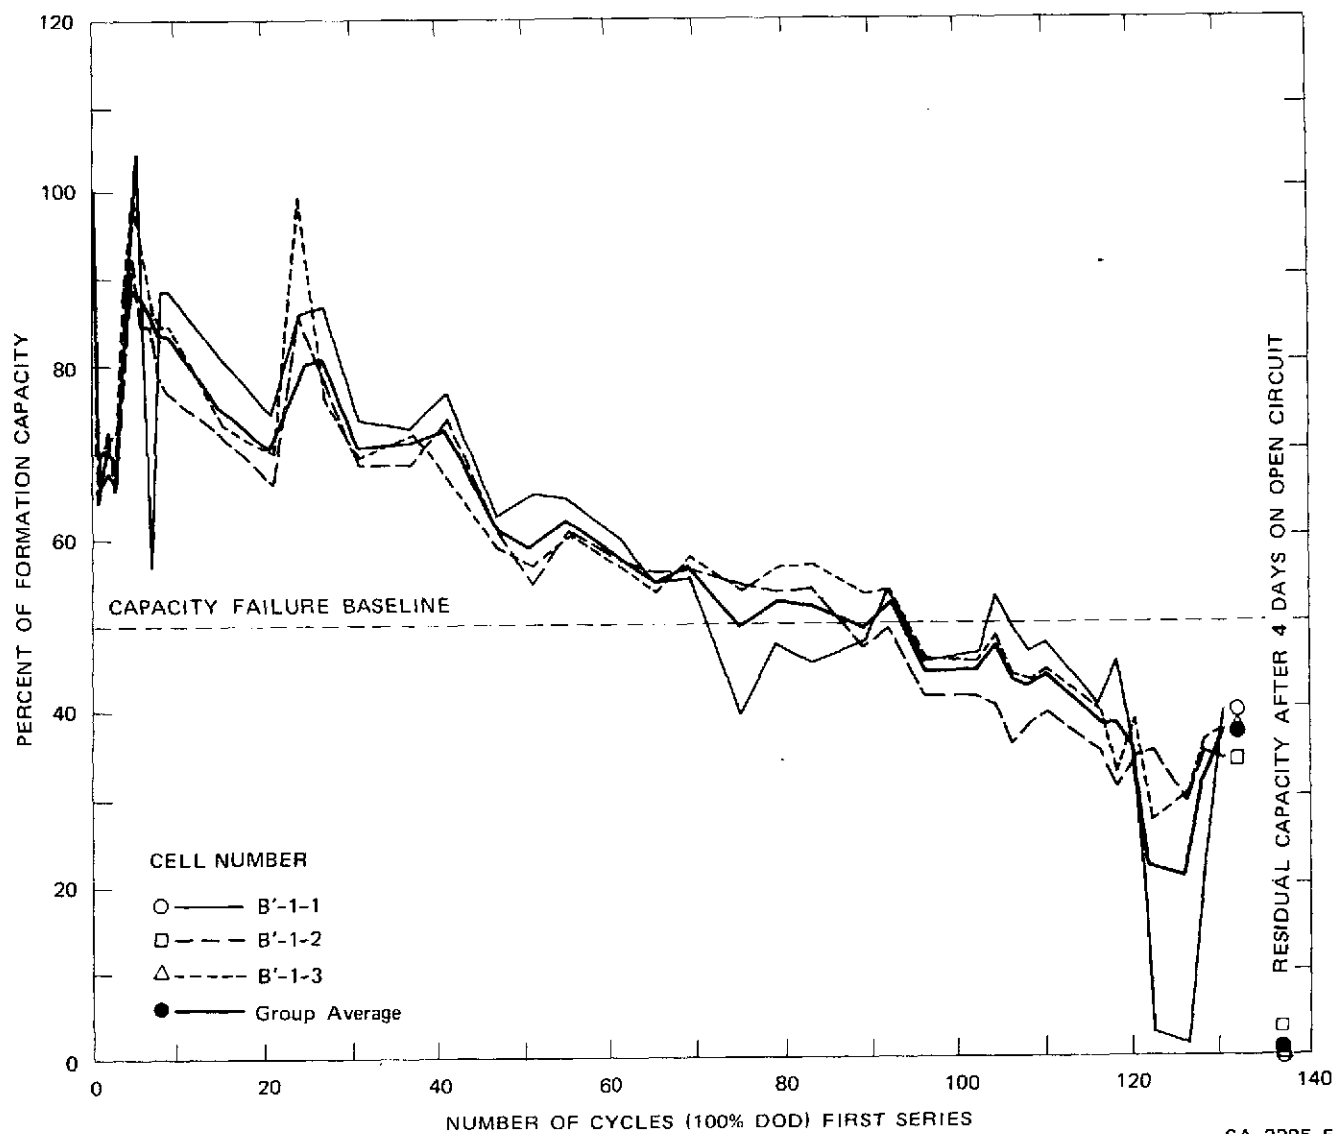
FIGURE 5   CAPACITY CHANGE WITH CYCLING

Each series comprised 12 test cells, grouped by threes as shown in Table 17. Each group represents a particular separator composition. Graphs of percent of formation capacity versus number of cycles display the decline in capacity. These graphs are shown as Figures 5 to 8 for the first series and as Figures 9 to 12 for the second series. The performance of each cell in a group and the group average are plotted in each graph. One may conceive of an envelope of curves or a band that would define each group average curve. Table 17 lists the group average numbers obtained for both test series.[*] The differences between the two series appears to be quite substantial, and these differences may be explained, at least in part, in the history of the cells.

Regular and automatic life cycling using a 2-cycle per day 100% DOD regime was started using the cell capacity data acquired during formation. Records of charge and discharge capacity were maintained; it was from these records that the curves in Figures 5 to 8 were constructed. Records for Cycles 15, 41, and 120 are presented in Tables 18a, 18b, and 18c.

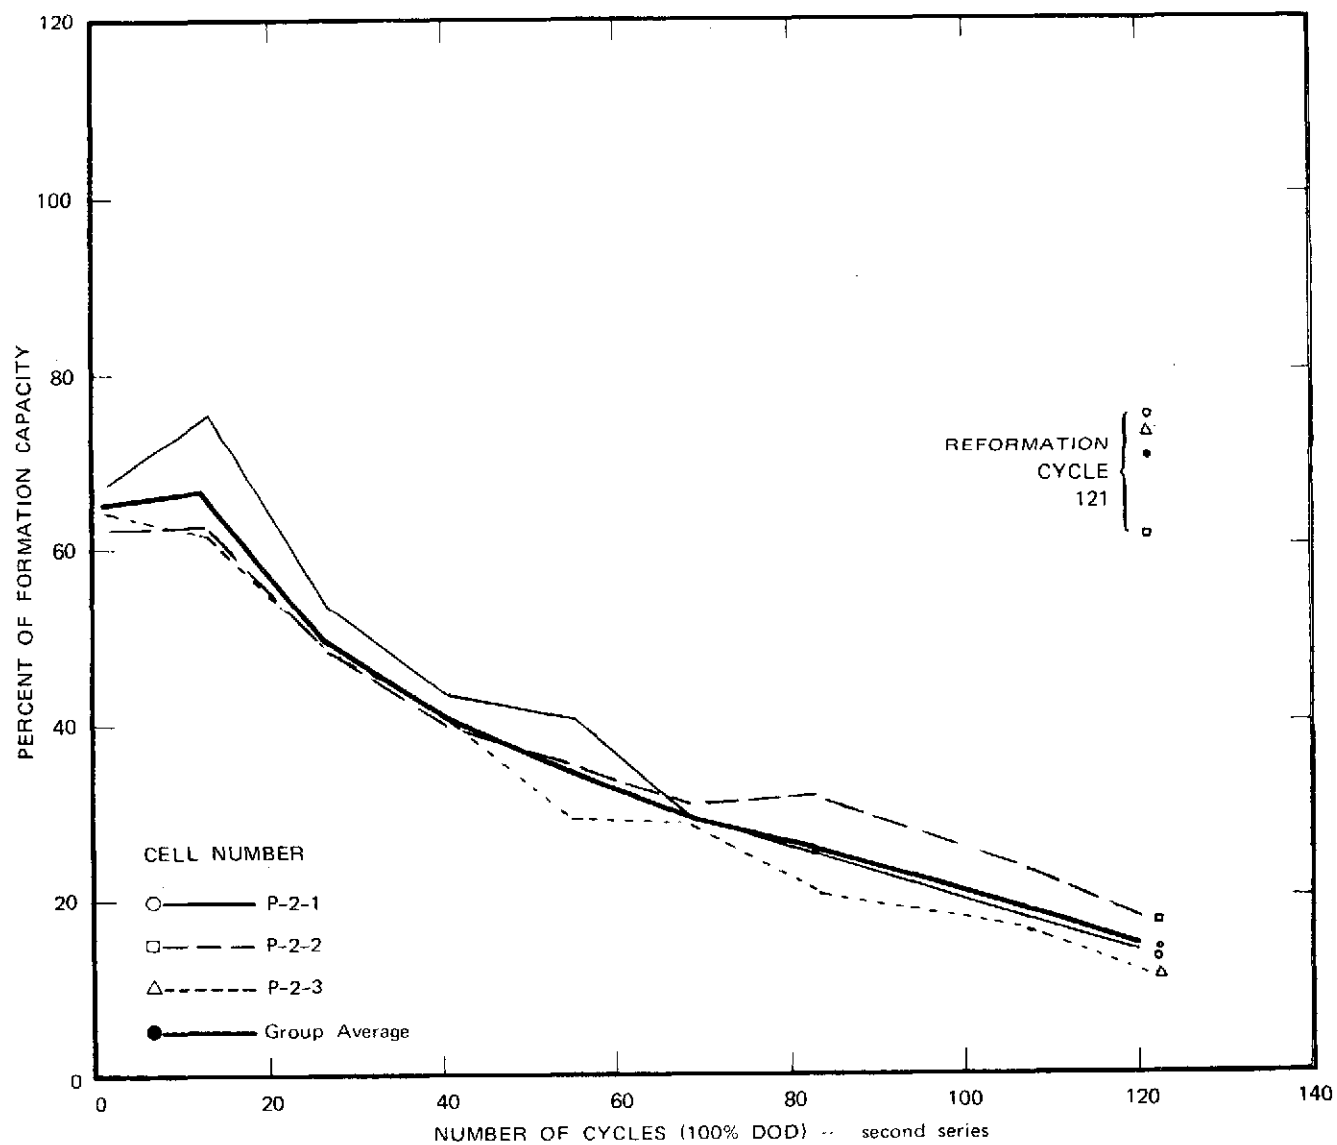
FIGURE 9   CAPACITY CHANGE WITH CYCLING

The capacities observed in formation charging and the performance data for regular 100% DOD life-cycling are presented in Tables 19a, 19b, and 19c. These tables present the numerical data taken at Cycles 13, 41, and 120 in the testing of the second series. Data such as these were used to plot the curves of Figures 9 through 12.
