LIFE CONSIDERATIONS OF THE SHUTTLE ORBITER DENSIFIED-TILE

THERMAL PROTECTION SYSTEM

Paul A. Cooper and James Wayne Sawyer NASA Langley Research Center Hampton, Virginia

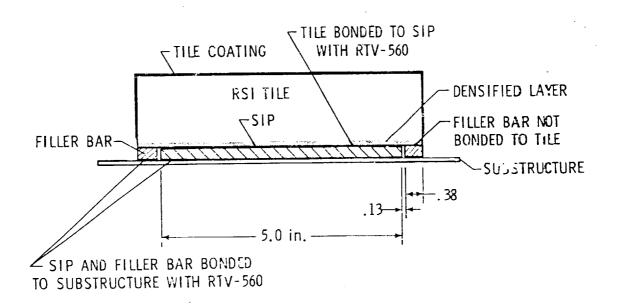
A schematic of a typical tile/HF ussembly is shown in Figure 1. The tile is composed of compacted 1.5-micron-diale er silica fibers bonded togethe. By colloidal silica fused during a high-temperature sintering process. Two types of tiles are used on the windward surface of the orbiter, a 9 lb/ft³ tile designated LI-950 and a higher strength 22 lb/ft² tile designated LI-2200. The tiles are coated on five sides with reaction-dured glass (RCG) consisting of silica, boron oxide, and silicon tetraboride co provide an abrasion-resistant watertight surface. The remaining uncoated side of the tile is densified by the application of a ceramic silorry at the surface for the SIP. A photomicrograph of the densified region is given in Figure 2 and shows the colloidal silica particles situated between the silica fibers. Most densification material remains within 0.10 in. of the bonding surface as shown in the second photomicrograph of Figure 2 with the larger particles occurring at the surface and with the particle size and number of particles decreasing gradually toward the interior of the tile.

The SIP is bonded to the tile and the aluminum substructure of the orbiter using an elastomeric room temperature vulcanizing (RTV) silicone adhesive. The SIF is a felt pad of nylon fibers compacted by passing a barbed needle normal to the rad surface in a sewing machine like process. The compacting process provides tensile strength and extensional stiffness in the pad thickness direction and provides a load transfer path between the substructure and the tile. A photomicrograph of the SIP is given in Figure 3 and shows a region of transverse fibers produced by the needling process. The RTV adhesive transfer ccat is also shown in Figure 3. This coat is bonded to the densified surface of the tile. A filler bar is bonded to the aluminum substructure between tiles to provide thermal protection for the substructure. A

Figure 1.- Schematic of ceramic TPS.

The thermal protection system (TPS) on the windward surface of the orbiter onsists of ceramic tiles bonded to strain isolator pads (SIP), which are in turn onded to the orbiter aluminum substructure as shown in the schematic of Figure 1. o prevent premature failure of the TPS at the interface of the SIP and the tile ue to stress concentrations caused by the localized transfer of load through the IP, the faying surface of the tiles was strengthened by a surface densification rocess. The greater static strength achieved by the surface densification does not ully translate into an equivalent increase in fatigue strength (ref. 1 and 2). atigue failure of the densified TPS takes the form of excessive elongation through he thickness of the SIP. On the other hand, fatigue failure of TFS with undensified iles involves complete separation at the SIP/tile interface (see ref. 3). Fatigue ailure of densified TPS is relatively heaign when compared with fatigue failure of ndensified TPS since a tile beging to loosen can be identified and replaced uring postflight maintenance.

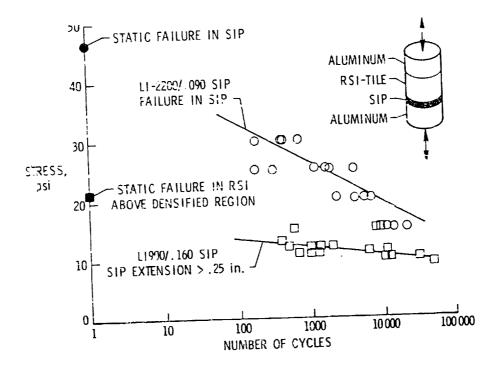
A series of fatigue characterization tests of densified LI-900 tile/0.160 SIP and densifiec LI-2200 tile/0.090 SIP specimens were performed with results reported in reference 3. The 2.25-in.-diameter specimens were tested under repeated fully reversed sinusoidal loads applied at 1 Hz with results as shown in Figure 4. The lower strength LI-900 tile/0.160 SIP failed under cyclic loads by SIP extension when a total travel of 0.25 in. was arbitrarily selected as a failure condition. A total travel of this amount would constitute excessive looseness on the orbiter. The higher strength LI-2200 tile/0.090 SIP specimens failed by complete separation of the SIP before a total SIP extension of 0.25 in. was reached. For a given stress level, the stronger TPS had several orders-of-magnitude increase in lifetime over the weaker TPS. A comparison of the growth of the SIP during the fatigue tests under a fully reversed sirusoidal applied stress of 12 psi for the two types of TPS is shown in Figure 5. The stress displacement curves shown in the figure indicate that the 0.160 SIP loosens much more rapidly than the 0.090 SIP.

Figure 4.- Fatigue of densified TFS subject to fully reversed sinusoidal loads (R = -1).

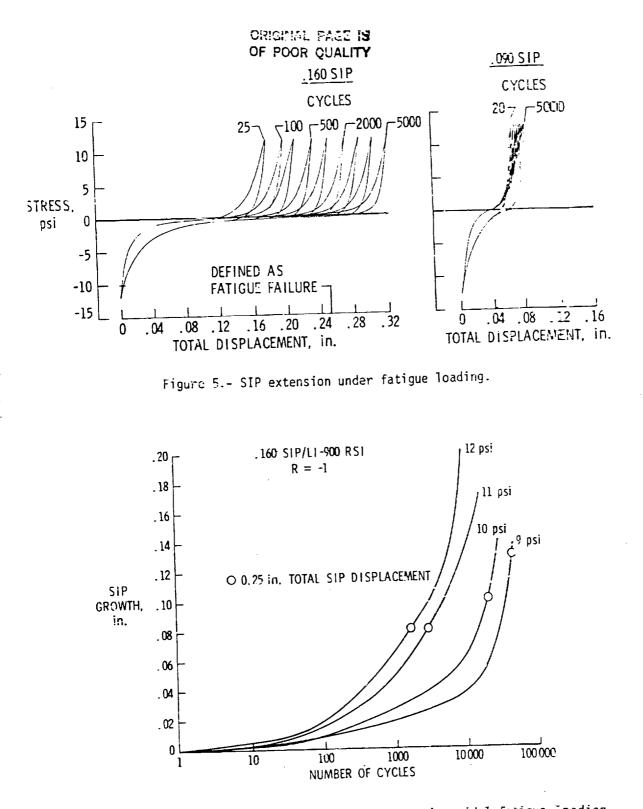
Figure 6 shows the measured growth of the 0.160 SIP during the fatigue test for various applied stress levels and indicates the number of cycles at which total displacement is equal to the assumed failure criteria of 0.25 in. As the number of cycles increases, the SIP transverse fibers continue to stretch and unravel resulting in an increase in total specimen travel and a continual loosening of the tile. The growth rate increases nearly exponentially as the growth increases.

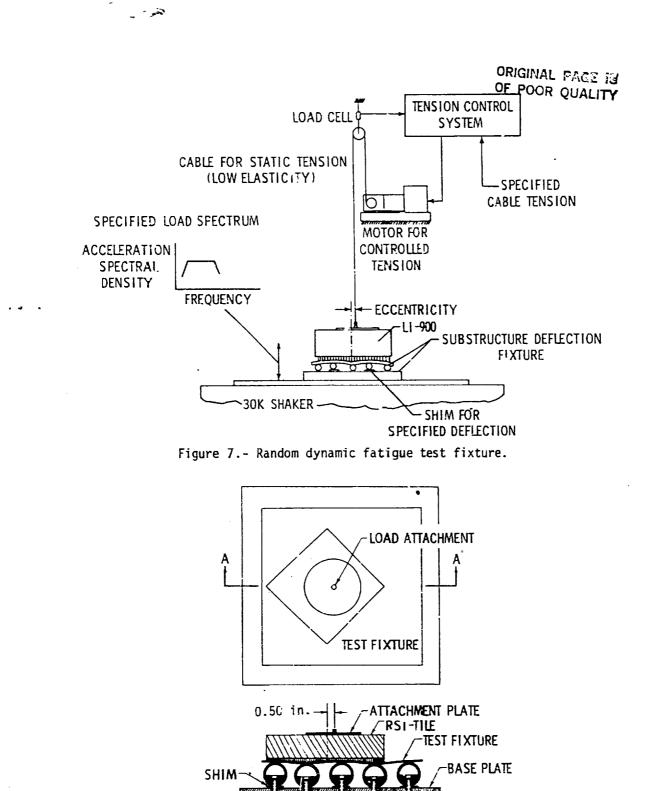
SECTION A-A

Figure 8.- Schematic of random dynamic load test setup.

The fixture surface on which the specimen is bended is first chemically etched, sprayed with a protective primer, and vacuum baked to remove all volatiles. The specimen is bonded to the test fixture with the tile diagonals parallel to the edge of the test fixture as shown in Figure 7. The tile is located on the test fixture so that one corner of the SIP is over the centerline of one of the tubes. A circular aluminum thin disk is bonded to the top of the tile using epcxy adhesive to provide a load attachment point for application of a steady tensile load and moment which simulate the effect of a steady aerodynamic gradient. The attachment point at the center of the disk is located 0.5 in. from the center of the tile measured along a tile diagonal perpendicular to the tube axes. To apply a random dynamic load to the specimen, the fixture, with the specimen in place and shims installed to simulate substructure deformations at a wing location, is bolted to the drive head of a 30,000 lb electromagnetic shaker. A schematic of the test setup is shown in Figure 8.

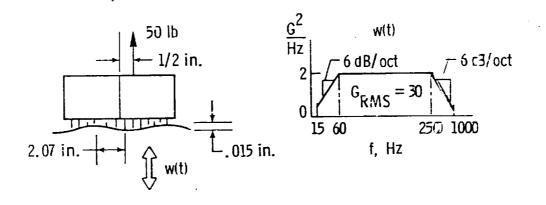
A series of tests were performed on a 2-in. thick by 6-in. square densified-LI-900 tile bonded to a 5-in. square 0.160 SIP. The specimer, installed on the thir plate with filler bars in place, was first given a wond verification test similar to that given actual densified tiles on the orbiter. The test consisted of a steacy load applied to the top of the tile which introduced a uniform tensile stress of 10 psi on the SIP followed by a compressive load of the same siress level to bring the tile back to its equilibrium position. The specimen was them given a 5-psi uniform tension stress followed by a 5-psi compression test with displacement response recorded to establish the stress displacement characteristics which existed before the random dynamic load test was performed. The specimen was then installed on the base plate using shims to provide a static substructure deflection amplitude of 0.215 in, with a half wavelength along the tile diagonal of 2.07 it. A tensile force of 50 lb displaced 1/2 in. from the tile center along the diagonal in the direction which causes the most severe SIP stress was applied and held constant for the curation of the dynamic test. The specimen was given a random base drive of 30 gras with the driving frequencies occurring mainly between 60 Hz and 250 Hz using the power stree tral density distribution shown in Figure 9. The dynamic test was conducted for a total of 2.5 hours with measurements of SIP growth at the most highly stressed contern taken every 1/2 hour with all loads removed. With one ascent mission assumed equal to 25 seconds of test time, the total test time simulated 360 ascent missions (100mission lifetime with a scatter factor of 3.6). Figure 10 contains a shotograph of the actual test setup, and Figure 11 provides a closeup view of the test specimen showing the installed instrumentation used to obtain dynamic resource information. On completion of the dynamic test, the specimen was again given a 5-psi static tension and compression test with load displacement measurements taken. Finally, the specimen was given a tensile test-to-failure to determine its residual strength.

Figure 9.- Test loads applied on densified TPS.

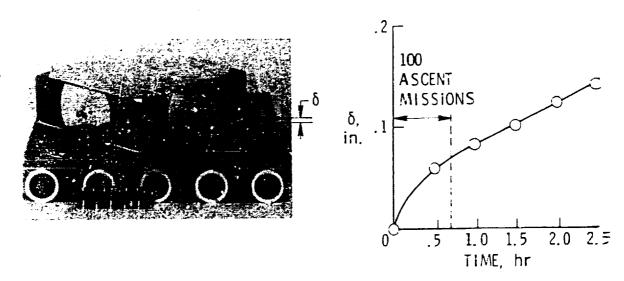
Figure 12 contains a picture of the tile after completion of the dynamic load test and before the final test-to-failure. The top plate shown in the figure replaces the load attachment disk used during the dynamic test so that the larger tensile loads required to fail the system can be applied. The figure also contains a plot of the development of permanent growth of the SIP at the highest stressed corner as the dynamic test progressed. By the conclusion of the test, the SIP had a permanent extension at this corner equal to the initial thickness of the SIP (i.=., 100-percent increase in thickness). Figure 13 presents a comparison of the applied stress vs. displacement measured during the ±5-psi static uniform load tests

Figure 12.- Permanent growth of SIP subjected to random dynamic loads.

Results of the random dynamic load test shown in Figure 12 indicate that a permanent SIP extension of 0.034 in. would occur under the simulated loads well before the 100-mission flight desired lifetime has been completed. One could conservatively estimate that this extension coupled with the increased loosening of the SIP shown in Figure 13 would cause a step of the order of 0.04 in. assuming the neighboring tile was under compression or at least remained unextended. Thus, if the assumed load simulation used in the random dynamic load tests is realistic and the thermal predictions of reference 6 are an accurate evaluation of actual conditions, increased incidence of burned filler bar can be expected during the lifetime of the orbiter.

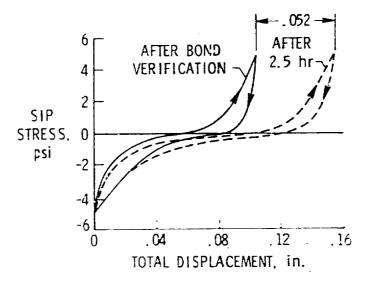
Figure 13.- Loosening of TPS due to multimission random dynamic loading.

performed before and after the dynamic test. The peak-to-peak measurement of 0.052 in. It an indication of the degree to which the SIP has loosened. The tile failed during the final test-to-failure in the parent undensified region at an ultimate static load of 422 lb. This failure load was 70 percent greater than the original bond verification load.

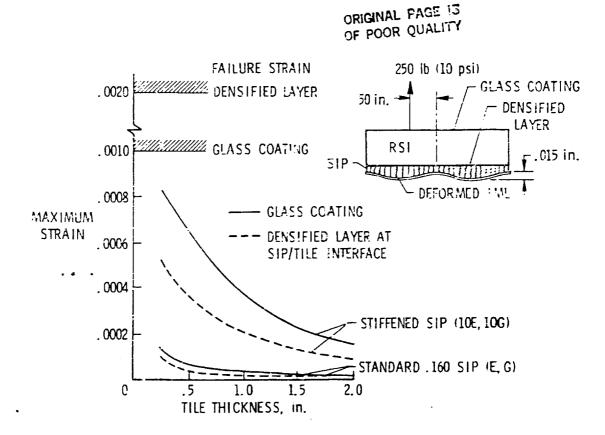
Using the analysis and the experimentally determined modulus of the densified region, a study was made of the maximum inplane strains in densified tiles of various thicknesses ranging from 0.25 in. to 2.0 in. The tiles were subjected to an inplane substructure strain equal to the yield strain of the aluminum plus the unconstrained thermal strain caused by a rise in substructure temperature of 280°F. In addition, the tiles were subjected to a tensile load of 250 lb offset from the tile center by 0.5 in. This combined load condition is greater than any actual condition expected on the orbiter tiles. Results of the study for a standard 0.160 SIP and a SIP with ten times the stiffness of the standard SIP are shown in Figure 15. Only for the thinnest tiles does the maximum strain in the densified region and the top costing approach the inplane failure strain. Thus, a considerable increase in SIP stiffness can be tolerated without compromising the inplane integrity of the tiles. A 0.290 SIP has approximately three times the stiffness range to function properly as an isolator of inplane strains.

Figure 15.- Effect of SIP stiffness on tile inplane strains for a range of tile thicknesses.

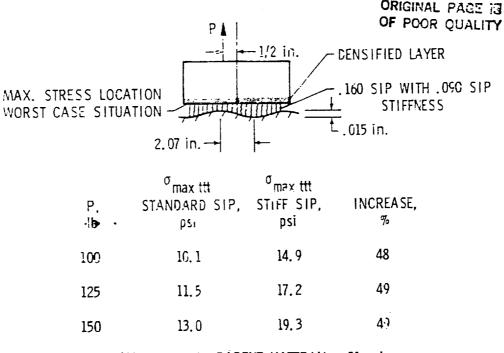
A SIP with a higher stiffness will increase the stress in the direction normal 'to the plane of the pad (transverse stress) in the region of the SIP/tile interface when substructure deformations are applied. To evaluate the effect of a stiffer SIP on the transverse stress at the SIP/tile interface, the stresses were computed using an analysis described in reference 9 for a standard 0.160 SIP and a 0.160-in. thick SIP with stiffness properties equal to that of a 0.090 SIP. A comparison of results for typical high-load conditions expected on orbiter tiles is shown in Figure 16. Use of the stiffer SIP causes approximately a 50-percent increase in the maximum stress at the SIP/tile interface for the load conditions considered. At the higher applied load levels shown in the figure, the computed stress in the SIP approaches the failure stress of the tile material so that tile strength in regions of high substructure deformations becomes the limiting factor for determining the maximum permissible increase in SIP stiffness. However, the stress computation shown is most likely conservative in that the maximum stress occurs at the boundary of the SIP, and the computations do not account for the relaxation of stress at SIP boundaries observed in laboratory tests.

AV $\sigma_{failure}$ IN PARENT MATERIAL \approx 21 psi
