STUDY OF MONOPROPELLANTS
FOR ELECTROTHERMAL THRUSTERS

EVALUATION TEST PROGRAM TASK SUMMARY REPORT

J.D. Kuenzly

MARCH 1974

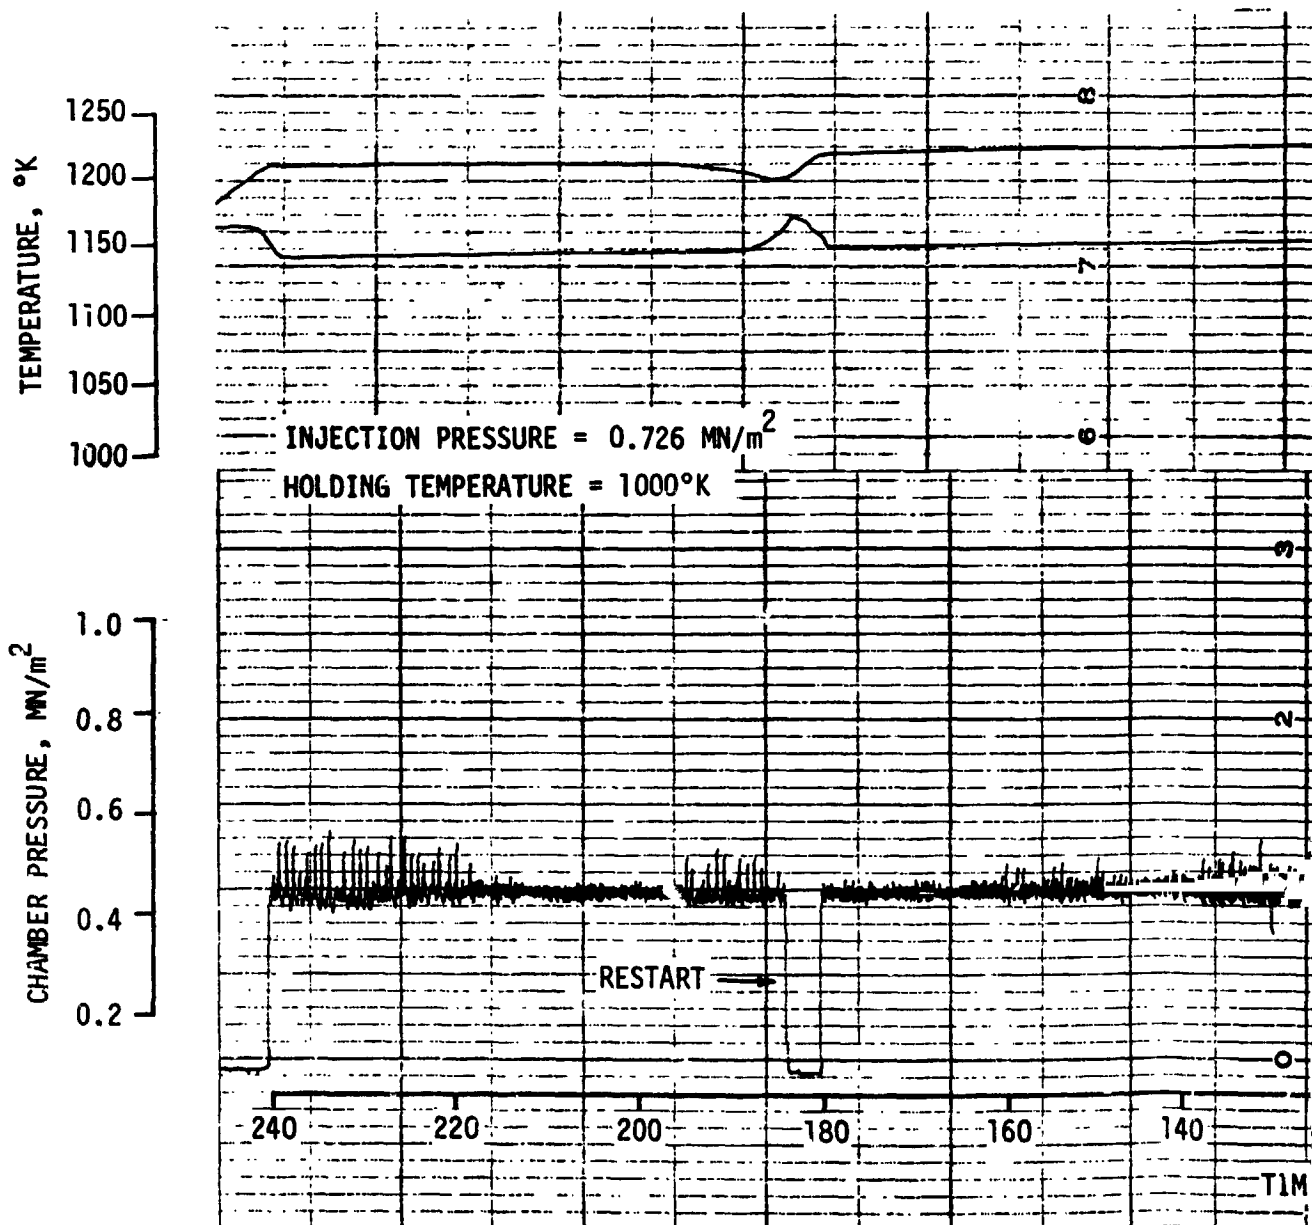
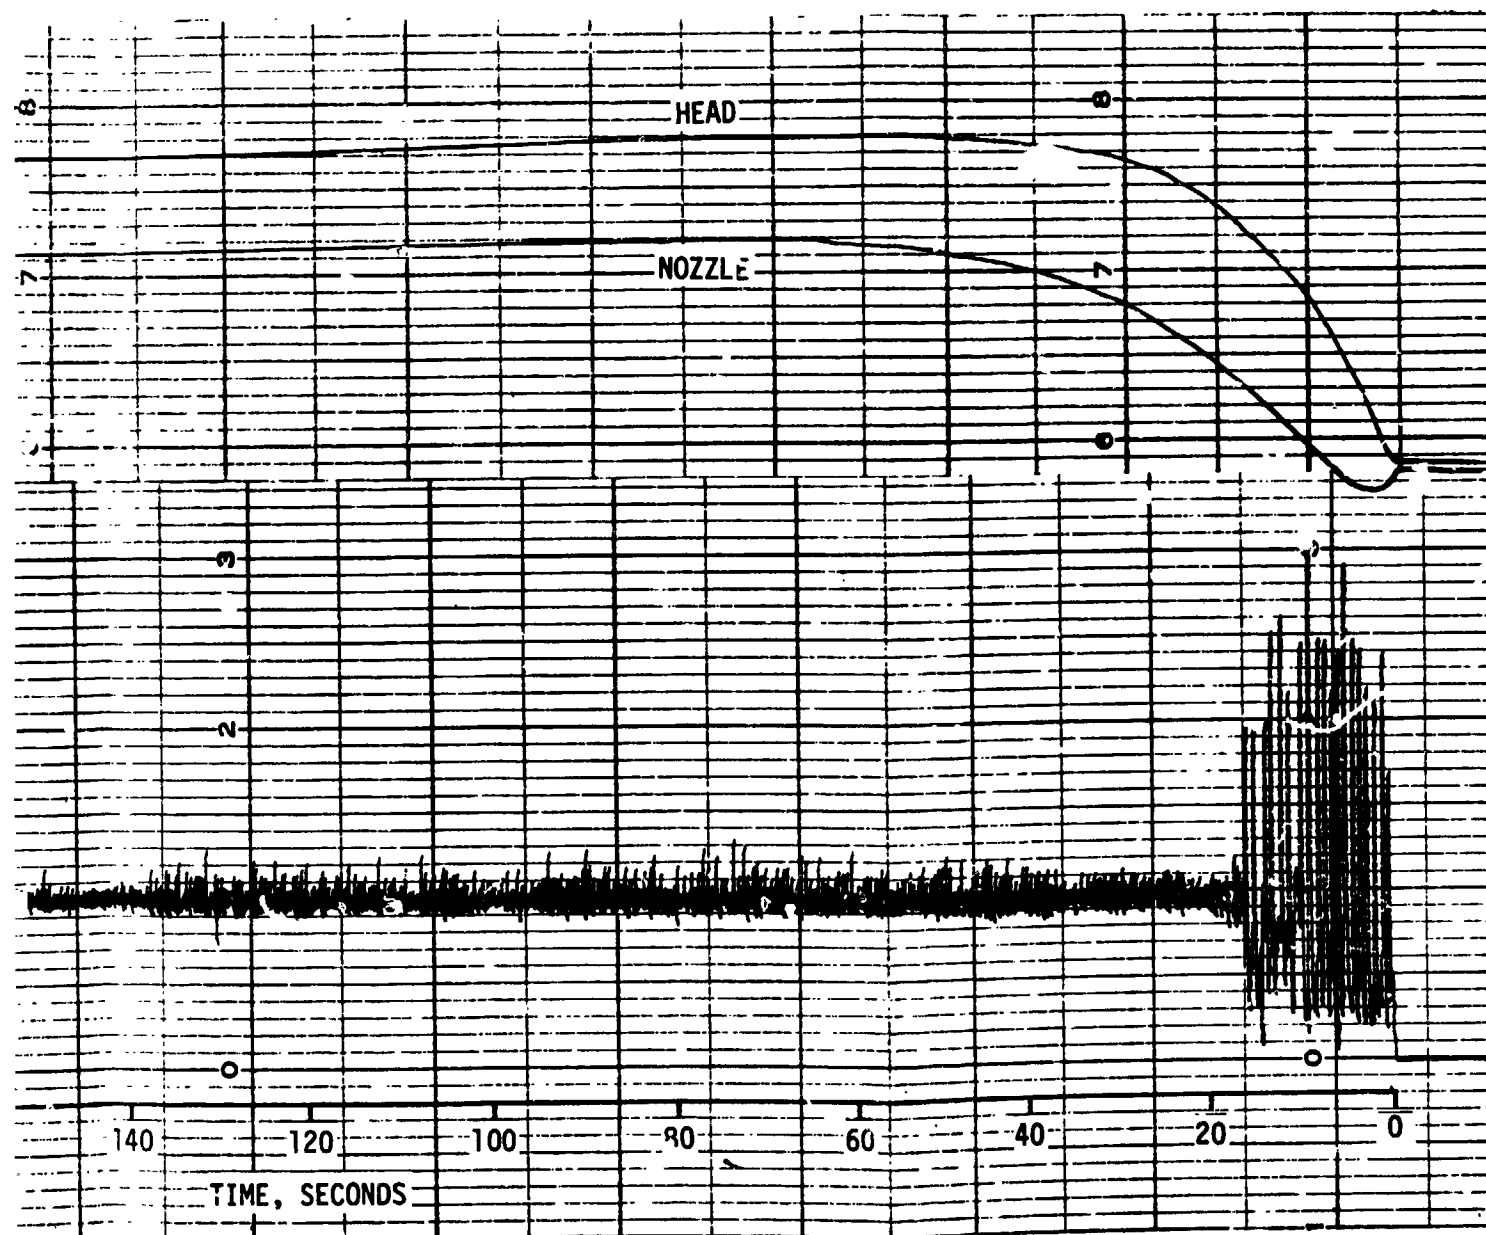
Figure 16. Preliminary Sea-Level Steady-State Operation with 76 Percent Hydrazine —— 24 Percent Hydrazine Azide

A total of 23.5 minutes steady-state operation was accumulated before testing was terminated by an injector failure (revealed by post-test inspection). The thruster exhibited metastable operation during this period. This mode is illustrated by the chamber pressure trace in Figure 16. Ignition at the holding temperature of 1000°K was very erratic. The large chamber pressure fluctuations were significantly reduced when the energy supplied by decomposition raised the thruster temperature to 1155°K. Chamber pressure roughness continued to decrease with time. High speed oscillograph chamber pressure traces reproduced in Figure 17 illustrate the roughness decrease.

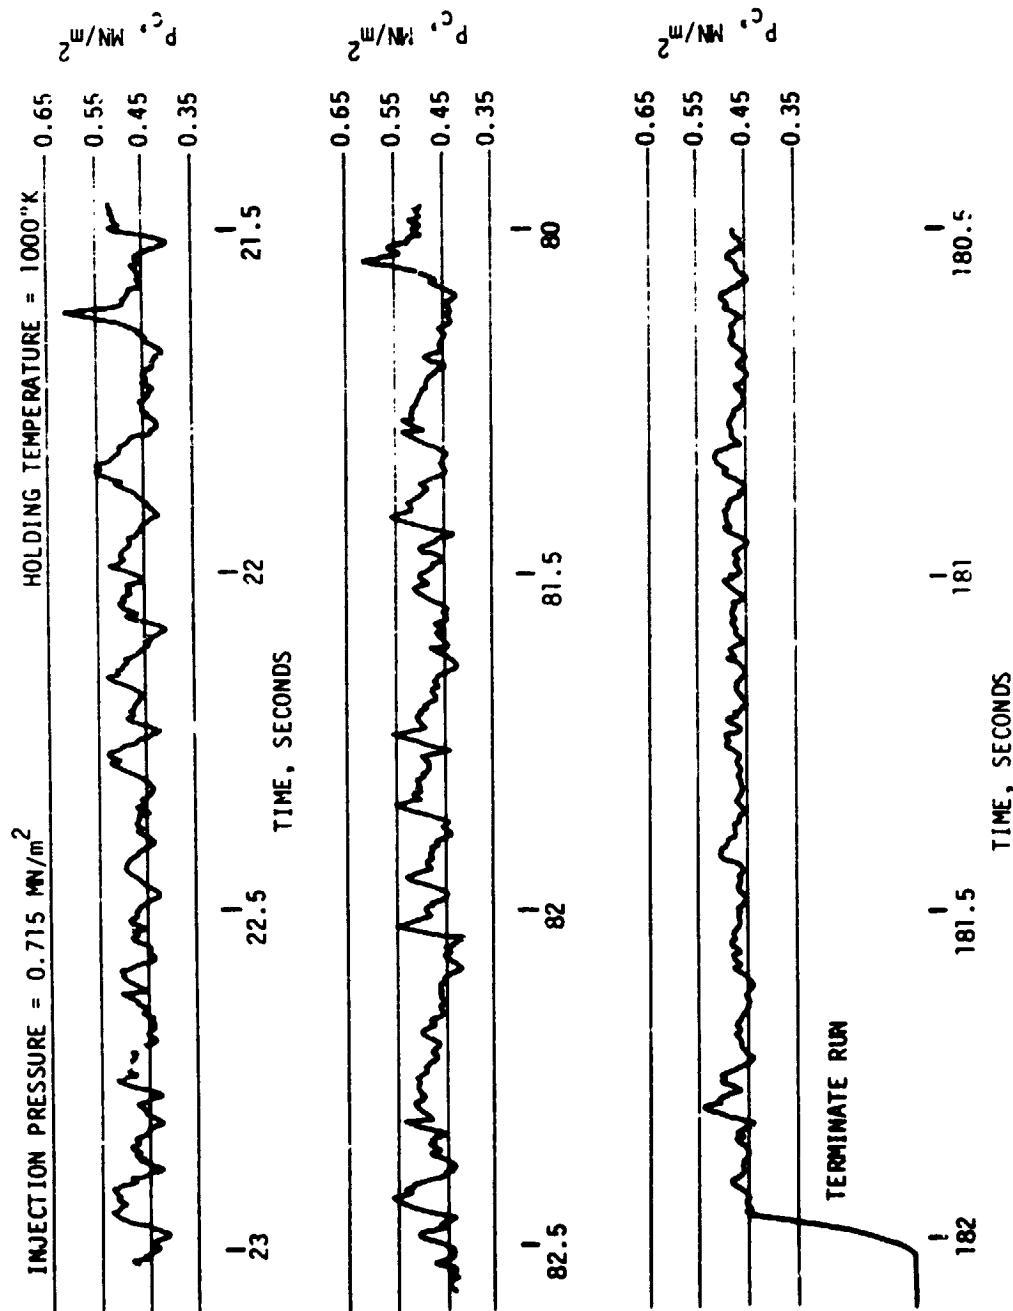
Stable operation could not be achieved at injection pressure above 0.83 MN/m^2. The injection pressure was reduced to 0.72 MN/m^2 and an additional 18 minutes steady-state time was accumulated when an abrupt loss of chamber pressure occurred. Operation during this period was characterized by smooth and very rough behavior. The chamber pressure trace just prior to and at injector failure is shown in Figure 18. Post-test inspection revealed that the injector ruptured at the first portion of the thermal relief bend (Figure 19).

Figure 18. Oscillograph Trace of Chamber Pressure Prior to and at Injector Failure

The unstable operation which led to an injector failure with the baseline thruster configuration indicated that undecomposed propellant traversed a considerable length of the screen pack. Subsequent decomposition of this propellant caused a pressure wave front to rapidly move towards the injector end of the thruster. The intensity of this wave front promoted
