DESIGN AND EVALUATION OF A FOAM-FILLED HAT-STIFFENED PANEL CONCEPT FOR  
AIRCRAFT PRIMARY STRUCTURAL APPLICATIONS

Damodar R. Ambur  
NASA Langley Research Center  
Hampton, VA 23665-5225

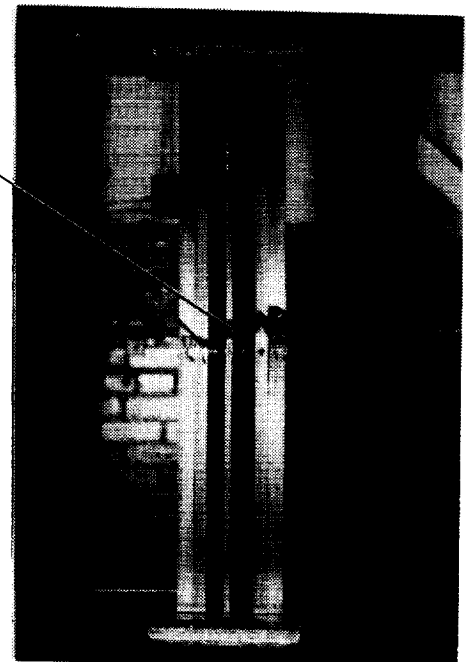
**Out-of-plane deflection  
Contour at failure**

**Dropped  
weight  
impact at  
20 ft-lb**

**Failure mode**

Figure 5. Failure mode of element specimen subjected to dropped-weight impact.

The location of impact is at mid-length of the specimen as shown in Figure 5. An impact energy level of 20 ft-lb was chosen as an upper bound for impact. As the specimen was loaded with the damage resulting from this impact, the specimen skin buckled at approximately 33,500 lb and the final failure of the specimen occurred at 35,552 lb. The failure mode was very similar to the element specimen without impact damage. This result suggests that the imposed damage scenario of 20 ft-lb on the stiffener cap does not result in any reduction in residual strength.

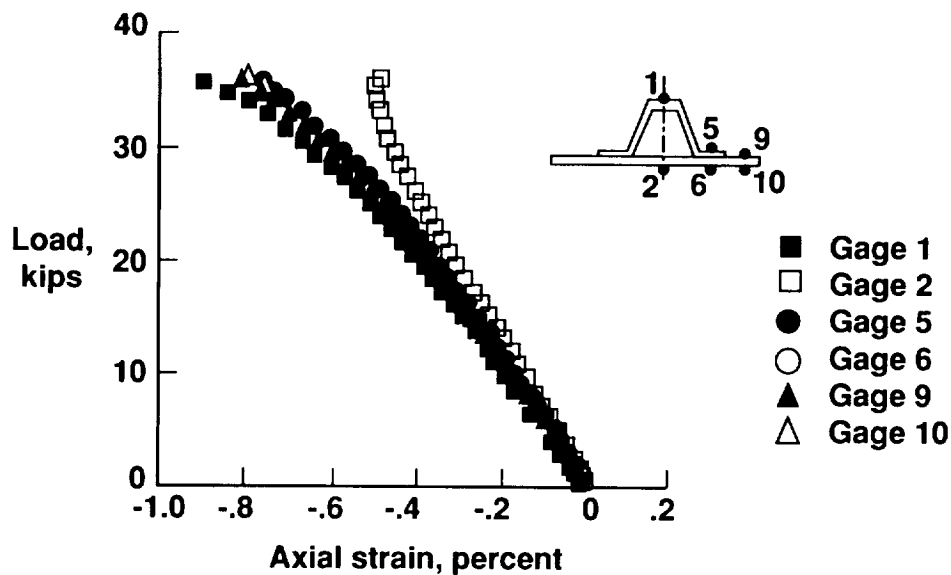
Figure 8. Axial strain results for undamaged element test specimen.

The strain results for the undamaged element specimen are plotted in Figure 8. The strain gages are mounted across the specimen at mid-length. All gages except gage 2 indicate a similar global bending trend which is nonlinear beyond approximately 15,000 lb. The initial response of gage 2 suggests local bending of the skin element under the stiffener and strain reversal at about 33,000 lb indicates local buckling of skin. The maximum value of the local strains at failure is approximately  $7,500\mu$  in./in.

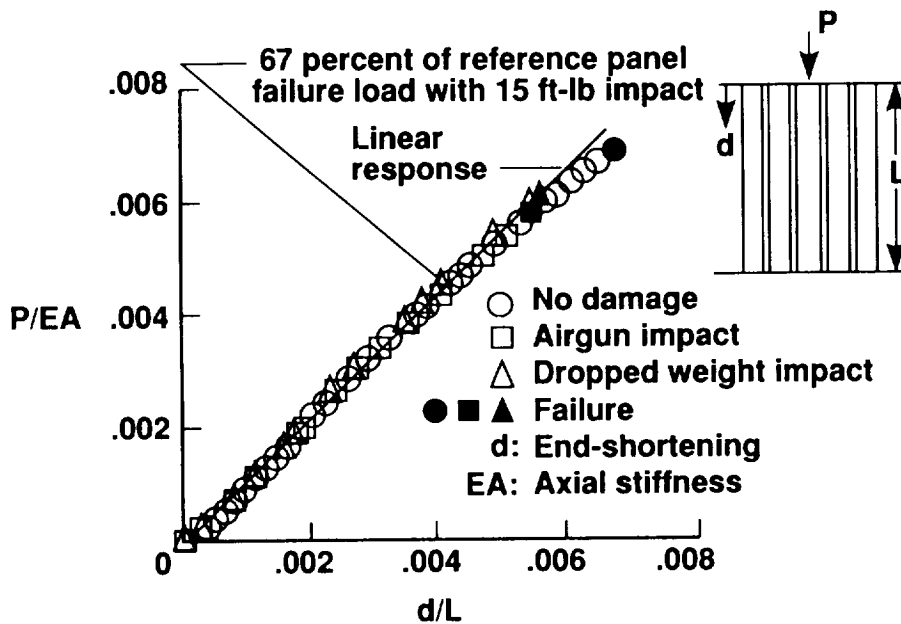
Figure 12. Summary of load versus end-shortening results for panel test specimens.

The panel specimen end-shortening results are summarized in Figure 12. The out-of-plane displacement results normalized by the length of the specimen are plotted as a function of the total applied load normalized by the axial stiffness. The responses of all the panel specimens tested are nonlinear. Compared to the undamaged panel results, both damaged panels exhibit degradation of 13 percent in load carrying ability. The response of the panel subjected to a 15 ft-lb dropped-weight impact falls on top of the response of the panel with a 20 ft-lb impact suggesting that damage due to the 15 ft-lb impact did not result in a stiffness degradation. For all the three panel specimens tested to failure, the global strain at failure is approximately  $5,500\mu$  in./in.

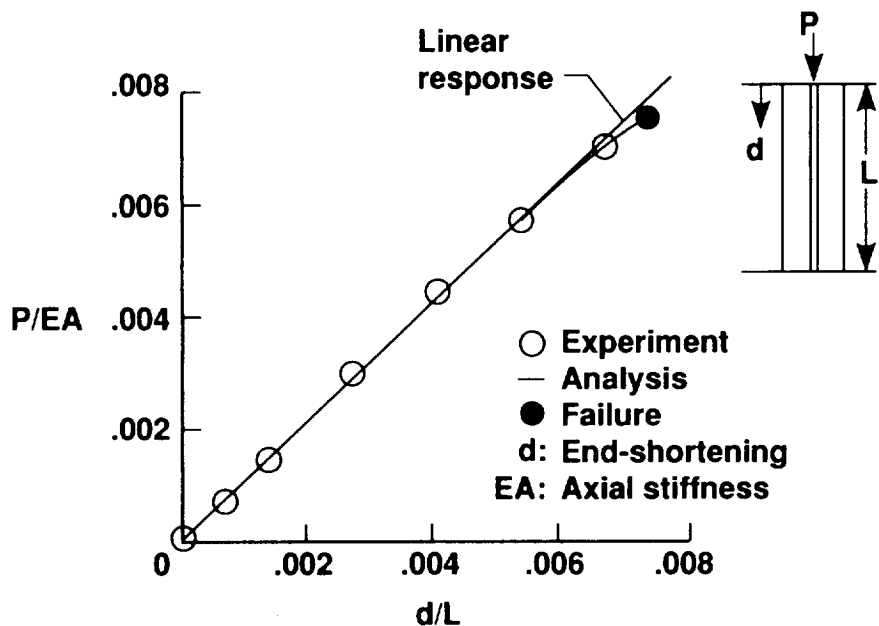
Figure 14. Correlation of element specimen end-shortening results.

The experimental end-shortening results for the element specimen are compared with analytical results in Figure 14. Although linear static and bifurcation buckling analyses for the specimen were performed prior to testing to make instrumentation and loading decisions, geometrically nonlinear static analysis was performed after the test to correlate the displacement and strain results. The DIAL finite element code (Ref. 4) was used to perform buckling and nonlinear static analyses. The analysis results obtained by using the modified Newton-Raphson method are presented as a solid line in the figure. The experimental results are presented as open circles with the failure event indicated by a filled circle. The correlation between the results is good.

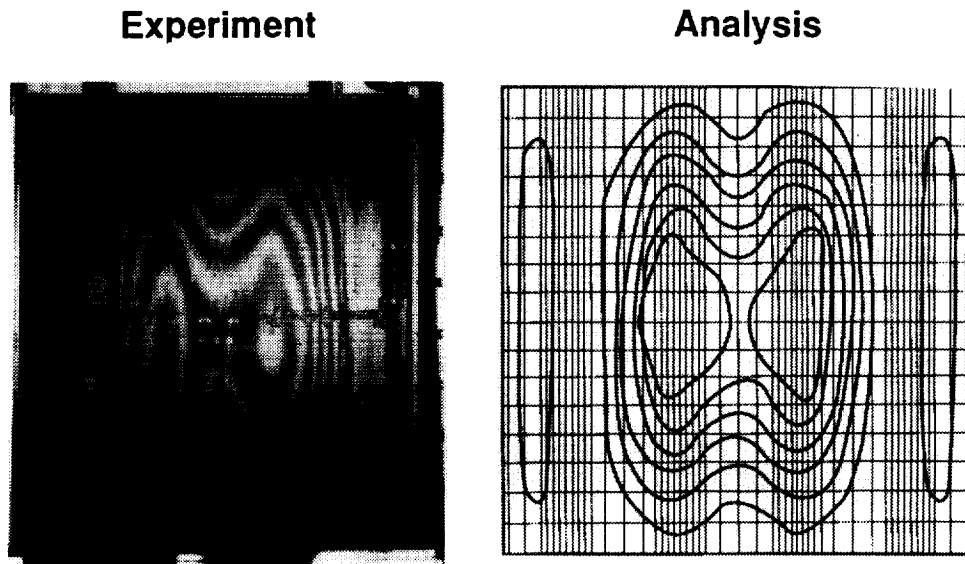
Figure 17. Out-of-plane displacement results for panel specimen at 75,000 lb.

The analytical results for panel static response are compared with the experimental results in Figure 17. As described earlier, the panel exhibited observable out-of-plane displacement beyond 50,000 lb in the form of two lobes at the central stiffener locations. The nonlinear analysis results are compared with the experimental results at 75,000 lb in the figure. The comparison between the analytical and experimental out-of-plane displacement shape and location is good.
