(NASA-RP-1375) FAILURES AND ANOMALIES ATTRIBUTED TO SPACECRAFT CHARGING (NASA, Marshall Space Flight Center) 31 p

Failures and Anomalies Attributed to Spacecraft Charging

NASA Reference Publication 1375

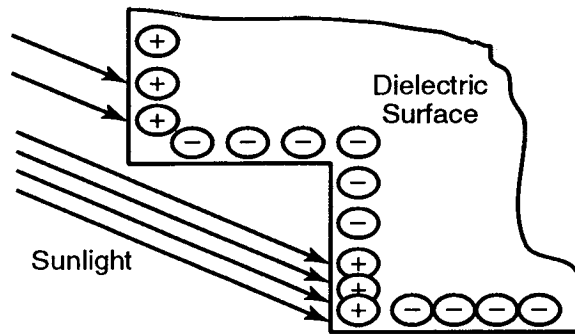
Differential charging is caused by a variation in the charged particle flux from surface to surface and the use of dielectric external surfaces which are poor distributors of accumulated charge.

The largest differential potentials will be between sunlit and shaded surfaces.

Absolute charging, sometimes referred to as frame charging, occurs when the satellite, as a whole, acquires a net potential relative to the ambient plasma. If the spacecraft is all metal (i.e., conductive), the entire spacecraft will be charged to the same potential. Absolute charging is nearly instantaneous, with characteristic periods on the order of microseconds. If dielectric surface materials are used on a spacecraft, and the current from surface to surface varies, surfaces may charge to different floating potentials, a process called differential charging (fig. 4).
