THE EFFECTS OF LIGHTNING ON DIGITAL

FLIGHT CONTROL SYSTEMS

J. Anderson Plumer
General Electric Company

James B. Craft
NASA Flight Research Center

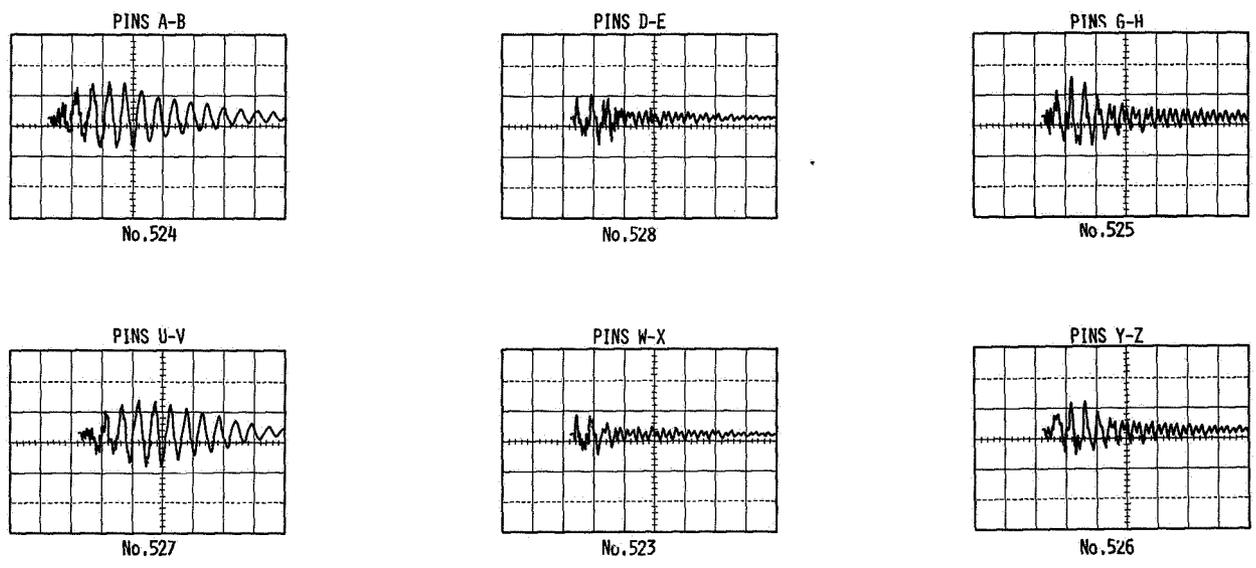
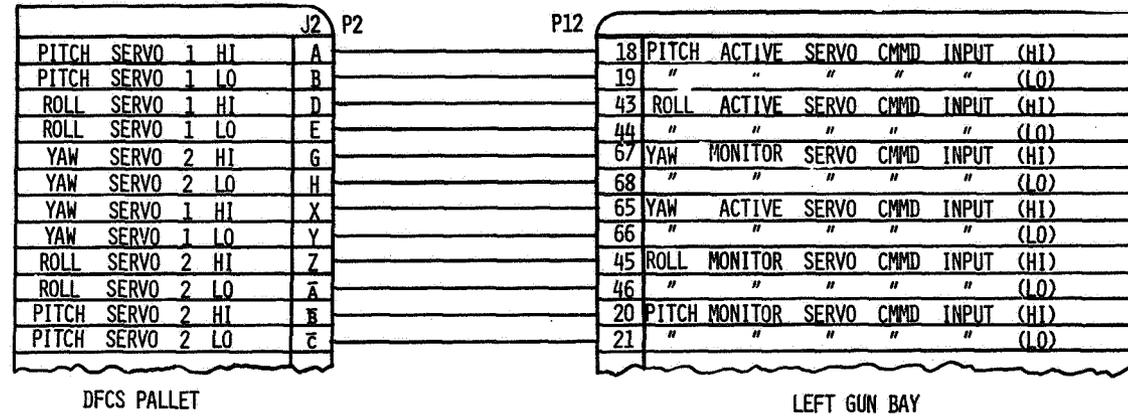
FIGURE 6 - INDUCED VOLTAGES ON CONTROL SENSOR INPUTS TO DFCS AT P4(OPEN).

Figure 6 shows voltages induced in the pitch, roll and yaw control sensor circuits coming to the DFCS computer, but the measurements were made at plug P4 with this plug disconnected from the DFCS system. These, therefore, are open circuit voltages and are not necessarily the same as the voltages which might appear at the closed interface, since DFCS input impedances would affect the voltages impressed across them. The characteristic frequencies of the open-circuit voltages measured at pins D-E (osc. 528), G-H (osc. 525), W-X (osc. 523) and Y-Z (osc. 526) have a fundamental frequency of about 1.7 megahertz with lower amplitude oscillations of several higher frequencies superimposed. These are induced in circuits coming from the DFCS stick transducer in the cockpit. The fundamental frequency of voltages measured at pins A-B (osc. 524) and U-V (osc. 527) in circuits coming from the rudder pedal transducer in the tail area is also 1.7 megahertz but without as much of the superimposed higher frequency component. Neither fundamental frequency is the same as that measured at the closed J25 interface in circuits also coming from the cockpit area.

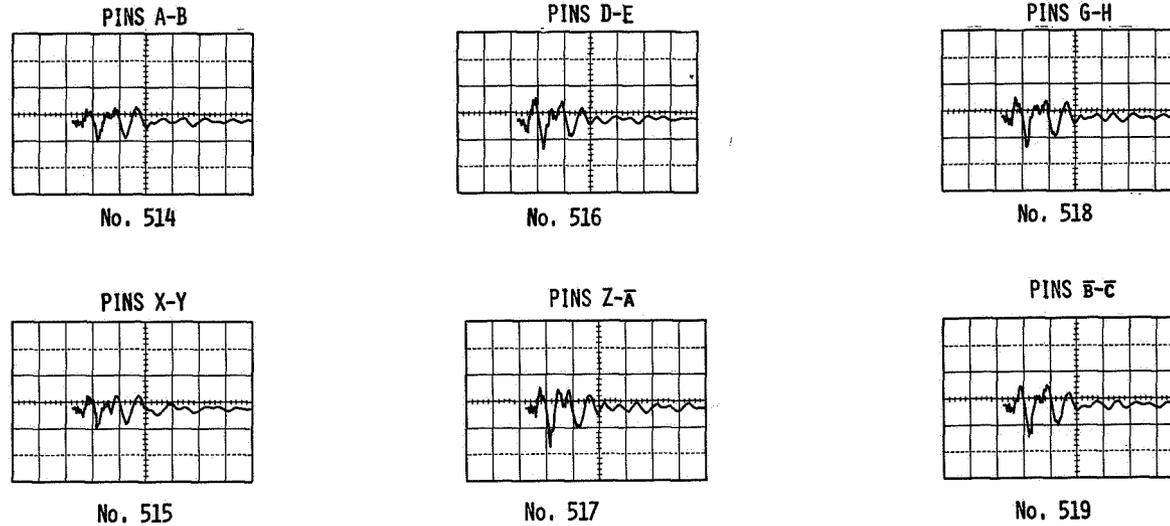
FIGURE 7 - INDUCED VOLTAGES ON DFCS DIGITAL CONTROL CIRCUITS AT J2 INTERFACE.

The closed circuit J2 interface measurements shown on Figure 7 are of the same 1 megahertz fundamental as those measured at the J25 interface of Figure 5, except that the polarity is reversed.

As another example, the DFCS digital control output cir-
cuits are considered. The schematic diagram of these circuits
is shown on Figure 9. Induced voltages measured at the J2
interface are shown on Figure 7 and range from 233 to 400 volts.
Those measured at the P12 end ranged between 222 and 422 volts.
At the DFCS, capacitor C2 has a 15V rating. Therefore it would

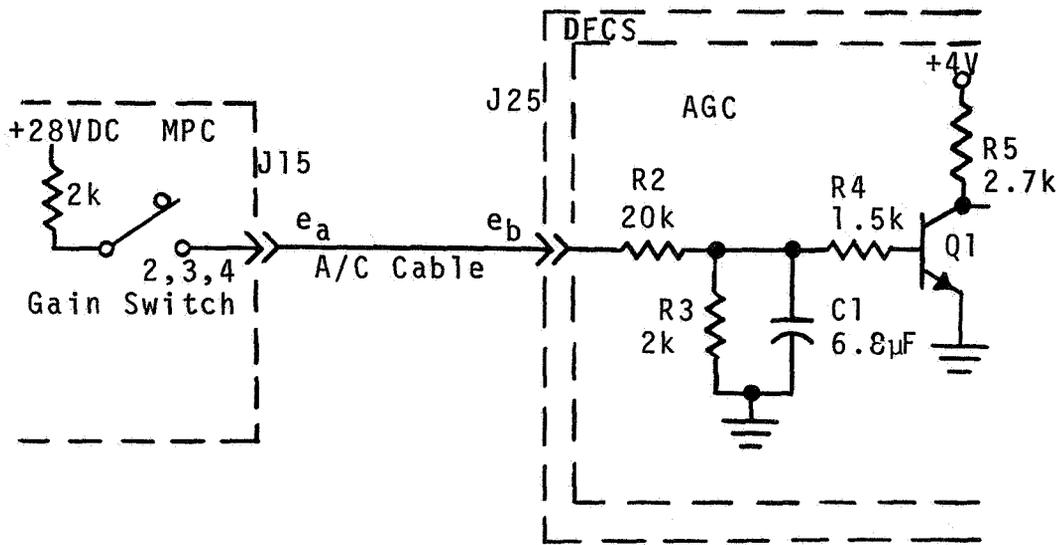
FIGURE 8 - ATTITUDE GAIN SWITCH POSITION 2, 3, and 4
         SIGNAL CIRCUIT FOR DFCS AND MPC INTERFACE.

The expected impact of the induced voltages measured in the
DFCS system on system operation was analyzed by DELCO Electronics,
manufacturer of the DFCS. Comparison of individual component
vulnerability data, when available, with induced voltage levels
at single circuit interfaces was utilized to determine vulnera-
bility of system components and effect on circuit operation. In
other cases, best engineering judgment was used. An example of
such an assessment is the attitude (yaw, pitch or roll) gain
logic power circuits (pins A-W) from the MPC panel to the DFCS
pallet. The schematic diagram of one of these circuits is shown
on Figure 8. Induced voltages at the J25 interface are shown
on Figure 5 (i.e. osc. 505). The voltages at the J25 interface
(DFCS) ranged from 566 to 865 volts, and at the J15 interface
(MPC), 1065 to 1132 volts. At the MPC, the induced voltage
exceeds the 1000 volt (at sea level) dielectric breakdown rating

of the switch. Arc-over may therefore occur either to case and
mounting or between contacts,with a possibility of switch fail-
ure.

This circuit (+28 VDC) provides a request to the computer
to change attitude control loop gain. If the wiper arm of the
switch burns open, the computer will notice no gain requests
and under this condition is programmed to assume attitude gain
position 1. The DFCS control will survive at this gain position.
If the switch would short such that two gain-position requests
exist, the computer is programmed to assume the lower gain of
the two requests. The DFCS control will survive.

At the AGC, the induced voltage exceeds the 500 volt dielec-
tric breakdown rating of the 20K resistor, R2. Arc-over of R2
may then expose capacitor C1 to damaging overvoltage, causing
it to short circuit. If it remains shorted during the entire
lightning flash, no further damage should occur. If C1 opens
between successive strokes of a multiple stroke flash, arc-
over(s) of the 1.5K resistor R4 on successive strokes may per-
manently destroy transistor Q1. If C1 is short circuited, the
AGC gain change circuit will be inhibited. Selection of this
gain position after the lightning flash will cause the computer
to select attitude gain position 1. The DFCS control will sur-
vive at that gain position. The same applies if transistor Q1
fails.

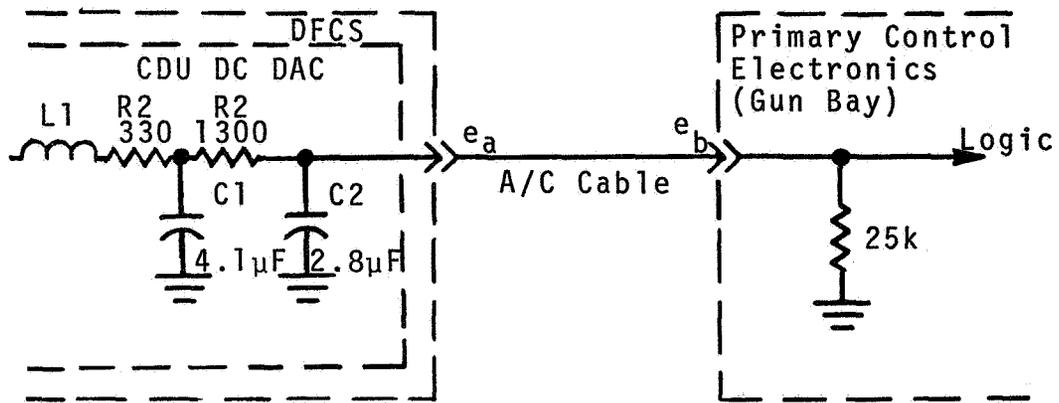
FIGURE 9 - DFCS DIGITAL CONTROL DIGITAL-TO ANALOG
            CONVERTER OUTPUT SIGNAL CIRCUIT TO
            PRIMARY CONTROL ELECTRONICS.

break down as a short circuit. The capacitor could then fail as an open circuit. In either case the remaining circuit components would probably survive the lightning stroke. These are dual circuits which provide attitude commands which are utilized as control surface inputs. The dual outputs are compared to each other for failure detection purposes. Since capacitor C2 can be failed as an open or short circuit, several combinations were considered. If C2 is shorted as a dual output, no failure detection would occur. The pilot would discover that a problem existed only by noting the lack of aircraft response to control stick position. If one of the dual command outputs contained C2 open circuited and the other short circuited, any off-neutral control stick position would trigger the failure detection circuit which would remove that attitude axis control from DFCS to the BCS. In the case of C2 open-circuted as a dual output, DFCS aircraft attitude control could be maintained.
