# **Fabrication of Composite Combustion Chamber/Nozzle For Fastrac Engine**

**T. Lawrence**  
**Marshall Space Flight Center**  
**Mailstop: ED34**  
**Huntsville, AL 35812**  
**Email: tim.lawrence@msfc.nasa.gov**

## **Abstract**

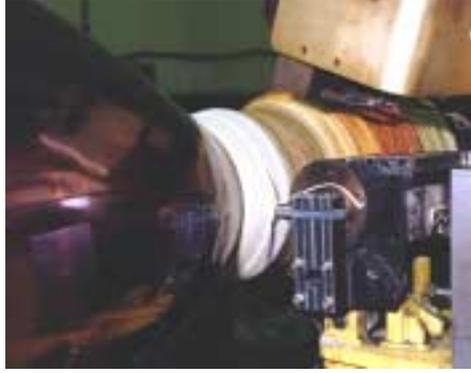
*Figure 2. Machining of new ramp in uncured Si-P liner*

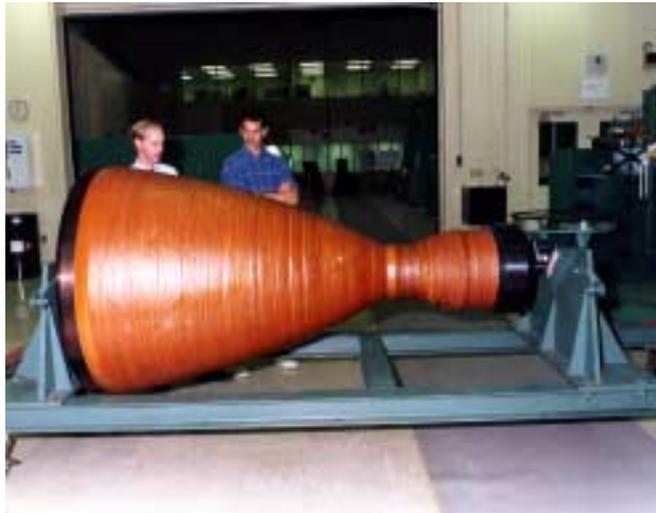
*Figure 3. Cured Si-P liner billet*

Once the tapewrapping is complete the part is vacuum bagged and cured in an autoclave. Because of the complex shape of the nozzle and the sensitivity of silica/phenolic to cracking during cure, development of an appropriate cure cycle was critical. The cure cycle was established using data generated from instrumented panels of similar thickness and the cure model developed by the RSRM project.

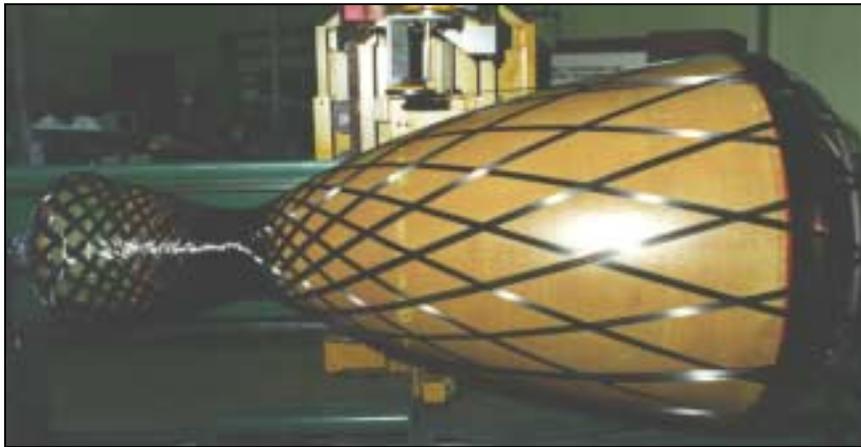
*Figure 6: Wet winding of carbon/epoxy over silica/phenolic liner covered with film adhesive.*

After the dry cycle, the liner is mounted onto the filament winding mandrel and the stainless steel flange is mated to the combustion chamber portion of the liner using Hysol® EA 9628 film adhesive. Film adhesive is applied to the entire liner surface and carbon/epoxy is then wet wound over the film adhesive (Figure 6). Thornel® T-300-12K carbon fiber and Epon® 828 resin were chosen because of their low-cost and commercial availability. Epi-Cure® W curing agent was chosen because it has an extended pot life which accommodates the time required for winding and curing of such a large part.

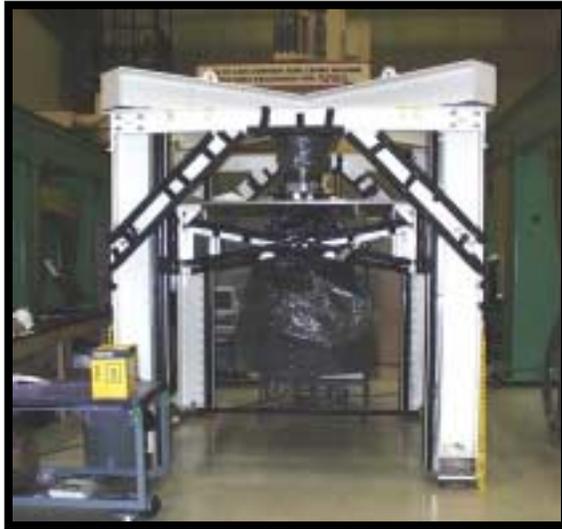
Figure 9: A photograph of a nozzle in the fixture with the belly band being bonded. (left)

During process development the bonding plates underwent significant refinement. The bonding plates for the belly band were modified to more closely match the taper of the nozzle. This allowed for a better mating with the nozzle and sufficient room for the belly band plates to actuate more effectively. In addition, the thickness of the exhaust duct support bracket bonding plates was increased to eliminate unwanted flexing. The reasons for the flexing were twofold. First, the exhaust duct support bracket is mounted at the largest diameter portion of the nozzle, so the width of its bonding plates is the smallest of all the plates. Second, during bonding the adhesive provides a resistance to placement of the hardware in the form of a hydraulic pressure. Flexing also occurred with the positioning plates that support each belly band half and actuates them toward the surface of the throat. As the plates were extended toward the throat, the weight of the belly band halves caused flexing. Separate actuating supports were installed to allow the positioning plates to be supported along their full range of motion.

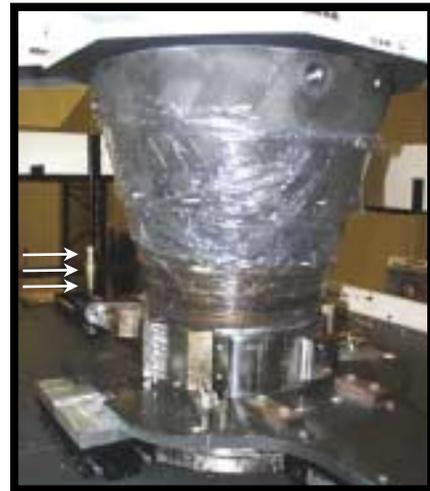
Figure 10: A close-up of the specialized tooling plate being used to bond the belly band. The arrows point to the plumb bob used to ensure angular position. (right)

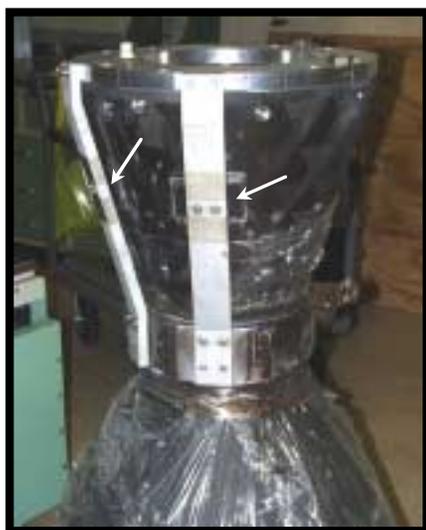
Figure 11: A photograph of the tooling used to bond the valve bracket support pads (arrows). This tooling fastens to the combustion chamber flange and the belly band to correctly position the pads. (left)

Tooling was also the key to sufficient accuracy and precision when bonding the composite/SMC components. The composite/SMC components are bonded to the nozzle in sets of 2-3 pieces each, using tooling that bolts to the previously used bonding plates or the previously bonded hardware. This tooling was developed based on models of the hardware to be attached to the nozzle during final assembly. Figure 11 shows the bonding of the valve bracket support pads to the nozzle.
