Problems Experienced and Envisioned for Dynamical Physical Systems

Robert S. Ryan

George C. Marshall Space Flight Center
Marshall Space Flight Center, Alabama

TECHNICAL PAPER

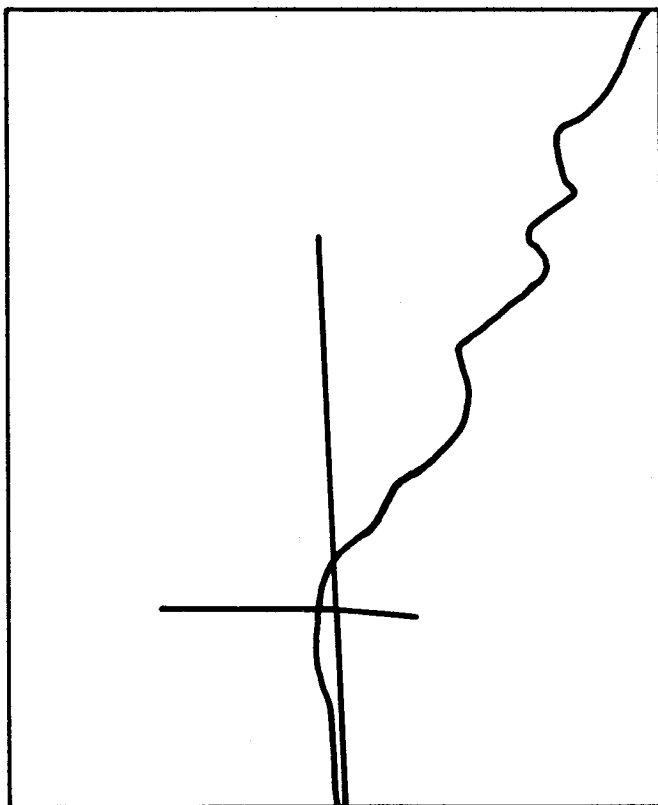
not only measure large scale or mean environments but to get an accurate quantification of the wind gust down to 25 m wavelengths [1]. The attempt to measure these small gust effects met with frustration. The smooth skin balloons were unstable (type of flutter or vortex shedding). In a controlled, no disturbance environment, a rising sphere would oscillate (Fig. 5). A classical problem most would say. Dr. Jim Scoggins found the solution by observing the golf ball, then instead of small dimples, he added many conical spikes to the sphere's skin. The problem was solved. The sphere was stable (Fig. 6). The resulting data base used throughout NASA is evidence [2]. As a result, this modified sphere was named Jimsphere (after Jim Scoggins) as well as the data base (Fig. 7). Many have a small tie clasp with a miniature Jimsphere as a reminder of the agony one sometimes must go through the innovation required for solution to unexpected problems.

Figure 5. Time lapse trace of rose balloon released at 11:25 p.m., August 2, 1963, during stable atmospheric conditions and light winds.

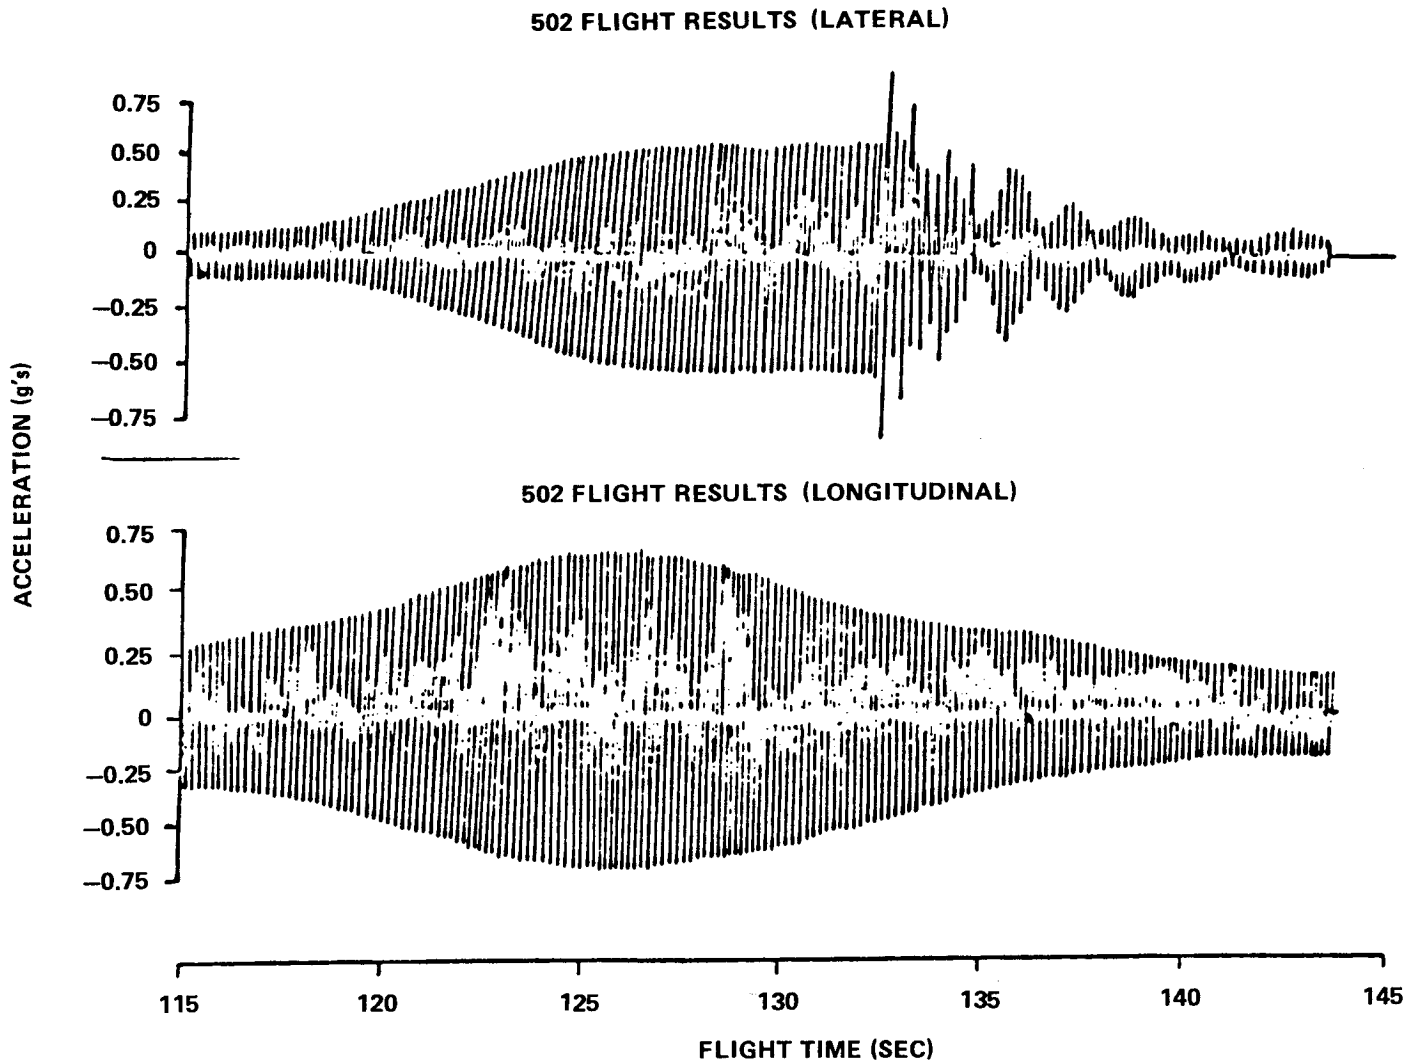
The Saturn V second launch experienced pogo during the first burn. The oscillation was near 5 Hz and produced both lateral and longitudinal accelerations of 0.3 g's and 0.5 g's, respectively, at the base of the LEM (Fig. 9). The primary structural mode was the first longitudinal free-free mode. The LEM was an unsymmetrical structure which also had a cross-coupled mode near 5 Hz. Thus, the reason for the lateral response [5,6]. The pogo instability acted as a forcing function driving the coupled LEM response. Conversely, the lateral LEM response was uncoupled from the pogo instability. An unrelated incident occurred during the pogo event. The SLA panel ruptured due to a flaw in the laminated honeycomb structure tearing apart from trapped sea level pressure (Fig. 10). This SLA failure caused some pain in that it focused investigation away from pogo, when in actuality, the two should have been pursued independently.

Figure 9. Flight results for the lateral and longitudinal acceleration of the LEM AS-502.

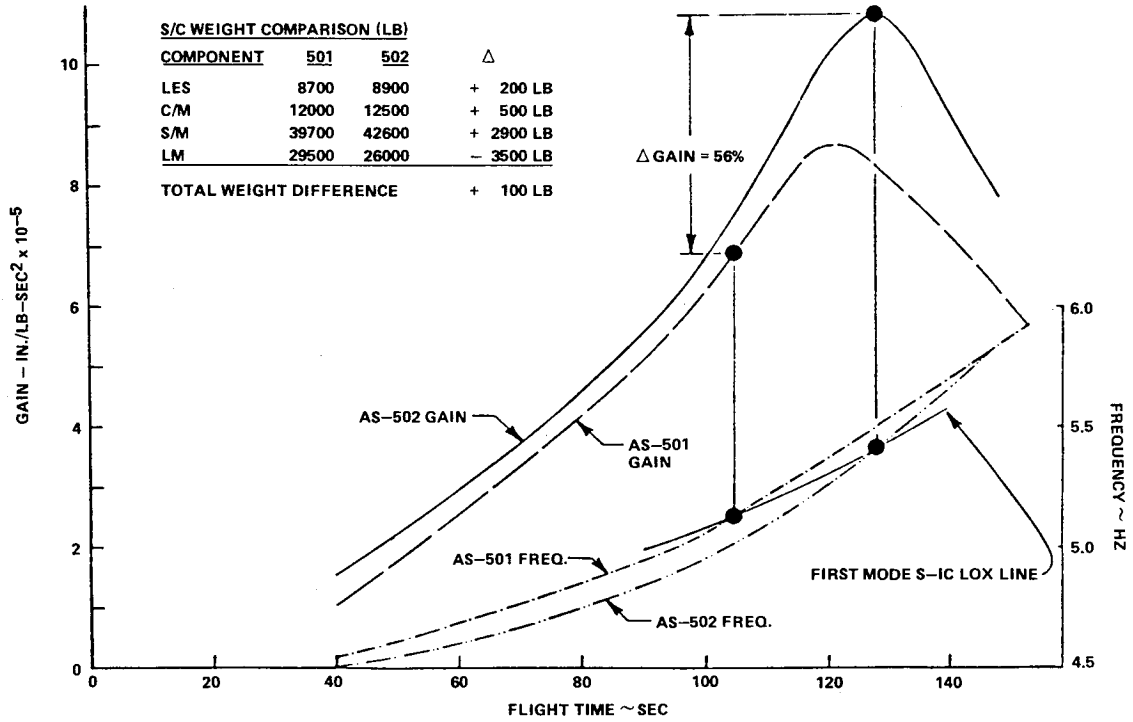
The response of the vehicle to pogo is shown on Figure 11, compared to an analytical model after the fact prediction of the response. Prediction of instability prior to flight was varied, most predicted a stable system while a few predicted slight instability. The early pogo models were, in fact, not accurate enough to handle the subtle changes that lead to problems. In fact, the first Saturn launch, AS-501, had no sign of pogo, while AS-502 had severe pogo. Why the difference? The only difference in the two vehicles was a 1,000-lb total weight change with a weight distribution change in the LEM area. Figure 11 shows the effect of this small weight change on the modal gain prominent in the pogo-coupled loop. This dramatically shows the effect of small changes creating large effects when a system is operating near a stability boundary and has a large energy source to feed the instability (engine thrust).

Figure 11. AS-501/AS-502 first mode longitudinal structural dynamic characteristics comparison.

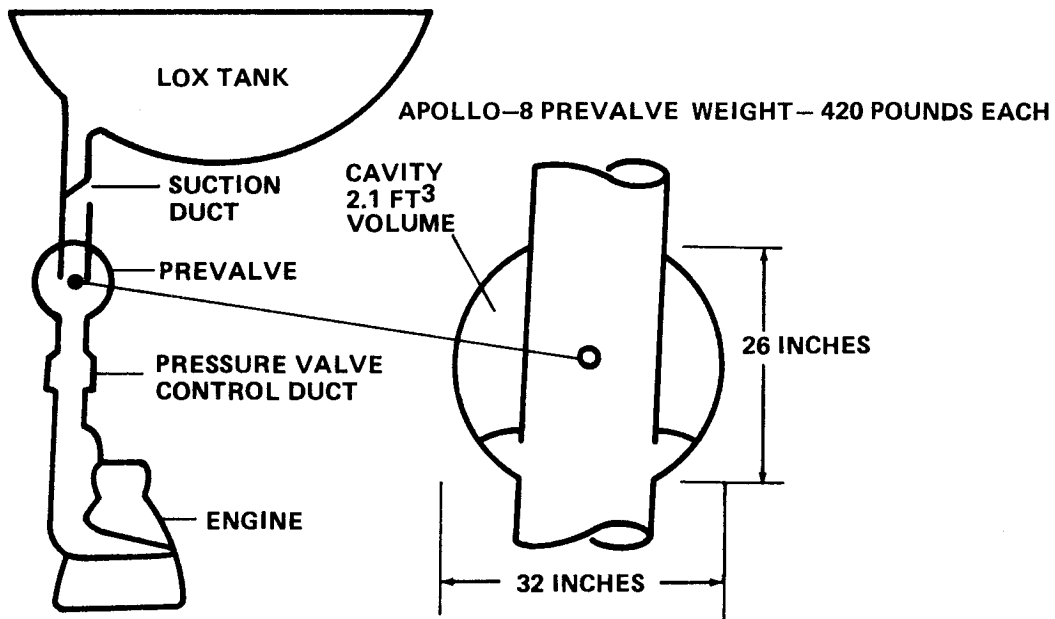
Figure 12. S-IC accumulator.

The problem was solved by incorporation of an accumulator in the fuel system (Fig. 12), detuning and desensitizing it. S-IC pogo did not reoccur during the Saturn program.

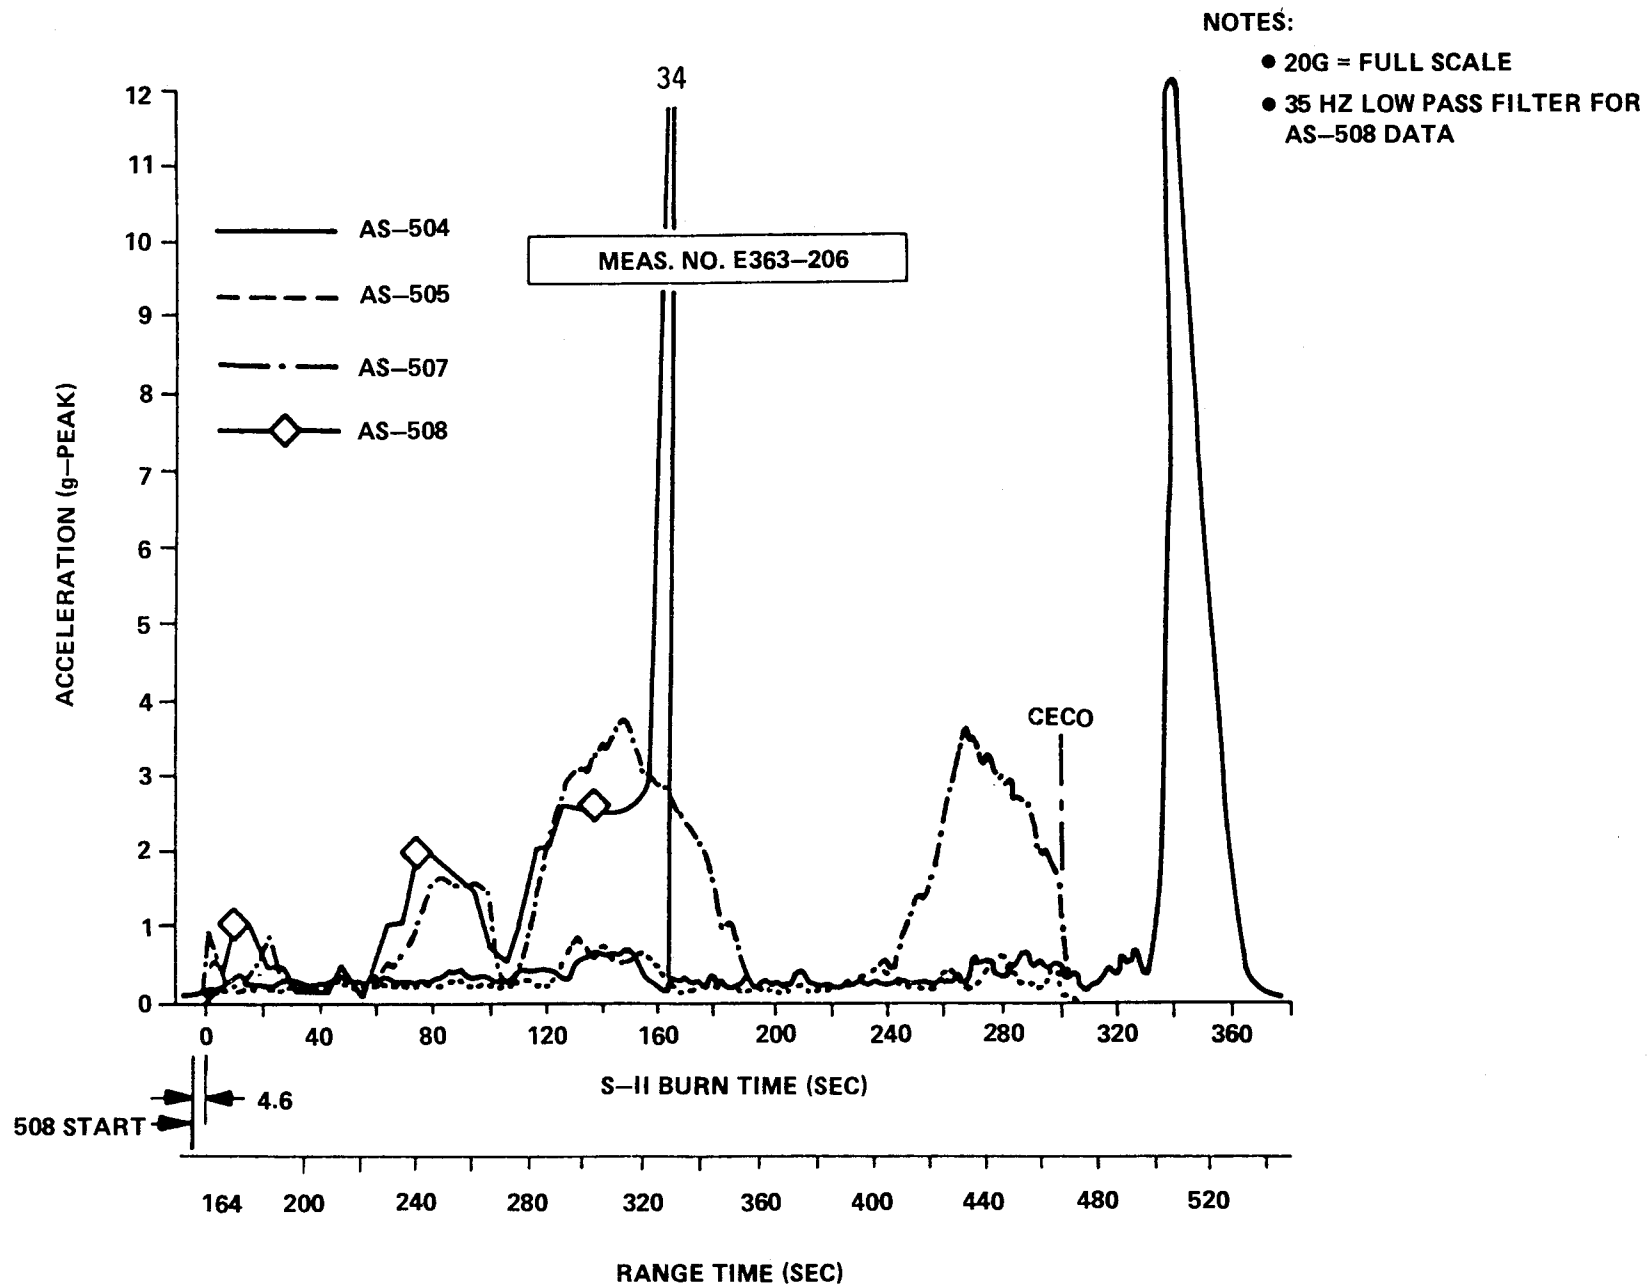
AS-507 was the next flight to experience significant pogo oscillations. Several bursts of pogo oscillations, termed "footballs," occurred in the vehicle response showing that the pogo loop was marginally stable at best. Figure 15 is an amplitude comparison of several S-II flights. The appearance of the footballs on the AS-507 flight caused much soul searching, analysis, etc. Nonlinear analysis was showing stable limit cycles. This led to the stable limit cycle theory. Many experts were disagreeing. Better line, engine, and hydroelastic data were becoming available, and the MSFC linear stability analysis was showing marginal to unstable conditions for AS-508. In spite of the variety of viewpoints, the stable limit cycle position was recommended to management and AS-508 was safe to fly.

Figure 15. Comparison of telemetered center engine thrust pad
acceleration envelopes.

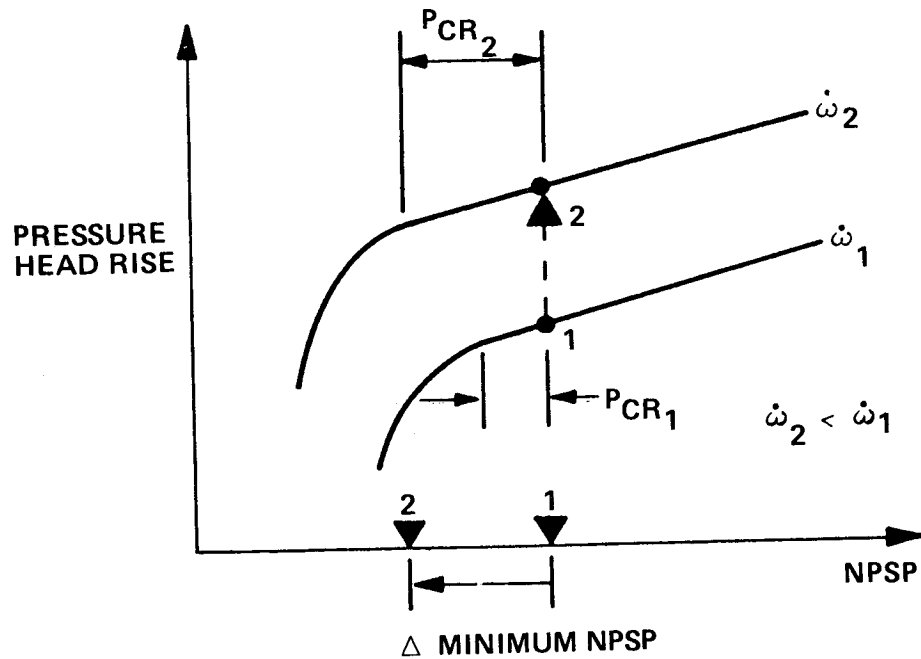
The violent pogo oscillation occurs because the pump operating pressure head rise drops below the knee of the curve at Pcr, hence deep cavitation and large nonlinearities. Why did AS-508 go berserk and AS-507 did not? It is believed that small differences kept the oscillation below Pcr and, therefore, the nonlinear damping produced a stable limit cycle, while AS-508 reached an amplitude where the nonlinear damping was overridden by the nonlinear pump gain characteristics (Fig. 18).

Figure 18. Effect of changing operating point on engine
performance curves.

After AS-508, there were no doubters. The S-II pogo problem had to be fixed. This was not to be easily accomplished. Several different techniques were pursued as fixes. Helium injection into the propellant line would lower the lox line frequency and decouple the system. Because of potential system impacts, this was ruled out. The J-2 engines could not be started with helium being injected into the line. It was finally decided to put a wrap around accumulator on the line near the pump and fill it after starting the engine. This meant that the line frequency would sweep the bulkhead and cross beam modes/frequencies introducing momentary resonance and instabilities. It was feared that these oscillations might trigger nonlinearities and become catastrophic. Also, failure modes could cause partial filling of the accumulator and worse stability problems. Much analysis and detailed design considerations were required to eliminate problems and verify they would not occur. Future flights, pogo free, were icing on the cake.

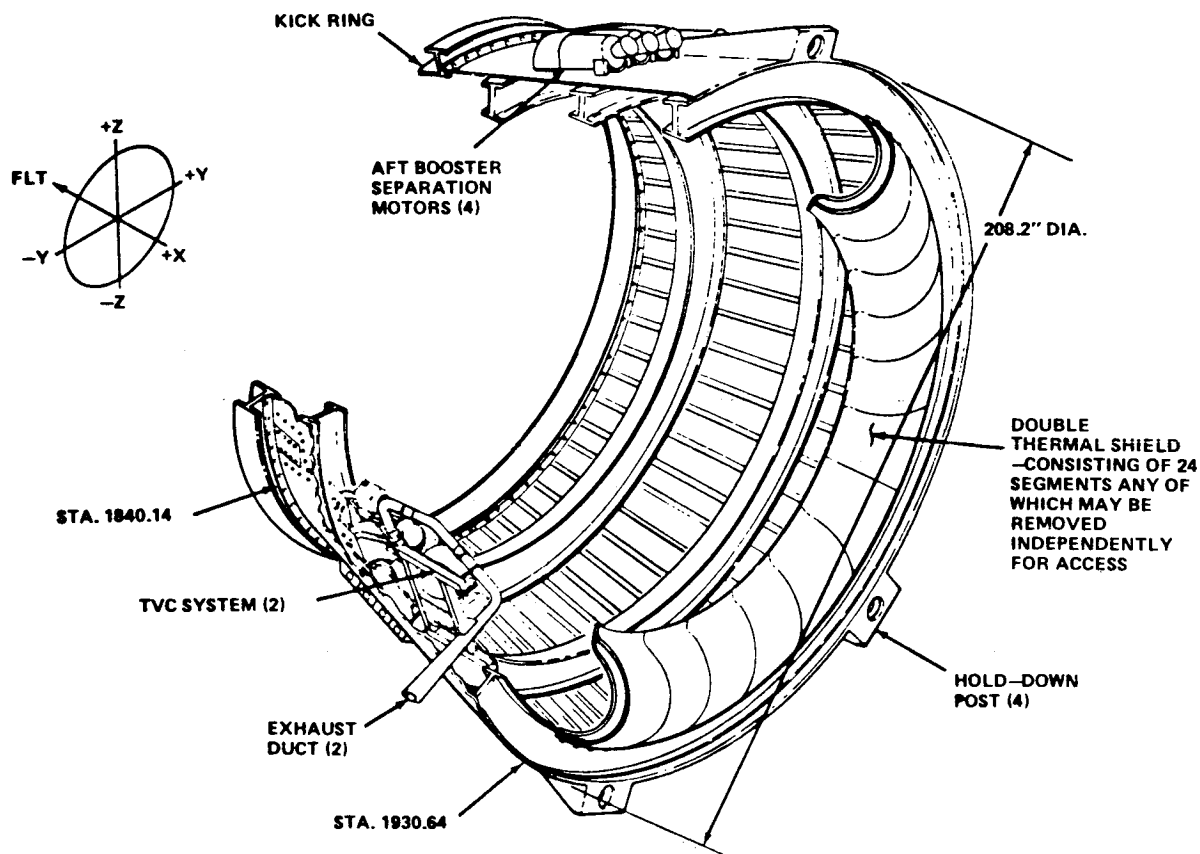
Figure 26. SRB heat shield.

An unusual flutter problem occurred on the Space Shuttle SRB aft thermal shield (heat shield) (Fig. 26). This heat shield was installed to protect the APU system during ascent flight and to augment protection during SRB reentry. During water impact, the shield had to rip out at fairly low load levels; otherwise, it would introduce substantial damage to aft skirt and nozzle hardware. This limited the stiffness that could be designed into the shield. During reentry, the SRB comes in nozzle first and at an angle of attack in the neighborhood of 100 deg creating cross flow on the shield. As a result of the q (reentry maximum dynamic pressure), the shield flutters and destroys itself. This phenomenon was observed during reentry acoustics environment wind tunnel testing. A major effort was expended trying to characterize this flutter and develop suppression devices (ones that would be very stiff during max q and then fail at water impact). It was decided to fly the first Shuttle flights without fixes and see what happened (not a manned flight safety issue). The shield did flutter and destruct; however, the thermal environments were not adverse. The end result has been to accept the flutter and lose the heat shield during reentry. In fact, a lighter shield has been designed based on eliminating reentry design requirements and which meets all ascent design requirements.

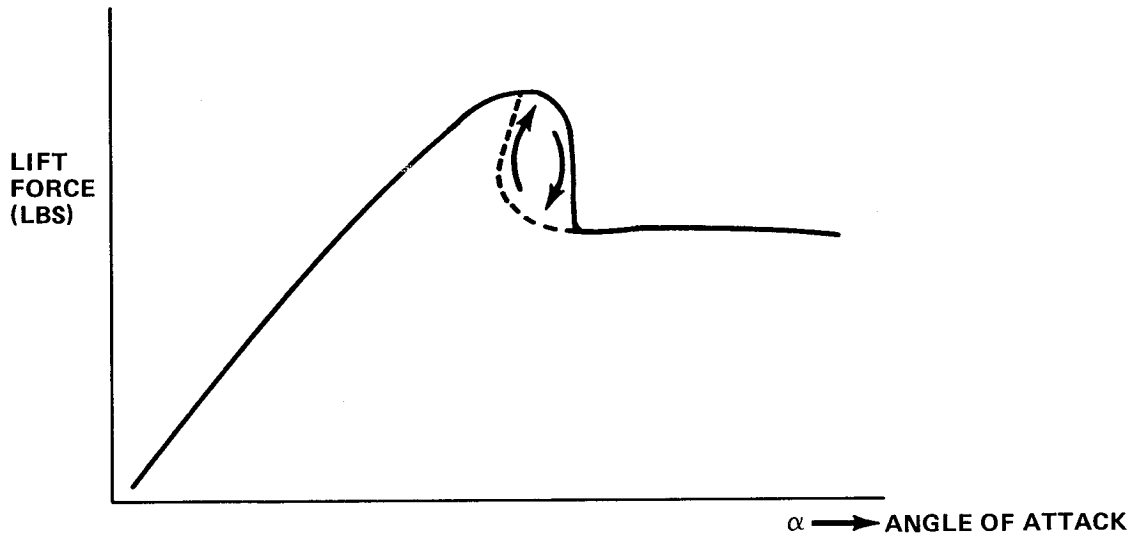
One classical problem which becomes more critical on high performance, throttleable engines is the bistable pump. This is a condition that exists on pumps optimized at the high output side and occurs at some point off optimum, say 65 percent power level. At this point, a hysteresis loop exists in the performance indicator, lift versus angle of attack (Fig. 27). This hysteresis loop at low angles of attack (low speeds) create the bistable oscillation.

Figure 27. Bistable pump characteristics.

The pump starts a limit cycle oscillation producing fluctuating flow resulting in a fluctuating thrust. In general, no damage occurs on the pumps; however, the engine thrust can cause vehicle loads problems. For the Shuttle system, there is a potential loads problem if the bistable condition occurs. Due to the high performance requirements of the Space Shuttle Main Engines, some pump to pump fluctuation in the stability point occurs, due to small variations in geometry arising from manufacturing tolerances. As a result, some pumps are bistable while most are not. Since the engine must operate anywhere between 65 percent and 109 percent of rated power level and bistable induced thrust fluctuations create loads and pogo problems, all pumps must be verified to be free of the bistable condition before flying. Pumps are acceptance tested at 65 percent to show they are clear of instabilities.

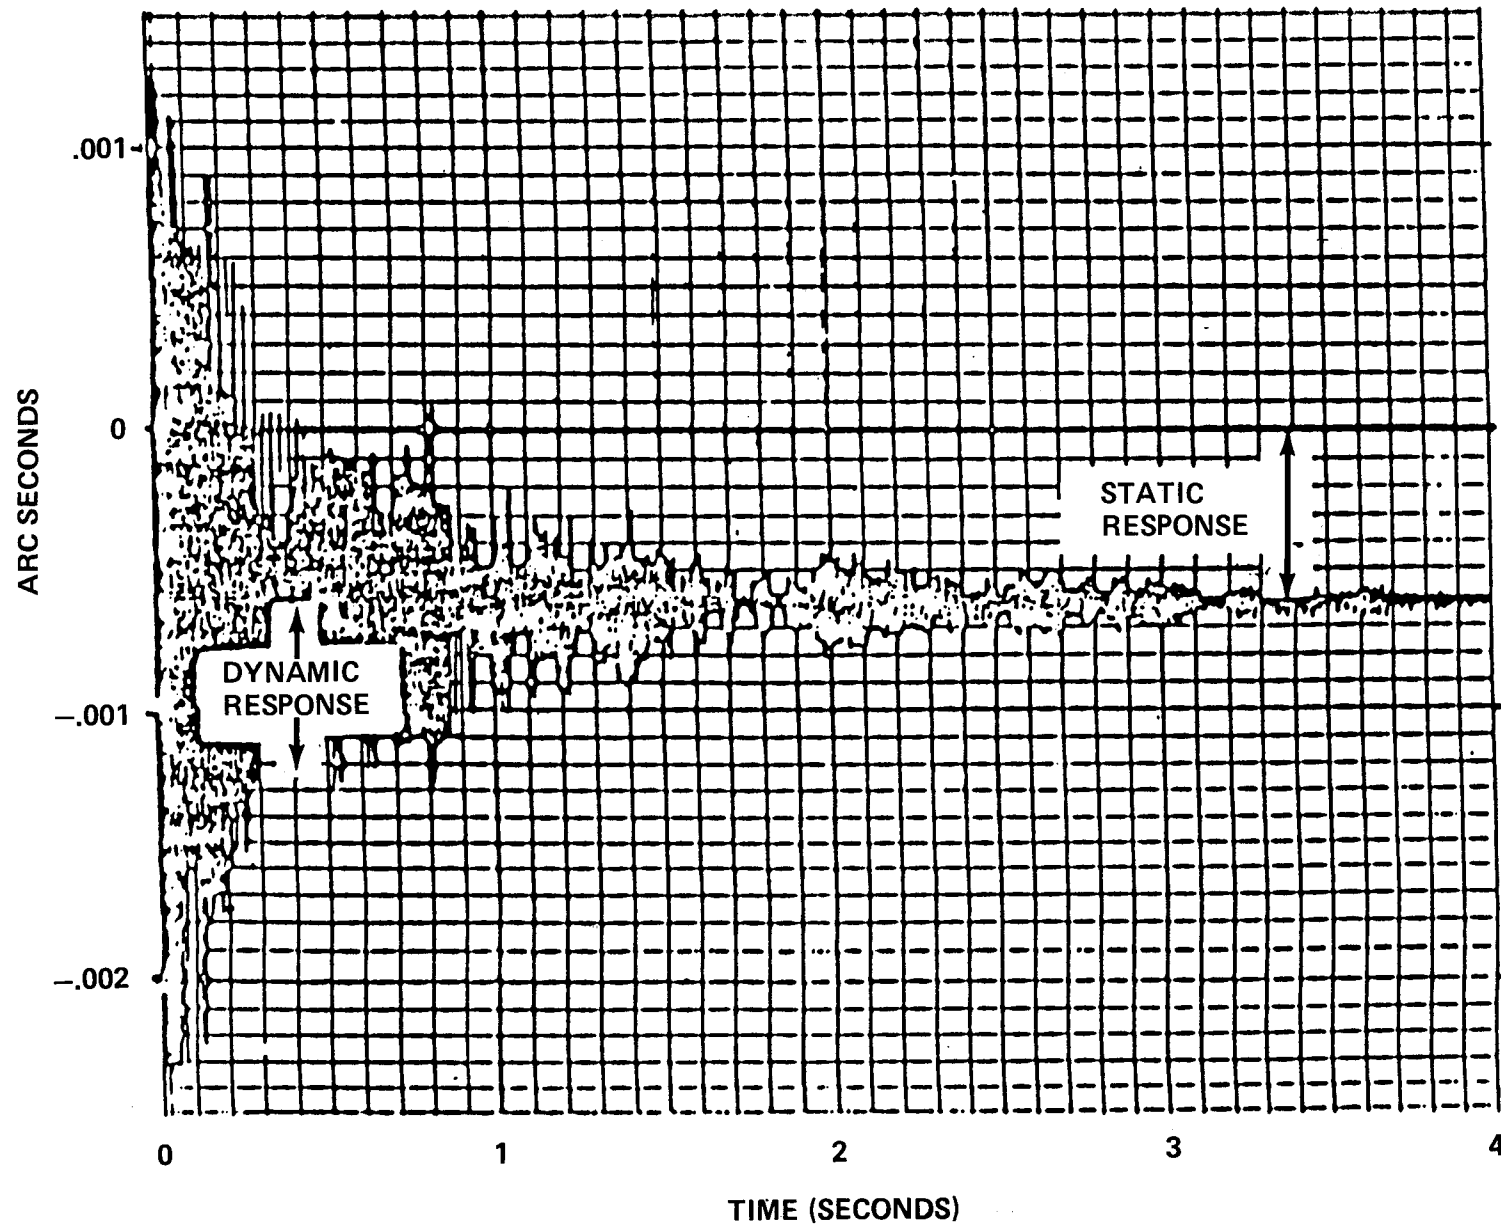
One problem occurs when thermal expansion is retarded by some type of friction restricting the motion (normally at a joint) until the load increases enough to break friction setting up dynamic excitation disturbing the line of sight. Most of the work today has been analytical and is of some concern operationally for Space Telescope. This is obvious when one sees the thermal cycle per orbit. The basic phenomenon is shown on Figure 33. Typical responses are shown on Figures 34 and 35. Experimental results have shown that with the force levels experienced on ST no creak problem will result.

Figure 35. Overall creak response.

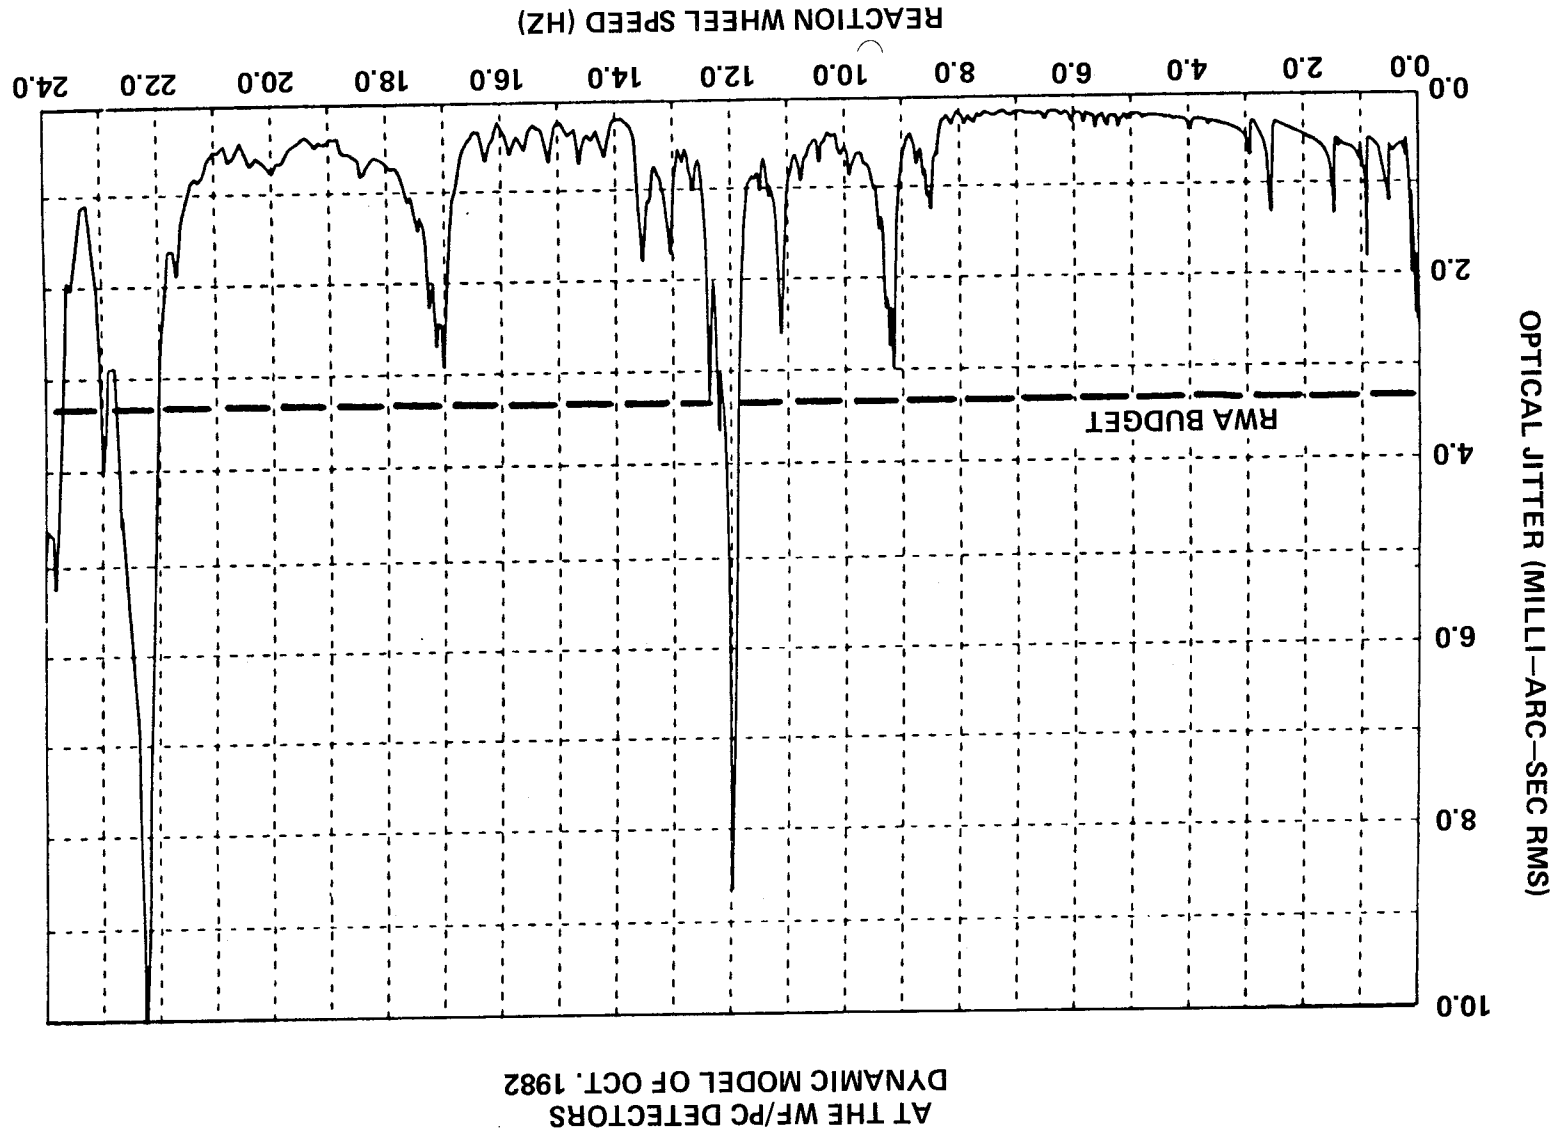
Jitter, a structural response caused when the momentum wheel speed passes through a structural mode frequency, in the Space Telescope clouds the images causing loss of goodness for the sighting. The main source of jitter is the momentum reaction wheels used for pointing control. Control actuation is accomplished by changing the speed of the various wheels. As the wheel speed sweeps through, high gain bending mode frequency structural response are excited causing jitter. Figures 36, 37, and 38 are typical responses in terms of light of sight for a particular experiment. The problem is compounded by the fact that modes through 100 Hz must be included for jitter analysis. This means a larger number of modes must be developed. High order modes are very difficult to predict. Key also is the value of the structural damping for each mode which again is not easily predicted or obtained. Assuming a minimum value for damping, the predicted jitter was excessive. This meant that some means of reaction wheel isolation should be developed as a backup fix.

Figure 36. Typical line-of-sight jitter.

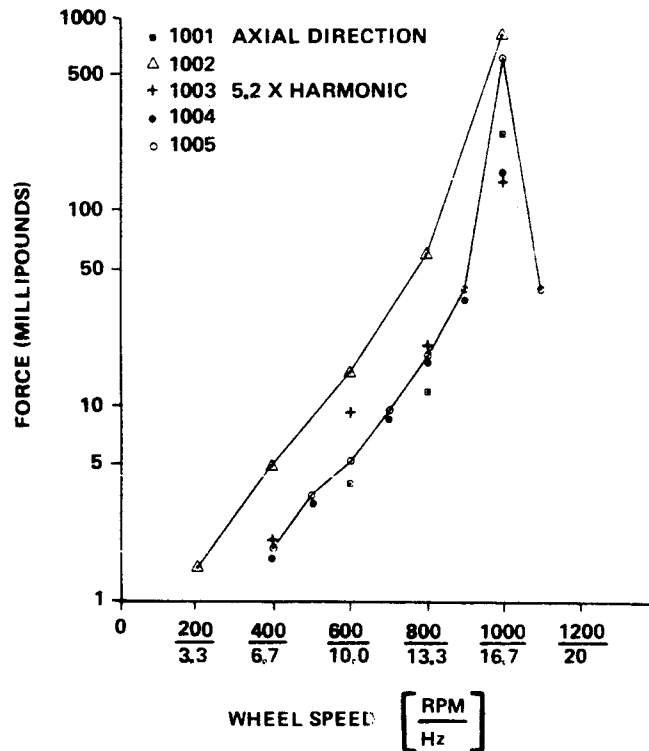
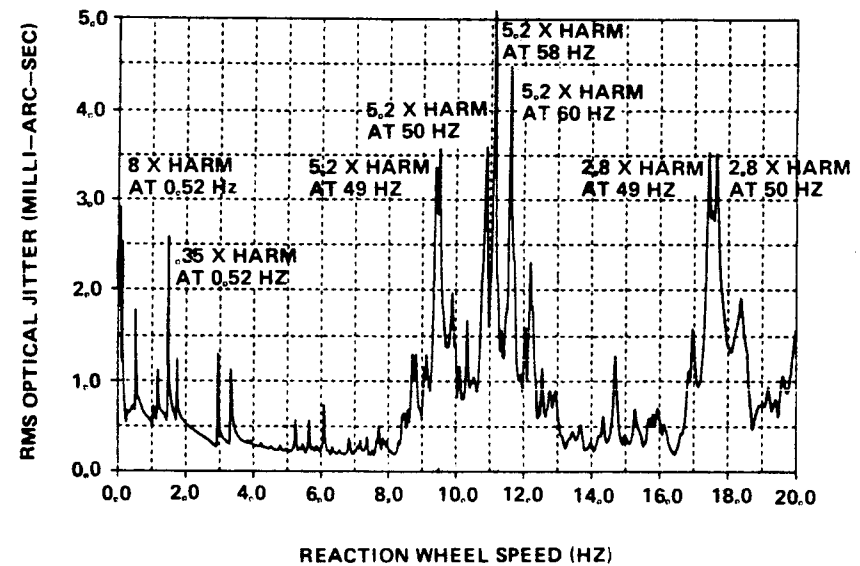
- 280 MODES BELOW 70 HZ. HIGHER FREQUENCY MODES MAY BE DRIVERS
- ASSUME 0.3% CRITICAL DAMPING (BASED ON ENGINEERING SIMULATOR TESTS) IN ALL MODES, EXCEPT 1% CRITICAL DAMPING ON THE AXIAL ROTOR MODE (BASED ON MEASUREMENT AT SPERRY)
- MAJOR HARMONIC COMPONENTS FORCE MODEL AS STEADY STATE SINE WAVE
- SPEEDS AND PHASE OF WHEELS NOT CORRELATED, HENCE TOTAL RESPONSE IN RSS OF WHEEL INDUCED JITTER

Figure 37. Reaction wheel assembly force and jitter.

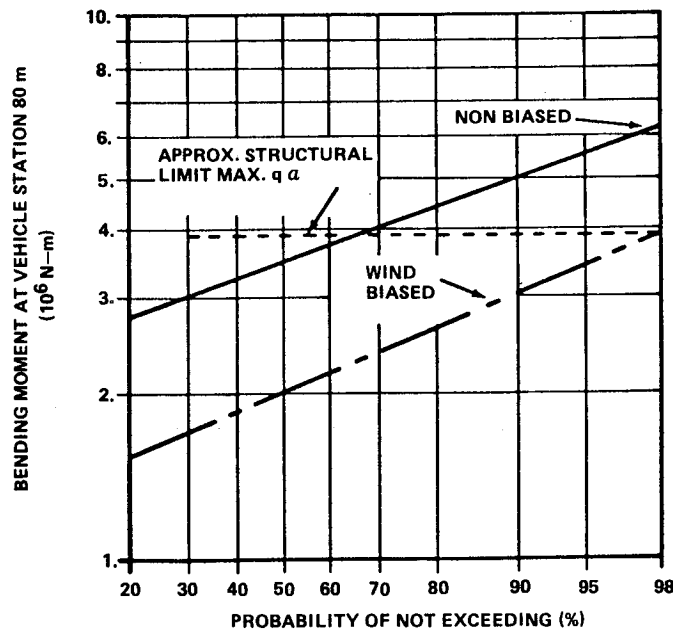
are shown on Figure 45 for one flight time, both with and without wind biasing giving 65 percent and 98 percent probability, respectively. As a result, the problem was solved using wind biasing and verified using Monte Carlo response analysis. Figure 46 shows the structural limit and bending moment versus flight time. Probability levels with and without wind biasing are used as parameters [32]. Skylab flew with a very good launch probability as a result of the wind bias profile and the change to a more realistic verification analysis approach.

Figure 45. Maximum bending moment at vehicle station 80 m versus probability of not exceeding for March sample of Jimsphere winds.

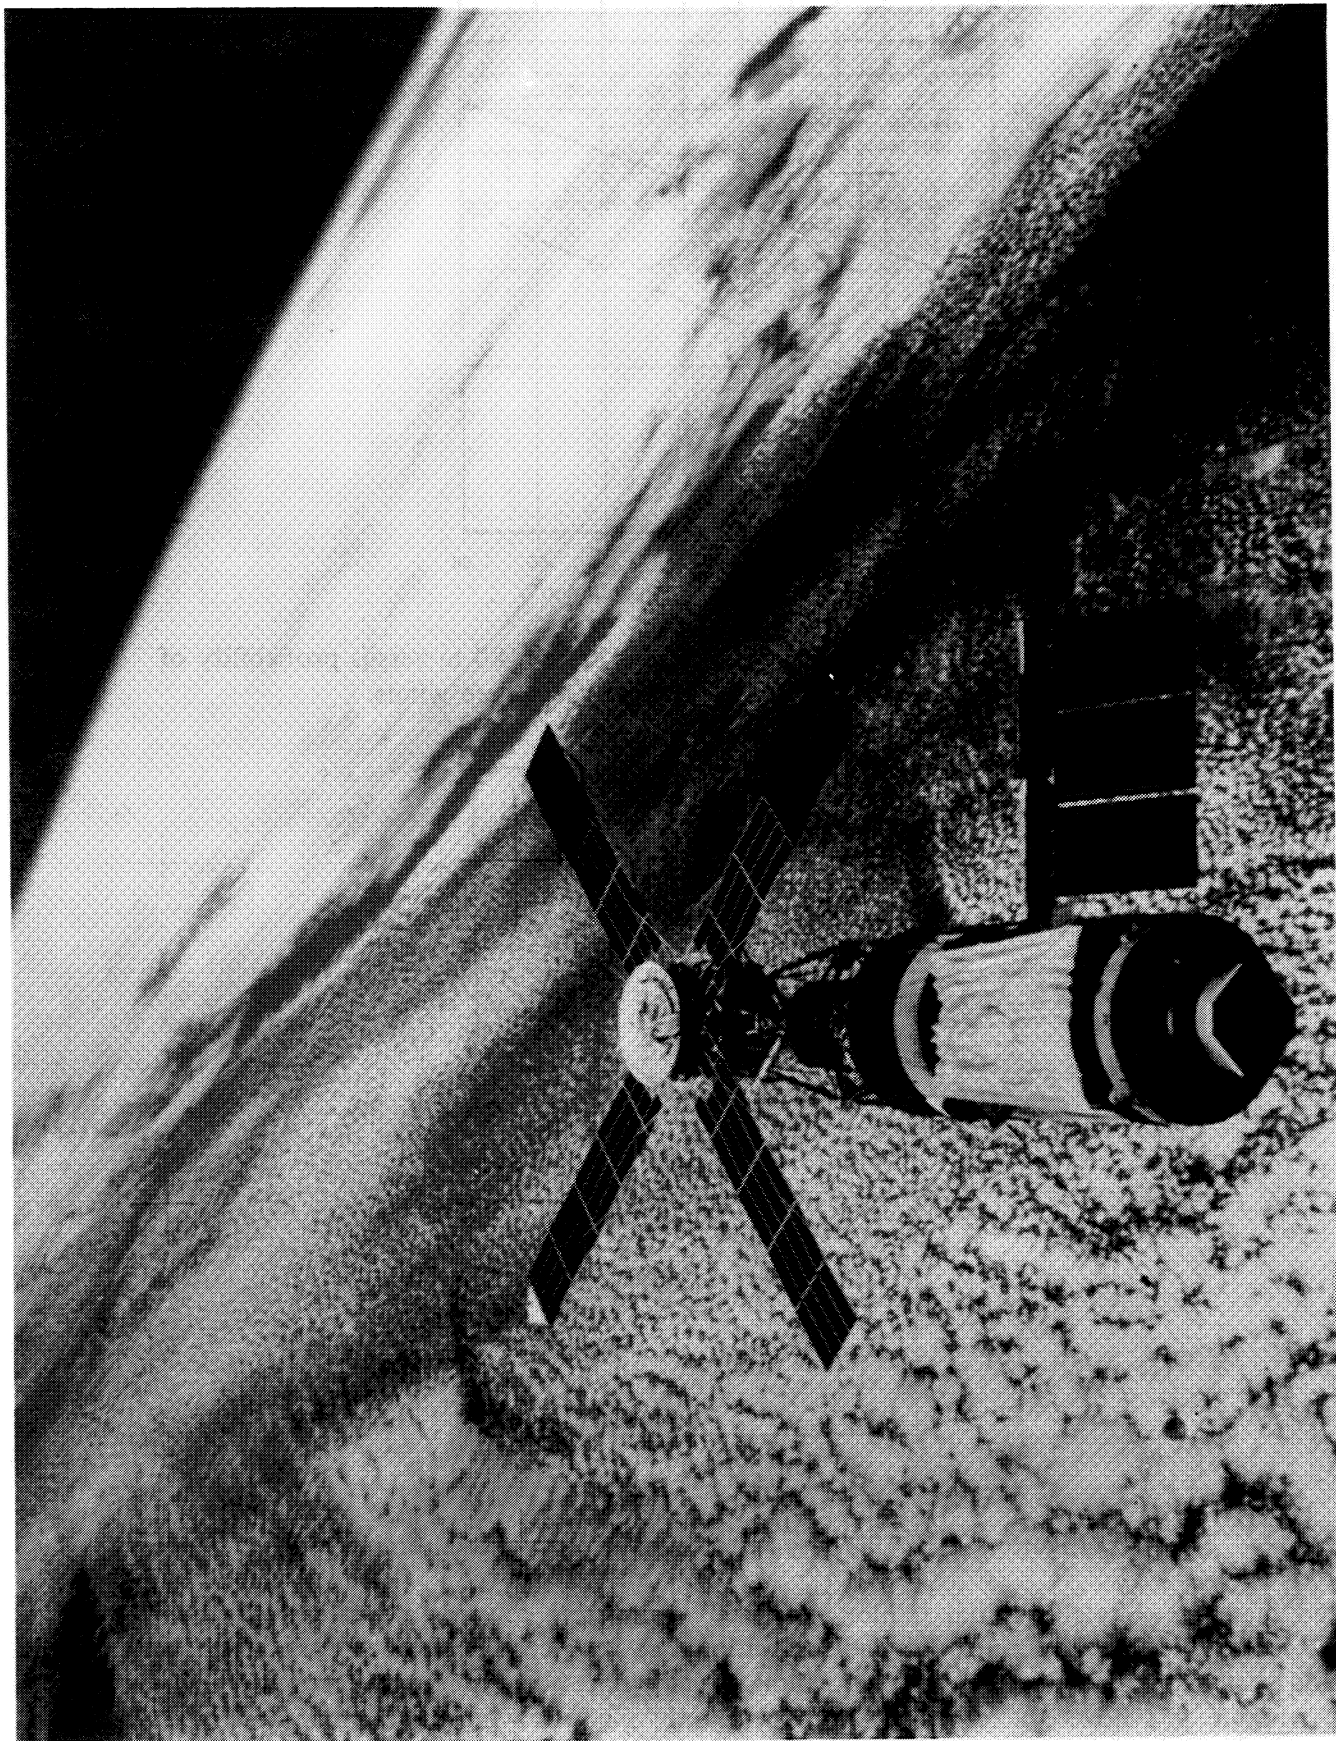
Figure 47. Skylab in orbit.

expected manner. Skylab's initial failure refocused engineering towards a systems' viewpoint with the warning to not neglect anything. Skylab's salvation was very costly, but demonstrates how teamwork and good systems engineering can solve problems. Many times one is not so fortunate and the mission is lost. Figure 47 shows the orbiting Skylab with only one solar wing and the man-deployed sun shield.

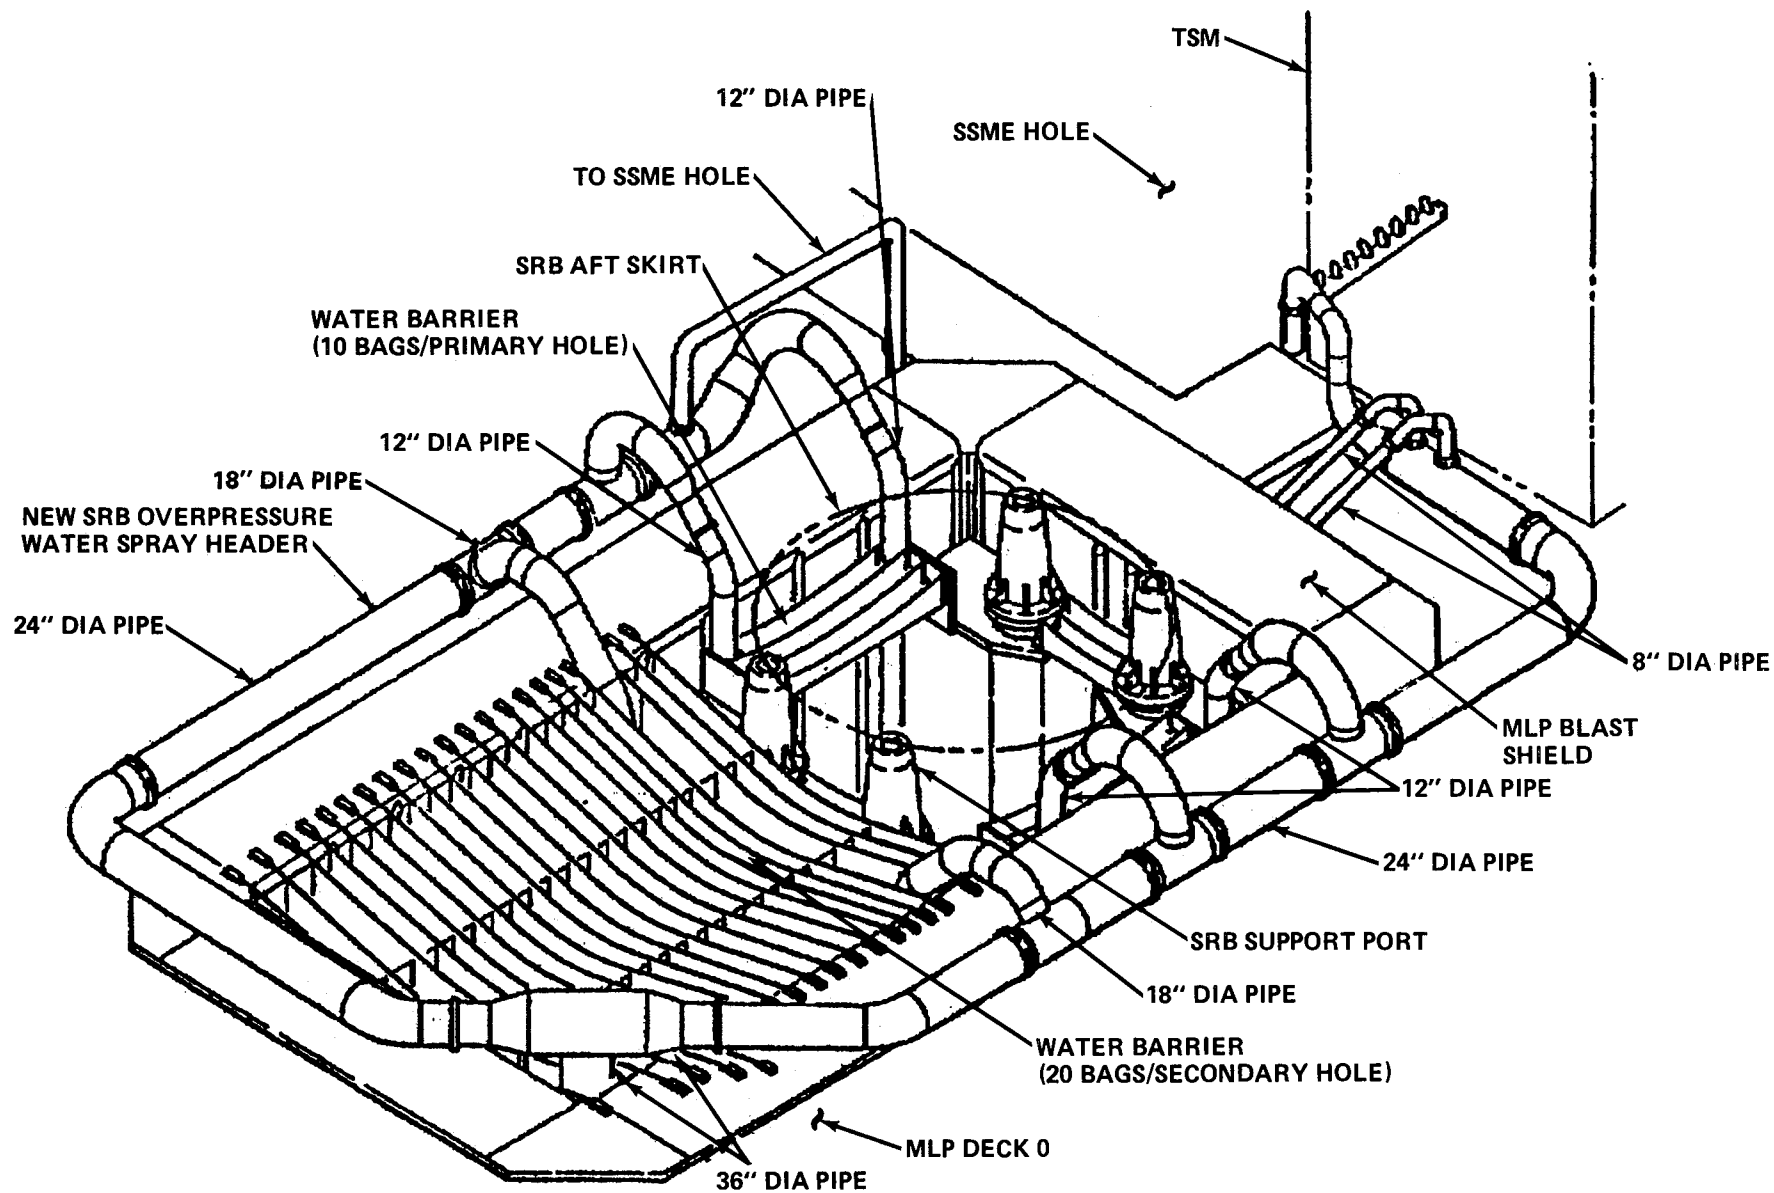
The small 6.4 percent scale model was used to predict ignition overpressure waves. Although some predicted from these data that the levels would be high, most did not [33-35]. Scaling of overpressure was not totally understood, hence the differences in predictions. STS-1 was launched without any major concern for overpressure. Luck prevailed. The SRB ignition overpressure was there in full force creating large vehicle responses but no failures. Launch film analysis showed large elevon deflections and accelerometers showed big responses in the payload bay, some very near the design values. The overpressure wave is caused by the high momentum exhaust displacing the air within the flame bucket (Fig. 52). It is a function of thrust rise rate, thrust magnitude, thermal conditions, and density. Clearly, it was too risky to launch the next Shuttle without a fix. The MSFC 6.4 percent model was reactivated along with the other special tests. A special intercenter working group was formed to direct the activities. Two basic approaches, wave blockage and plume injection with water, were pursued. Specialists were called upon and testing started. Adding water directly to SRM plumes greatly reduced the overpressure, in fact, sufficiently to eliminate the response problem. Several people raised concerns over the ability to scale the data to full scale. These concerns resulted in the use of larger water troughs (in conjunction with the water injection) in each SRB primary and drift (secondary) exhaust hole, creating a shield or blockage. The troughs were quickly destroyed when the SRB thrust impinged on them after liftoff. Permanent steel blockage could not be effectively used. The plates would have to be in place during the time of the overpressure wave, then moved out of plume impingement. The water troughs met these requirements. Since Eastern Test Range (ETR) was using water for acoustic suppression, additional lines were run and the system finalized. Figure 53 shows the water system and water troughs in place for STS-2. STS-2 was launched on time. The overpressure suppression system worked better than predicted. Figure 54 shows the overpressure magnitude for STS-1 (before fix) and STS-2 (after fix) [27-29]. Nine more launches have further proven the success of this concept. Space Shuttle slipped through the overpressure problem; however, the message is clear. When a potential problem exists that can cause such large responses, analytical and testing work should totally ring out the details. This was not done on Shuttle and, in retrospect, we were lucky. When a dissenter exists, understand his point before proceeding. The high pressure of getting the Shuttle launched in conjunction with a low budget is probably the main reason the problem was missed.

Figure 53. Overpressure mods STS-2 configuration.
