Problems Experienced and Envisioned for Dynamical Physical Systems

Robert S. Ryan

George C. Marshall Space Flight Center
Marshall Space Flight Center, Alabama

TECHNICAL PAPER

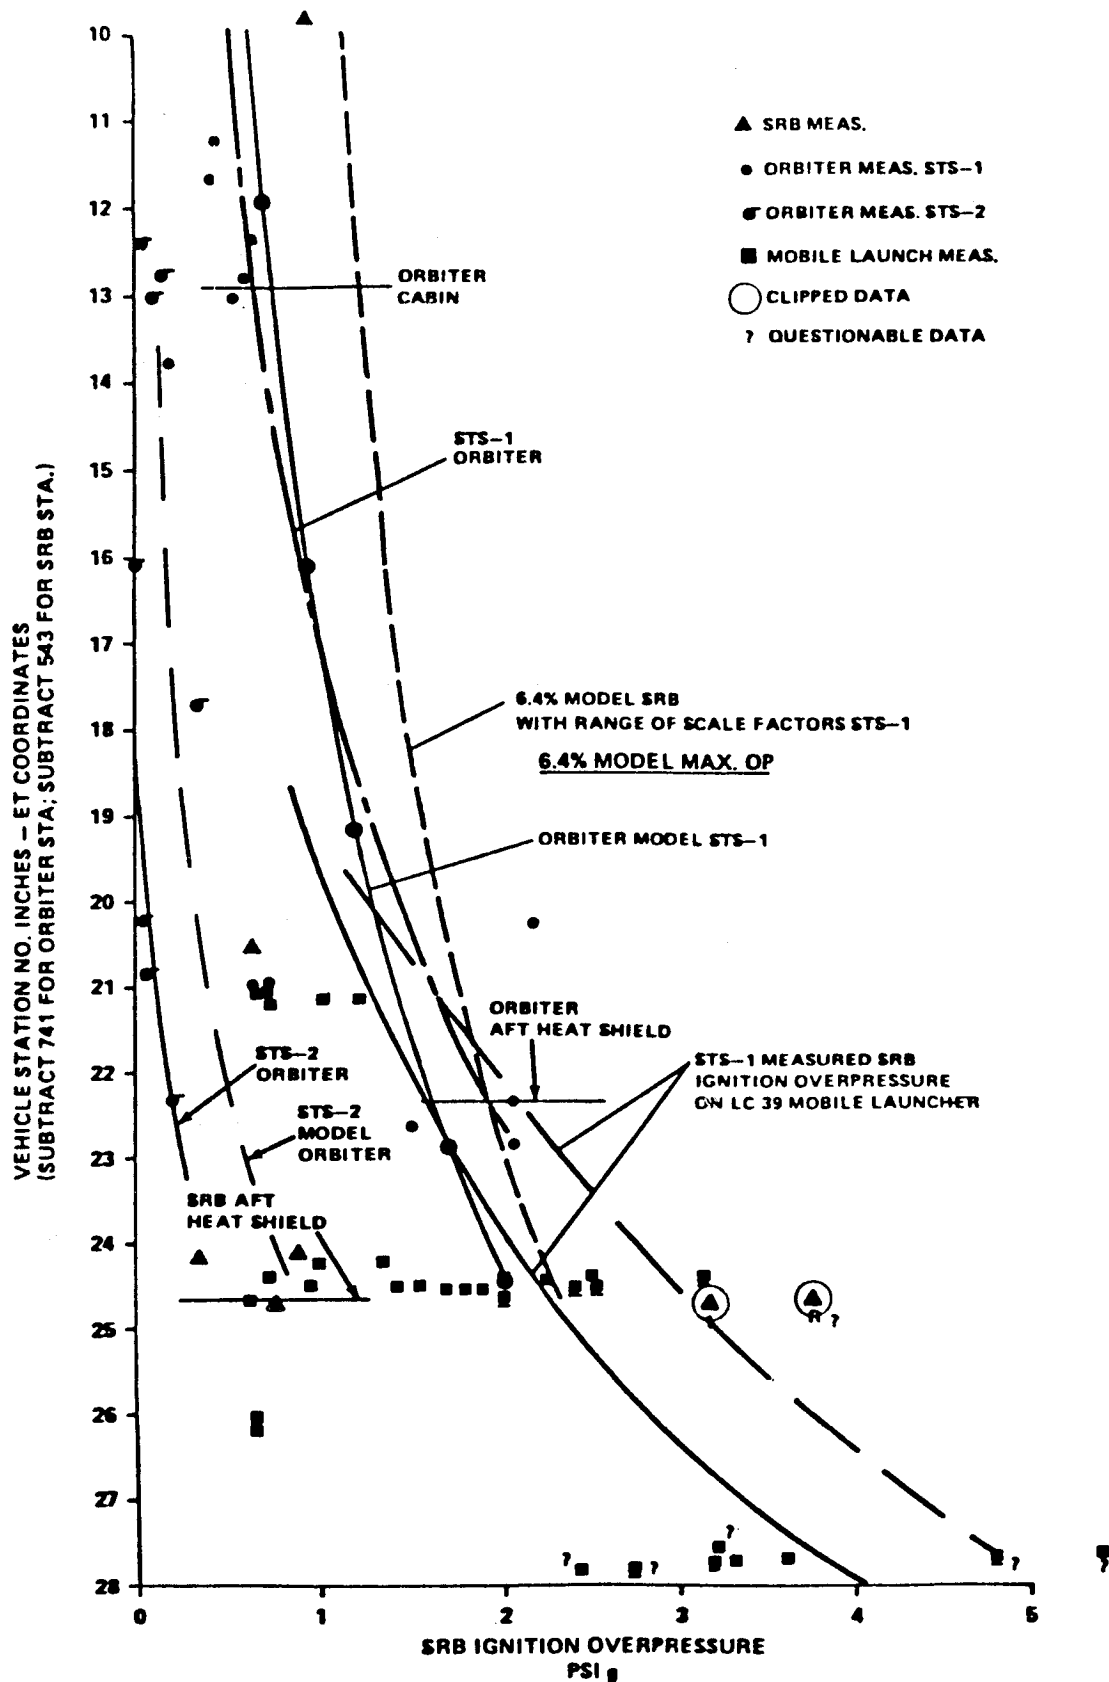
The small 6.4 percent scale model was used to predict ignition overpressure waves. Although some predicted from these data that the levels would be high, most did not [33-35]. Scaling of overpressure was not totally understood, hence the differences in predictions. STS-1 was launched without any major concern for overpressure. Luck prevailed. The SRB ignition overpressure was there in full force creating large vehicle responses but no failures. Launch film analysis showed large elevon deflections and accelerometers showed big responses in the payload bay, some very near the design values. The overpressure wave is caused by the high momentum exhaust displacing the air within the flame bucket (Fig. 52). It is a function of thrust rise rate, thrust magnitude, thermal conditions, and density. Clearly, it was too risky to launch the next Shuttle without a fix. The MSFC 6.4 percent model was reactivated along with the other special tests. A special intercenter working group was formed to direct the activities. Two basic approaches, wave blockage and plume injection with water, were pursued. Specialists were called upon and testing started. Adding water directly to SRM plumes greatly reduced the overpressure, in fact, sufficiently to eliminate the response problem. Several people raised concerns over the ability to scale the data to full scale. These concerns resulted in the use of larger water troughs (in conjunction with the water injection) in each SRB primary and drift (secondary) exhaust hole, creating a shield or blockage. The troughs were quickly destroyed when the SRB thrust impinged on them after liftoff. Permanent steel blockage could not be effectively used. The plates would have to be in place during the time of the overpressure wave, then moved out of plume impingement. The water troughs met these requirements. Since Eastern Test Range (ETR) was using water for acoustic suppression, additional lines were run and the system finalized. Figure 53 shows the water system and water troughs in place for STS-2. STS-2 was launched on time. The overpressure suppression system worked better than predicted. Figure 54 shows the overpressure magnitude for STS-1 (before fix) and STS-2 (after fix) [27-29]. Nine more launches have further proven the success of this concept. Space Shuttle slipped through the overpressure problem; however, the message is clear. When a potential problem exists that can cause such large responses, analytical and testing work should totally ring out the details. This was not done on Shuttle and, in retrospect, we were lucky. When a dissenter exists, understand his point before proceeding. The high pressure of getting the Shuttle launched in conjunction with a low budget is probably the main reason the problem was missed.

Figure 54. STS-1 measured SRB ignition overpressure versus vehicle station.

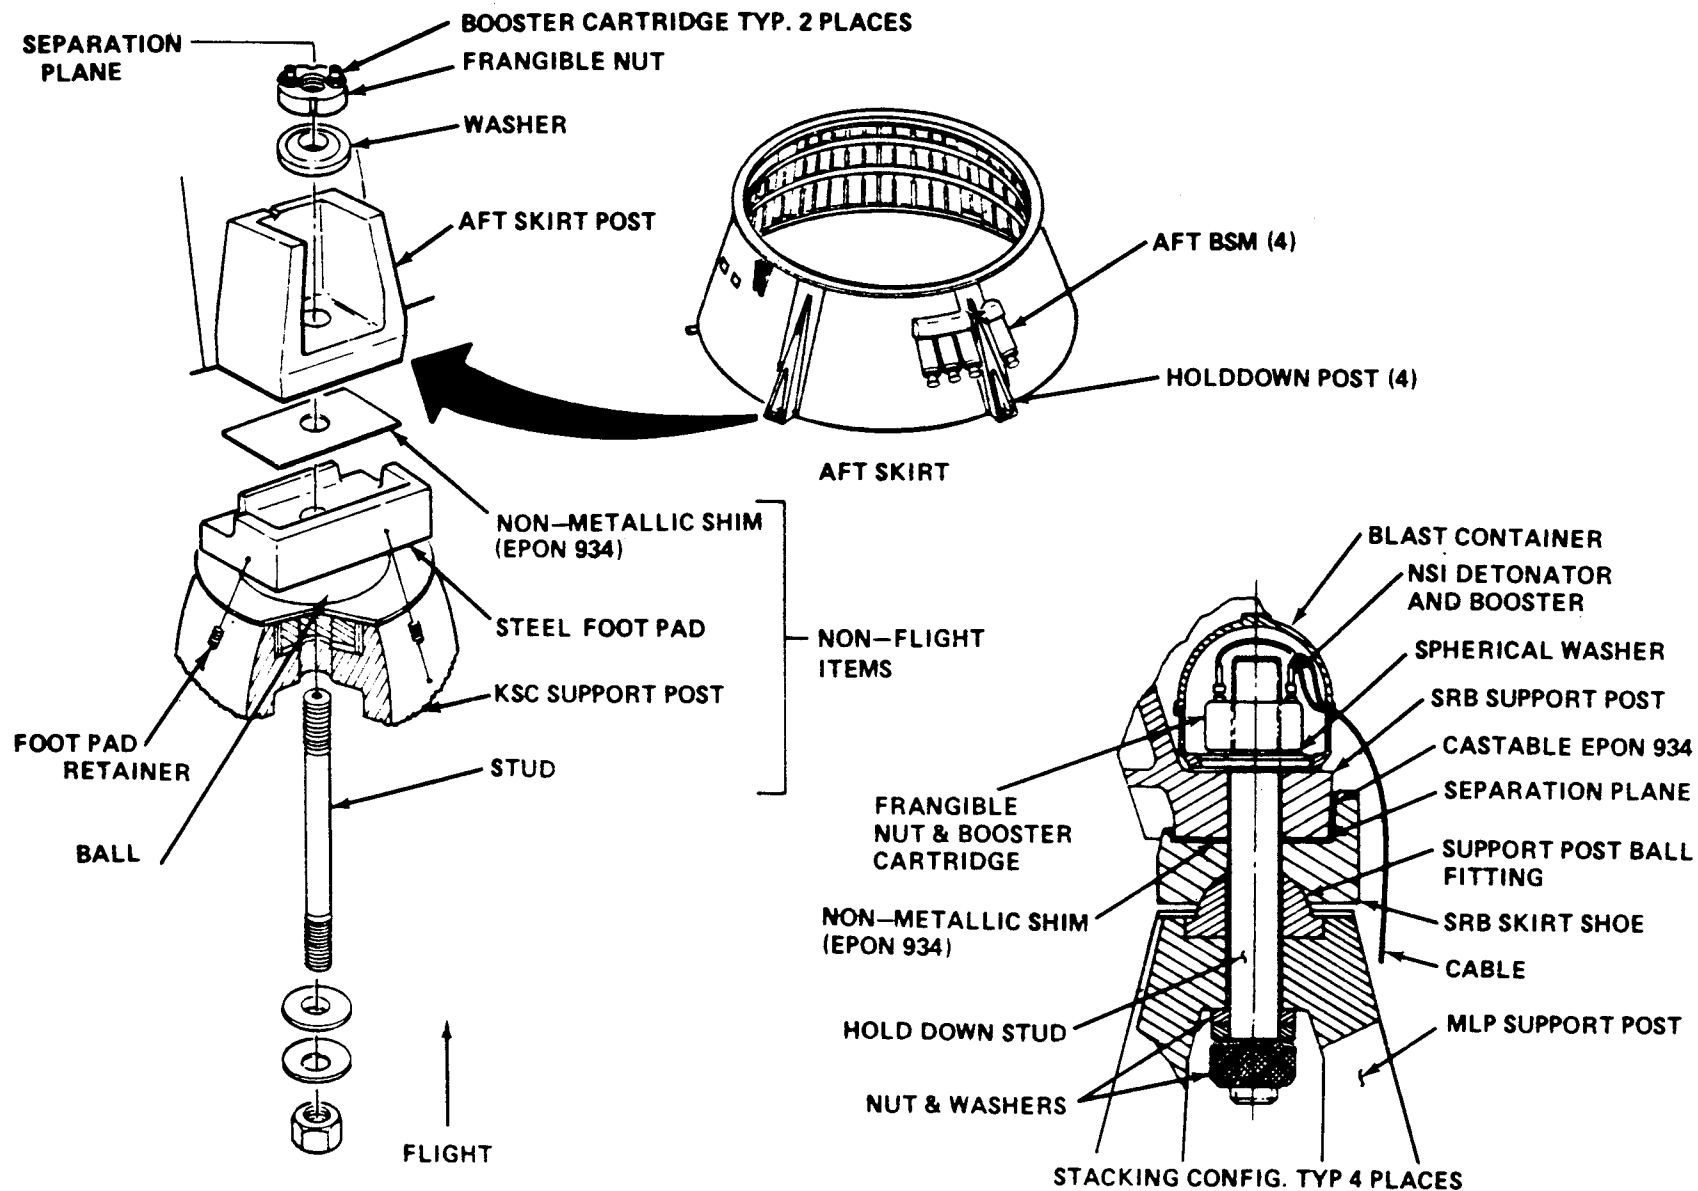
Figure 58. SRB holddown bolt and foot pad.

Another problem that occurred during liftoff was the SRB holddown bolt design loads. Each SRB is held to the pad by four holddown bolts through footpads (Fig. 58). These bolts are designed to take the load from the SSME buildup and then to be fractured (pyrotechnics) at SRM ignition. In addition, the bolts must be captured so that they do not become a debris source. Predicting and measuring this load was a major problem due to the complex load paths from the load origin to a load in the bolt. Early attempts to back the bolt load out of flight data showed loads slightly in excess of design (safety factor less than 1.4), not a desirable situation. Using laboratory tests and finally a strain gauged bolt, it was shown that bolt loads were within design and no problem existed. Holddown bolts also showed the potential of not extruding when the pyros fired. In fact, the flight films have shown three examples where bolts did not extrude. Nonextrusion is not a problem, since the vehicle liftoff motion would pull the footpads off the bolt with no adverse effects. It was found that timing differences between firing of the redundant charge on each bolt could cause bolt hangup by setting up coupled dynamic motion of the bolt which caused the bolt to hang up. Additional analysis showed that as long as the pyros fire (nut fractured), Shuttle would lift off successfully, pulling the bolts out as a result of liftoff.

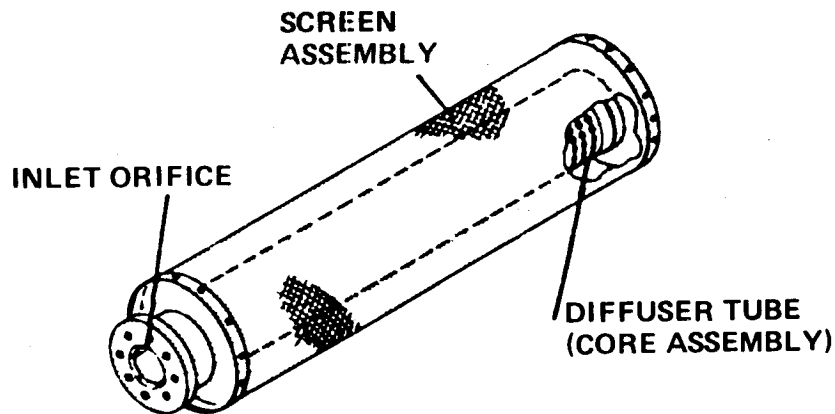
Figure 62. ET diffuser.

1) Propellant Diffuser. The ET diffuser was a baffling problem in that during ground testing, including the systems main propulsion test, cracks occurred and pieces broke out (Fig. 62). Existing accelerometers on the external tank skin provides no clues. A series of mechanical vibration tests could not produce a failure. Neither could acoustical analysis. This led to the development of a series of flow tests that duplicated the inlet pipe geometry, flow rates, and gas density. This test was the clincher. When the system characteristics were duplicated, the diffuser failed. What was happening is clear in retrospect, the turbulence of the flow contained a large amount of energy at the natural frequency of the diffuser shell mode. The forced response of this shell mode, to turbulent flow, failed the diffuser shell. Redesigning the diffuser to detune it and have more strength resulted in an acceptable solution.

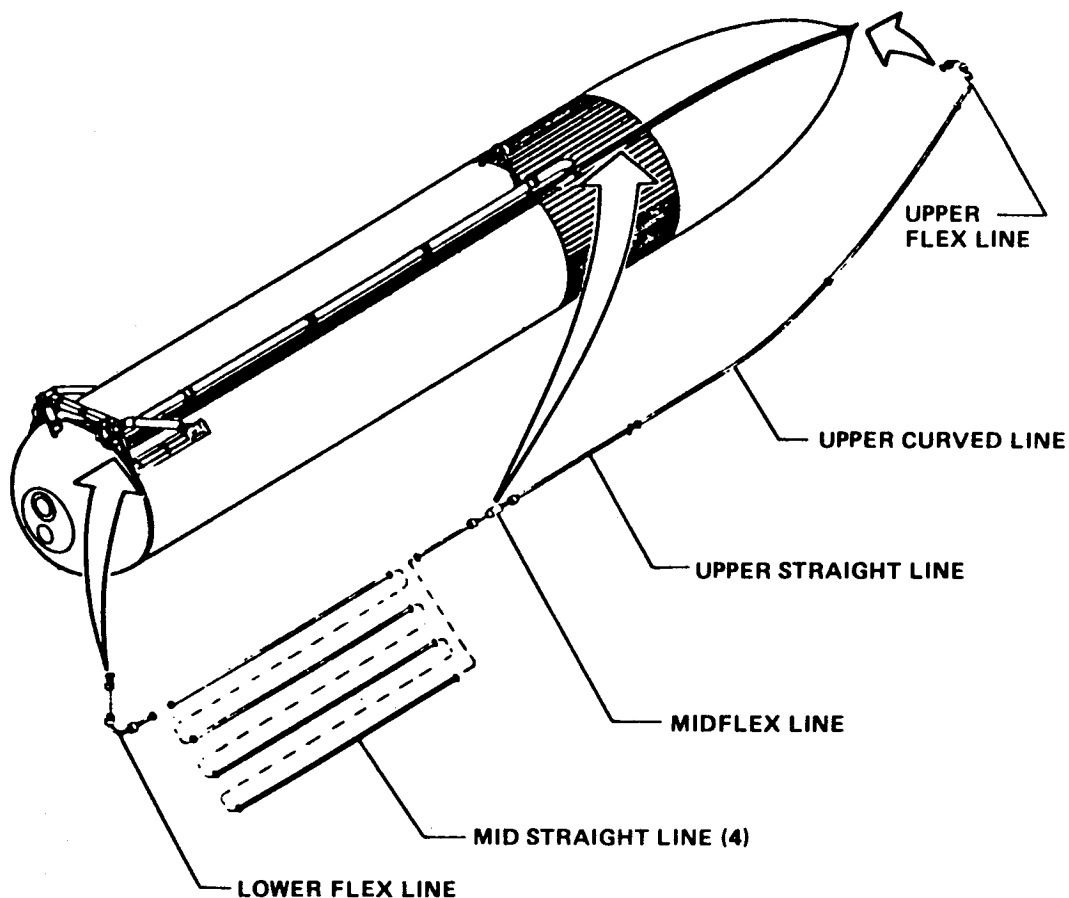
Figure 63. ET protuberance cross flow.

2) Protuberances, External Aerodynamic Loads. The protuberance problems arise from an inadequate environment definition early in the program. These early predictions basically assumed no cross flow around the tank and were based on smooth body flow. As wind tunnel testing proceeded, this assumption broke down, since substantial cross flow existed for the tank in the ascent configuration (Figs. 63, 64, and 65). Protuberance model testing showed original drag loads for smooth body flow to be in error. This led to loads which exceeded design specifications. The end result was some redesign and, in other cases, verification testing at a higher limit load. With these changes and additional verification testing, ET protuberances have shown no problems in Shuttle operations.

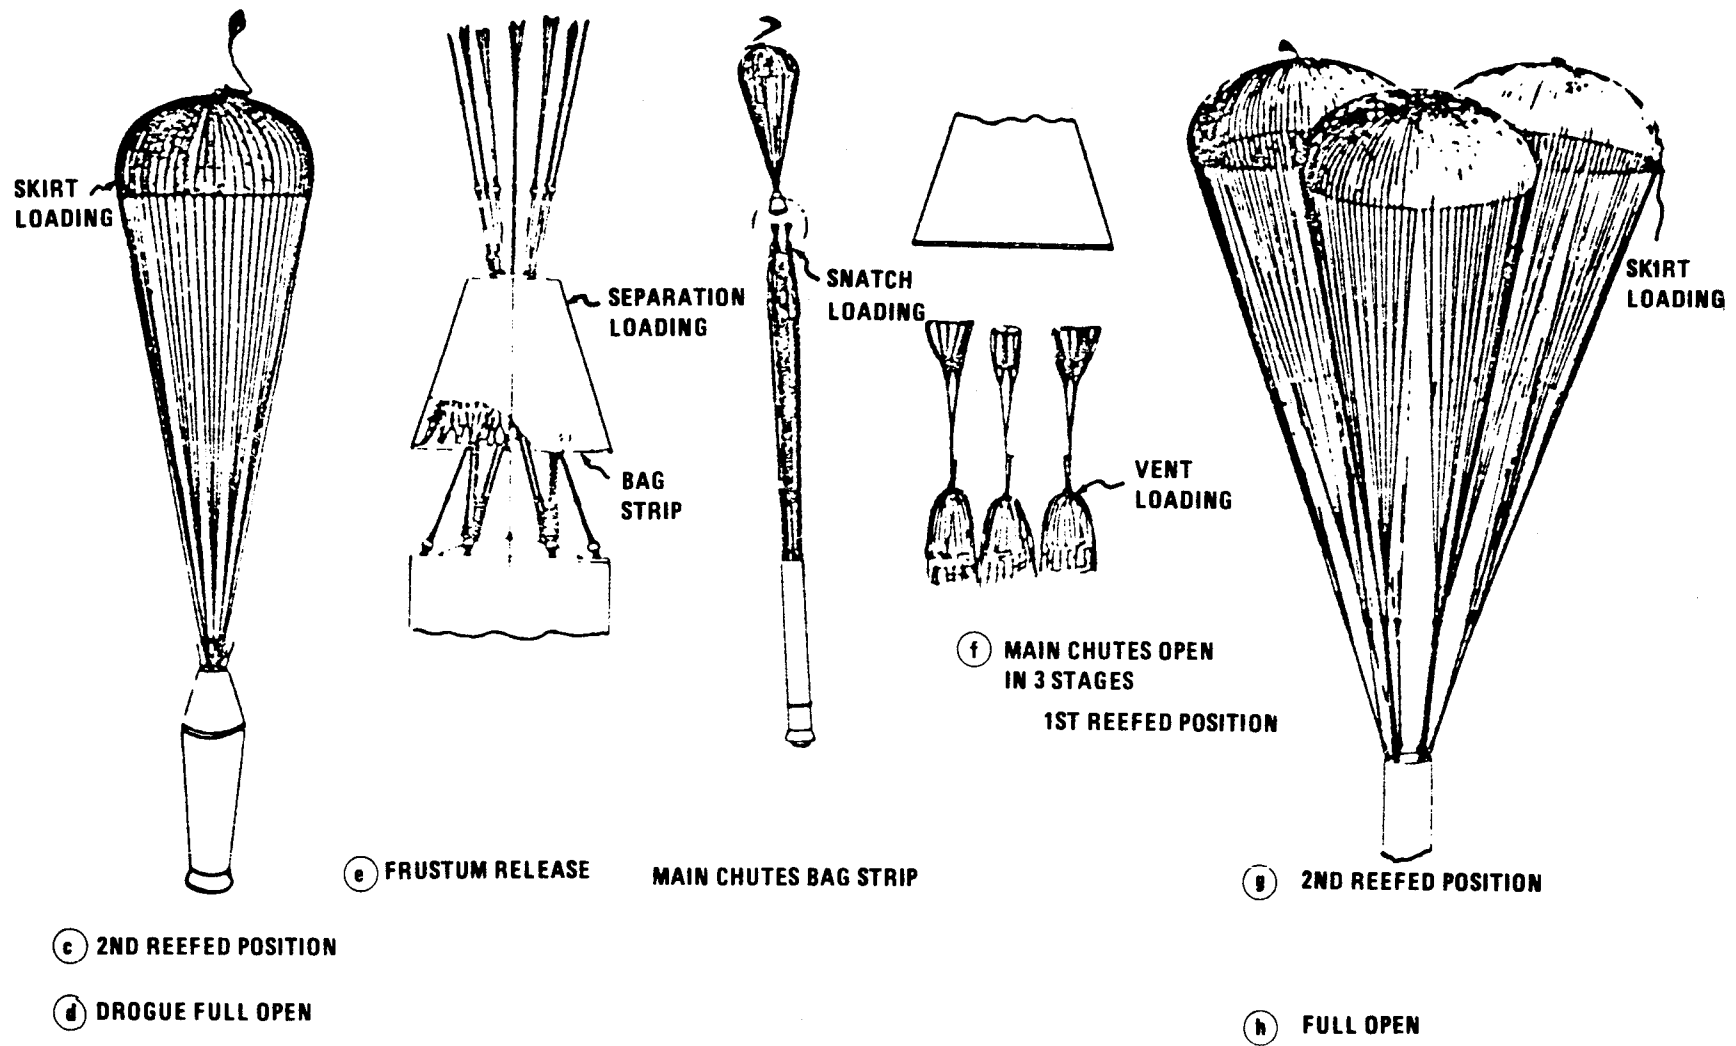
Figure 68 depicts the critical areas during chute deployment. The drogue chute goes through the second disreefing and fully opens. The critical area for this sequence is chute skirt loading. At this time, the frustum releases with separation loading and bag stripping the critical areas.

a) Parachute Tear Problem. The problem that has occurred concerns the main chute during frustum extraction. The chute is burned, ripped, and either does not have correct inflation or does not inflate at all. Two problems have been uncovered, one is associated with how the chute is packed allowing it to skip out and catch other parts, such as reefing cutters. The other has been associated with the high speed extraction burning the material reducing its strength or cutting inside the frustum. The first was solved by repacking. The second by removing all potential sources of contact with foreign objects. References 37 through 45 give the overall parachute design and verification program including sled testing and drop testing.

Figure 68. SRB parachute sequence of events.

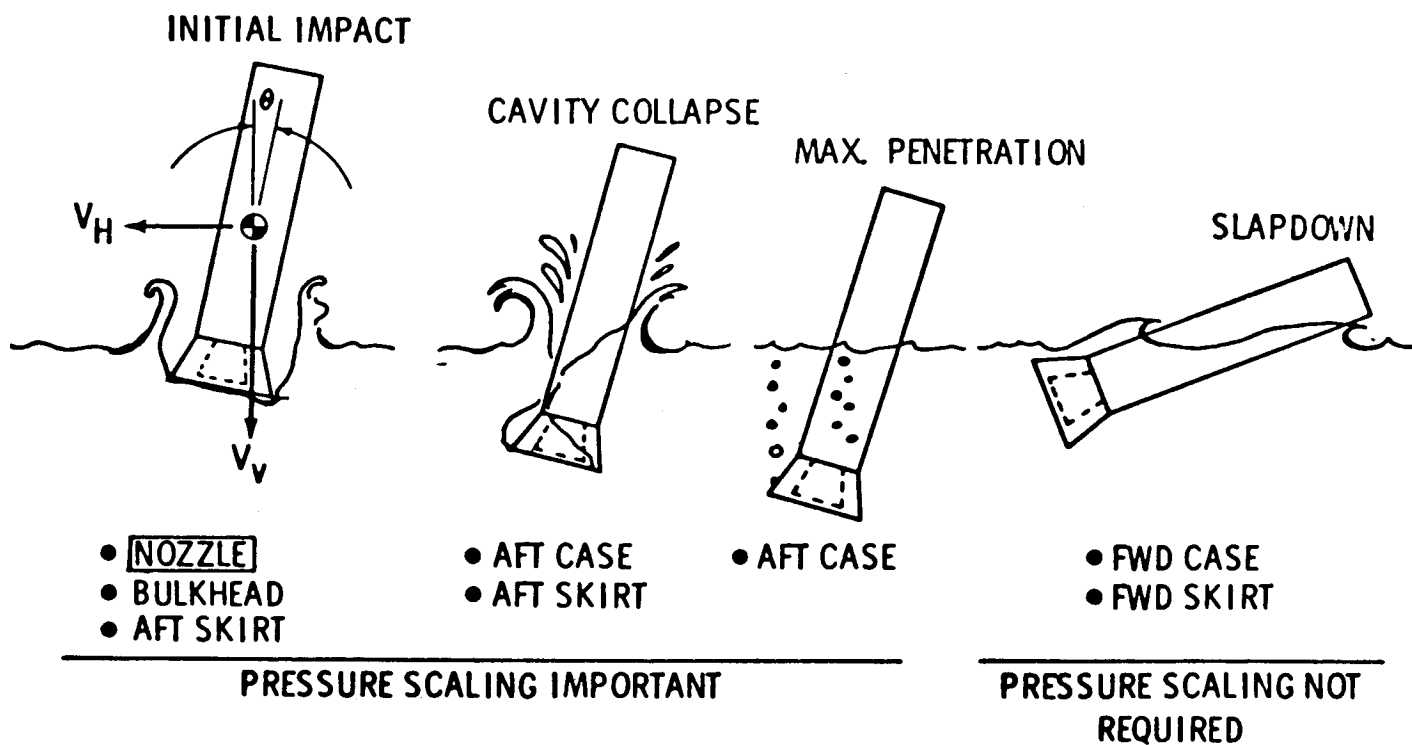
b) Excessive Water Impact Loads. Several events take place during water impact. It was found that some of these required pressure scaling to properly define the loads. Figure 69 gives the significant loading events and where pressure scaling was required. To satisfy the pressure scaling requirements, Navy Ordnance Laboratory and their pressure scale facility were used. Using these test data, water collapse load rings were installed for flight. On most of the Shuttle flights, the water collapse load rings have been damaged indicating the magnitude of these loads. Cavity collapse loads can occur with either the tail trailing or leading the vehicle. The tail trailing case has low pressures and loads while the tail leading has high pressure and loads. These are summarized in graphics form in Figures 70 and 71. In general, SRB impacts the water tail leading. Since the rings are a small refurbishment item and no other collapse load damage has occurred, no fix is intended. Large chutes under development for the skirt loads problem will help the water collapse problem.

Figure 69. SRB water impact significant loading events.

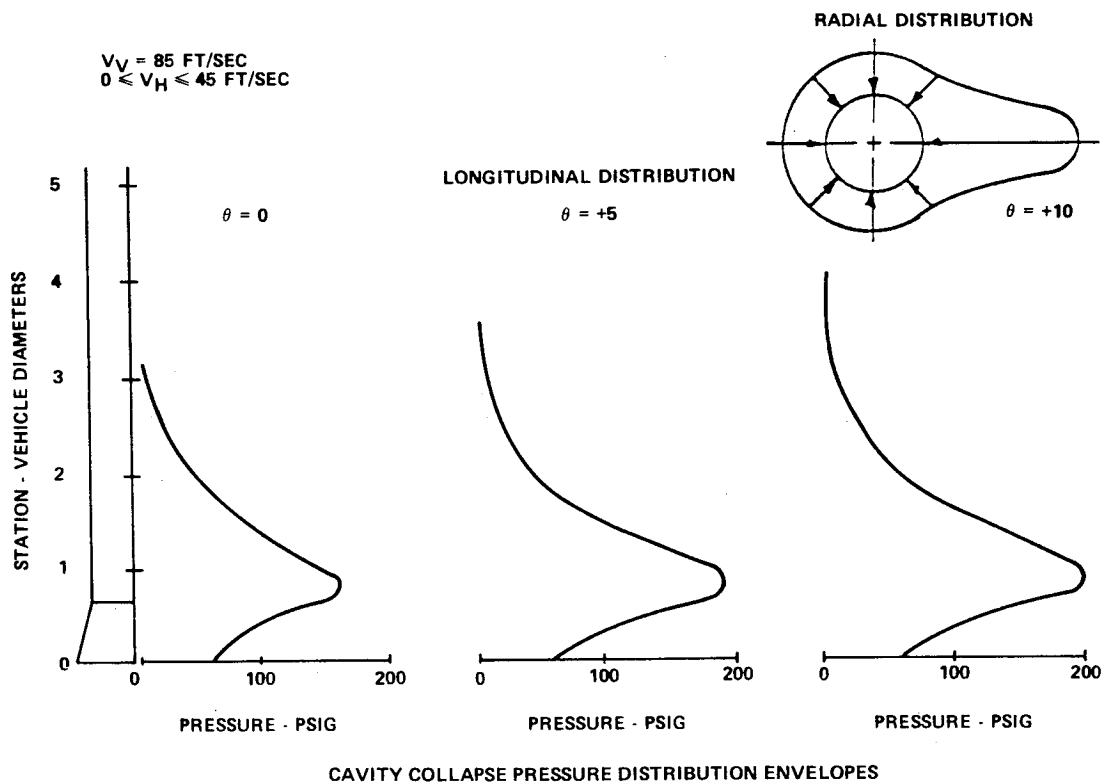
As stated previously, the other problem area has been the water impact loads of the skirt. These SRB nozzle loads could not be determined directly in the scale model test due to scaling problems. The nozzle system is composed of actuators, the nozzle, a series of laminated rings to allow for gimballing the nozzle, and a snubber for response containment. Figure 72 is a schematic of this arrangement. Scaling these rigid body test loads up to a full scale elastic body response using detailed elastic body impulse response mispredicted the actual loads experienced in flight. Much damage has been incurred to skirt, actuators, etc., leading to much higher than predicted refurbishment. This has resulted in many test programs, both full scale (skirt only) and scale model, in order to better define these loads and arrive at fixes. Fixes have included clips on the rings, foam to change water flow, etc. Presently, minimum damage is occurring; however, large parachutes are scheduled for use that would eliminate the problem.

Figure 71. SRB aft skirt water impact loads.

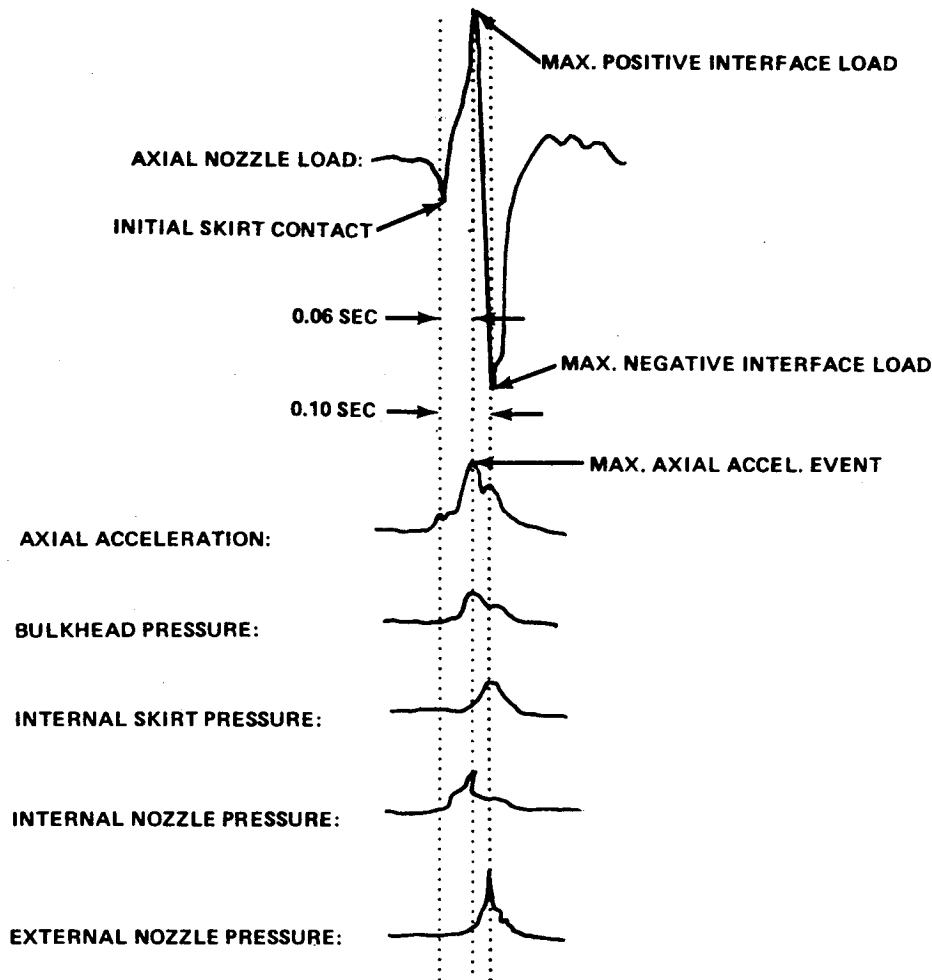
One interesting phenomenon occurred during initial impact in the nozzle area. The nozzle was first loaded in a positive direction as the nozzle attempted to move into the water. The water subsequently filled the aft skirt, then circulated, thereby creating a negative loading on the nozzle, the negative direction load being the peak load. Figure 73 shows this event and the loads for the nozzle, bulkhead pressure, internal skirt pressure, and internal and external nozzle pressure.

Figure 73. Typical initial impact dynamic events.

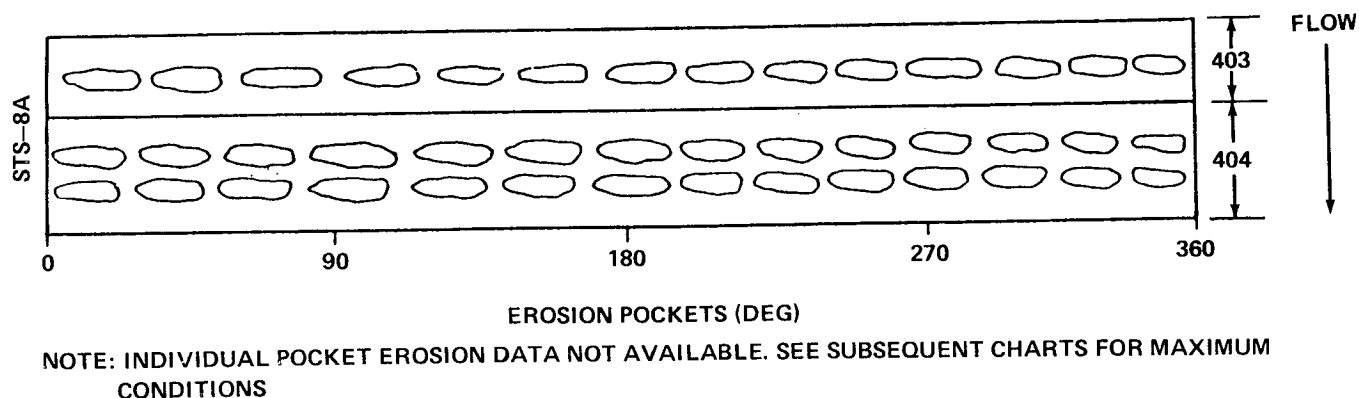
3) Excessive Nozzle Erosion. The SRB has experienced a problem associated with the thermal lining in the nozzle. In the throat area, erosion pockets have occurred on two flights, one of which was close to a burn through (Fig. 74). The thermal lining is a carbon epoxy composite laid up in layers with specific fiber orientation. During manufacturing if any contamination or process flow interruptions occur, then the material properties degrade, making the liner more susceptible to environments. The liners are several inches thick and are built up (fiber lay up) and machined in sections and fastened to the inside of the nozzle (Fig. 75). Because of manufacturing (lay up) problems, ring sections 403 and 404 have different fiber angles than the other ring sections (Fig. 76). Herein lies the problem. Manufacturing problems (quality) in conjunction with the flow and thermal environment induces tension in the surface which then turns loose, continuing until equilibrium or burn through occurs. Complete resolution of this problem has not been completed at this time. All aspects of thermal dynamics flow, etc., are being pursued to better understand the problem.

Figure 75. STS-11 nozzle flight assessment.

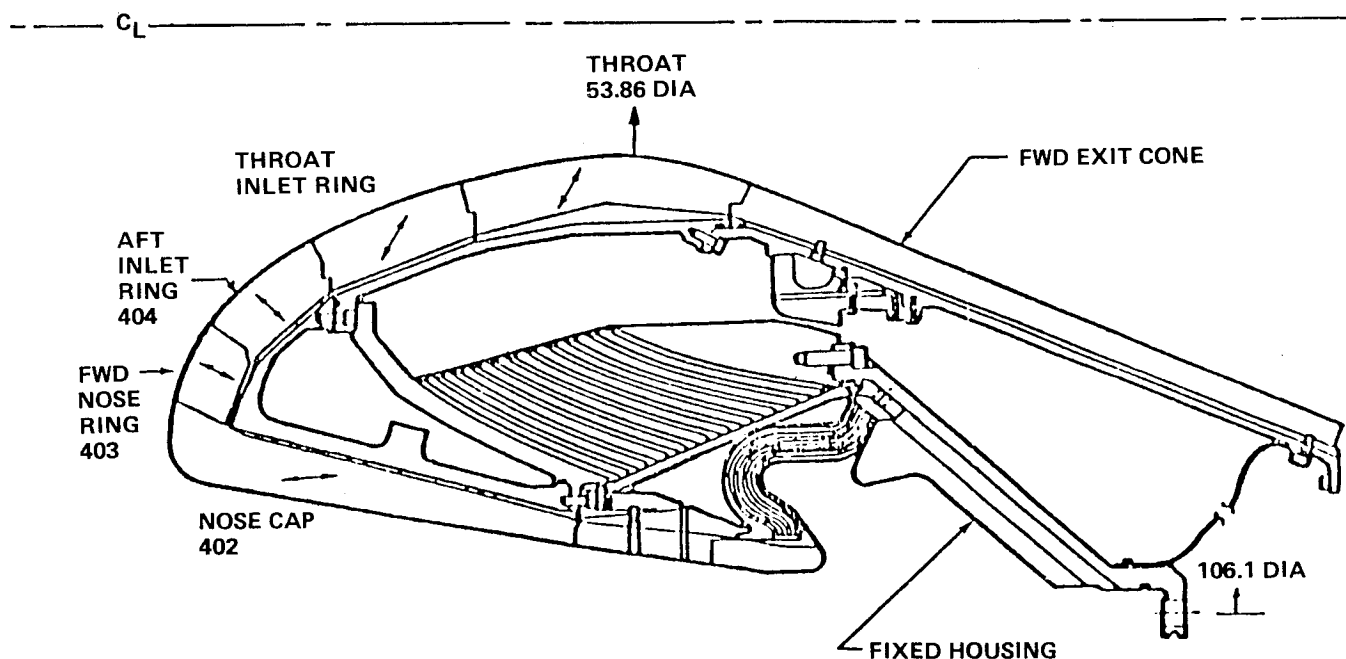
Figure 76. SRM nozzle liner assembly.

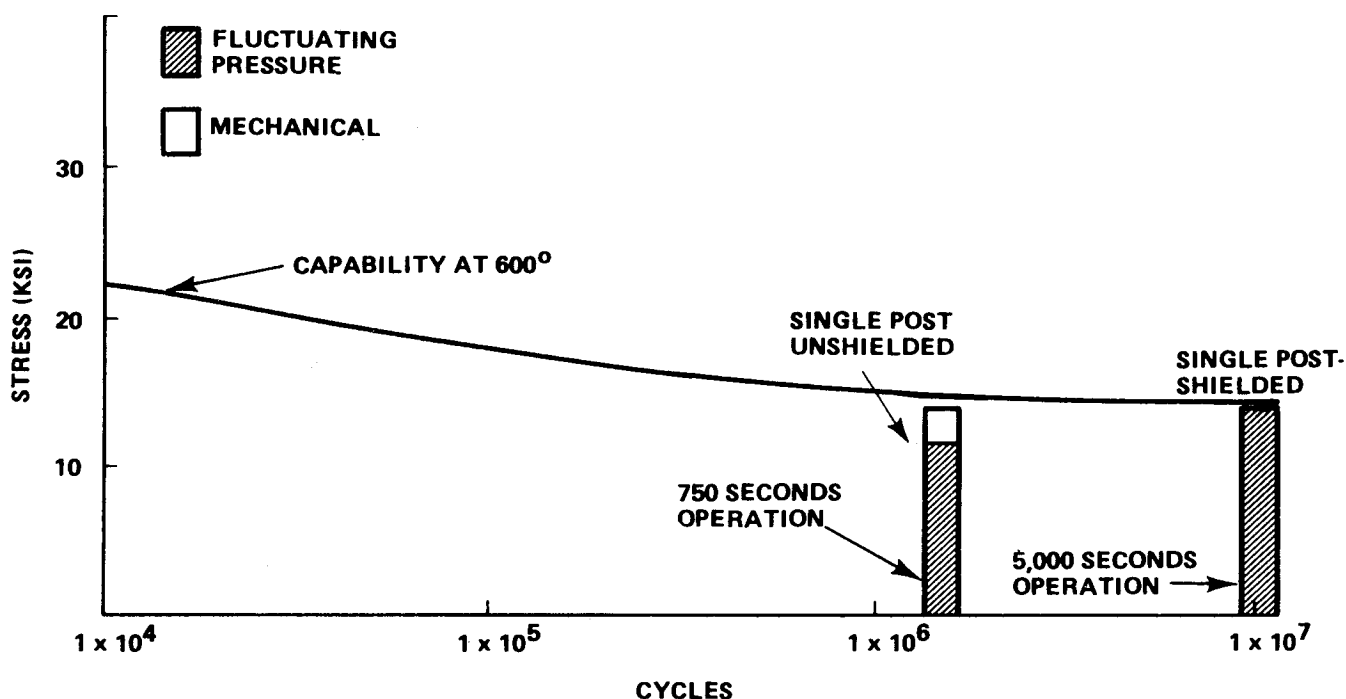
These SSME operating conditions generate environments where many parts are operating at or beyond their endurance limits, producing a limited lifetime. The design point on the SN curve is very flat, making lifetime very sensitive to small changes in the static and alternating stresses (5 percent alternating stresses change lifetime up to an order of magnitude), manufacturing errors, and material deterioration (Fig. 77).

Figure 77. Alternating stress versus lifetime.

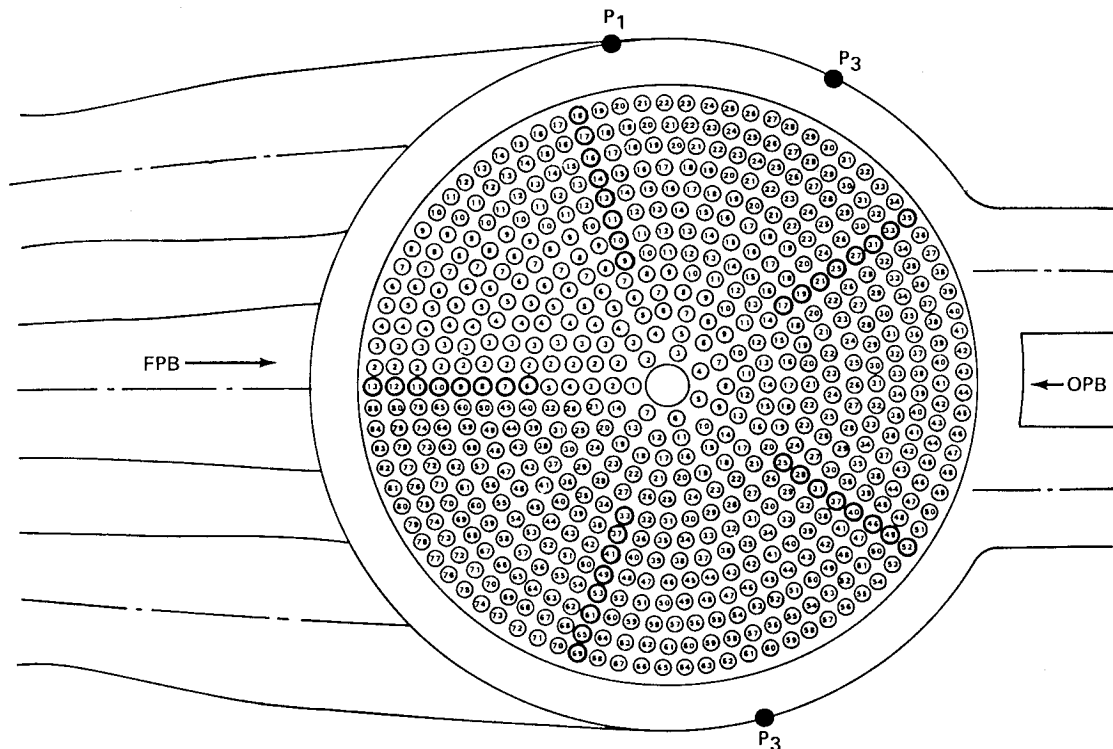
between the lox dome and the primary injector plate. Figure 78 shows a top plane view of the lox post array with the three transfer tubes from the hydrogen preburner and the two transfer tubes from the lox preburner.

Figure 78. High-frequency pressure transducer locations in engine.

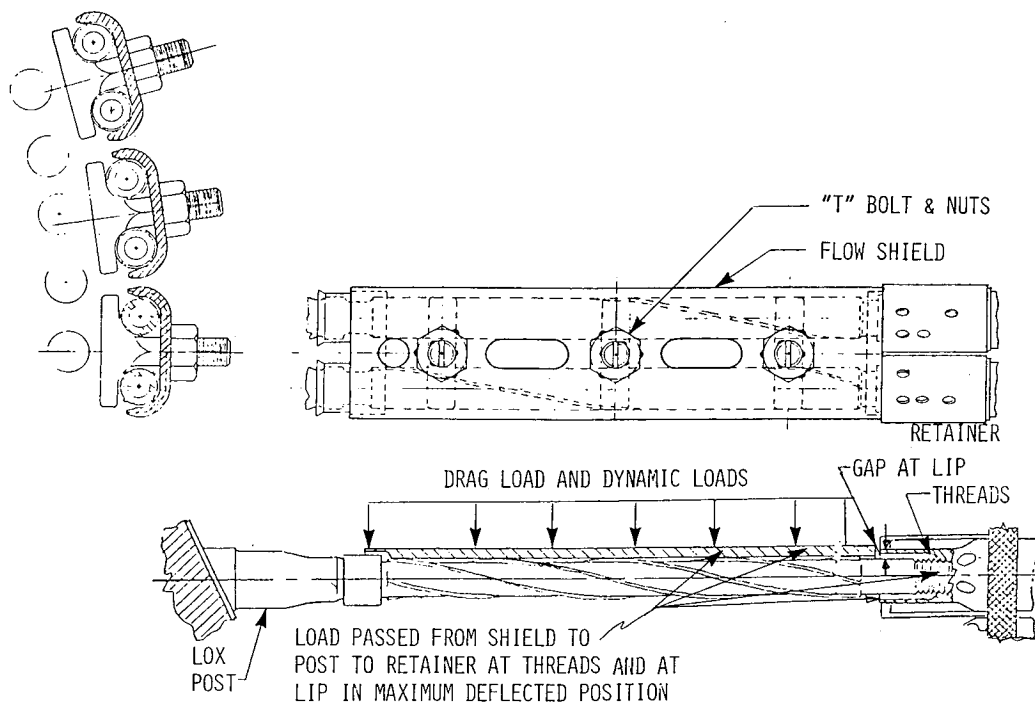
High velocity gas at a temperature of approximately 1800°F flows through the injector, then through the gap at the base of each post and around the tip of the injector plate, where it mixes with the liquid oxygen flowing down the center of the post. This flow environment, coupled with mechanical vibrations and variable dynamic characteristics, produces severe high cycle fatigue loading on the lox posts. This is worsened by high static stresses from the thermal and static pressure loads. Flow shields (Fig. 79) have been added to the outermost row, but the posts are still high cycle fatigue life limited, and there have since been two related engine failures during demonstration firings.

Metallurgical analysis determined that the failure mechanism was high cycle fatigue, initiating in the threads of the face plate retainer. Sources of alternating stress at that point are mechanical oscillations, vortex shedding, and fluctuating pressures (flow and acoustics). Static loads arising from thermal gradients and internal flow induced pressures are superimposed as a high mean stress to the alternating loads. Despite the presence of the flow shields, the highest fatigue loads and most frequent occurrence of fatigue cracks are in the outermost posts, row 13, and the next row, 12.

Figure 79. Lox post shield configuration.

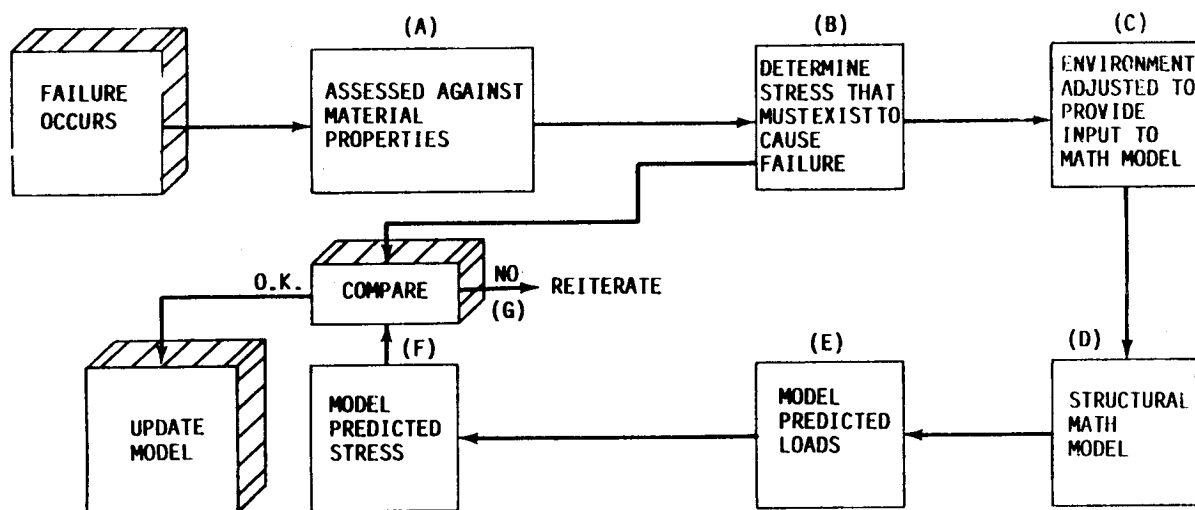
The approach used to rationalize the hypothesized failure mode was the approach shown on Figure 80. This is an alternate approach derived for attacking SSME lifetime problems in the absence of adequate flow data. A component failure is used as an empirical failure reference point, determining the stress level required for failure from the SN curve (minimum properties, maximum predicted temperature and pressures). The environments are "backed out" of these empirically derived data using the analytical dynamic model. The environments thus derived serve as a means of evaluating new designs and higher engine performance levels, as well as determining life limits.

(1) EMPIRICALLY UPDATED MODEL CAN BE USED TO PREDICT REDESIGNED CONFIGURATION CAPABILITY.

(2) THE INPUT ENVIRONMENTS ARE NOT ACCURATELY CHARACTERIZED

Figure 80. SSME lifetime verification analysis for special problem areas.

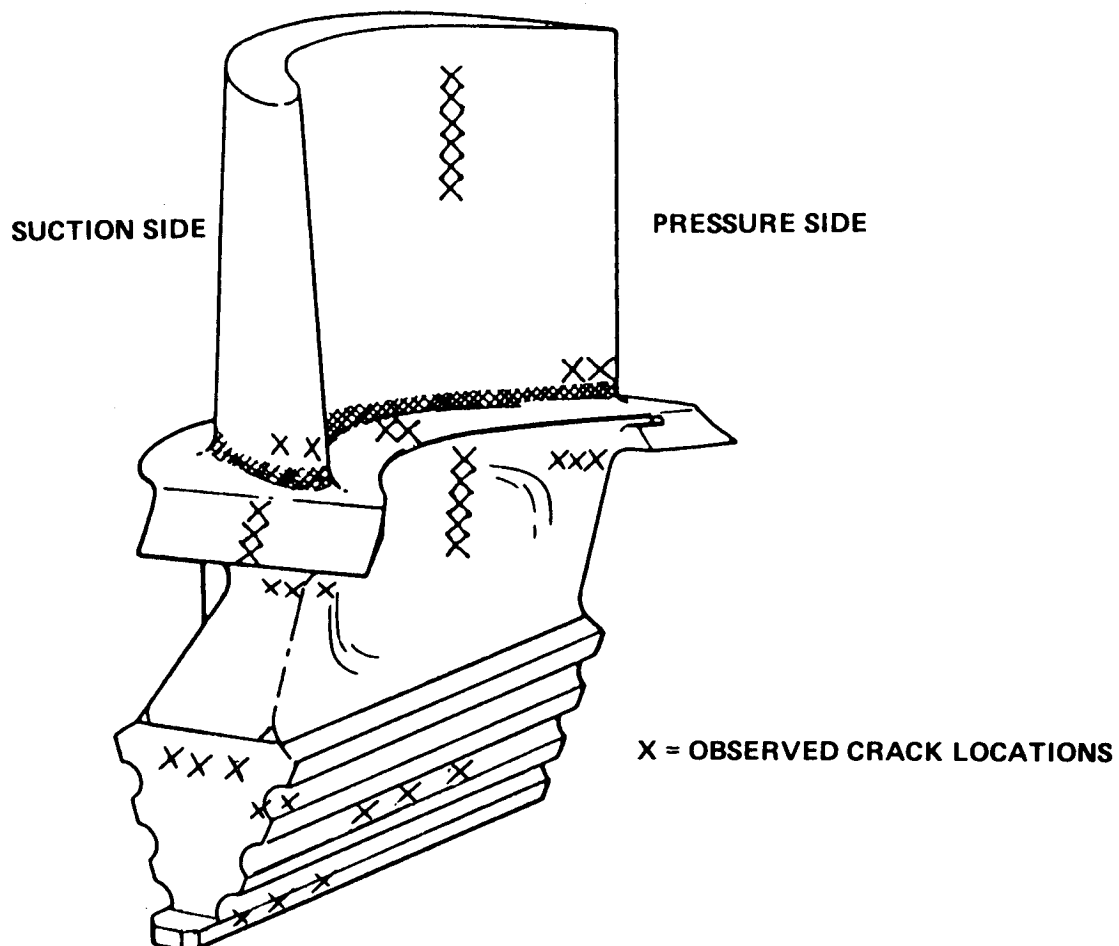
Figure 81. Areas of high stress and observed crack formation.

The high pressure fuel turbopump (HPFTP) is a three-stage centrifugal pump that is directly driven by a two-stage hot-gas turbine. The turbine is powered by hydrogen rich steam generated by the fuel preburner. Hot gas enters the turbine and flows across the shielded support struts, through the first and second stage nozzles and blades, and is discharged into the hot gas manifold. Requirements for high performance within a restricted envelope have led to a complex, cyclic-load-producing configuration of 13 struts, 41 first stage turbine blades at the locations shown in Figure 81. Although none have precipitated an engine failure, turbine blade life improvement remains a major goal in the SSME program.

Each instance of blade cracking has been addressed using an analytical/empirical approach similar to that described for the lox posts; loads and stresses are calculated by analysis, and the models are adjusted as required to be compatible with observed phenomena. A detailed finite element model has been generated for the blades. Detailed definition of the forcing functions has been accomplished by accurate modeling of the strut/nozzle/blade configuration, and the output has been matched to results obtained from special air rig and "whirlygig" tests. Basic material strength and fatigue data have been obtained over a range of operating stresses and temperatures. Figure 82 shows the form of the engineering solution with all of the data taken into consideration, including the observed frequency of the particular blade cracking incident under investigation. Curve 1 is for rated engine power level (RPL) assuming 5,000 sec of life. Curve 2 is full or maximum engine power level (FPL) and 5,000 sec of life, while curve 3 is the same power level assuming 2,500 sec of life. The mean stress for RPL is 46 Ksi, and for FPL, it is 55 Ksi. The blade operating temperature is in the 1,600 to 1,700° range, resulting in a low allowable alternating stress.

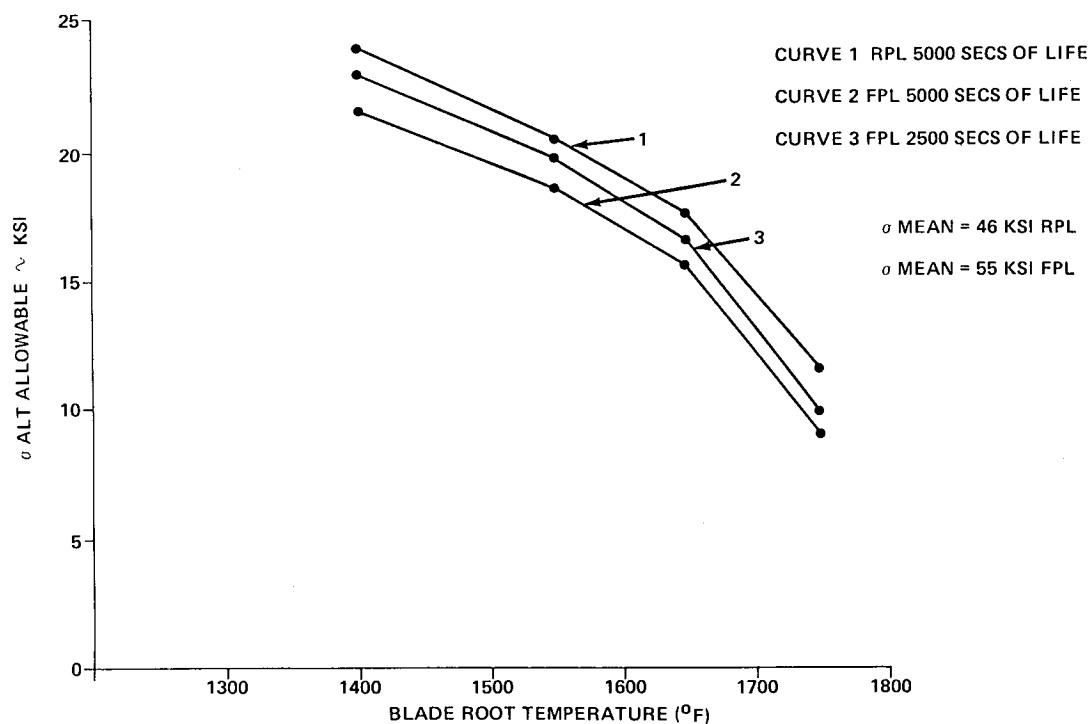
Figure 82. Alternating stress versus blade root temperature allowable.

At the present time, there are no serious blade cracking problems, although cracking still exists. Each instance of blade cracking has been solved by material-related improvements or environment modifications. Periodic inspections are required, however, and the average blade changeout interval of 3,000 to 5,000 sec is far short of the design goal of 27,000 sec. Studies for long-term improvement in blade life are in progress. Improved materials are being considered, including advanced superalloys in the single crystal form, and environment reduction techniques are under study, including different type dampers.

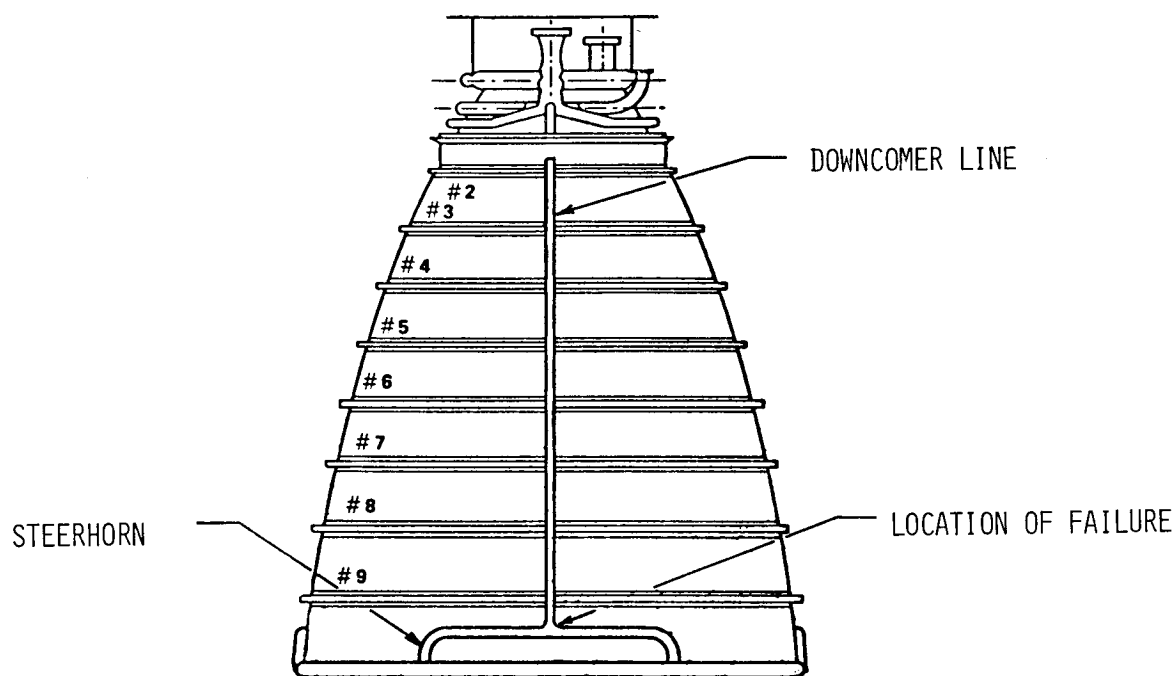
3) Nozzle and Steerhorn Engine Side Loads. The SSME nozzle has three engine downcomer coolant liners that take hydrogen from the main fuel valve to the aft nozzle manifold. The aft nozzle manifold feeds the coolant tubes which, in essence, is the engine nozzle. Two of these coolant lines have failed during hot engine firings due to high cycle fatigue. Figure 83 gives the basic configuration, showing the downcomer line (steerhorn). A history of cracking nozzle tubes has also plagued the engine.

The loads on the line nozzle system arise from firing of a high-expansion-ratio nozzle at sea level atmospheric conditions. The plume does not fill the nozzle until the internal pressure is greater than atmospheric pressure. As the nozzle plume flow velocity increases, it passes through a region where a Mach disc or cone exits the nozzle (Fig. 84). Two distinct phenomena occur during this thrust buildup phase. The first occurs around 600 to 700 psia chamber pressure. In this case, the plume is basically cylindrical in nature and is directionally unstable, moving around radially within the nozzle. The loads induced by this case drive the actuator design. The second occurs around 1,200 psia where the Mach cone leaves or enters the nozzle, creating high local shock loads. Figure 85 shows a typical thrust buildup and shutdown curve and stress response measured on the nozzle steerhorn. Response due to the side loads is clearly shown in this figure. The large strain amplitude occurs due to the excitation of the n = 0 (expansion mode) and the n = 6 (shell mode). Notice that the response is very sharp and around 250 Hz (the insert shows a blowup of the response) [2,48,59].

Figure 83. Description of nozzle system.
