Vacuum/Zero Net-Gravity Application for On-Orbit TPS Tile Repair

Gale A. Harvey, Donald H. Humes, and Emilie J. Siochi
NASA Langley Research Center

Twenty-Third IEST-NASA/AST/AIAA/CSA
Space Simulation Conference
Annapolis, MD
November 11, 2004

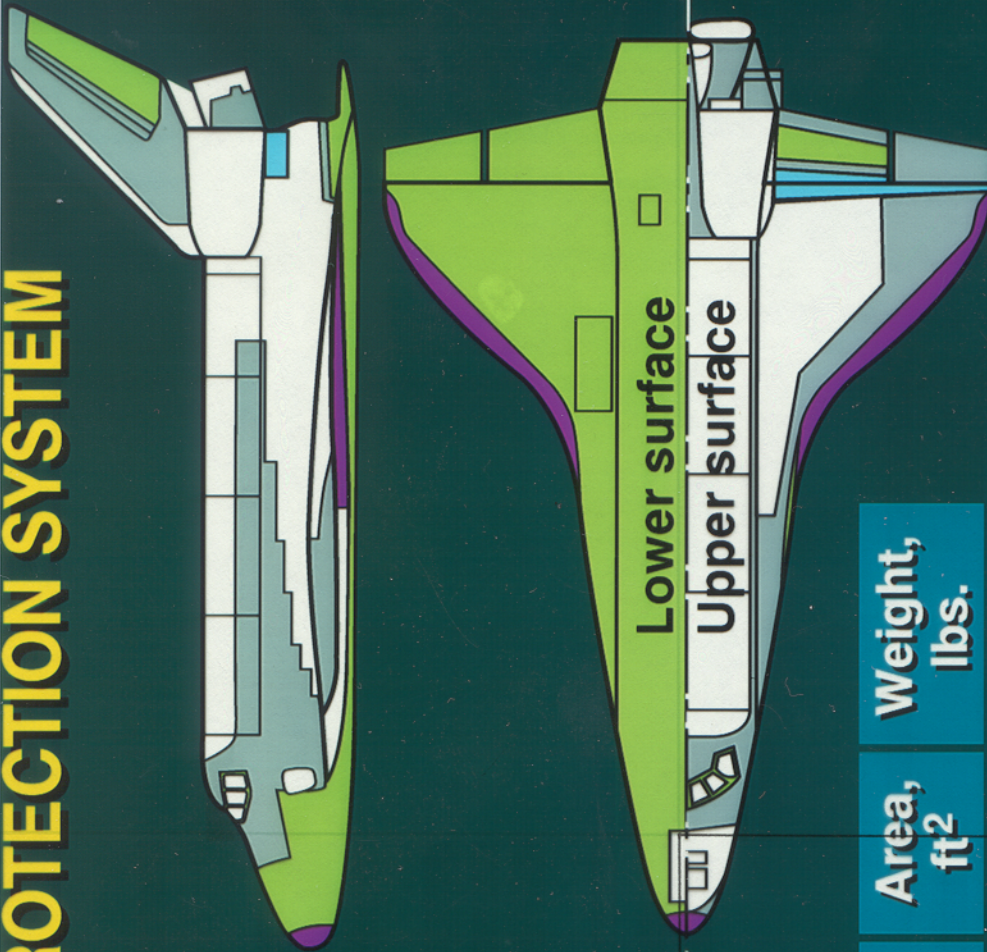
1. Space Shuttle Orbiter Thermal Protection System.

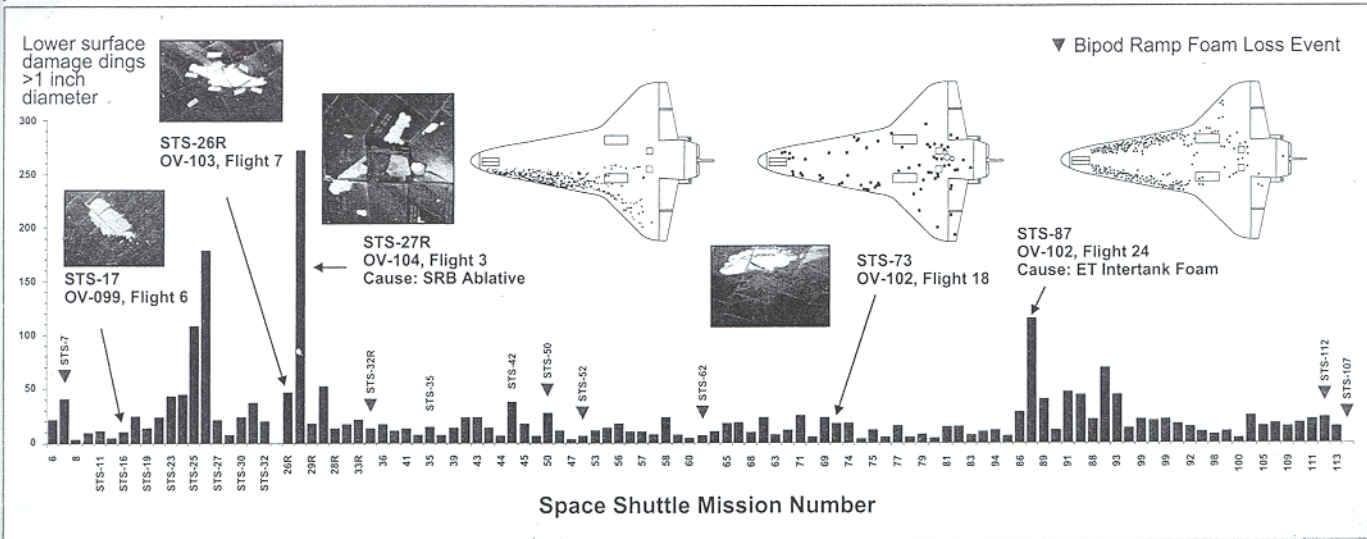
2. This chart shows the number of dings greater than one inch in diameter on the lower surface of the Orbiter after each mission from STS-6 through STS-113.

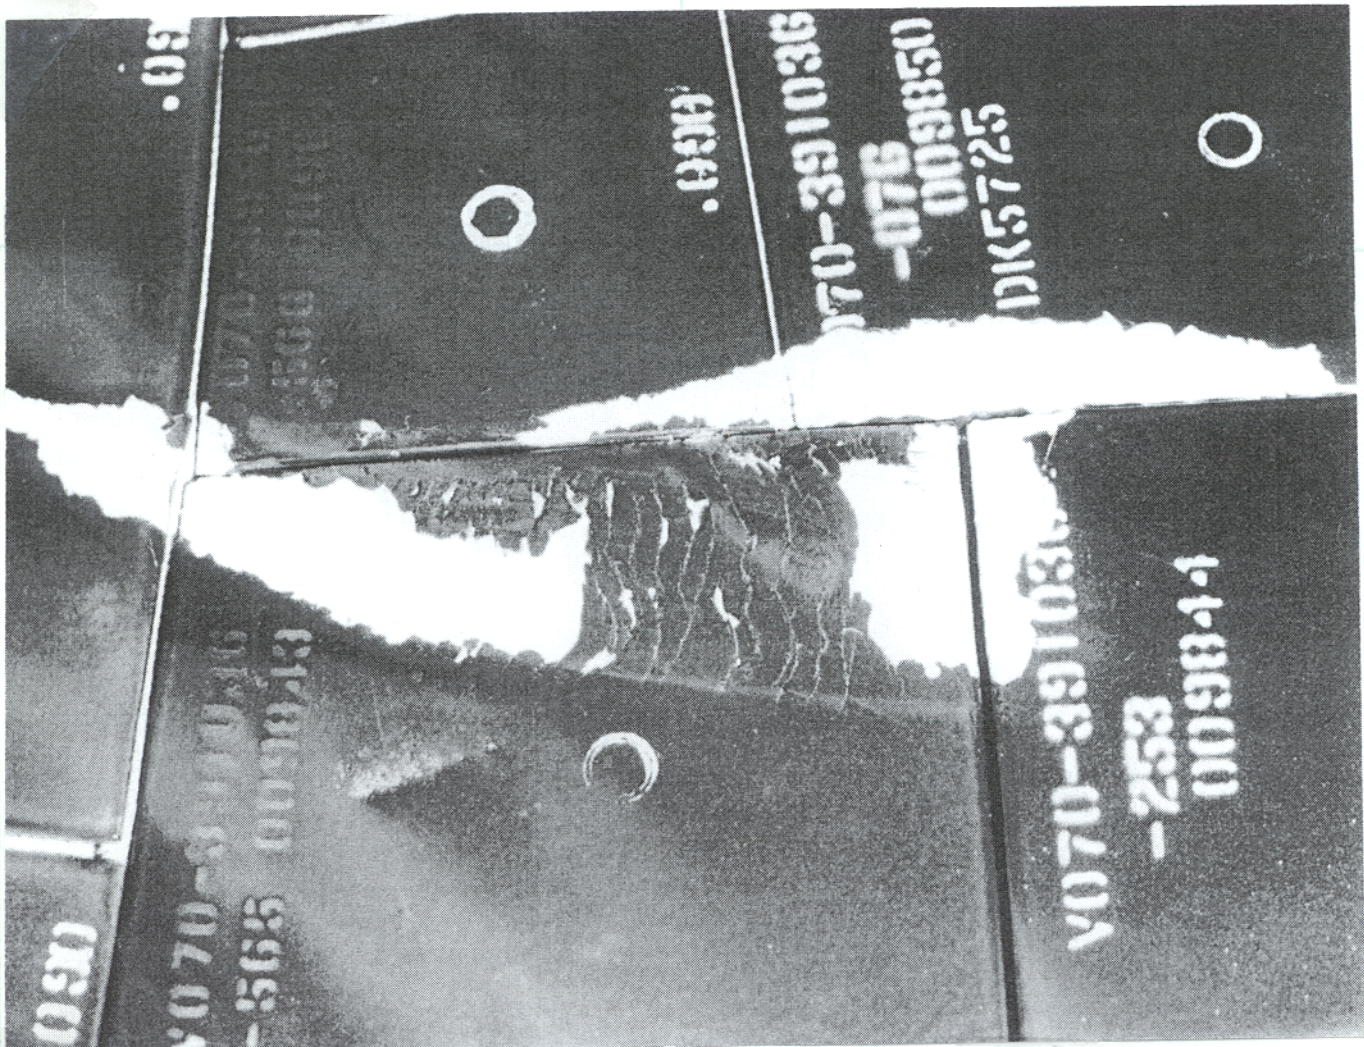
3. Impact damage in HRSI (TPS tile), right hand forward chine, STS 49.

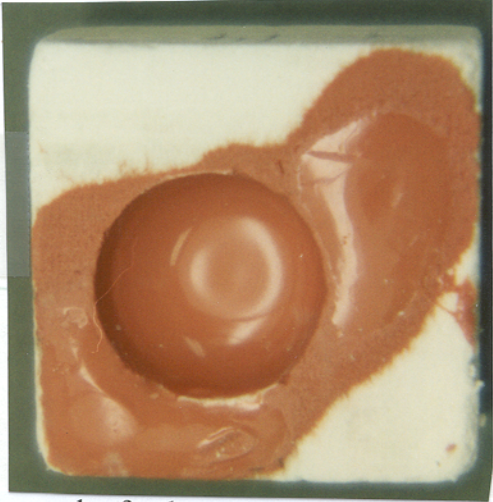
7. Photograph of color-enhanced phenyl methyl silicone mixed in air and dispensed into 1-inch pit in tile core in vacuum zero net gravity facility.

The first vacuum/zero net-gravity test was performed September 14, 2004. The first four tests are listed in Table 1. The first test demonstrated the operability of the facility. The phenyl-methyl silicone based repair material was premixed and placed in the cartridge of a small caulking gun-like dispenser. The tin catalyst-cure liquid resin had been previously vacuum degassed, but was not degassed again after the catalyst had been mixed in. Large bubbles (air and ethanol) were observed forming and bursting in the silicone injected into the HRSI core cavity-cup. A photograph of the cured silicone in the HRSI core cavity-cup is shown in figure 7.

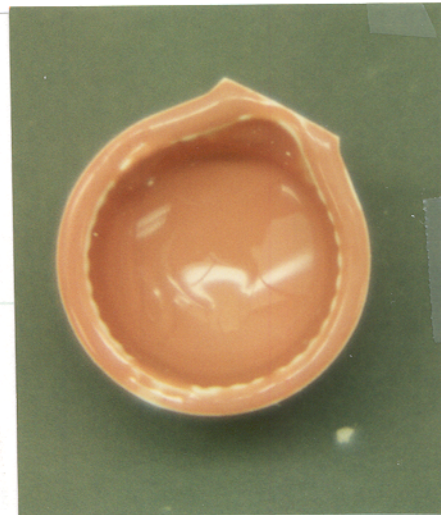
9. Photograph of color enhanced phenyl methyl silicone vacuum degassed after mixing in air and dispensed in vacuum/zero-net gravity facility.

The third vacuum/zero-net gravity test was performed September 29, 2004. The phenyl methyl silicone based repair material was premixed and vacuum degassed after mixing in the catalyst. Again the tip of the dispensing nozzle was inserted about ¼-inch into the cavity-cup. A few bubbles formed and burst during dispensing of the silicone into the cup. The silicone wicked into the cup, covering the floor of the cup. About half of the silicone remained in the cup and about half dripped onto the floor (and was collected in an aluminum foil pan). A photograph of the cured silicone in the cup is shown in figure 9.

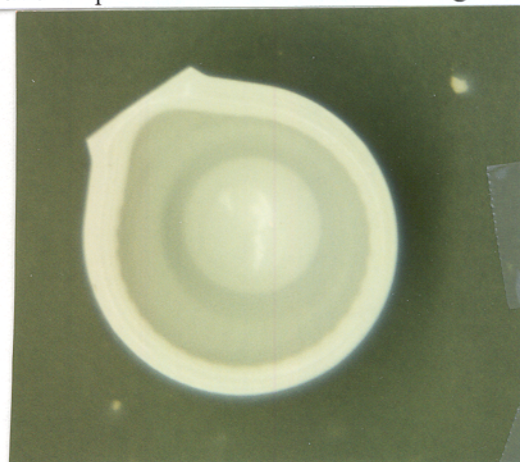
10. Photograph of vinyl silicone mixed and dispensed into 1-inch cup in vacuum/zero net gravity facility.

The fourth vacuum/zero-net gravity test was performed October 6, 2004. The vinyl silicone based repair material was not degassed and was not premixed. That is the resin and catalyst were mixed in the mixing nozzle during the dispensing of the material into the cavity cup. The tip of the nozzle was inserted about ¾-inch into the cavity-cup. A very few bubbles formed at the tip of the nozzle at the beginning of the dispensing of the silicone, and then no bubbles were observed for the remainder of the dispensing. 3.8 gm of silicone wicked into the bottom of the cup, and formed a deep meniscus within the cup. About 6.3 gm of the silicone dripped out of the cup. The vinyl silicone is a low viscosity

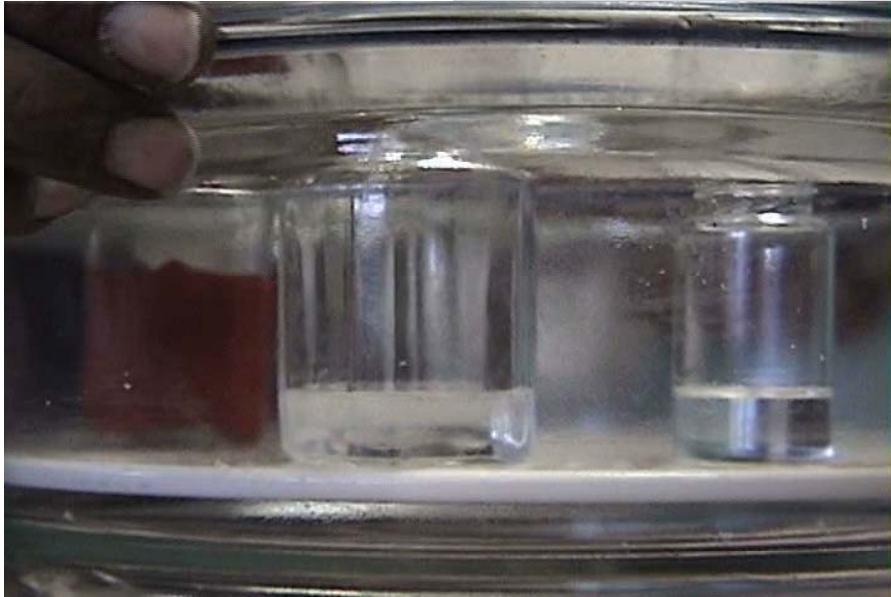
Prior to Application
of Reduced
Pressure

A Few Seconds After
Application of Reduced
Pressure

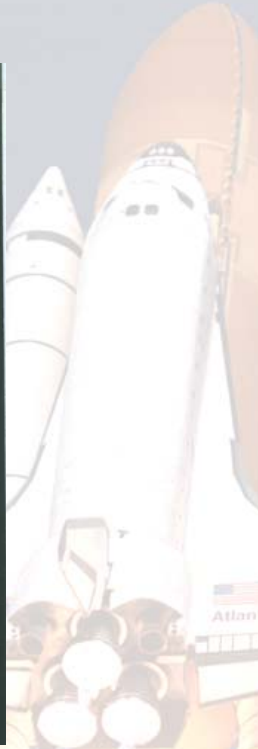
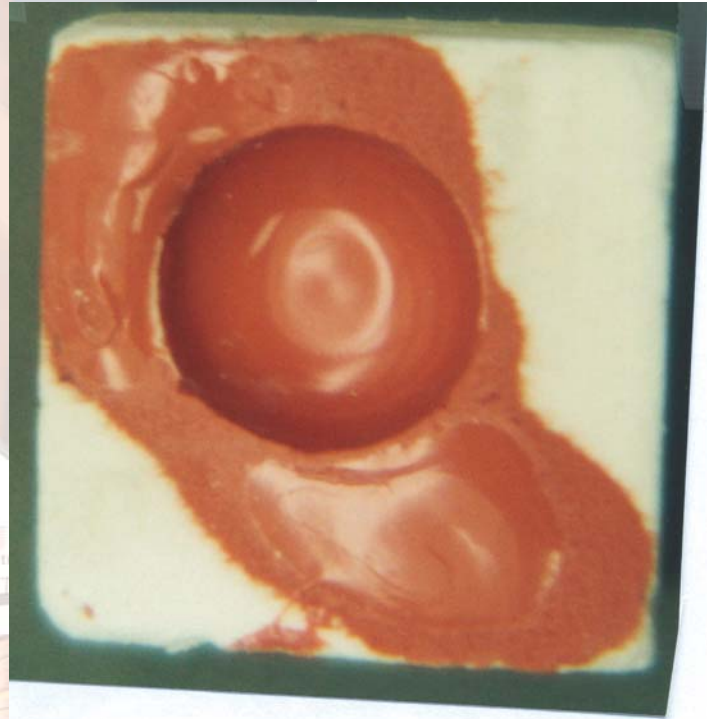
Effect of Dispensing Environment on RTV

In Air

Under Vacuum

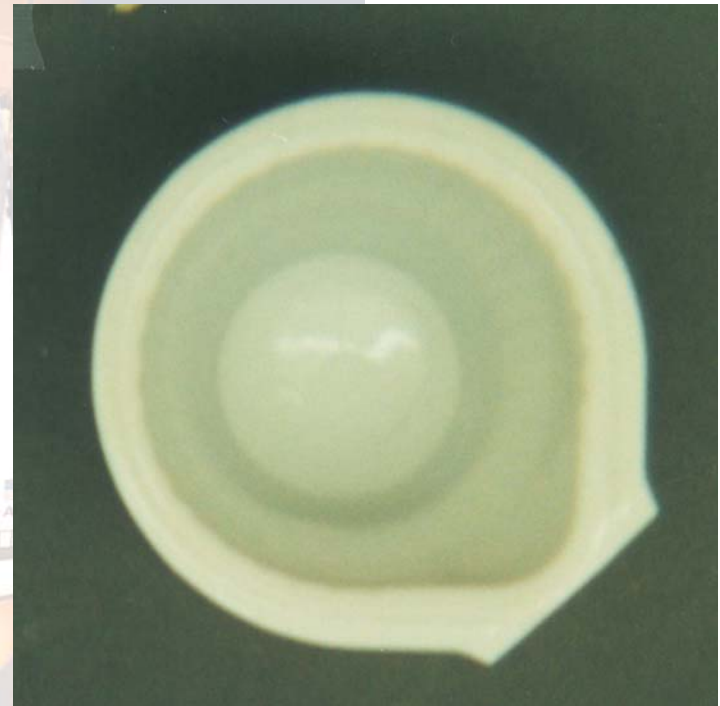
Effect of Entrained Air on Injection into Damage Cavity

Mixed in Air

Mixed in Vacuum
