# Nondestructive Evaluation for the Space Shuttle's Wing Leading Edge

Eric I. Madaras\*, William P. Winfree†, William H. Prosser\*,  
Russell A. Wincheski\*, and K. Elliot Cramer\*  
*NASA Langley Research Center, Hampton, VA 23681*

The loss of the Space Shuttle Columbia highlighted concerns about the integrity of the Shuttle's thermal protection system, which includes Reinforced Carbon-Carbon (RCC) on the leading edge. This led NASA to investigate nondestructive evaluation (NDE) methods for certifying the integrity of the Shuttle's wing leading edge. That investigation was performed simultaneously with a large study conducted to understand the impact damage caused by errant debris. Among the many advanced NDE methods investigated for applicability to the RCC material, advanced digital radiography, high resolution computed tomography, thermography, ultrasound, acoustic emission and eddy current systems have demonstrated the maturity and success for application to the Shuttle RCC panels. For the purposes of evaluating the RCC panels while they are installed on the orbiters, thermographic detection incorporating principal component analysis (PCA) and eddy current array scanning sys

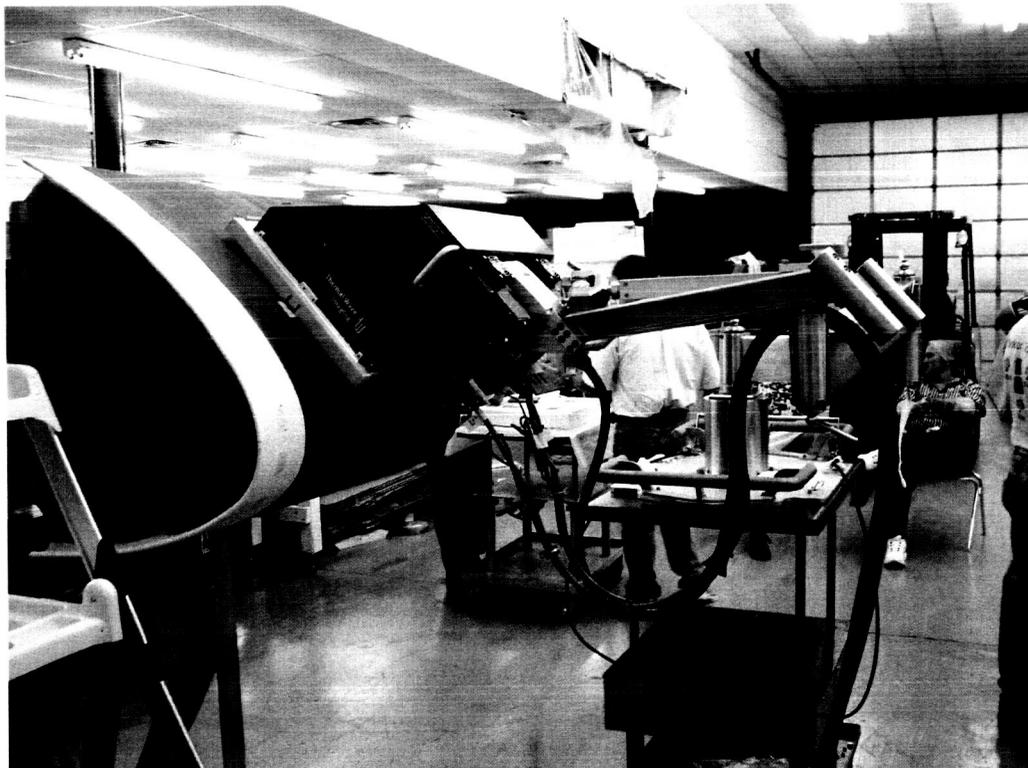
**Figure 3. Evaluation of thermography system on RCC panel.** *Picture illustrates the system mounted on a movable cart measuring an RCC panel during testing at Oceaneering Space Systems in Houston, TX*

Figure 3 shows a photograph of the thermography system during acceptance testing. This system will ultimately be deployed in the Orbiter Processing Facilities at KSC. The system has a thermal hood to direct the energy from the high intensity flash lamps to the inspection surface in an efficient manner. The area of the hood's opening allows 0.9 square feet of RCC to be measured at a time. An image takes 14 seconds to acquire and an additional 15 seconds to process. The whole system is mounted on a cart that is confined to a track that follows the orbiter wing. The system can be rapidly and safely positioned along the whole edge of the orbiter wing. It is currently estimated that all the

RCC panels on the wing and on the nose of the shuttle can be scanned in about one week's time. In extensive testing, thermography demonstrated its ability to detect subsurface delaminations in the carbon-carbon, damaged SiC coatings, and erosion of the carbon-carbon material under the SiC coating. The system is required to detect a 0.375 inch diameter flaw through out the thickness of the RCC panel.

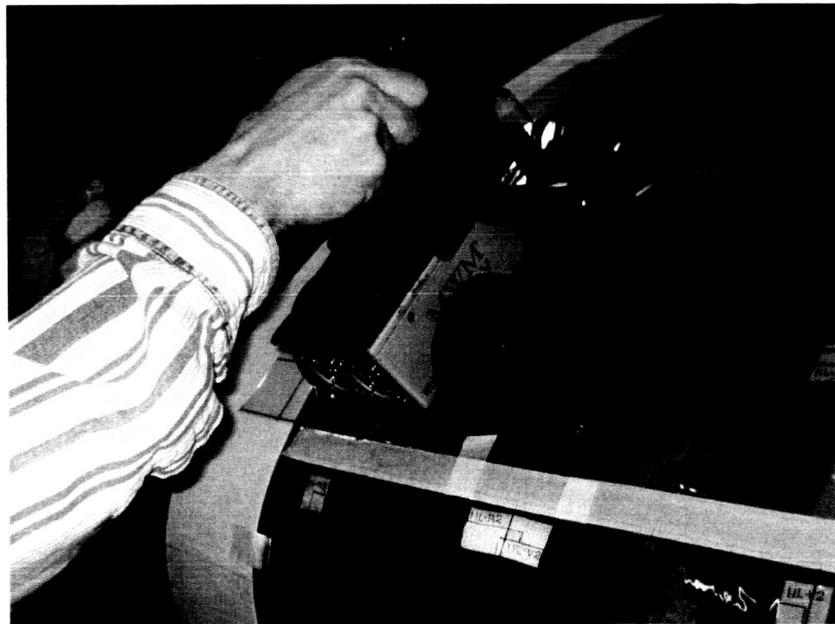
**Figure 6. Eddy current array being used to rapidly scan an RCC panel.** *The array system shown can produce a nearly four-inch wide scan of RCC material with one pass of the rolling carriage. Multiple passes will build up a coherent image of the in-phase and out of phase signals from the RCC material.*

Figure 6 shows an eddy current array being used to rapidly scan an RCC panel. The panel has a thin layer of plastic laid over the RCC to eliminate potential contamination and wear to the surface and to delineate a scan grid. This system can produce nearly a four-inch wide scan of RCC material with one pass of the rolling carriage at one inch per second. The system can scan a one-foot square area in less than 60 seconds with a real time output display. The information provided to the operator includes information about the thickness of the SiC protective layer as well as the conductivity of the carbon-carbon substrate. That information can be translated into information about erosion of the SiC surface layer and damage or cracking of the carbon-carbon substrate.
