Problems Experienced and Envisioned for Dynamical Physical Systems

Robert S. Ryan

George C. Marshall Space Flight Center
Marshall Space Flight Center, Alabama

TECHNICAL PAPER

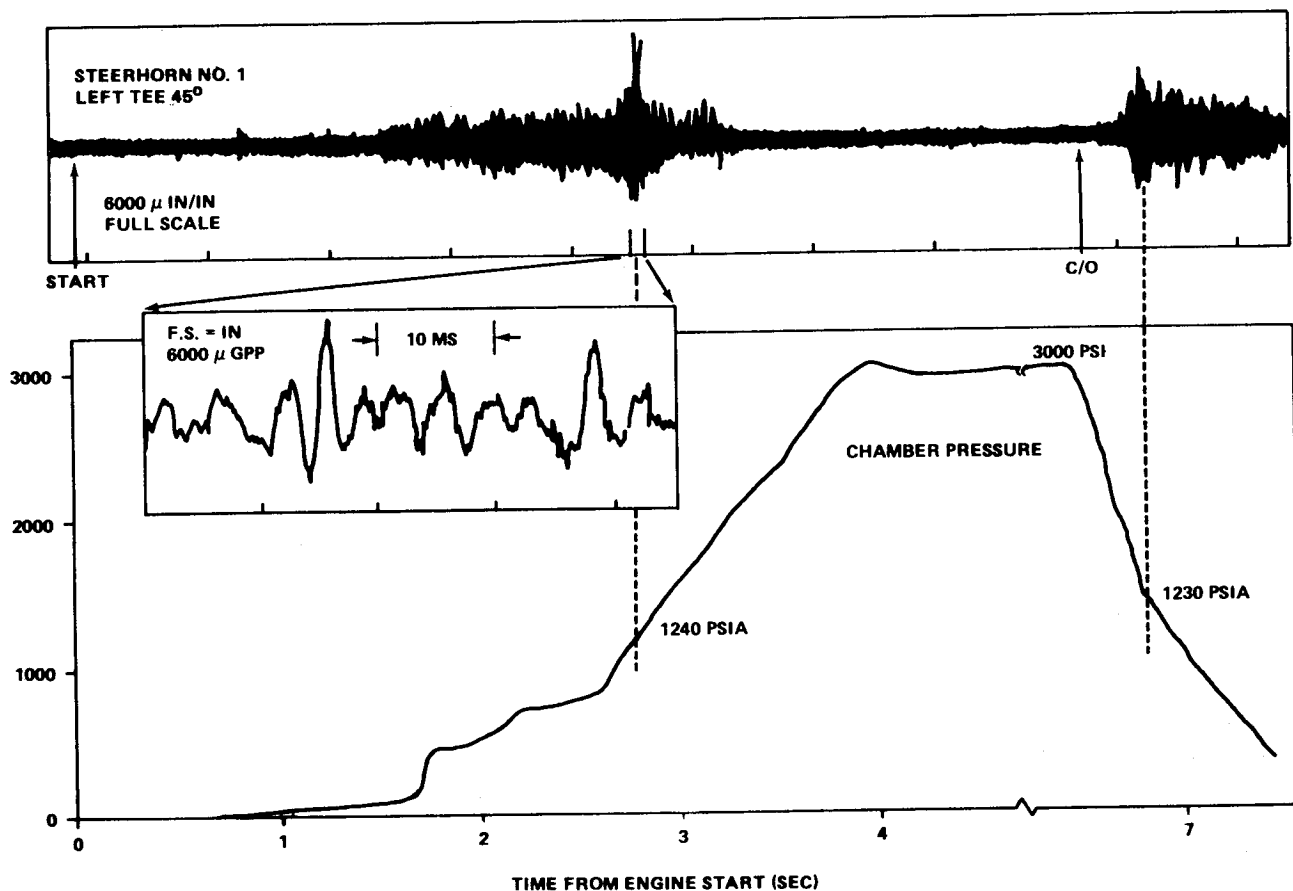
ENGINE 0007, TEST 901-250

Figure 85. Steerhorn strains in transient operation.

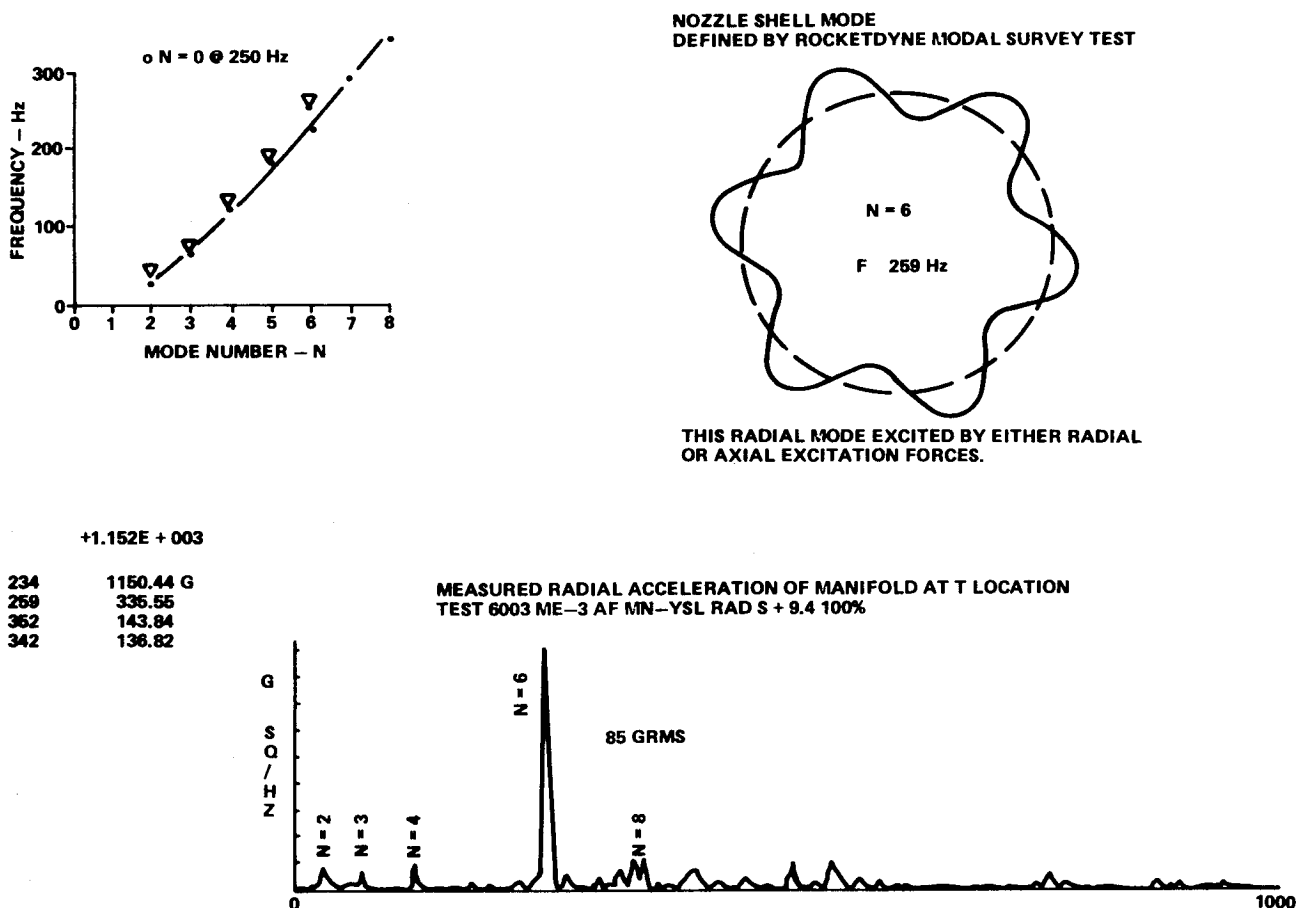
Figure 86 depicts the n = 6 shell mode on the right-hand side. The left-hand side of the figure shows the shell mode frequencies as a function of n-number. At the bottom of the figure is a spectrum of the measured acceleration of the engine nozzle aft manifold showing presence of all n modes but by far the larger peak occurring for the n = 0 and n = 6 modes.

Figure 86. Nozzle shell mode defined by modal survey test.

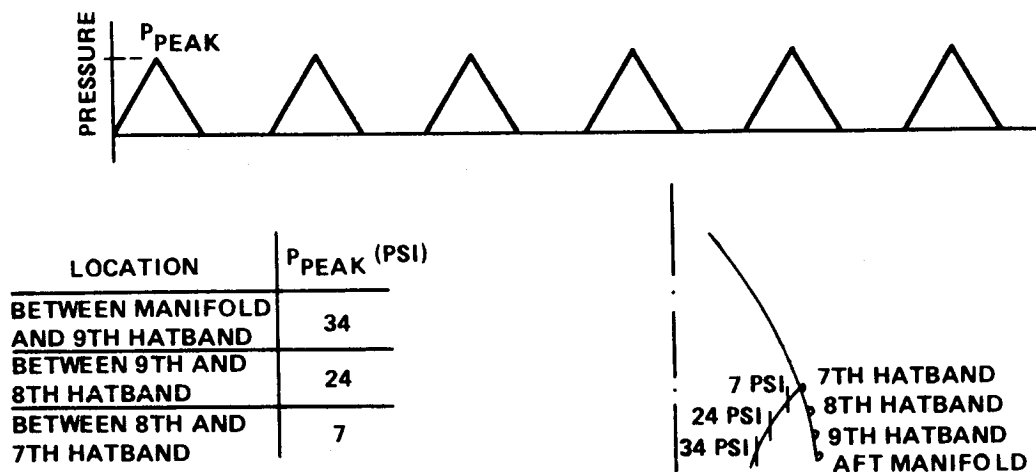
Two test programs were instituted to finalize these loads and the redesign: Scale model engine cold-flow test and full-scale flight nozzle dynamic test (Fig. 87). The dynamic model used in this analysis was verified in a full-scale dynamic test. Analytical modes had good agreement with test modes. The cold-flow model test varied the flow rate, etc., and determined the forcing functions. A full set of pressure gauges was mounted so that the force distribution could be determined. These results were scaled to full scale.

LOCATION	P_{PEAK} (PSI)
BETWEEN MANIFOLD AND 9TH HATBAND	34
BETWEEN 9TH AND 8TH HATBAND	24
BETWEEN 8TH AND 7TH HATBAND	7

PRESSURE DISTRIBUTION IS UNIFORM CIRCUMFERENTIALLY

Figure 87. Nozzle model pressure pulses.

Using these test-derived forcing functions, a dynamic response analysis was made for both the original design and the redesigned steerhorn configurations (steam loop). Good agreement with hot-firing data was obtained. The reduction in loads is approximately 40 percent for the redesigned case, providing infinite life. Based on this analytical work and the statistics of the hot-firing data, a lifetime prediction of the redesigned steerhorn was accomplished verifying a redesign that would meet the 55-mission lifetime requirement.

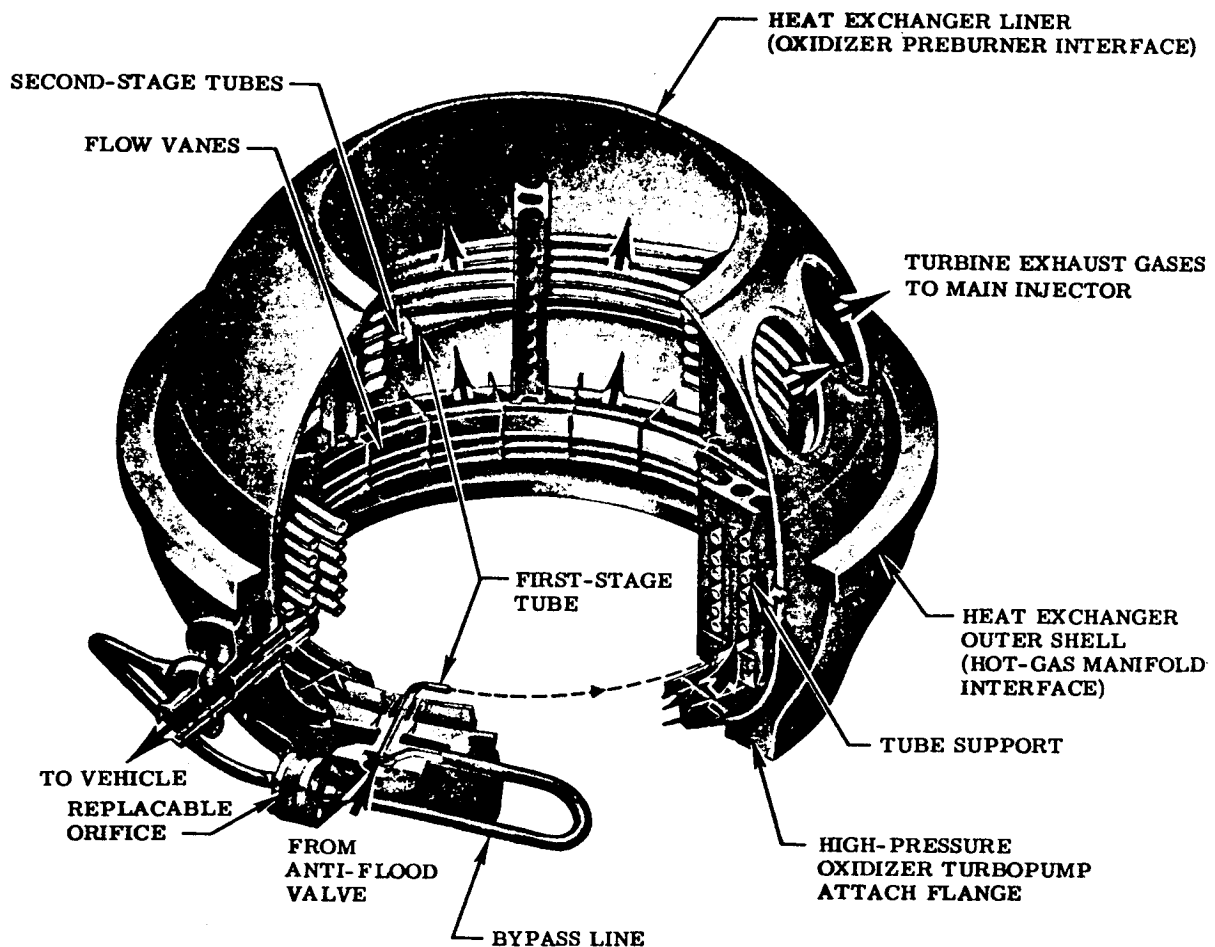
4) Heat Exchanger (HEX). The heat exchanger is a multipath, single-pass, coil pack installed in the oxidizer side of the hot-gas manifold (HGM). It has an orificed bypass line directly outside. It converts liquid oxygen to gaseous oxygen pressurant for ET oxygen tank and pogo accumulator pressurization. The coil pack consists of a helically wound, small tube approximately 30.6 in. long, in series with two parallel, larger tubes each approximately 310 in. long. The coil pack is held in place by a support assembly that is attached to the HGM liner. The cross-flow of hot turbine exhaust gases from the high-pressure oxidizer turbopump (HPOTP) provides the heat energy needed to convert liquid oxygen to gas (Fig. 88). A failure occurred during main engine hot firing where a line fractured due to vibration at a point where the welder struck a bad arc. The prime cause was a defect from welding. In addition, tube wear has been a concern where the tubes pass through the supports. The wear has not led to a failure. In fact, under extensive vibration testing (7.5 hr in each axis) the wear did not cause failure. Wear cannot be predicted analytically. As a result, the special tests have been run (in addition to the 7.5 hr, 5 each axis) in order to verify that manufacturing tolerances would not lead to a problem. Great care must be expended to insure that no problem occurs since gaseous oxygen is present producing high potential for fires. The vibration of coils and lines are typical of the kind of dynamic problems engineers must be continually aware of.

Figure 88. SSME heat exchanger.

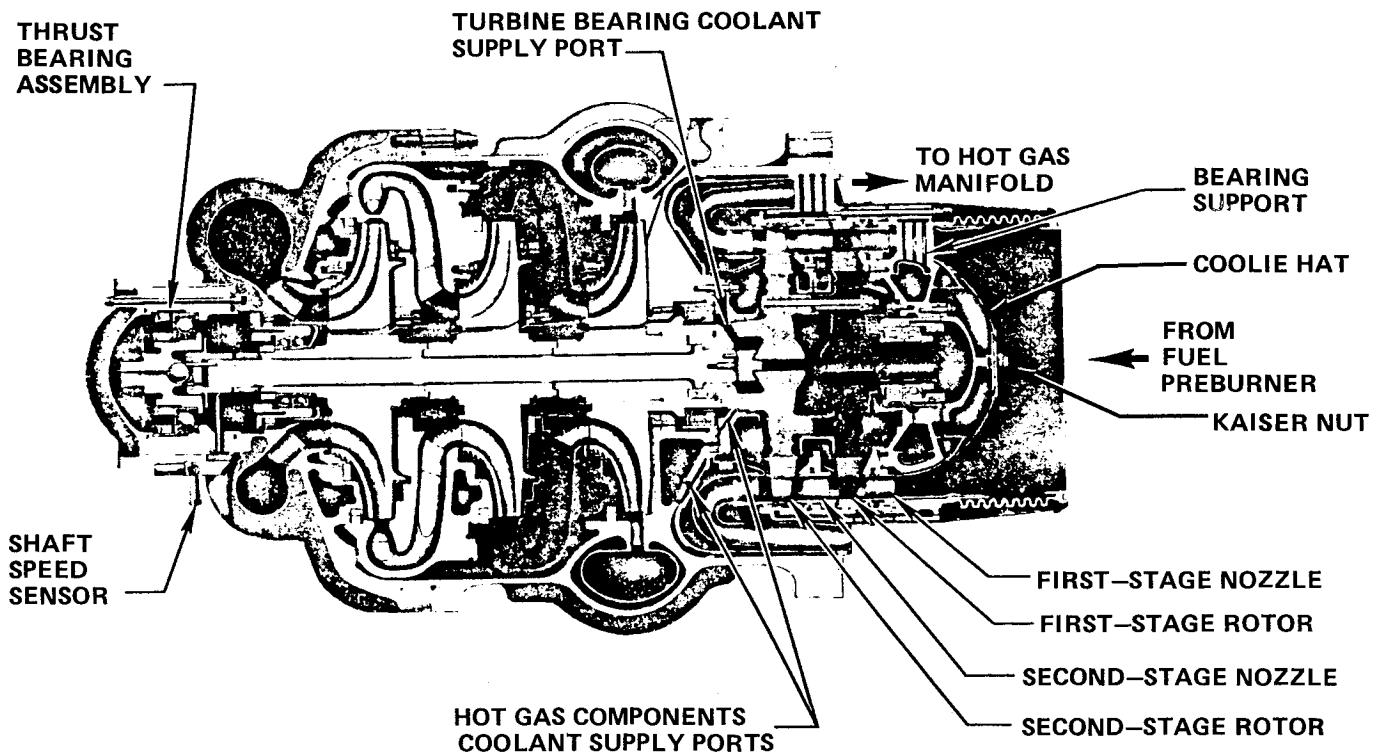
5) Coolie Hat/Nut. The HPFTP is powered by hot-gas (hydrogen-rich steam) generated by the fuel preburner (FPB). The preburner hot gas flows directly on the coolie hat (flow diverter and protector) which is held in place with a large nut (Fig. 89). Early in the program, the nut kept loosening due to thermal cycles and vibration. No major problems resulted; however, it was deemed worthy of a redesign. The redesign allowed some leak paths, since the cavity behind the coolie hat was a lower pressure than the hot gas. In addition, the Augmented Spark Igniter (ASI) system created poor mixing and a direct impingement of oxidizer and fuel on the nut. As a result, the unit was burned in the coolie hat area, shutting down an engine. Figure 90 shows this impingement and hot gas flow path. Obviously, the problem had to be solved through a redesign eliminating the leak path. The problem illustrates how apparently small changes instituted to solve one problem and improper evaluation and design can lead to a more dramatic problem. It also illustrates the various problems encountered in high performance systems with stringent environments. Failures of this nature also have large program impacts, since a failure board was formed with indepth investigation and some schedule slip.

Figure 89. Fuel pump cut away showing coolie hat.

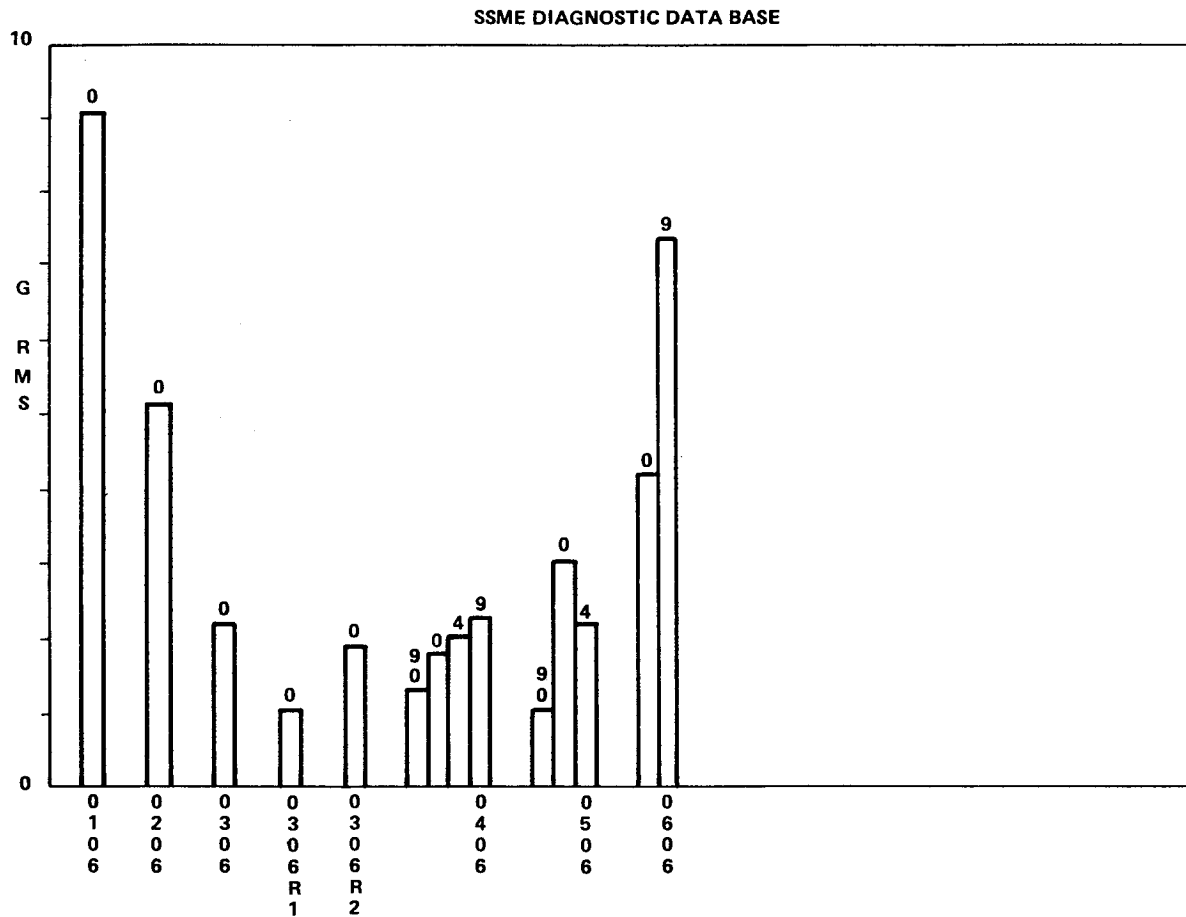
As mentioned previously, the pump response is very sensitive to small changes. Figure 91 is the average response of one pump for each of its eight builds (each build is a changeout of bearings, seals, or turbine blades, etc.; however, all major parts are the same). Notice the large variation in response even though each met all specifications including rebalancing. Responses range from 1.5 to 9 g's synchronous.

Figure 91. Pump response variation as function of builds (refurbishment).

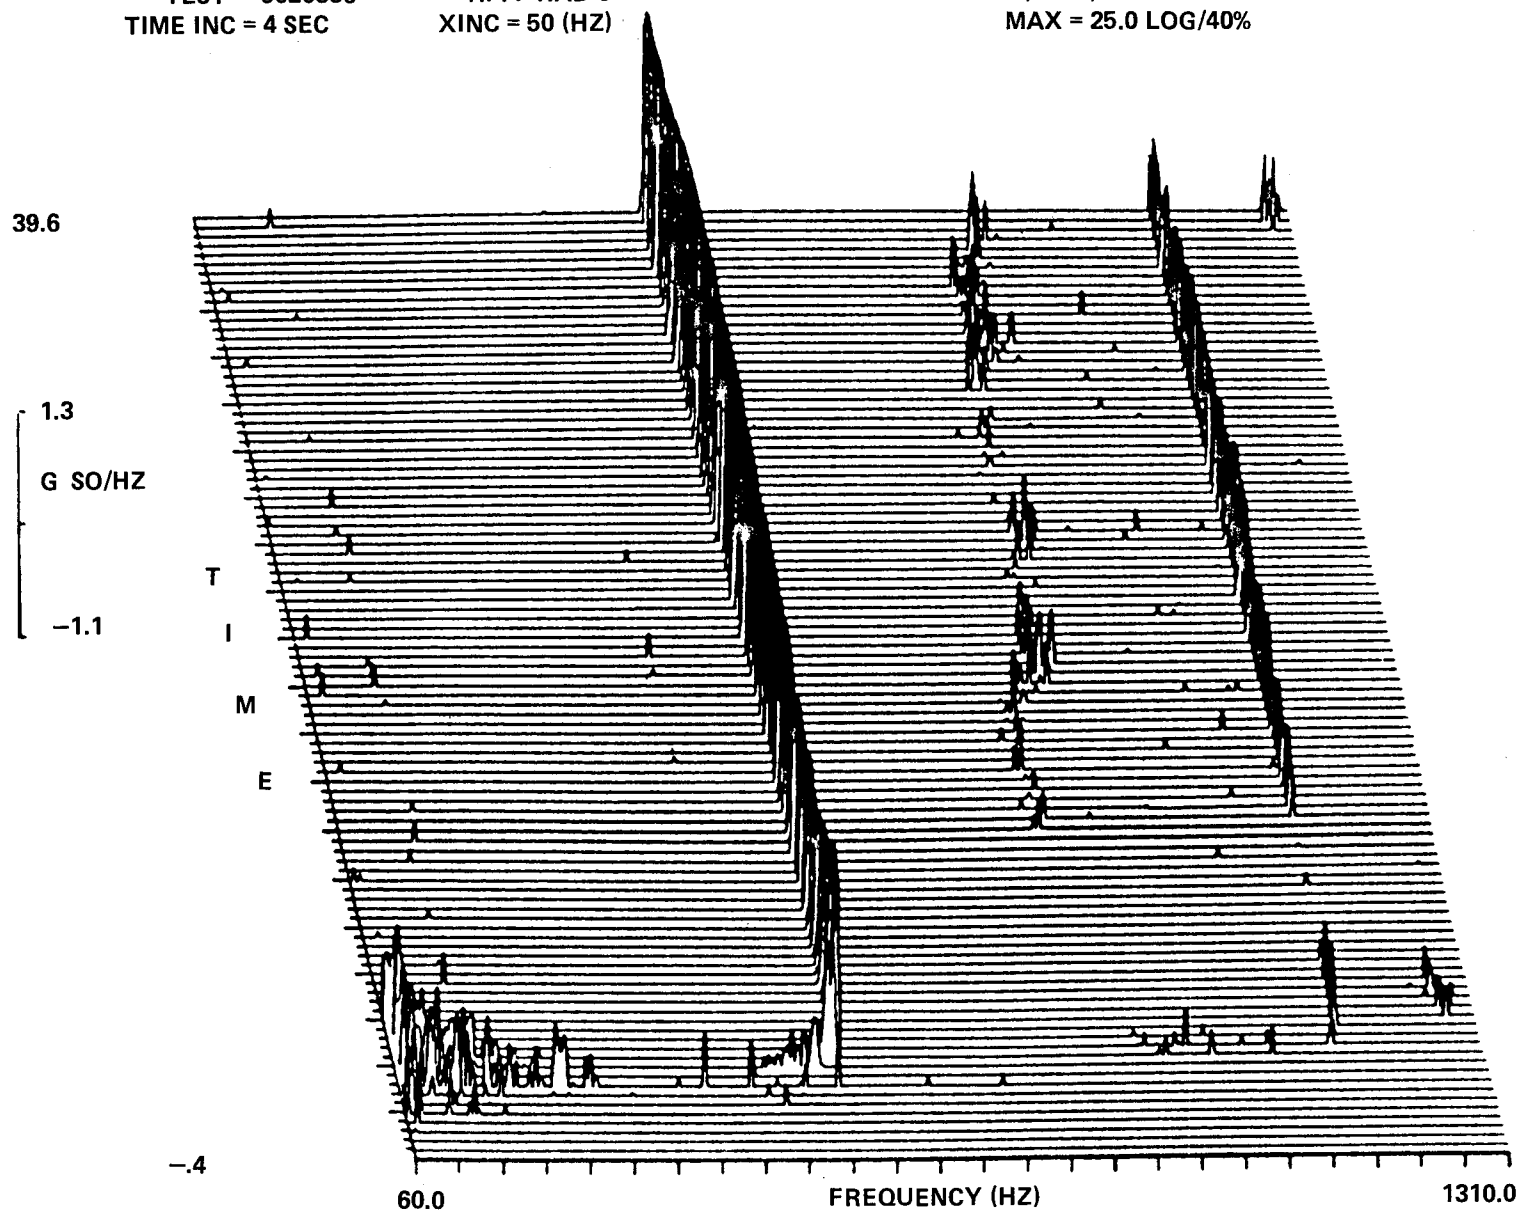
A typical pump response (isoplot) is shown on Figure 92. The predominant response is synchronous with a small 2 N response. Isoplots are a series of spectrum plots every 0.4 sec giving a pictorial of frequencies versus time. Amplitude is shown but is hard to read due to the overlapping of spectrums. Individual spectrums are used to get correct amplitudes. Anomalous behavior would show up as additional frequencies on the isoplot.

Figure 92. Typical isoplot of a pump accelerometer response.

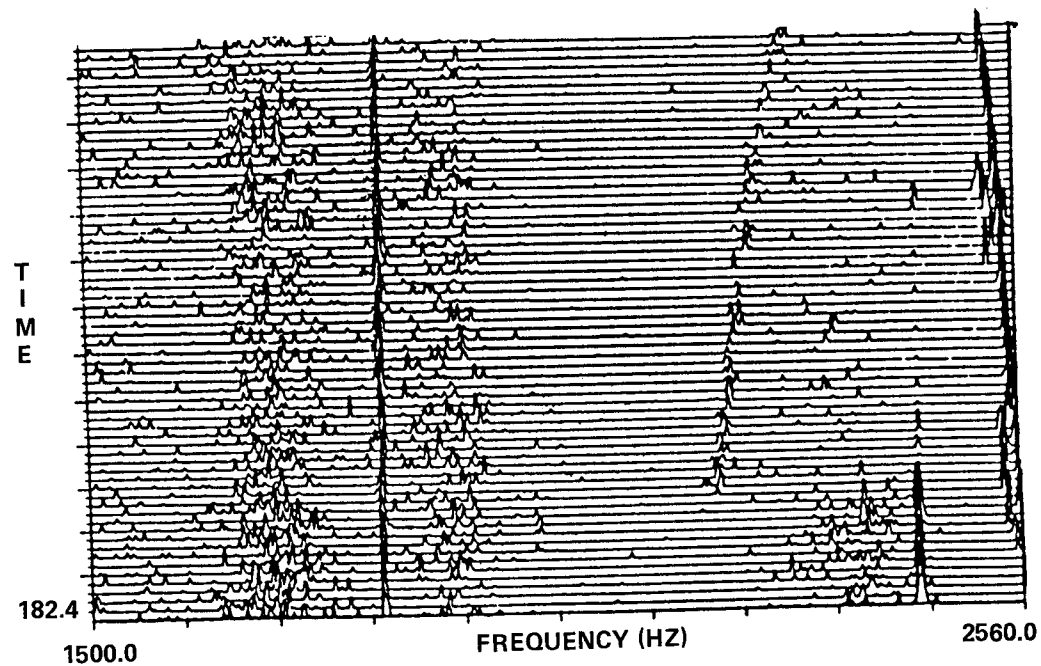
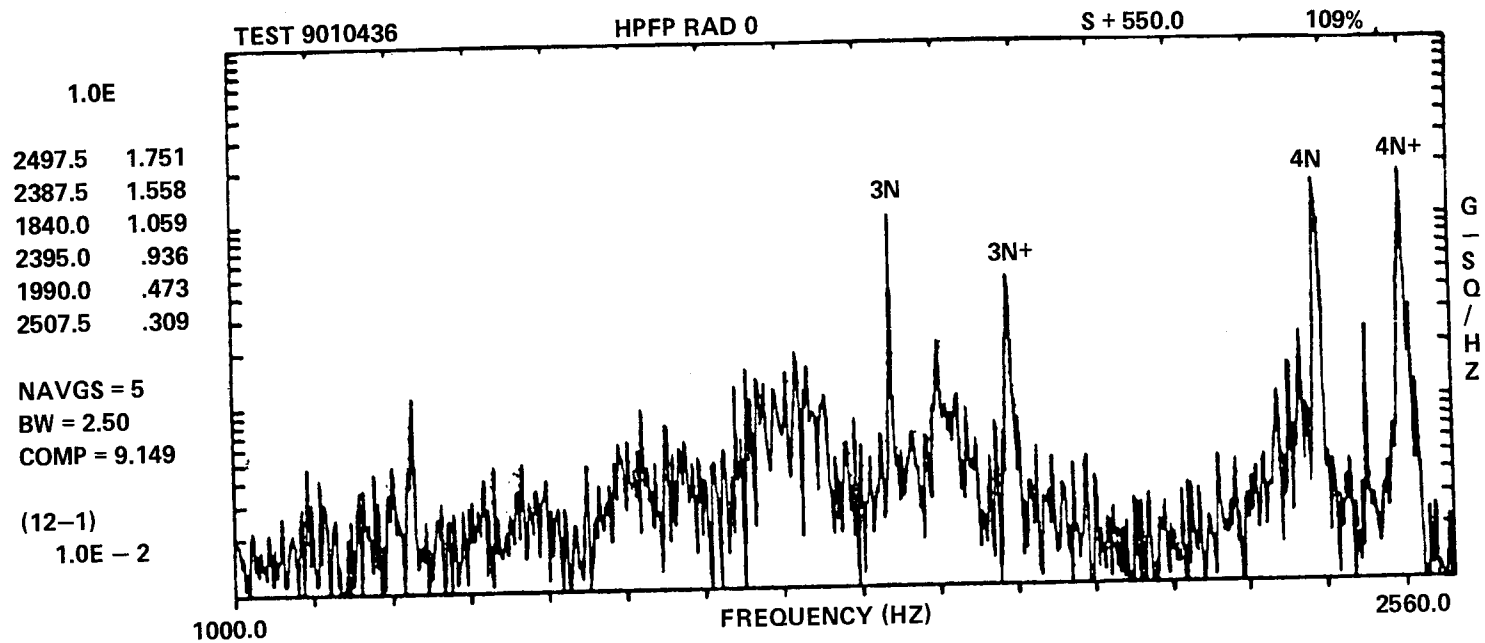
Figure 93 is an isoplot for a pump with rubbing. Notice the distinct 3N and 4N frequencies. Also, notice that distinct frequencies exist slightly above 3N and 4N. These are indicated on the individual spectrum placed above the isoplot. Many times, these frequencies are not constant with power level but move around indicating something like brake squeal going on (Fig. 94).

Figure 93. Isoplot showing frequencies indicating rubbing.

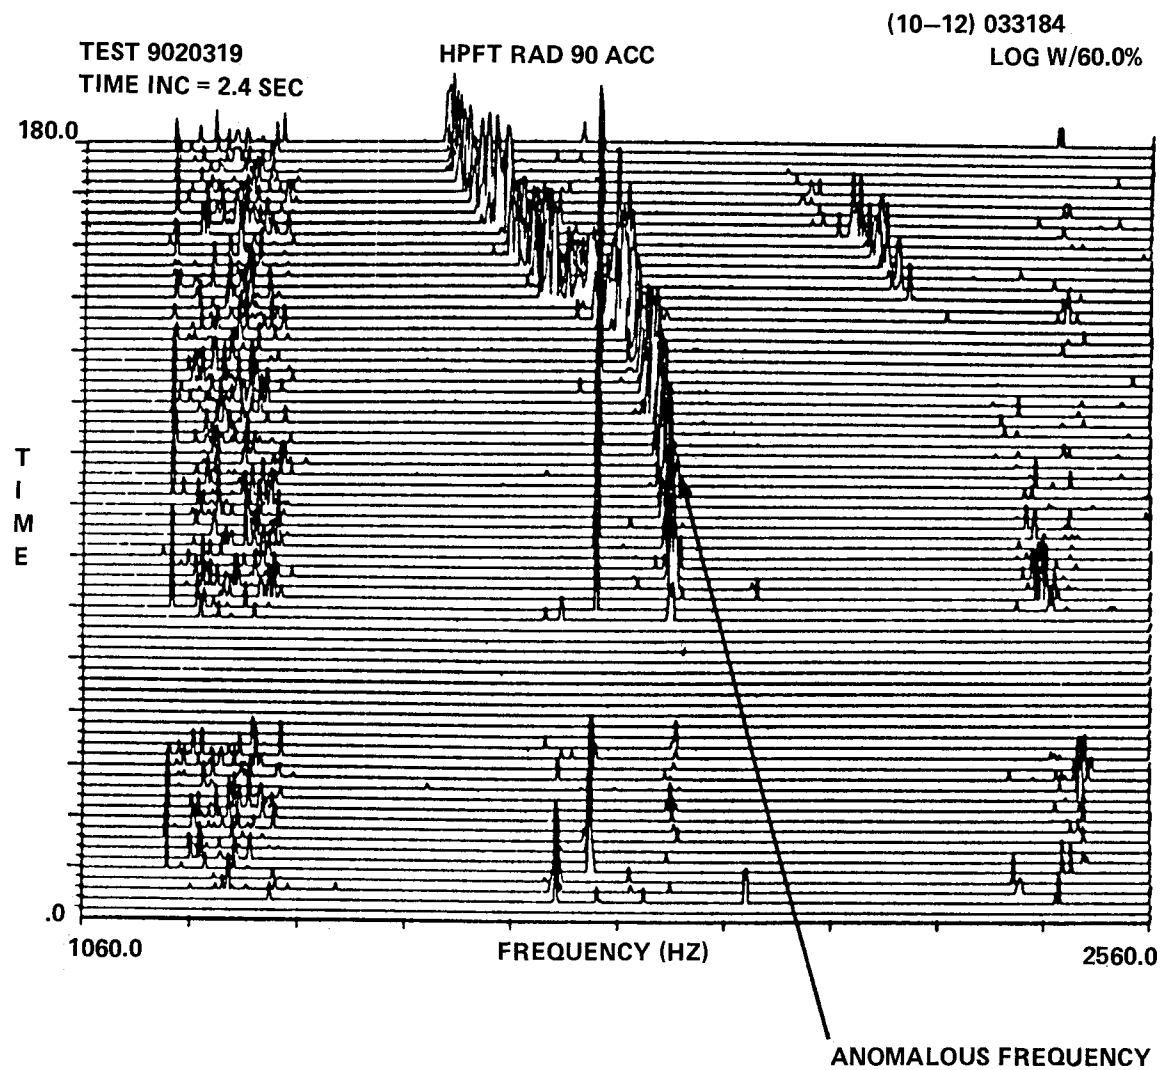
Figure 94. Anomalous frequencies in response data.

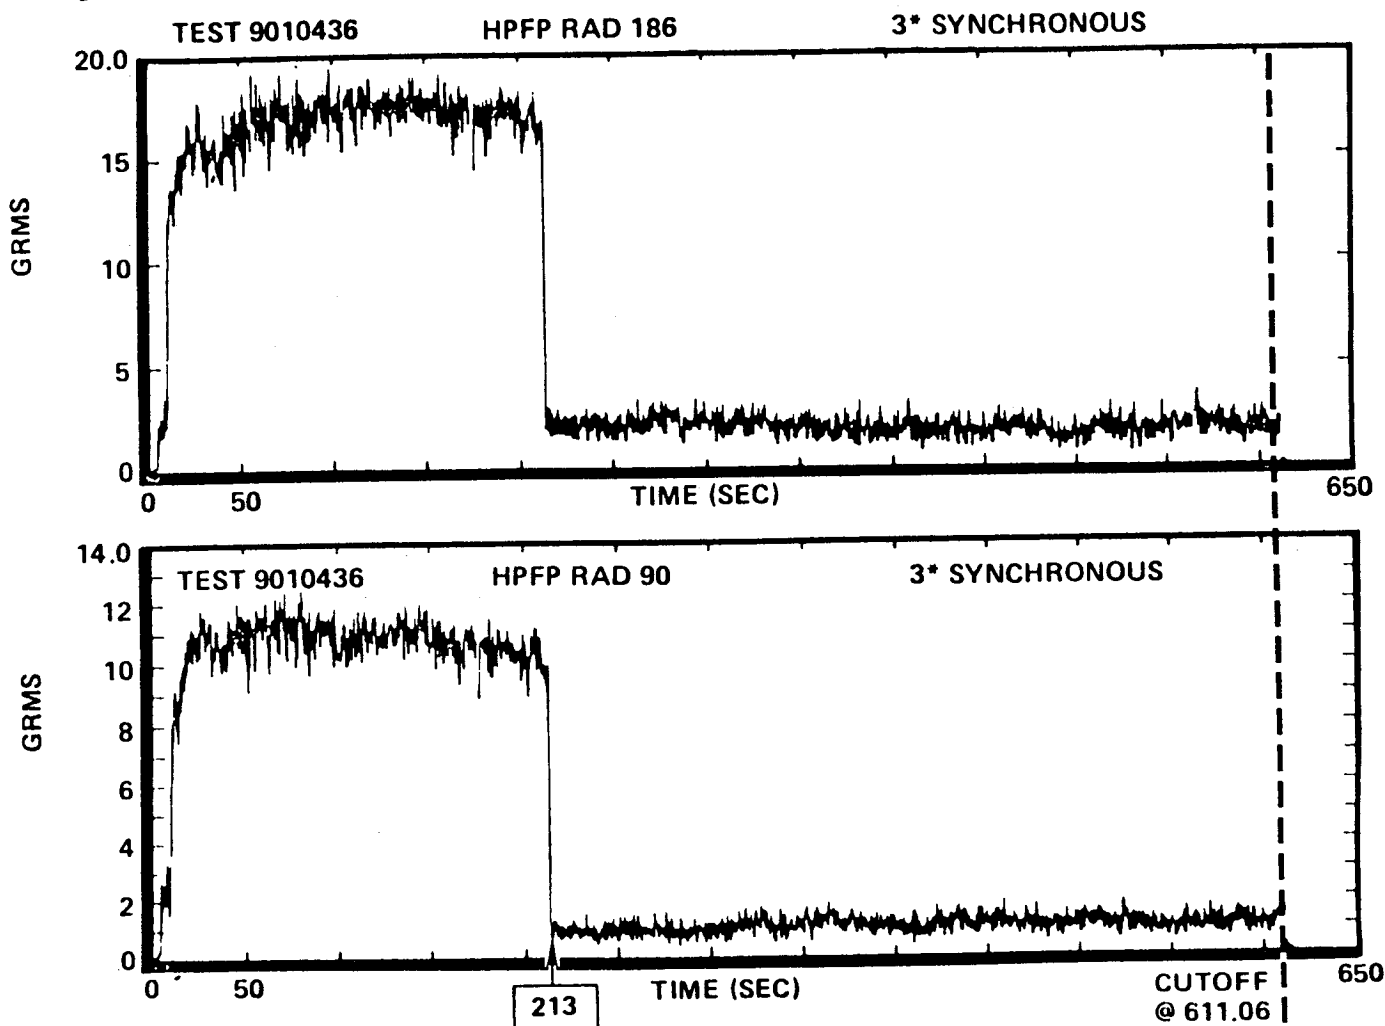
Figure 95. three times synchronous response anomaly.

On one occasion, the frequencies indicating rubbing (2, 3, and 4N) came in at the start of the firing very high, then after approximately 100 sec it went away (Fig. 95). This indicates that either the rubbing went away or the rubbing became continuous around the shaft.

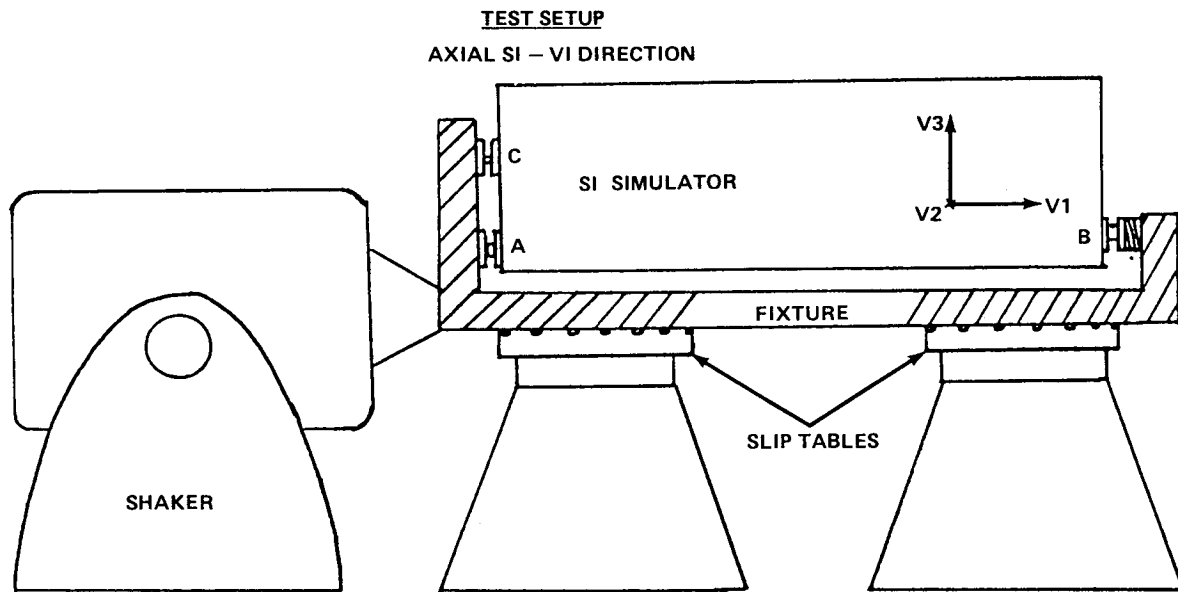
Space Telescope, to fly in 1986, has had some minor problems in the dynamics area. Loads variability, creak, and jitter were discussed in a previous section. The other main problem areas have been associated with the Scientific Instrument (SI) latches. These are latches installed so that the SI can be removed on-orbit for maintenance, film retrieval, etc. The SI's and their latches are both axial and radial (Figs. 96 and 97). The latches and their response characteristics were very important to the individual instrument pointing accuracy (line-of-sight) and to the overall dynamic response for loads. Because of the criticality of these, an extensive qualification program on a vibration shake table was performed. Static and dynamic tests to determine the appropriate stiffnesses of the latches were also performed.

Figure 96. ST axial latch in test setup.

The first attempt to vibration qualify the latches was not successful. Latches were damaged beyond use (cracking and surface wear). This was not an acceptable condition. Various coatings have been tried to solve the problem. Tungsten-carbide-cobalt coatings were added to the retainers of the axial SI latches A and C. Additionally, the aluminum oxide coating on the 440C ball of the A latch was eliminated. The modified hardware successfully completed vibration qualification testing without degradation. Similar modifications were made to the radial SI latches. Subsequent vibration qualification testing of the modified radial latches generated particulates at the B and C latches. Although the wearing of the latch surfaces was not significant, the small particles presented a potential contamination problem for the ST optical elements. Brayco lubricant has been added to the latches to entrap the particulates. Figure 96 shows the test setup for the axial SI showing the latches A, B, and C. Figure 97 is a detail

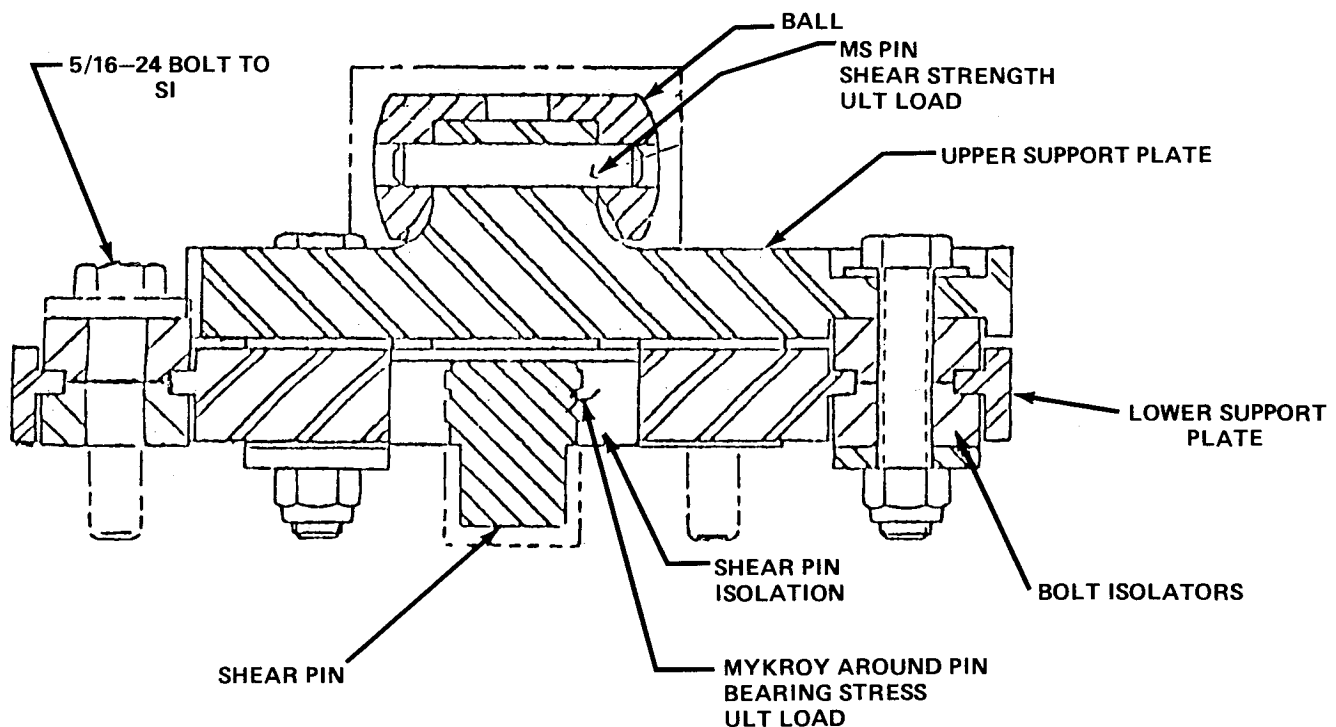
Figure 97. Typical axial latch.

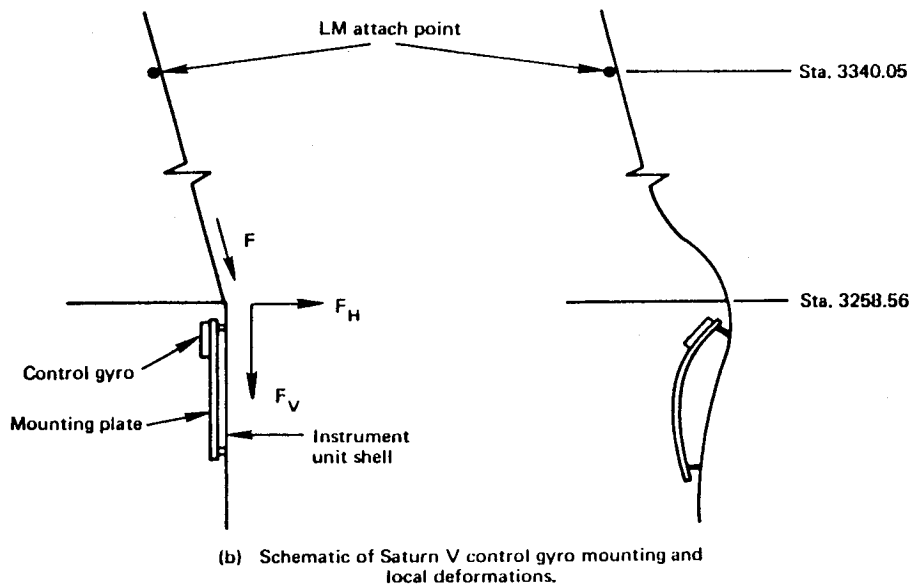
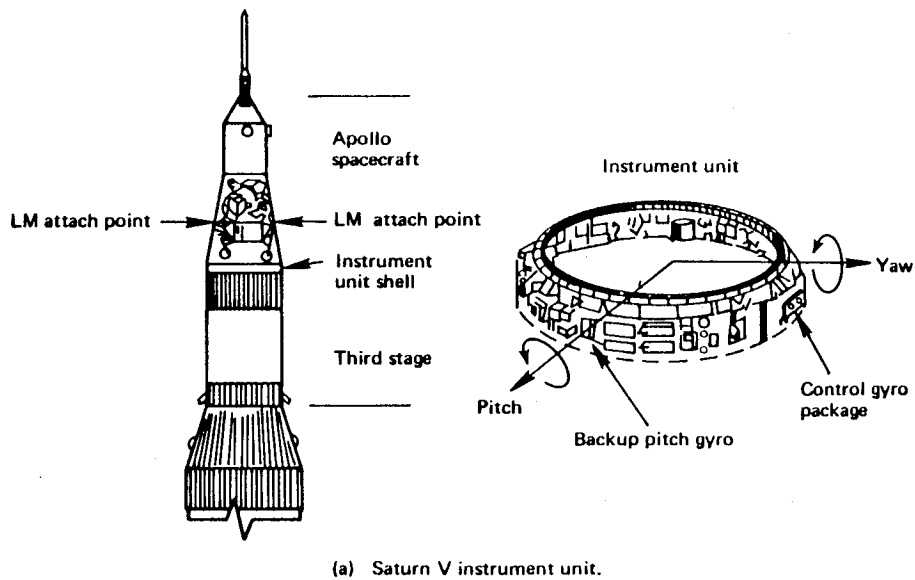
The local effect problem occurred in the Instrument Unit (IU) stage at the rate gyro location. The rate gyro deflection was much larger than classical beam modes predicted. The effect was not found in scale model testing due to reduced fidelity in this area of the structure. Full scale dynamic testing uncovered the effect. The IU stage was located on top of the S-IVB stage. On the upper side were the SLA panels which were the interstage between the IU and the service module. Inside this area was the Lunar Excursion Module (LEM). Since the service module was a smaller diameter than the IU, the SLA panel loads were at an angle to the IU creating both a static and dynamic distortion (Fig. 98). Not anticipating this angular load path caused the modeling error. At the time this error was found, finite element modeling was less critical. As a result of the modeling error correction, the control system (filter) was redesigned and all flights experienced no problem in this area. The lesson is clear, know what is critical to the system, then model that area accurately.

(a) Saturn V instrument unit.

(b) Schematic of Saturn V control gyro mounting and local deformations.

Figure 98. Saturn V local deformation.

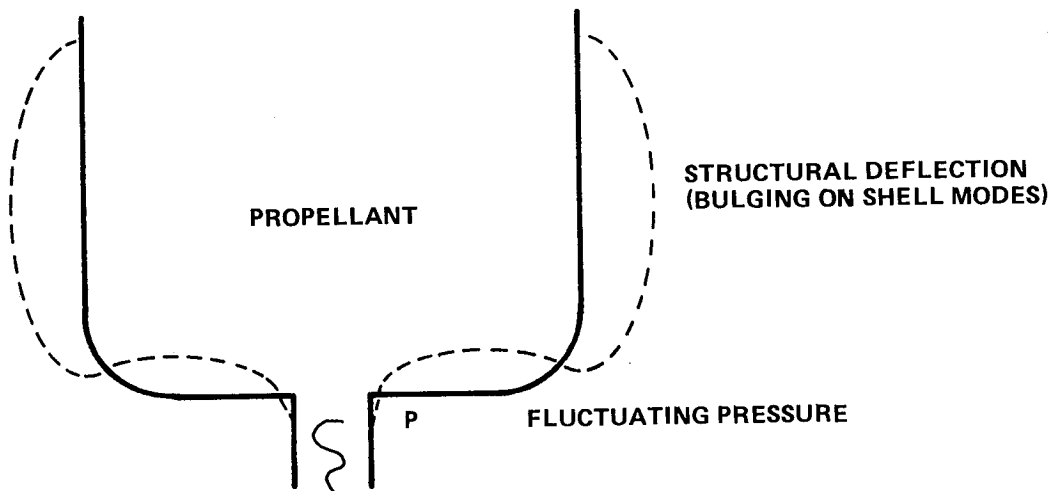
As shown previously, the S-II pogo problem was caused when the tank/fluid bulkhead mode was resonating with the longitudinal mode and engine thrust frame crossbeam mode. In this case, the pressure wave was greatly amplified due to the hydroelastic effect (Fig. 100). Initially, an experimental program was run to obtain data for analysis. In the final phases of this program, an analytical hydroelastic model was developed and verified.

Figure 100. Hydroelastic effect.

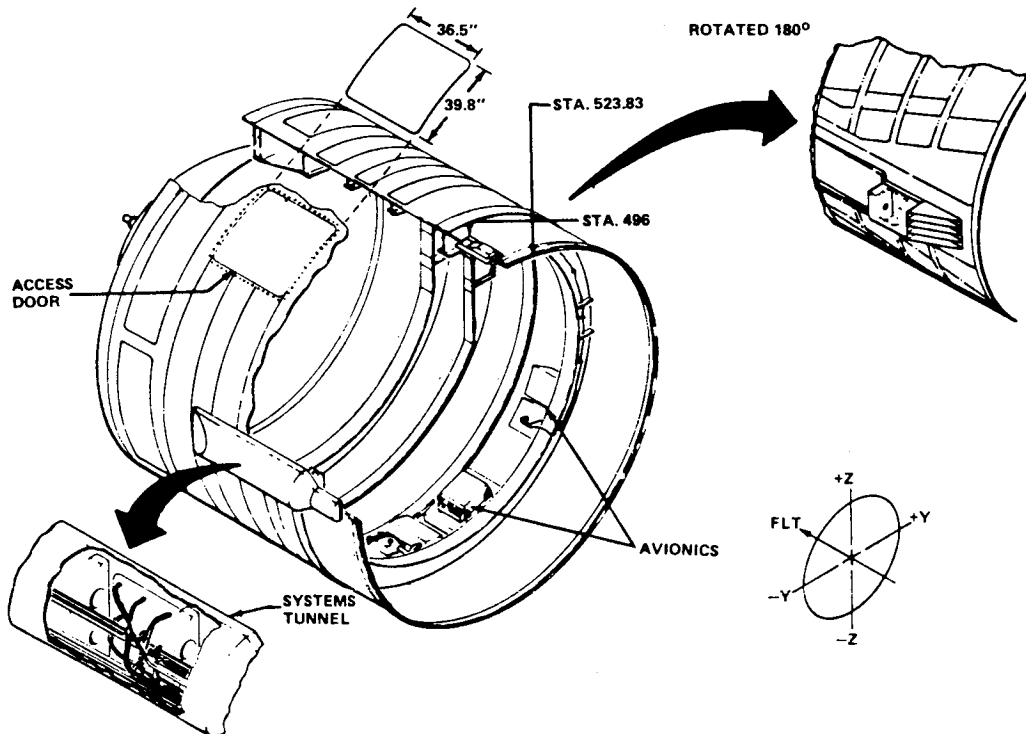
2) Local Deflection of Rate Gyro Mount. Local deflection of rate gyro mountings was the second problem uncovered on the full scale ground vibration test. This distortion was caused by the loca

l modes of the instrument ring frame in the front of the SRB forward segment. The ring was not modeled as a flexible element under the assumption that its frequency would be too high to respond elastically to the first fundamental bending modes. The assumption turned out to be erroneous and had to be corrected. Two things had to be accomplished. The finite element model was corrected giving a good match to test data. This was a simple task, merely putting in the extra elastic elements associated with the gain or change the control system shaping networks (bending mode filters). It was decided to stiffen the ring with brackets (Figs. 102 and 103) and test verify. This was accomplished first using the forward SRB interstage while the liftoff (full SRB) configuration was being unstacked and the SRB burnout (empty SRB) configuration was restacked for dynamic testing of the condition. The fix was preliminarily verified using this element test, then finally verified from the system standpoint during the SRB burnout dynamic test.

Figure 102. SRB forward interstage section.

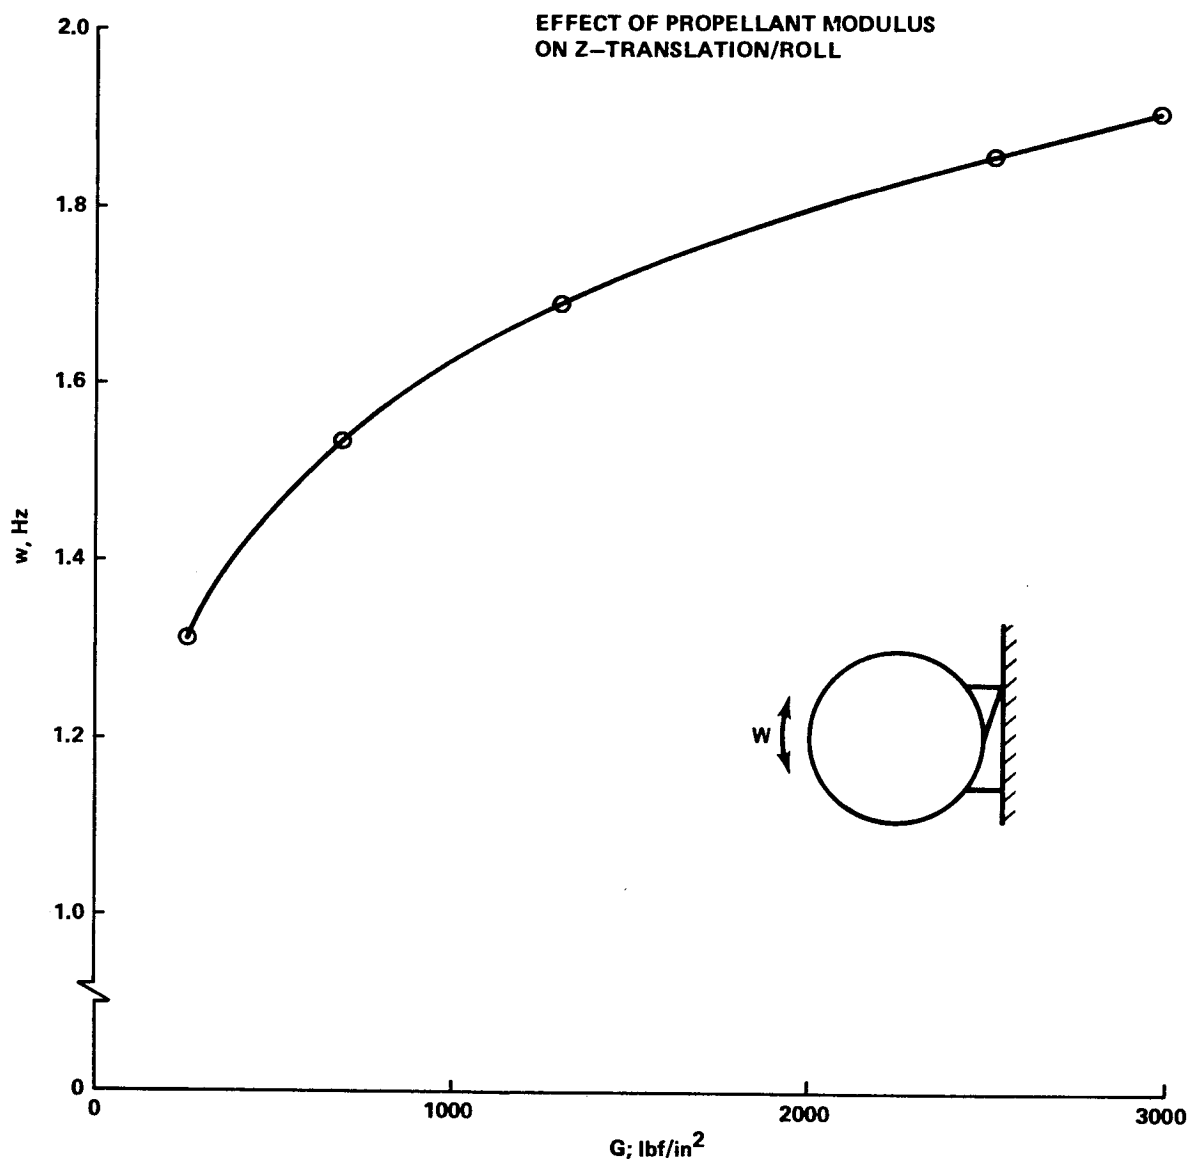
temperature between a winter launch and a summer launch led to the requirement for two different dynamic models of the SRB's. The propellant elasticity affected two basic vehicle modes, the longitudinal mode of the propellant moving dynamically relative to the SRB skin and the SRB gear train mode of the solids rolling in a rigid body sense against the rear SRB to External Tank interface, discussed under system response. Analytically, it was very hard if not impossible to model the viscoelastic effects. In order to achieve an adequate model, extensive dynamic test programs in addition to the full scale and allup quarter scale test programs were carried out. The first was a coupon test which determined the material properties of the propellant as a function of temperature, pressure, frequency, age, and amplitude [60]. Using properties derived in this manner, the pre-liftoff model was determined. Figure 104 shows how the gear train mode frequency varies as a function of propellant shear modulus, with the SRB/ET struts fixed to ground. Running the quarter scale model without internal SRB pressure showed the model to be good in terms of propellant shear modulus, with the SRB/ET struts fixed to ground. Running the quarter scale model without internal SRB pressure showed the model to be good in terms of elasticity and shell stiffness. In this case, however, special modulus tests had to be run on the inert propellant used in the dynamic test, since it had different characteristics than live propellant.

Figure 104. Gear train mode frequency as a function of propellant shear modules.

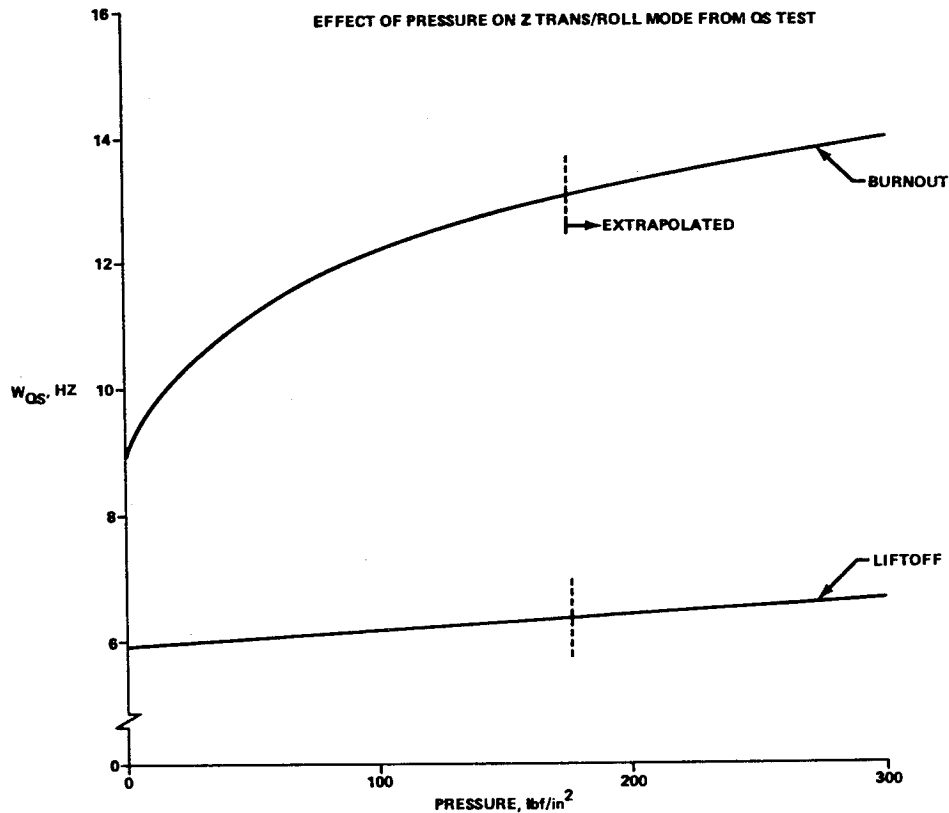
2) <u>Dynamic Effects on Stiffness of Internal Pressure.</u> The next problem occurred when internal pressure was included. Differential stiffness analytical techniques grossly overpredicted the stiffening effect of pressure in a dynamic situation. The same technique predicts accurately static effects for a radial punch load. No reason has been determined for this overprediction. As a result, the stiffening effect of pressure was determined experimentally using the quarter scale SRB element model fixed to ground. Figure 105 shows the frequency of the translation/roll mode as a function of internal pressure for an SRB with no propellant and one with the propellant fully loaded. Notice that the mass and viscoelastic effects of the propellant reduced greatly the pressure effect [60].

Figure 5. Gear train mode frequency as a function of internal pressure.
