Guidance, Navigation & Control (GN&C) Best Practices for Human-Rated Spacecraft Systems

Neil Dennehy
NESC

Program Management Challenge 2008

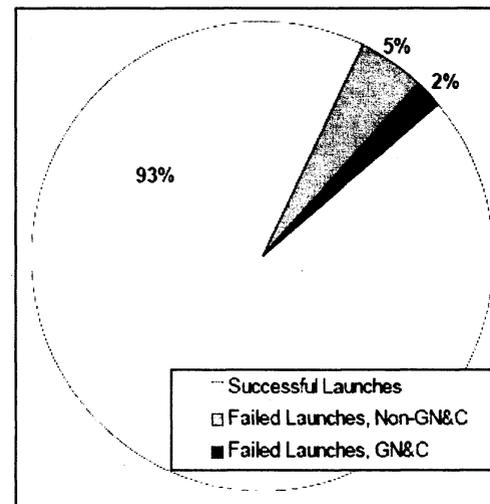
GN&C Related Worldwide Launch Vehicle Failures

- Over the ten year period of 1996 to 2006, 21 out of the 773 launch attempts worldwide, experienced a known GN&C anomaly
 - 15 resulted in a catastrophic launch failure
- Approximately one-third (15) of all 52 catastrophic launch failures worldwide over this ten year period were GN&C-related
- Design flaws identified as largest (40%) single cause of GN&C-related catastrophic launch failures (6 out of 15)
- Avionics and Flight Software were equally large (20%) failure causes at the component level

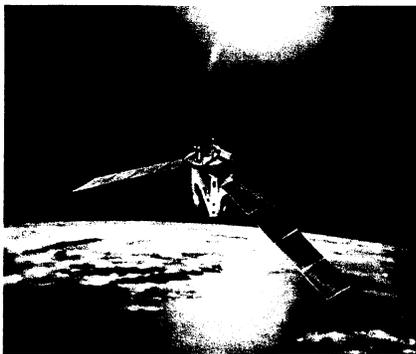
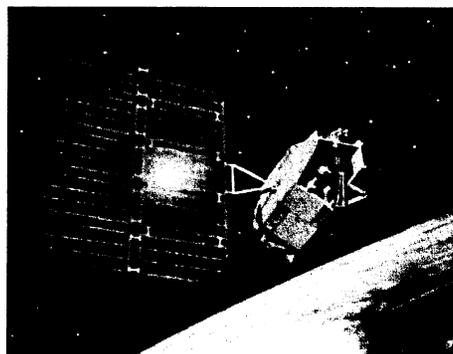
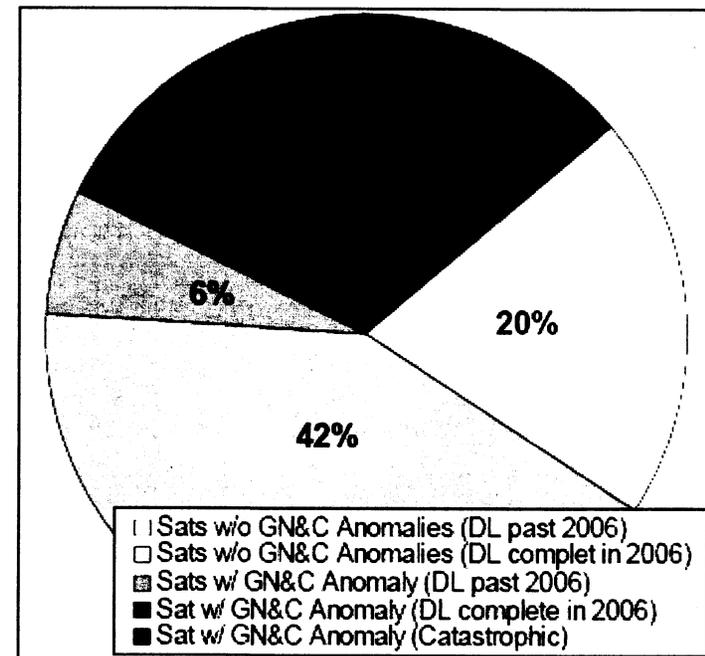
GN&C Related NASA Spacecraft Failures

- Over the ten year period of 1996 to 2006, 38% (30 out of 79) of all NASA spacecraft experienced a known GN&C anomaly
- 8% of all NASA experienced a catastrophic satellite failure over this same time period
- 50% of catastrophic GN&C anomalies occurred within 10% of the satellite's design life
- Largest contributing causes of catastrophic GN&C anomalies were:
 - Design (33%)
 - Software (33%)
 - Operational (17%)

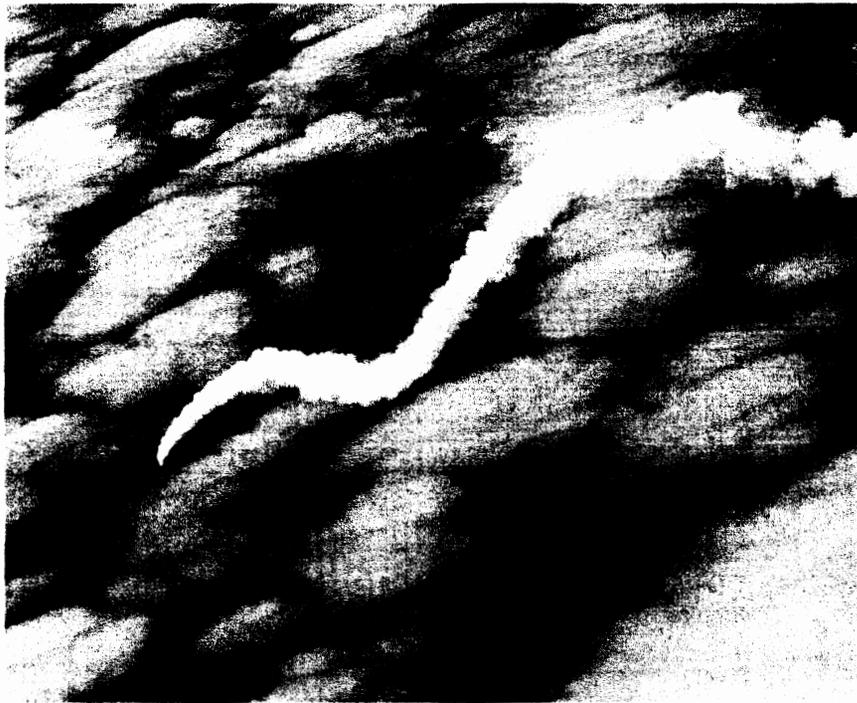
X-43A / Pegasus Launch June 2, 2001

NASA Dryden Flight Research Center Photo Collection
<http://www.dfrc.nasa.gov/gallery/photo/index.html>
NASA Photo: EC01-0182-11 Date: June 2, 2001 Photo by: Jim Ross
The X-43A/Pegasus combination dropped into the Pacific Ocean after losing control early in the first free-flight attempt.

- The trajectory that was selected to achieve the mission was at a lower altitude (i.e. a higher dynamic pressure) than a typical Pegasus trajectory.
- Flight went as planned after B-52 drop until pitch-up maneuver.
- Diverging roll oscillation at 2.5-Hz frequency occurred during pitch-up.
- Roll oscillation continued to diverge until about 13 seconds into flight.
- Rudder electro-mechanical actuator stalled & ceased to respond to autopilot at that point causing loss of yaw control.
- Loss of yaw control caused X-43A stack sideslip to diverge rapidly to over 8°.
- Structural overload of starboard elevon occurred at 13.5 sec.
- Loss of control caused X-43A stack to deviate significantly from planned trajectory.
- Vehicle terminated by range control about 49 sec. after release.

1. The vehicle control system design was deficient for the trajectory flown due to inaccurate analytical models which overestimated design margins.
BP #8: *Over-reliance/Over-Confidence on Pegasus heritage.*
BP #17: *Failure to adhere to "Test as You Fly" approach.*

2. Failure triggered by divergent roll oscillatory motion at 2.5 Hz, caused by excessive control system gain.
BP #12: *Insufficient control system stability margins.*

4. Rudder actuator stall occurred as consequence of divergent roll which accelerated loss of control.
BP #14: *Inadequate dynamic modeling.*
5. Flight failure was only reproduced when all modeling inaccuracies with uncertainty variations were incorporated in system-level linear analysis model & nonlinear simulation model.
BP #15: *Independent Truth Model should have identified un-modeled effects.*

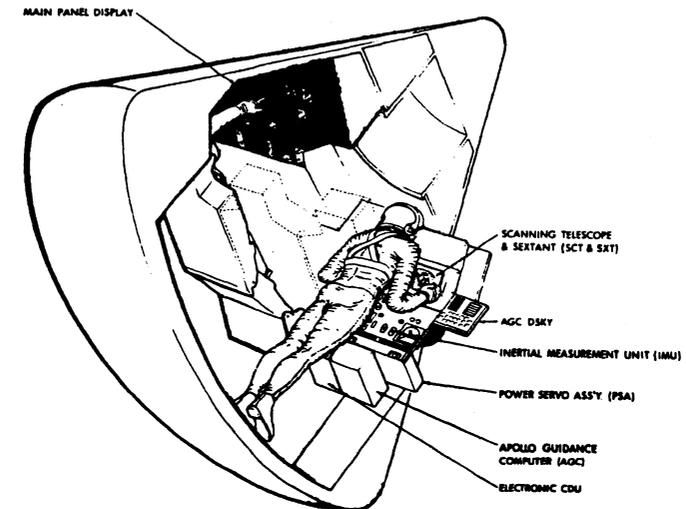
**Flight-Like Cockpit Mockups
(such as MIT/IL Apollo Hybrid
Simulator) Allowed Apollo
Astronauts Hands-On Training
Which Influenced the GN&C
Design**

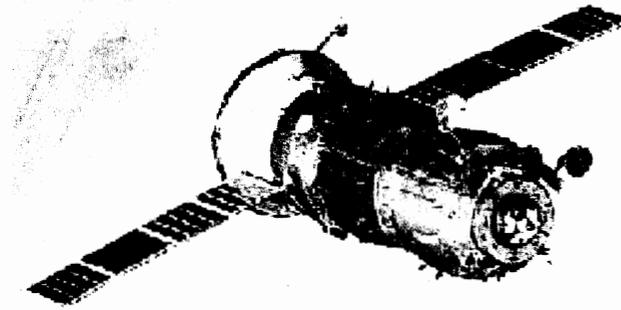
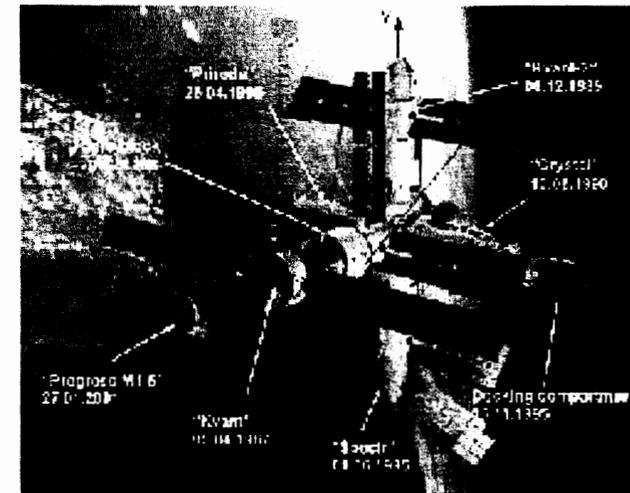
- Progress-M spacecraft is an unmanned cargo and resupply vehicle used to send equipment to Mir.
- On 6/25/97 a 2nd test was performed of the manual Toru proximity docking system as a lower cost substitute for the autonomous Kurs rendezvous and docking system.
- Operator on Mir had difficulty determining range and range rate with the Kurs radar switched off.
- Progress went off course and collided with a solar array and radiator on the Spektr module and then the module itself.
- Spektr hull was breached causing significant air loss before Spektr module could be sealed off.
- Evacuation of the station was narrowly avoided.
- There were three immediate causes of the crash:
 - The higher than planned initial closing rate
 - Late realization that closing rate was too high
 - Incorrect final avoidance maneuvering

- 2. The operator continued to maneuver and aim for the docking port after noticing that the closing rate was higher than expected.**
BP #14: Failure to explain test anomalies.

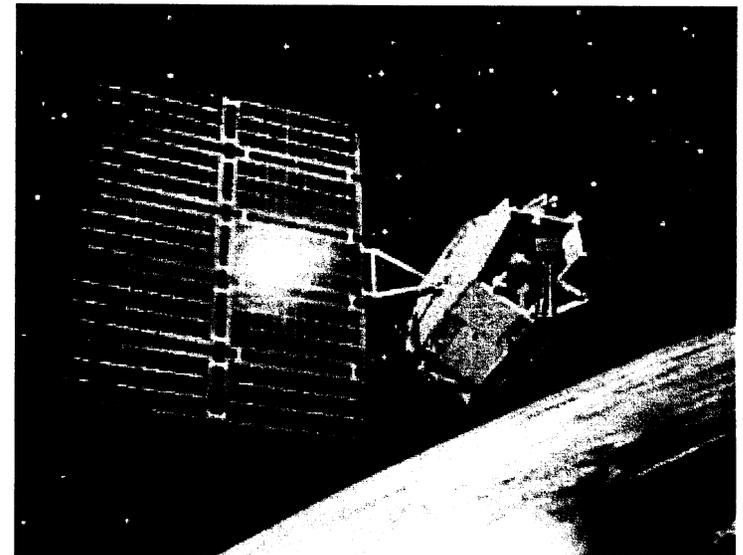
LEWIS was launched on August 23, 1997 into low Earth Orbit.

- 1. At launch, LEWIS was under control of the A-side processor. At first contact it had already switched to the B-side and was unable to playback SSR data.**
- 2. After 45 hours of nadir pointing on B-side, the Ground crew switched control back to the A-side. The attitude was uncontrolled so the A-side Sun pointing mode was entered.**
- 3. After verifying that the spacecraft had been stable in the Sun mode for four hours of operation, the Ground crew entered a nine-hour rest period and ceased operations for the day.**
- 4. During that unattended period, the spacecraft entered a flat spin that resulted in a loss of solar power and a fatal battery discharge. Contact with the spacecraft was lost on August 26.**
- 5. The spacecraft re-entered the atmosphere and was destroyed on 28 September 1997.**

2. X-axis spin rate was not sensed and could not be controlled.
BP #3: *Ensure implementation of comprehensive Abort/Safe Haven strategies/functions.*
3. The Ground crew failed to adequately monitor spacecraft health and safety during the critical initial mission phase.
BP #21: *Ensure sufficiency of GN&C engineering telemetry data.*

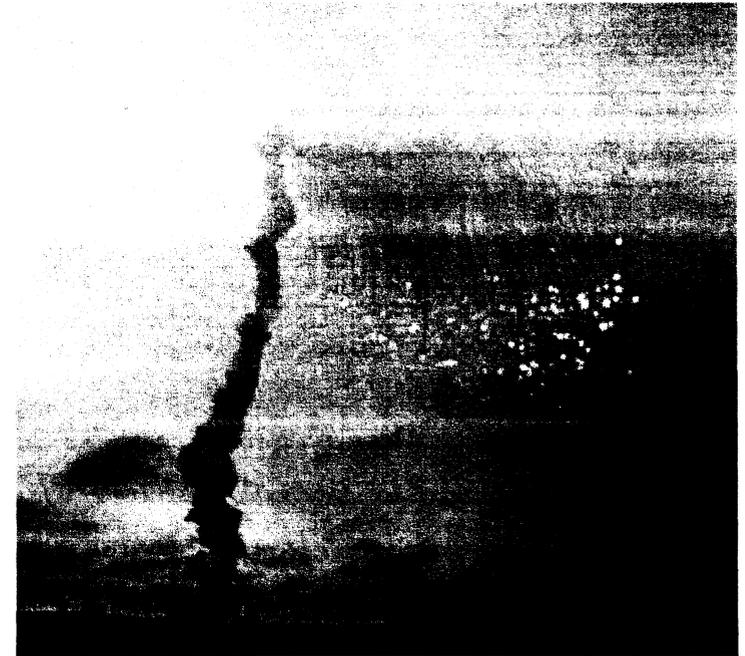
The maiden flight of the Ariane 5 launcher on June 4, 1996 relied on identical GN&C hardware and software for redundancy.

- 39 seconds into the flight the primary Inertial Reference Unit (SRI-1) stopped sending correct attitude data due to a software exception.
- The On-Board Computer (OBC) switched to the backup inertial unit, but SRI-2 also failed due to its independently determined (but identical) software exception.
- The OBC could not switch back to SRI-1 so it took data that was actually part of a diagnostic message written to the bus by SRI-2. This data was interpreted as flight data and used for thrust vector control.
- The sudden swivelling of both solid booster nozzles up to the limit caused the launcher to tilt sharply giving rise to intense aerodynamic loads leading to destruction of the vehicle.

- BP #8: *Heritage software for Ariane-4 was inappropriate for Ariane-5.***
 - BP #20: *Database confusion over reference trajectories.***
 - BP #17: *Failure to adhere to “Test as You Fly” approach.***

2. Switchover to the backup unit was accomplished, but SRI-2 immediately failed in the same way as SRI-1.
 - BP # 7: *Evaluate if redundancy using identical GN&C components increases or decreases reliability.***

3. The OBC could not switch back to SRI-1 so it accepted SRI-2 diagnostic data as attitude data and generated improper TVC commands.
 - BP #3: *Ensure that Abort/Safe Haven strategies/functions are properly implemented. Ariane-5 was lacking a simple and reliable “Never Give Up” flight control capability.***

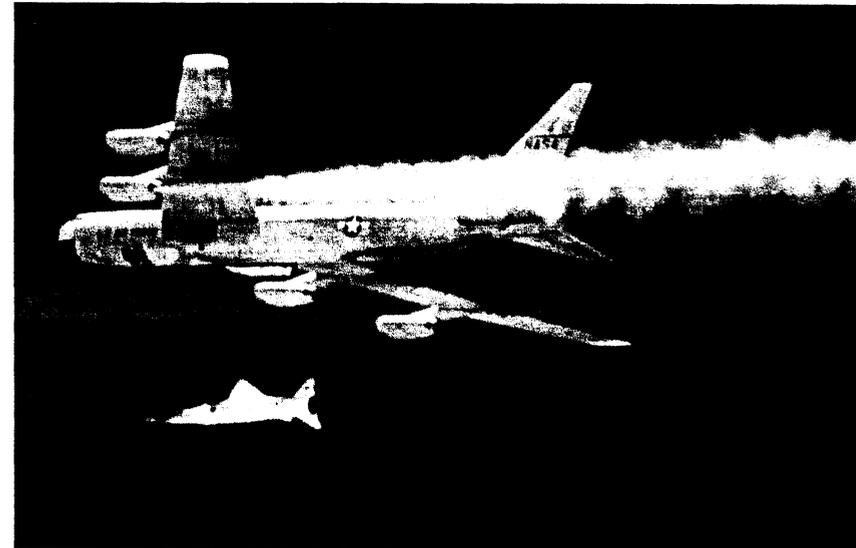
The HXLV (Pegasus) was used to accelerate the Hyper-X Research Vehicle (HXRV) to the required Mach number and operational altitude for demonstration.

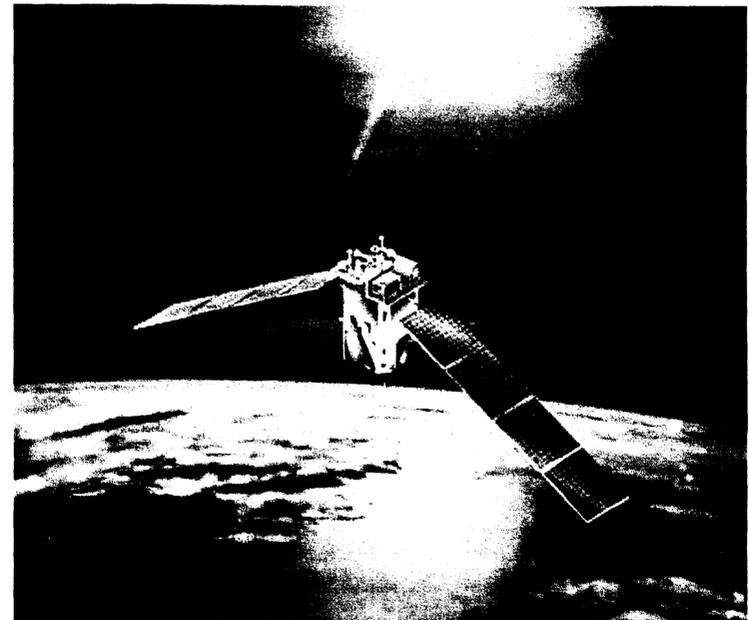
The Thermosphere, Ionosphere, Mesosphere, Energetics and Dynamics (TIMED) spacecraft was launched on 7 December 2001 into low Earth orbit. There were 4 separate GN&C anomalies early in the mission:

1. Shortly after separation there was a steady increase in spacecraft system momentum.
2. Coming out of eclipse and seeing the Sun for the first time in Sun Pointing Mode, the spacecraft pointed an incorrect axis toward the Sun.
3. The Nadir Pointing Mode, which is used for Science observations, had an unanticipated 2.1 Hz oscillation.
4. Momentum dumping occurred 10 times/day rather than the expected once/day.
