Problems Experienced and Envisioned for Dynamical Physical Systems

Robert S. Ryan

George C. Marshall Space Flight Center
Marshall Space Flight Center, Alabama

TECHNICAL PAPER

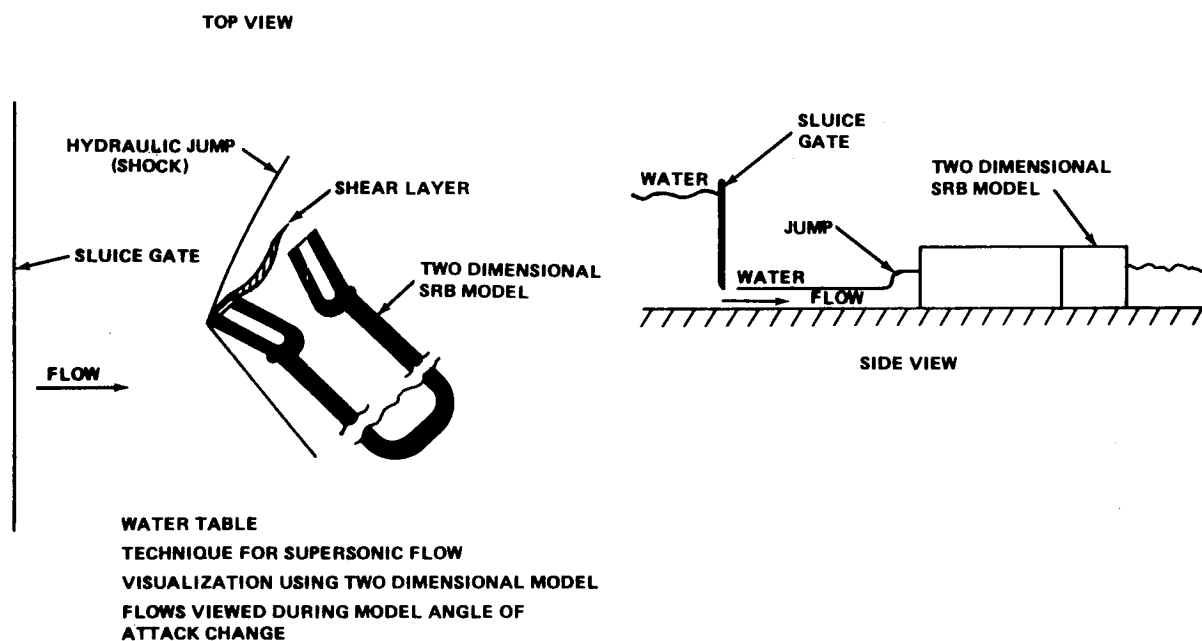
SRB reentry. The first step towards resolving this problem was to analytically predict results in conjunction with scale model wind tunnel tests and 2-D water flow tests. Table 9 lists the problem solution tasks pursued. Figure 106 shows the effects of the large angles of attack produced in the water flow test.

These angles of attack expected during reentry introduce large cross flows which create a hydraulic jump (shock) and a shear layer. Carrying this information to the three-dimensional SRB during reentry and conducting analytical analysis, it was found that there existed an oscillating shear layer off the nozzle lip coupling with the basic acoustical cavity mode of the internal motor cavity. At certain Mach numbers, these modes are in resonance. Figure 107 depicts the basic phenomenon.

Figure 106. Water table test setup and results.

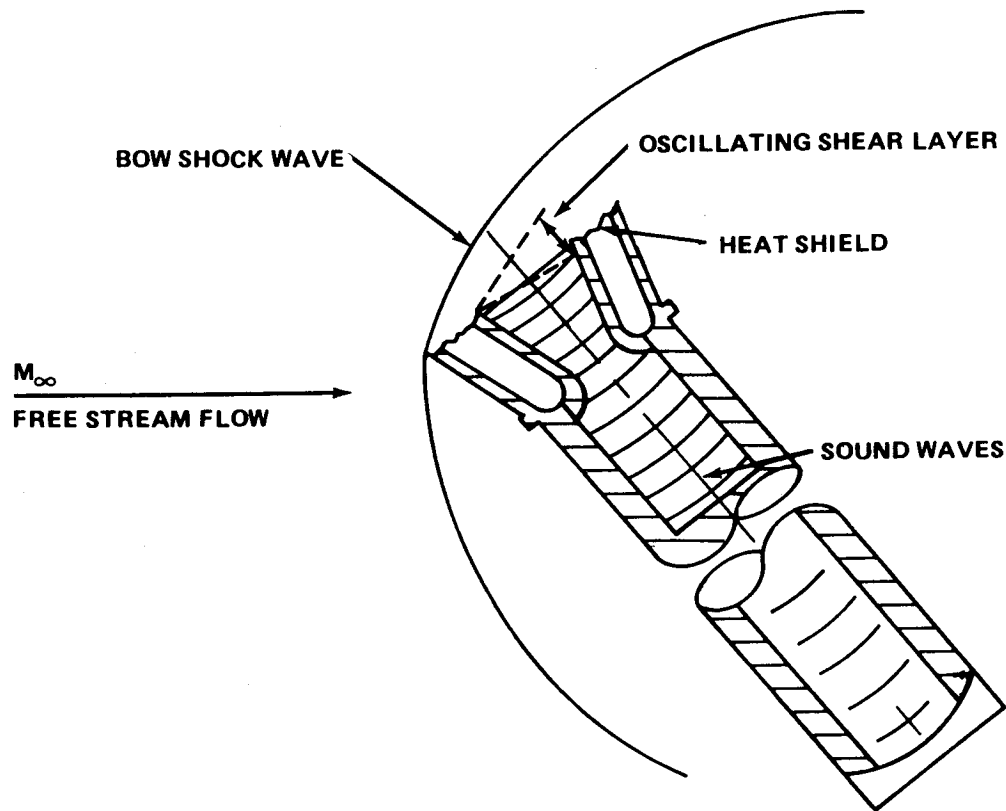
Figure 107. Resonance modes.

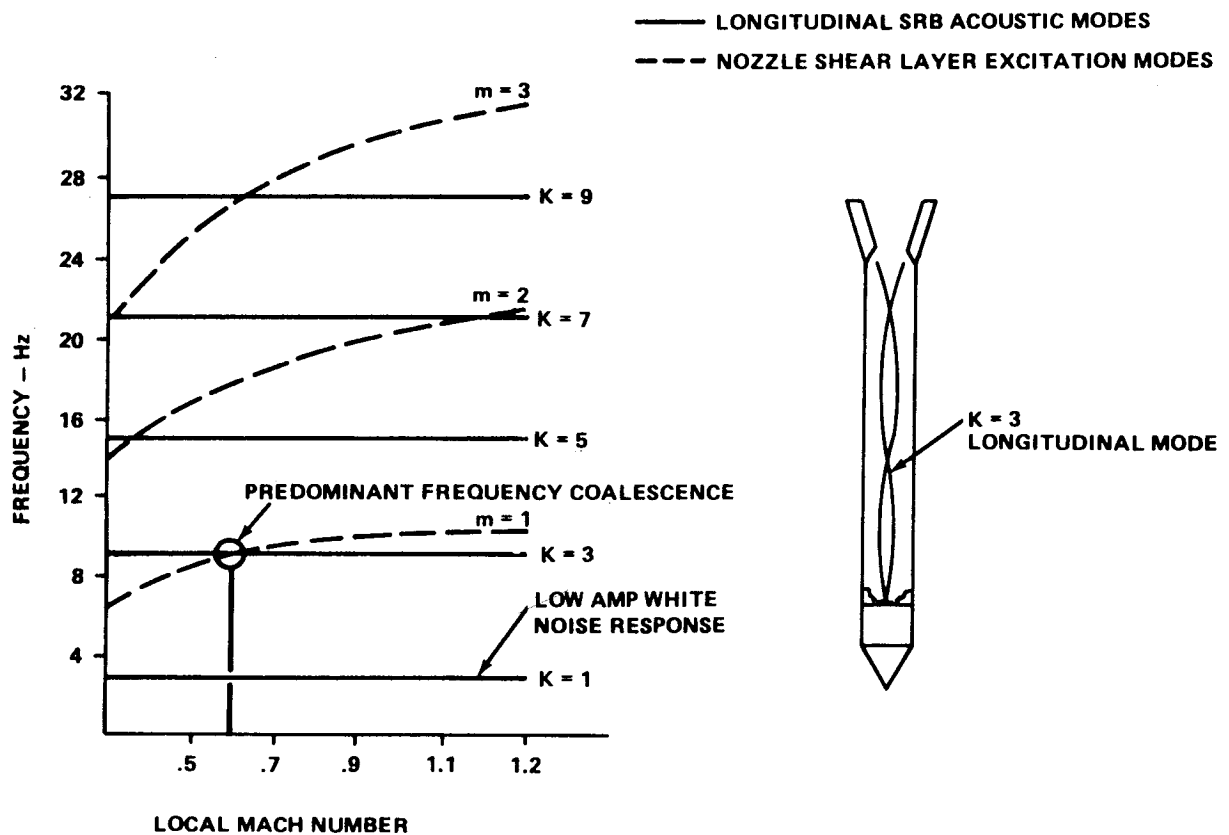
A plot of the longitudinal SRB cavity acoustical modes are plotted as solid lines on Figure 108. The nozzle shear layer excitation modes (sharp edge created) are illustrated as dotted lines. Notice the resonance for K = 3 and the M = 1 modes at a local Mach number of approximately 0.6.

Figure 108. SRB motor frequency prediction model.

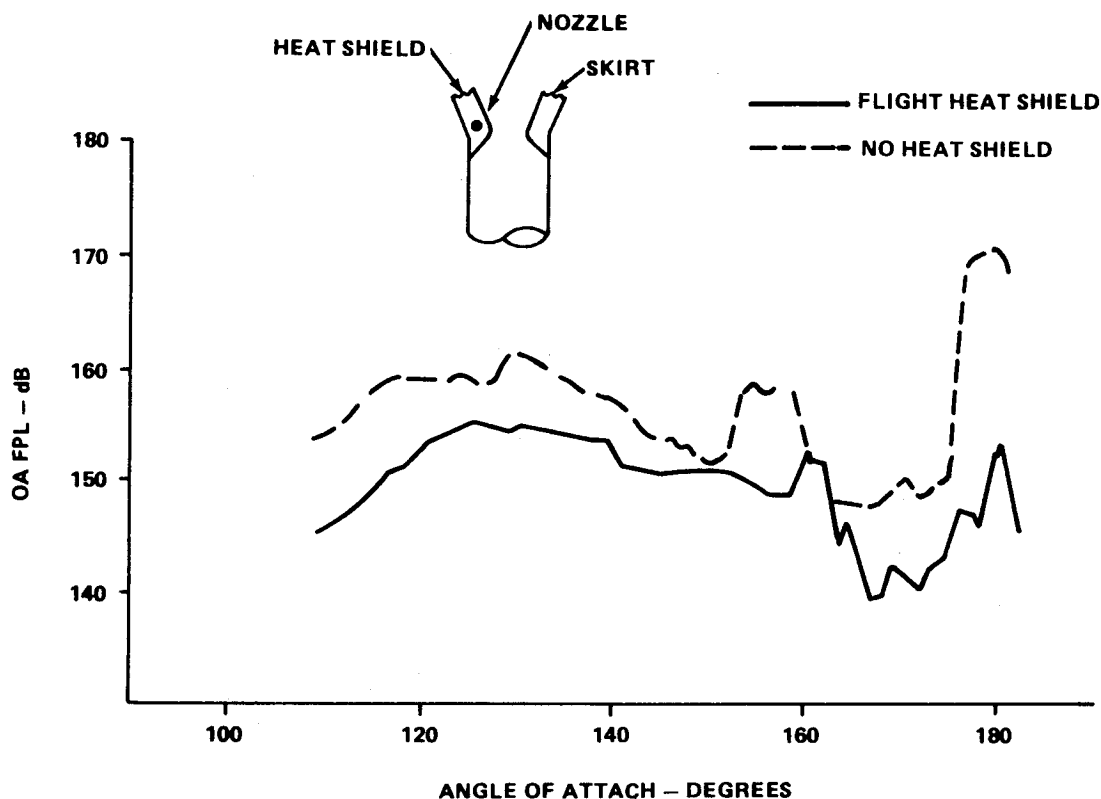
These modes were verified in MSFC's 14-in. wind tunnel, the AEDC tunnel, and Ames using a larger model. At the same time, many means for reducing the environments were investigated. Figure 109 shows the environment as a function of angle of attack with and without the nozzle thermal curtain, showing that the curtain reduced the environments. This led to the preliminary requirement that the thermal curtain must survive reentry. Later studies have eliminated this requirement.

Figure 109. Environment as a function of angle of attack.

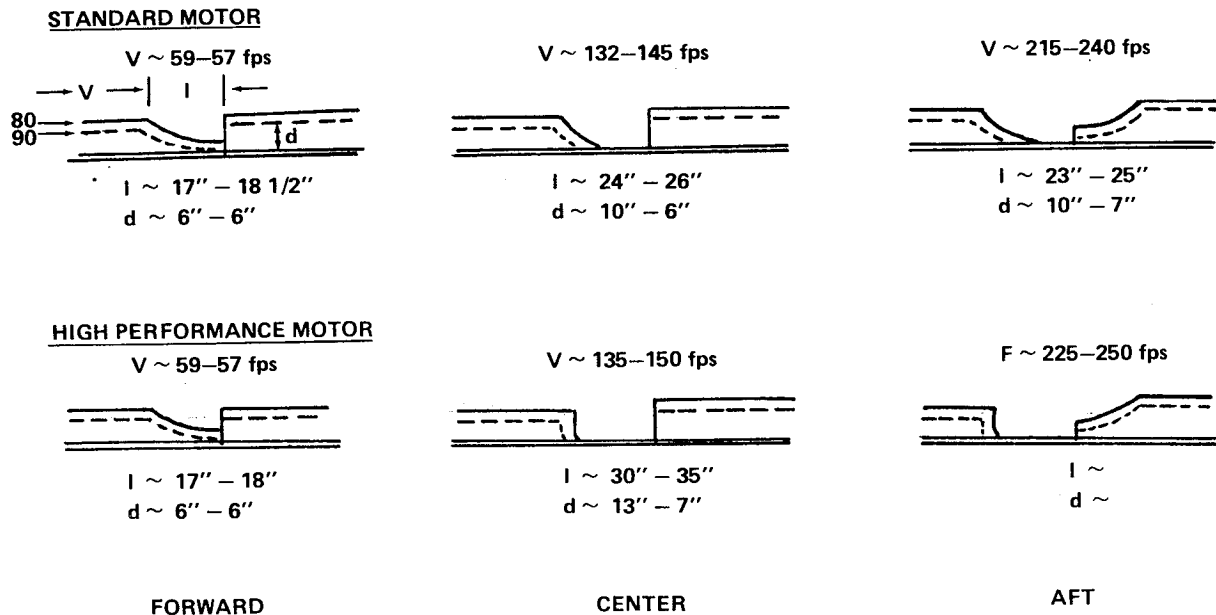
Acoustical tuning also occurs internally in the SRB main cavity. This second SRB acoustical mode tuning has occurred during the later portions of SRB burn (80 to 120 sec). In this case, the normal longitudinal internal cavity acoustical mode was excited and driven by a gap mode associated with the gap and thermal protectors between each segment joint (Fig. 110).

The phenomenon varies from flight to flight due to the small changes in the gap. Resulting vehicle accelerations have not been dangerous but are felt on the total structure including Orbiter. A large statistic base of response from static firings have been used to quantify the phenomenon. Figure 111 shows analytically how gap size and flow conditions. Although it is probably impossible to predict

Figure 110. SRM motor segment and cavities.

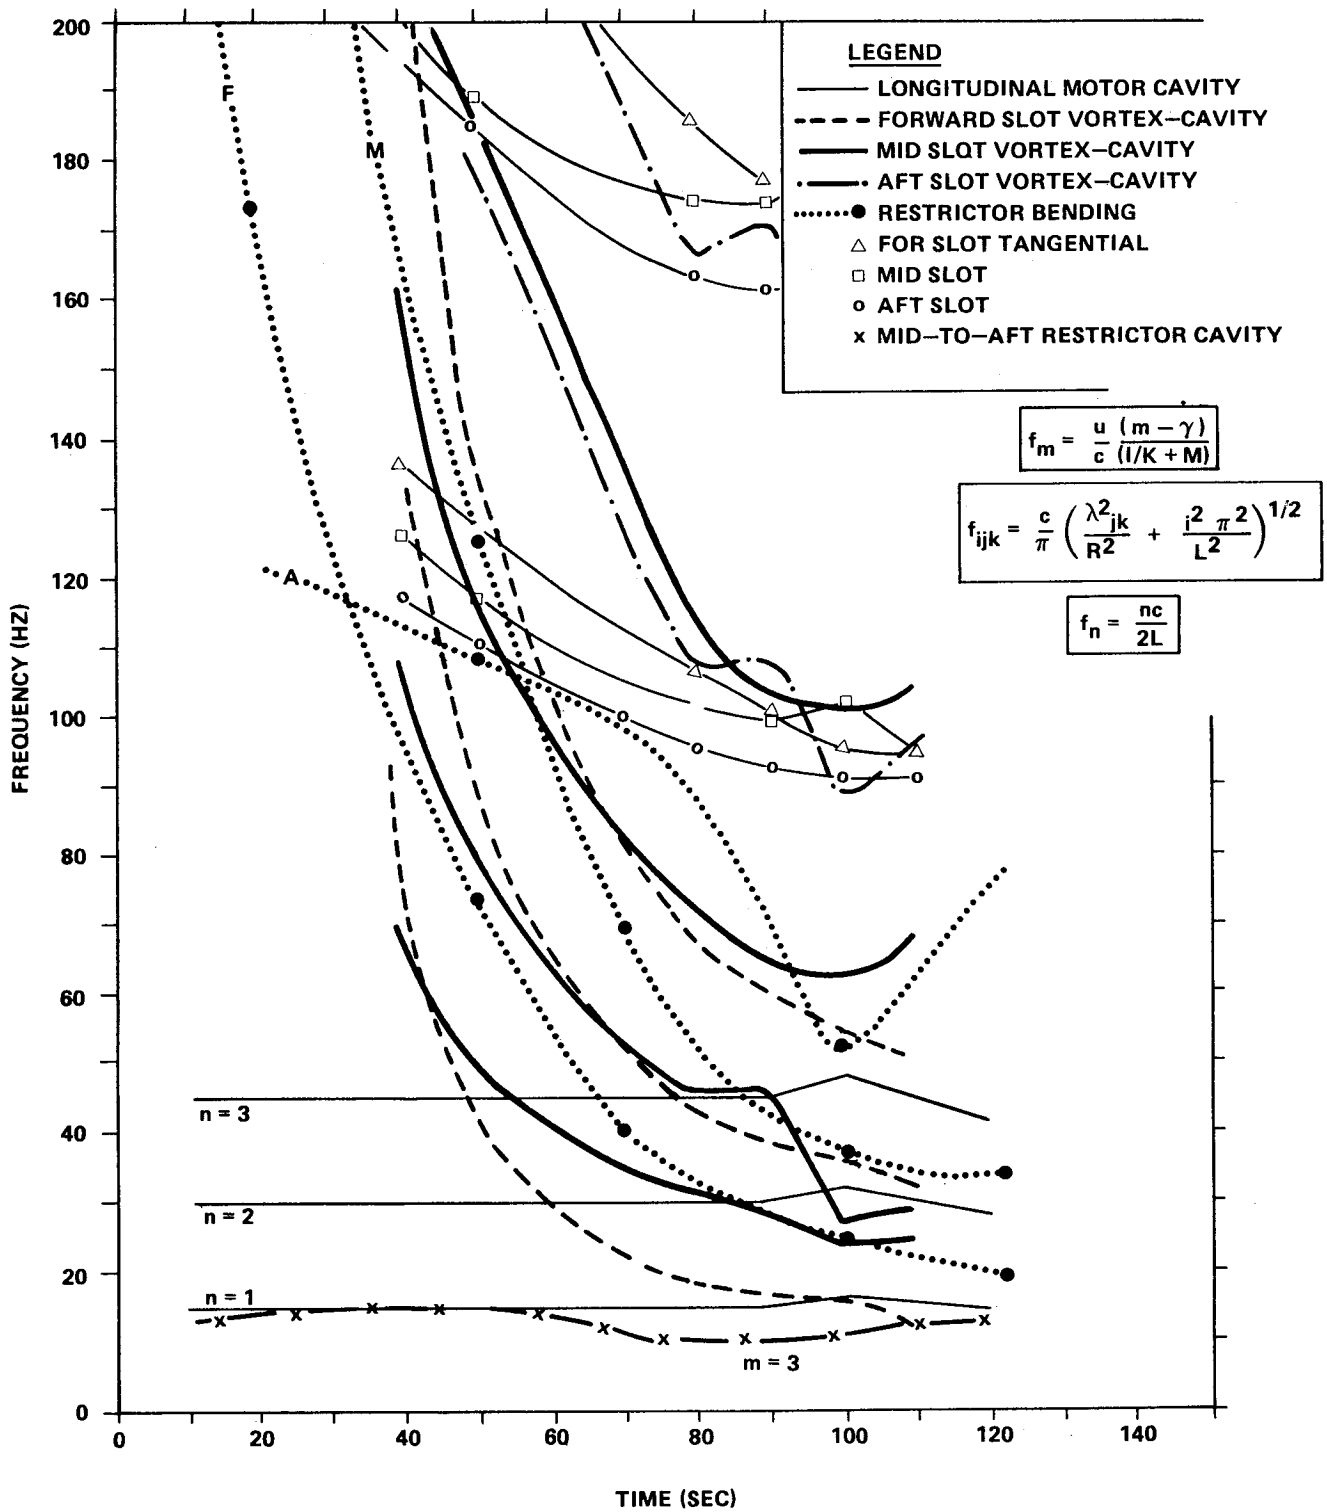
Figure 111. Segment gap longitudinal motor cavity tuning.

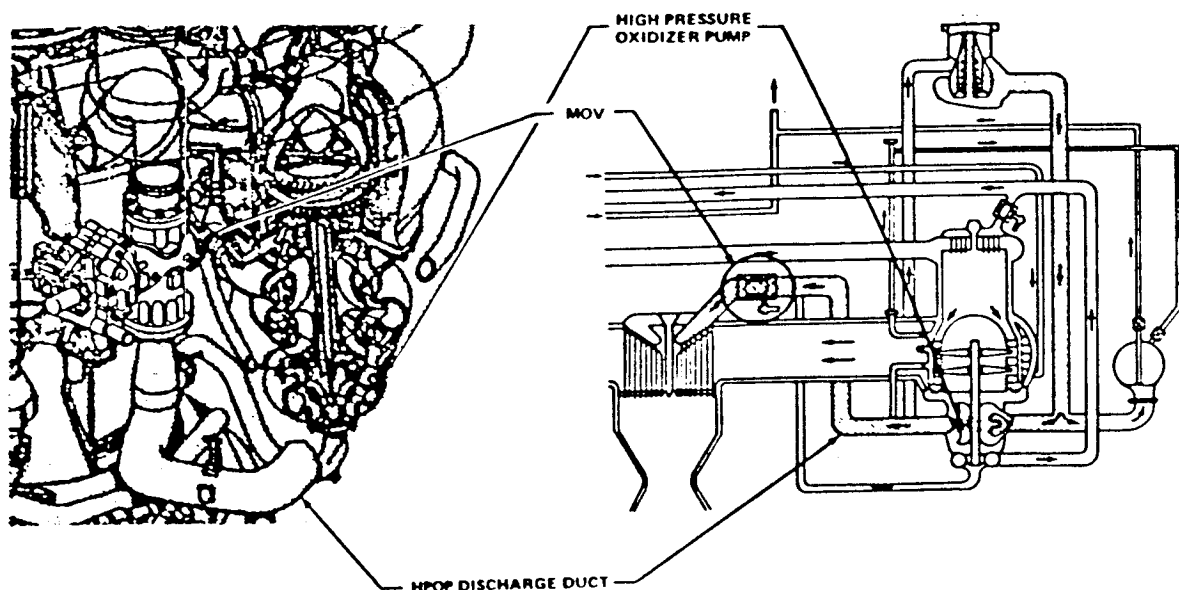
The SSME has experienced acoustical modes tuning with structural modes. One major engine failure has occurred as a result of this type tuning. This involved the main oxidizer valve (MOV) which caught fire due to the high acoustical energy inducing high thermal loads on the valve seal. At the time of the initial failure, acoustical tuning was not considered as a probable cause. Flutter created by valve position was the generally accepted cause. Much analysis and extensive ground flow testing of the valve were required to isolate the cause. This was achieved by systematically closing off each internal cavity with putty. The fix was simply to "close" the gap with a filler washer. Figure 112 shows the (MOV) location on the engine and where it fits in the flow from the lox pump. Figure 113 shows the basic geometry and two different sleeve configurations showing the gap at the valve to line fitting flange that was the acoustical cavity which caused the problem.

Figure 112. Location and function of main oxidizer valve.

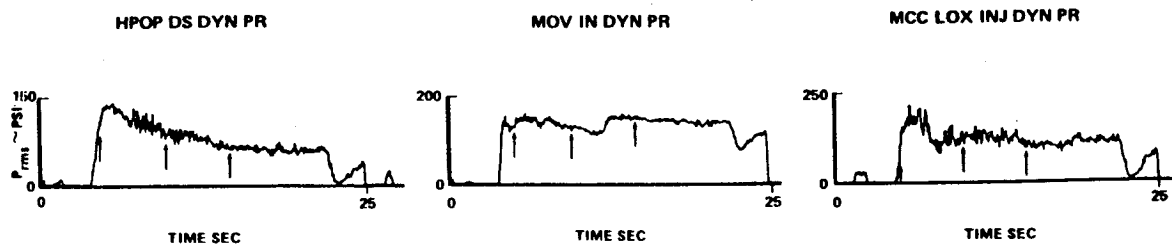
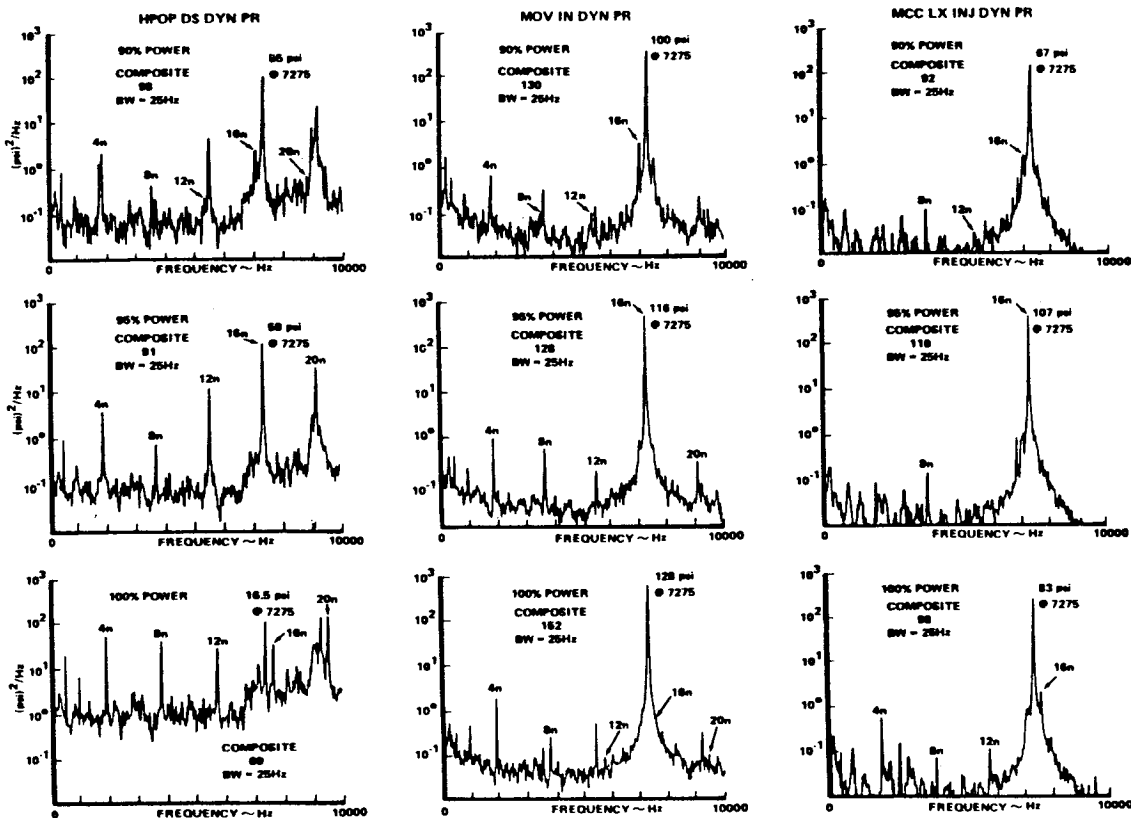
Figure 114 shows how the dynamic pressure at various locations in the lox system responds during hot firing test. Notice the large amplification of the 16N pump induced pressure due to tuning the MOV and downstream at the main combustion chamber inlet. The resulting acceleration of the valve was very large as shown on Figure 115. The phenomenon that occurs is illustrated on Figure 116, which shows how the gap mode tunes with the longitudinal standing wave in the valve sleeve areas.

Figure 114. Typical fluctuating pressure spectral distribution (Test 013).

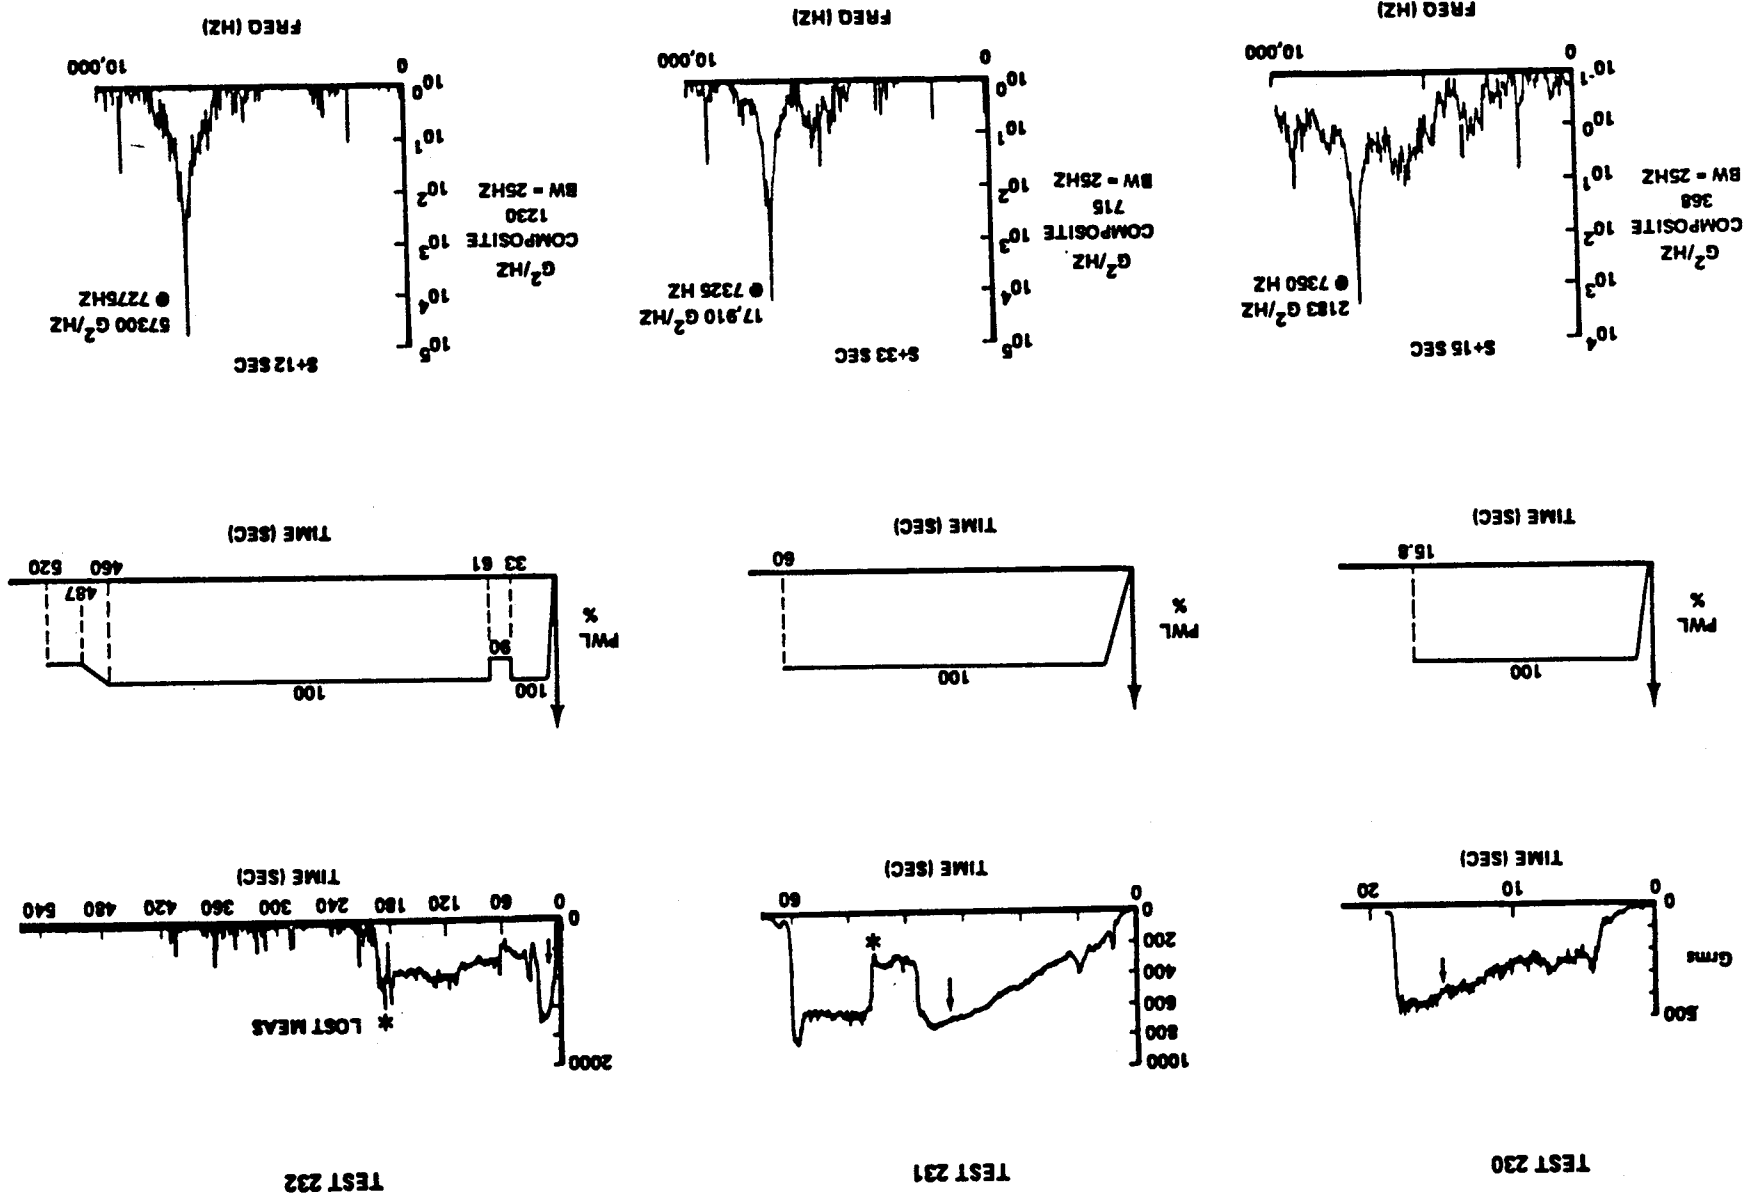
Figure 115. Variation in g-level from test to test.

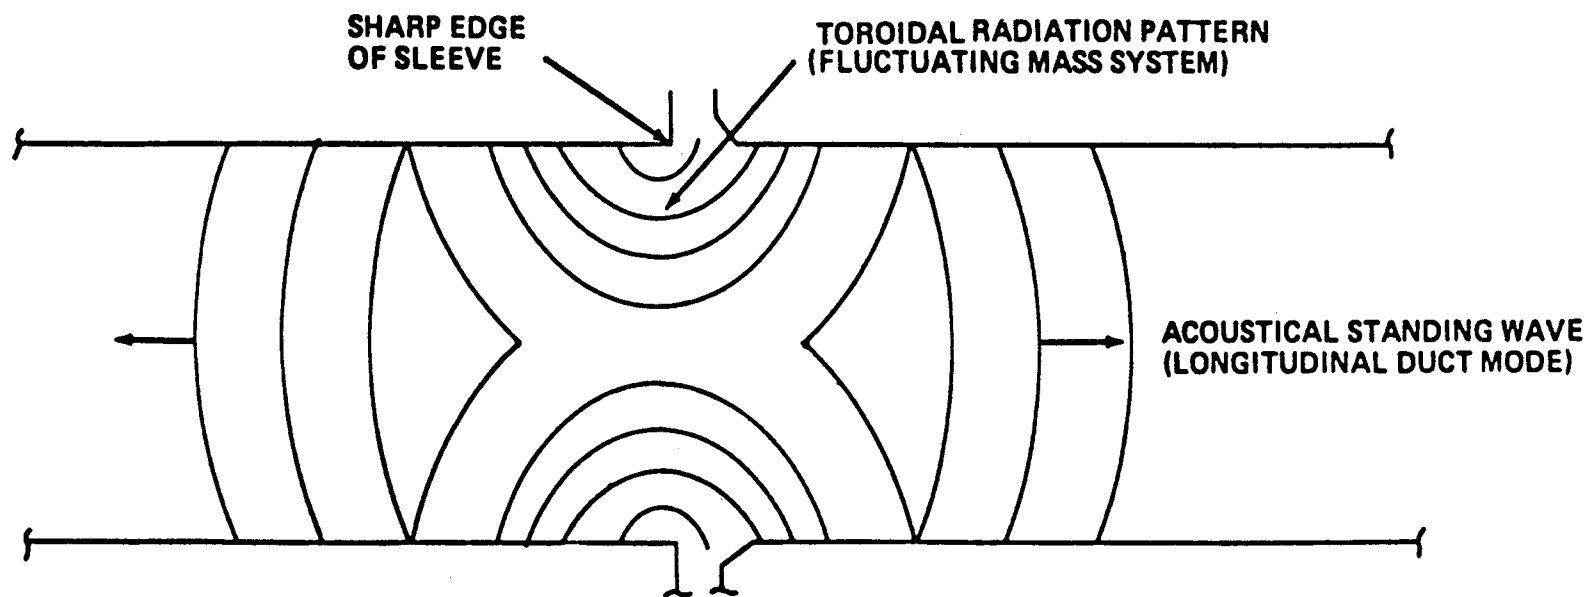
Figure 116. Mechanism relating to anomalous discrete frequency.

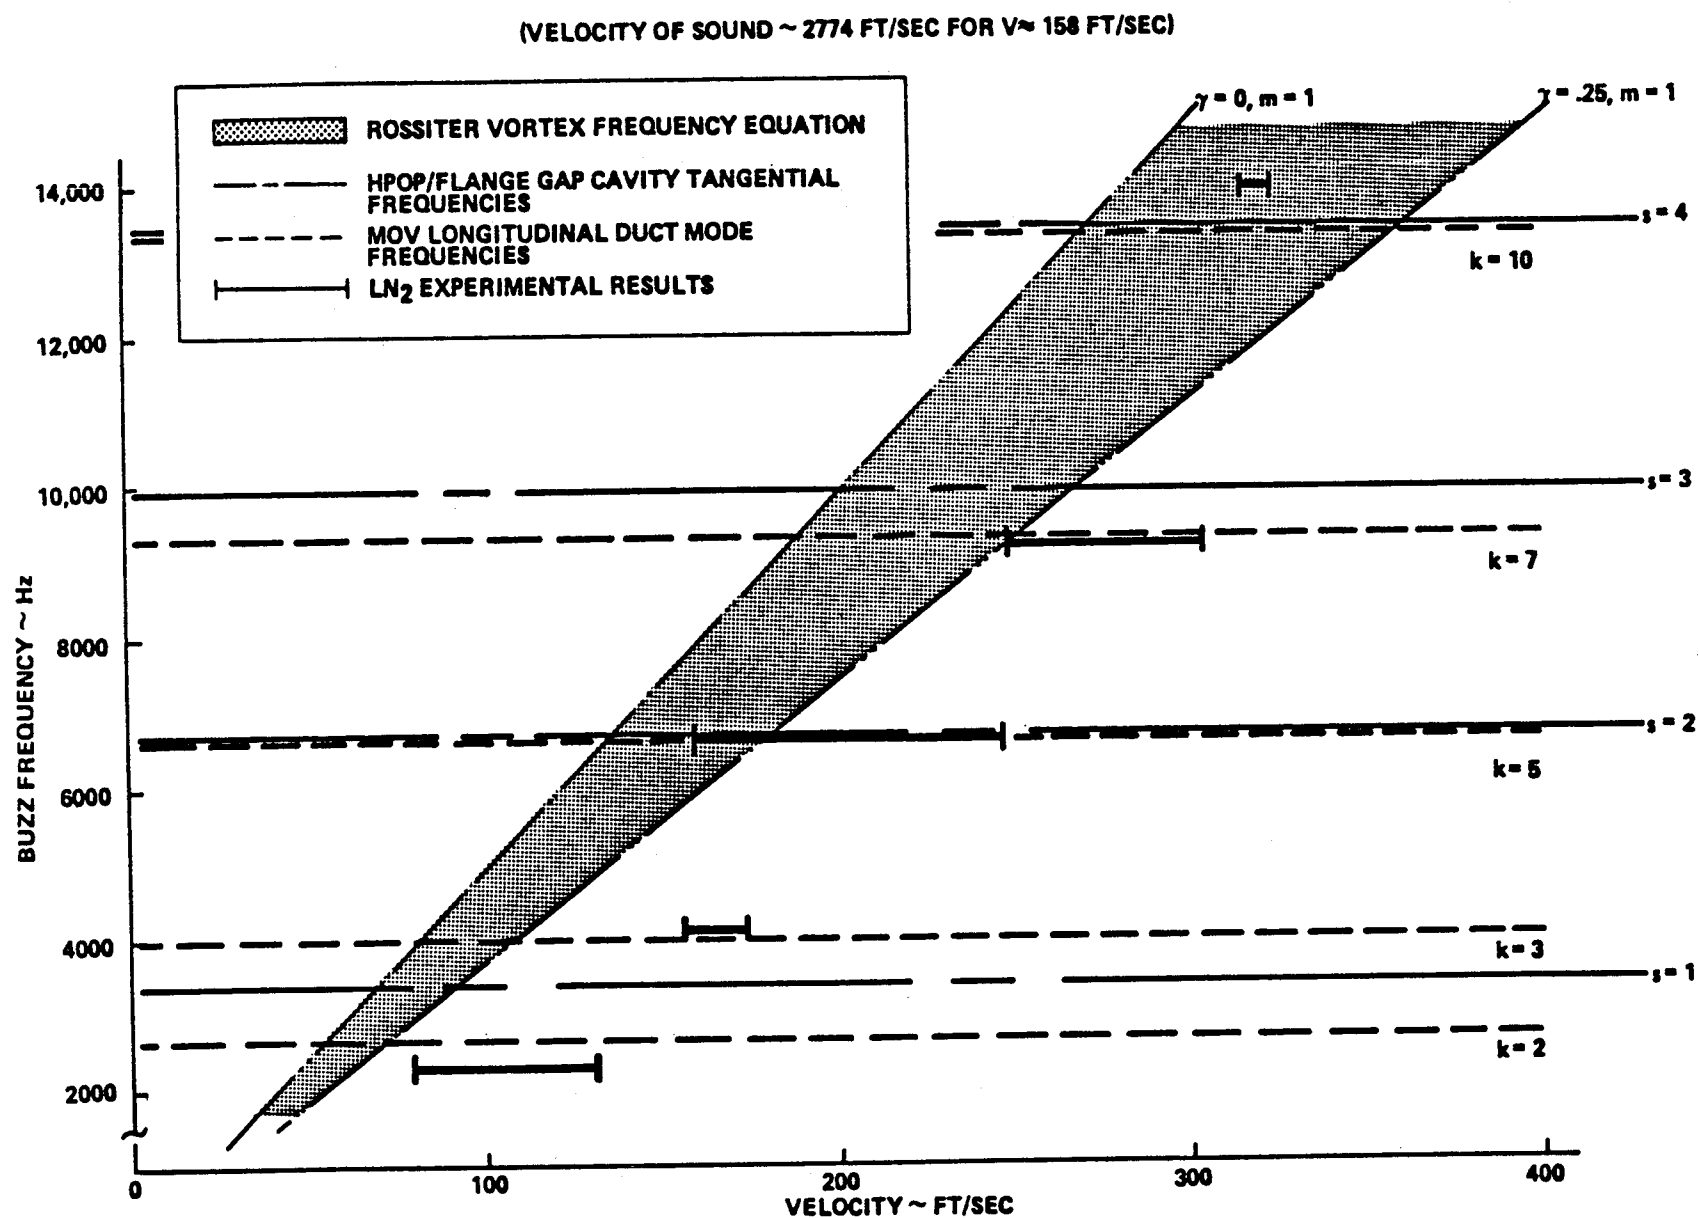
Much analytical work was accomplished to define these modes and their variations due to manufacturing tolerances. Figure 117 shows these two modes with the potential tuning areas. Shown on the same graph are the results obtained with a blowdown ground test program verifying the cause. The fix was simply a washer put in to the seal cavity (Fig. 118). This fix solved the problem as shown in Figure 119, which is a comparison of the response before and after the fix. No further evidence of MOV tuning has occurred [46,47].

Figure 117. Anomalous discrete frequency mechanism.

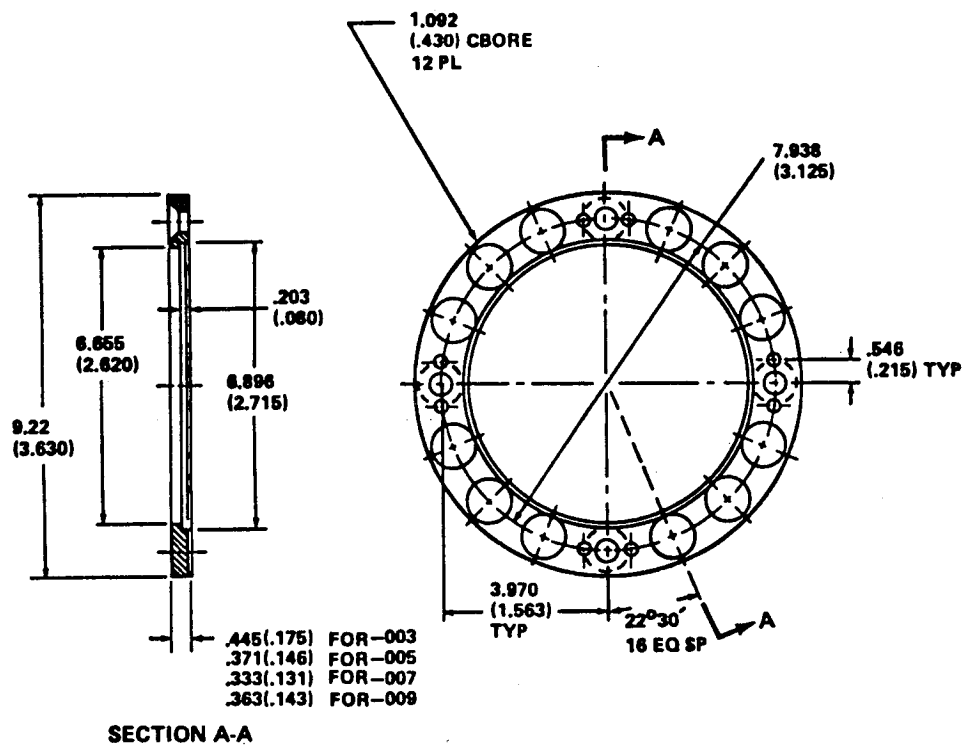
Figure 118. Main oxidizer valve shim fix configurations.

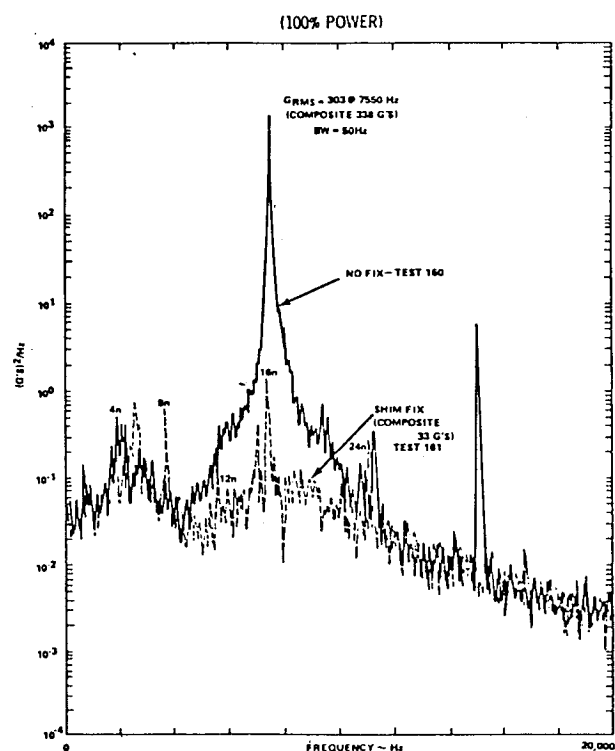
Figure 119. Comparison of hot firing axial accelerometer with and without fix.

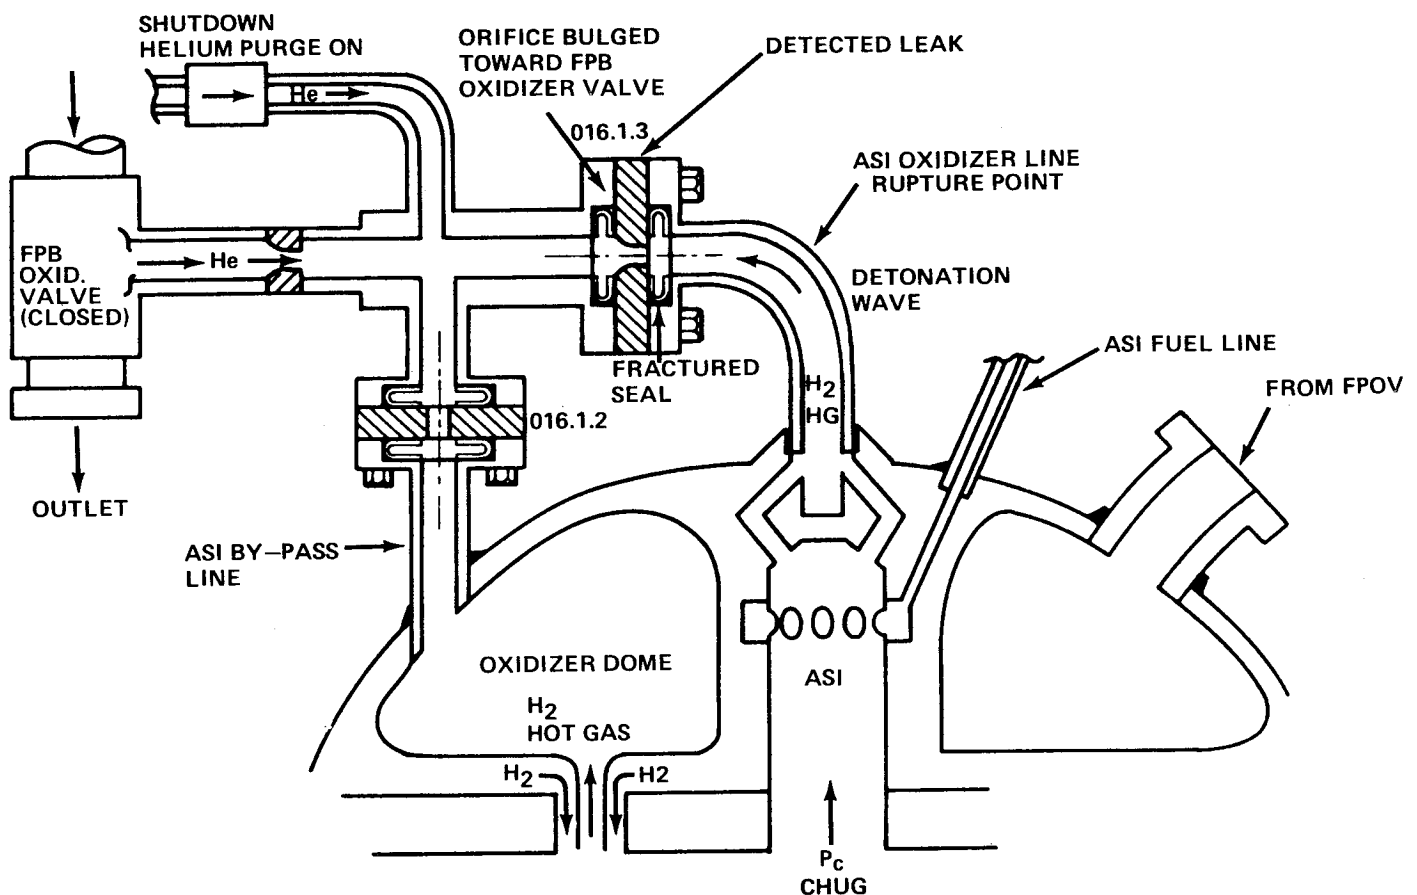
The second failure involving dynamic tuning did not involve the total engine, but only the fuel preburner oxidizer system ASI line and orifice which failed. Figure 120 shows the flow and where the failure occurred.

The problem occurs at shutdown when the engine is chugging, sucking hot gas and hydrogen into the ASI line just above the igniter. This gas explosion creates a pressure wave. This pressure wave is doubled at the orifice, failing the part and in one case the liner. The pressure wave varies substantially from one shutdown to the other depending on the amount and mixture of the gas sucked up into the line.

Figure 120. Fuel preburner oxidizer system.

The fix was very simple: Change the shutdown purge to eliminate the gas backflow. As an added precaution until ground hot firing test verified the changed purge, the ASI line was also wrapped with a fiber and epoxied. No further incident has occurred in ground testing or on Shuttle flights.

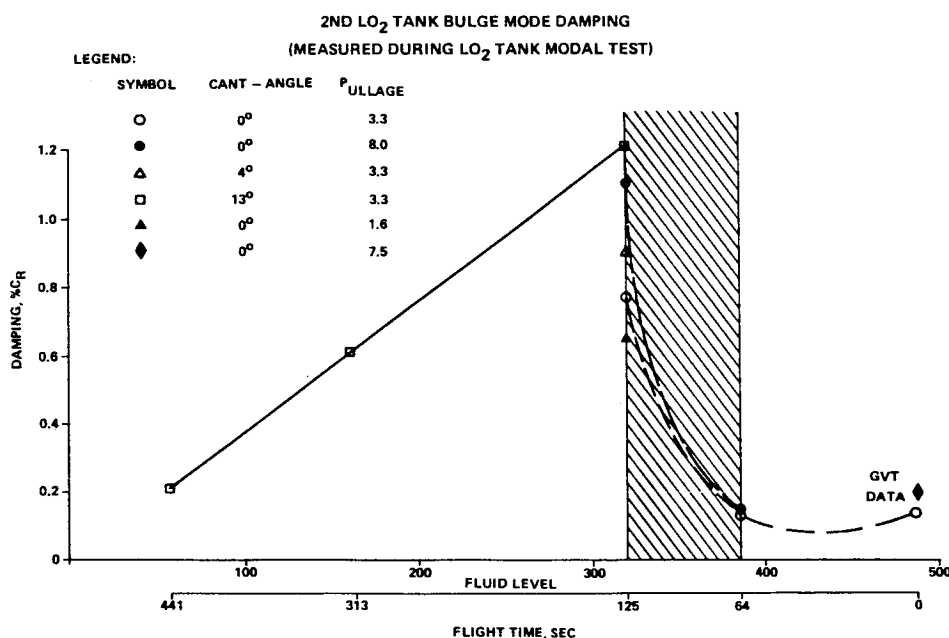
One very interesting problem of this type occurred during the lox tank hydroelastic dynamic testing of the ET. The damping of the second LO_2 tank bulge mode varied up to an order of magnitude depending on the fill level and tank tilt angle (Fig. 121). The complete explanation of modes which tuned has not been formulated; however, the results were very clear. Many special tests were run to determine if something in the test setup was the culprit. Nothing was found. It was finally decided that the full scale Shuttle system test would be used as a final verification of this effect and determine the damping to be used for system analysis. The full scale system test verified the full scale lox tank test values showing the effect was real. Since the Shuttle has an excellent pogo suppression system, the low damping values were of no consequence. The lesson: One must be ready at all times for surprises and problems in verification testing that takes time and effort to verify and understand [61].

Figure 121. ET hydroelastic mode damping.

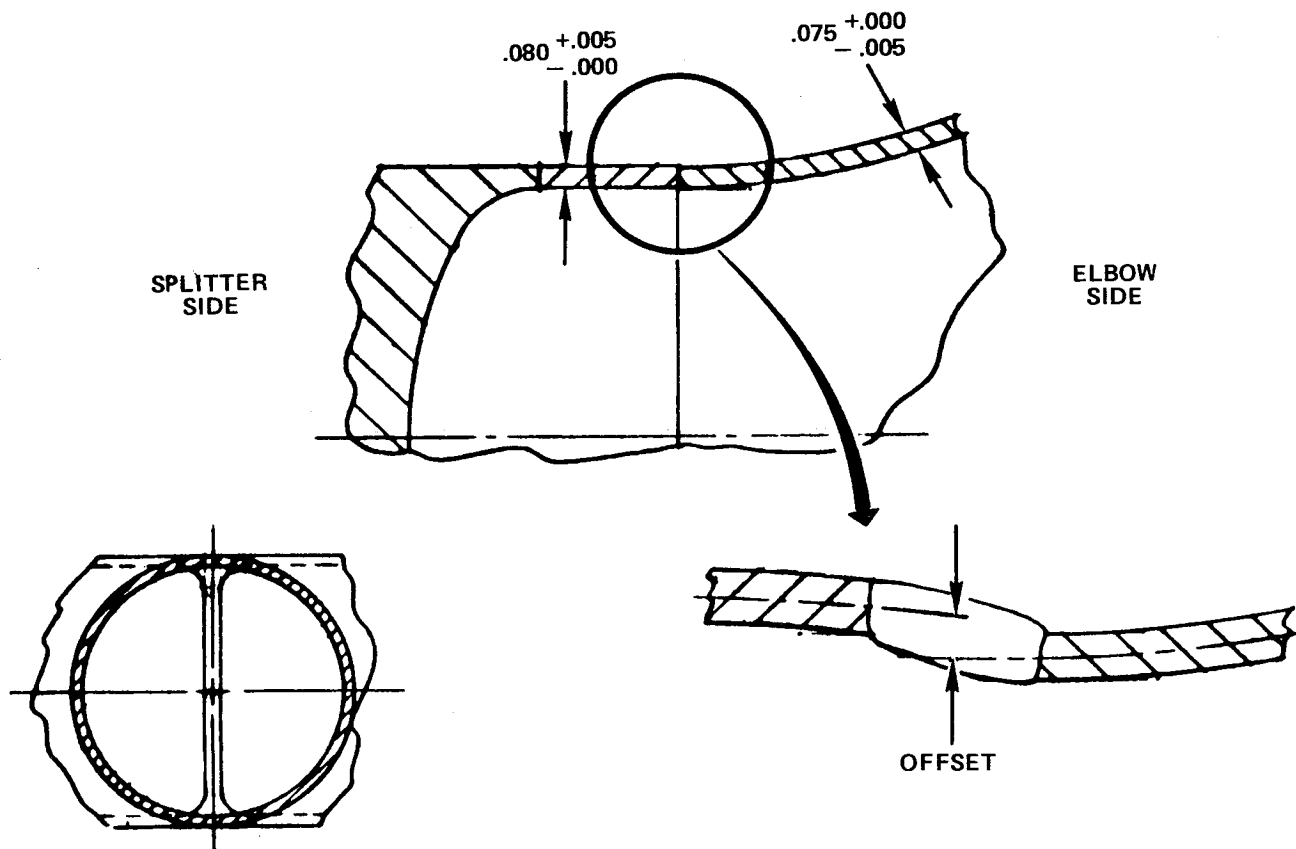
The weld offset problem has resulted in an intensive effort to establish the magnitude of each weld offset and the degradation in capability of each weld. Figure 122 shows a typical line while Figure 123 shows the type of weld offset experienced. Much effort has been required to analytically and experimentally determine actual capabilities of all welded lines on the SSME.

Figure 123. Weld joint.
