A LABORATORY INVESTIGATION OF THE ICING CHARACTERISTICS OF THE

BENDIX-STROMBERG CARBURETOR MODEL PD-12F5 WITH THE

PRATT & WHITNEY R-1830-C4 INTERMEDIATE

REAR ENGINE SECTION

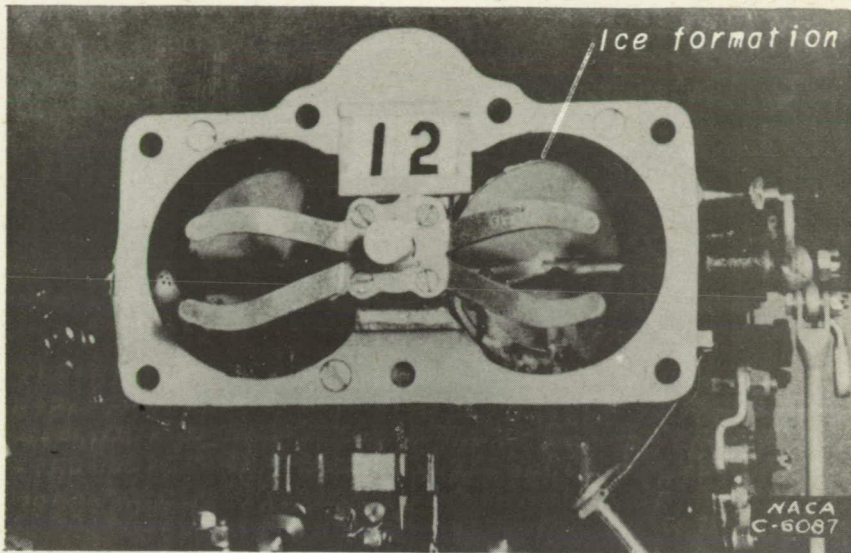
Classification of the icing according to its effect does not take into consideration the type, the size, or the location of the ice formation. The small mass of ice protruding from the edge of the throttle plates (see fig. 3) after run 12 of series A (cruising power) reduced the air flow by 200 pounds per hour. The much larger ice formation (see fig. 4) caused by fuel evaporation in run 71 of series A had no effect on air flow. A formation like that shown in figure 4 may have some effect on engine operation by disturbing the mixture distribution but, because variations in mixture distribution could not be measured in any way, icing has been classified only with respect to the effect on mass air flow.

Figure 3. - Icing affecting engine operation at cruising power. Run 12; bottom view of Bendix-Stromberg PD-12F5 carburetor; carburetor-air temperature, 40° F; relative humidity, 84 percent; initial air flow, 4030 pounds per hour.

4. Application of heat to the carburetor body and throttles would prevent much of the icing occurring on these parts.

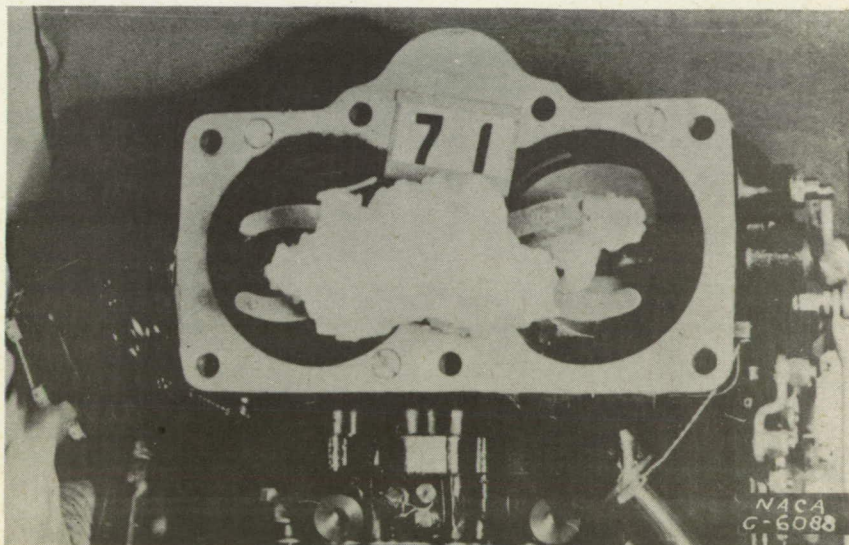
Figure 4. - Visible icing at cruising power. Run 71, bottom view of Bendix-Stromberg PD-12F5 carburetor; carburetor-air temperature, 66° F; water-injection rate, 500 grams per minute; initial air flow, 3990 pounds per hour.

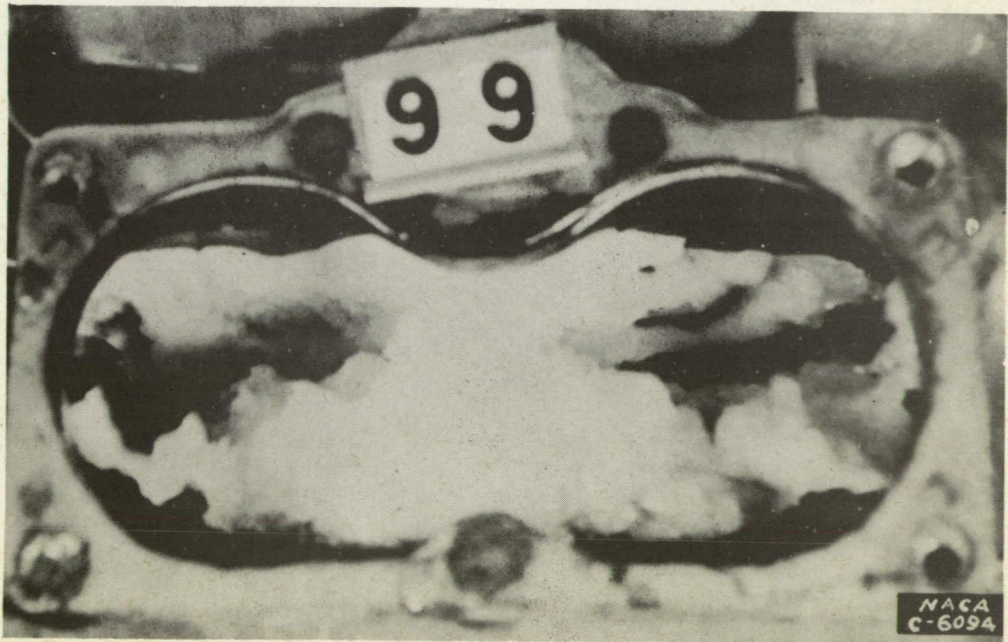
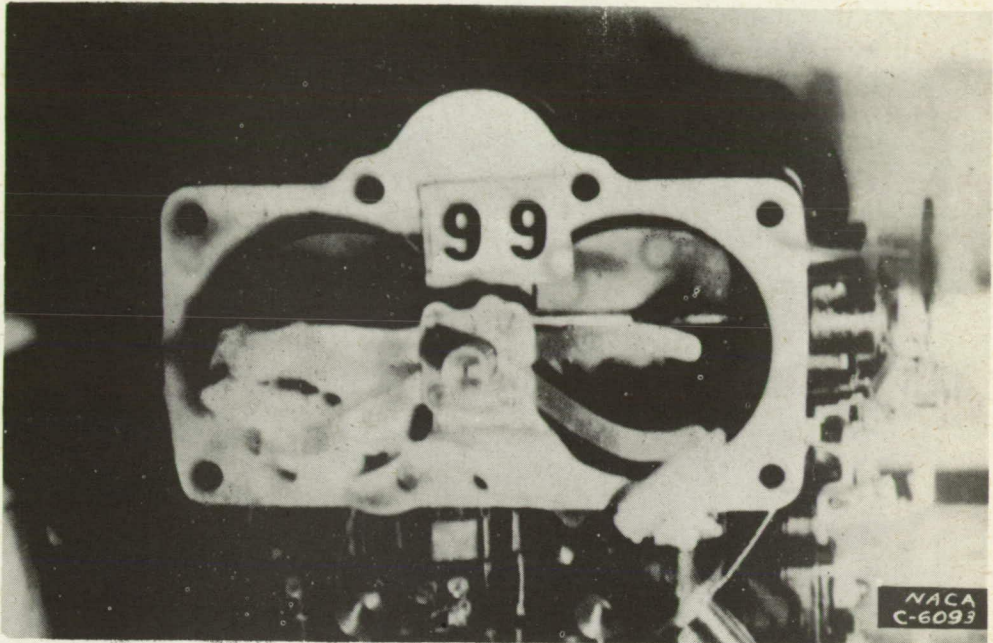
When the moisture content was increased above 0.009 pound per
pound of dry air, the upper limit of enthalpy for icing affecting
engine operation increased to about 29 Btu per pound of air and then
more slowly to about 35 Btu per pound of air as the water content
increased to about 0.060 pound per pound of air. The predominating
ice formations occurred on the turning vanes and the X-bar below the
carburetor. This icing was probably caused by the refrigerating
effect of evaporating fuel. Ice formations of the type that occurred
at high rates of free-water injection are shown in figure 7.

8. For moisture contents in excess of saturation, icing occurred on the carburetor X-bar and on the turning vanes in the supercharger-impeller entrance.

(a) Bottom view of carburetor showing ice formations
     on X-bar.

(b) Ice formations in engine air passage.

Figure 7. - Evaporation icing affecting engine operation at
           cruising power. Run 99; Bendix-Stromberg PD-12F5
           carburetor; carburetor-air temperature 40° F;
           water-injection rate, 500 grams per minute;

3. The presence in the induction system of obstructions such as X-bars, turning vanes, and thermometer bulbs increases the icing hazard by permitting the accumulation of ice on them and, in some cases, by increasing the turbulence of the evaporating fuel-air mixture and allowing it to strike the metal surfaces in the system and cool them below the freezing point. An ideal induction system should have no obstructions or protuberances and should have an expanding section below the point of fuel injection to allow any ice formed to pass through freely and also to decrease turbulence.
