May 11, 1965

National Aeronautics and Space Administration  
Goddard Space Flight Center  
Greenbelt, Maryland

Subject: Monthly Progress Report No. 6  
Contract NAS 5-9006

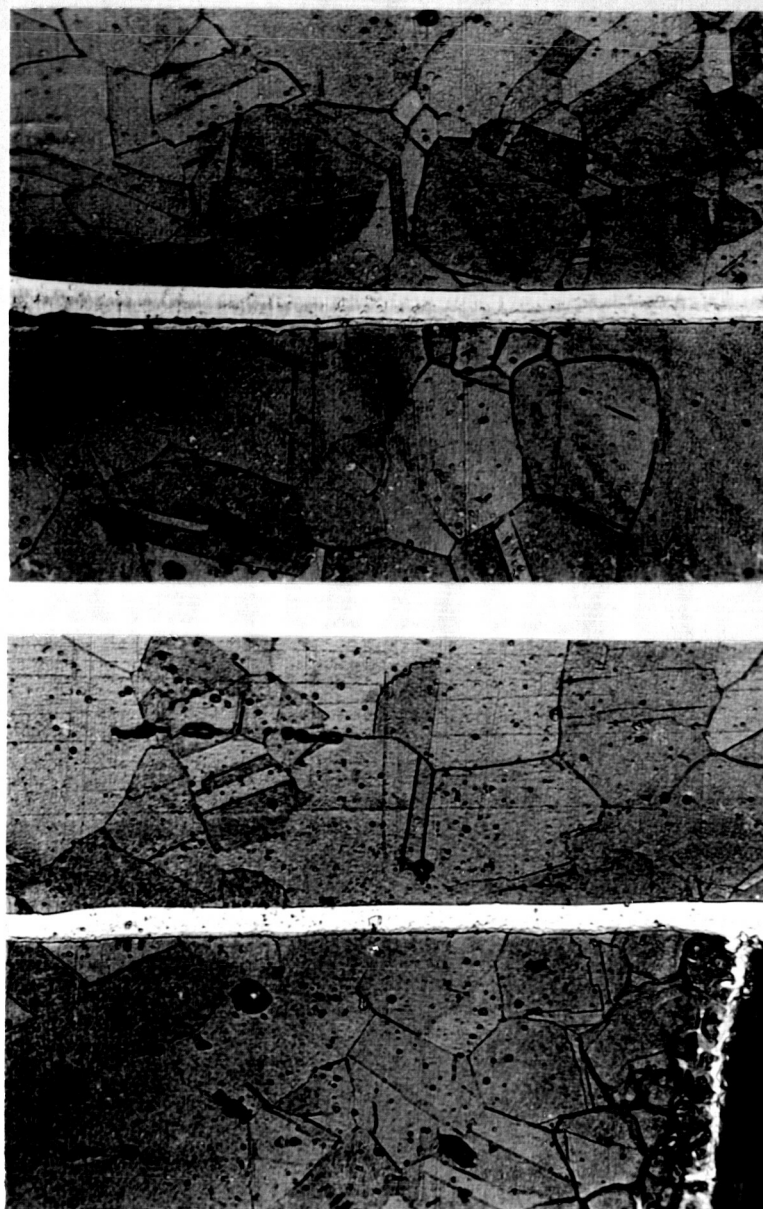
Cover

Edge of bond area  
showing difference  
in plate thickness

The photomicrographs in Figure 1 show a section of the bond. The locale of the bond is the shadowy line close to the frame. In the top photomicrograph it can be observed from the area adjacent to the bond zone that the gold plating on the cover is much thicker than on the re-plated picture frame. Measurement of the observed difference in plating thicknesses in this section showed that the plating on the cover is 0.0006-inch thick and the plating on the frame is 0.0001-inch thick. The average plating thicknesses on both parts was reported to be approximately 200 microinches (0.0002 inch) in a private communication from Zell. The difference measured in this section is presumed to be consistent over the entire surfaces of the cover and picture frame, in this sample and in other samples. The thin layer on the picture frame, being restrained by the more rigid Kovar substrate, cannot yield and plastically deform to the same extent as the thicker coating on the cover, which can display more bulk behavior.
