DEVELOPMENT, FABRICATION, AND DELIVERY  
OF NEODYMIUM DOPED YAG  
LASER RODS

NASA CR 70873

3rd Quarterly Report  
Covering Period from September 18, 1965 to December 18, 1965

Contract No. NAS8-11865

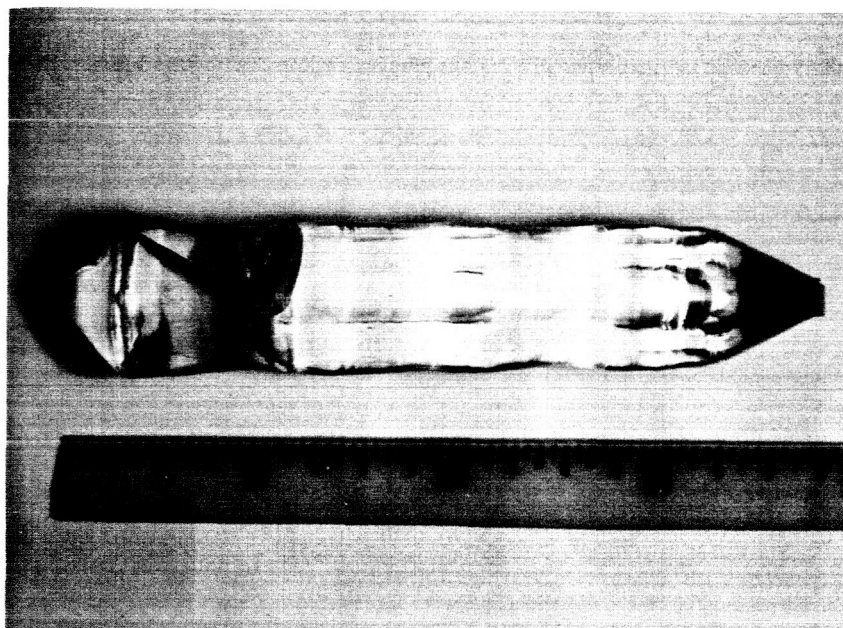
FIGURE 1 ILLUSTRATION OF CRACK PROBLEM  
IN LARGEST SIZE Nd:YAG CRYSTALS

Major effort was concentrated on learning how best to operate the scaled-up growth stations for the consistent production of high quality Nd:YAG crystals large enough to yield laser rods 1/4-inch diameter by 1-1/2 inches long (or as long as possible). During the last quarter, operating personnel became sufficiently familiar with the new setups so that the diameter fluctuation described in the previous quarterly report was largely eliminated. As a result, a number of crystals were grown that were 3 to 3-1/2 inches long and 0.6 to 0.75 inch in diameter. During growth, as nearly as could be judged by eye under less-than-optimal viewing conditions, internal quality appeared excellent. However, as growth experience with this size range accumulated, a new problem was encountered with considerable regularity: these larger crystals seemed to be much more susceptible to cracking than were the smaller sizes. Figure 1 shows a typical example of the kind of failure that occurred. Normally, the cracks developed within about one minute after shutdown, although one crystal cracked during growth, shortly before it was scheduled to be pulled from the melt. When this cracking was first encountered, it was considered a thermal shock problem caused primarily by too rapid and uneven cooling of the crystal after it had been pulled from the melt. Therefore, the shutdown procedure was drastically revised so as to stretch out the initial cool-down over a much longer period of time. However, the cracking persisted. Closer examination of the crystals then revealed that the cracks always passed through, and probably originated at, a type of surface irregularity that was characteristic of this series of

growth runs. These surface defects were roughly hemispherical depressions usually 1 to 3 mm in diameter, numbering perhaps two or three, and found only after 2 to 2.5 inches of growth. Their cause is known: after about 2 to 2.5 inches of growth had occurred, small bubbles were observed to begin accumulating in the melt. These were never seen floating free: most of them remained attached to the crucible wall, but occasionally one or two were seen attached to the crystal at the level of the growth interface. There they interfered with growth, resulting in the kind of depressions described above whose sharply irregular contours must surely make them prime suspects as crack initiators. The origin of these bubbles is a speculative matter at present; however, experimental work is in progress aimed at learning how to prevent their formation.

Although cracks have occasionally occurred in Nd:YAG crystals during earlier periods of this program, they were usually caused by some kind of easily recognizable and fairly drastic change in some system parameter during the course of a run such as e. g. , sudden furnace shut-down. The presently encountered crack problem has a more subtle origin and did not even become obvious until the largest size Nd:YAG crystals were being grown regularly and in an otherwise well-controlled fashion. However, the apparent correlation between the bubble attachment to the growing crystal and subsequent cracking seems quite reasonable at the present time, and steps are being taken to determine how best to eliminate the problem. The fact should be emphasized here that the bubble formation/cracking difficulties have not been encountered in the growth of smaller crystals, such as those required for the fabrication of 3 mm x 75 mm rods.

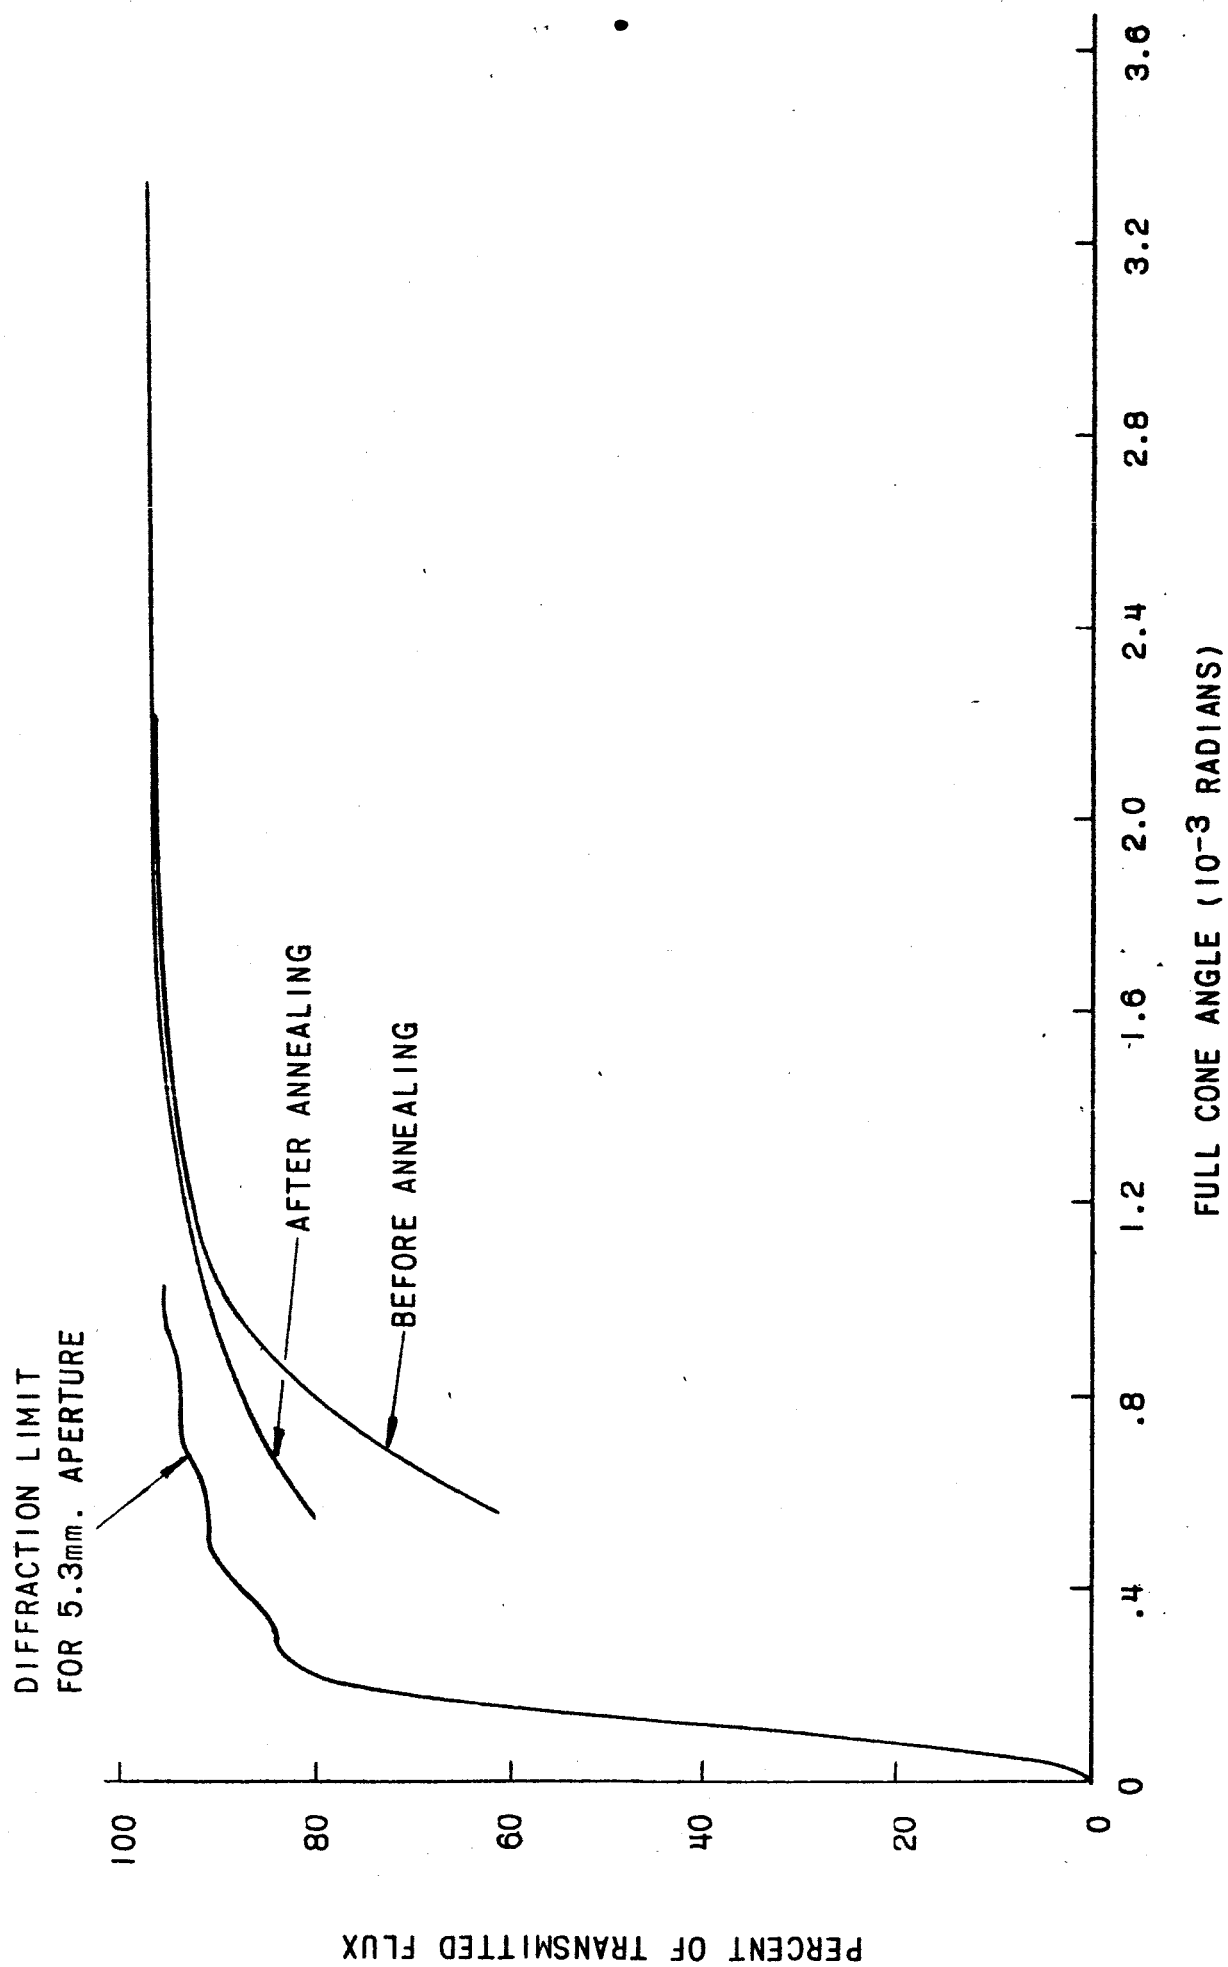
FIGURE 2.. EFFECT OF ANNEALING AT 1850°C ON PASSIVE BEAM DIVERGENCE OF ROD 1493B.

Long-time (40 hr) annealing at 1850-1870°C caused no perceptible change in the appearance of the optical inhomogeneities associated with the tube region, both in Nd:YAG and undoped YAG rods. However, annealing a tube-free rod for only five

hours at 1850°C caused an apparent improvement of some 20% in passive beam divergence. Additional experimental work is planned in order to gain further knowledge about the reproducibility of the effect and to ascertain whether still further improvement in optical quality might be obtained via annealing.

Twyman-Green photographs and far field photographs appear identical (see Table I); however, the passive beam divergence seemed significantly improved (Figure 2). An attempt was made to reanneal this same rod at 1900°C; however, a temporary overshoot in temperature resulted in meltdown. Additional tests are planned as rods become available.
