2014 NEPP Tasks Update for Ceramic and Tantalum Capacitors

Alexander Teverovsky
AS&D, Inc.
Work performed for Parts, Packaging, and Assembly Technologies Office,
NASA GSFC, Code 562
Alexander.A.Teverovsky@nasa.gov

Deliverable to NASA Electronic Parts and Packaging (NEPP) Program to be published on nepp.nasa.gov originally presented by Alexander Teverovsky at the NASA Electronic Parts and Packaging (NEPP) Electronics Technology Workshop, Greenbelt, MD, June 17-19, 2014.

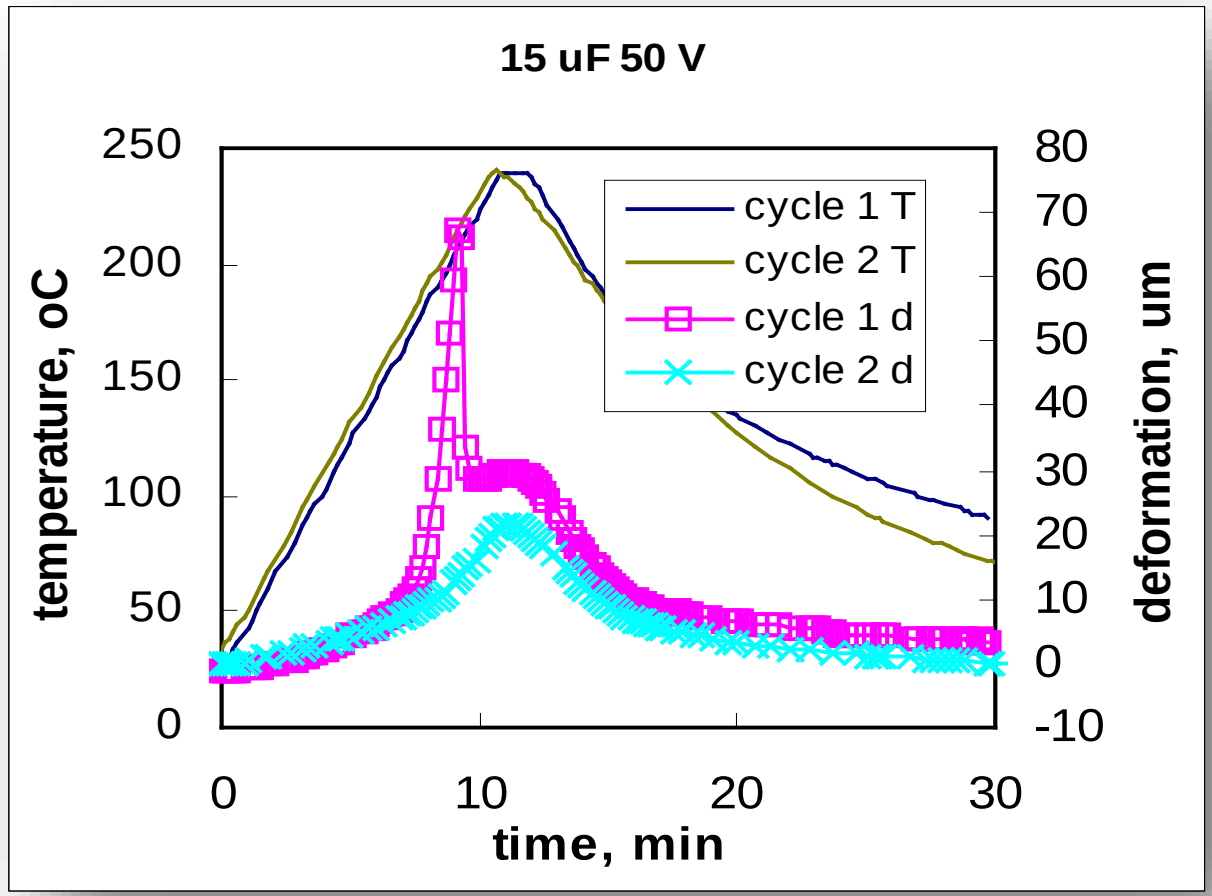
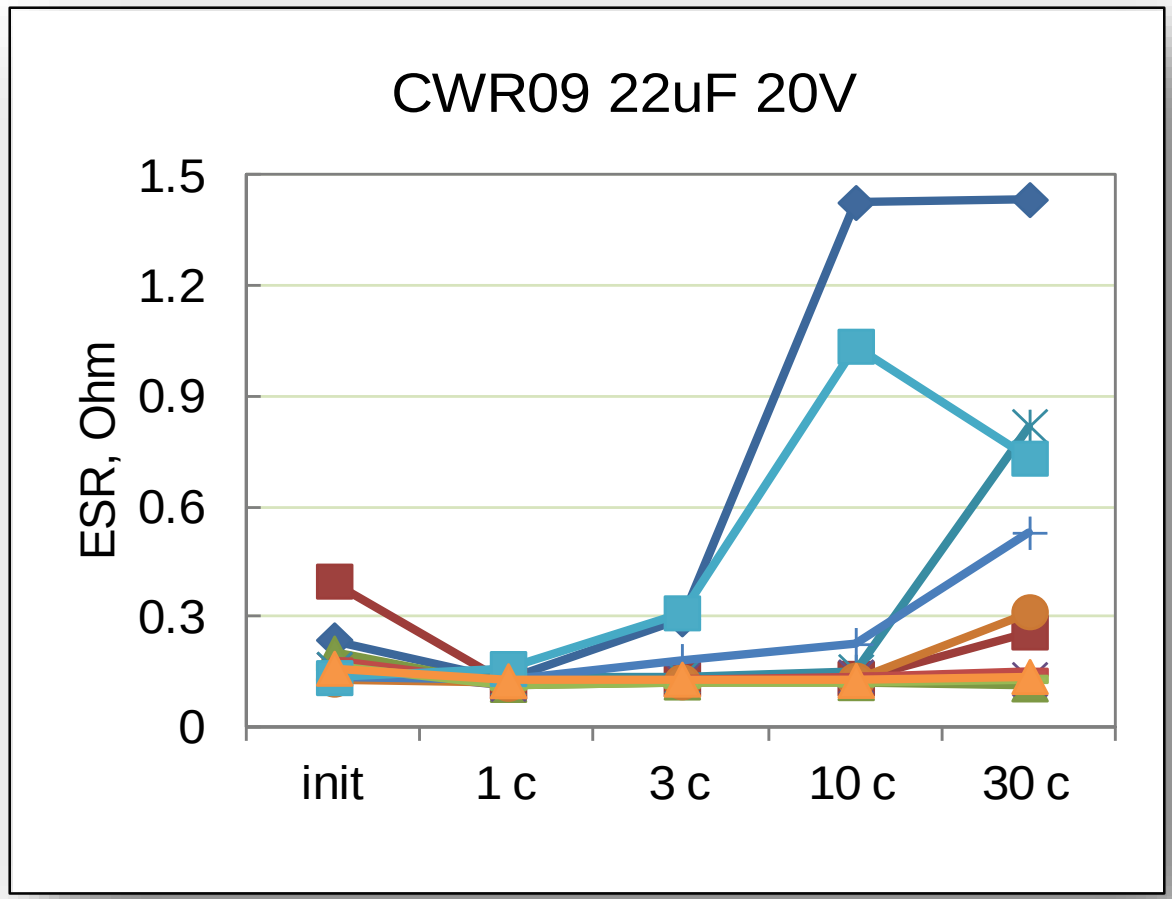
✓Baking to avoid pop-corning.
✓Multiple soldering cycles might degrade ESR and DCL.
✓Recent projects' failures (linear regulator oscillated due to increased ESR, first turn-on failures)

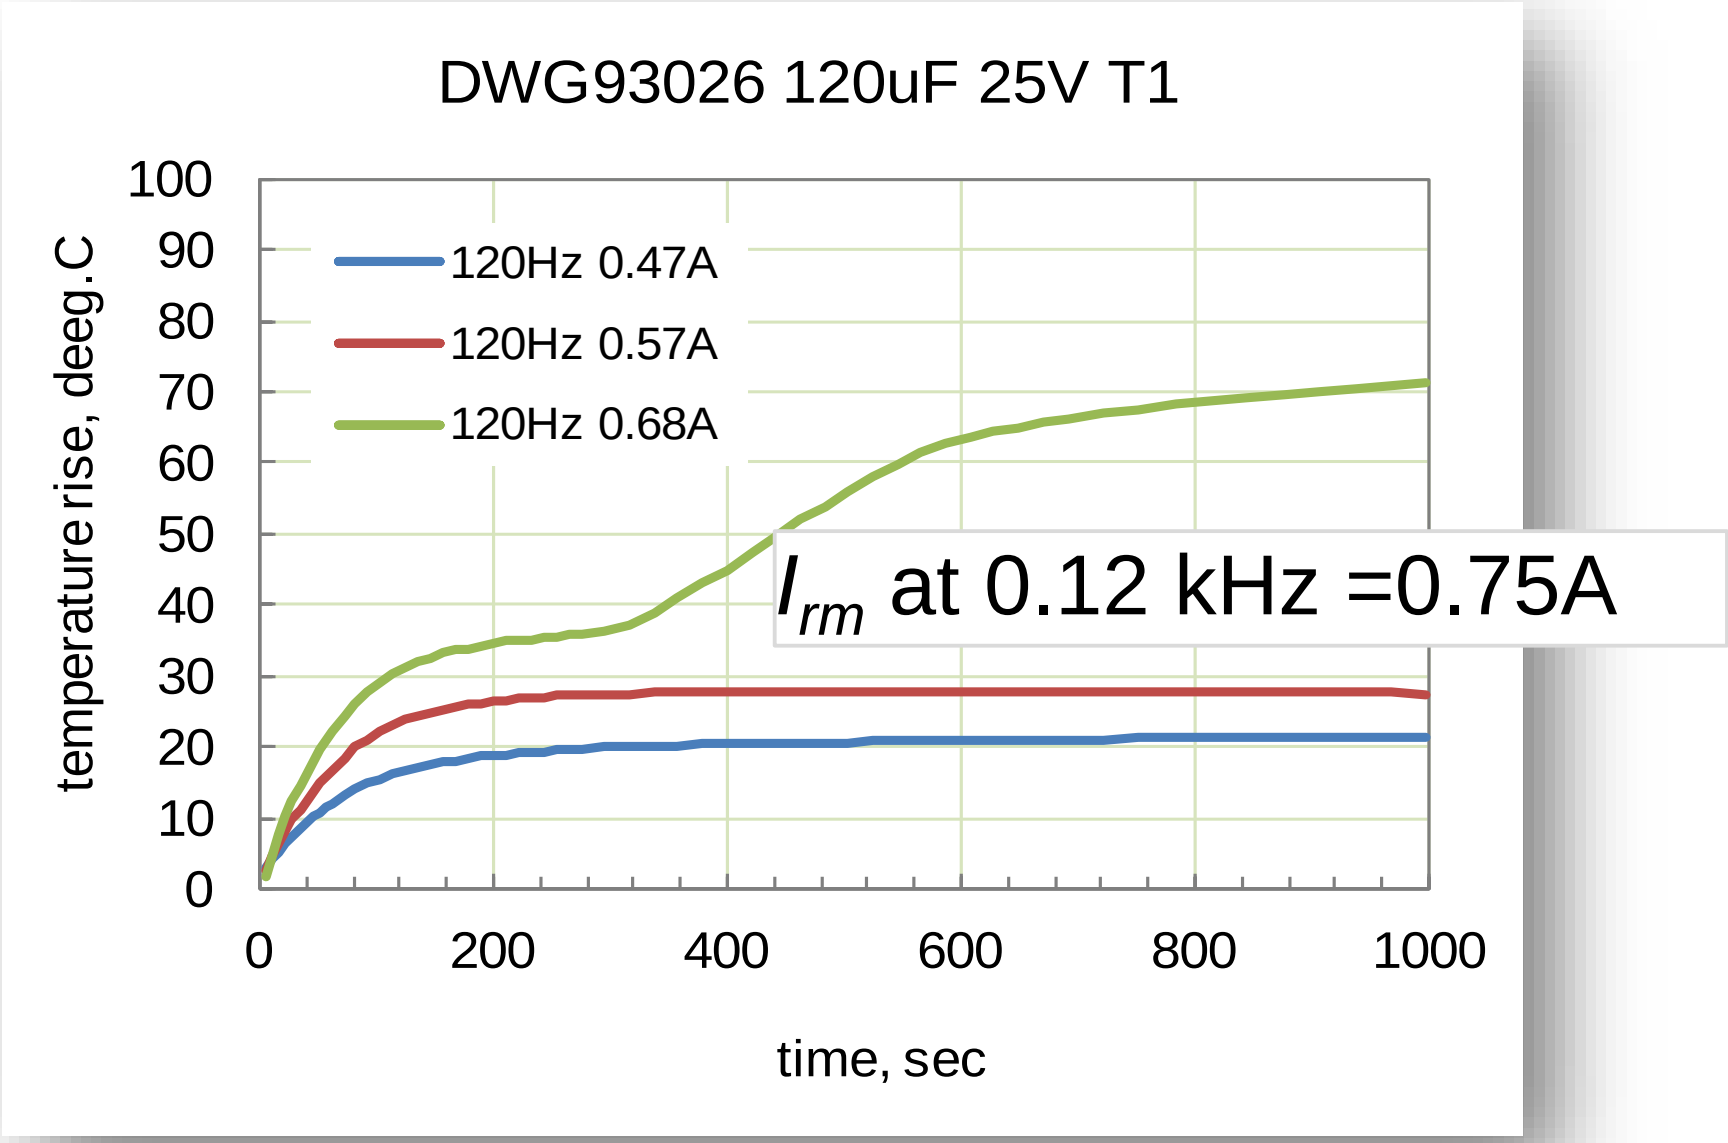
Failure in vacuum chamber

Thermal run-away in vacuum happened at currents below I_{rm}.

- ✓ Guidelines for S&Q have been updated to include ripple current requirements.
- ✓ Requirements for vibration testing should be specified.

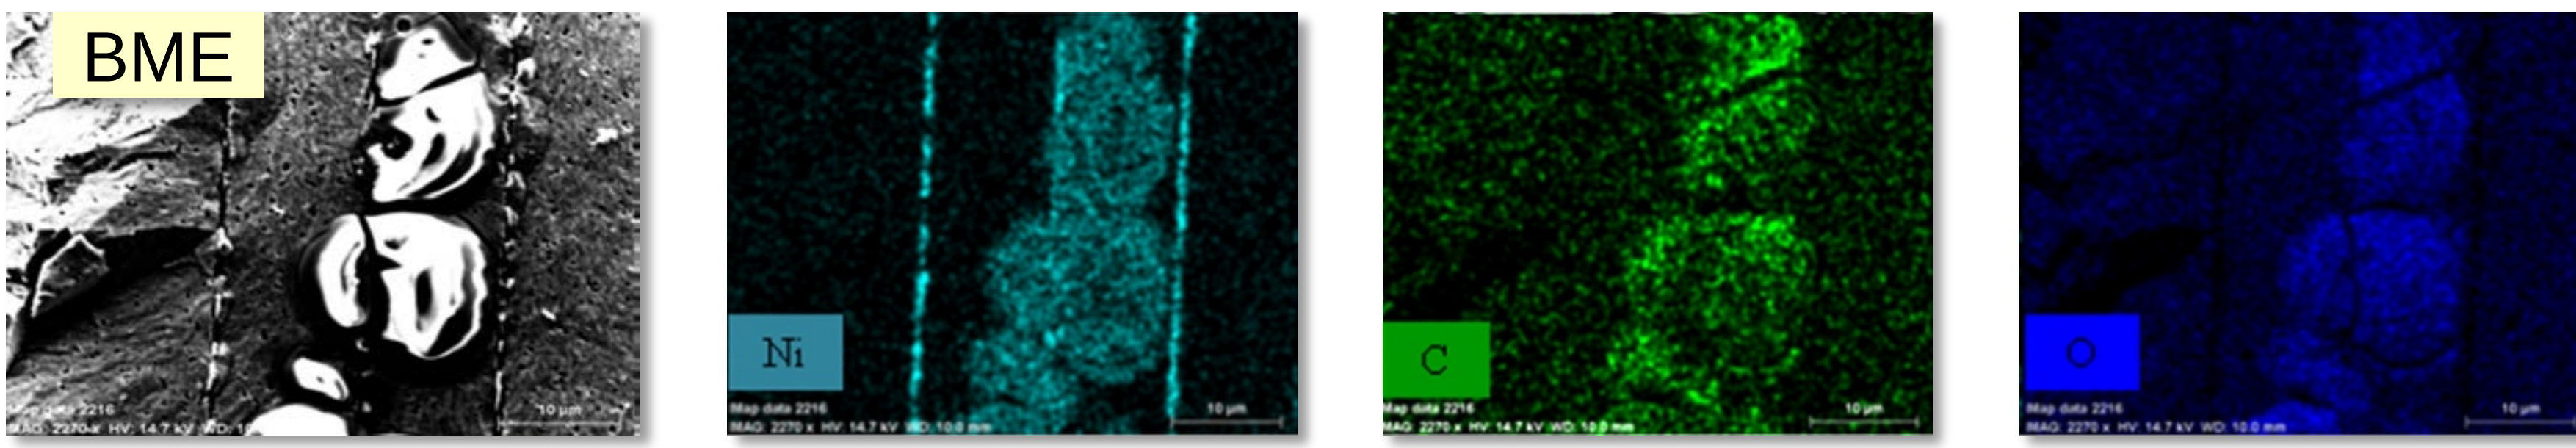
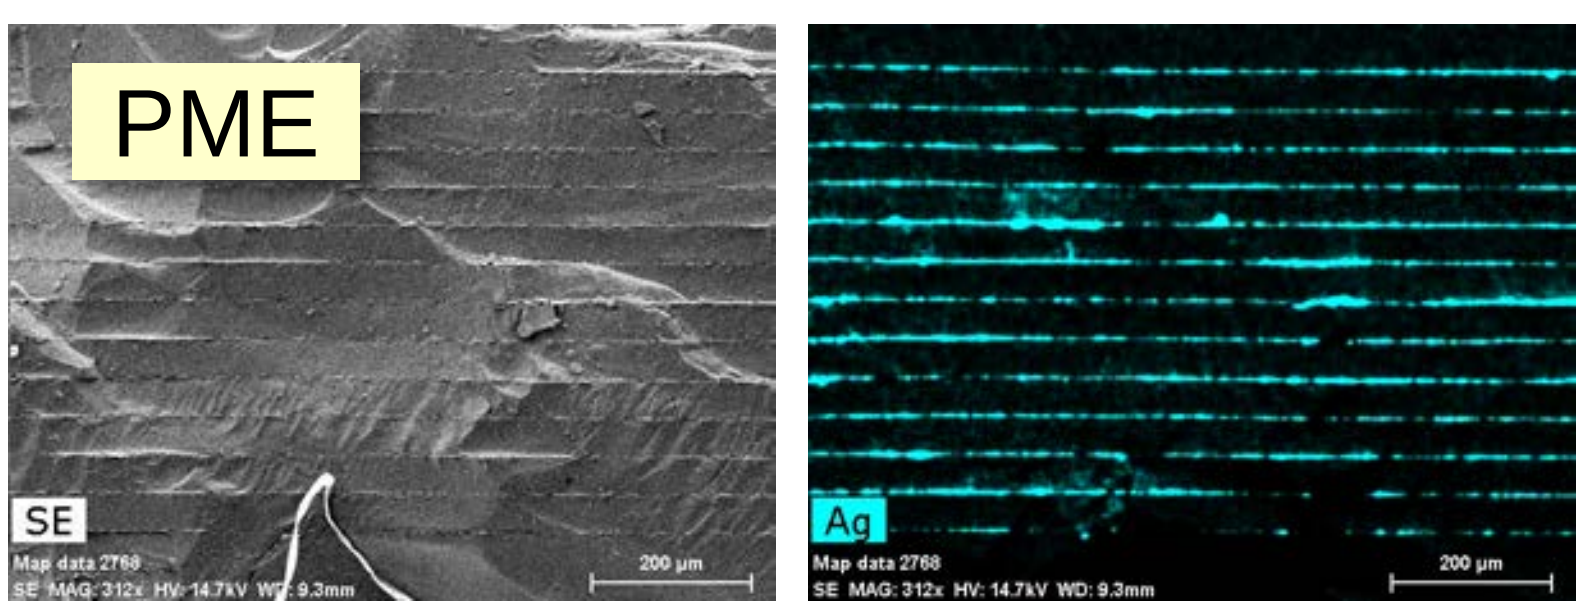
- HSSLV testing of various types of PME and BME capacitors showed that all PME capacitors with cracks failed, compared to16% for BME.
- Failed BME capacitors had much greater IR.
- Cracks in BME can be revealed by THB testing at V >> 1.3V.
- Manual soldering have a detrimental effect on MLCCs with defects.

- Probability of failures for PME is greater than for BME capacitors.
- The difference is due to the specifics of electro-chemical behavior of Ni and Ag/Pd and formed products.
- HSSLV testing is not effective for BME.

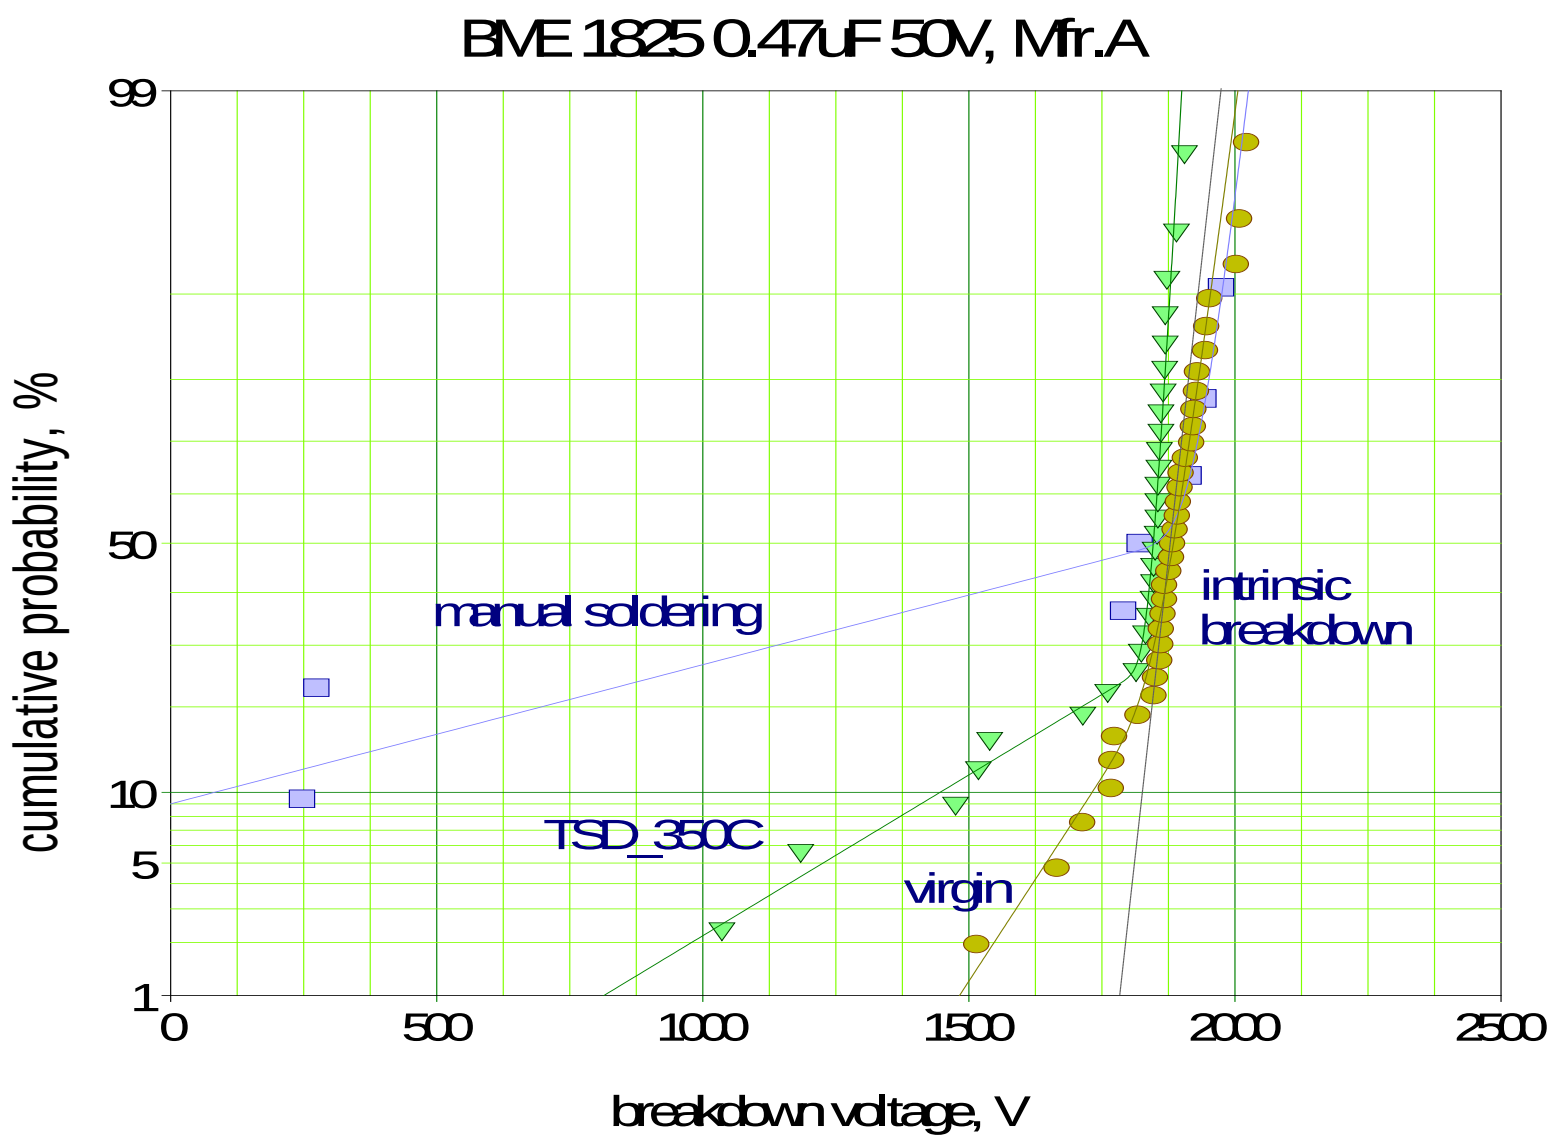
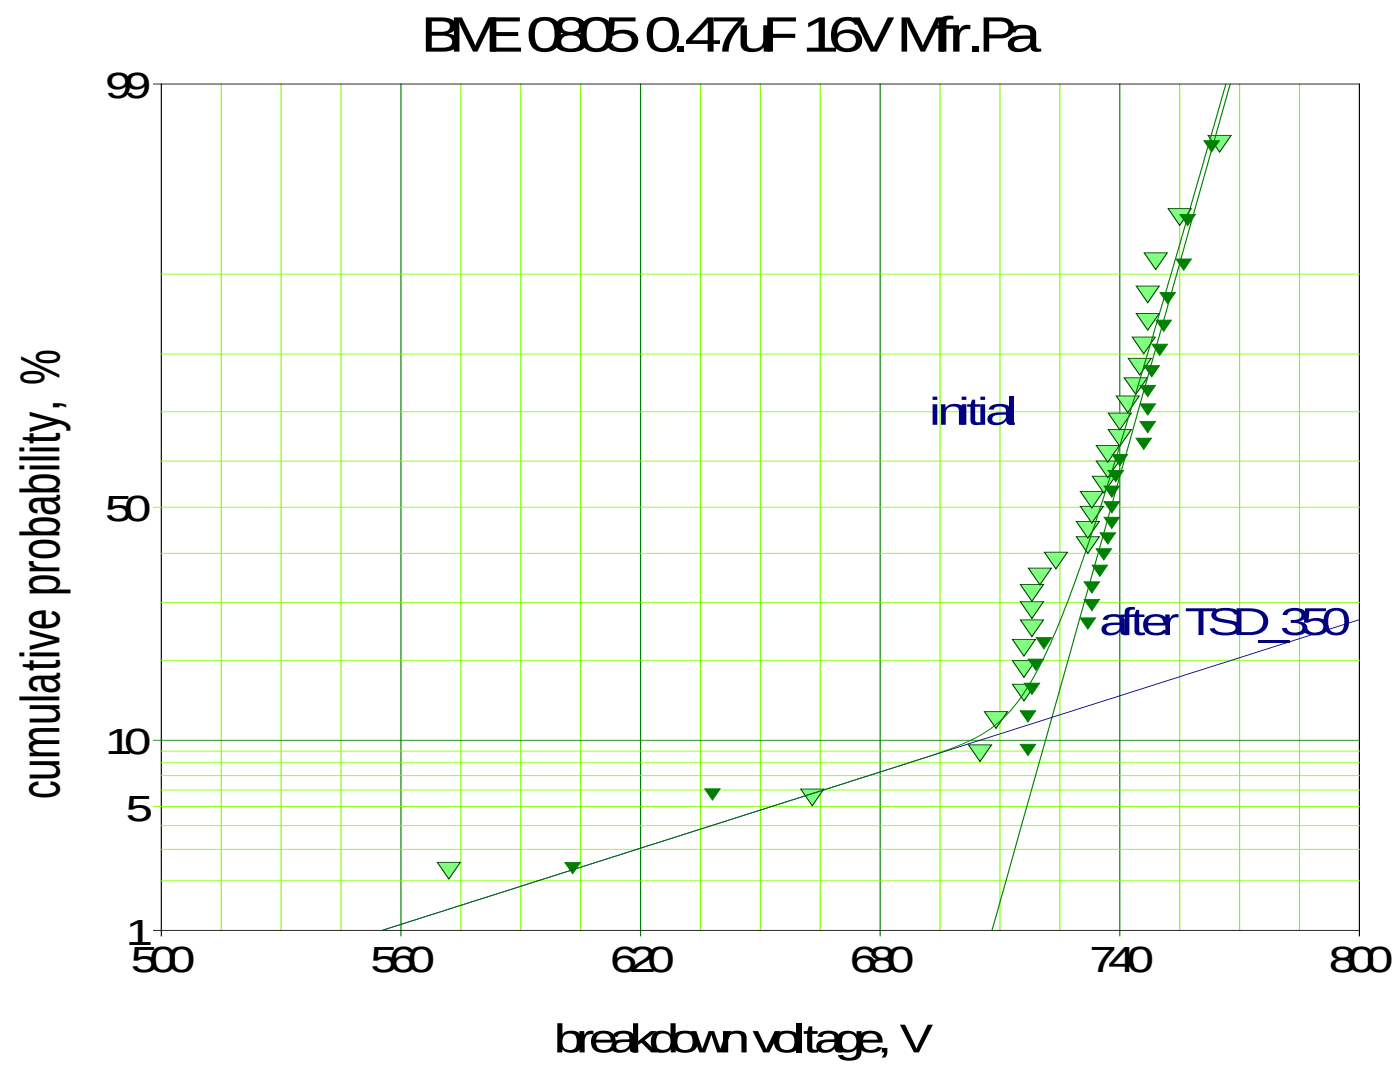
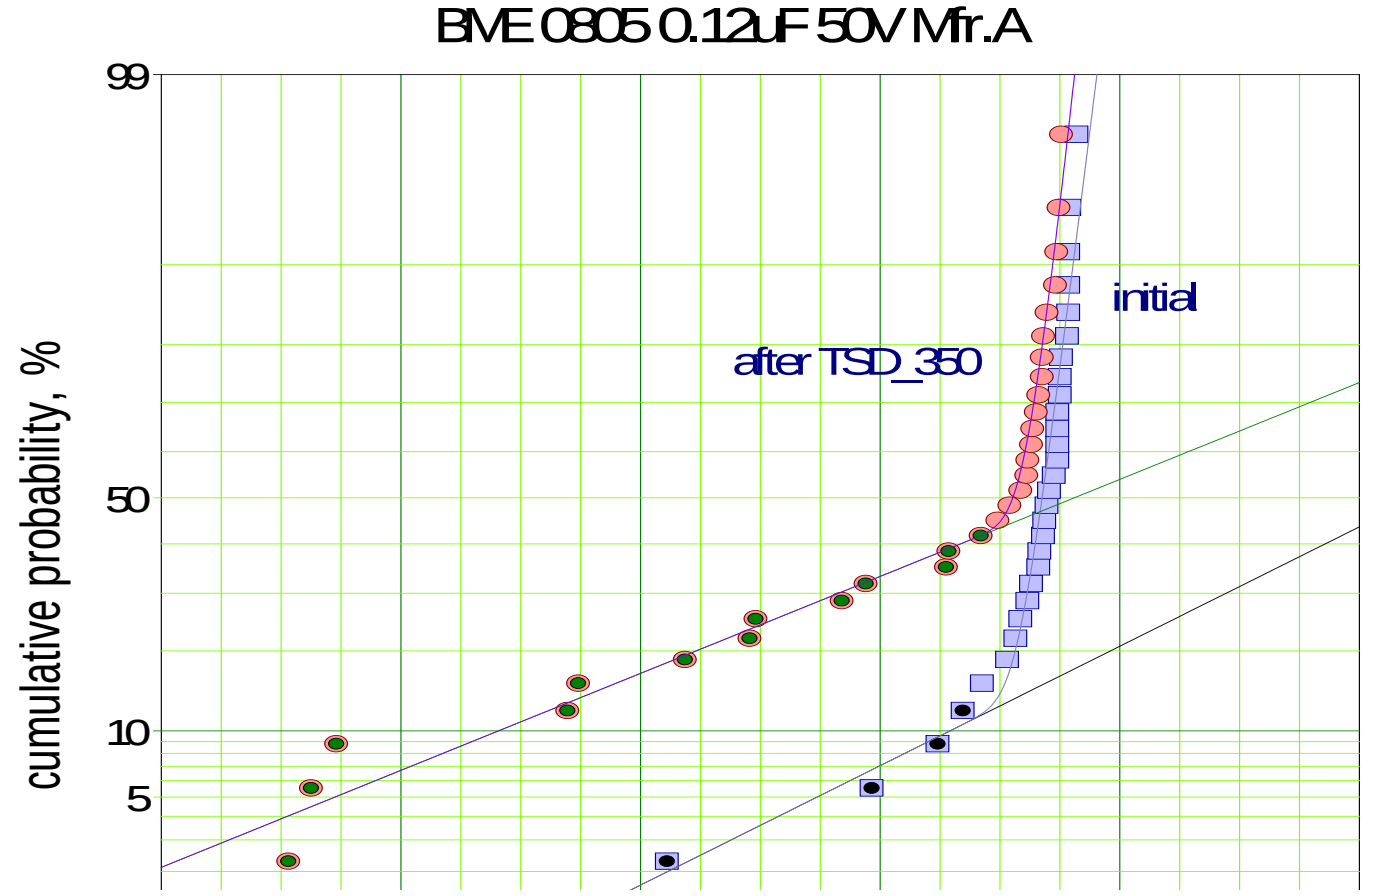
Effect of Soldering Stresses on VBR

- ✓Some lots are sensitive to TSD stress.
- ✓Stresses related to manual soldering can degrade VBR.
- ✓VBR can be used as one of tests to qualify MLCCs for manual soldering.

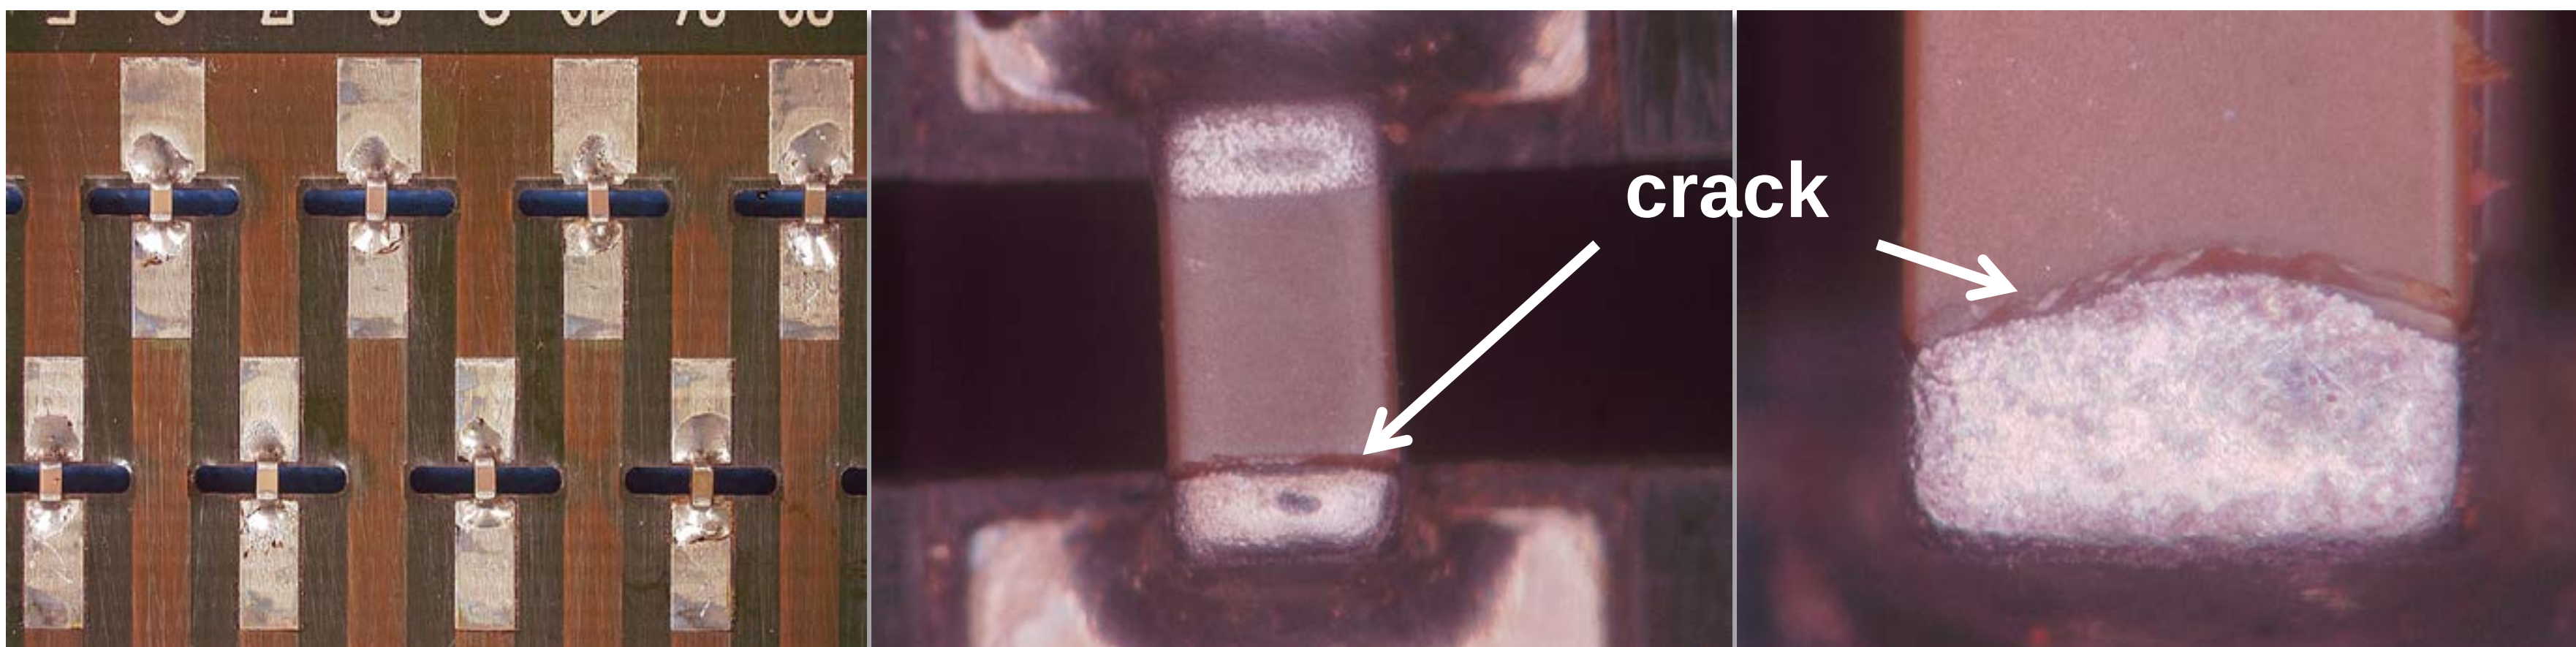
- It is often assumed that large size MLCCs are more vulnerable to cracking.
- Out of 40 samples of 0603 size MLCCs soldered with a soldering iron set to 315°C, 10 samples had intermittent or no contact.
- Failures were due to cracks along the terminations.
- No failures when parts were soldered onto a board preheated to 150°C.

- ✓ Manual soldering can cause cracking of small size capacitors.
- ✓ Preheating of the board is critical to reduce the probability of failures.

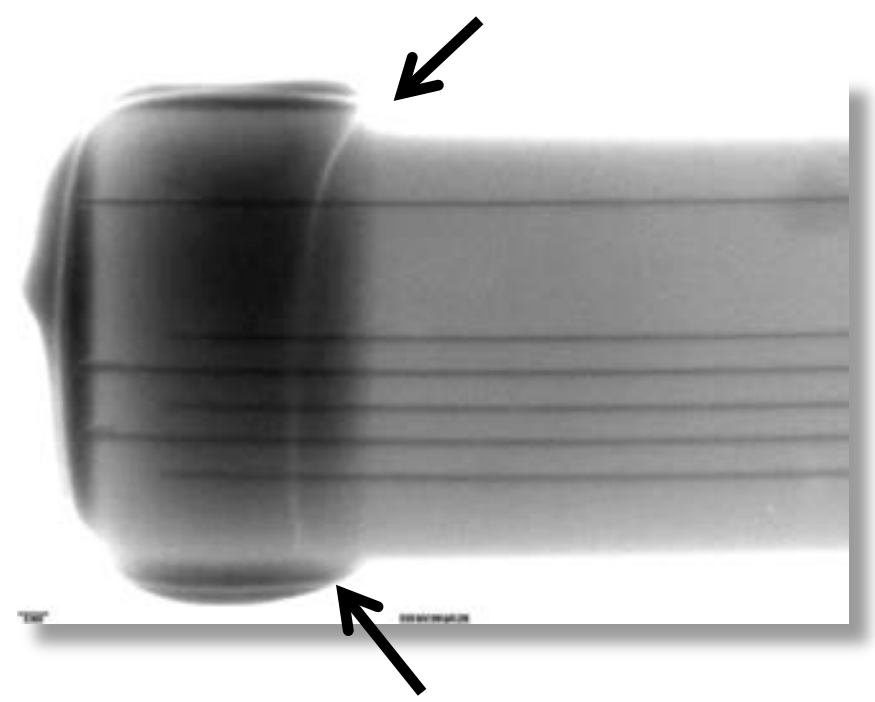
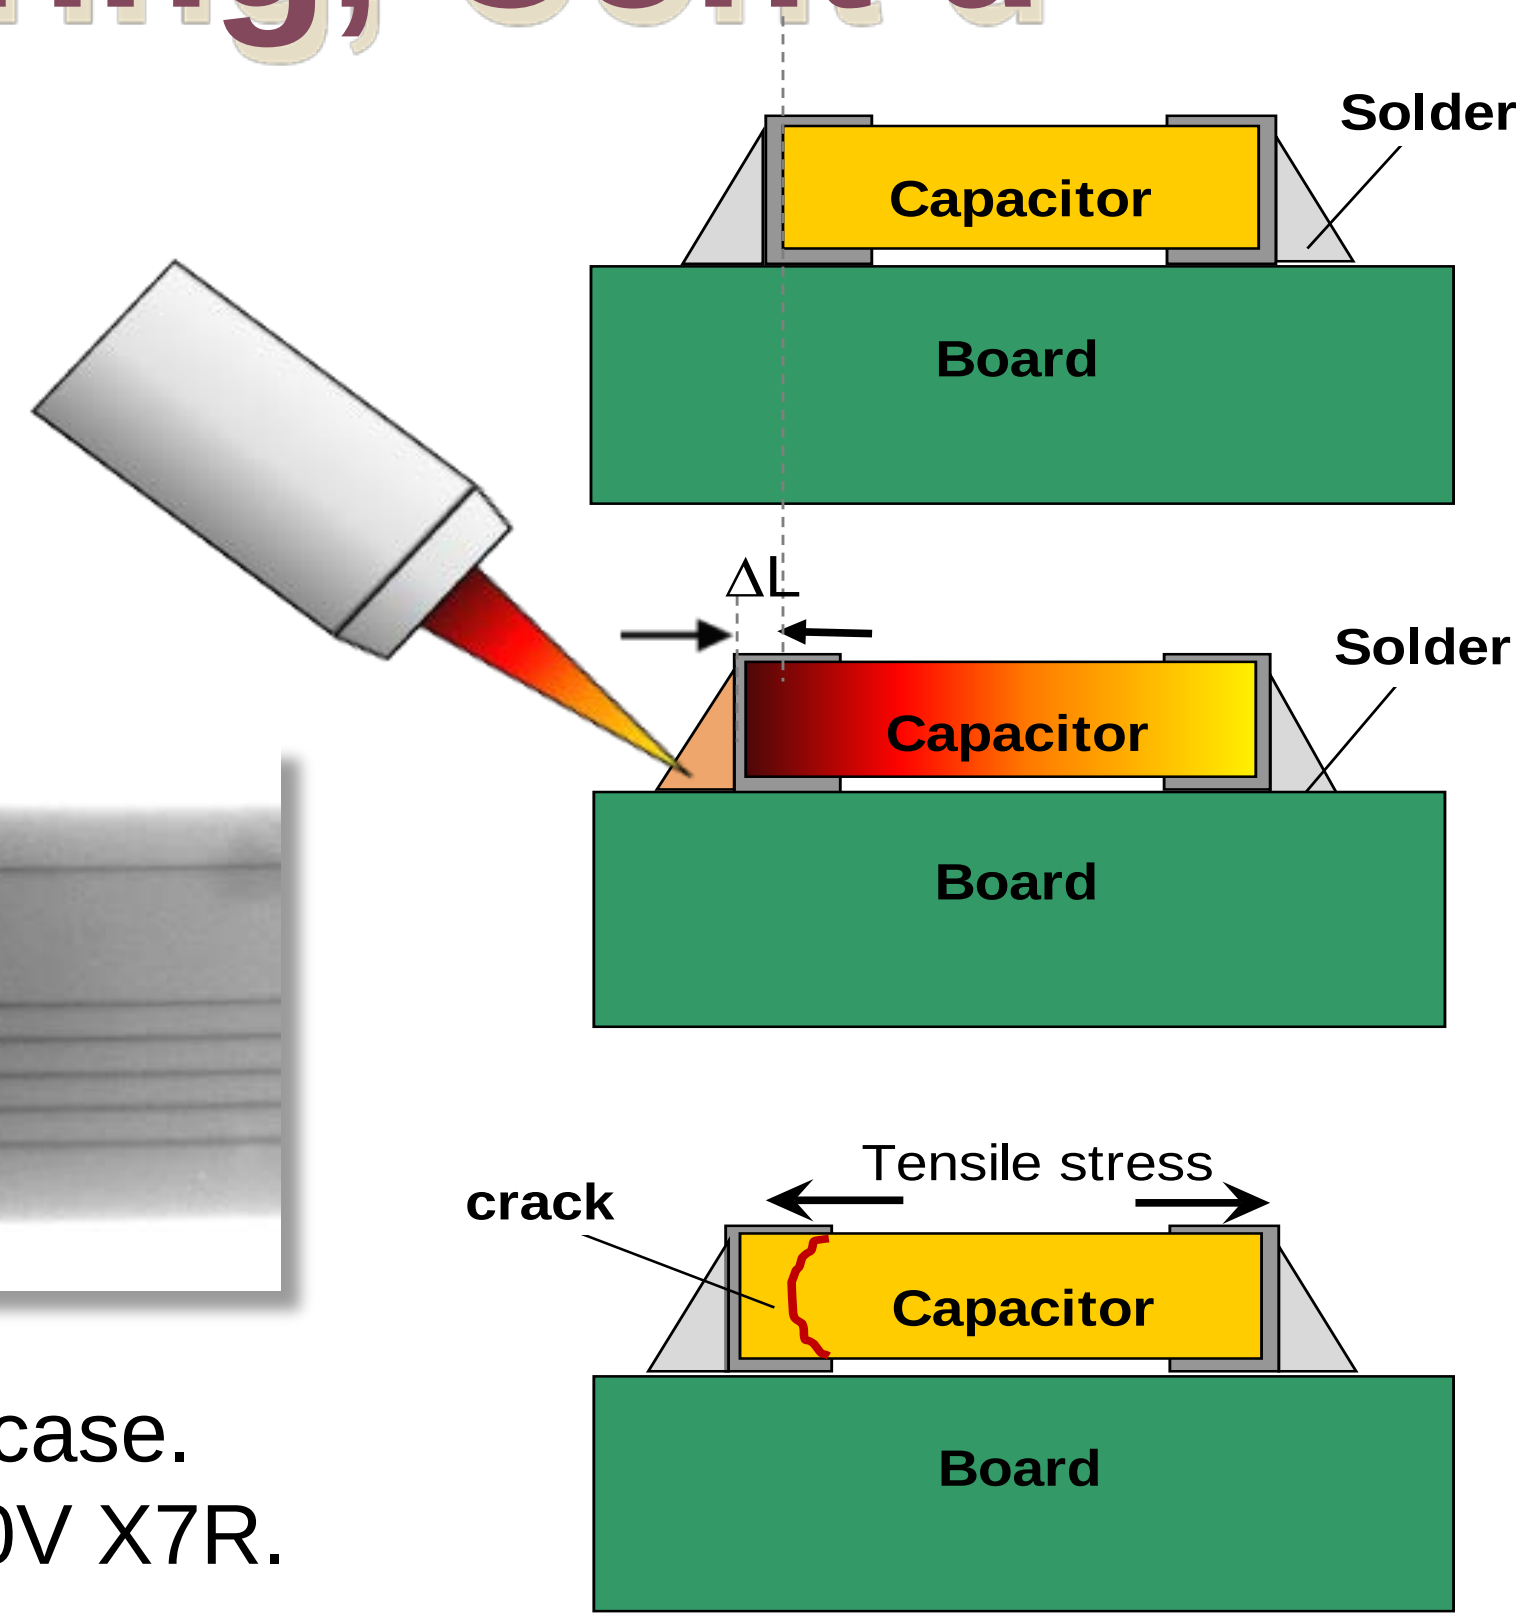
- ❑ Post-soldering touch-up to improve the attachment might result in tensile stresses.
- ❑ Tensile stresses can cause cracking.

Project failure case.
0402, 1000pF 50V X7R.

✓ To decrease the probability of fracturing during soldering, both, the reduction of the level of stress and selection of robust capacitors are necessary.
