APPLICATION OF BORON/EPOXY REINFORCED  
ALUMINUM STRINGERS FOR THE  
CH-54B HELICOPTER TAIL CONE

PHASE I: DESIGN, ANALYSIS, FABRICATION  
AND TEST

Sikorsky Aircraft  
Division of United Aircraft Corporation

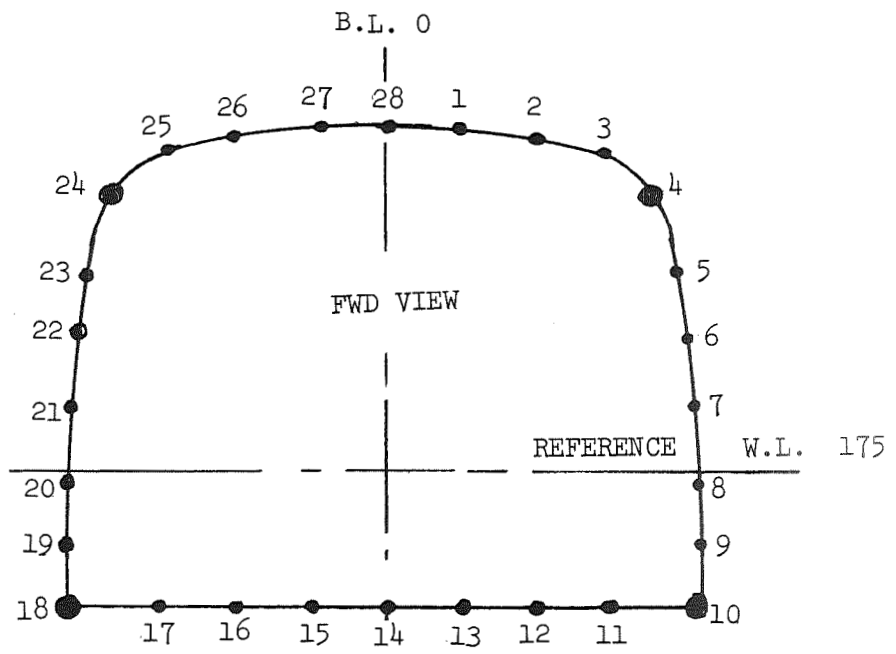
FIGURE 2-7. TAIL CONE STRINGER NUMBERING SYSTEM.

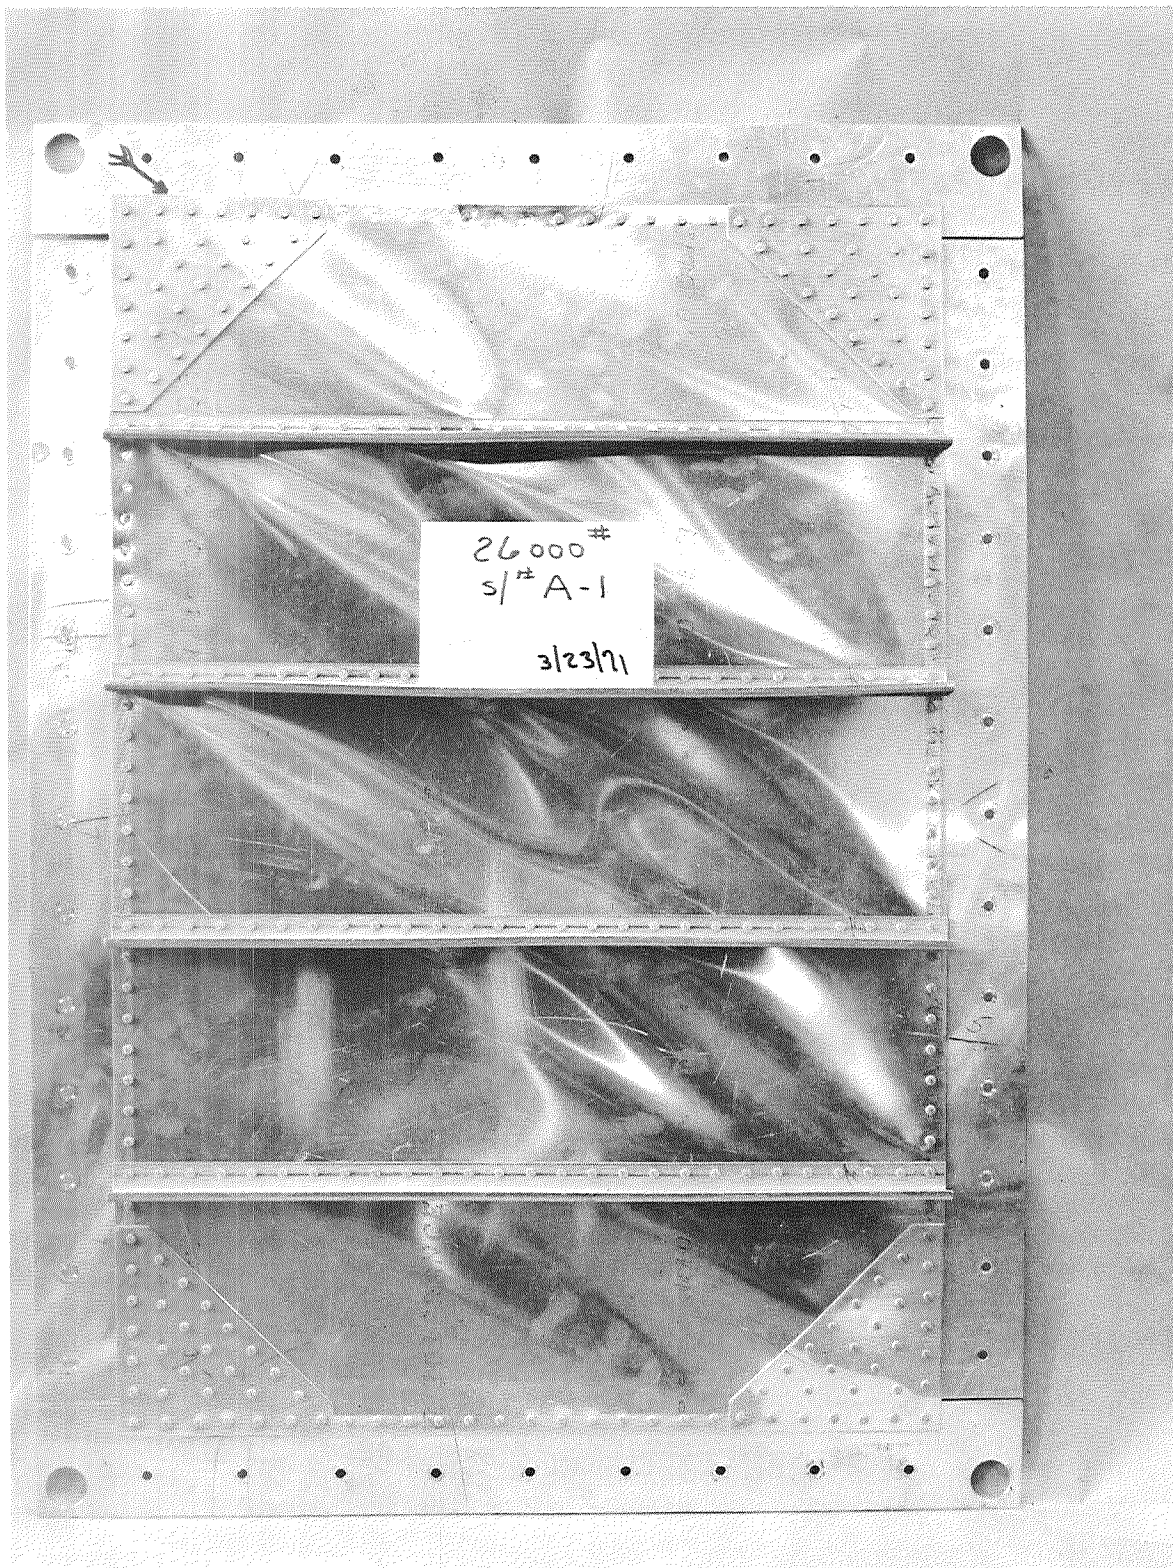
FIGURE 7-6. SHEAR FAILURE OF NONREINFORCED TEST PANEL.

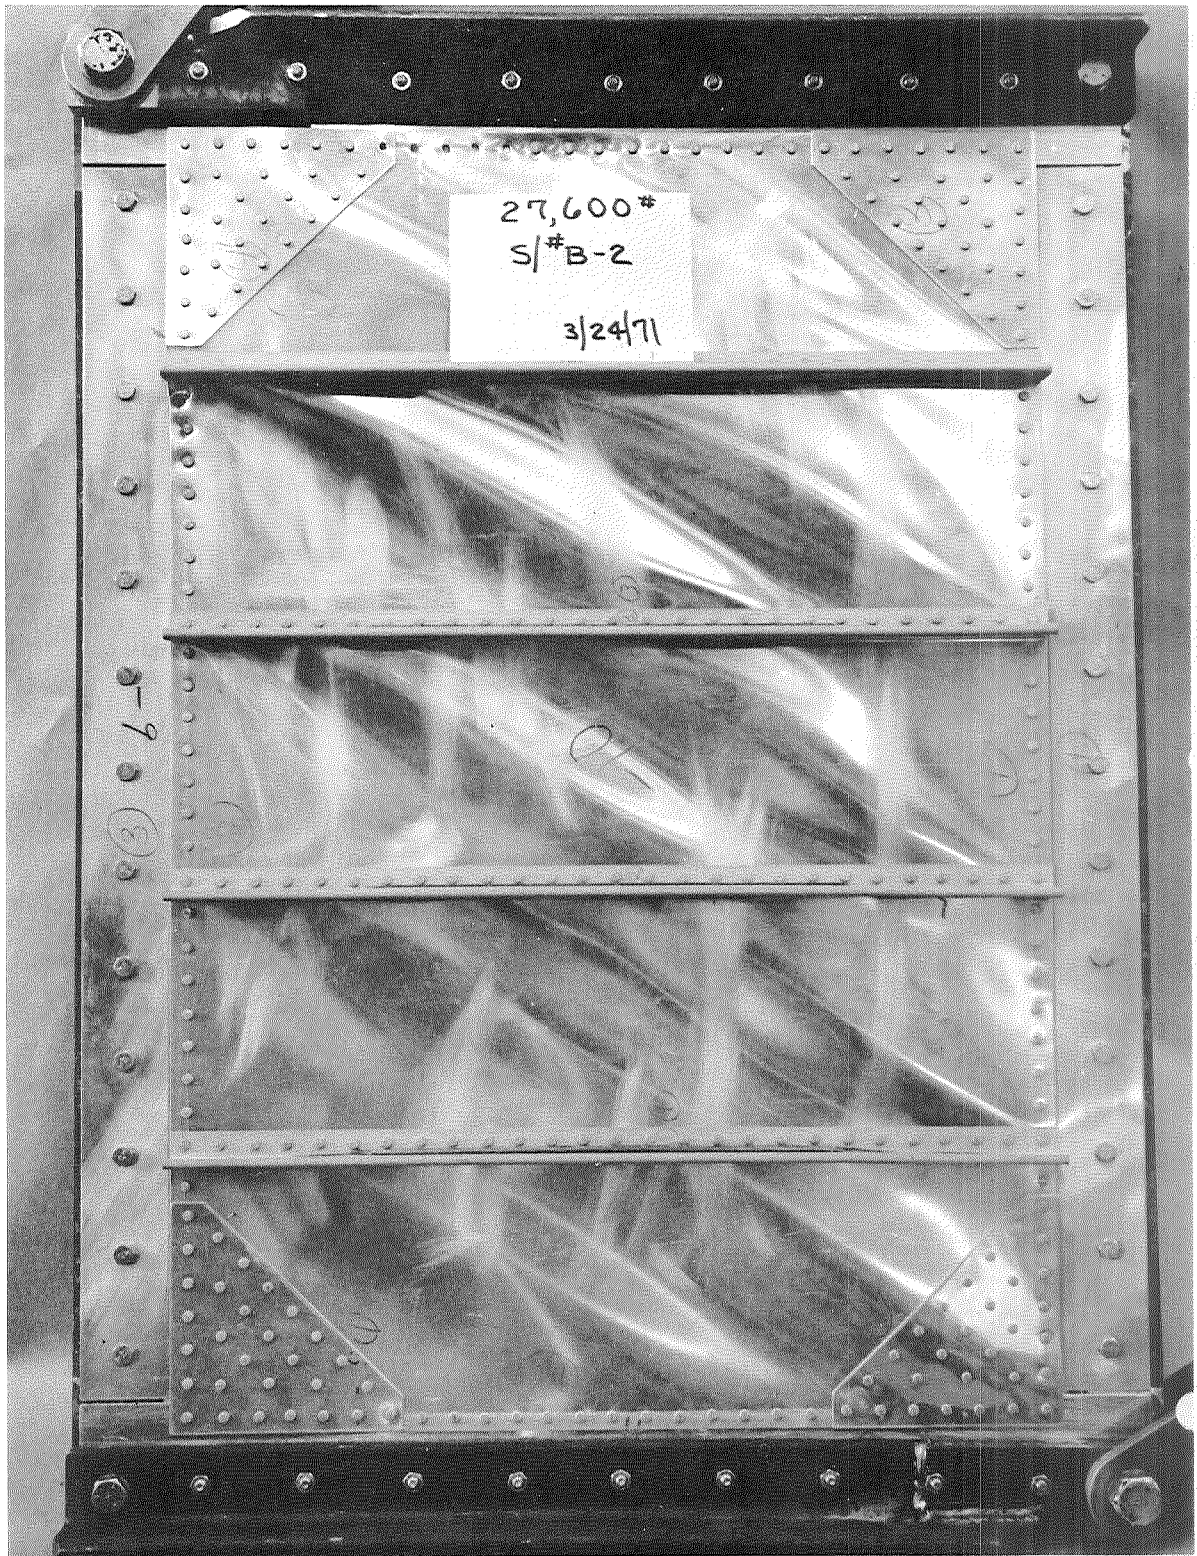
FIGURE 7-7. SHEAR FAILURE OF BORON/EPOXY REINFORCED STRINGER TEST PANEL.

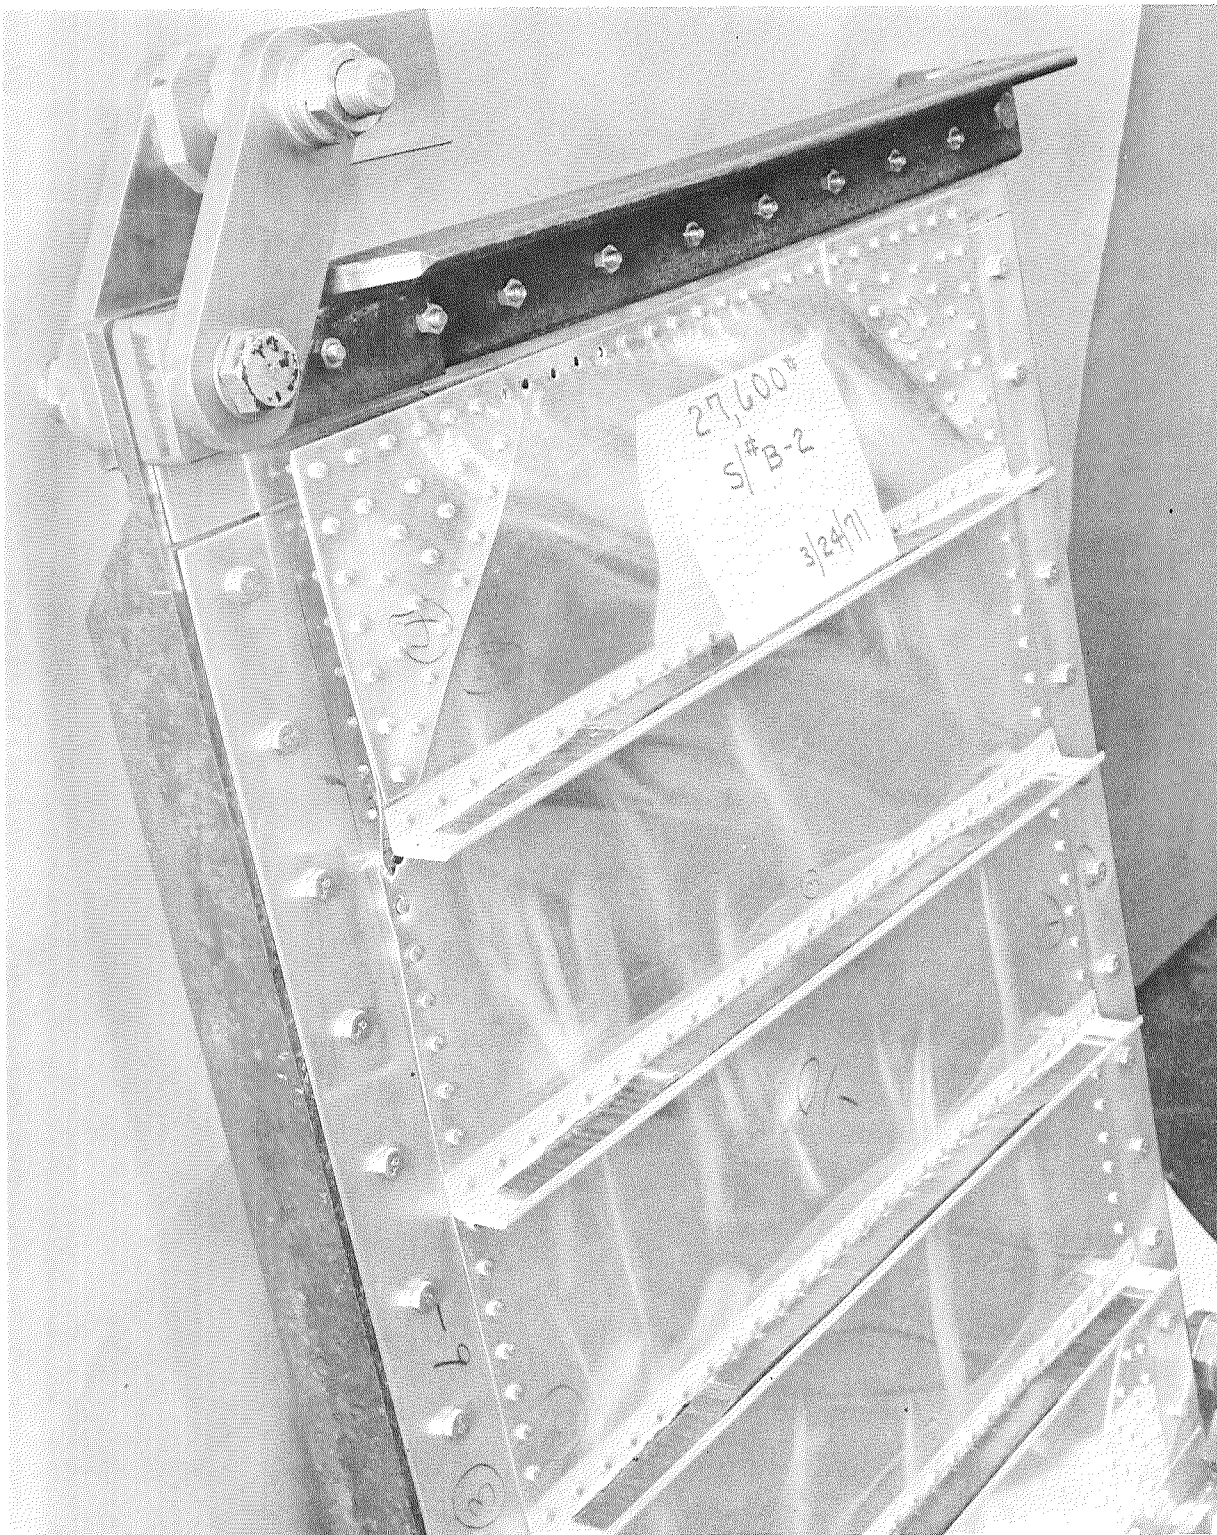
FIGURE 7-8.      DETAIL OF SHEAR FAILURE OF BORON/EPOXY REINFORCED STRINGER TEST PANEL.
