Radiation Failures in Intel 14nm Microprocessors

Presented at the *25-th Annual SEE Symposium*, San Diego, CA, May 2016

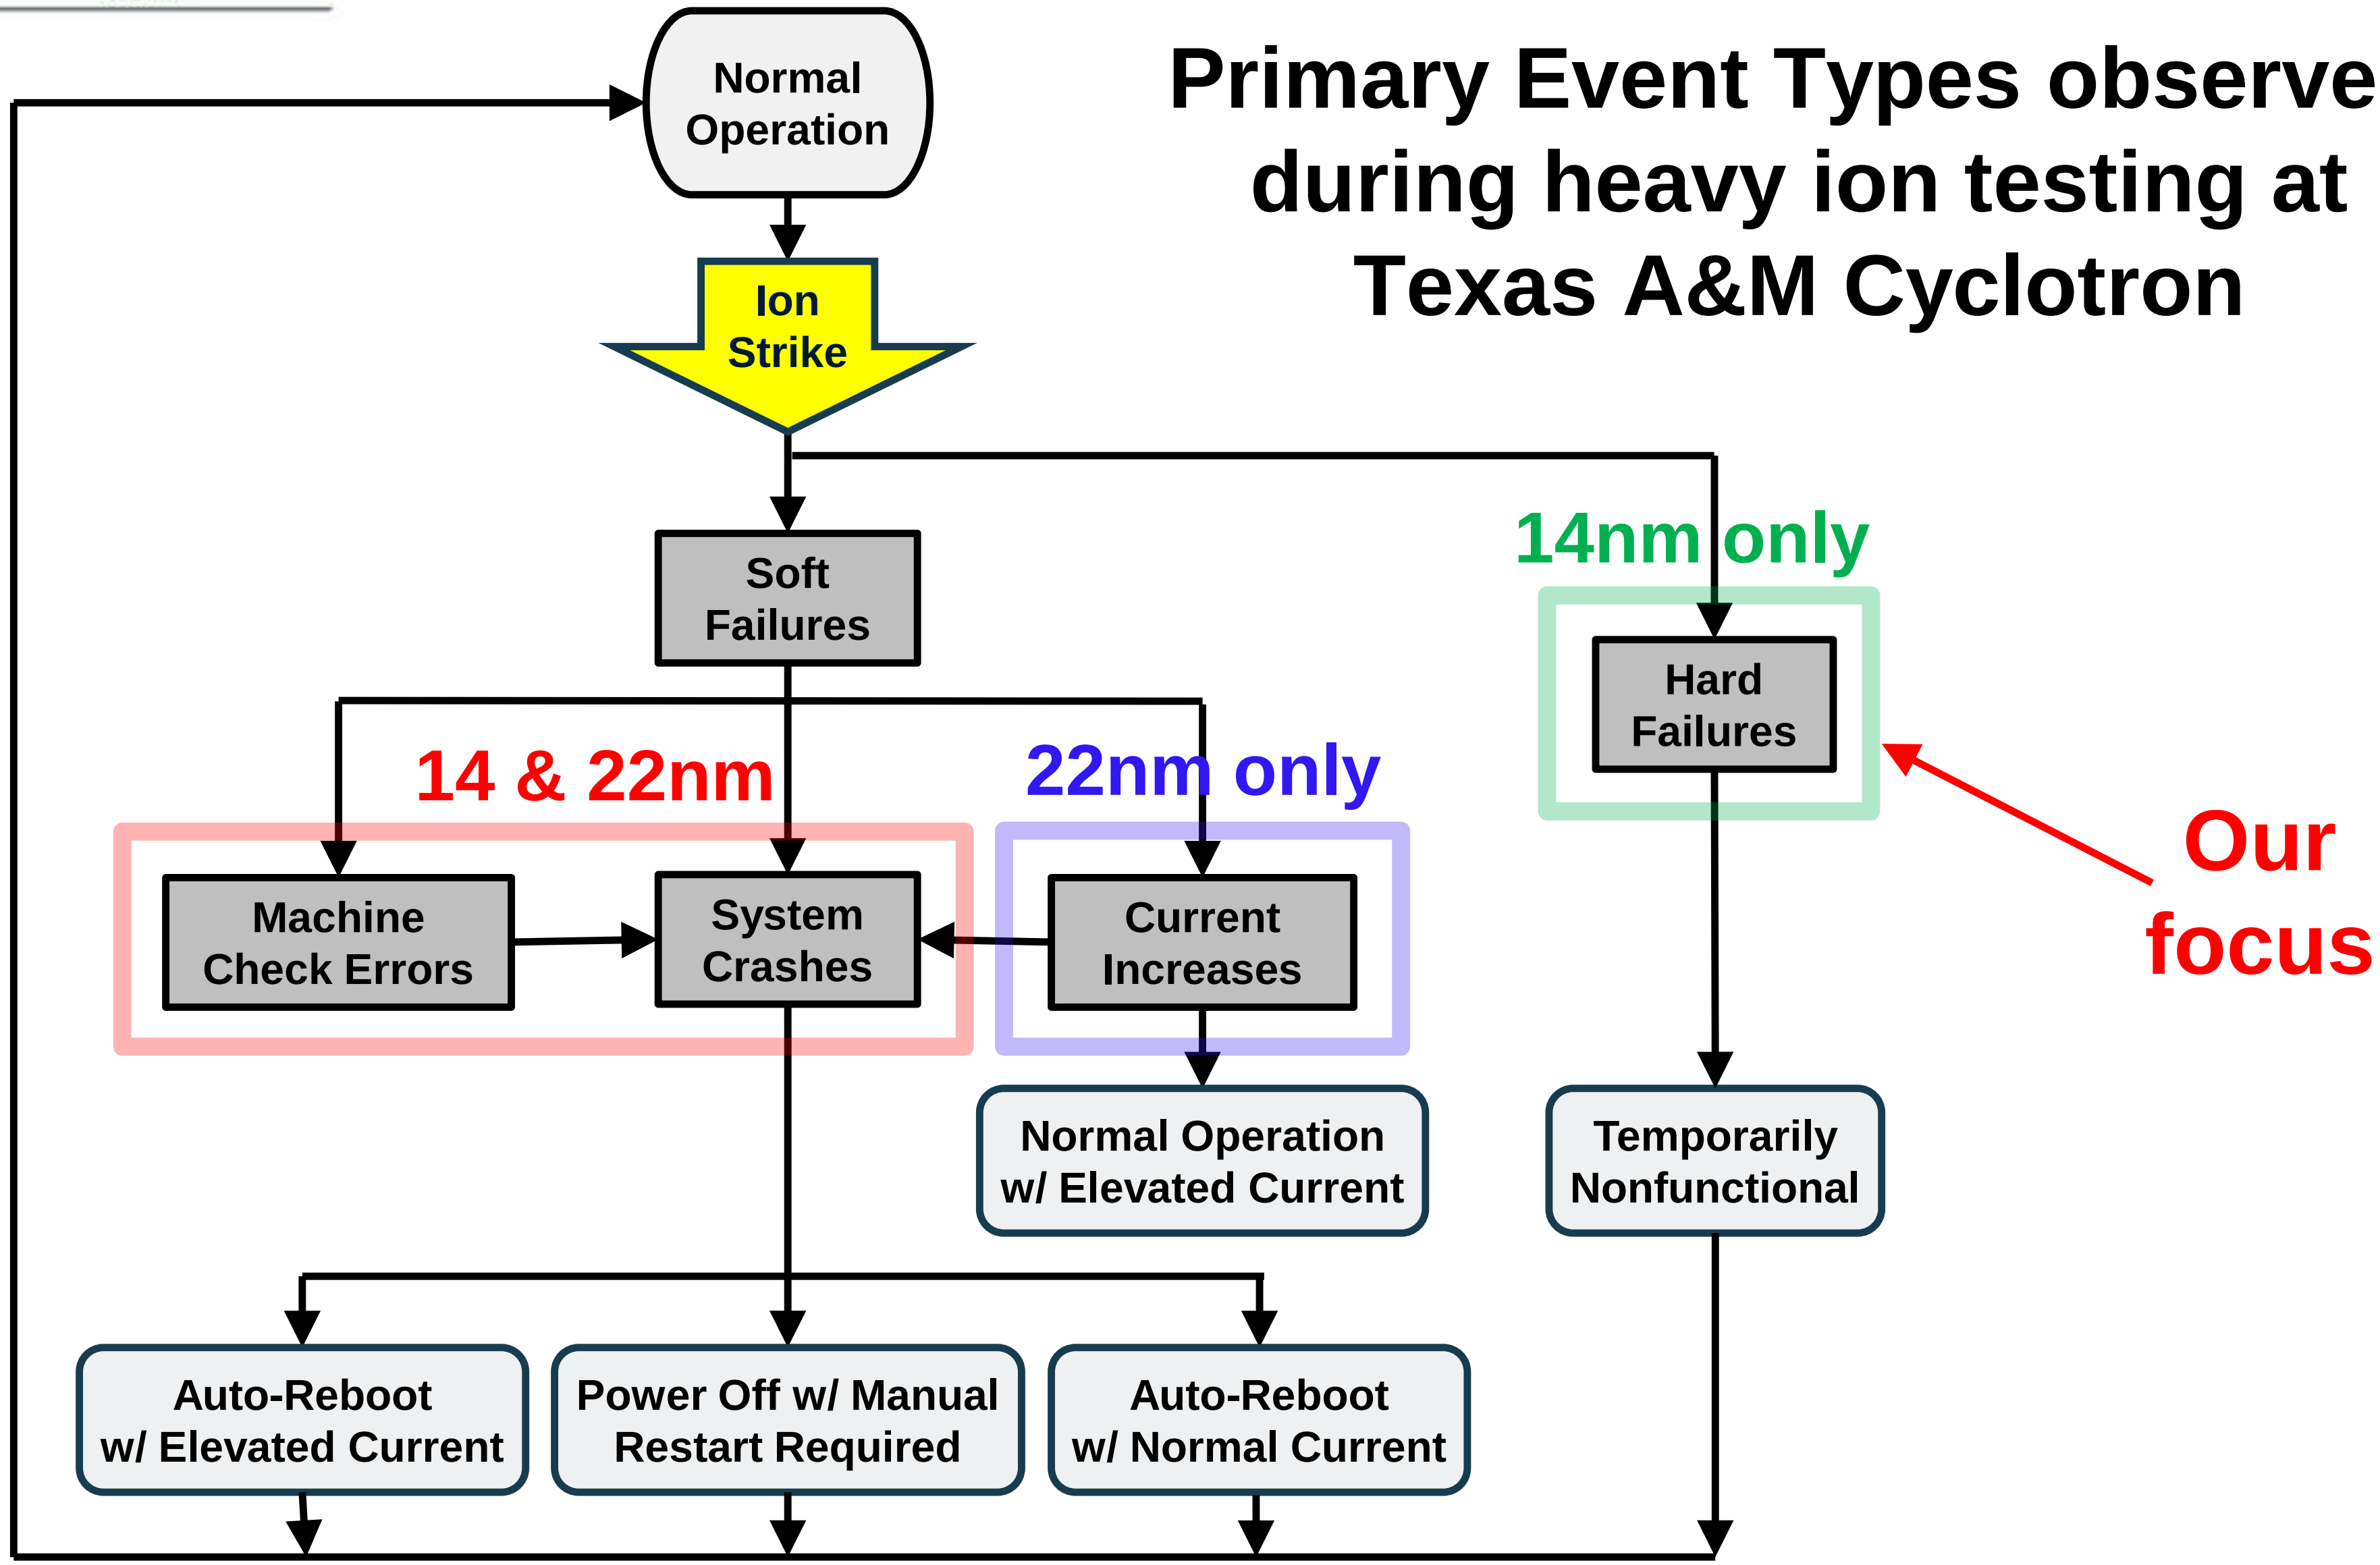
Primary Event Types observed during heavy ion testing at Texas A&M Cyclotron

- System crash observed followed by inability to boot system for 30 min to hours
- Observed at 45° angles of incidence
- Occurs less often than system crashes. Very limited statistics – only 4 events
- **System crash observed followed by *permanent inability* to boot. A single event observed**

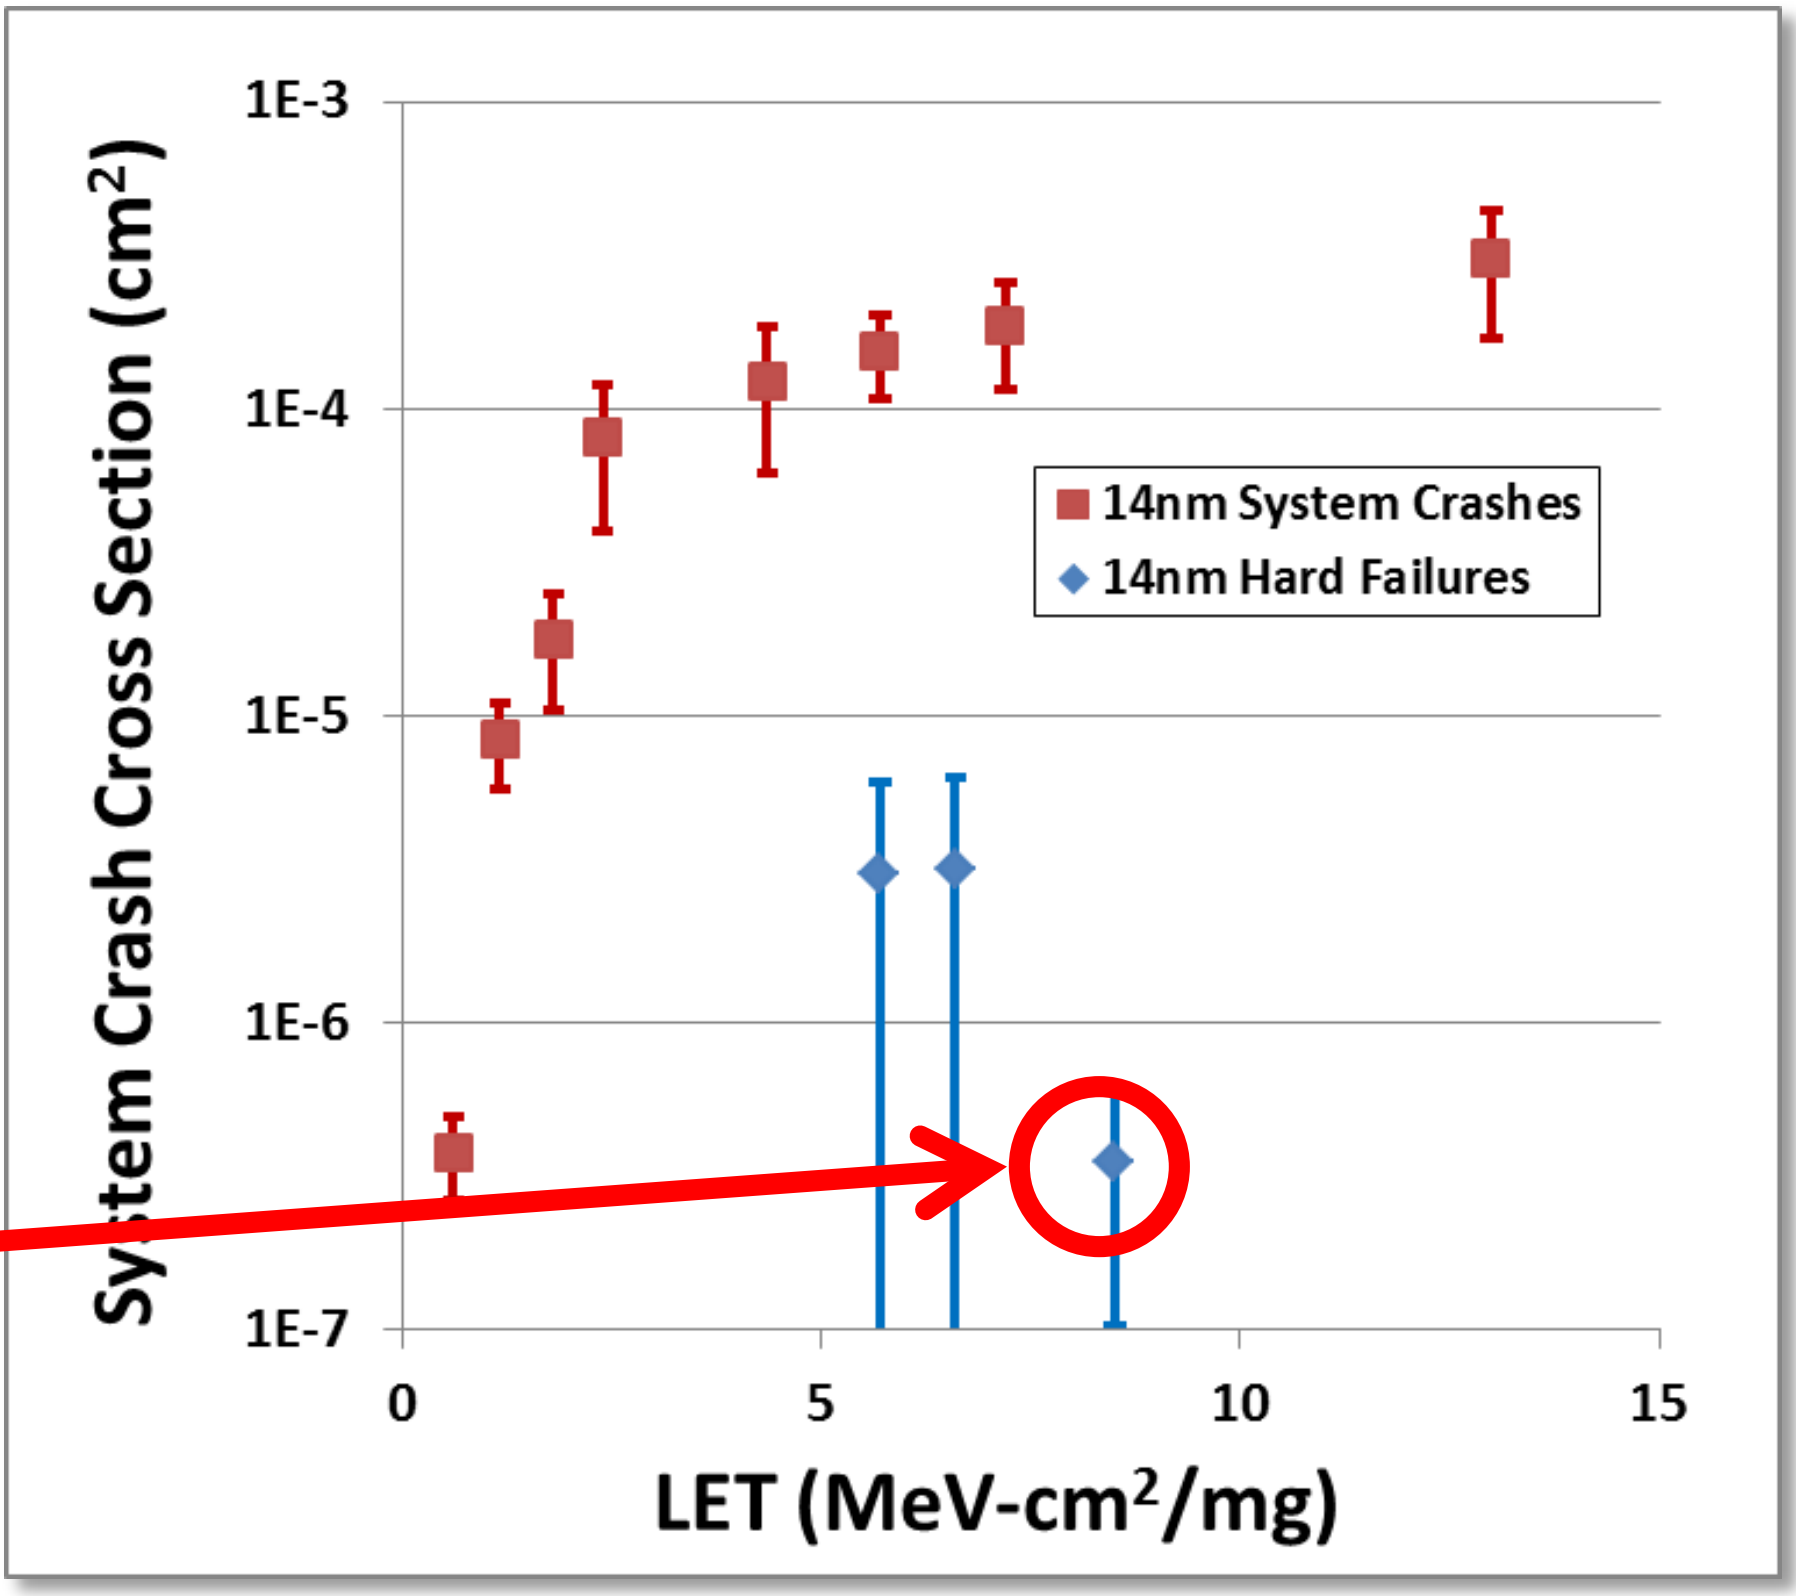
Hard Failures" in 14nm FinFET devices

Understanding hard failure root cause is critical to future FinFET use in radiation environments

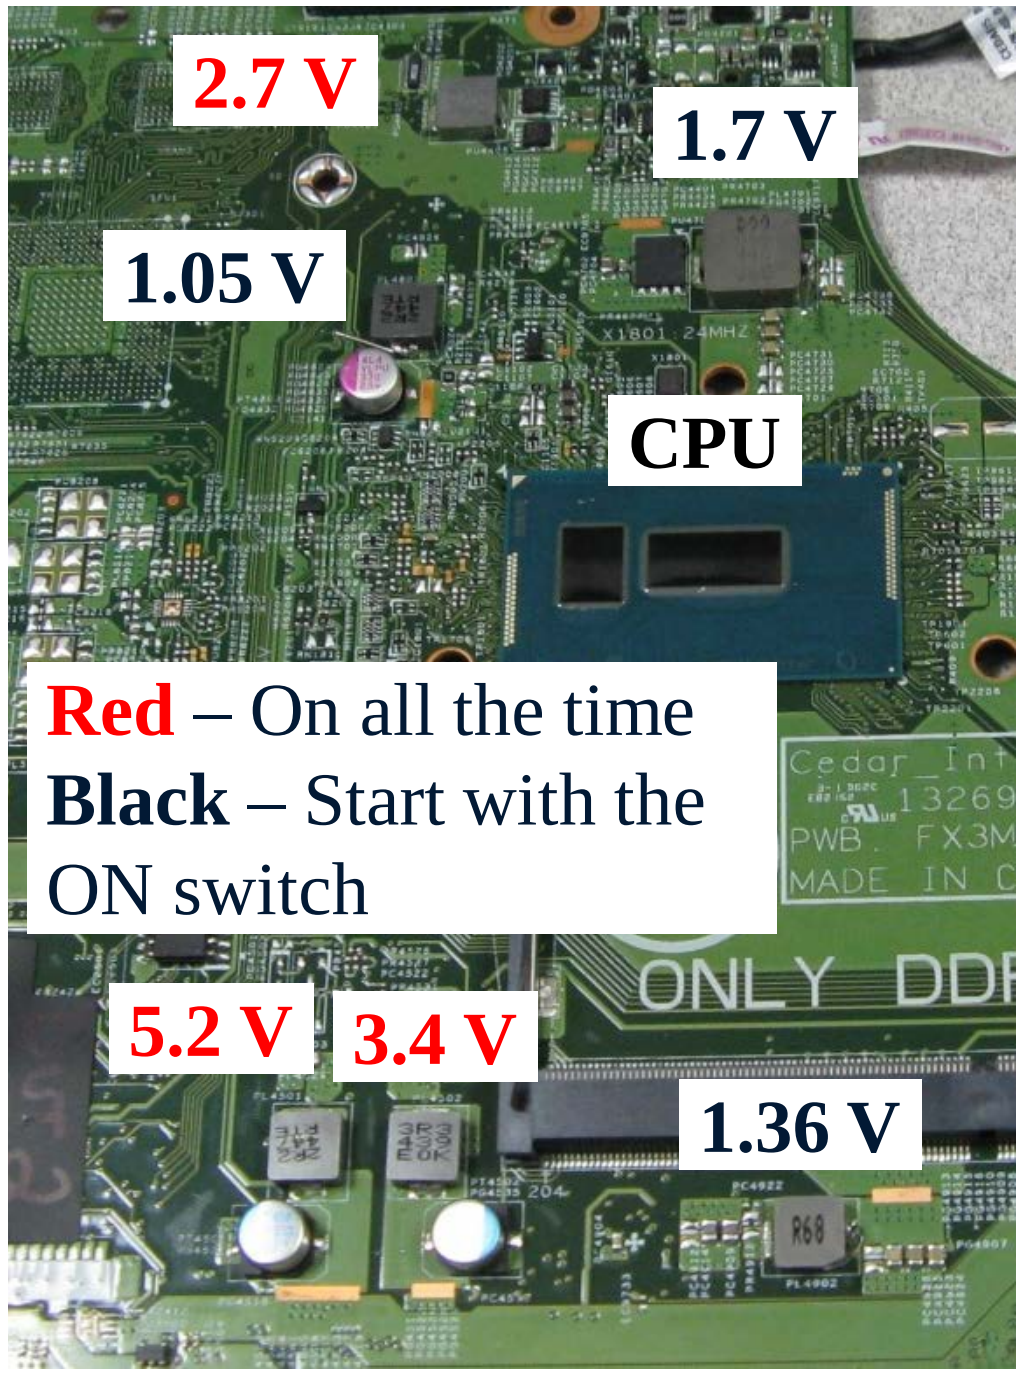
Power supply to the CPU (Dell laptop mother board)

A (special) case of "hard failure"

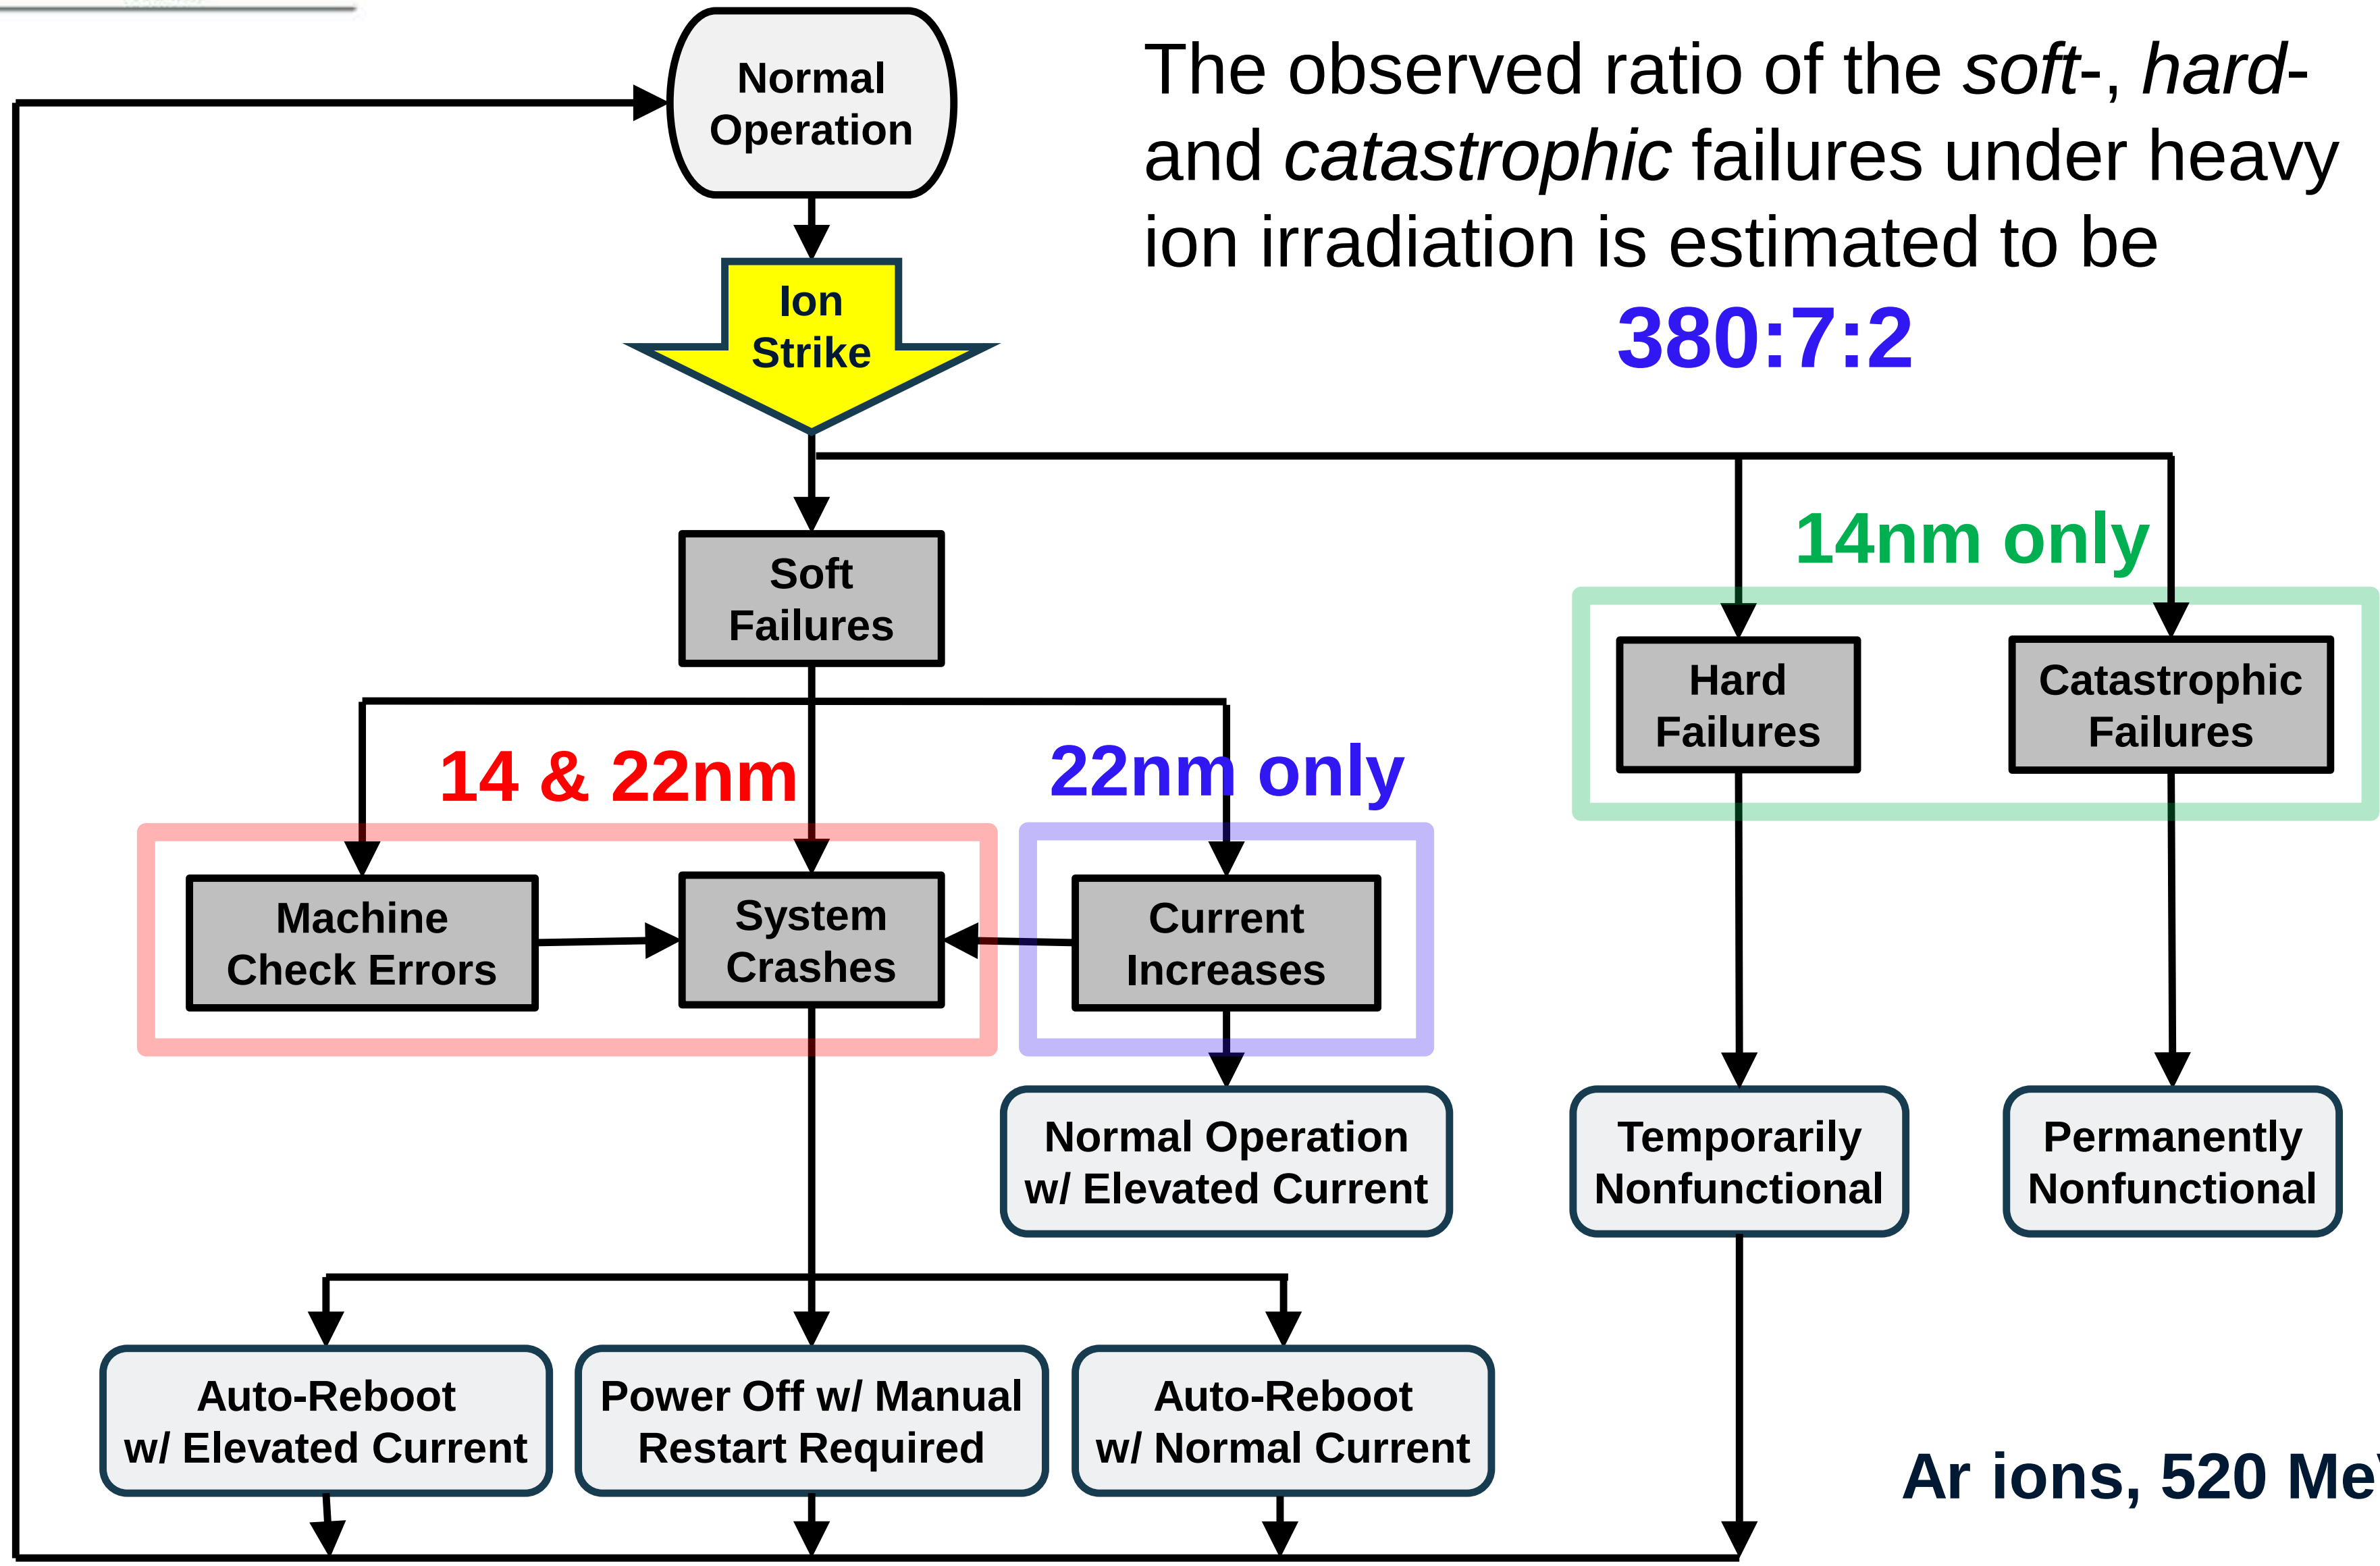
Heavy Ion Event Types (expanded)

The observed ratio of the *soft*-, *hard*- and *catastrophic* failures under heavy ion irradiation is estimated to be

380:7:2

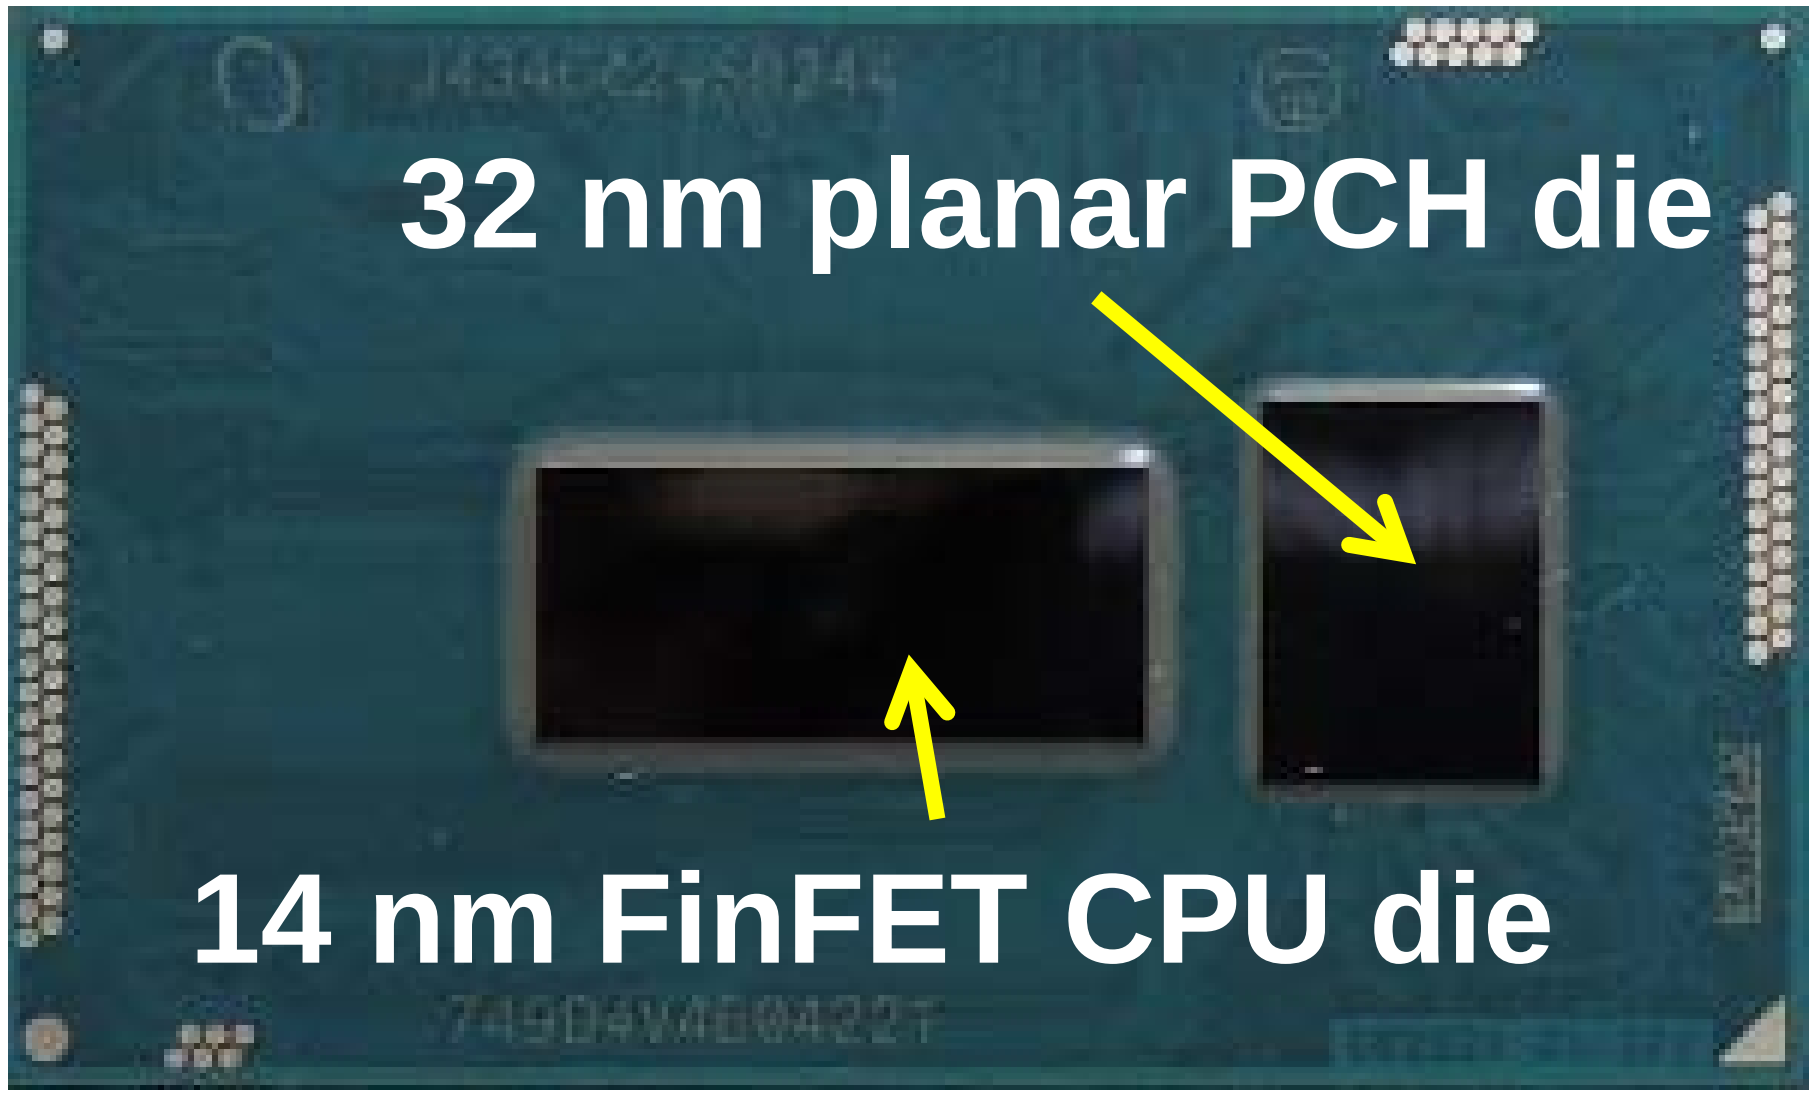
14nm Intel Microprocessor Package

BGA package, 2 die,
PCH = Platform Controller Hub

- **Heavy-ion-induced *hard-* and *catastrophic* failures do not appear to be related to the Intel 14nm Tri-Gate FinFET process. They originate from a small (9 μm × 140 μm) area on the 32nm planar PCH die (not the CPU) as initially speculated**

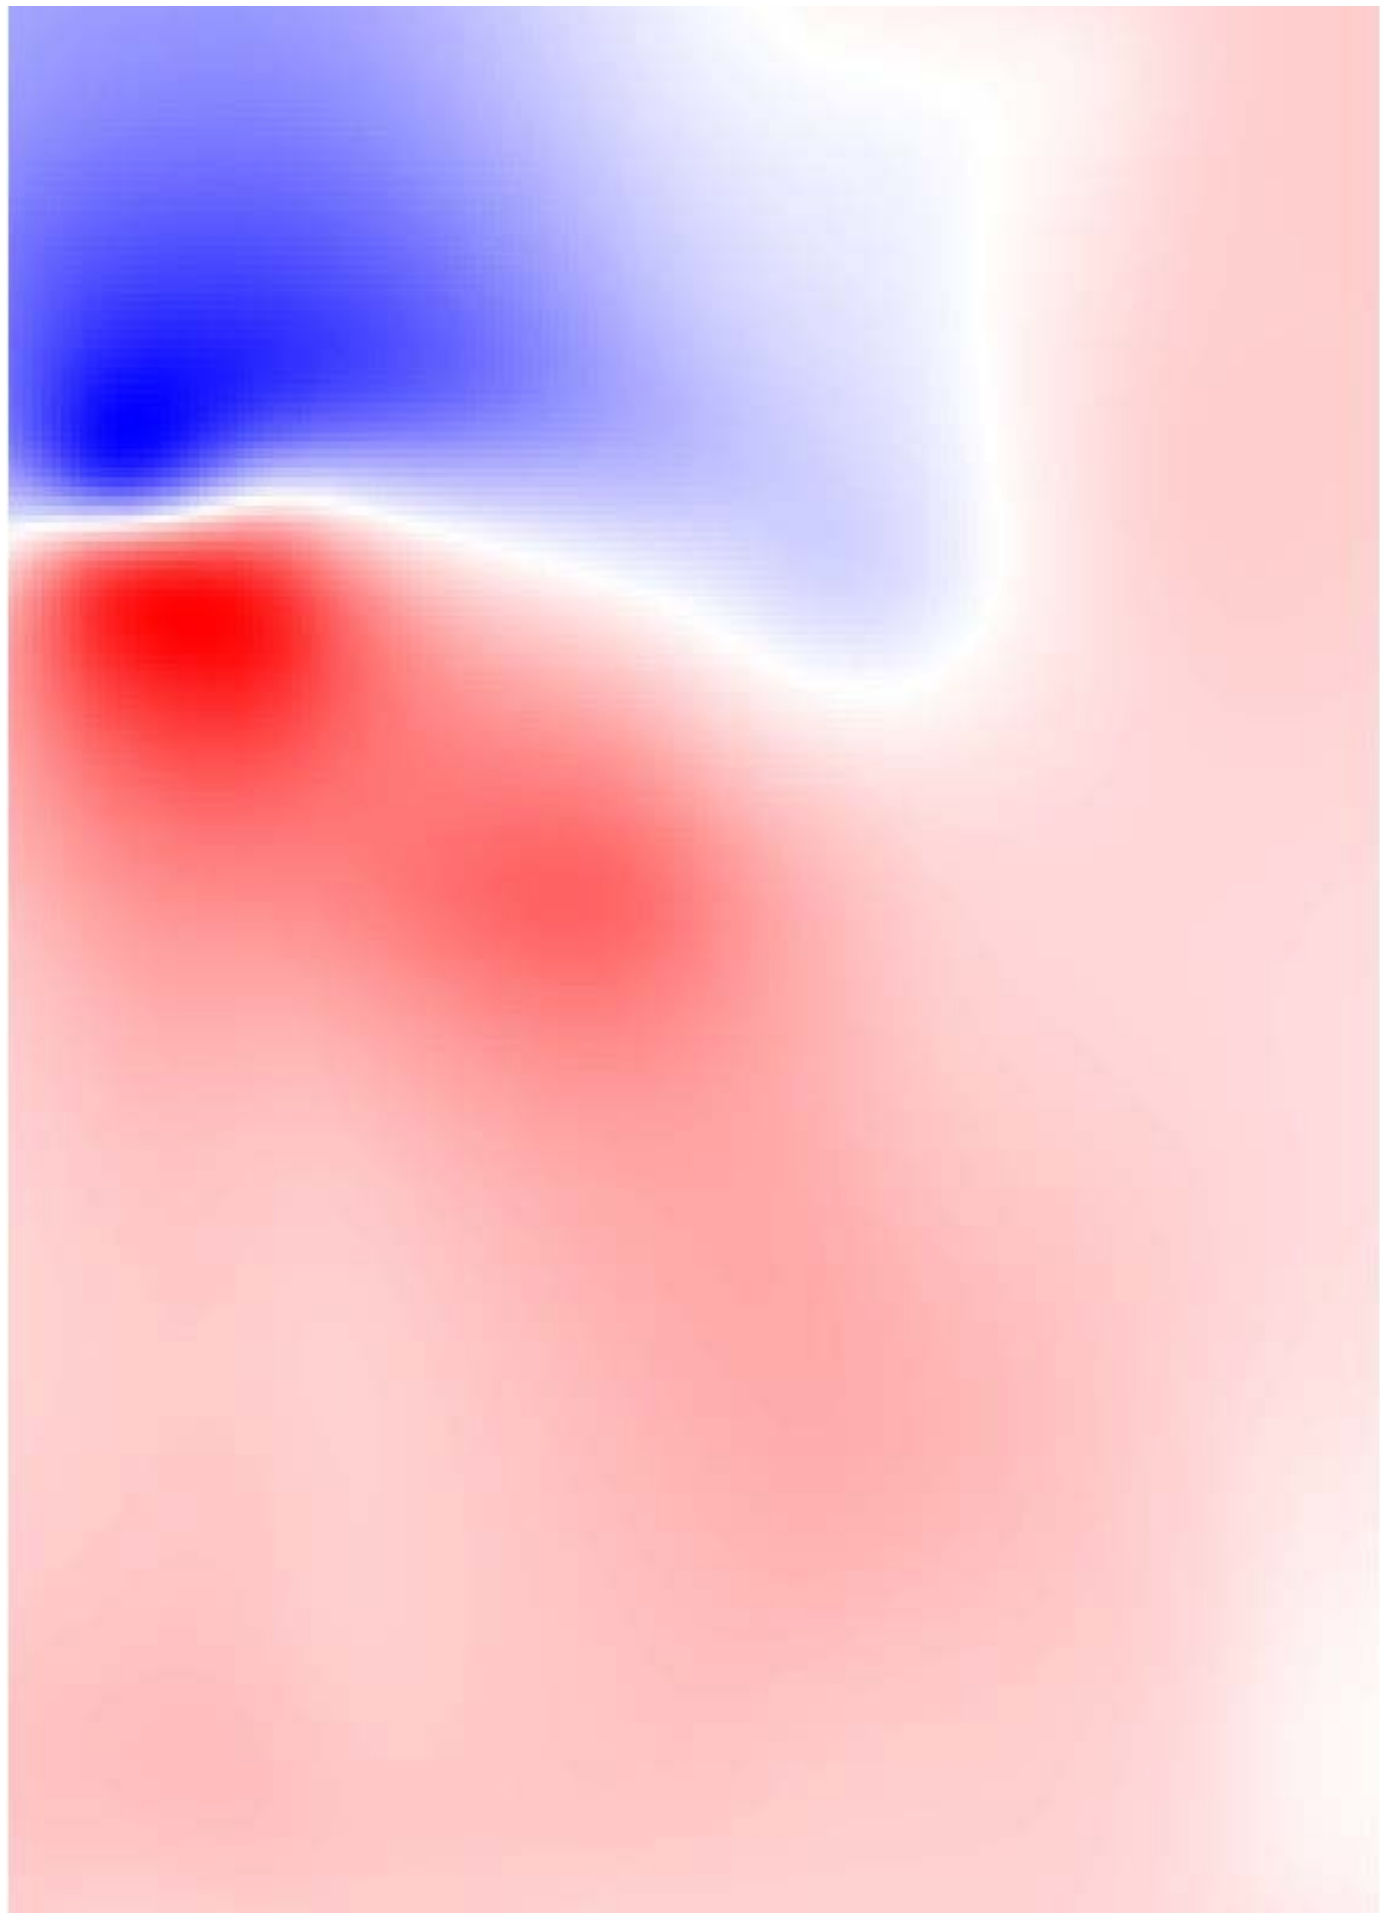
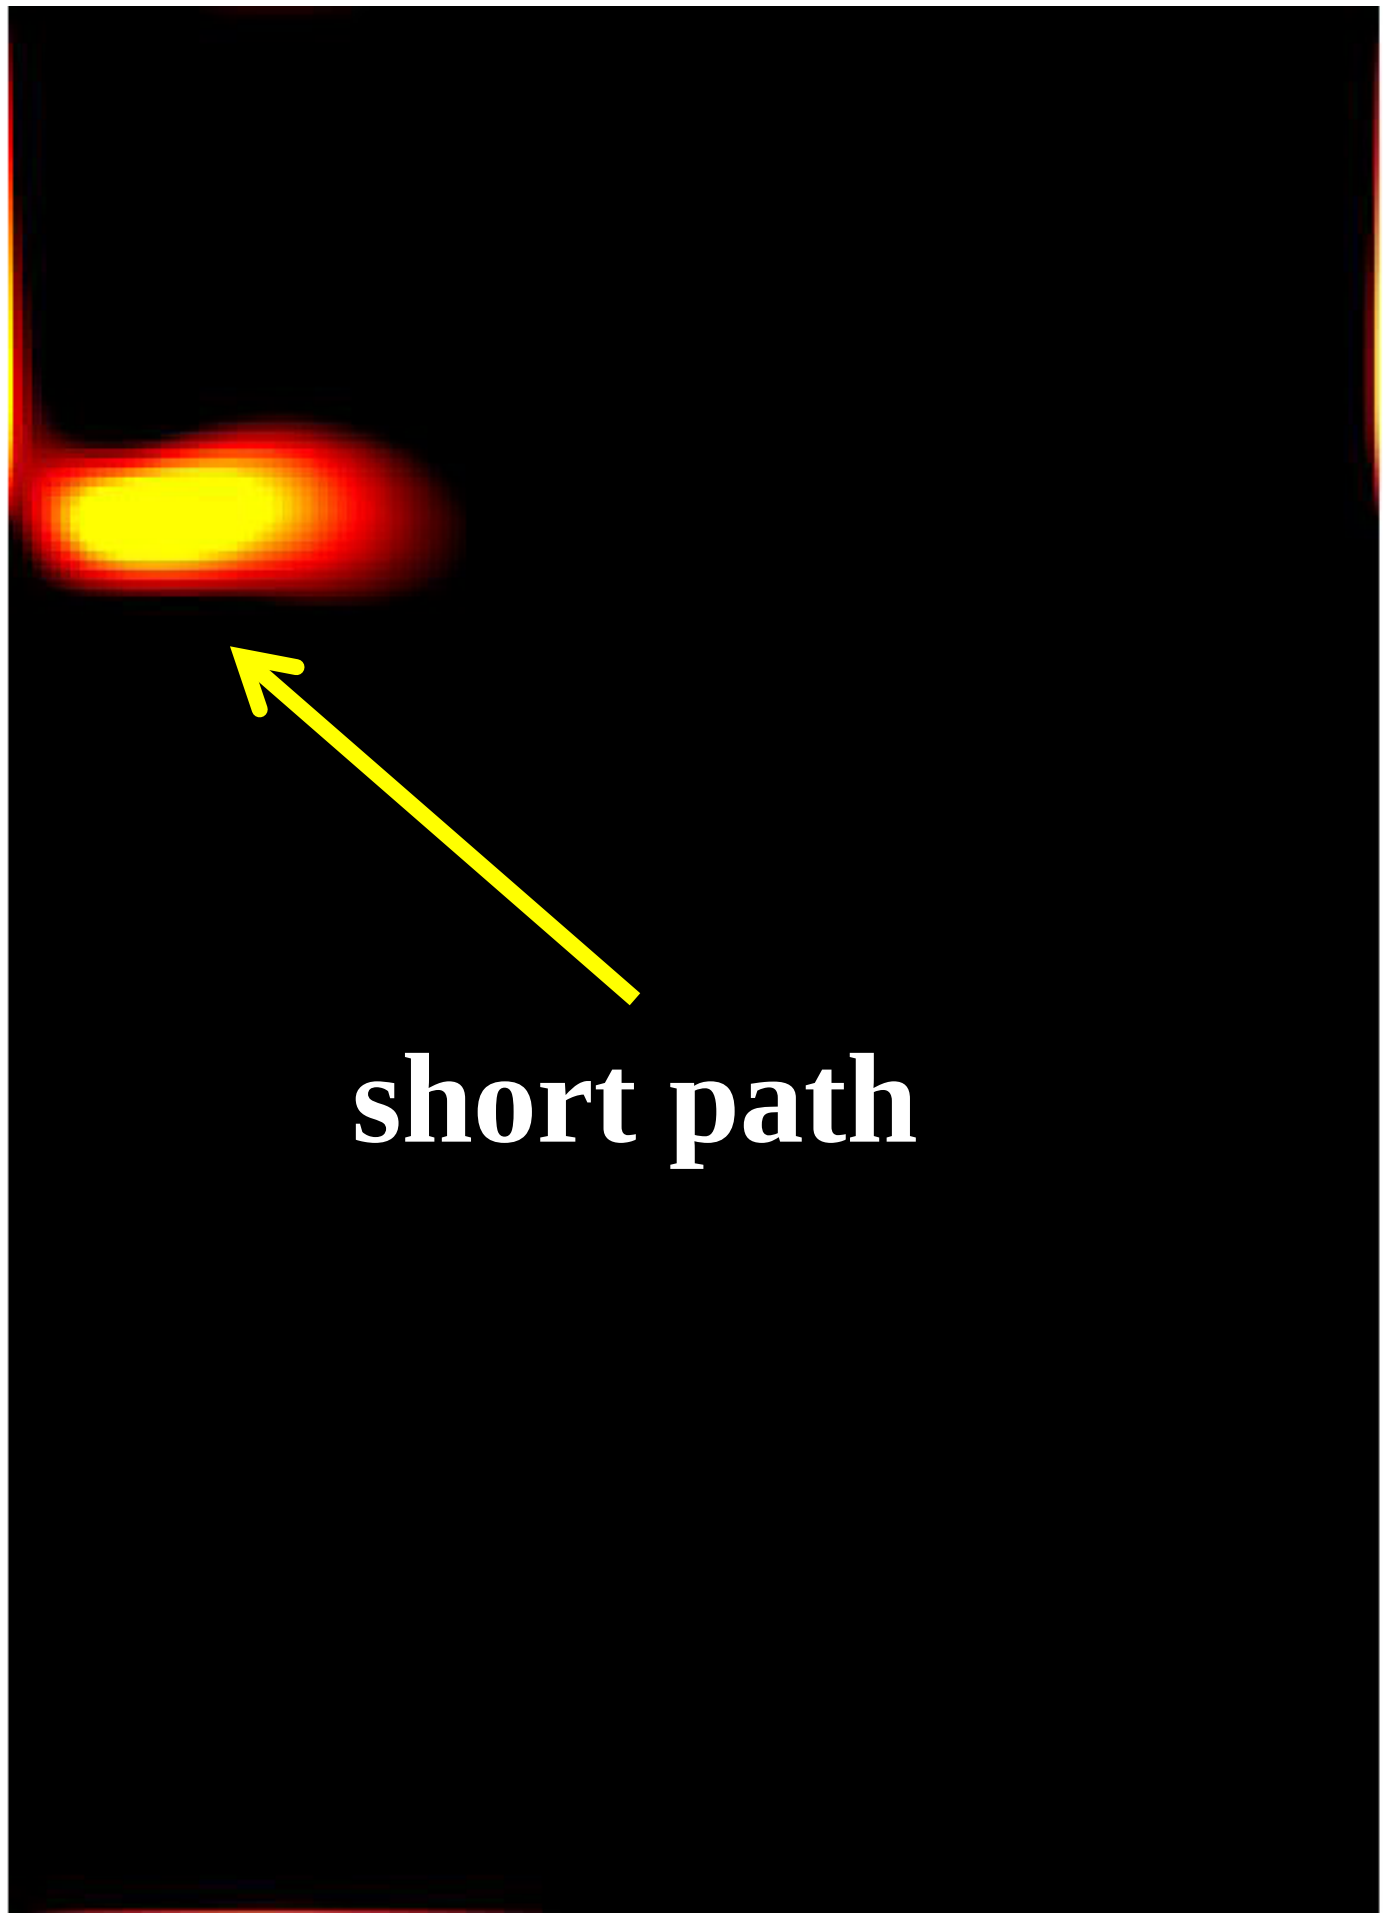
Magnetic microscope: PCH die

Two boards – identical results!

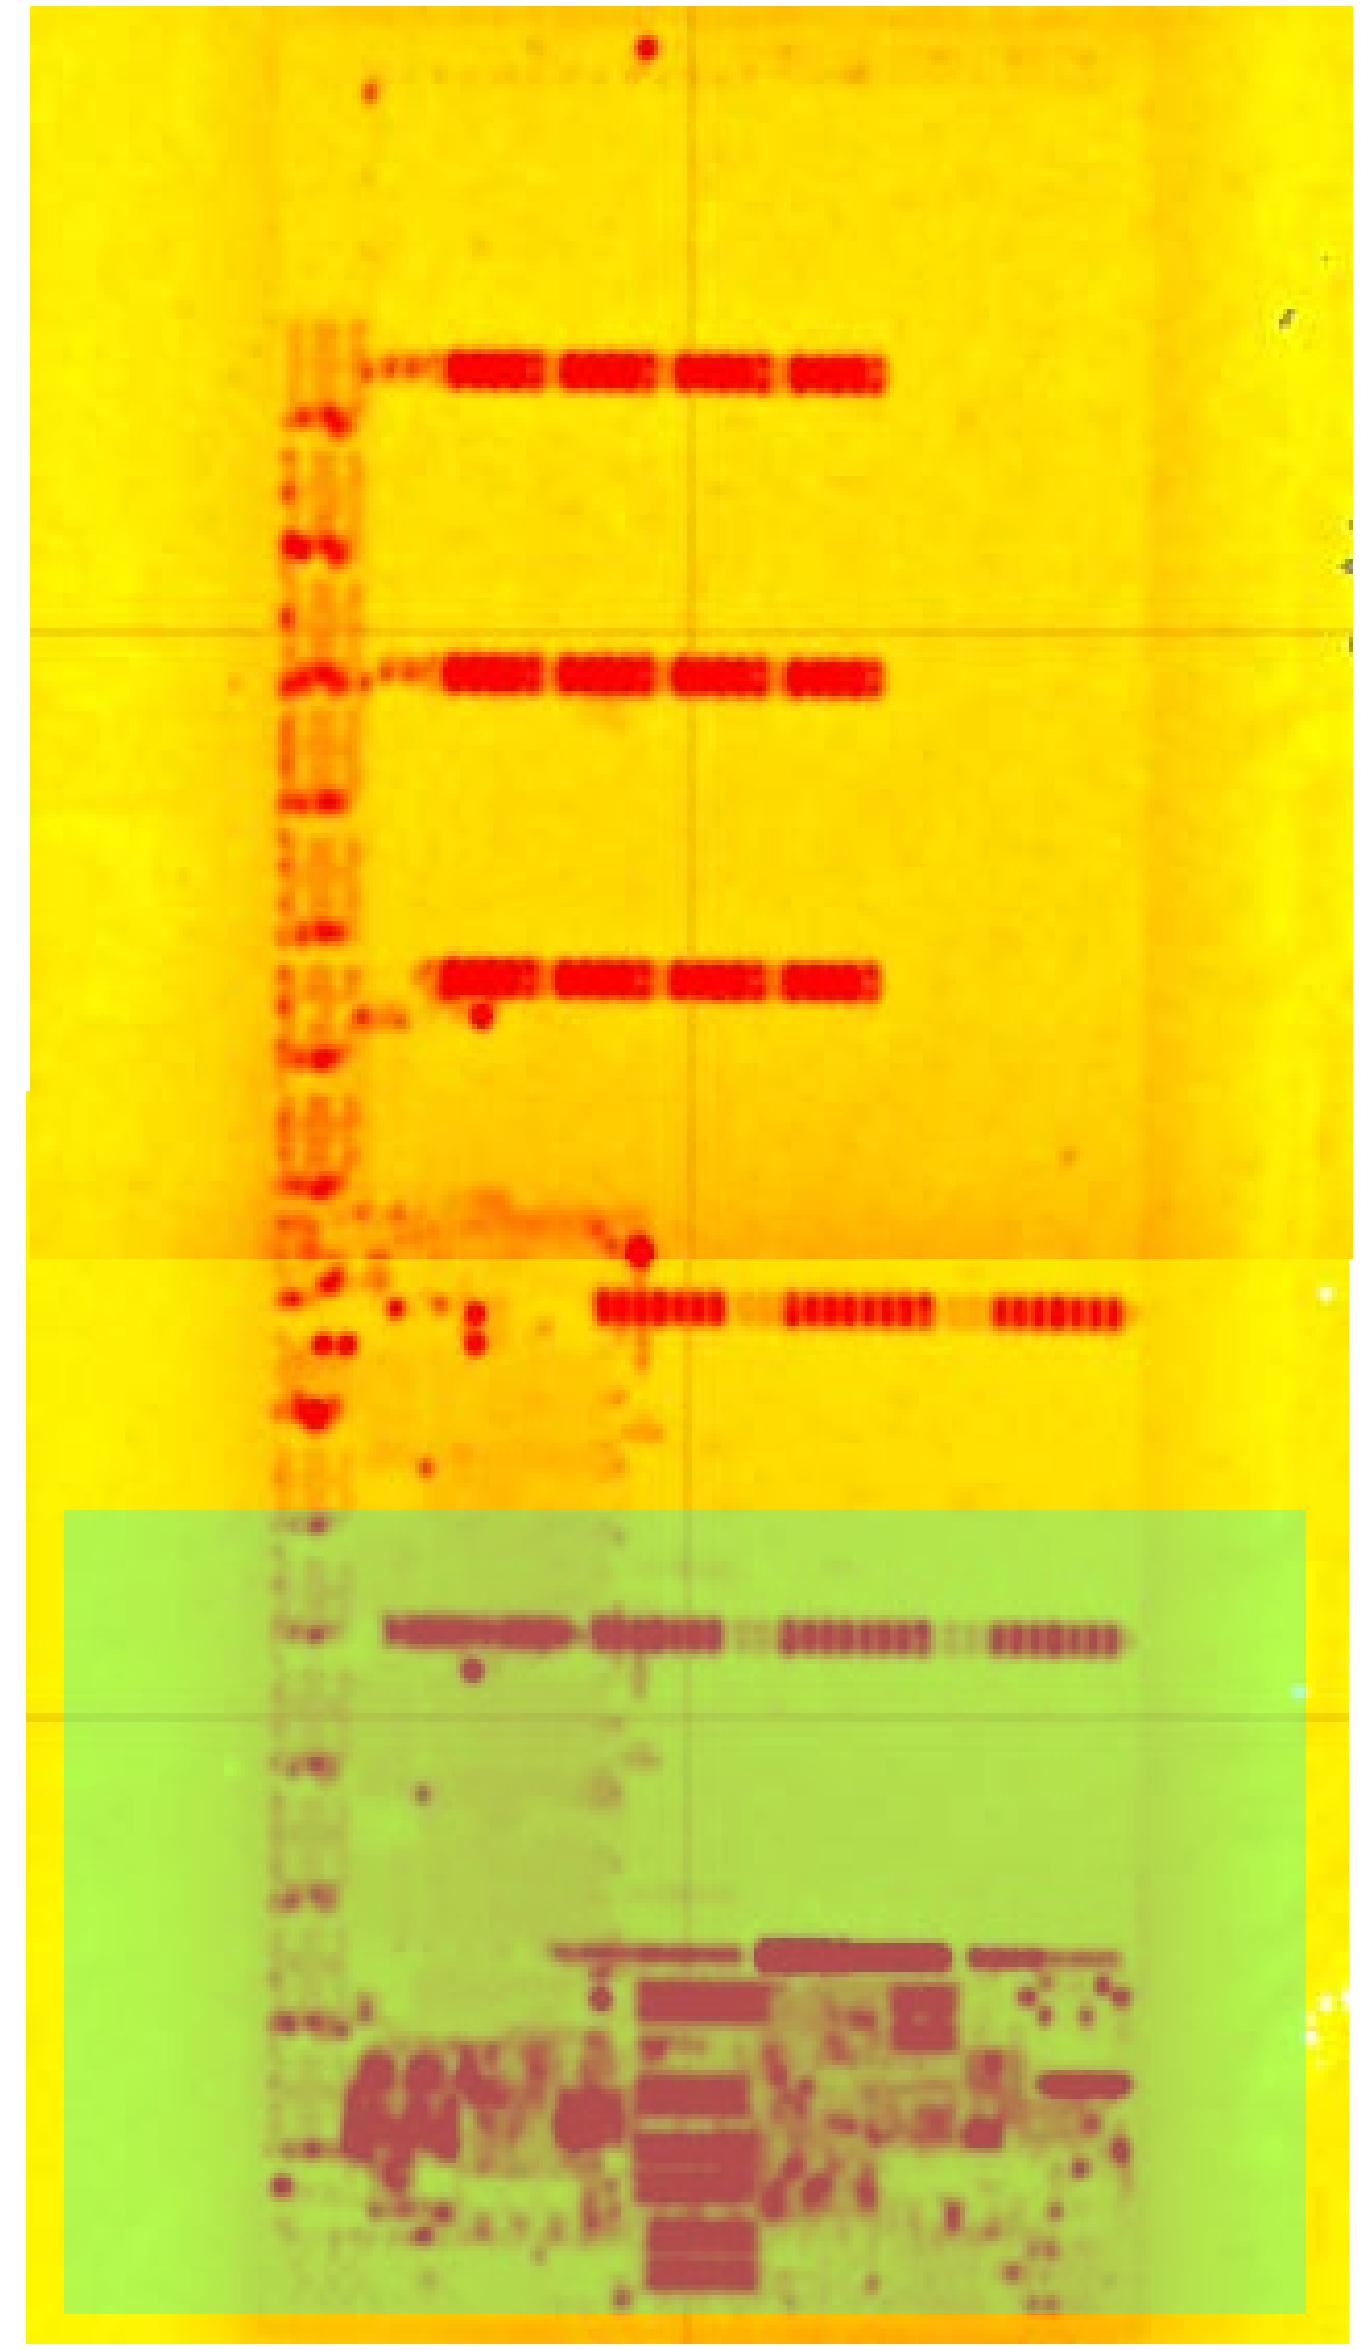
The CPU die

- 1064 nm laser causes soft failures on the CPU die at powers of 2 – 5 mW (×1 objective, scan rate 217 μs/pixel)

- The bottom 1/3 of the die is much more sensitive that the upper 2/3

- 1340 nm laser at up to 80 mW power did not cause ANY upset at multiple scans
