Radiation Failures in Intel 14nm Microprocessors

Presented at the *25-th Annual SEE Symposium*, San Diego, CA, May 2016

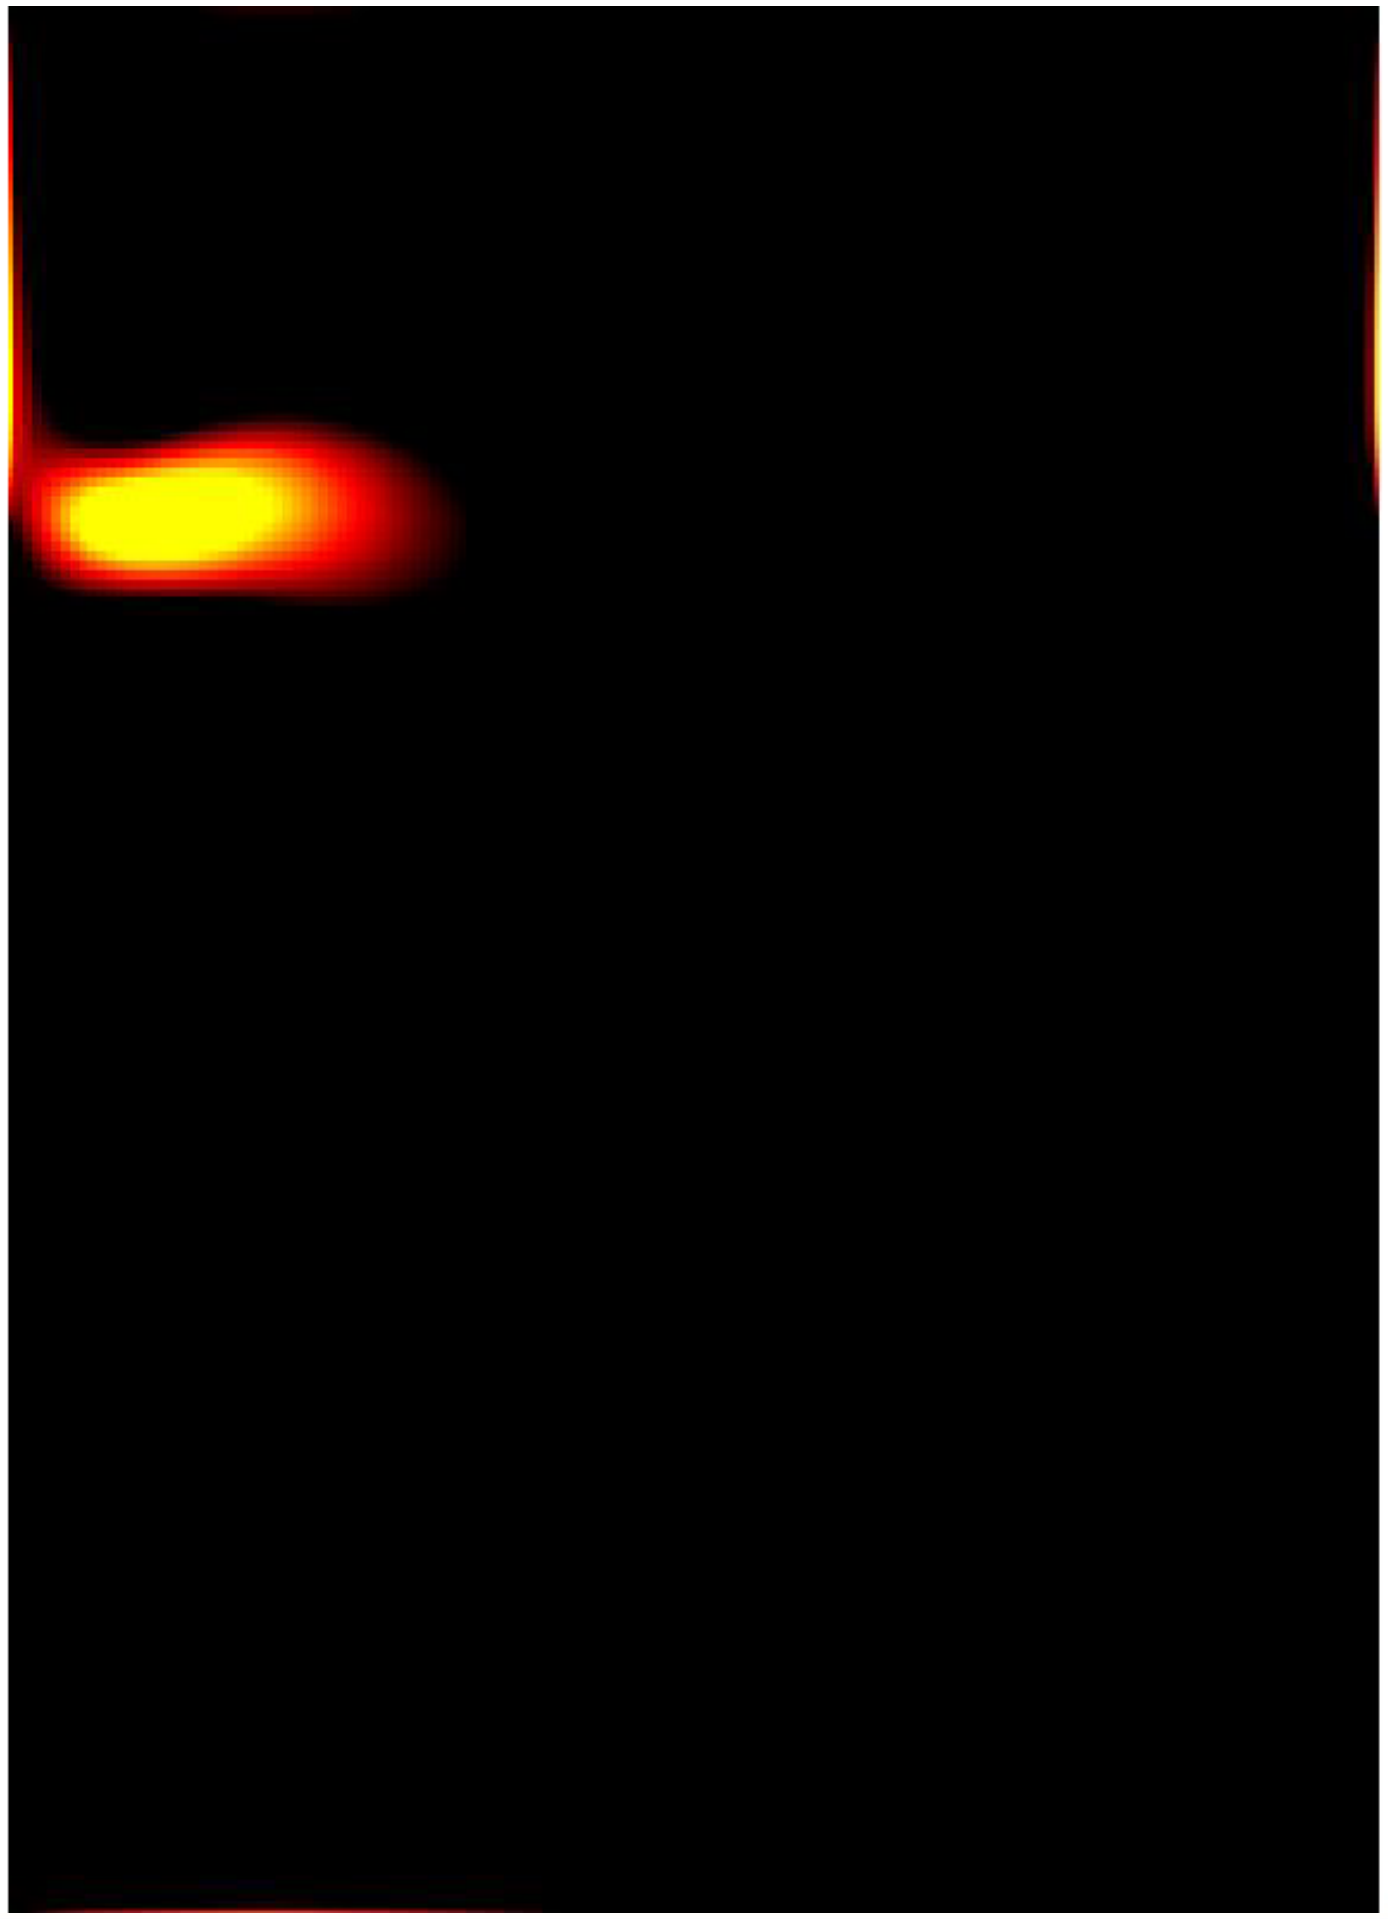
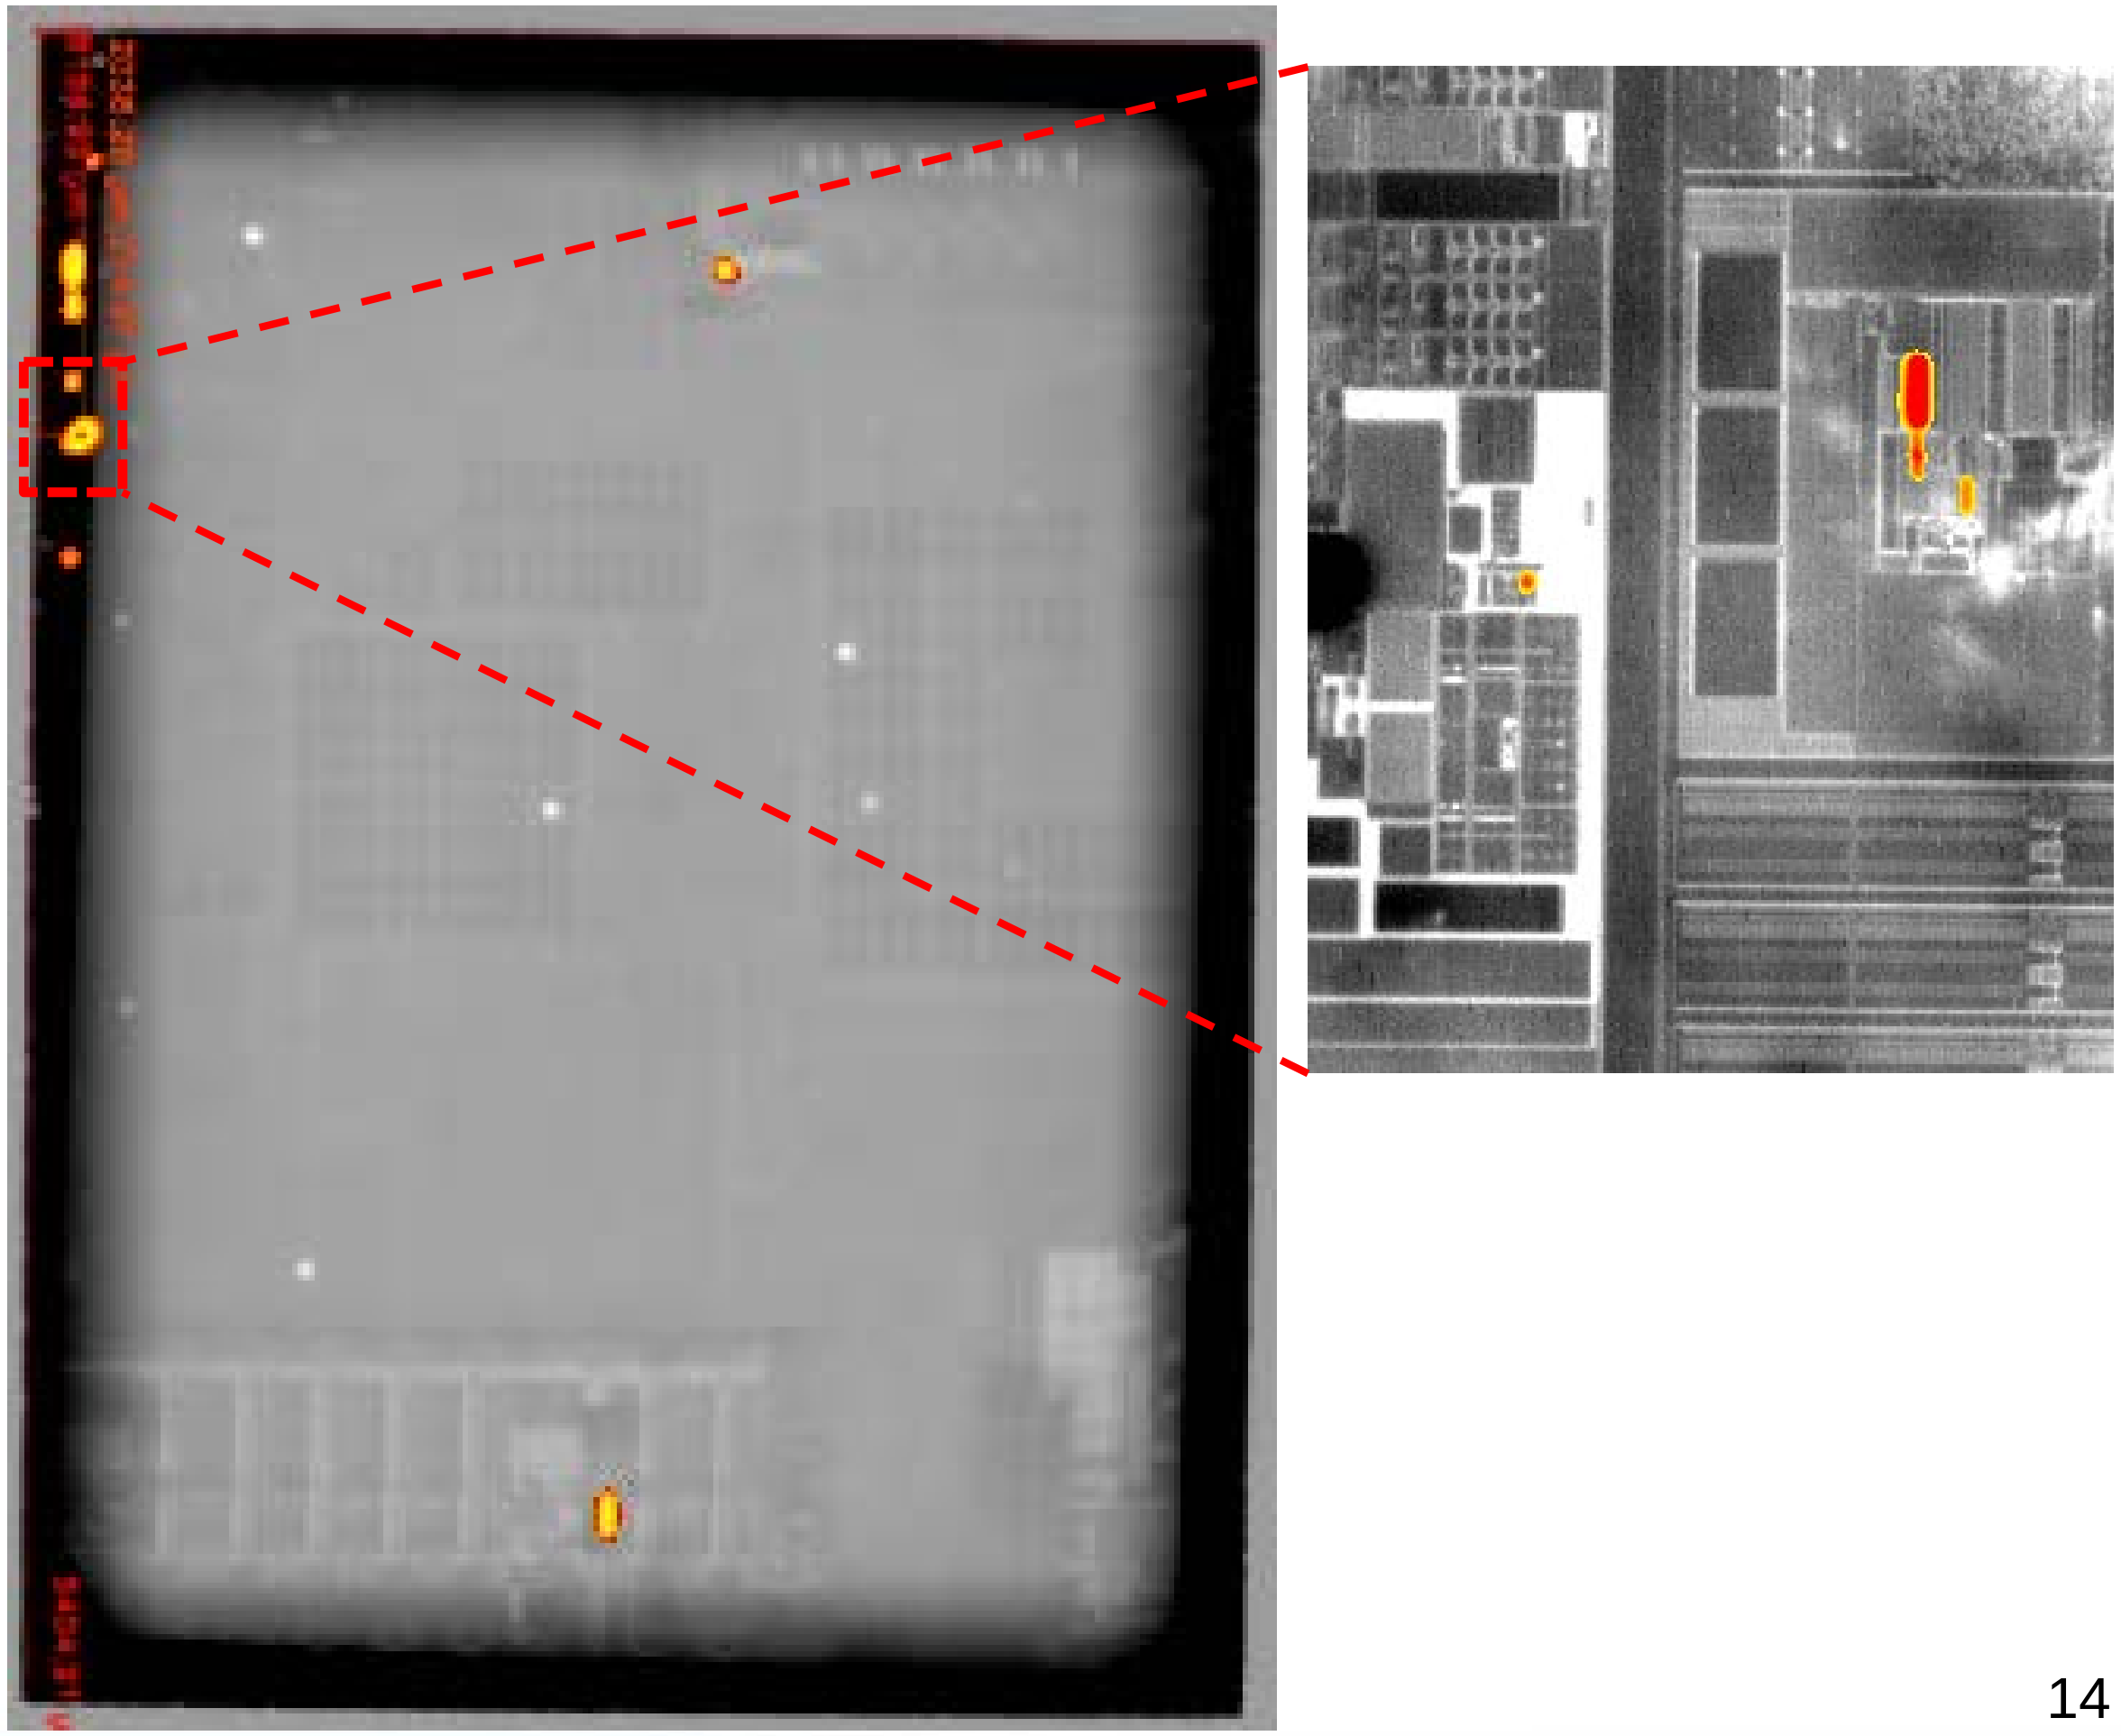
Photoemission from the PCH die

Short path (catastrophically failed package)

IR photoemission from a healthy package

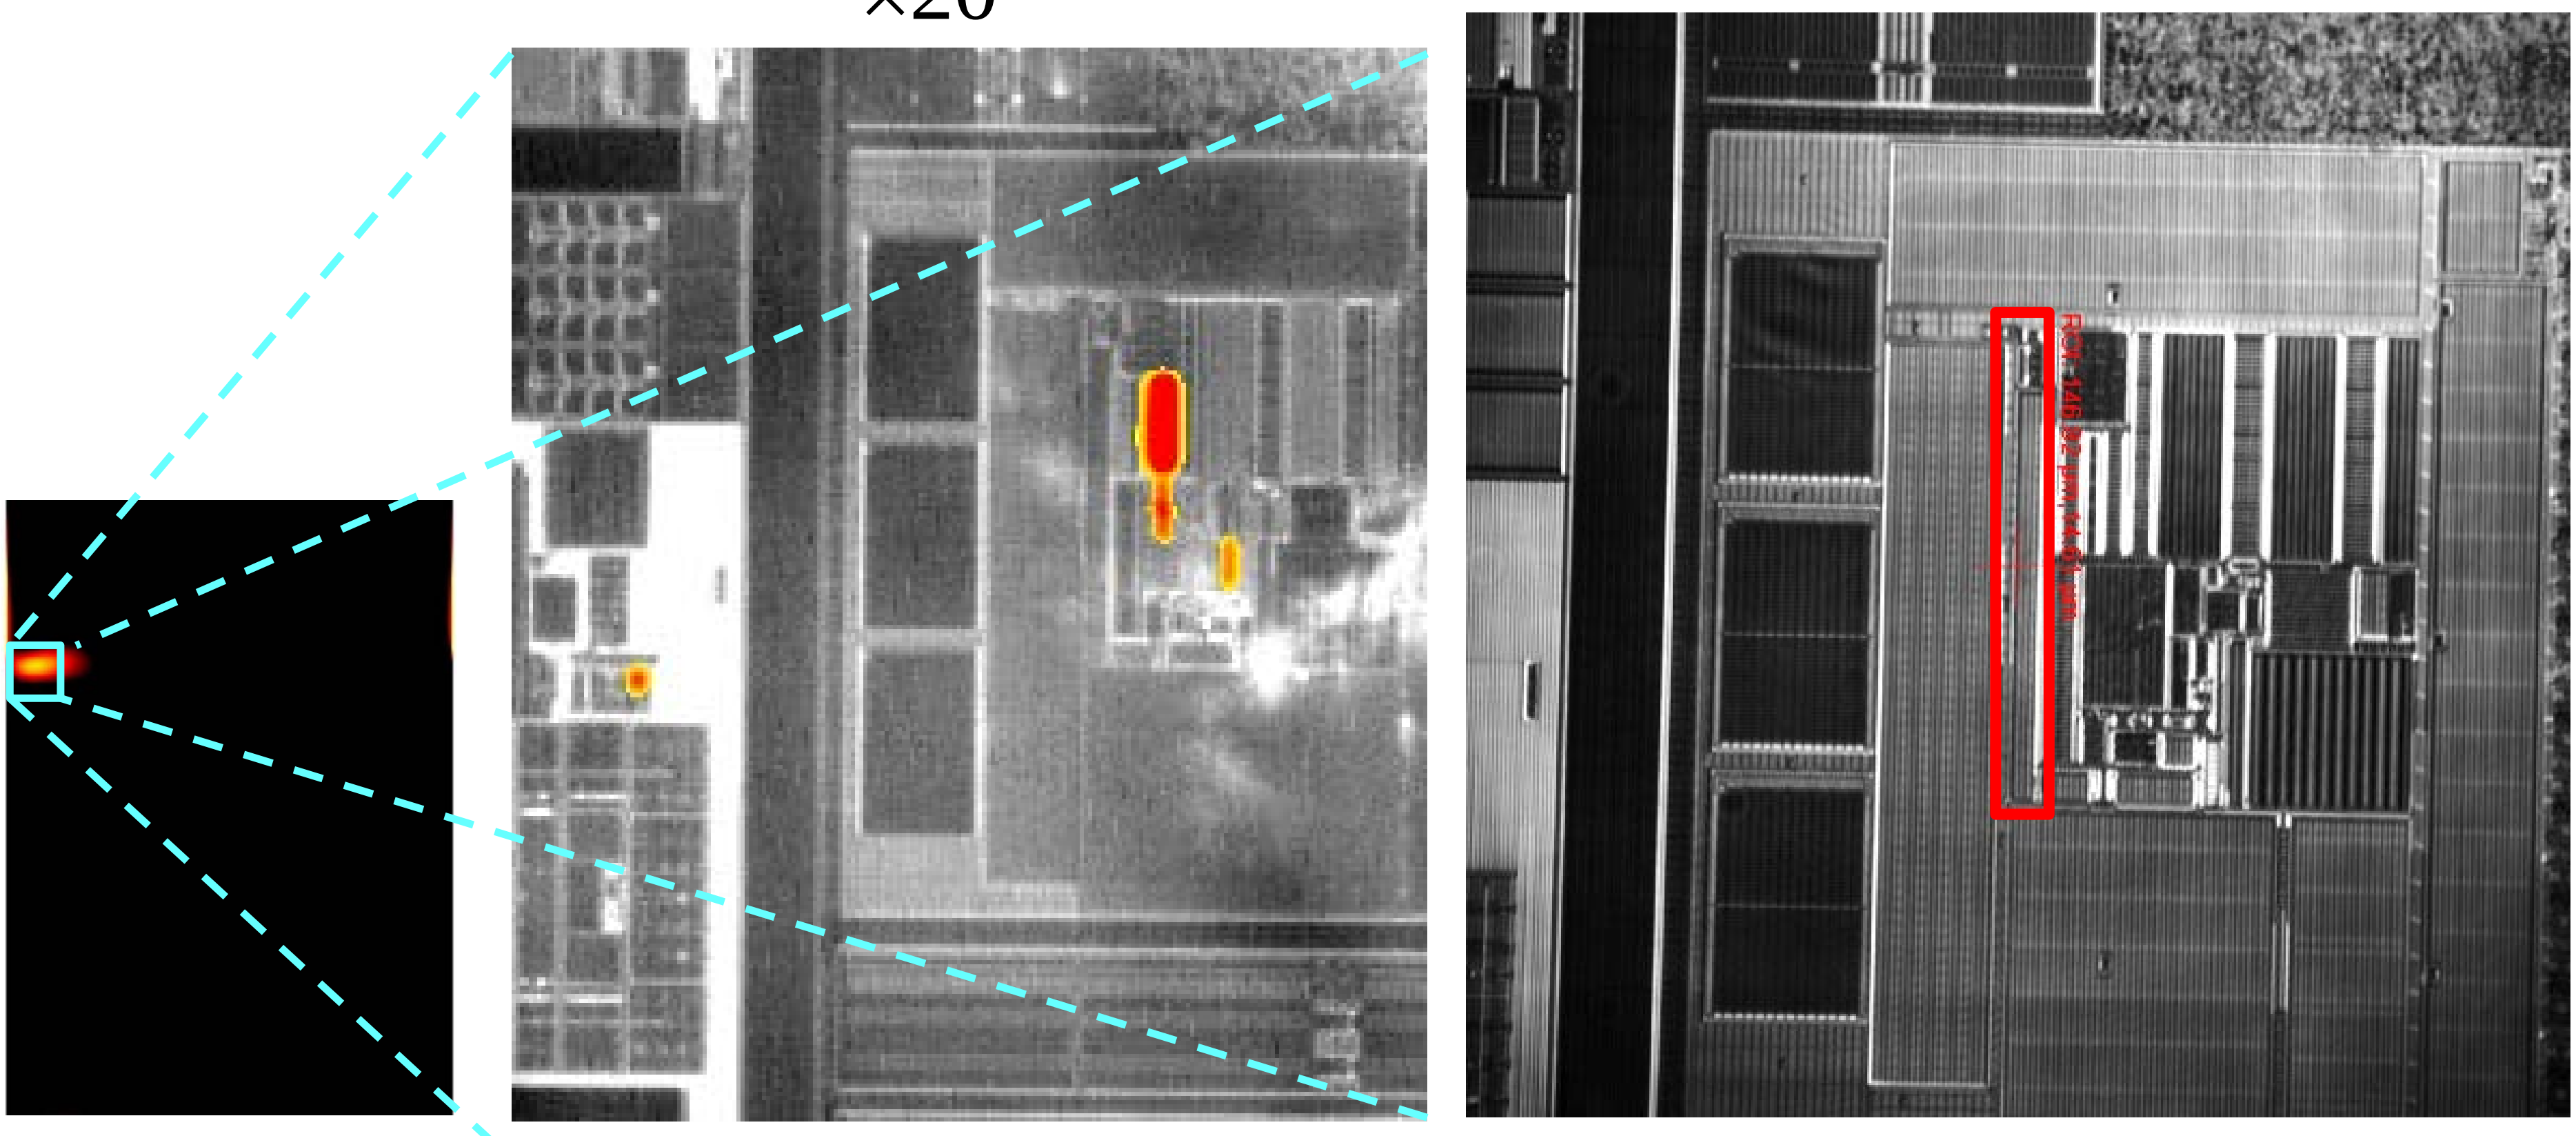
1064 nm laser on the PCH die

- The most sensitive area (9 µm × 140 µm) on the PCH die occasionally causes hard failures for about 10 min at laser power of about 5 mW!
- 1340 nm laser @ up to 80 mW does not cause ANY upsets

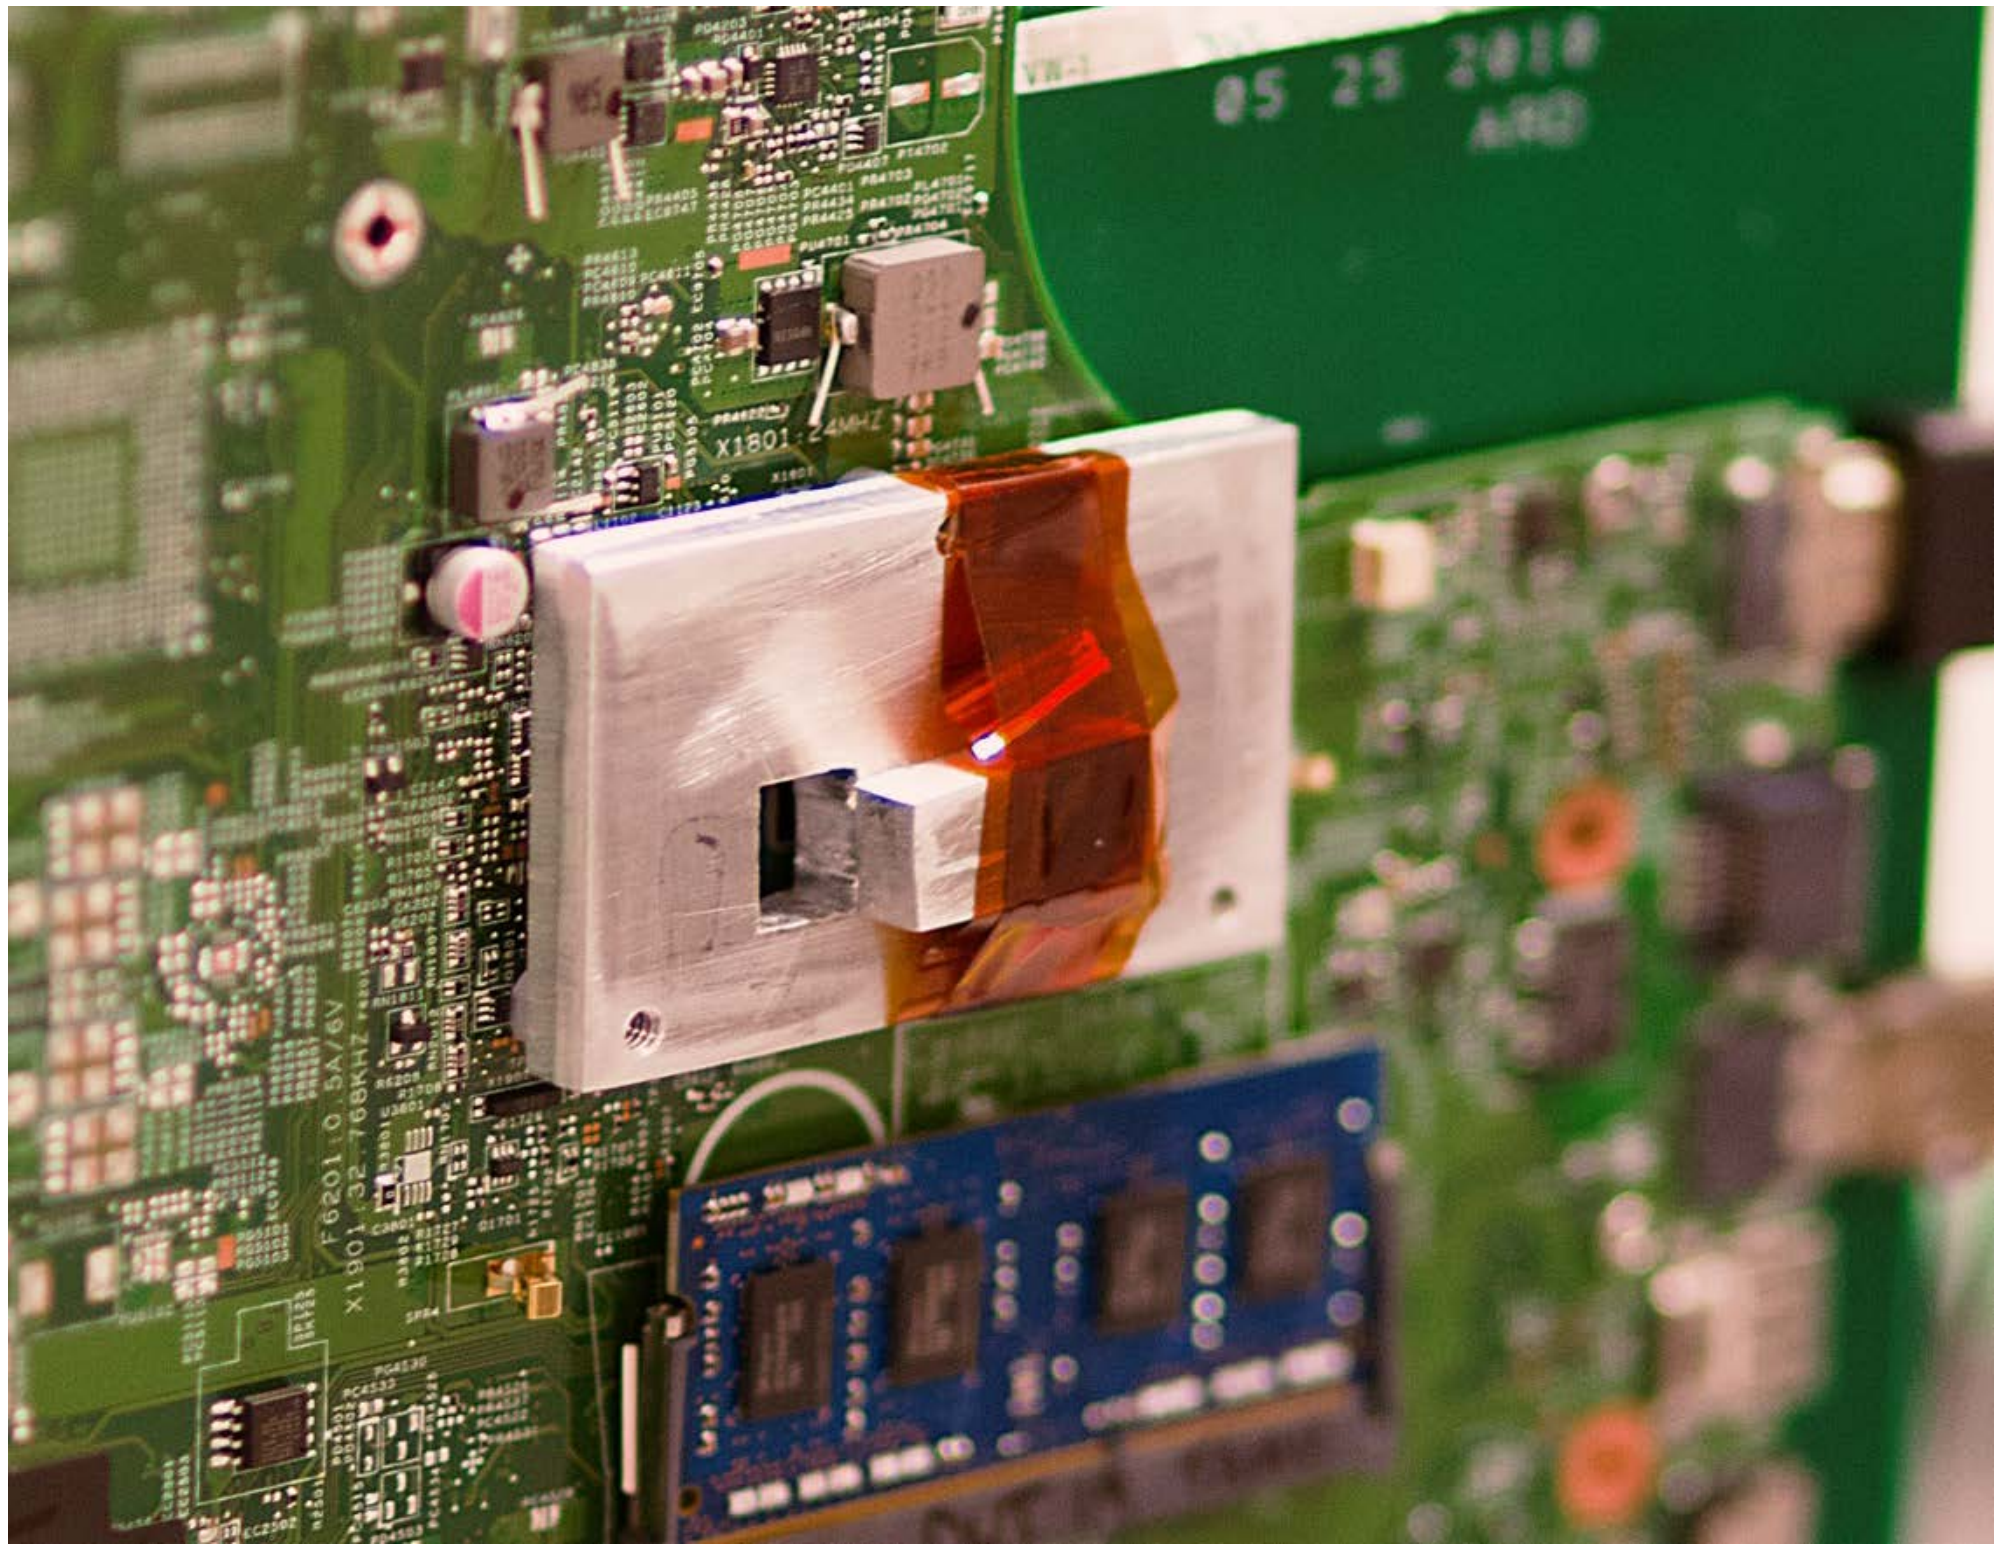
Recent tests (May, 2016) at TAMU

- Two hard failures on the PCH die
- No hard failure on the CPU die
