Fractographic Analysis of the Low Energy
Fracture of an Aluminum Alloy
by

J. Tanaka, C. A. Pampillo and J. R. Low, Jr.

National Aeronautics and Space Administration
Research Grant NGR 39-087-300

NASA Technical Report No. 1

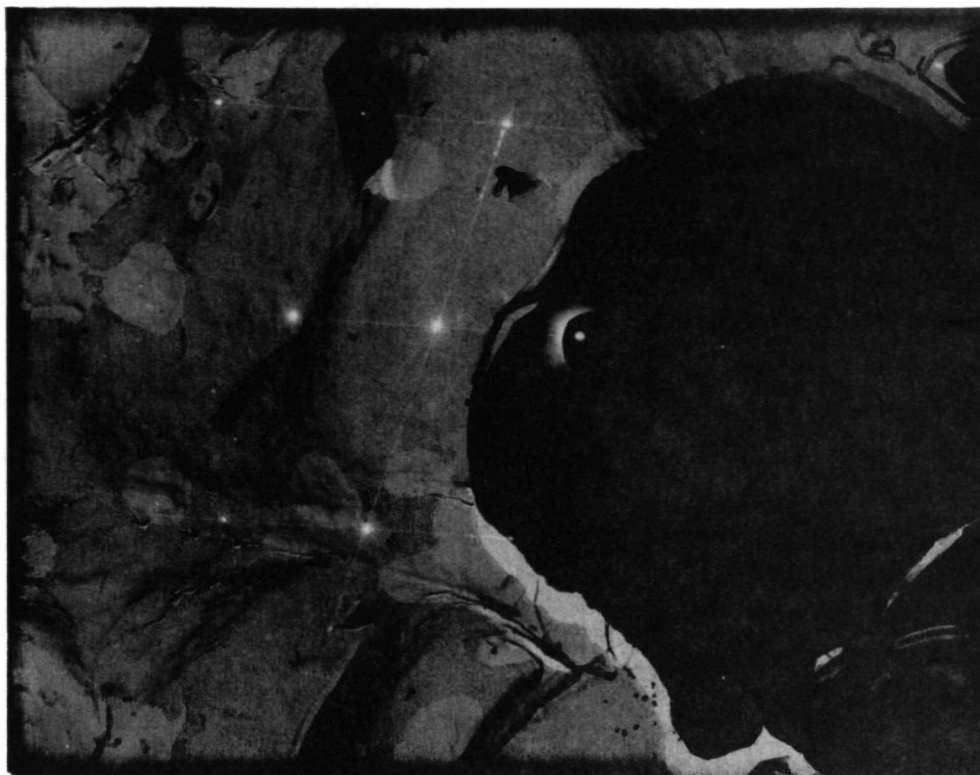
Fig. 22 a & b Electron Diffraction Patterns of Particles A and B of Fig. 20

For the particles containing Cu, it was possible to obtain electron diffraction patterns whenever they appeared thin enough in the extraction replicas.

Figures 22a and b shows diffraction patterns for the particles A and B shown in Figure 20 and in the micro probe micrograph in Figure 21. An analysis of the diffraction patterns obtained of the particles in the extraction replicas might correspond to Al_4Cu_9 or $\text{Cu}_{15}\text{Si}_4$ and pure Si or Cu_5Si or CuAl_2 .
