NATIONAL AERONAUTICS AND SPACE ADMINISTRATION

*Technical Memorandum 33-692*

*Implementation of the 64-Meter-Diameter Antennas  
at the Deep Space Stations in  
Australia and Spain*

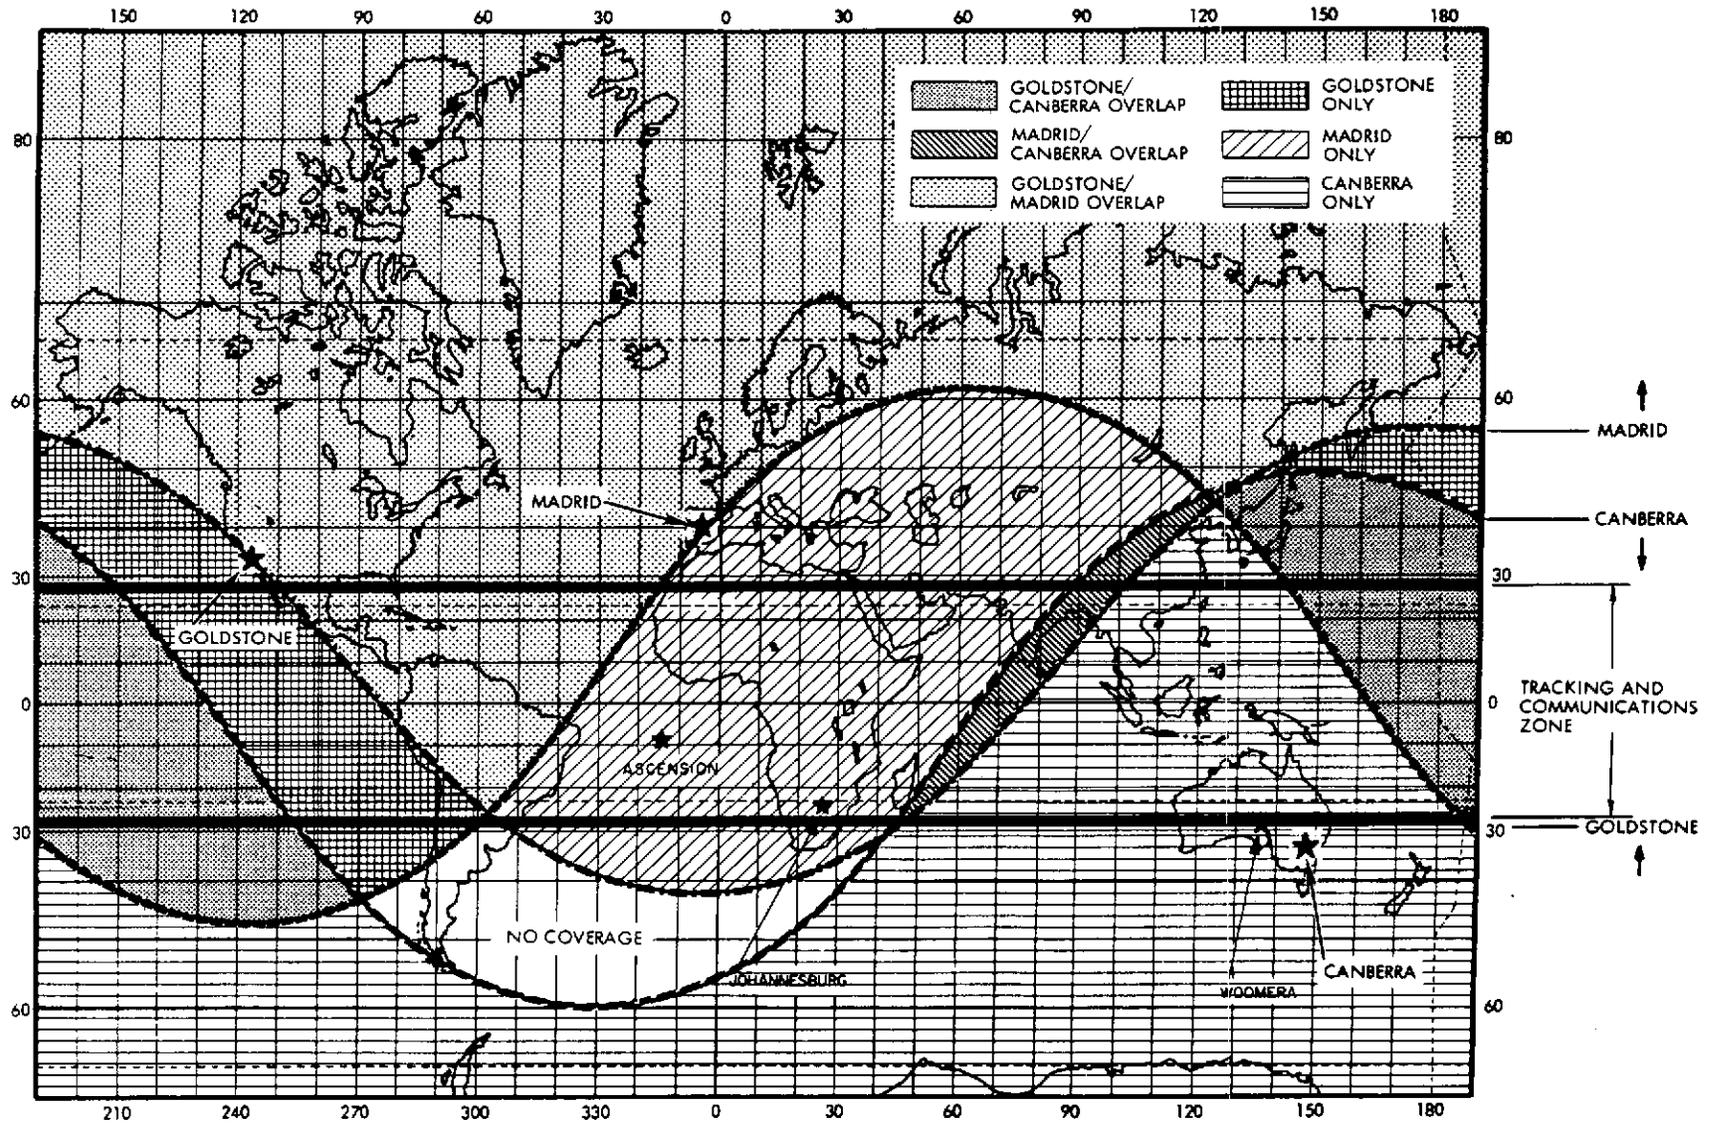
Fig. 1. Continuous coverage of planetary spacecraft provided by the three-station subnet of 64-m antennas operating down to 6-deg elevation (receive mode and 20-kW transmit mode)

Results of studies showed that the locations selected would provide 99.9% coverage between 28.5°N latitude and 28.5°S latitude, which is the zone of interest. Figure 1 shows the coverage provided by the three-station subnet with the antennas operating as low as a 6-deg elevation in the receive mode and 20-kW transmit mode.

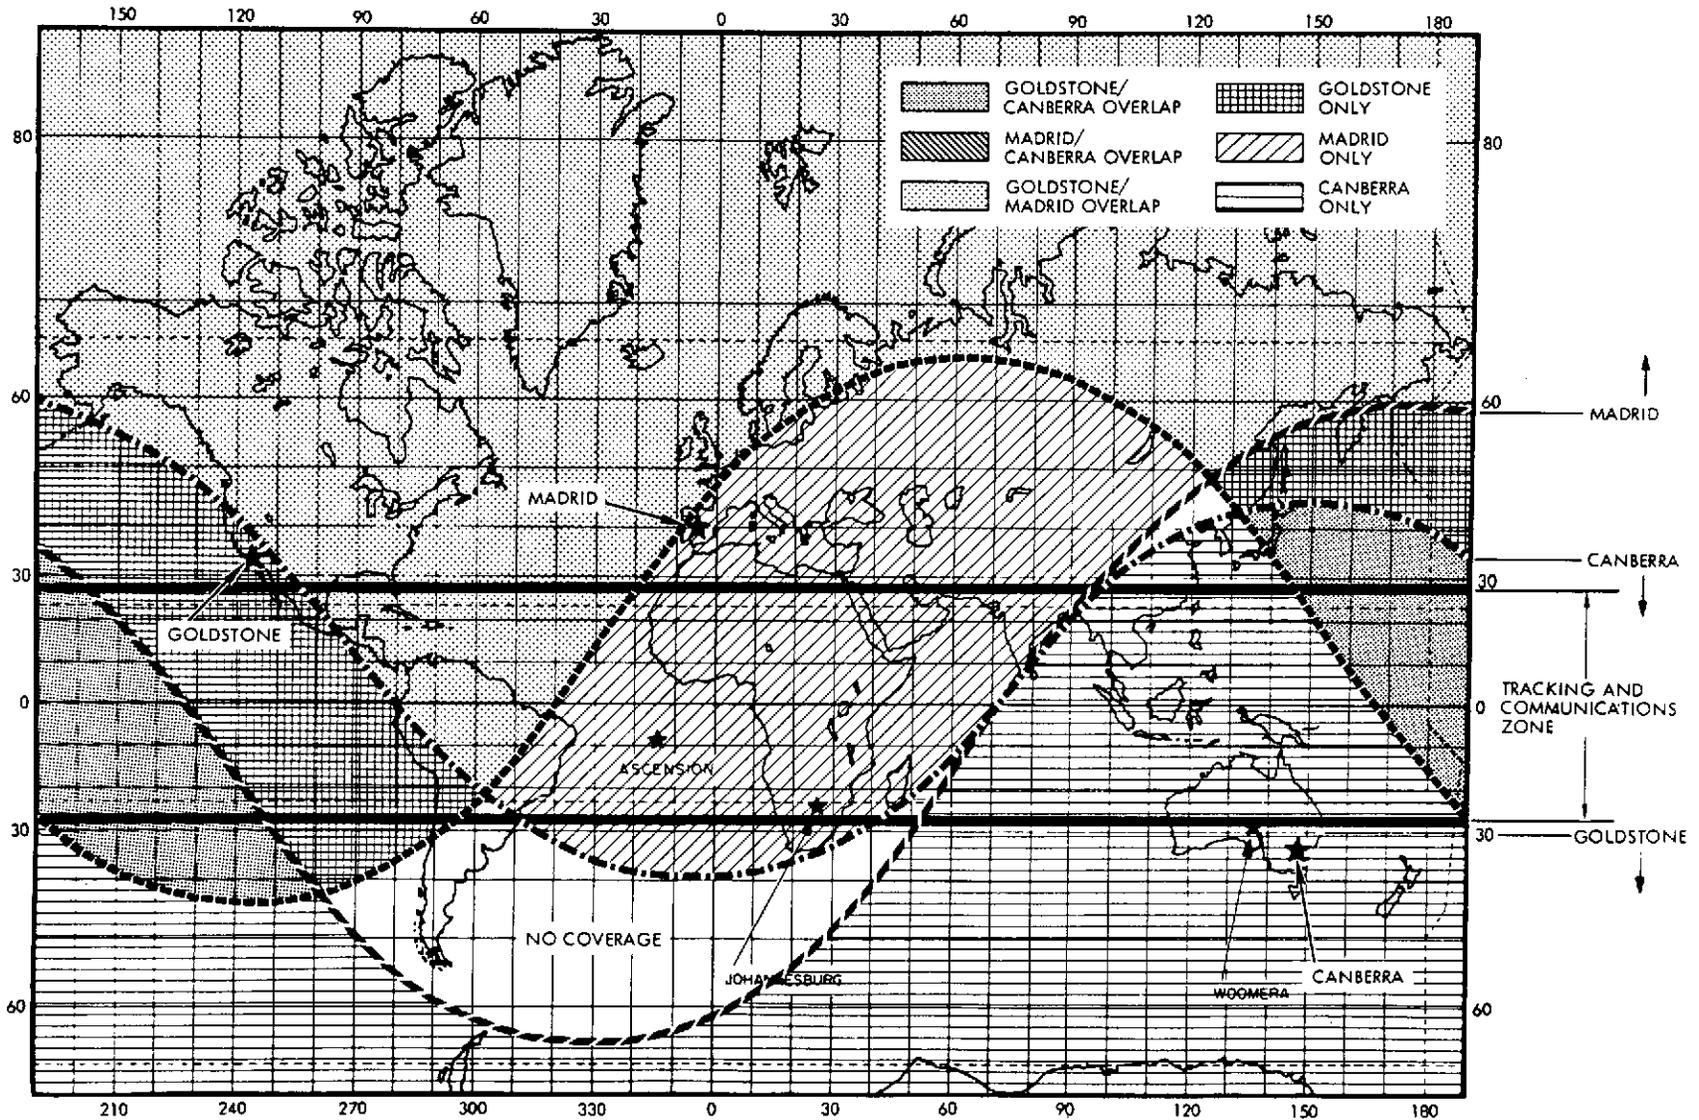
Fig. 2. Continuous coverage of planetary spacecraft provided by the three-station subnet of 64-m antennas operating down to 10-deg elevation (post-1975 era high power transmit mode)

Figure 2 shows the coverage provided by the three-station subnet operating down to a 10-deg elevation for the higher power transmit mode.

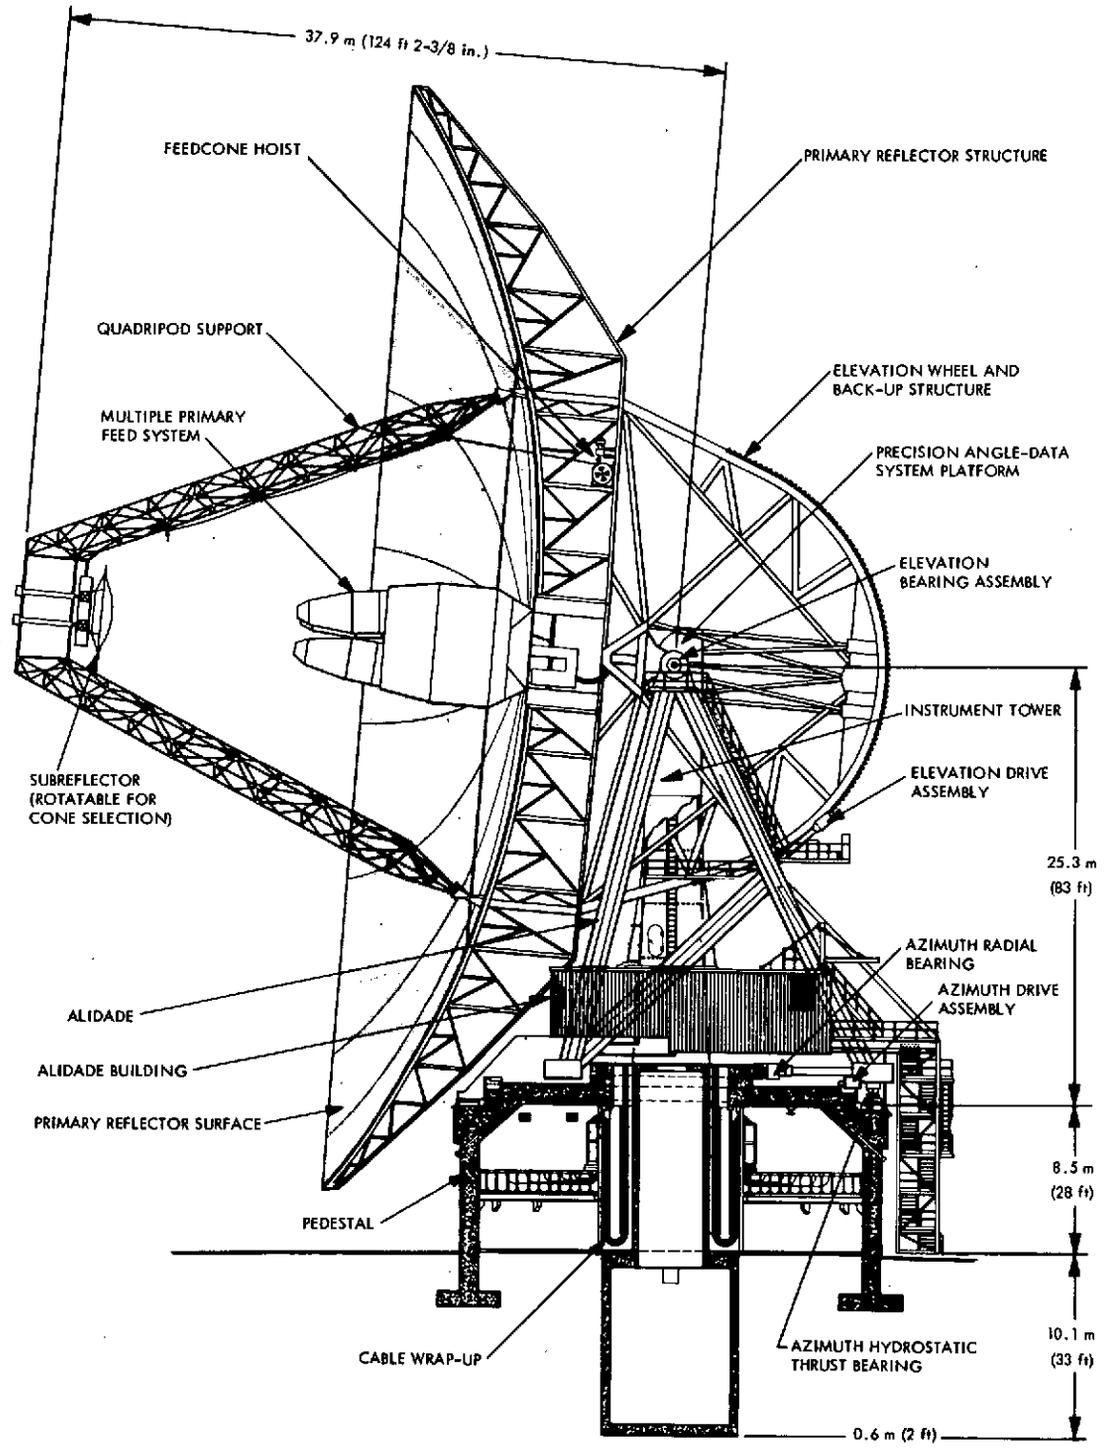
Fig. 11. Antenna major components

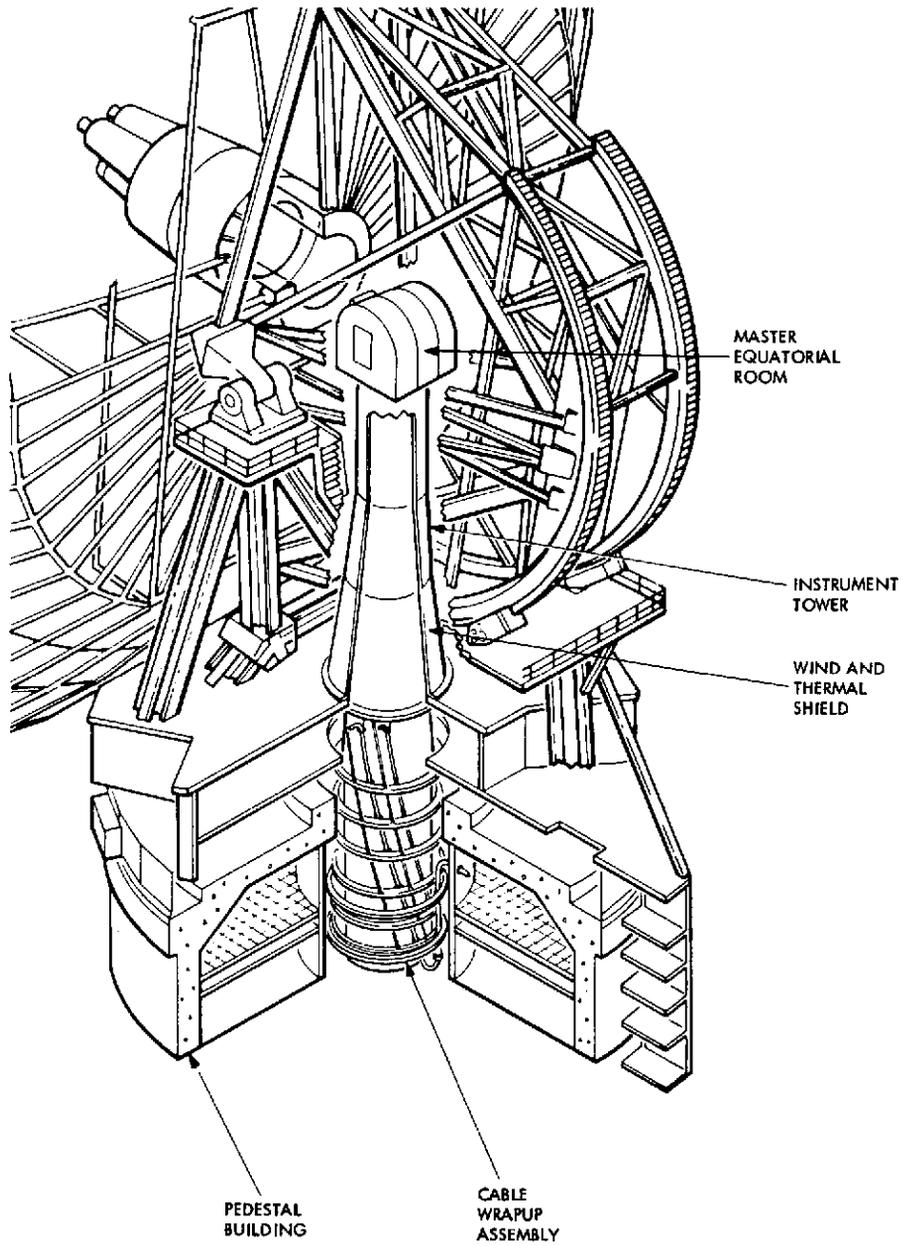
Fig. 12. Pedestal, cable wrapup, and instrument tower

Figure 12 illustrates the pedestal, instrument tower, and cable wrapup.

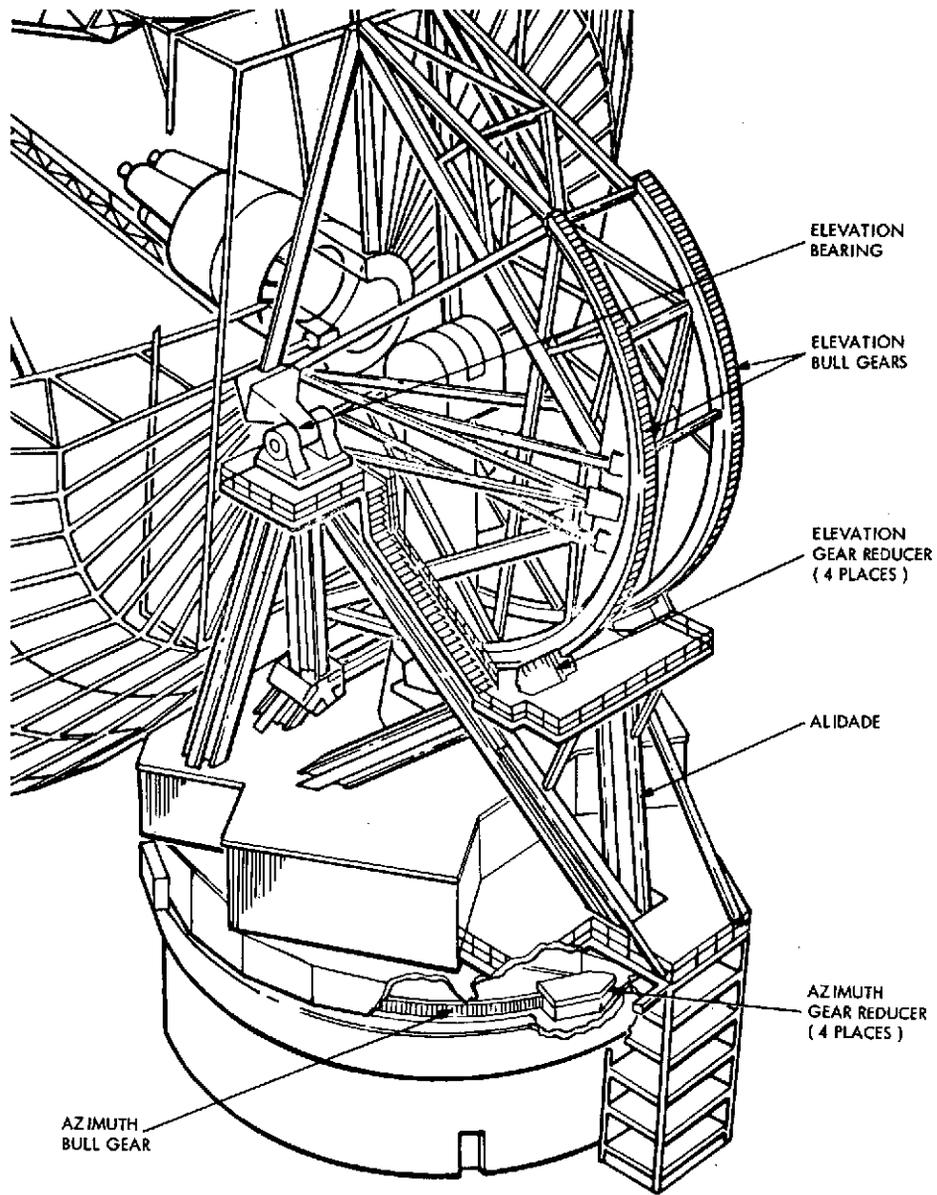
Fig. 13. Antenna mount

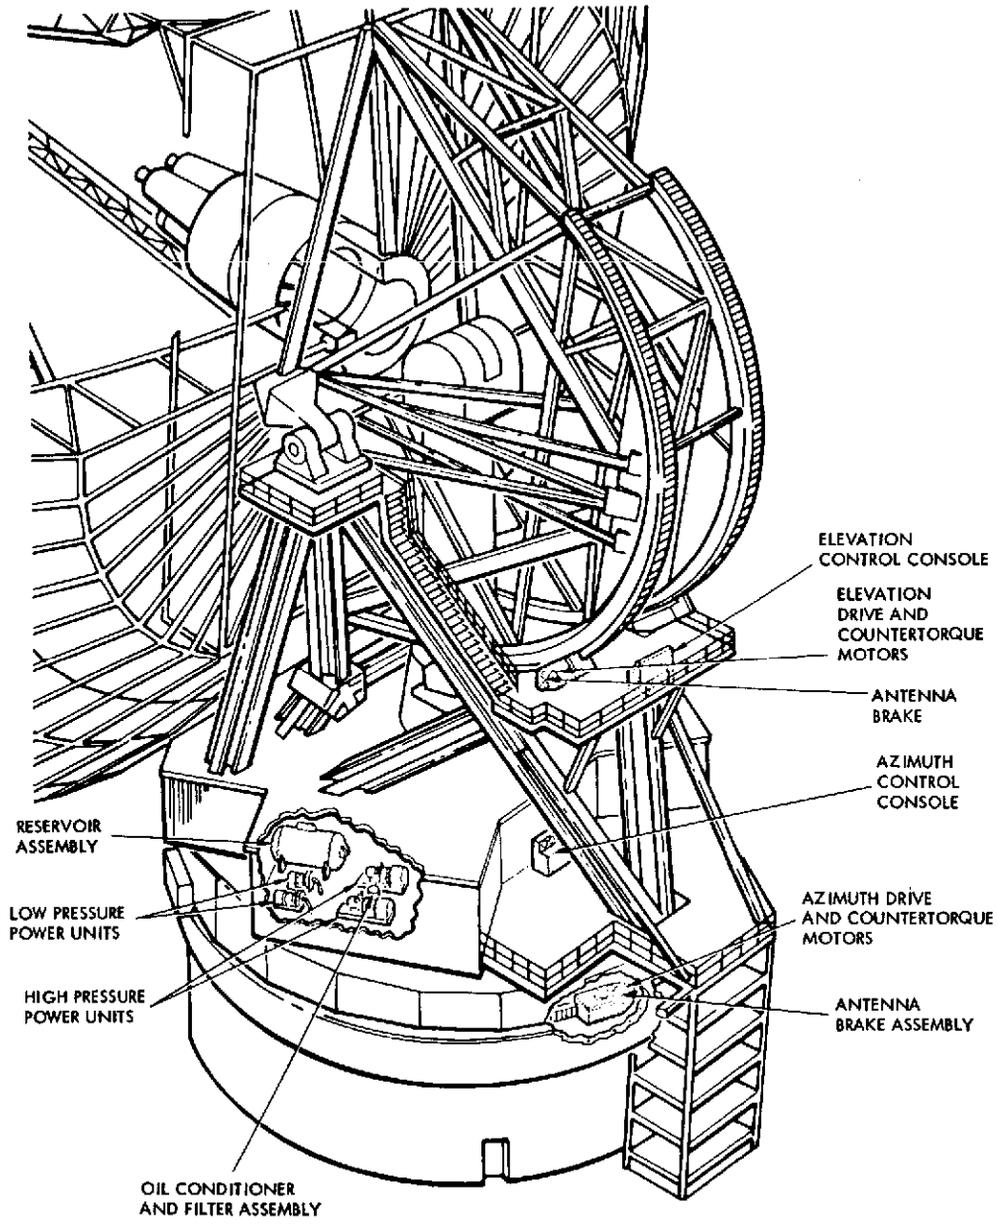
Fig. 14. Servo hydraulics assembly

The servo hydraulics assembly (Fig. 14) consists of the hydraulic equipment necessary to move the tipping structure about the elevation axis and the alidade about the azimuth axis. The servo hydraulics assembly comprises hydraulic drive motors and counter torque motors (four of each type for each axis, one of each type for each gear reducer); two redundant low-pressure and two high-pressure hydraulic power units; two control consoles; an oil-conditioning network; brake assemblies; and electronic control and electrical power interfaces. The high-pressure pumps are pressure compensated to provide fluid flow at a constant pressure regardless of the flow demand, within the capacity of the pumps. The high-pressure pumps are driven by 149-kW (200 hp) electric motors and operate at a pressure of  $18.6 \text{ MN/m}^2$  ( $2700 \text{ lb/in.}^2$ ). The actual rate control of the antenna is through electrically controlled

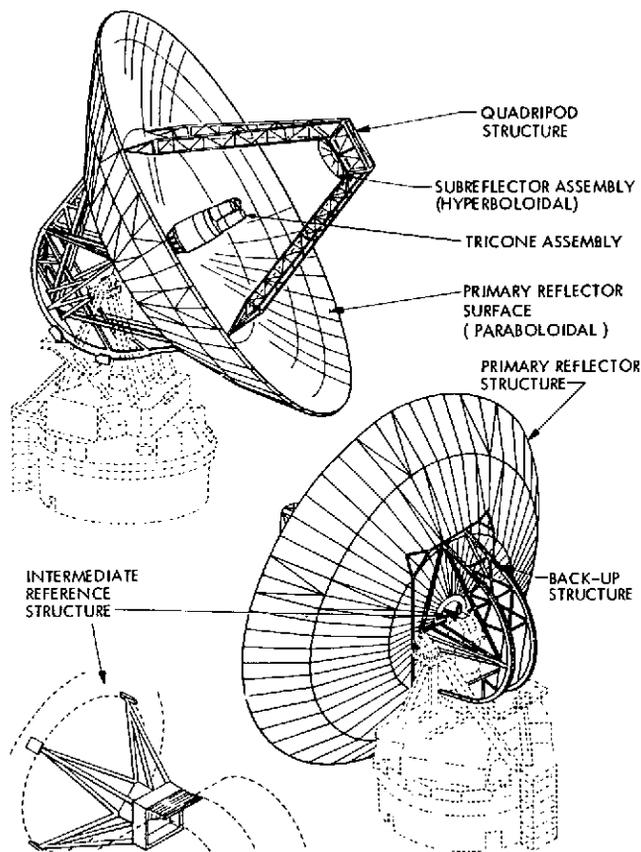
Fig. 15. Tipping assembly

The tipping structure of the antenna (Fig. 15) include the primary reflector backup structure, primary paraboloidal reflector surface, secondary hyperboloidal reflector surface, supporting quadri-pod structure, Cassegrain multiple feed cone support, and the intermediate reference structure.

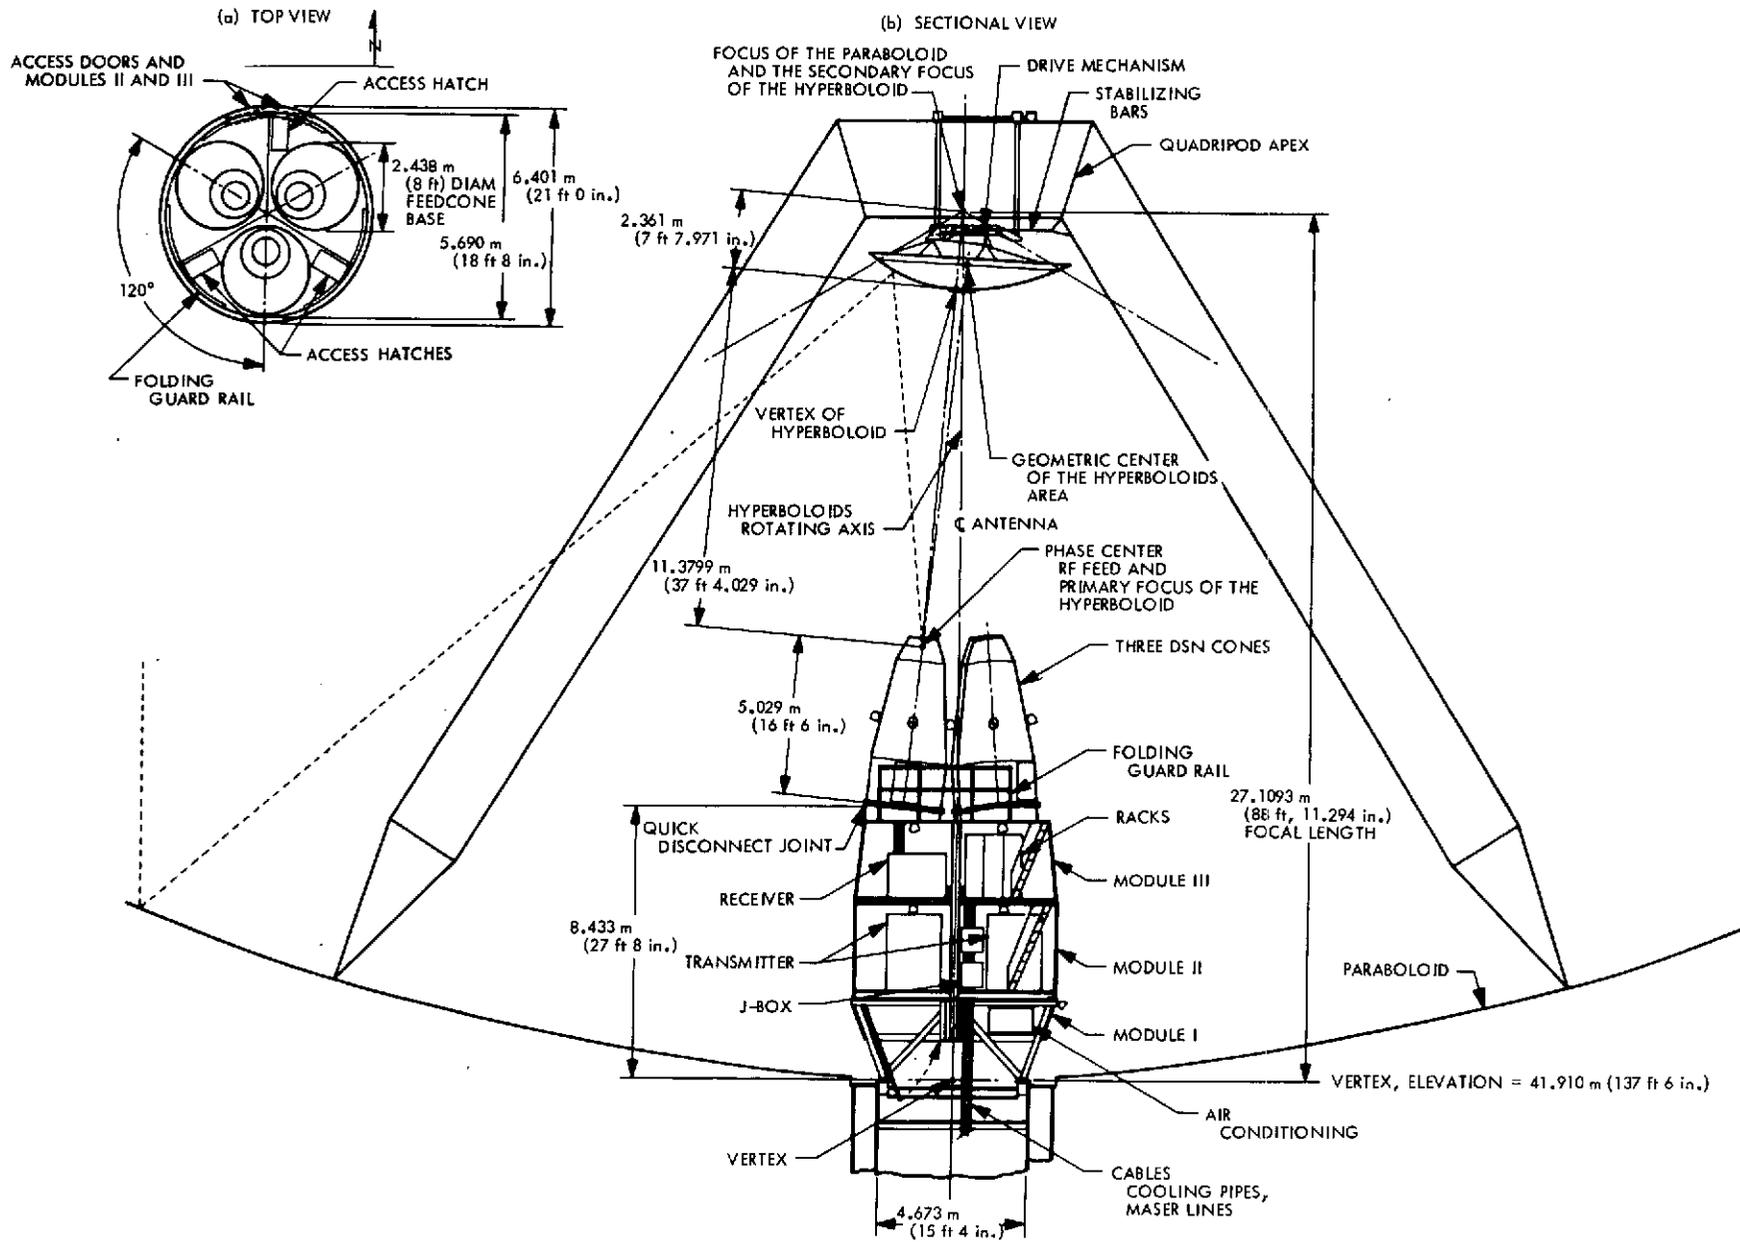
Fig. 16. Multiple primary feed system

Figure 16 shows the overall tricone configuration. The three feedcones are mounted by quick disconnects on a three-module support assembly which houses various ancillary equipment. The feedcones themselves are similar to standard DSN feedcones.

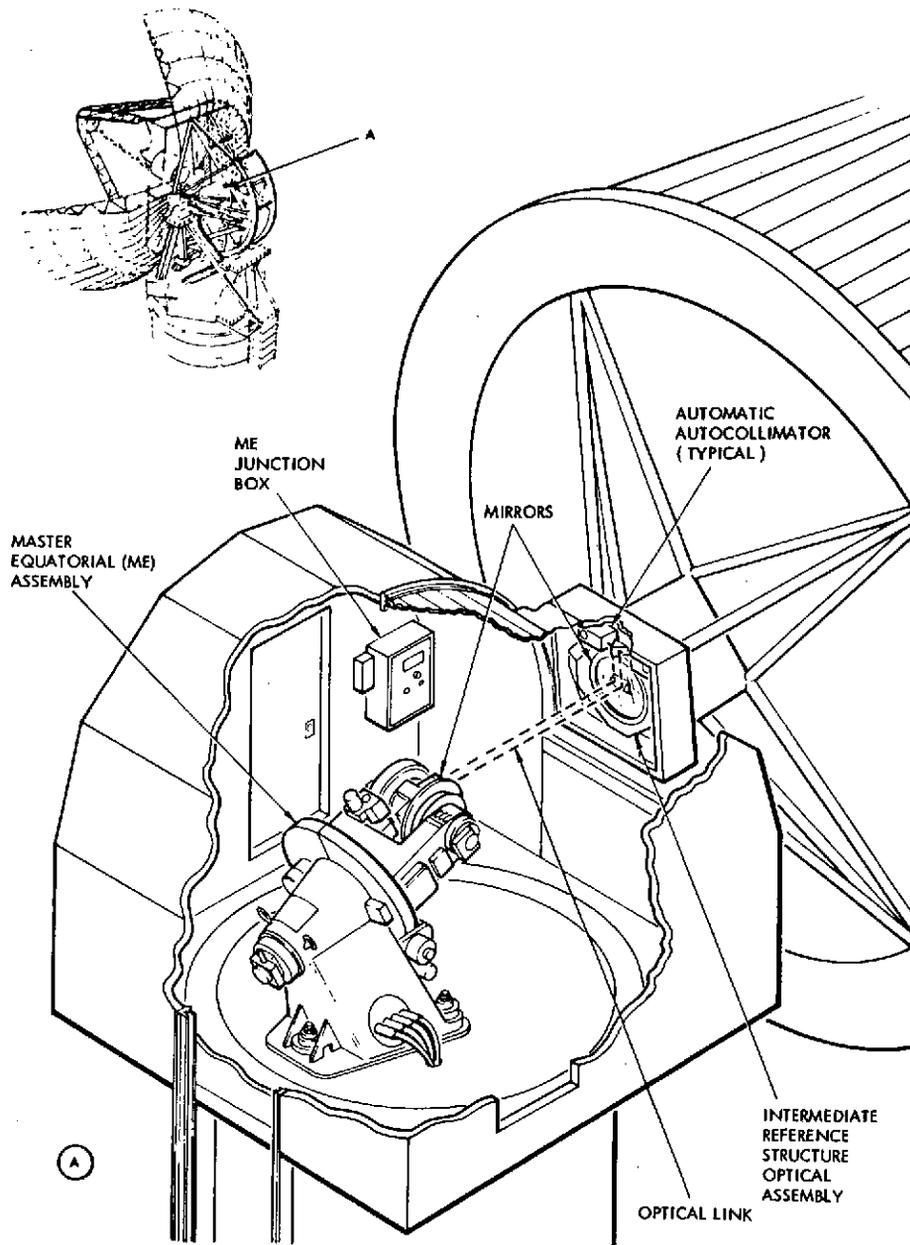
Fig. 17. Angle data assembly antenna mounted components

The angle data assembly (Fig. 17) provides and controls a precisely aligned equatorial mount (Master Equatorial) that serves as the primary angle reference for control of antenna position; a secondary angle reference in azimuth and elevation coordinates; and digital readout of antenna position in hour-angle declination, and azimuth elevation coordinates.

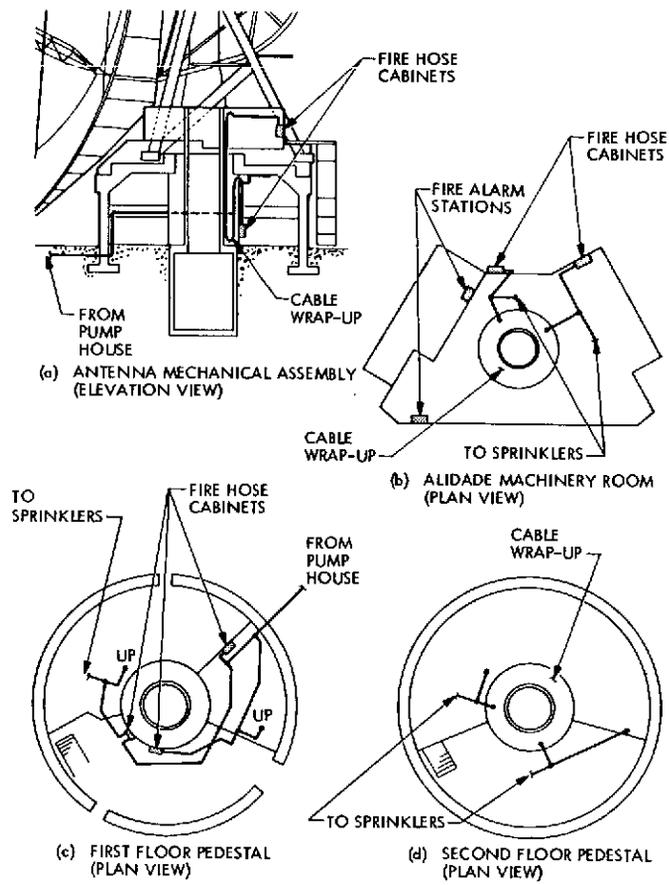
Fig. 18. Fire alarm and water distribution network

The fire water distribution network includes ceiling-mounted fire sprinklers, fire hoses, an auxiliary pump to increase water pressure, and associated controls, piping, and valving. The fire sprinklers are located in all-enclosed work spaces in the pedestal and alidade areas, and the fire hoses are mounted in steel cabinets about the antenna structure. Fire extinguishers are mounted within the fire hose cabinets, and on the walls within enclosed areas. All user fire protection equipment is painted bright red, and is in well lighted locations (Fig. 18).
