REPORT OF APOLLO 204 REVIEW BOARD

APPENDIX D

PANELS 19 thru 21

REPORT OF PANEL 20
IN-FLIGHT FIRE EMERGENCY PROVISIONS PANEL
APPENDIX D-20
TO
FINAL REPORT OF
APOLLO 204 REVIEW BOARD

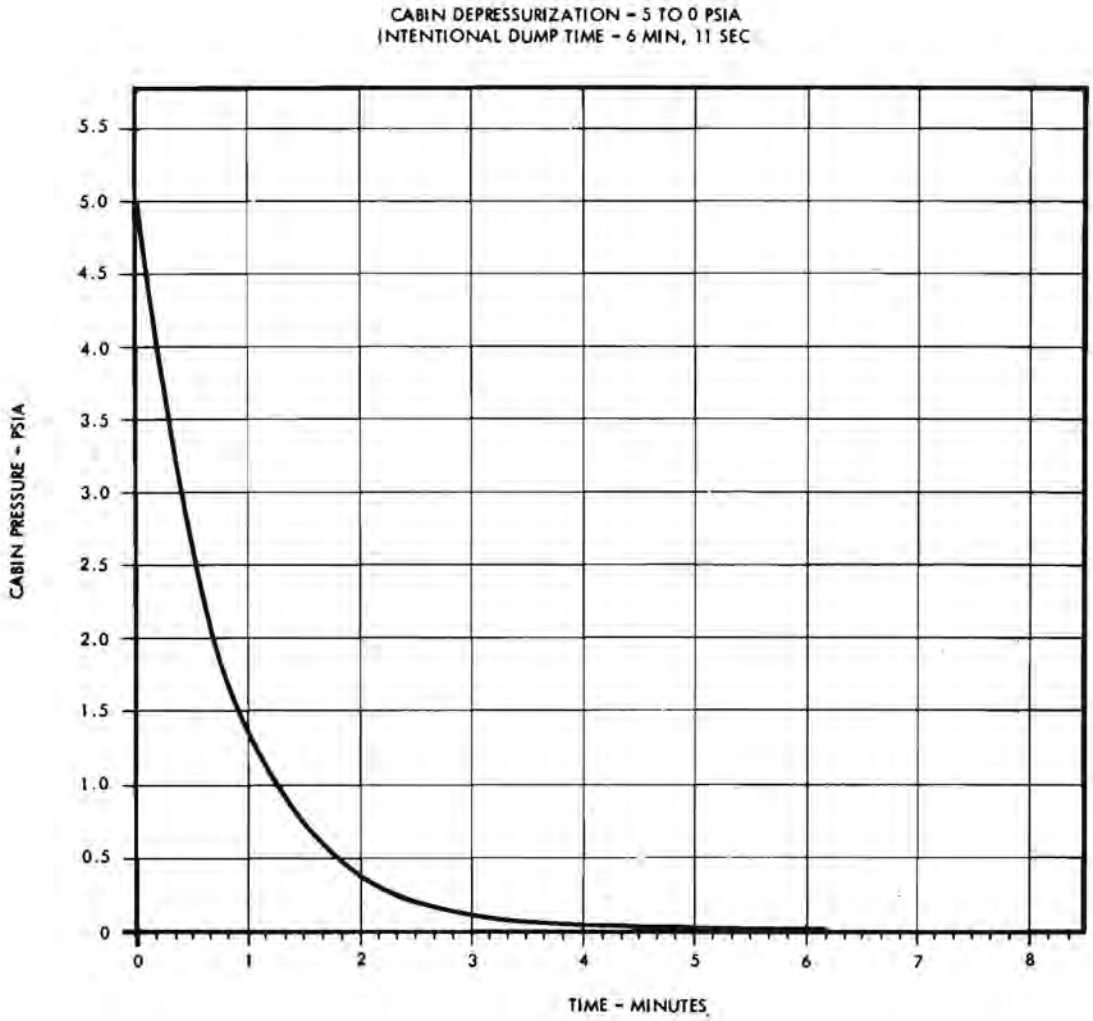
Figure 2.7-11. Cabin Depressurization Rates (Sheet 1 of 2)

b. CABIN PRESSURE VENT DURING ORBIT. The venting of cabin pressure was the only method available for Apollo crewmen to use in extinguishing a fire. The procedures and times for venting the cabin are covered in other areas of this report so only the time required to evacuate the cabin to 0.5 psia will be discussed. Based on reference material, it was assumed that 0.5 psi was the maximum pressure that could be utilized to effectively retard an in-flight fire. Figure 2.7-11 of the Apollo Operations Handbook (Enclosure 20-5) shows that the time required to depressurize the cabin from 5 to 0.5 psia is 1 minute and 45 seconds. It can be noted on the referenced figure that due to the relatively higher differential pressures present when the cabin venting is initiated, the initial depressurization rate is quite rapid. As an example, the time required to drop cabin pressure from 5 to 2 psia is only 45 seconds.

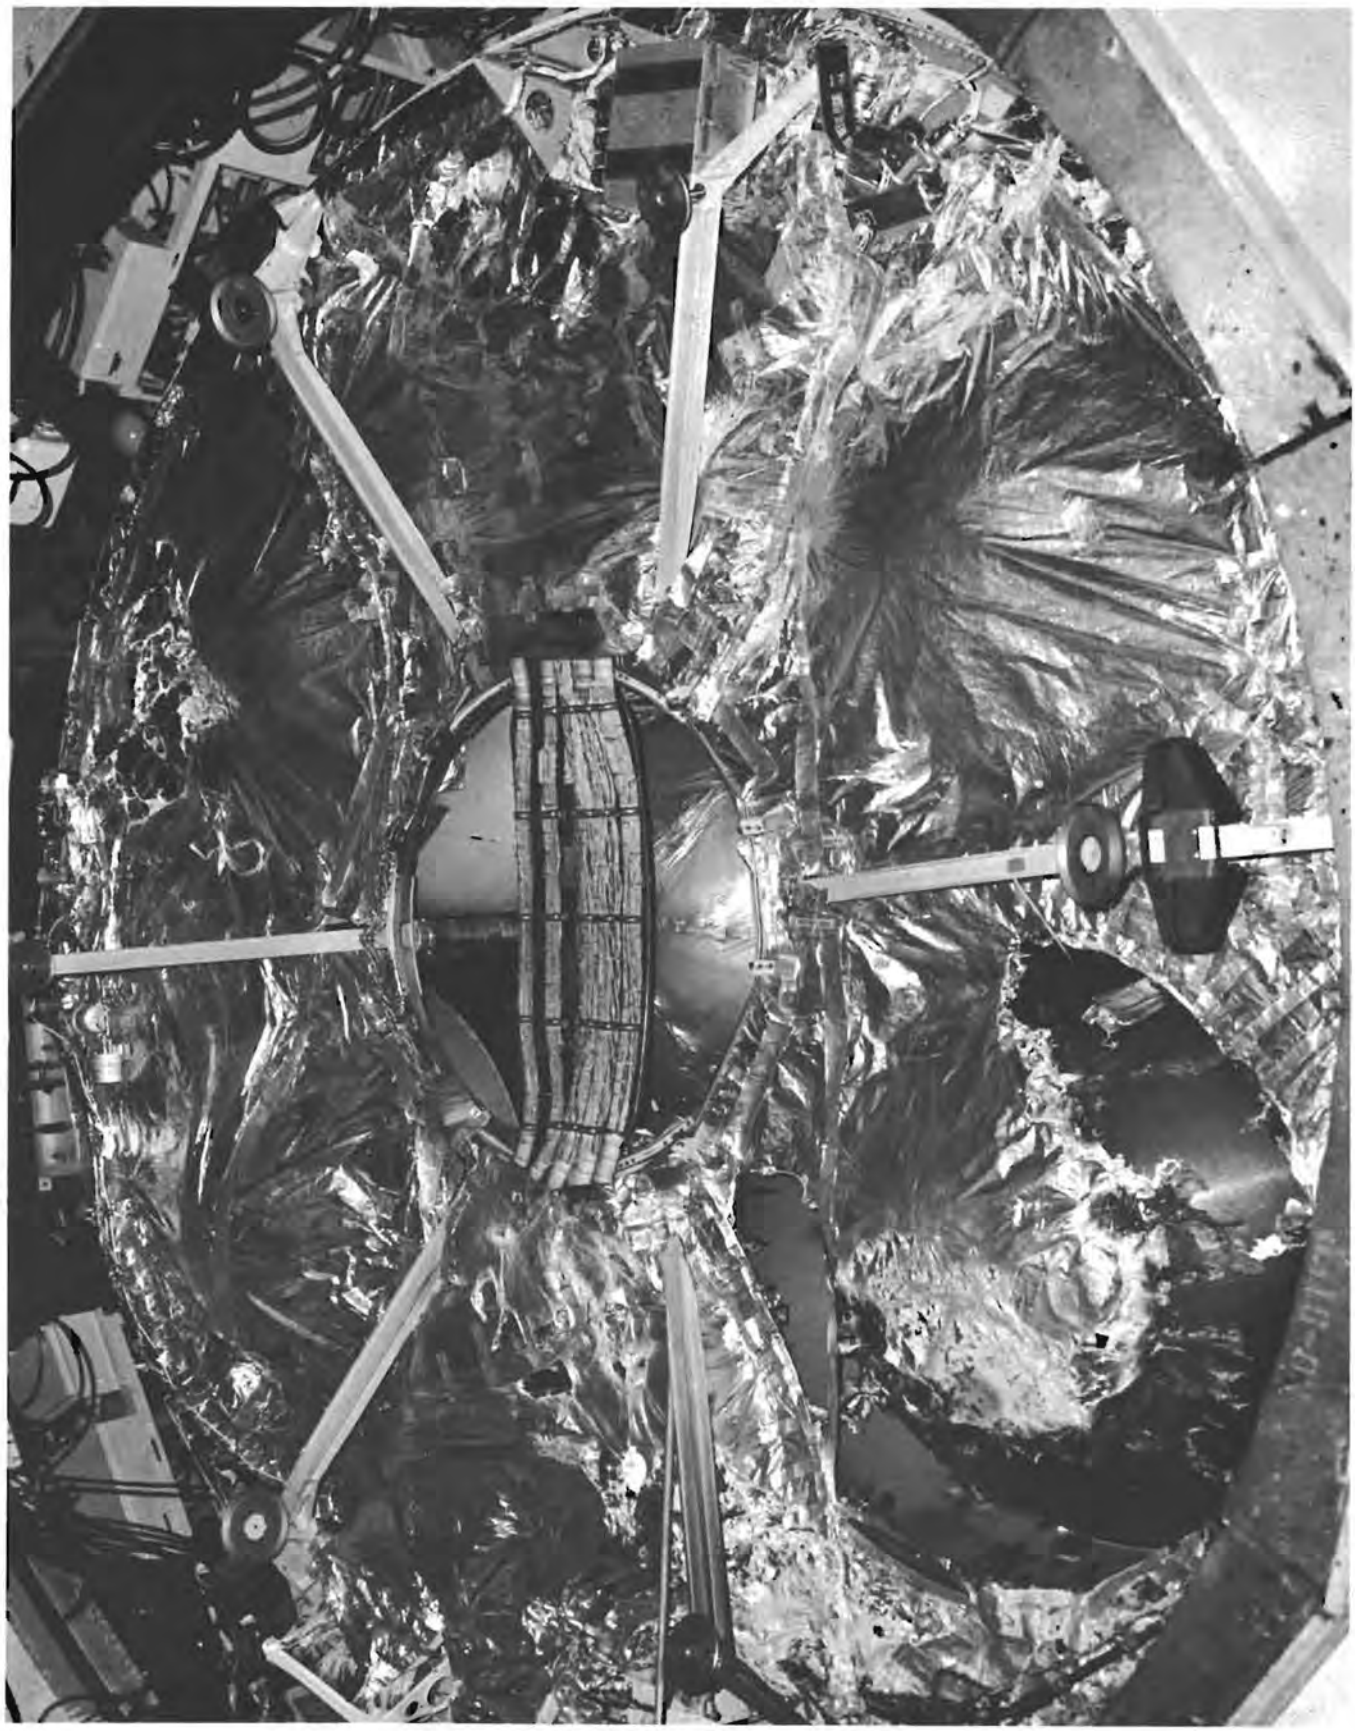
ENCLOSURE 21-3

Detailed inspections of the S/M interior and exterior areas by Quality Control Inspectors, systems engineers and 204 Panel Members (References 21-1 thru 21-4) found the S/M suffered minor damage by fire. (See Enclosures 21-3 and 21-4.)

b. The fire damage to the S/M resulted from a source located above the S/M.

TOP DECK OF SERVICE MODULE WITH MYLAR INSTALLED

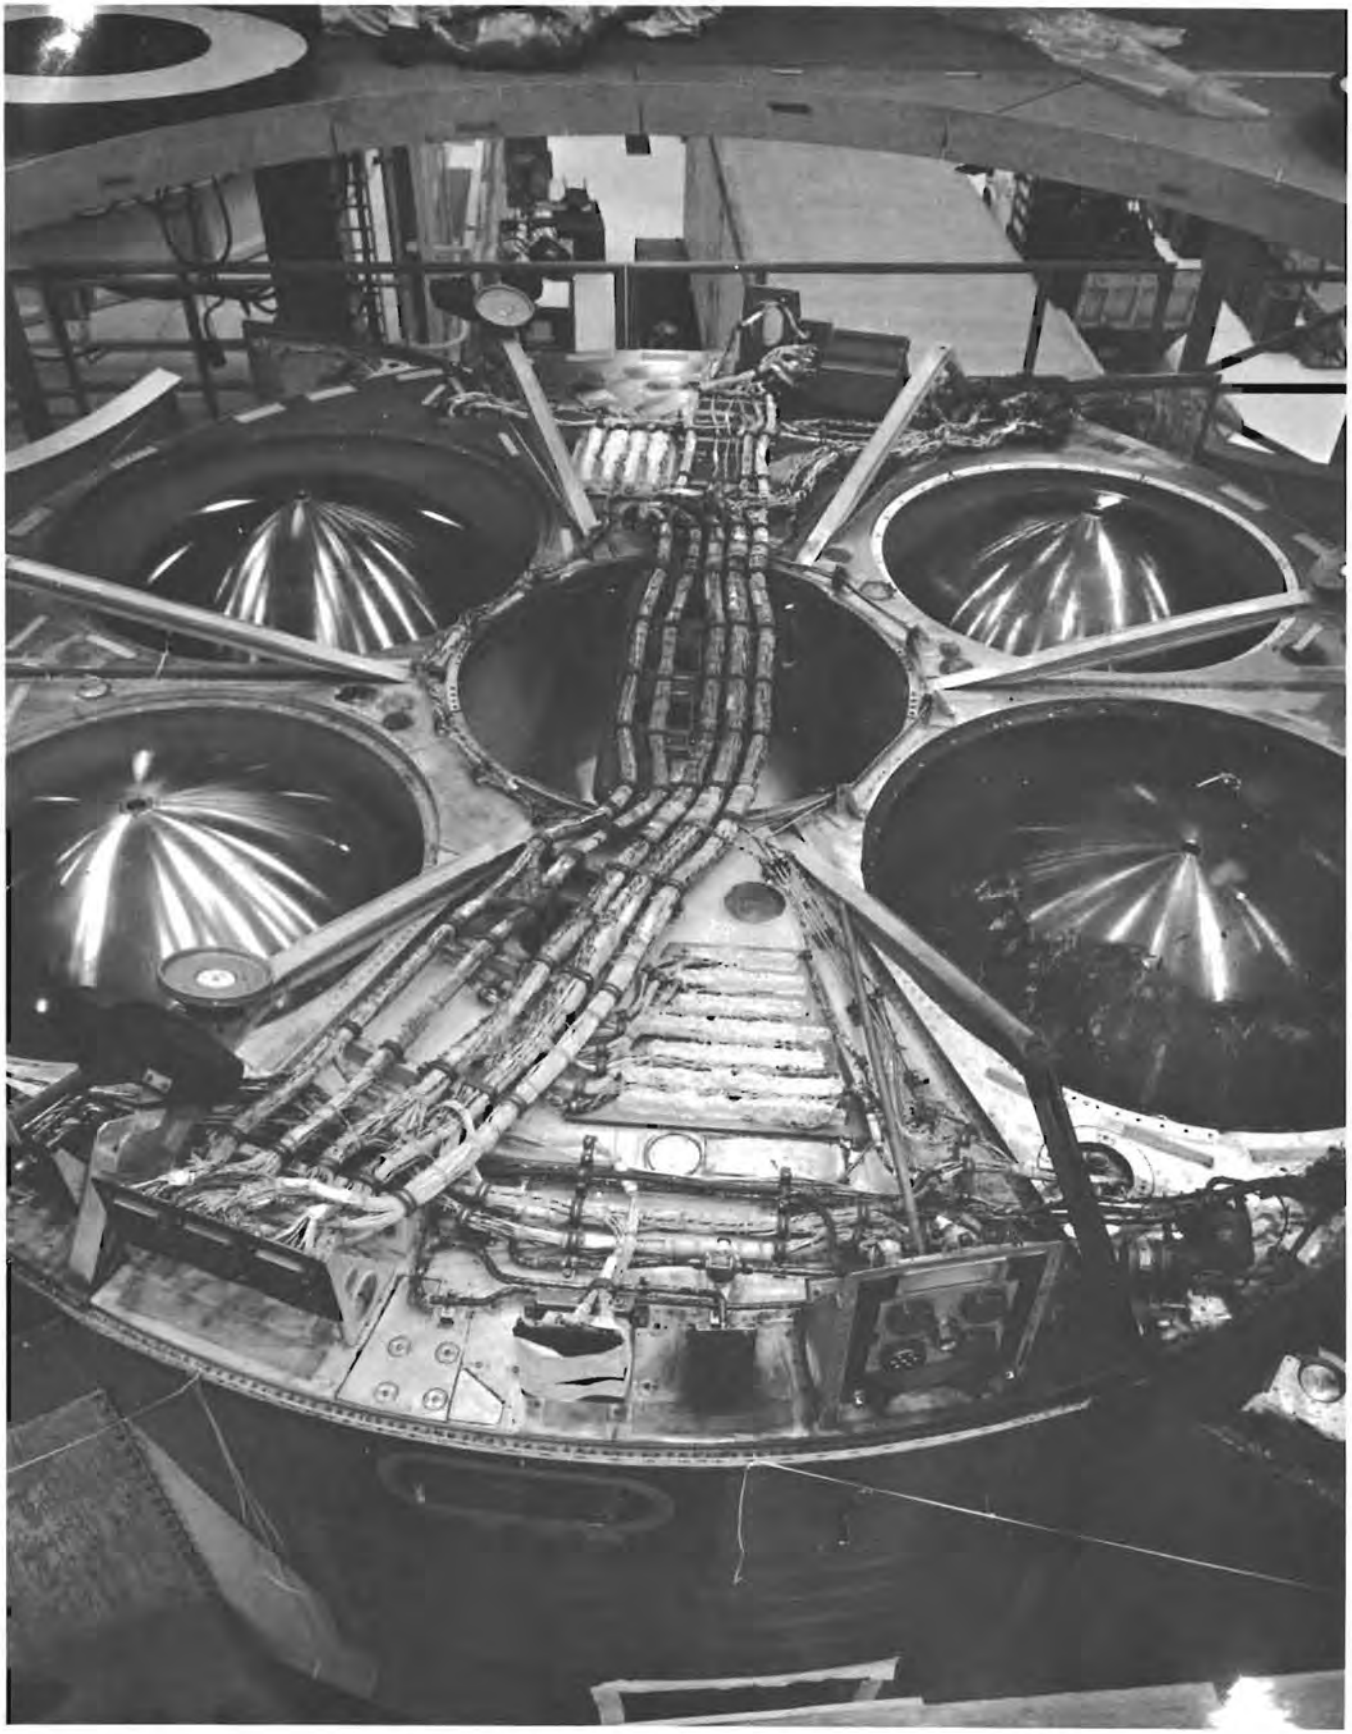
ENCLOSURE 21–4

TOP DECK OF SERVICE MODULE WITH MYLAR REMOVED
