NASA TM X-62,435

FRACTOGRAPHY OF THE HIGH TEMPERATURE HYDROGEN ATTACK
OF A MEDIUM CARBON STEEL

Howard G. Nelson and R. Dale Moorhead

Ames Research Center
Moffett Field, Calif. 94035

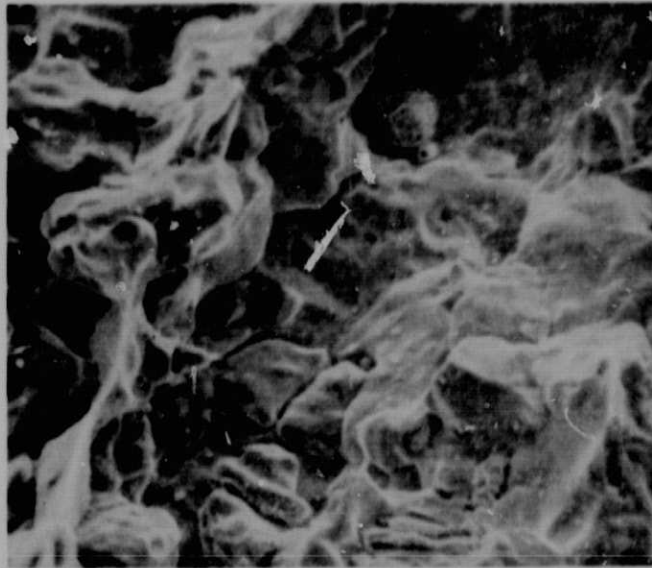
(c)

Fig. 5 - Concluded.

The interior surface of the largest bubble shown in Fig. 2 was examined in an effort to establish the fracture mode associated with massive bubble growth. Figure 5 consists of four SEM micrographs of the interior surface of the sectioned bubble at various magnifications. At the higher magnifications (Figs. 5c and 5d) it is seen that both primary and secondary cracking occurred by intergranular separation. The grain surfaces, however, do not show the flat, smooth facets normally observed with intergranular fracture. Instead, the grains are seen to be somewhat rough and rounded, more typical of the fracture surface of material failed by a diffusion associated creep-rupture mechanism at very high temperatures.⁽⁹⁾ For carbon steel, a 575° C exposure temperature is not high compared with true melting temperature of about 1500° C, and thus diffusion associated creep-rupture would not normally be expected. This suggests that an additional influence may be important in addition to the simple mechanical consideration of the formation of a high internal pressure. Carbon, for example, has been shown to increase self-diffusion in alpha-iron by as much as four orders of magnitude.⁽¹⁰⁾ One possibility is that bubble growth may be enhanced at locations where carbon concentrations are high or, alternatively, similar enhancement may be realized as the result of the presence of hydrogen in solution. Certainly, more work is required to understand this observation.

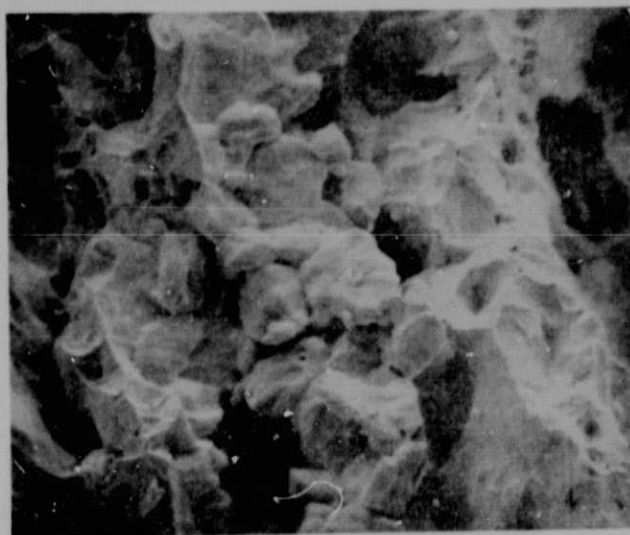
(b) Specimen exposed to hydrogen environment showing intergranular separation and dimples.

exposed to hydrogen occurred by the normally observed ductile mode of void coalescence with the resulting dimpled surface morphology (Fig. 6a). After hydrogen exposure, a mixed-mode fracture surface, consisting of varying amounts of intergranular separation and dimple formation (Fig. 6b), was observed depending on exposed time. Because of the rounded nature of the grain faces (Fig. 6b), similar to those previously observed (Figs. 5c and 5d), the intergranular portion of the failure most probably occurred during hydrogen exposure. Additionally, scattered areas of what appeared to be cleavage failure (Fig. 6c) were found on the fracture surfaces of the specimens given maximum hydrogen exposure. This latter observation suggests that the strength of the metal lattice may have been affected by the presence of the reaction product.
