Functional Interrupts and Destructive Failures from Single Event Effect Testing of Point-Of-Load Devices

35-word Abstract: We show examples of single event functional interrupt and destructive failure in modern POL devices. The increasing complexity and diversity of the design and process introduce hard SEE modes that are triggered by various mechanisms.

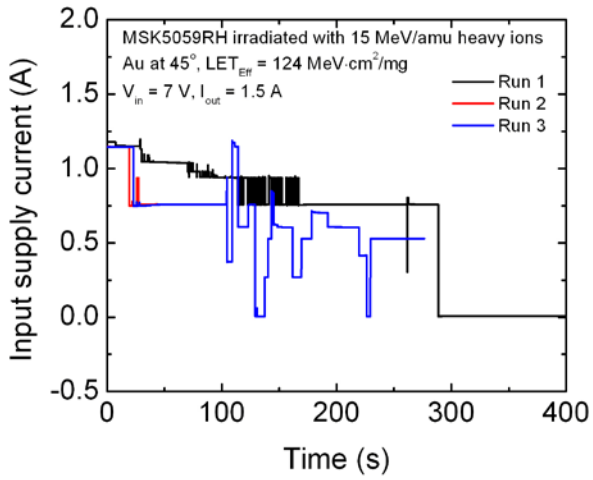
We evaluated the MSK5059RH buck regulator through several test campaigns with heavy ion and pulsed-laser irradiation. We observed an output dropout event during the initial heavy ion test at TAMU. Two parts were irradiated with identical electrical and radiation test conditions. We observed the dropout in one part. Figure 1 shows the supply current as a function of irradiation time, during three runs with Au at 45°, and device settings of V_{in} = 7 V, V_{out} = 3.3 V, and I_{out} = 1.5 A. During the first run, the input supply current showed degradation in a step fashion, decreasing from approximately 1.18 A to 0.9 A, followed by a bigger decrease to 0.75 A. The output voltage degraded from 3.3 V to 2 V accordingly.

Finally the input supply current decreased to approximately 0.006 A, and the output dropped to 0 V. The device recovered normal operations after a power cycle. We observed similar behaviors during the following runs. The device failed to regulate with V_{in} = 10 V and I_{out} = 1.5 A, following the third run, indicating functional degradation.

Figure 1. Input supply current as a function of irradiation time for the MSK5059RH, irradiated with Au at 45° for LET_{eff} = 124 MeV·cm^2/mg, V_{in} = 7 V, V_{out} = 3.3 V, and I_{out} = 1.5 V. The traces show results from 3 irradiation runs in succession.

We also observed more severe output dropouts that required power cycling to recover functionality. We believe that the event shown in Figure 1 is caused by heavy-ion dose deposition and/or device self-heating.

The part had accumulated approximately 120 krad(Si) prior to the dropout event. The total dose from heavy ion irradiation differs significantly from ^{60}Co, due to its highly non-uniform distribution and much higher recombination efficiency [11]. In fact, the calculated dose does not account for recombination at all. Therefore the given TID value is conservative. Micro-dose effects are known to cause threshold voltage shifts in some deep micron CMOS devices. However micro-dose effects are unlikely to significantly impact the gain degradation and/or leakage current in the given bipolar technology.

It is more probable that elevated temperature caused the output dropout. Although we did not observe destructive failure from the initial heavy ion test in TAMU, the part eventually showed functional degradation following the third dropout event, indicating possible internal physical damage from over-heating. We further discuss the destructive failure associated with the MSK5059RH below.

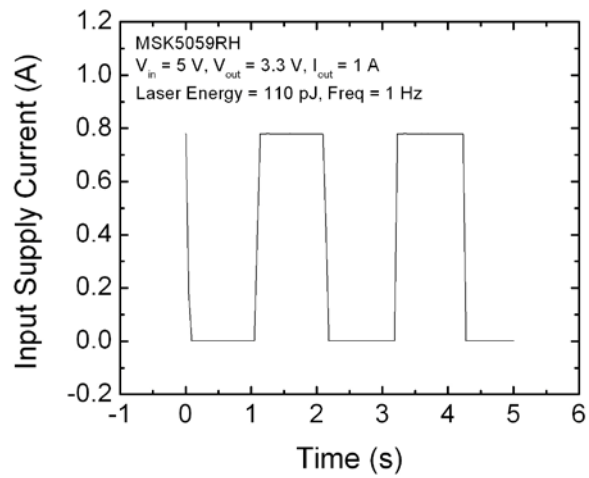
In addition to the heavy ion irradiations, we used a pulsed-laser to further investigate the locations of the sensitive regions. We found that scanning across one particular die location resulted in output dropouts, for V_{in} = 5 V, V_{out} = 3.3 V, and I_{out} = 0.2 to 4 A. Figure 2 shows the input current as a function of time. The output dropped out and recovered with a regular frequency on the same order as the laser pulse. We determined that the energy threshold was between 55 and 110 pJ. These laser energy values correspond to LETs of approximately 165 to 330 MeV·cm^2/mg, based on empirical data from previous tests [10].

We examined a microphotograph of the IC layout (not shown here due to vendor confidentiality), and determined that the sensitive location is occupied by a junction capacitor, which lies across the collector-base region of an NPN transistor in the band gap reference. The photocurrent from the pulsed-laser is amplified through the NPN transistor gain, thereby disrupting the reference loop.

Figure 2. Input supply current as a function of irradiation time for the MSK5059RH, irradiated with pulsed-laser, for energy of 110 pJ, V_{in} = 5 V, V_{out} = 3.3 V, and I_{out} = 1 V.

We first discuss the laser test results for the MSK5059RH. The fact that the voltage dropouts from laser irradiation were relatively insensitive to the output load is contrary to the heavy ion test results, where the functional interrupt only occurred for higher output loads (1.5 and 4 A). Also, the dropouts from laser irradiation did not require power cycling to recover, unlike the dropouts from the heavy ion tests. The output recovered as soon as the laser was removed from the sensitive location. The different characteristics suggest that the degradation mechanism from the laser test is likely different from either of the heavy ion tests. The laser energy threshold was between 55 to 110 pJ, which is approximately equivalent to LETs of 165 to 330 MeV·cm^2/mg, according to NRL [10]. These values are much higher than the effective LETs used during the heavy ion test campaigns. This may explain why we did not observe these event types during the heavy ion tests.

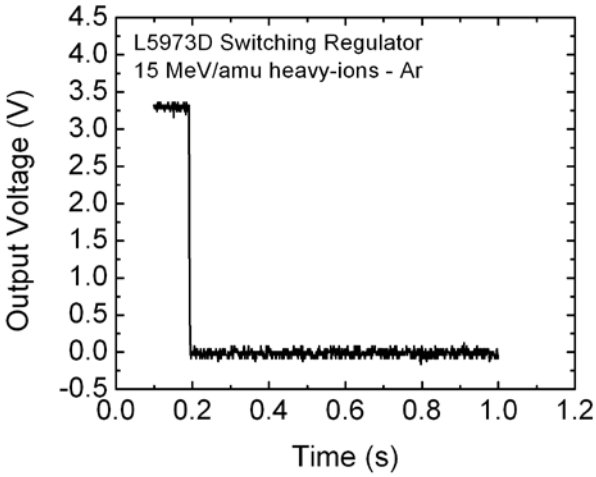
The L5973D buck regulator is manufactured with commercial CMOS and bipolar processes, with integrated laterally diffused power MOSFET (LDMOS). We irradiated two parts with 15 MeV/amu heavy-ions at TAMU. The device settings were V_{in} = 12 and 25 V, V_{out} = 3.3 V and I_{out} = 1.6 A. The majority of the events were rail-to-rail output voltage dropouts. The dropout duration varied from approximately 10 ms to over 800 ms. The events are self recoverable. The worst case dropouts exceeded the oscilloscope setting of 0.8 s, as shown in Figure 3. The event cross section at LET = 17.2 MeV·cm^2/mg is approximately 1.5 × 10^{-6} cm^2. Further tests are required to determine the saturation cross section LET and threshold LET.

Figure 3. Output voltage as a function of time for the L5973D, irradiated with Ar, for V_{in} = 12 V and I_{out} = 1.6 A.

The switching regulator designs often employ current limit functions, to protect the device from over current conditions. A heavy ion strike can produce an internal current/voltage pulse, which could activate the built-in safety features and cause a temporary functional interrupt. The L5973D includes several such features, which may have prompted the voltage dropouts. There are two current limiting circuits that control the current flow through the power switch. The pulse by pulse current limit will force the power switch off, when the current reaches the internal threshold. And the frequency shifter reduces the switching frequency to lower the duty cycle. The inhibit function will set the device to standby mode, when the inhibit pin exceeds 2.2 V. However the current will be reduced to less than 100 µA during standby mode. In our case, the input current is approximately 0.017 A during the dropouts. Aside from these protection circuits, we have already shown in the MSK5059RH, that a strike on a sensitive node in the reference circuitry can disable the output. Furthermore, the pulse width modulator (PWM) is typically a sensitive component in switching regulators. Strikes on the PWM can cause missing pulses and/or phase shifts, which can produce voltage glitches. However, rail-to-rail dropouts are unlikely. We believe that the dropouts in the L5973D most likely originate from heavy ion strikes in the reference loop circuitry and/or the internal current limit circuitry. The duration of these dropouts can be problematic for many applications.

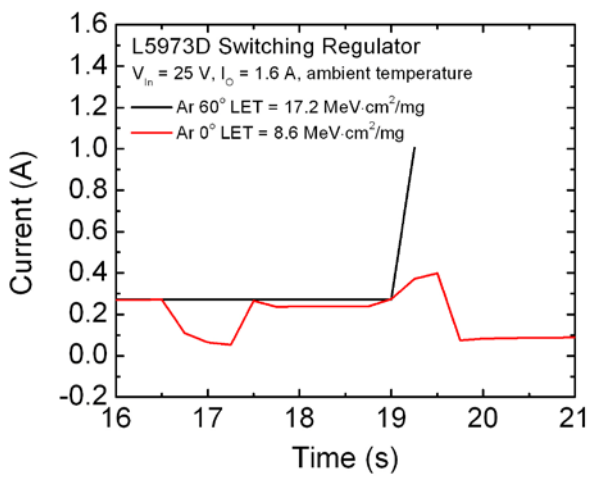
We also observed destructive failures. Figures 4 and 5 show the input current and output voltage, respectively, for irradiation with Ar at 0° and 60°, with LET = 8.6 and 17.2 MeV·cm^2/mg. The device settings were V_{in} = 25 V, and I_{out} = 1.6 A. Both destructive events occurred when we initially increased the input voltage to 25 V from 16 V. The first event occurred for 60° tilt angle. The input current spiked sharply to approximately 1 A before the device power was shut off. The output voltage increased to approximately 6 V, decreased to 2 V, then dropped to 0 V, within approximately 60 ms. The second destructive event occurred for 0° tilt angle. The input current showed an initial decrease to approximately 50 mA. The output voltage fluctuated from 3.3 V to 0 V, before dropping out completely.

Figure 4. Input current vs. time during destructive events for the L5973D, irradiated with Ar at 0° and 60°, for V_{in} = 25 V and I_{out} = 1.6 A.

The input supply terminal is directly connected to the drain of the LDMOS. The input current signatures indicate that the failure either originated from the power MOSFET, in which case the mechanism is SEB and/or SEGR, or that a current surge from a SEL propagated to the power MOSFET, leading to destructive failure. SEL is a localized phenomenon. So the SEL current would need to propagate through several stages of circuitry to reach the power MOSFET. We believe that SEGR and/or SEB of the LDMOS are more probable.

A SEGR will either short the gate-to-source junction, resulting in a low device input current, or short the gate-to-drain junction, resulting in an initially high input current. The event from the 60° irradiation, which showed a high current signature, is consistent with a SEGR that shorted the gate-and-drain junctions. The event from the 0° irradiation can be caused by a SEGR of either type. Although the input current decreased initially, the time scale between the current readings (taken from the power supply) is on the order of 250 ms. Therefore we may not be able to capture an initial current spike from a SEGR, which can occur within picoseconds. The 0° incident event is also consistent with a SEGR shorting the gate and source junctions, producing a low drain to source current.

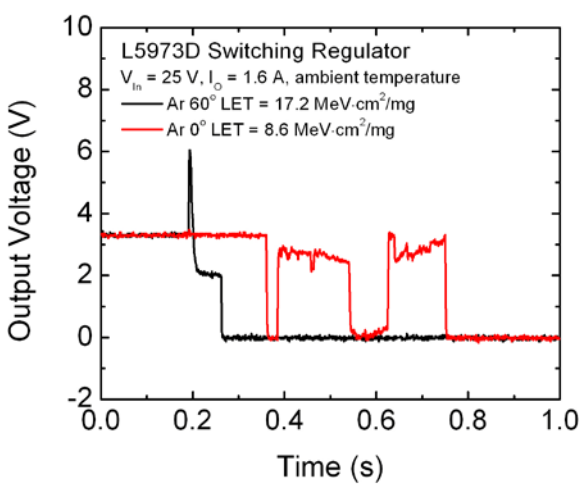
Figure 5. Output voltage vs. time during destructive events for the L5973D, irradiated with Ar at 0° and 60°, for V_{in} = 25 V and I_{out} = 1.6 A.
