NASA Technical Paper 1379

Lubrication and Failure Mechanisms
of Molybdenum Disulfide Films
II - Effect of Substrate Roughness

Robert L. Fusaro

DECEMBER 1978

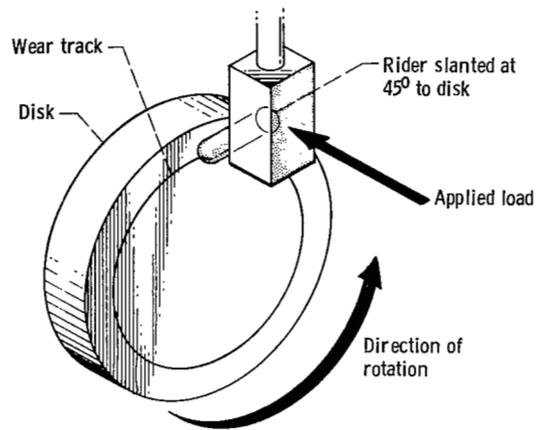
Figure 1. - Schematic diagram of friction specimens.

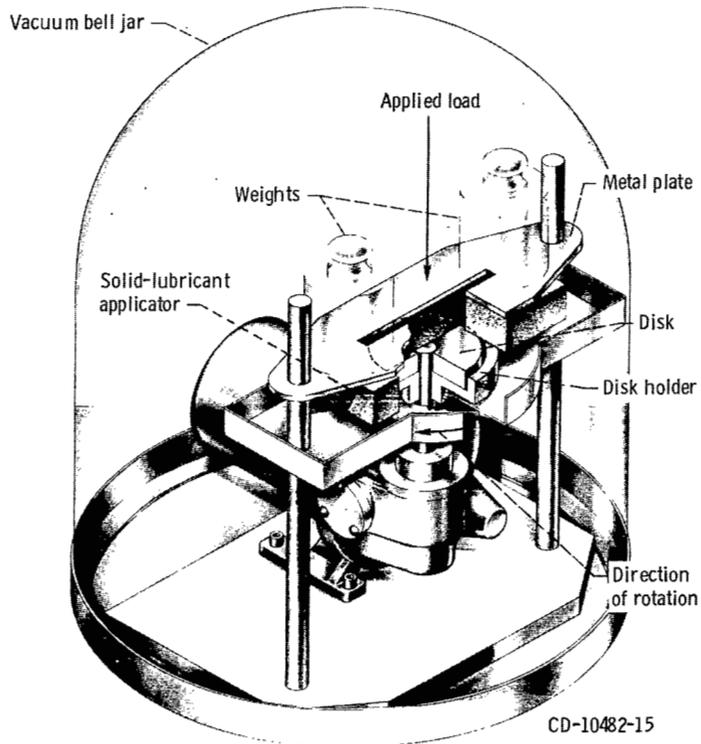
Figure 2. - Apparatus used to apply MoS₂ films.

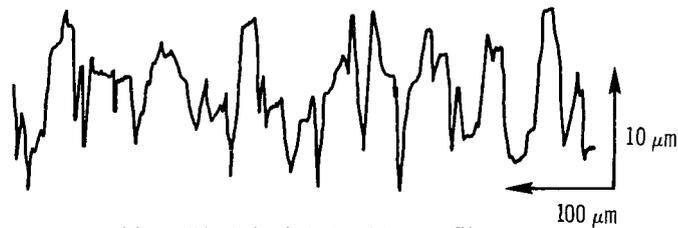
(a) Polished substrate with MoS₂ film.

(b) Sanded substrate with MoS₂ film.

(c) Sandblasted substrate with MoS₂ film.

Figure 4. - Photomicrographs and surface profiles of 440C HT stainless-steel disks with different surface finishes after application of rubbed MoS₂ films.

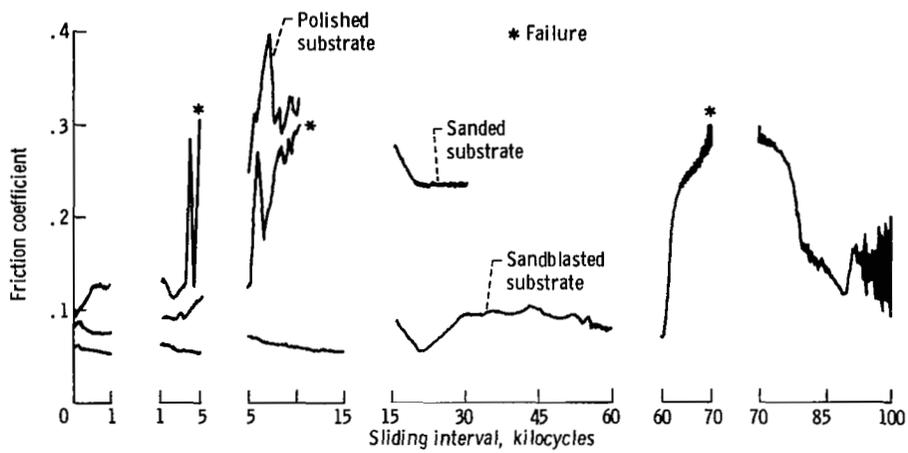
Figure 5. - Friction coefficient in moist air (10 000-ppm H₂O) as a function of kilocycles of sliding for rubbed MoS₂ films applied to 440C HT-stainless-steel disks with different surface finishes.

Each test was continued past the arbitrarily chosen failure point - a friction coefficient of 0.30. In each case both the friction coefficient (fig. 5) and the rider wear rate (table I) decreased. Thus either the transformed MoS_2 was providing lubrication, or MoS_2 at the sides of the wear track or deeper in the valleys (of the rough surfaces) had found its way into the contact region. The small reductions in friction coefficient and rider wear rate for the MoS_2 film applied to the polished surface suggest that the main contribution probably came from exposure of new MoS_2 (from deeper in the valleys of the rough surfaces).

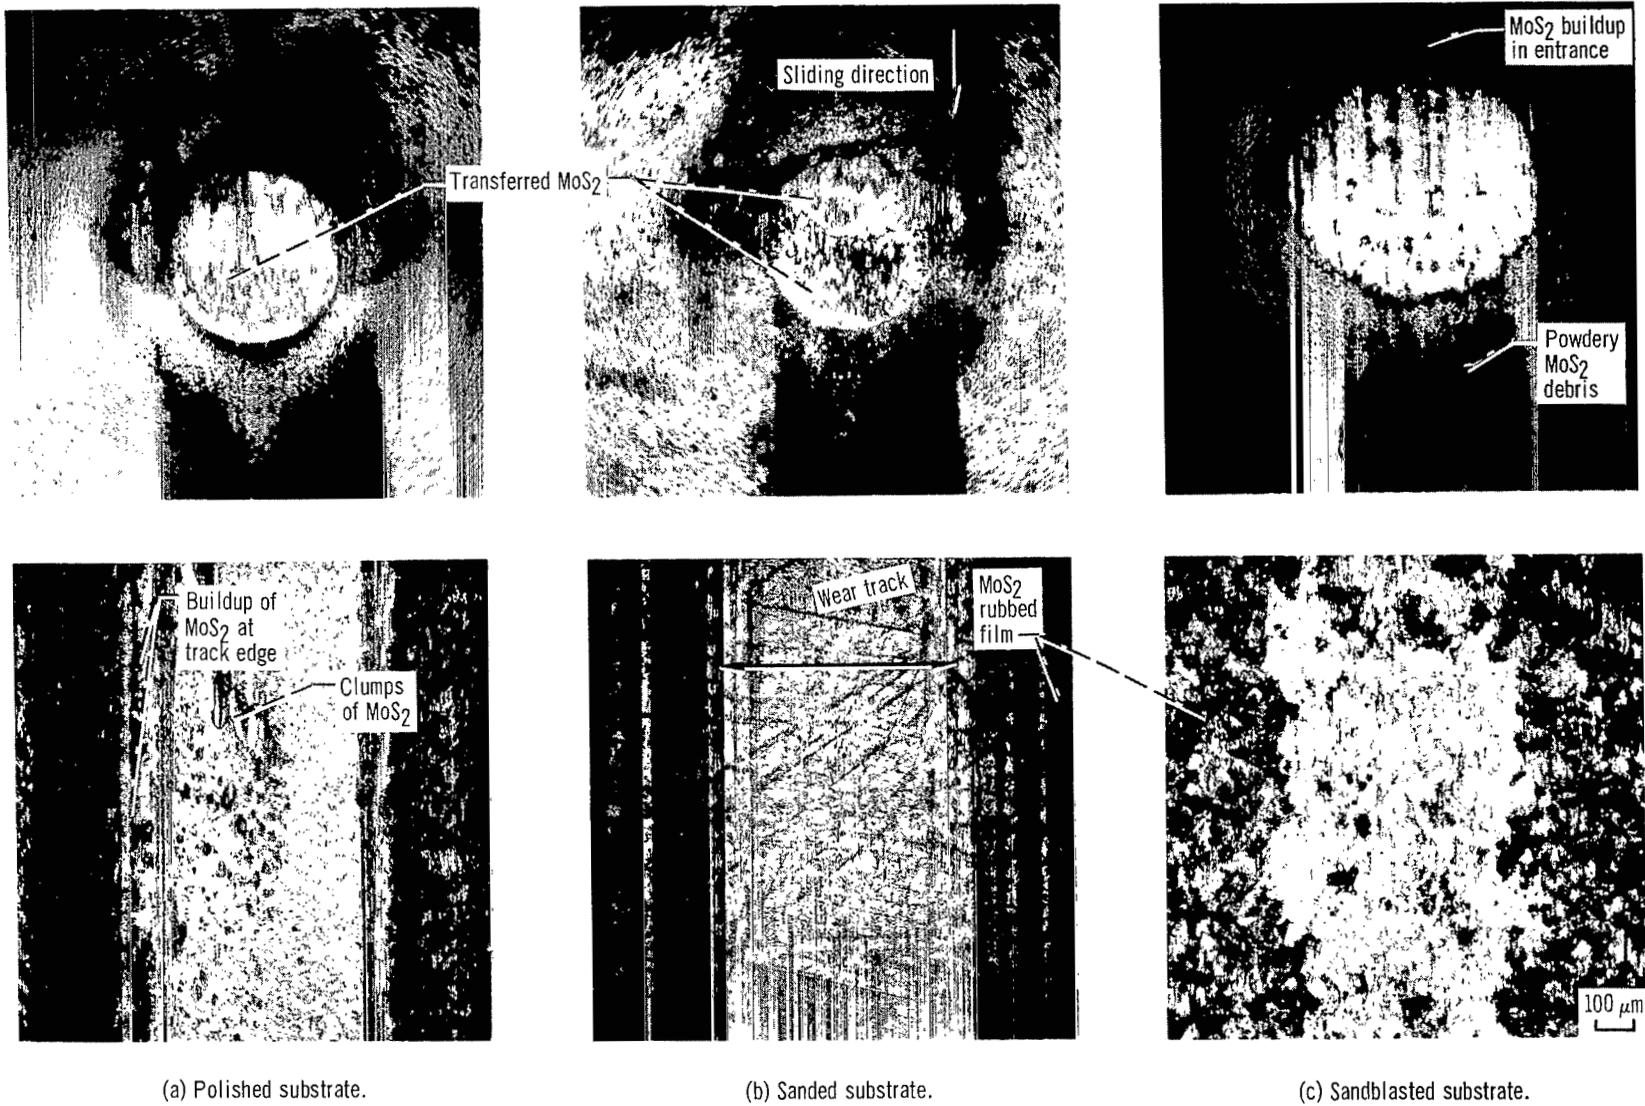
Figure 6. - Photomicrographs (taken after 1 kilocycle of sliding in moist air (10 000-ppm H₂O)) of rider wear scars and wear tracks on rubbed MoS₂ films applied to 440C HT stainless-steel disks with different surface finishes.

As shown in figures 6 and 7, MoS₂ did not produce a continuous film on the disk wear track, regardless of the substrate surface finish to which the MoS₂ was applied. On the polished substrate surface, individual platelets of MoS₂ formed and tended to

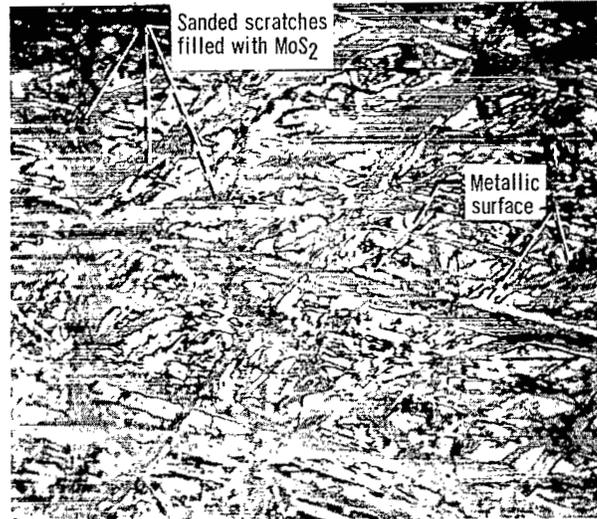
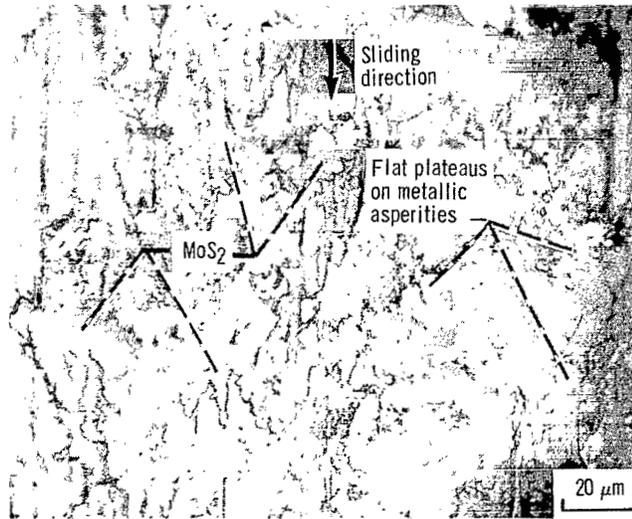
(a) Polished substrate.

(b) Sanded substrate.

(c) Sandblasted substrate.

Figure 7. - High-magnification photomicrographs (taken after 1 kilocycle of sliding in moist air (10 000-ppm H₂O)) of wear tracks on rubbed MoS₂ films applied to 440C HT steel-stainless disks with different surface finishes.

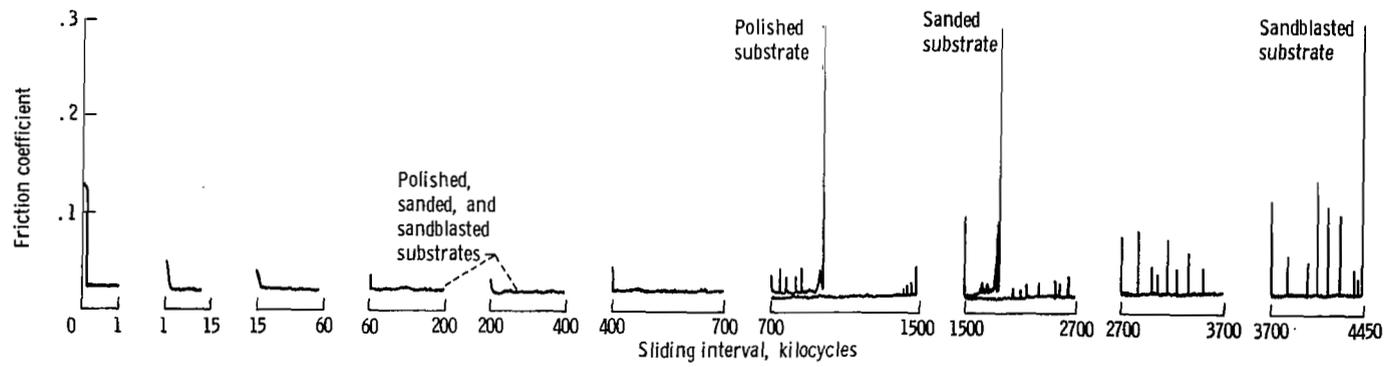
Figure 11. - Friction coefficient in dry argon (<20-ppm H₂O) as a function of kilocycles of sliding for rubbed MoS₂ films applied to 440C HT stainless-steel disks with different surface finishes.

In the first part of this investigation (ref. 13), it was shown that the transformation of MoS_2 on the sliding surfaces did not occur in dry argon (<20-ppm H_2O). Thus, a series of experiments was also conducted in dry argon to determine the effect of substrate surface roughness on the lubricating properties of MoS_2 films when transformation of MoS_2 was not the principal mechanism of failure. Friction traces for these tests (fig. 11) illustrate that the friction coefficient was not affected by the roughness of the substrate - the value being slightly less than 0.02 for the first 700 cycles. Wear life, however, was affected, just as it was in moist air; that is, the rougher the surface, the longer the wear life. Even on the polished substrate, wear life was much greater in dry argon than in moist air. The wear lives obtained were 950 kilocycles for the polished substrate, 1860 kilocycles for the sanded substrate, and 4450 kilocycles for the sandblasted substrate.

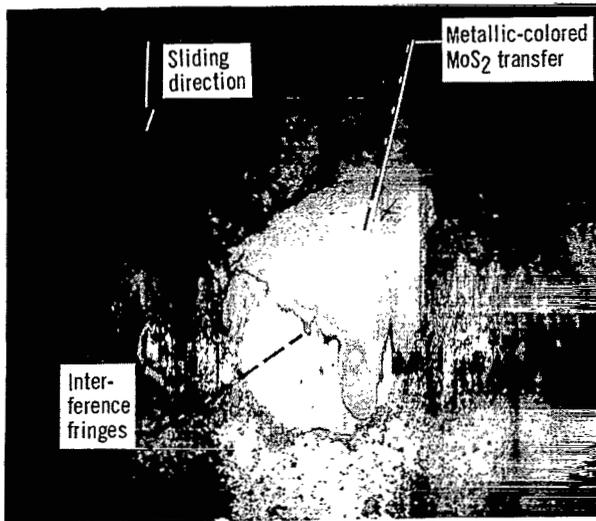
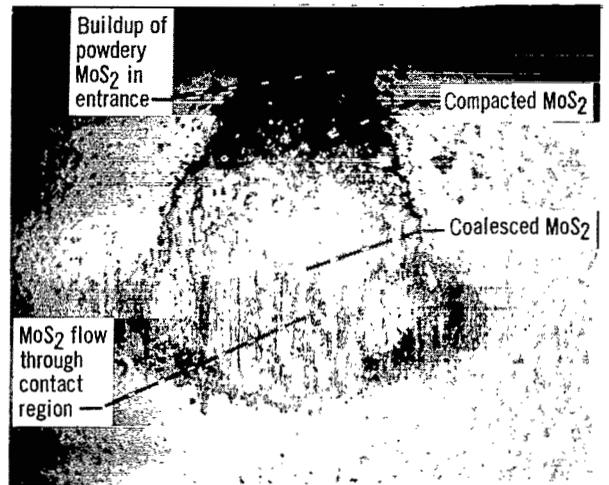
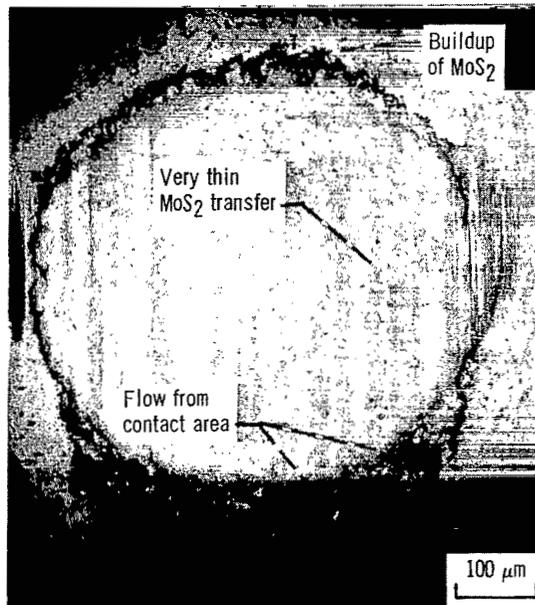
(a) Polished substrate.

(b) Sanded substrate.

(c) Sandblasted substrate.

Figure 12. - Photomicrographs (taken after 1 kilocycle of sliding in dry argon (< 20-ppm H₂O)) of wear scars and transfer films on riders that slid on rubbed MoS₂ films applied to 440C HT stainless-steel disks with different surface finishes.

The wear and transfer to the riders after 1 kilocycle of sliding in dry argon can be compared for the three surface finishes in figure 12. As in moist air, the smoother the substrate surface, the greater the transfer to the rider and the less the wear. Even though transfer and rider wear were different at this point, the friction coefficients were the same. After 15 kilocycles of sliding, the transfer films for riders on the polished

and sanded substrates became like those for riders on the sandblasted substrate after 1 kilocycle of sliding (fig. 12(c)). That is, very thin films of MoS_2 were found on the rider scar.

The MoS_2 builds up in the entrance region of the rider scar, compresses, and eventually coalesces as it flows across the rider scar and is deposited in the exit region (fig. 12).
