FLIGHT CHARACTERISTICS AT TRANSONIC SPEEDS

I - P-80A AIRPLANE INVESTIGATION

By H. H. Brown

Ames Aeronautical Laboratory

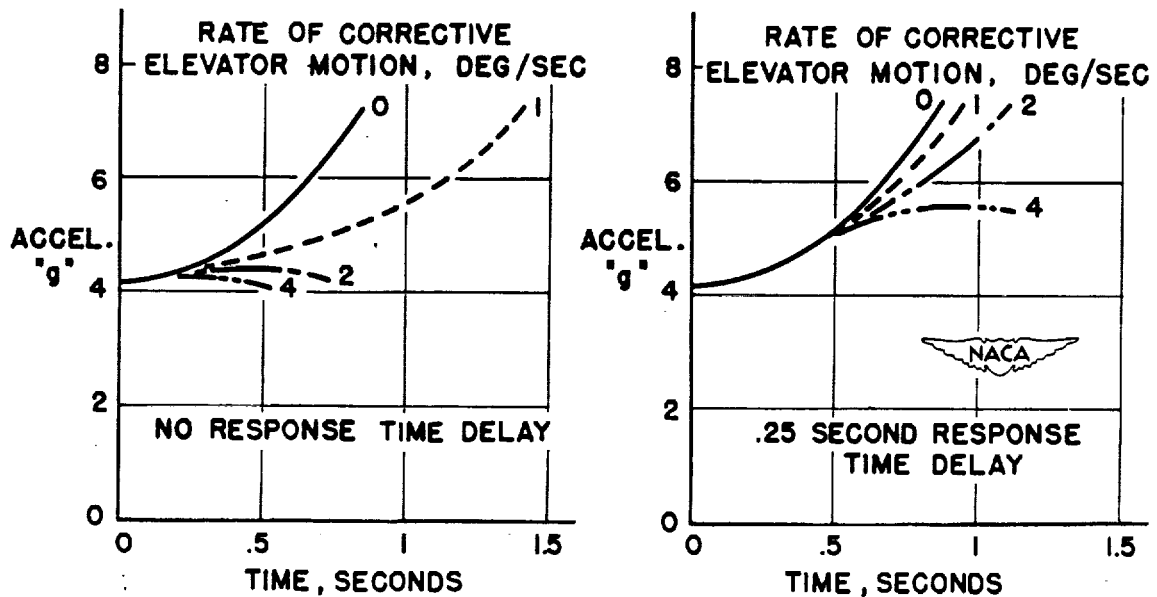
Figure 8.- Effect of rate of response and time delay in preventing a stall.

Since the airplane is unstable at high Mach numbers, it becomes of interest to determine what rates of elevator response are required of the pilot to forestall such a pitch-up as did occur. By using the conditions at the start of the pitch-up, the change in the normal acceleration factor with time was determined with various rates of elevator motion using a step-by-step solution of the equations of motions. The results are shown in figure 8. With no time delay in the pilot response a rate of elevator motion of 2° per second was sufficient to prevent the acceleration building up to a stall. With a quarter-second time delay, which is about the best response which can be expected from a pilot, a rate of elevator motion of almost 4° per second was needed to prevent a stall. For time delays much longer than a quarter of a second, the required rates became unreasonably large. Actually a pilot responds to a change in acceleration and since the pitch-up motion at first produced only a small acceleration change, the pilot's response time was quite long. As a result, it is improbable that a pilot will be able to prevent such a stall.
