NASA Technical Memorandum 81595

Effect of Substrate Surface Finish on the Lubrication and Failure Mechanisms of Molybdenum Disulfide Films

Robert L. Fusaro
*Lewis Research Center
Cleveland, Ohio*

Prepared for the
Annual Meeting of the American Society of Lubrication Engineers
Pittsburgh, Pennsylvania, May 11-14, 1981

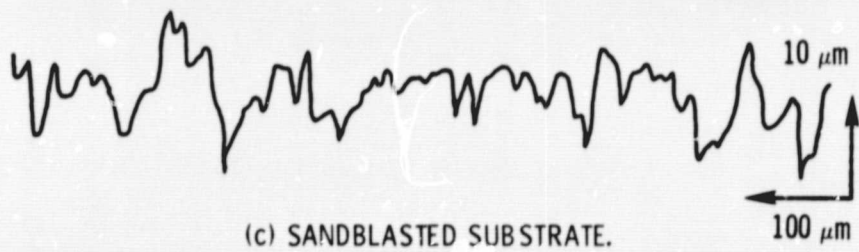
(a) POLISHED SUBSTRATE.

(b) SANDED SUBSTRATE.

Figure 3. - Photomicrographs and surface profiles of 440C HT stainless-steel disks with different surface finishes before application of rubbed MoS₂ films.

(c) SANDBLASTED SUBSTRATE.

The MoS_2 powder was rubbed onto 440C HT steel disks with three surface finishes: lapped and polished, sanded, and sandblasted. Figure 3 gives photomicrographs and surface profiles of the three substrate surfaces before the MoS_2 films were applied. Figure 4 shows photomicrographs and surface profiles after the MoS_2 films were applied to these surfaces.

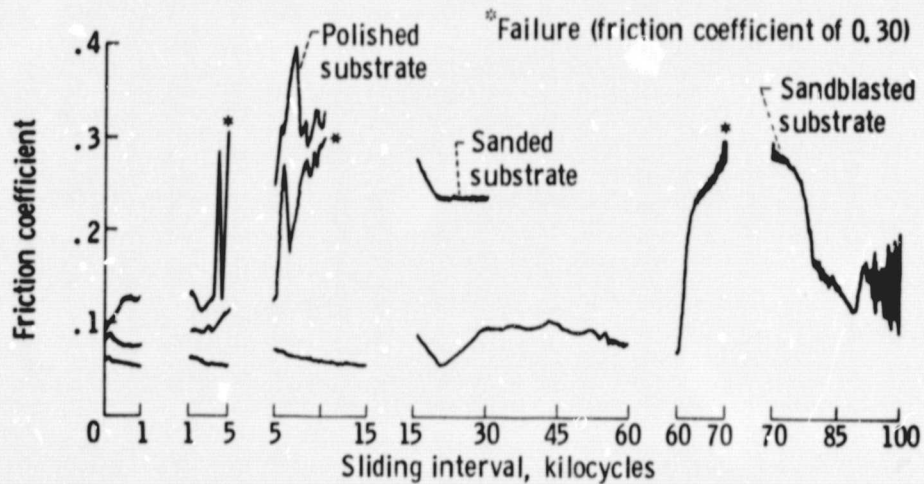
Figure 5. - Friction coefficient in moist air (10 000-ppm H₂O) as a function of kilocycles of sliding for rubbed MoS₂ films applied to 440C HT stainless-steel disks with different surface finishes.

The effect of substrate surface finish on friction coefficient and wear life in a moist-air test atmosphere ($10\ 000\text{-ppm H}_2\text{O}$) is shown in figure 5. The gaps in the traces represent the intervals when the tests were stopped so that wear measurements could be made and the sliding surfaces could be observed with an optical microscope. The sandblasted surface gave a lower friction coefficient for a longer time than did either the sanded surface or the polished surface.

sanblasted surface after 60 kilocycles. Sliding was continued past this point to determine how friction and rider wear were affected. The friction coefficient increased beyond 0.30 and then dropped below 0.30 (fig. 5).

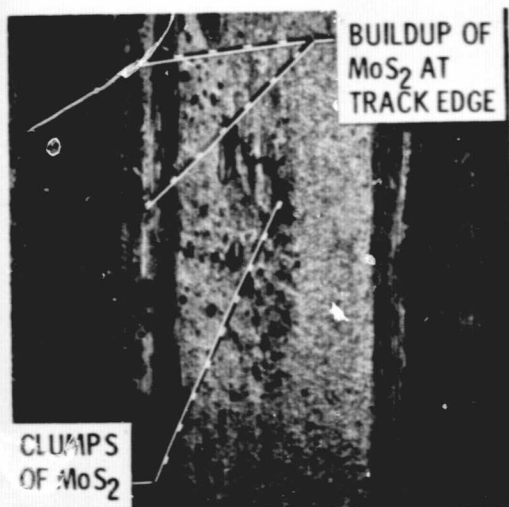
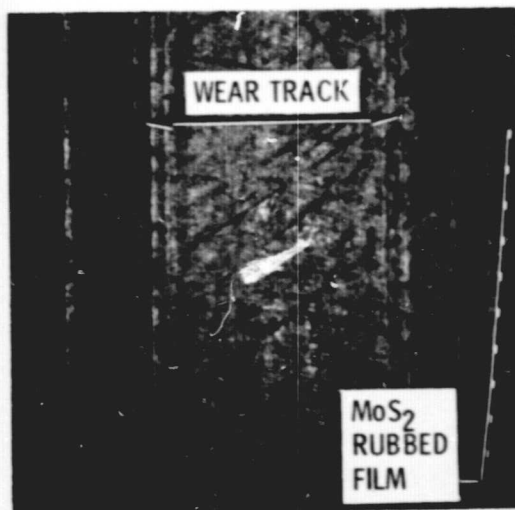
(a) POLISHED SUBSTRATE.

(b) SANDED SUBSTRATE.

(c) SANDBLASTED SUBSTRATE.

Figure 6. - Photomicrographs (taken after 1 kilocycle of sliding in moist air (10 000-ppm H₂O)) of rider wear scars and wear tracks on rubbed MoS₂ films applied to 440C HT stainless-steel disks with different surface finishes.

Figure 6, which gives photomicrographs of rider wear scars and MoS_2 film wear tracks after 1 kilocycle of sliding, illustrates the difference in rider wear and transfer. Figure 7 gives high-magnification photomicrographs of the central area of the MoS_2 film wear tracks.

As shown in figures 6 and 7, MoS_2 did not produce a continuous film on the disk wear track, regardless of the substrate surface finish to which the MoS_2 was applied. On the polished substrate surface, individual platelets of MoS_2 formed and tended to coalesce, however a continuous film of MoS_2 was not produced on the wear track (fig. 7(a)). Excess MoS_2 was either displaced to the sides of the wear track or coalesced to form clumps (fig. 6(a)). The MoS_2 tended to fill up the scratches on the wear track of the sanded substrate surface (fig. 7(b)), and the area between the scratches was either void of MoS_2 or covered with a film too thin to observe. The amount of MoS_2 on the wear track of the sandblasted substrate surface appeared to be greater than for the other two surfaces; however, the film still did not cover the wear track completely. "Flats" on the metallic asperities can be seen in the wear

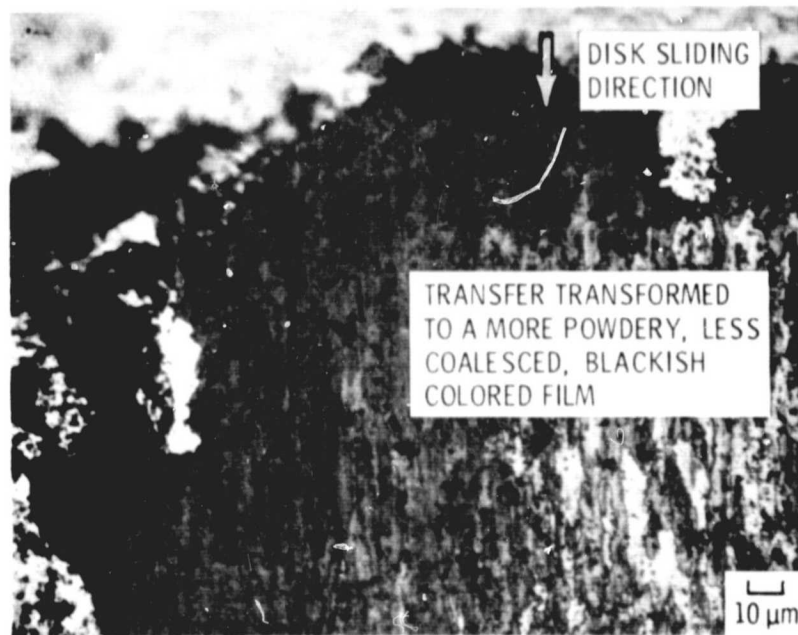
(a) AFTER 1 kilocycle OF SLIDING.

(b) AFTER 10 kilocycles OF SLIDING (AFTER FAILURE).

Figure 10. - High magnification photomicrographs of the transfer in the entrance region to the 440C HT stainless steel rider which slid on the MoS₂ film applied to the sanded substrate showing the difference in transfer before and after failure in moist air.
