No. 1790

INVESTIGATION OF ICING CHARACTERISTICS OF TYPICAL
LIGHT-AIRPLANE ENGINE INDUCTION SYSTEMS

By Willard D. Coles

Lewis Flight Propulsion Laboratory
Cleveland, Ohio

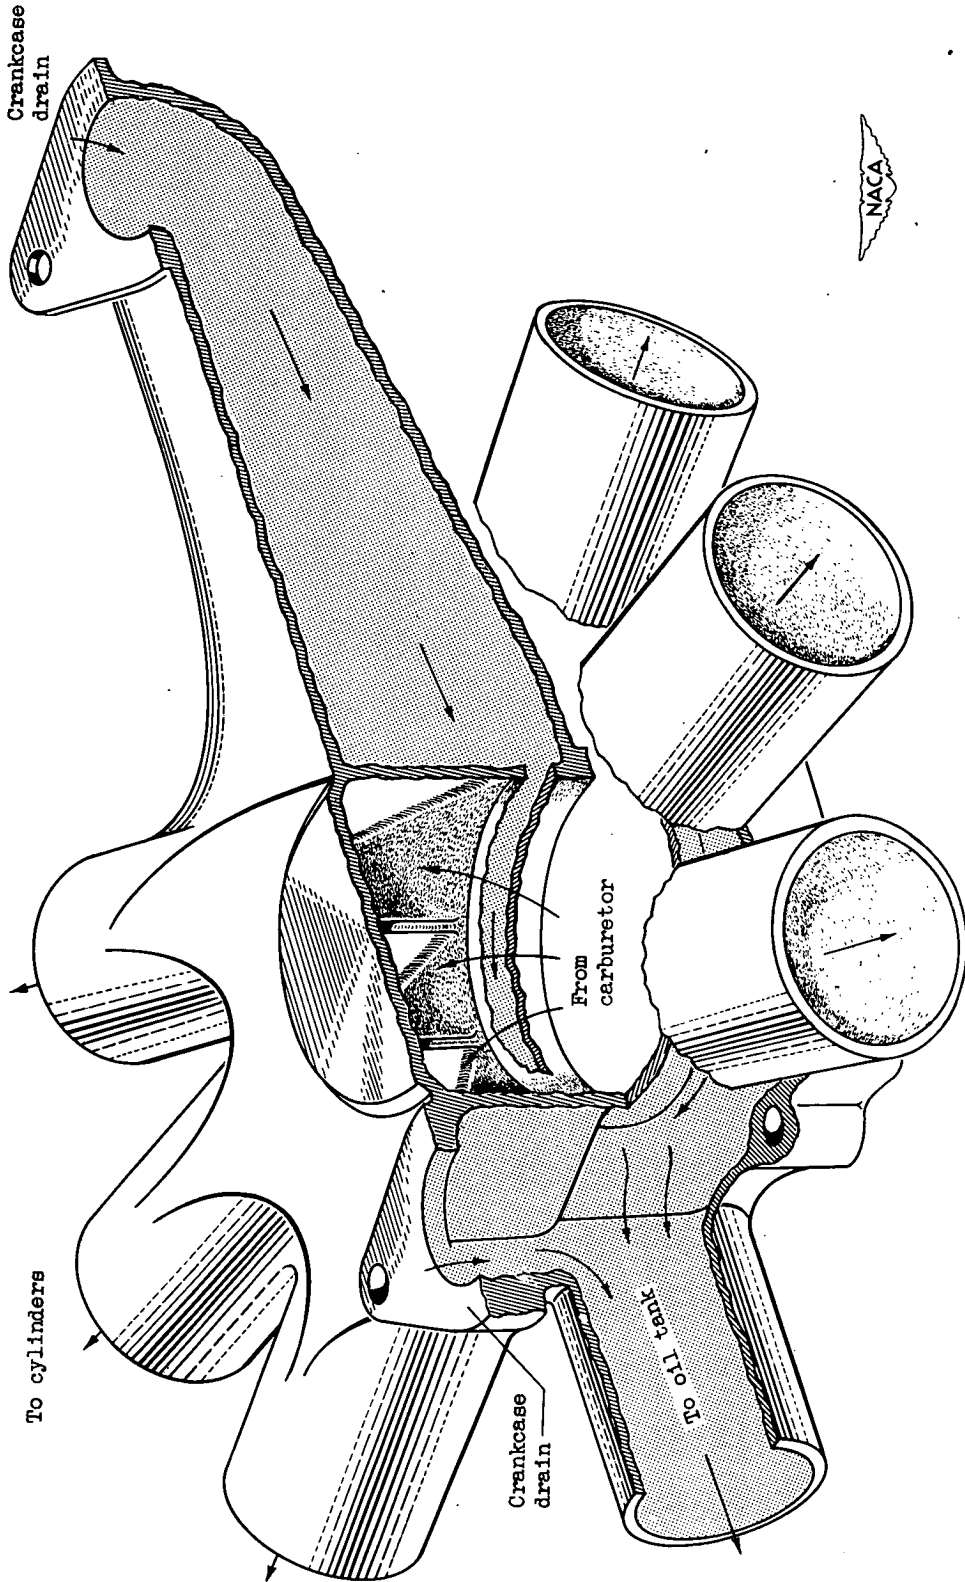
Figure 3. - Concluded. Pressure-type carburetor and oil-jacketed manifold.

(b) Sectional view of manifold showing oil and mixture passages.

On an engine using a pressure-type carburetor, the oil-jacketed manifold system is bolted to the crankcase and has scavenge-oil inlets at the front and the rear with an outlet to the oil tank at the rear. As shown in figure 3, the manifold riser from the carburetor and the six outlets to the cylinders pass through the oil jacket. The top of the manifold is unheated, except for conduction from the jacketed part. In the laboratory investigation, the oil-jacketed manifold system consisted of a tank, a pump, a steam-to-oil heat exchanger, temperature- and flow-measurement equipment, and the jacketed manifold. Interior observation of the carburetor and the manifold was provided by a window in the bottom of the plenum chamber below the carburetor, a transparent plastic tube between the carburetor and the manifold, a window in the collector ring assembly, and glass extension tubes from the manifold outlets to the collector ring. (See fig. 1.) The fuel temperature was regulated to simulate flight conditions by means of a simple heat exchanger.
