NASA Contractor Report 159275

B-747 FLIGHT CONTROL SYSTEM MAINTENANCE AND RELIABILITY DATA BASE FOR COST EFFECTIVENESS TRADEOFF STUDIES

R. H. Edwards
T. P. Enright
Boeing Commercial Airplane Company
P.O. Box 3707
Seattle, Washington 98124

Contract NAS1-15588
August 1980

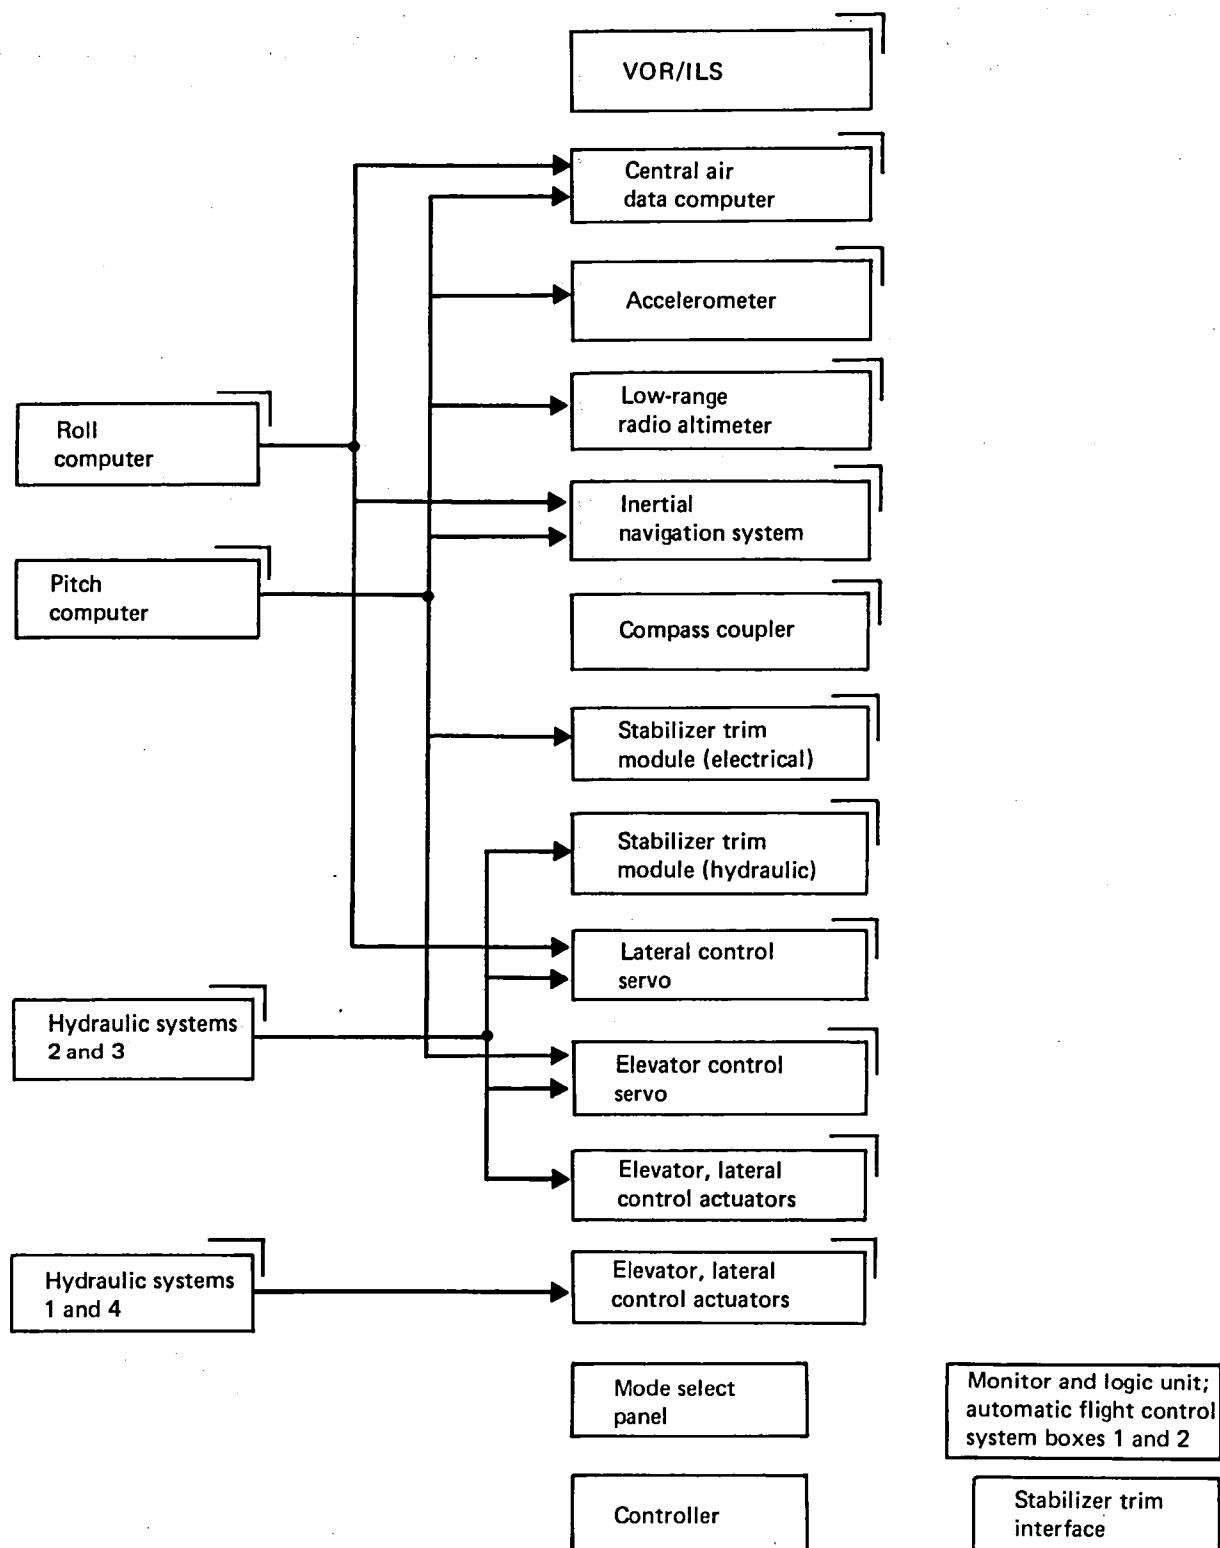
The first step in the CARSRA analysis is to assemble the required equipment modules in the form of a dependency tree shown in figure 1. Each module is shown as a rectangular block, with the "angle" at the top right corner indicating another module of the same component name. The dependency tree represents the system configured for single channel operation in the cruise and descend flight phase. Module dependencies change according to flight phase. Table 5 lists the requirements for both single and dual channel operation for the sensors. Three distinct flight phases can be identified. The first phase is climb; the second phase cruise, descend, and initial approach; the third phase final approach and land. Thus, the dependency tree drawn for the climb phase does not include the accelerometer modules. For the approach and land phase, the VOR/ILS and compass coupler modules will be connected with lines from the roll and pitch computer modules establishing dependencies between channel A and module number one and between channel B and module number two.

Figure 1. Dependency Tree for Flight Control Using Autopilot

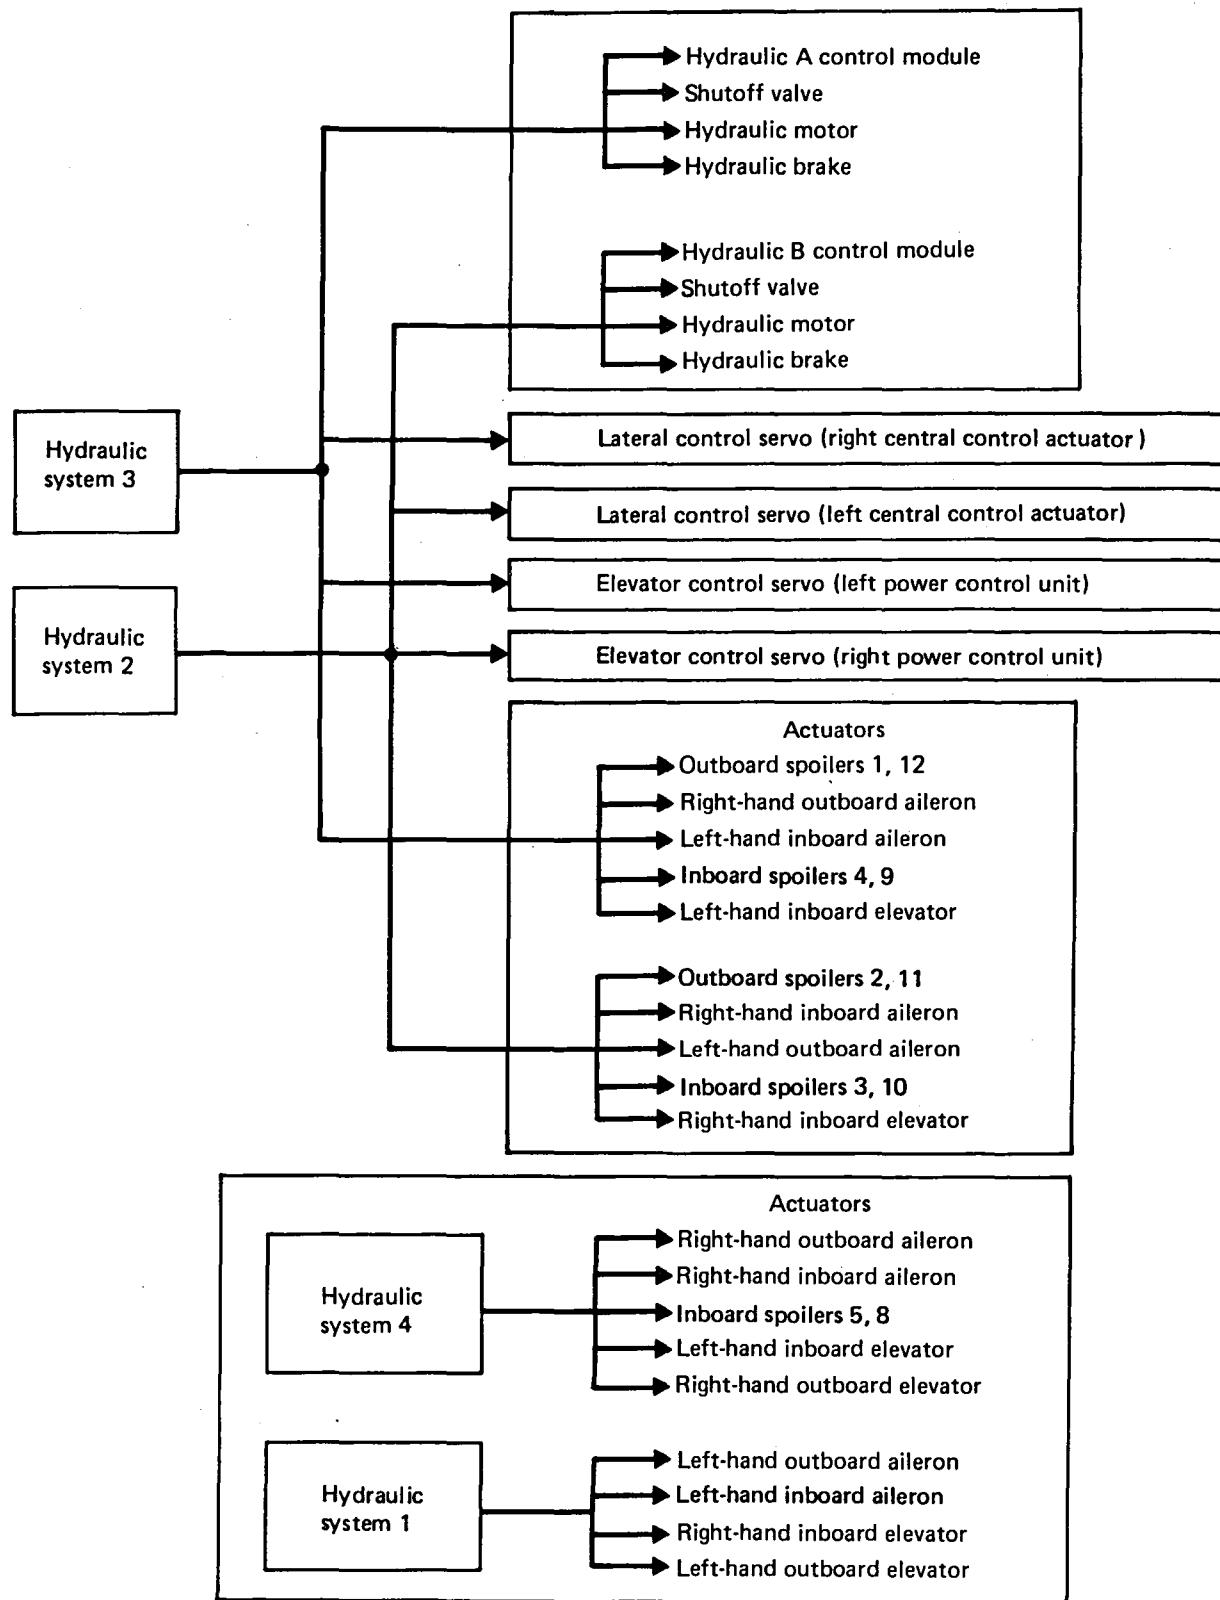
The hydraulic and mechanical elements of the figure 1 dependency tree are detailed in figure 2. Hydraulic system numbers two and three are the main flight control actuation power sources and are modeled as a stage separate from hydraulic system numbers one and four.

Figure 2. Flight Control Hydraulic System Dependencies

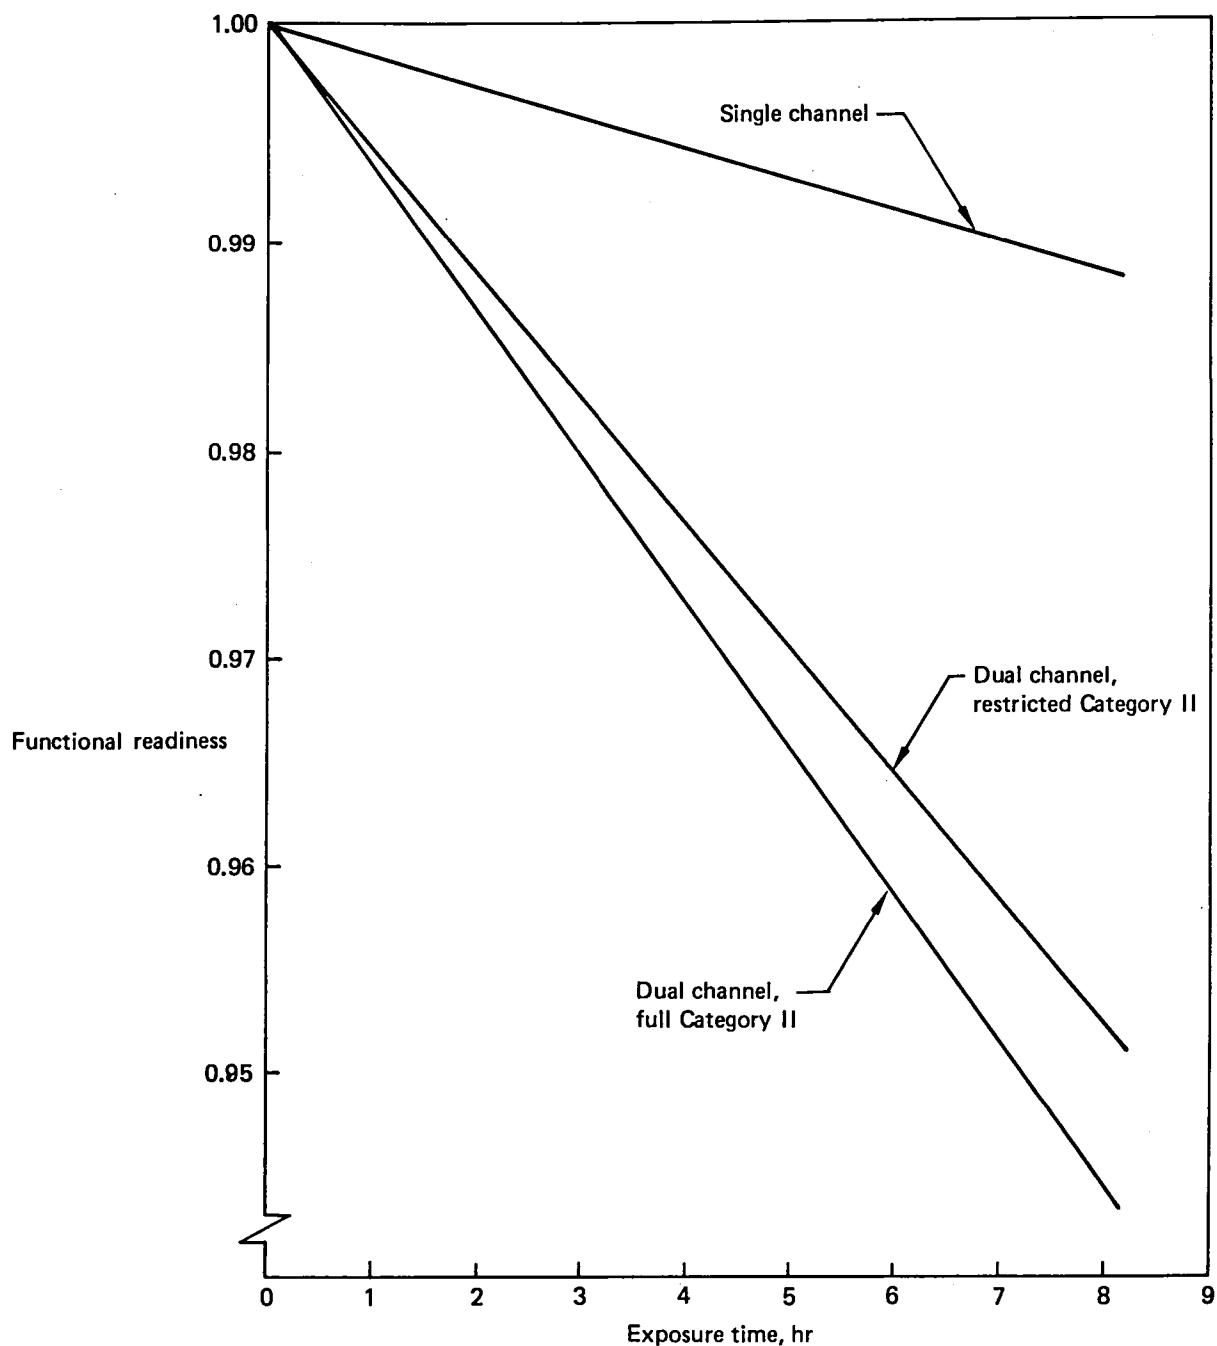
Autoland is a function that is required at the beginning of the final approach phase. Full category II and restricted category II functional readiness were analyzed in the reference 1 study for the electronic portion only. The functional readiness was computed again by including the hydraulic and mechanical elements plus wiring and connector failures.

The results are shown in figure 3. Functional readiness for a single channel landing is shown for comparison. During the landing phase, the probability of completing the landing in that category is shown in table 7.

Figure 3. Functional Readiness for Automatic Flight Control at Final Approach

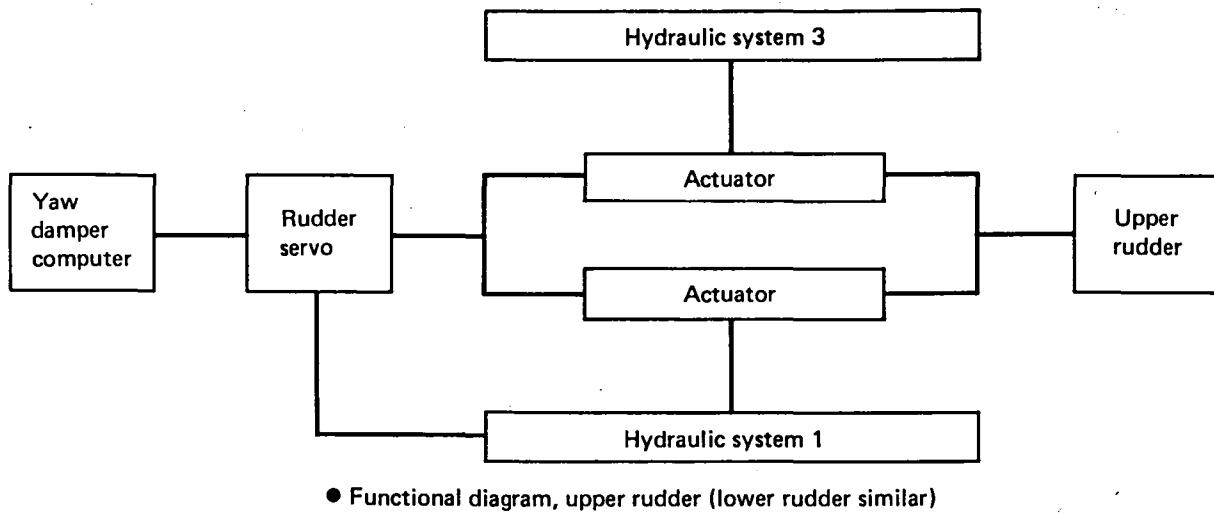
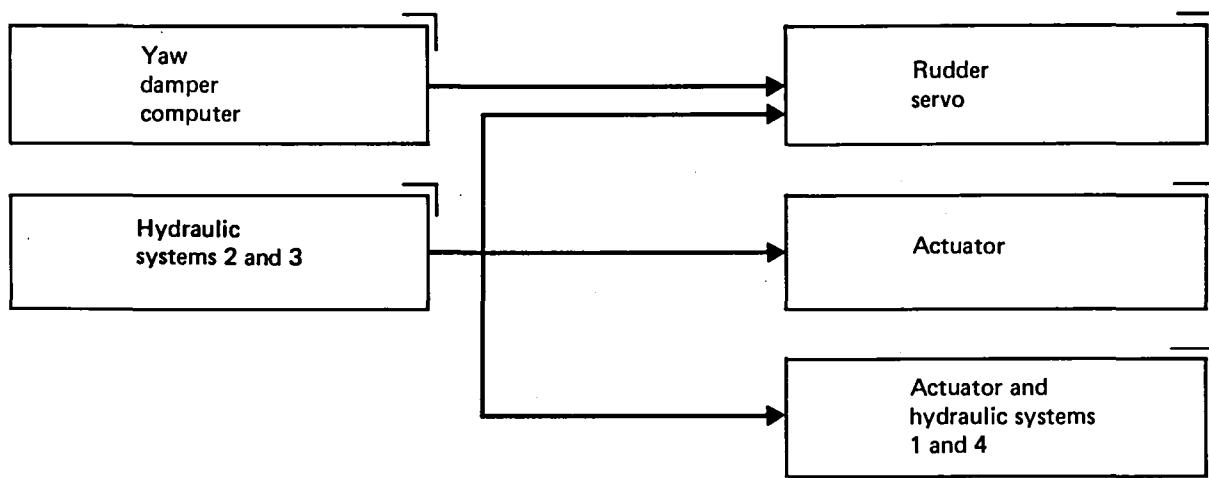
The yaw damper components are identified in table 1 and are shown in a functional diagram together with the dependency tree in figure 4. Failure probability for a typical 747 flight of 4 hours is 0.98×10^{-6} , if wiring and connector failures are not considered. This figure increases to 1.1×10^{-6} when wiring and connector failures are included.

● Dependency tree, upper and lower rudder

Figure 4. Yaw Damper System Functional Diagram and Dependency Tree

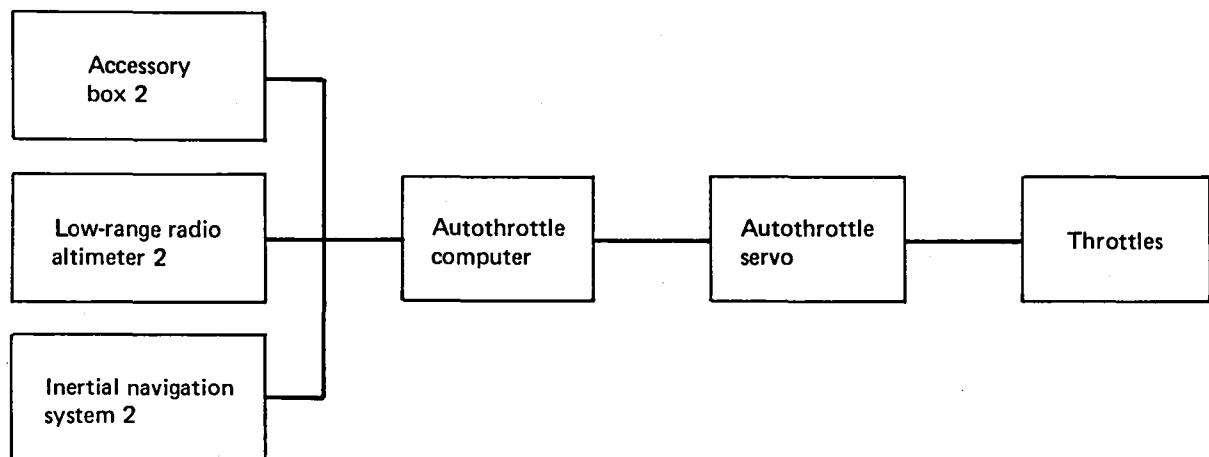
The autothrottle maintains a preselected airspeed during approach and landing. It is a single channel system. Figure 5 shows the block diagram for autothrottle components. Since the system is required at the beginning of the approach phase of a flight, the functional readiness was computed. For a typical 4-hour flight length and a functional readiness criterion of any single module failure causing system failure, 99.65% of all flights will have autothrottle available at the beginning of approach.

Figure 5. Functional Diagram for the Autothrottle System

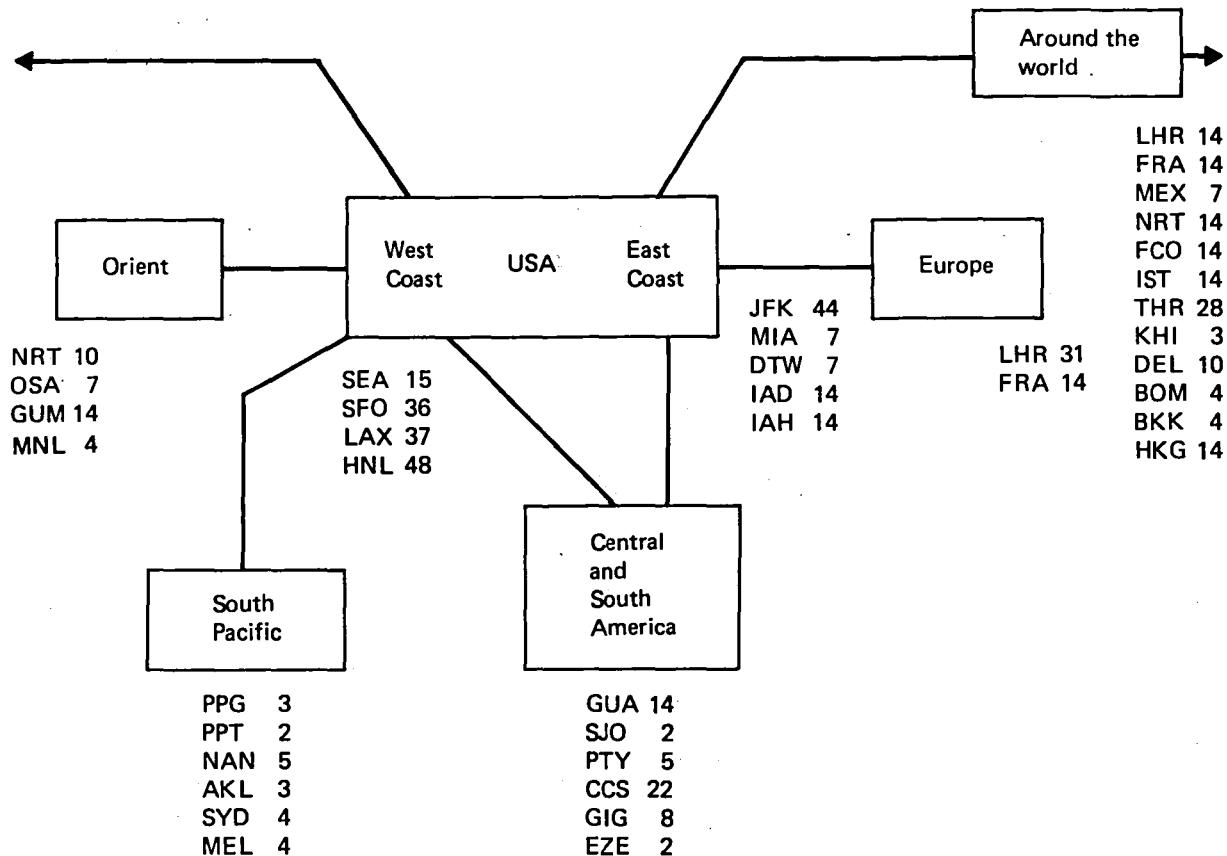
Operating Network—The airline operates the B-747 in five main regions: South America, South Pacific, the Orient, Europe, and World Service. Figure 6 shows the network as a block diagram with routes radiating from the U.S.A. Apart from the World Service, no service exists between the regions, each outbound flight returning to a U.S. gateway. Airplanes are routed through New York or San Francisco for maintenance check visits. Appendix D includes additional details of Pan Am's operating network.

- Three-letter station codes and flights per week—schedule for November 1978.
- Station codes are defined in appendix D.

Figure 6. Pan Am 747 Fleet Operating Network

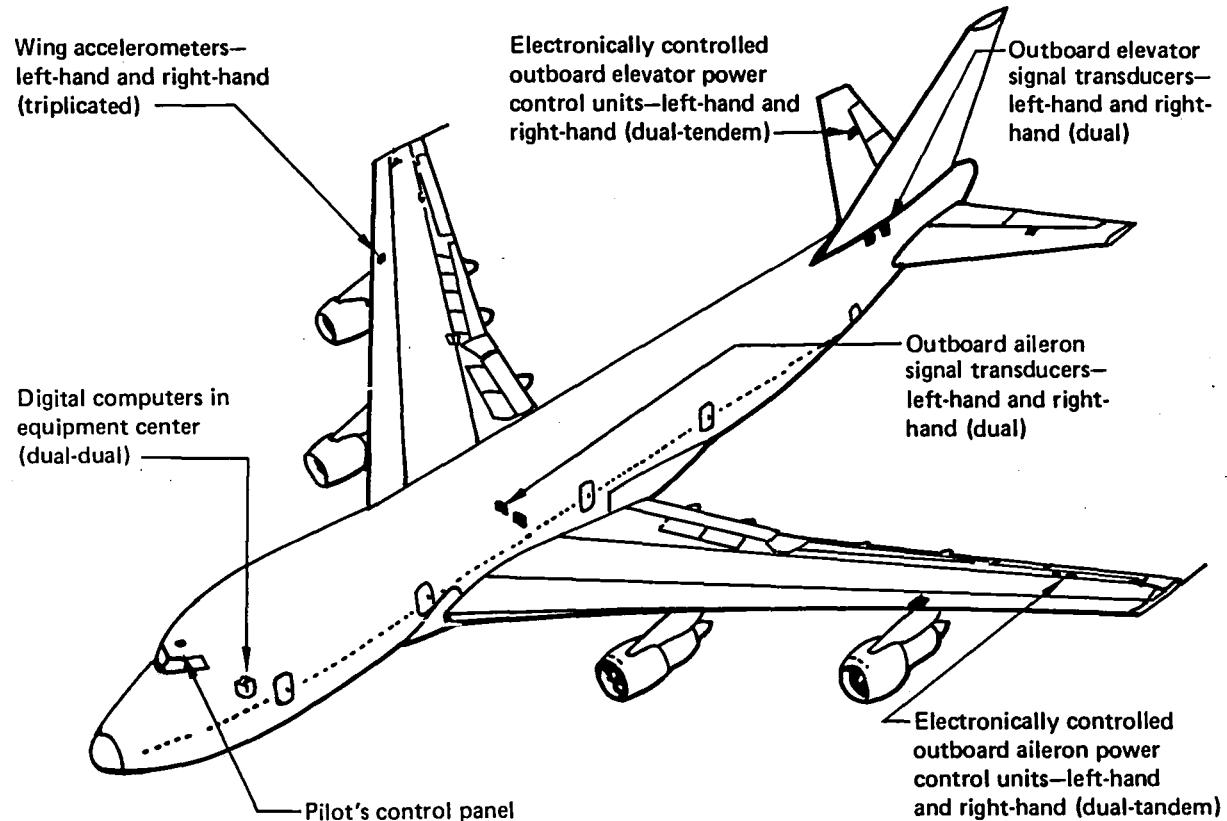
The wing load alleviation system concept of the 747-EET study is mechanized as a dual channel digital one-fail-operational system. Figure 7 shows the location of the components. Dual self-monitoring digital computers are the central components. They are packaged in two one-half air transport radio boxes installed in the electronics bay. Control law computation is dual redundant in each channel and resembles a dual-dual scheme. The computers also manage failure detection and isolation, system reconfiguration after failures, and preflight and maintenance tests.

Figure 7. Component Location for Wing Load Alleviation-Equipped 747

Wing motion is sensed for control law computation. A triple redundant set of accelerometers is located in each wing where the outboard engine nacelle strut attaches to the front spar.

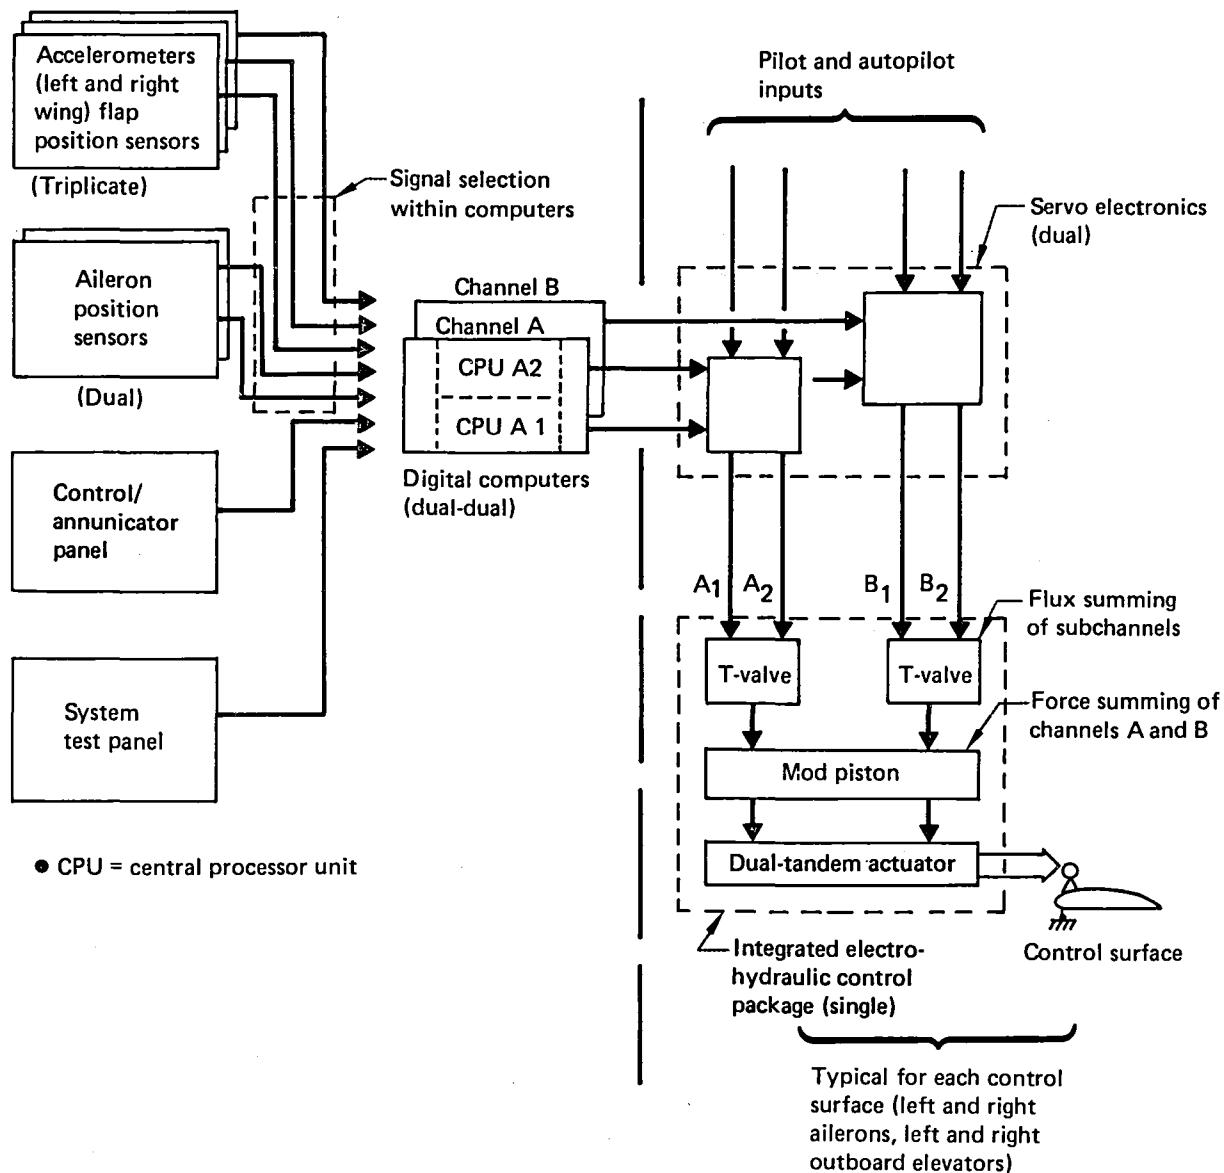
The functional diagram (fig. 8) shows the elements of the system for one control surface. Each sensor set is cross-strapped to the two computers. Signal selection and failure detection are performed in each computer. The WLA computers command symmetric deflection of the outboard ailerons and outboard elevators. At each power control unit, the WLA and pilot or autopilot commands are electrically summed. The electrohydraulic actuators are dual tandem with electrical and hydraulic fail-operational capability.

Figure 8. Wing Load Alleviation Functional Diagram

Each power control unit consists of two electrical and two hydraulic channels. In each electrical channel two servo amplifiers receive commands from one WLA computer and electrically transduced pilot or autopilot commands. The two servo amplifiers drive a T-valve that positions a modulating piston and also the main control valve.

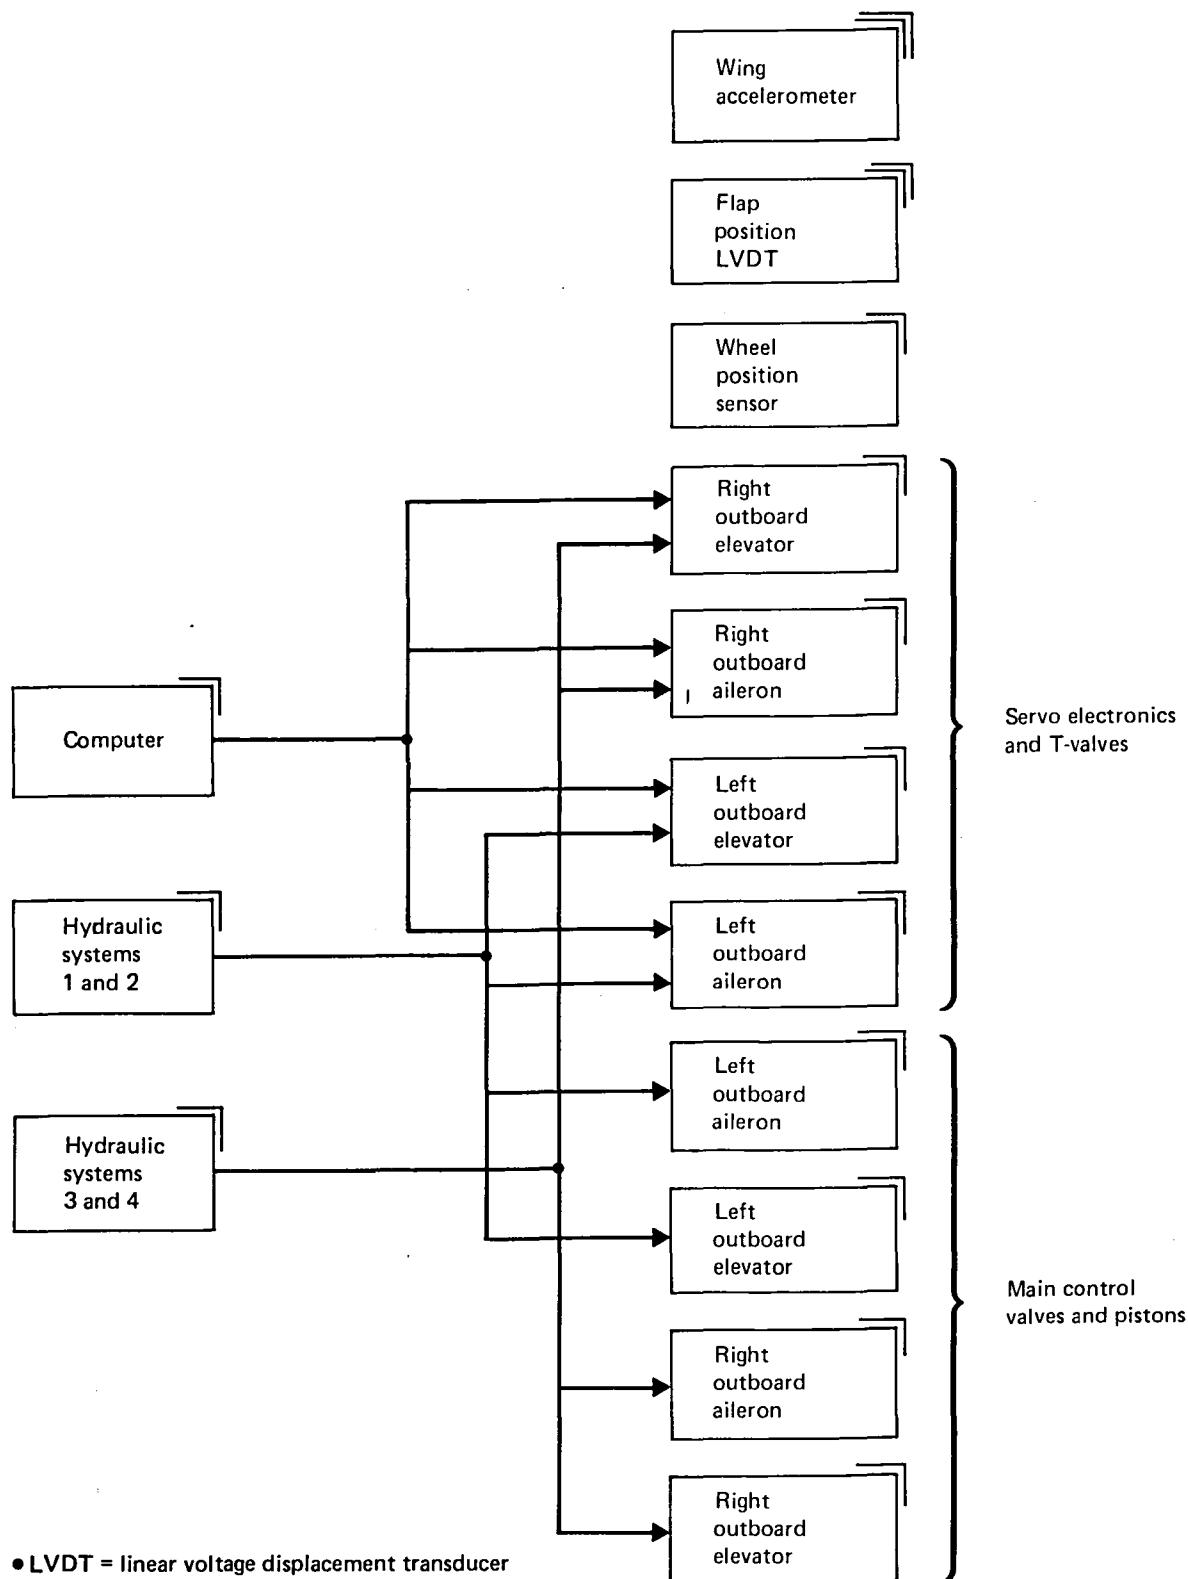
The dependency tree for the WLA system is shown in figure 9. The method for showing the levels of redundancy by the number of corner marks at the top right edge of each module is the same as that used for the combined flight control system analysis in section 4.4. Failure combinations that do not result in loss of the WLA function are as follows:

Figure 9. Wing Load Alleviation System Dependency Tree

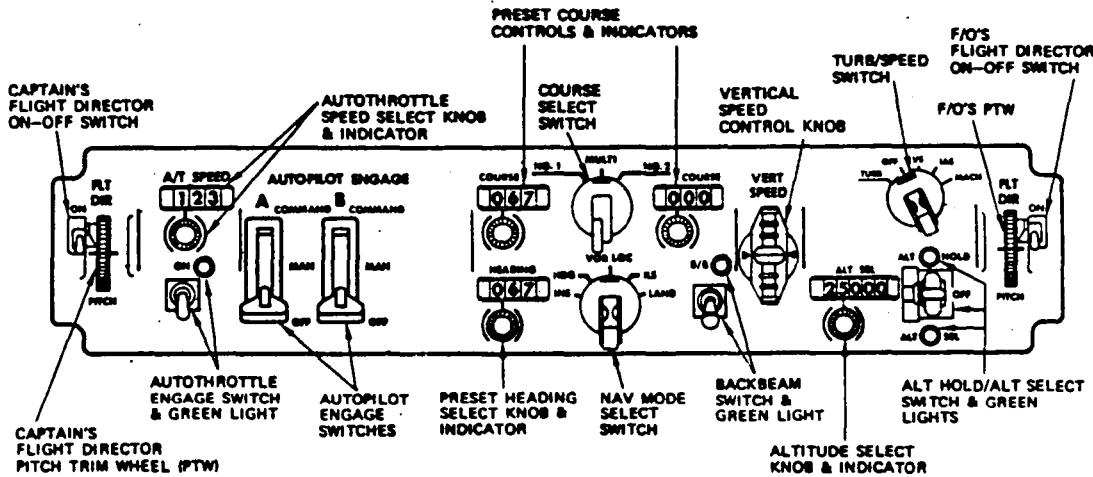
The autopilot may be engaged during the climb to minimize the workload and enhance safety by allowing the pilot flying to broaden his scan and watch for other traffic. When the autopilot is used during initial climb, it may be used in heading or VOR/LOC mode with altitude select set for cruise altitude or clearance altitude and the pitch mode set for IAS. Figure A1 shows the various modes on the mode select panel.

Figure A1. Mode Select Panel Functions
