PRELIMINARY FLOOR, SEAT,
AND DUMMY DATA

Mark R. Cannon
Richard E. Zimmerman
Simula Inc.
Phoenix, Arizona

NASA/FAA Government/Industry CID Workshop
NASA Langley Research Center
April 10, 1985

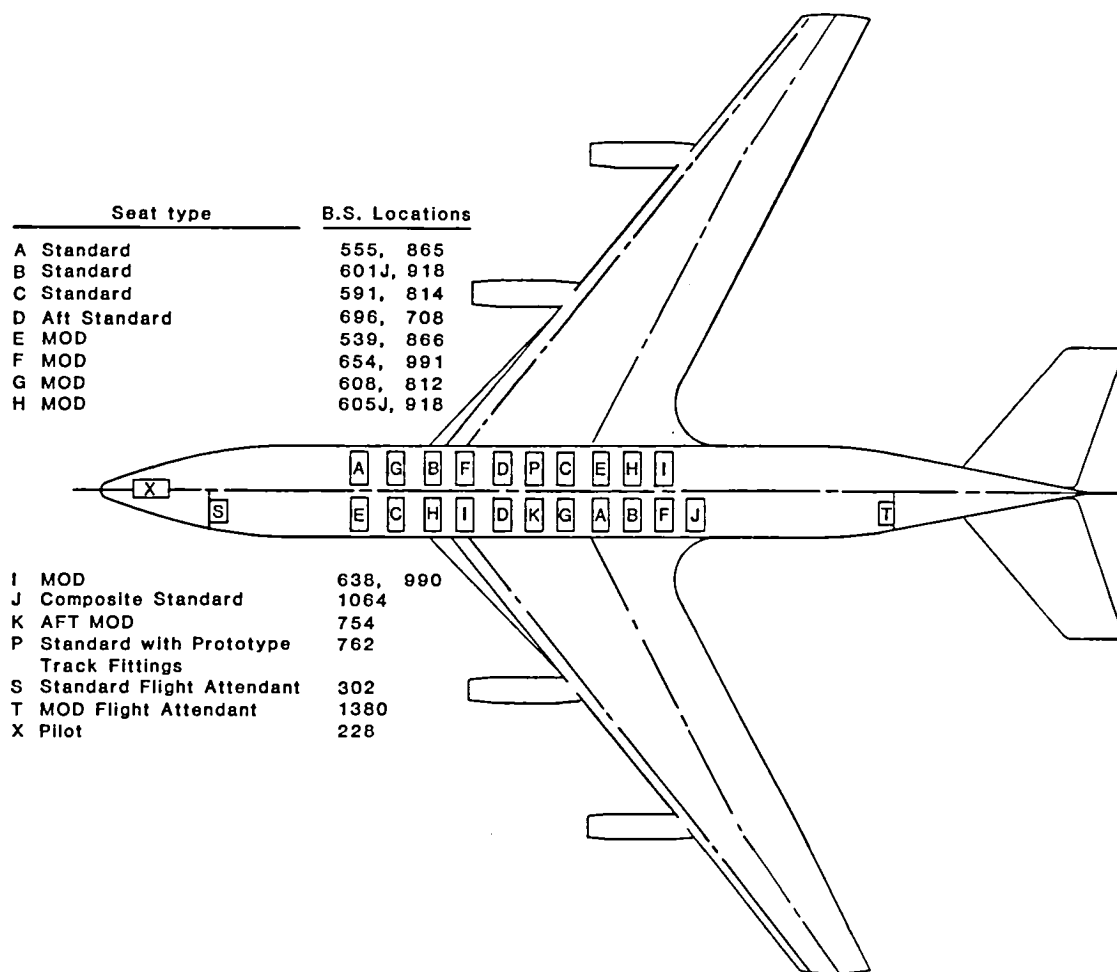
Figure 2.

POSITION OF SEAT EXPERIMENTS ABOARD AIRCRAFT

Figure 2 shows where various seating experiments were in the aircraft; they were arranged in two sets. There was a set of eight seats up front, a couple of seats in between, and then another set of eight in the aft part of the aircraft. The experiment was reproduced in this way because the G loading might have been quite different in the aft portion of the cabin from that in the forward part of the cabin. It was thought that data for two different crash environments might be obtained. The pitch (seat spacing) on these seat experiments was very large compared to a commercial transport. It was felt that if seats with the dummies in them were put as close together as they would be in a commercial transport, the different seat designs would interact with one another in an unpredictable and uncontrolled manner. It was believed that if the seats interacted with the dummies striking seats ahead of them it would not be possible to interpret the data. For example, it might be impossible to differentiate between acceleration due to floor input and dummy impact. Also, stroking seats mounted behind nonstroking seats could be a problem with a small pitch. Therefore, the seats were isolated as much as possible in the available cabin space. The placing of the seats also considered the proximity of modified and unmodified seats of the same type and the probability of failure.

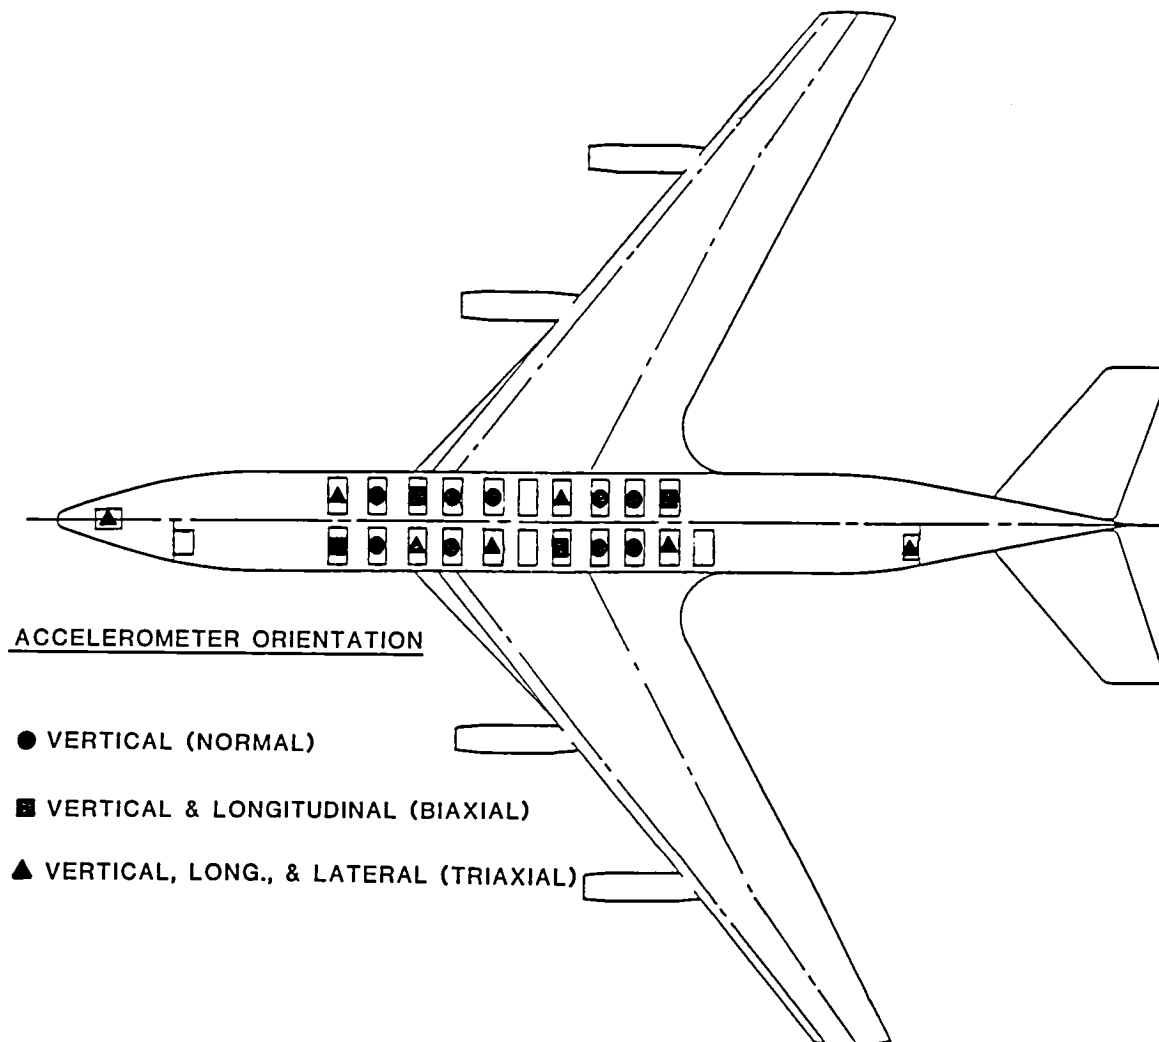
Figure 3.

LOCATION OF FLOOR ACCELEROMETERS

Figure 3 shows where the accelerometers were placed on the floor plan. There were vertical accelerometers at all locations because the floor was not anticipated to have much rigidity in that direction and the acceleration could easily vary with location. Because of the limitations of data channels, the decision was made to infer that the lateral acceleration on one side of the aircraft would be similar to data obtainable on the other side. It was reasoned that acceleration could not vary much in the lateral direction because the structure had much greater rigidity in that direction. The same reasoning was applied to the longitudinal direction. The lateral and longitudinal accelerations were measured only at selected locations. Accelerometers were also placed on the seat pan and in the dummy. There were also tensiometers on the lap belts of the instrumented dummies and on the pilot and flight attendant restraint harnesses.

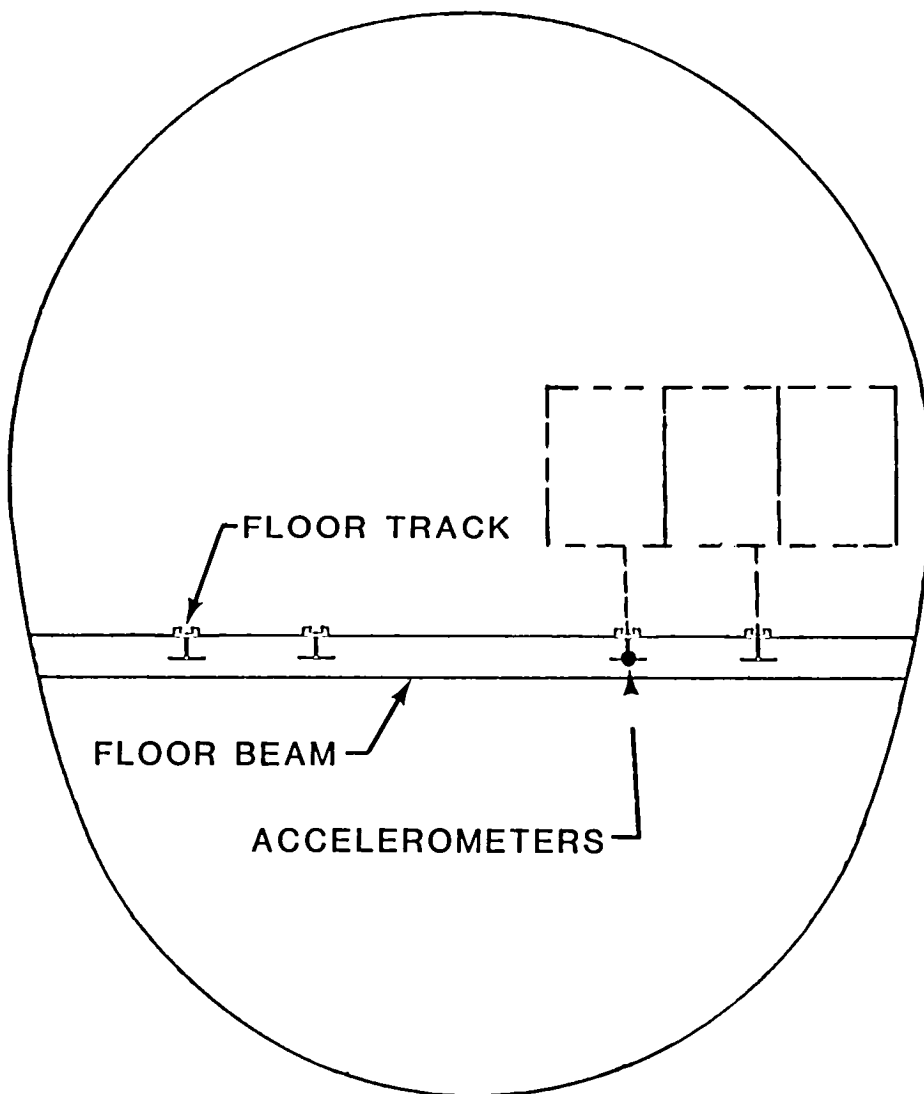
Figure 4.

TYPICAL MOUNTING LOCATION OF BIAXIAL
AND TRIAXIAL ACCELEROMETERS IN THE FLOOR

The floor accelerometers were mounted on the floor beams under the aisle end legs of the seat structure, as shown in figure 4.

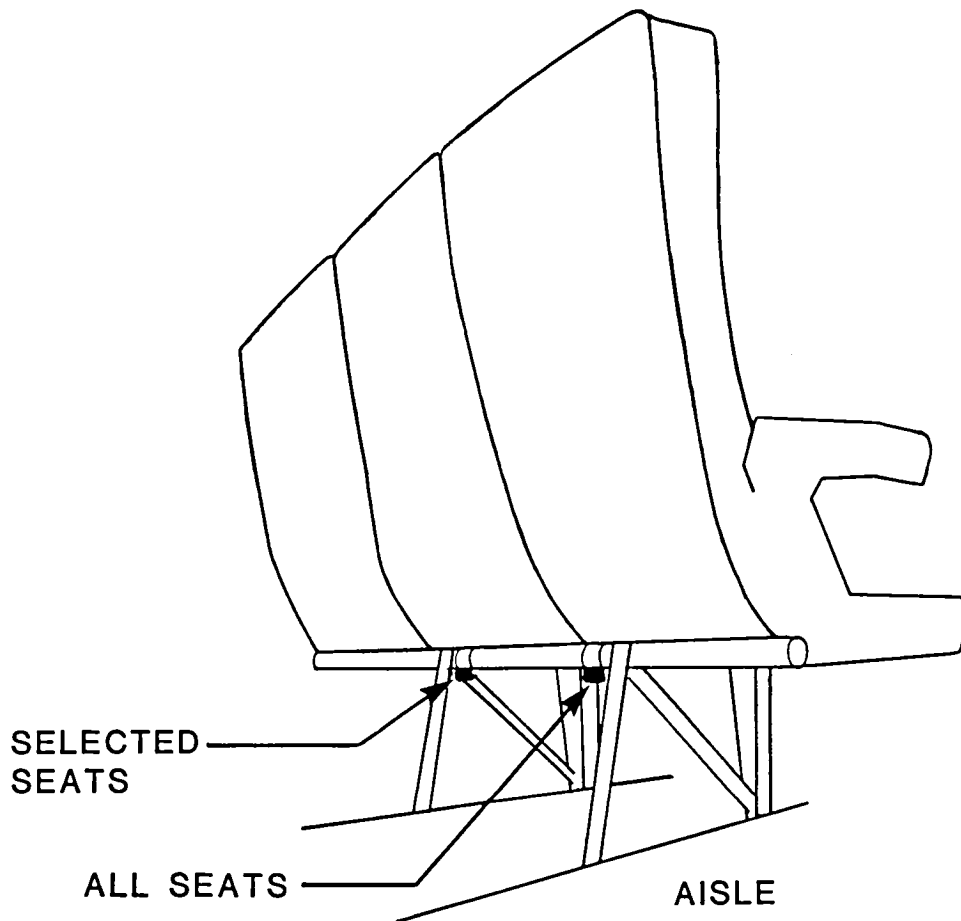
Figure 5.

POSITION OF ACCELEROMETERS ON THE SEAT

All of the seats had an accelerometer mounted at the hardest point on the seat structure, on the seat pan near the rear leg (fig. 5). The leg that was closest to the aisle was selected because it was likely to experience the highest deceleration due to the assymetry of the seat structure. This was based on the assumption that the more heavily loaded window-end of the seat would yield first. On some of the seats there was a second accelerometer near the window end (a uniaxial longitudinal accelerometer only). It was placed there because the two ends of an assymmetric stroking seat would probably experience quite different longitudinal accelerations.

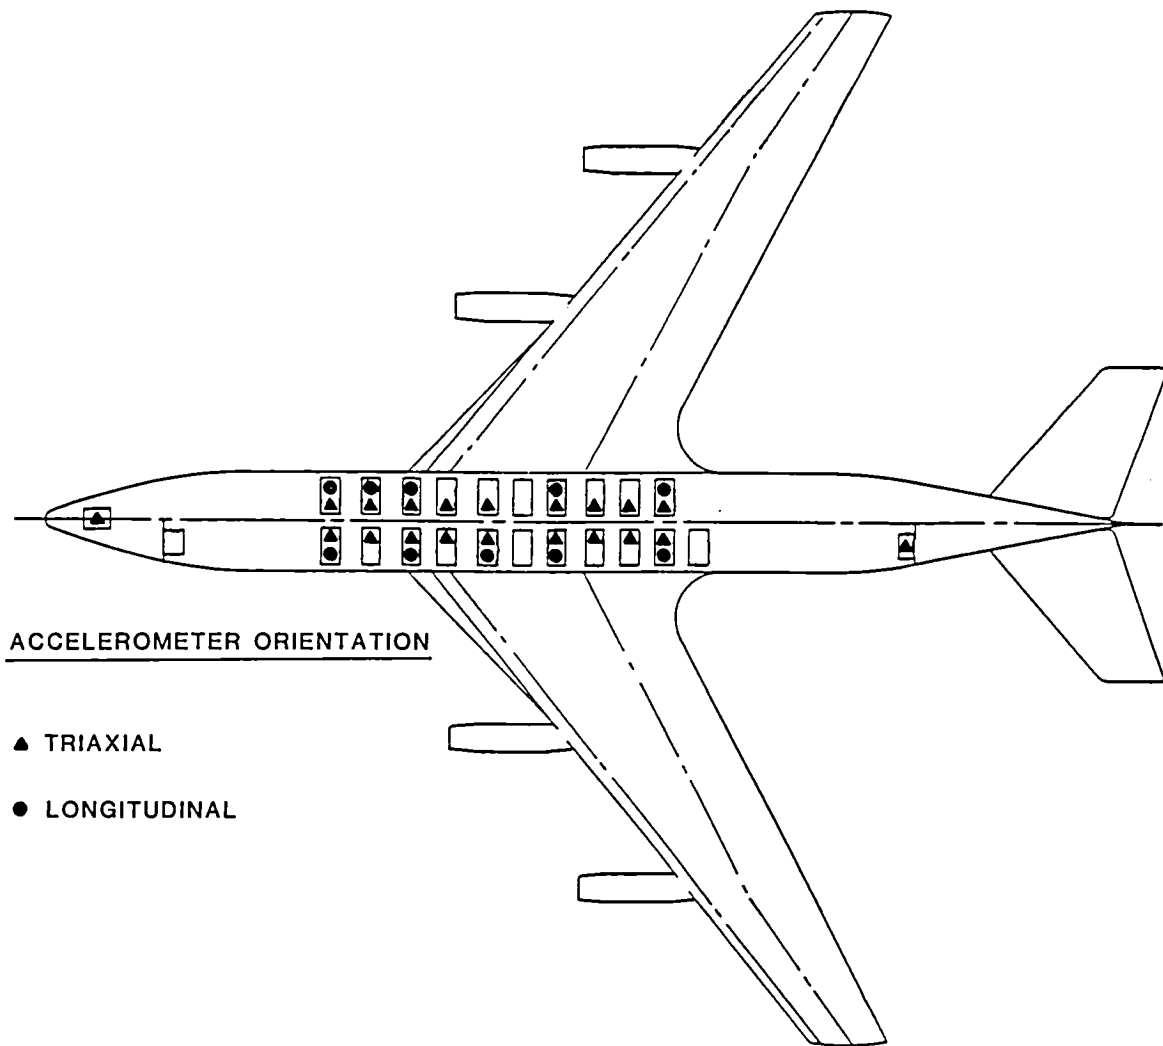
Figure 6.

SEAT LOCATIONS WITH ACCELEROMETERS

Figure 6 shows which seats were equipped with the two different arrangements of seat pan accelerometers.

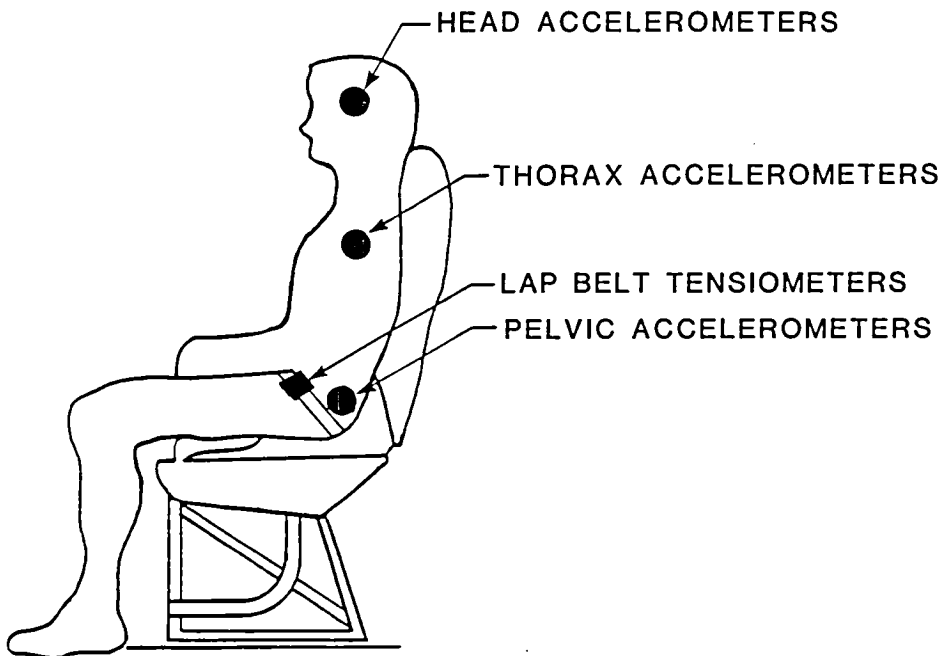
Figure 7.

LOCATION OF DUMMY INSTRUMENTATION

The pelvis, thorax, and head of selected dummies were instrumented. All had at least a triaxial pelvis accelerometer and lap belt tensiometers. Tensiometers were also placed on the pilot and flight attendant restraint harnesses. Three dummies had biaxial head accelerometers and either biaxial or triaxial thorax accelerometers. (See fig. 7.)

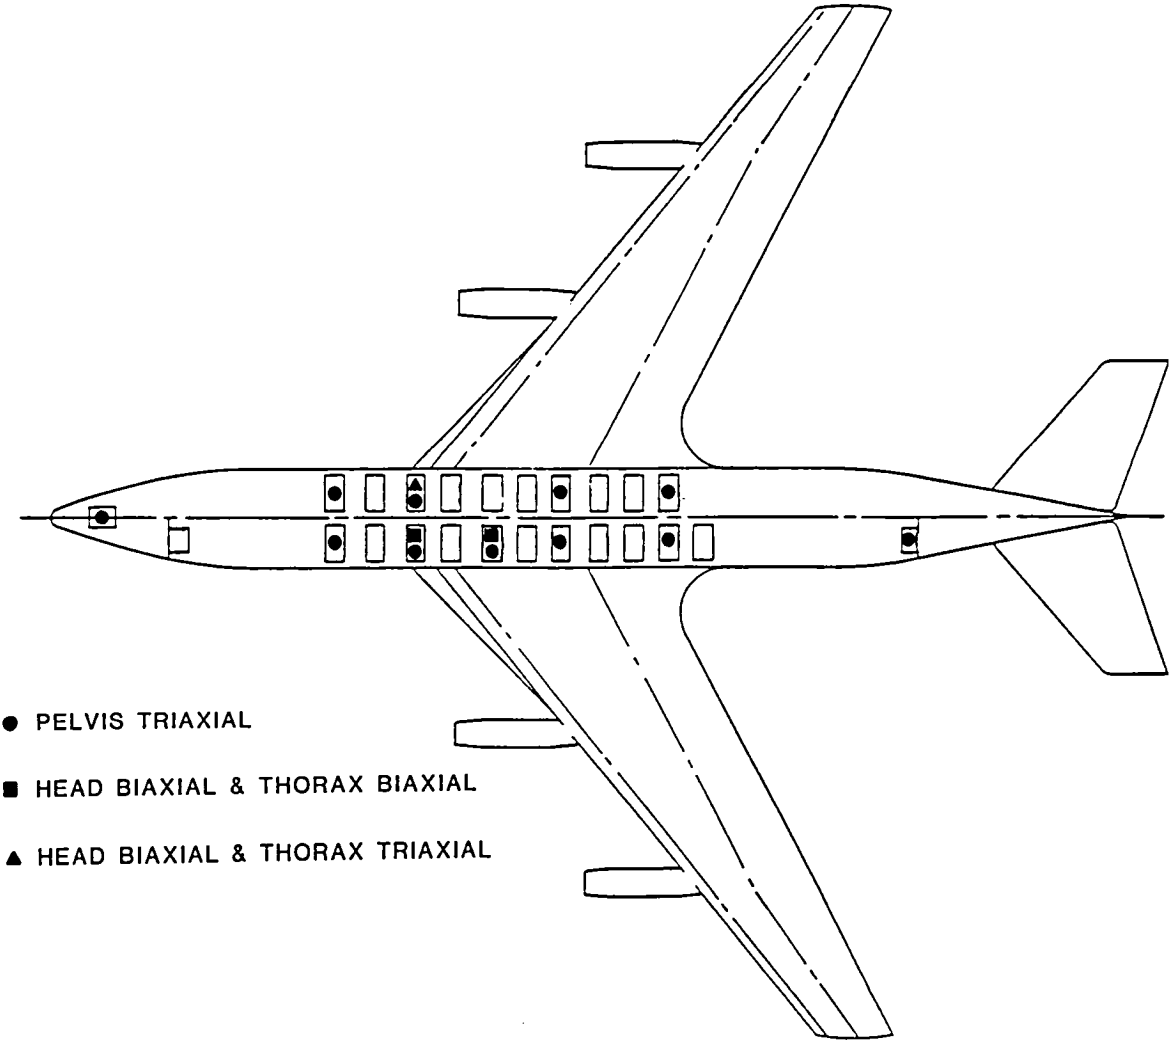
Figure 8.

DUMMY LOCATIONS WITH ACCELEROMETERS

Figure 8 shows where the various dummy instrumentation configurations were placed in the aircraft.

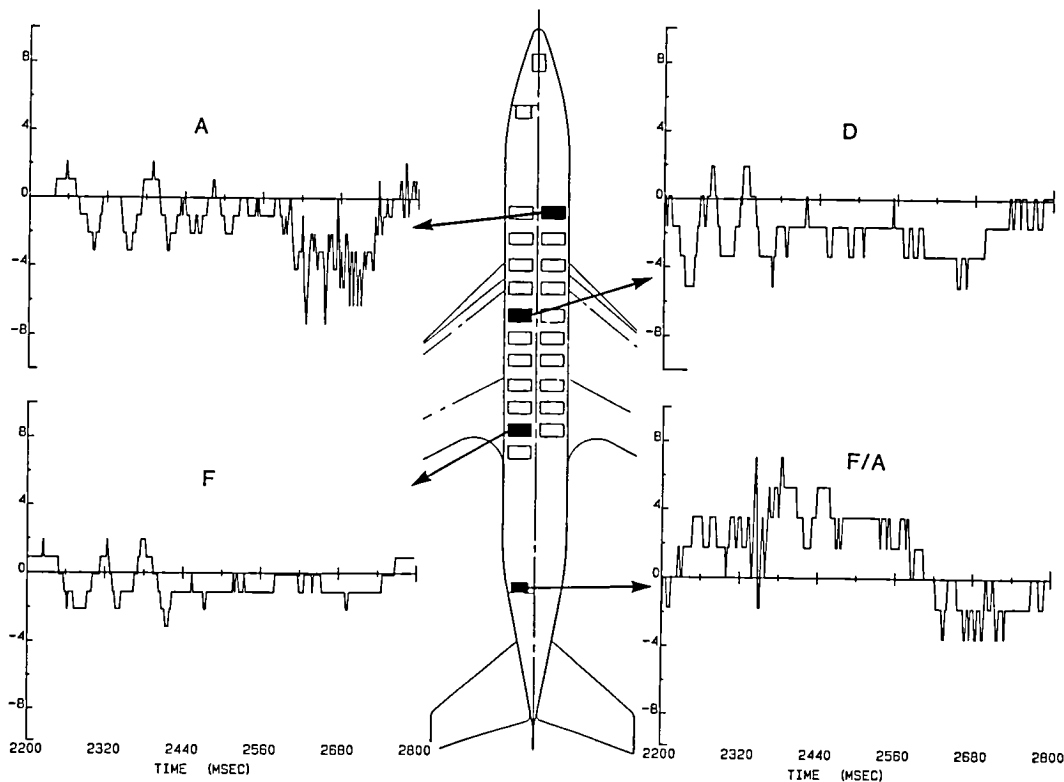
Figure 9.

VERTICAL FLOOR ACCELERATIONS (G) - GROUND IMPACT

Figure 9 shows vertical acceleration during ground impact. This includes the engine, and then the fuselage, striking the ground. Accelerations are shown for four different points in the aircraft, at the aft flight attendant seat and at three other points along the length of the cabin. There are accelerations similar to those shown in reference 2: 2-4 G accelerations at most locations and somewhat higher at the flight attendant seat. The data is consistent with the physical observations made after the test. Figures 10 and 11 show the longitudinal and lateral components of accelerations at the same locations.

The floor acceleration data of interest occurred when the aircraft struck the ground, and also when the aircraft struck the obstacles that were to cut the wings. Obstacle impact is of some interest for the crashworthiness experiments because somewhat larger accelerations occurred at this time. This is true in all axes. The times associated with these events were as follows:

- Wing/ground impact at approximately 33731.06 sec (2200 msec)*
- Fuselage/ground impact at approximately 33731.46 sec (2600 msec)
- Fuselage/obstacle impact at approximately 33732.91 sec (4050 msec)

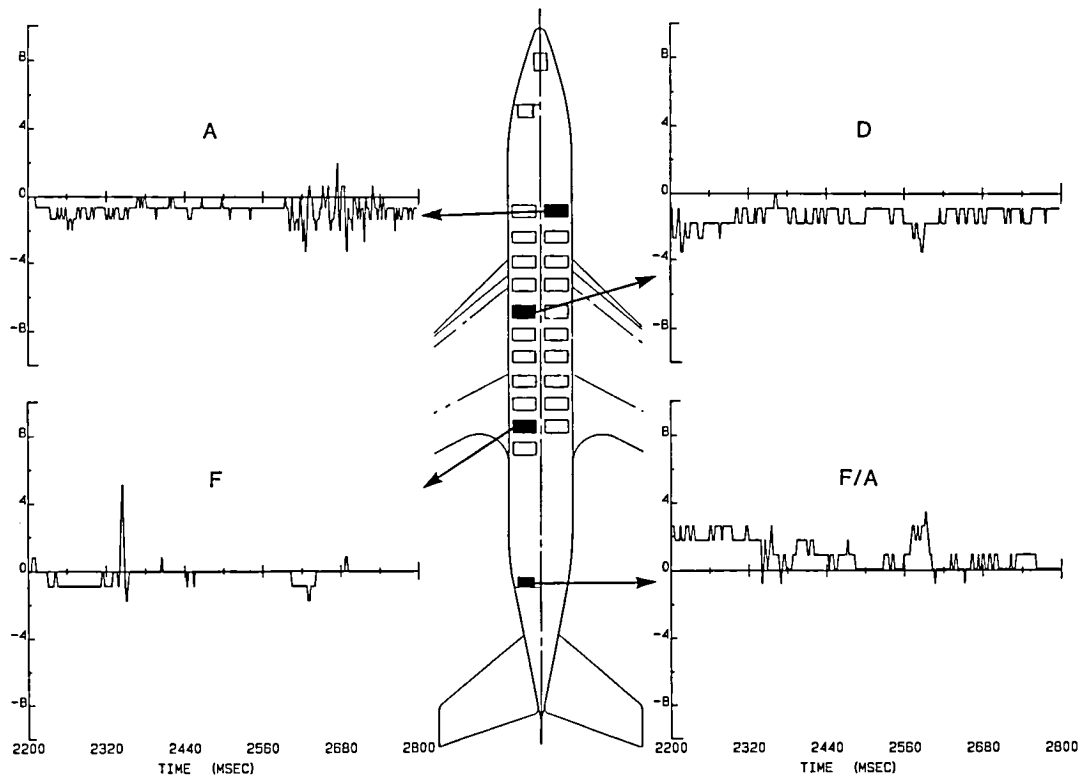
Figure 10.

LONGITUDINAL FLOOR ACCELERATIONS (G) - GROUND IMPACT

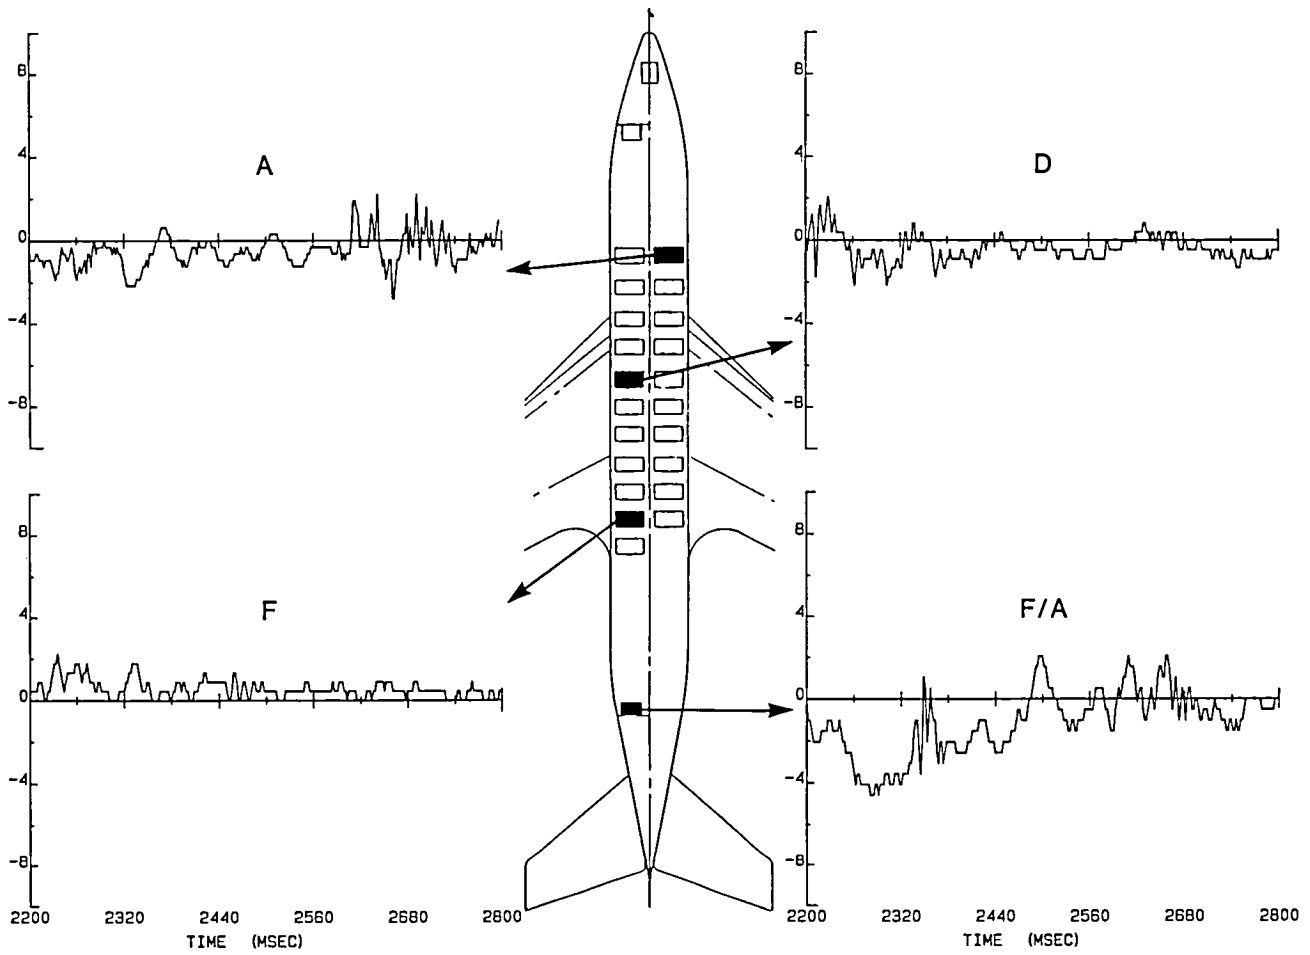
Figure 11.

LATERAL FLOOR ACCELERATIONS (G) - GROUND IMPACT

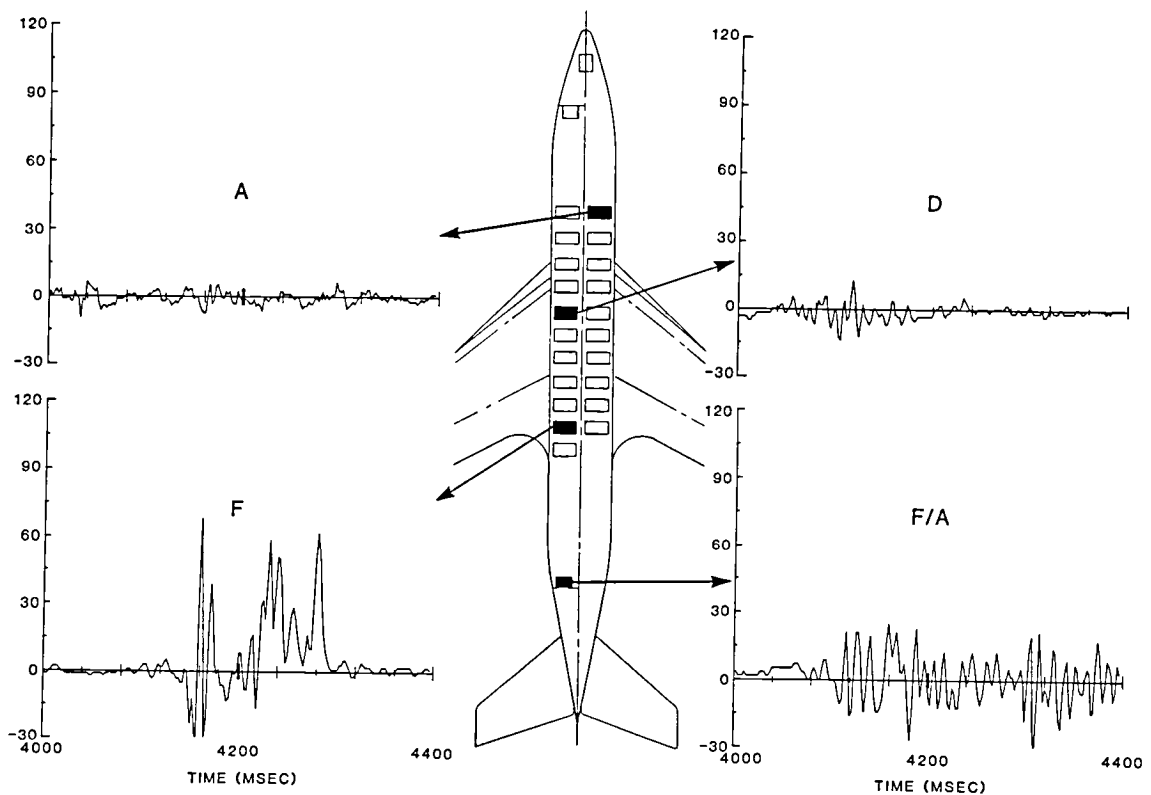
Figure 12.

VERTICAL FLOOR ACCELERATIONS (G) - OBSTACLE IMPACT

When the aircraft hit the obstacles there were some 15- to 20-G vertical acceleration peaks. (See fig. 12.) They were very sharp peaks, with little energy. That is typical of data for all three coordinate axes. The channel for seat F shows a higher acceleration, but it is not really consistent with the other channels. (Apparently an instrumentation problem existed.) This channel behaved well during ground impact, but not after the aircraft hit the obstacle. Serious doubt exists that there were accelerations of such magnitude. Figures 13 and 14 show the longitudinal and lateral acceleration components at the same locations.

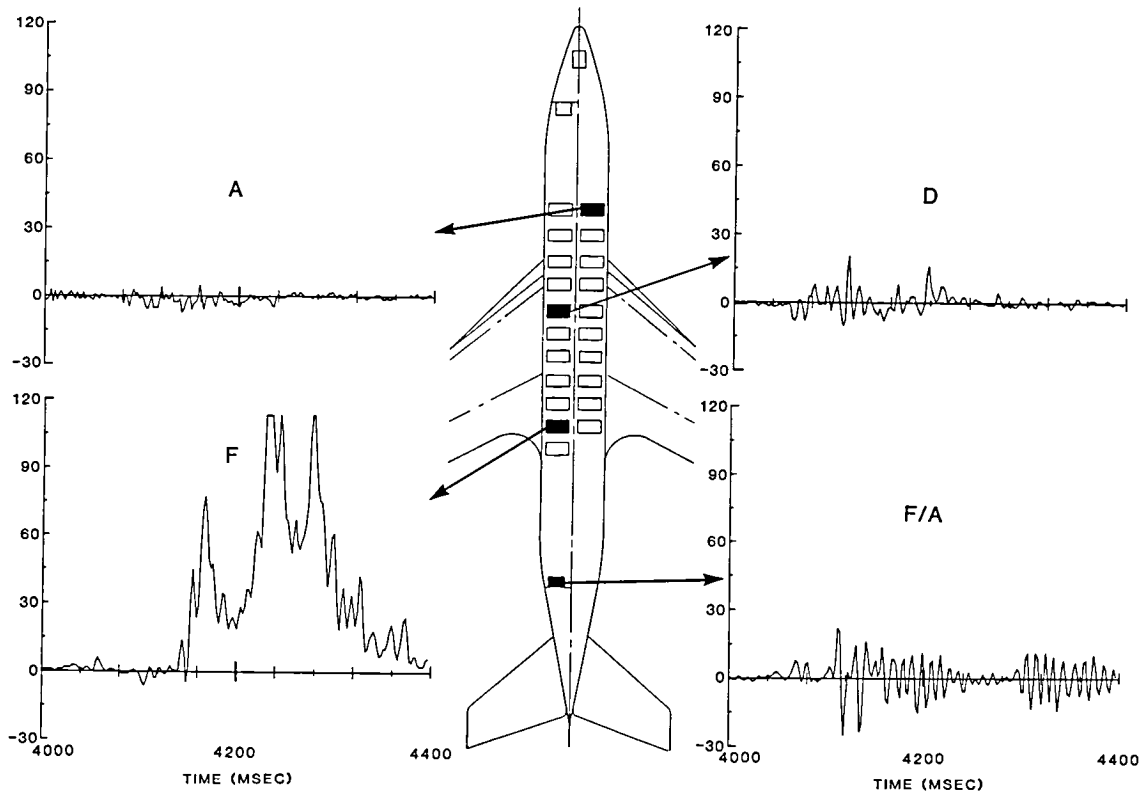
Figure 13.

LONGITUDINAL FLOOR ACCELERATIONS (G) - OBSTACLE IMPACT

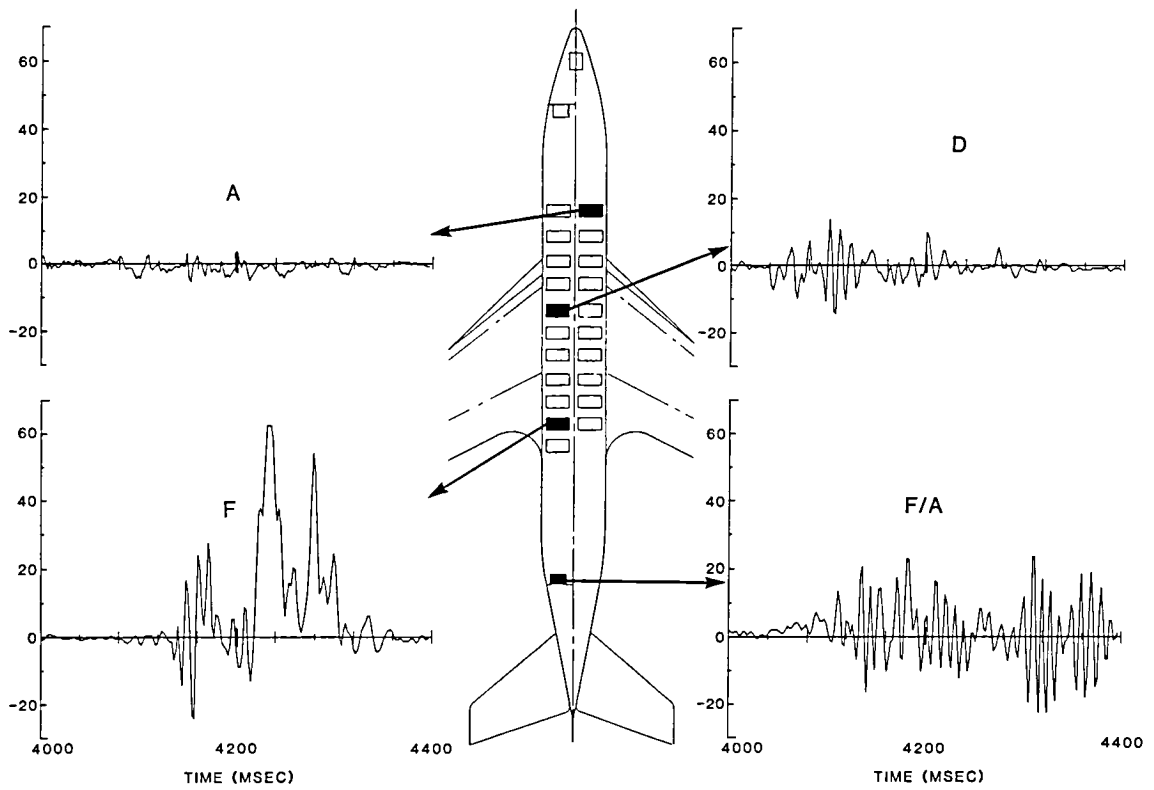
Figure 14.

LATERAL FLOOR ACCELERATIONS (G) - OBSTACLE IMPACT

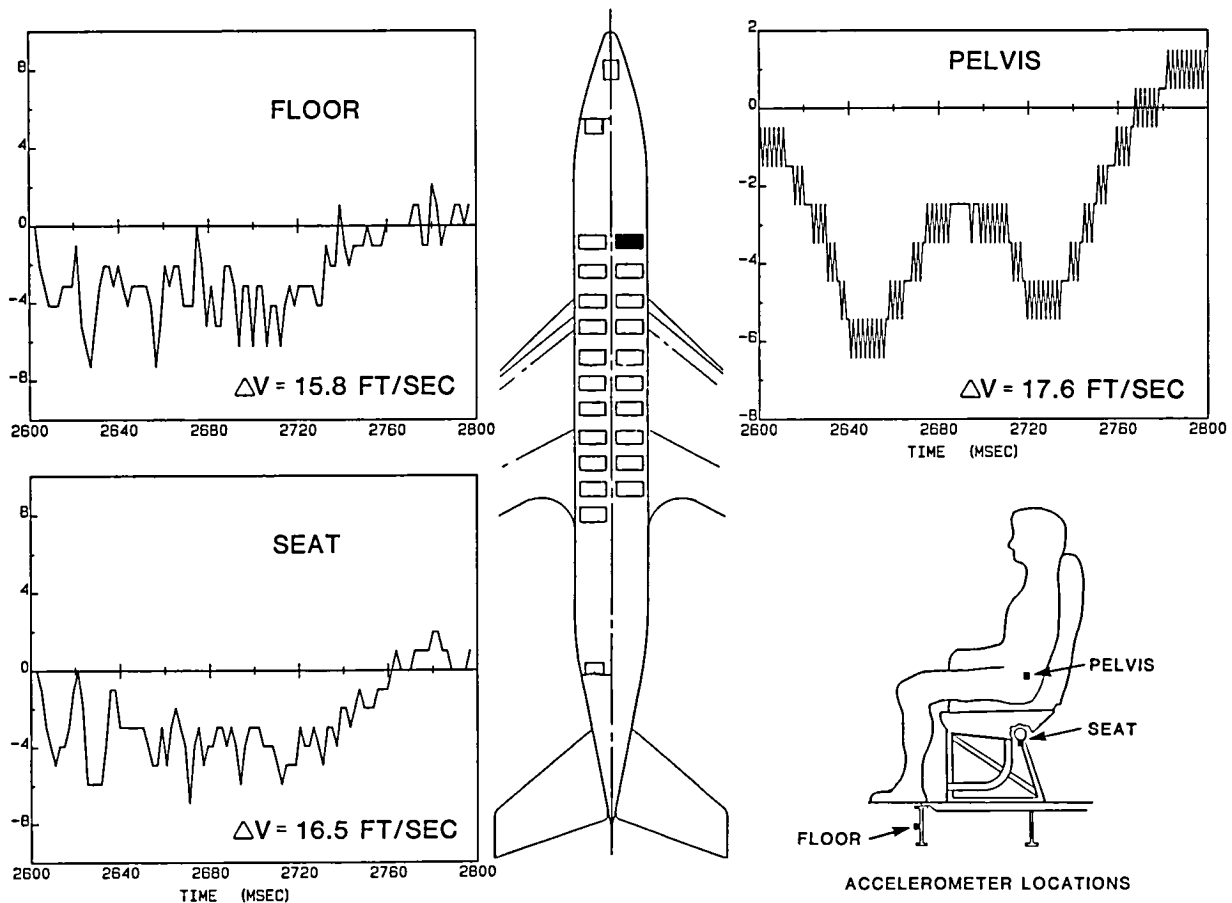
Figure 15.

VERTICAL ACCELERATIONS - SEAT A (R.H.) GROUND IMPACT

The next three figures (Figures 15-17) show vertical, longitudinal, and lateral accelerations for the floor, seat, and dummy pelvis at Seat A. They are arranged so that the floor accelerations near the bottom end of the seat leg, the seat pan acceleration near the top end of the leg, and the dummy pelvis accelerations above this leg can be viewed simultaneously. The figures therefore display how the floor accelerations were transmitted through the seat/occupant system. The seat pan acceleration is reasonably similar to the floor acceleration. This would be expected in view of the relatively rigid seat leg structure and the fact that nothing deformed. Therefore, this is a good indication that the data is probably valid. The pelvis of the dummy responded somewhat differently, as expected. Approximate velocity changes are shown for the three accelerations; they are not identical. But when the resolution of the data as indicated by the steps in the pelvis data is considered along with other potential instrumentation errors, the correlation between the velocity changes shown here is reasonably good. Also, note that these velocity changes are reasonably consistent with the velocity changes that were demonstrated in references 2 and 3. For the longitudinal acceleration components (fig. 16), the seat pan response again reflects the floor response fairly closely. For the lateral accelerations (fig. 17), the seat pan acceleration is not nearly as similar to the floor acceleration. This is as expected, because the seat is much less rigid in the lateral direction.

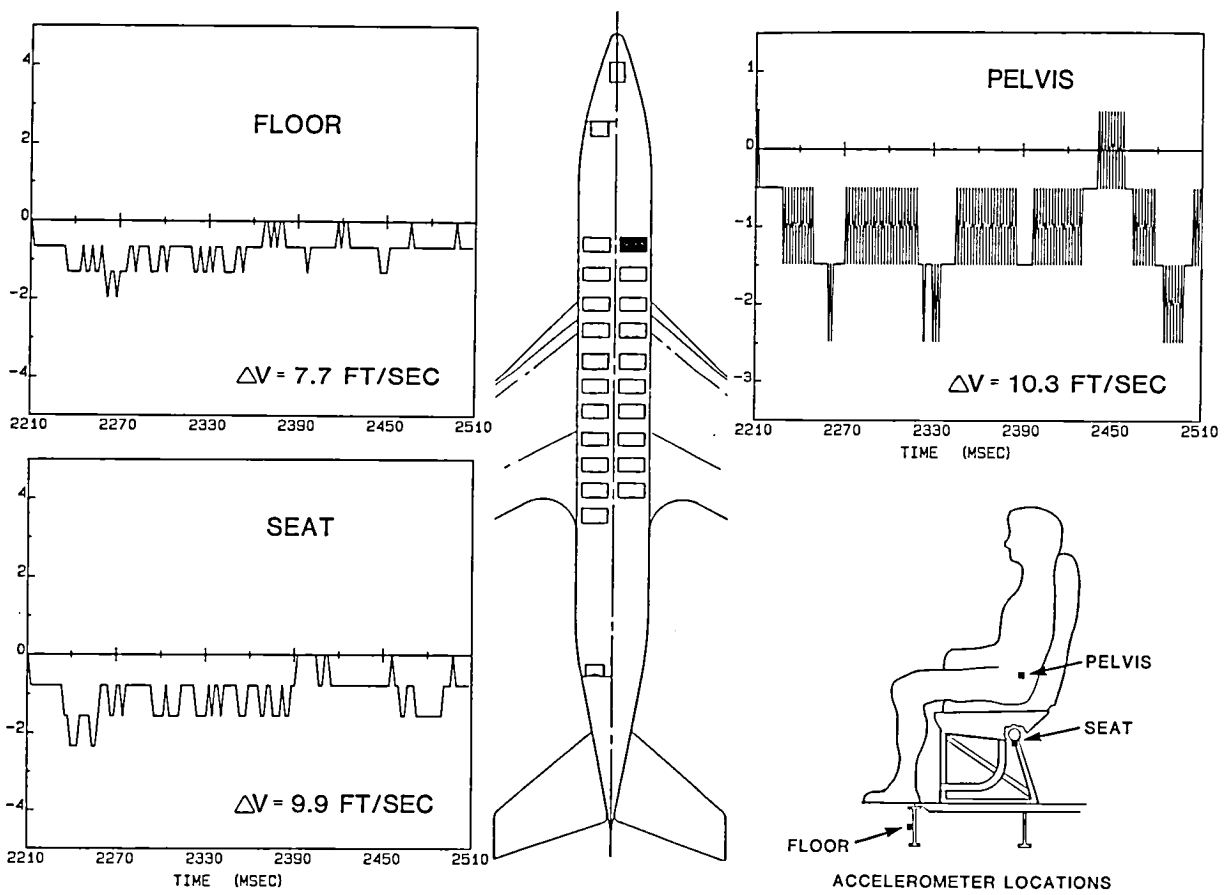
Figure 16.

LONGITUDINAL ACCELERATIONS - SEAT A (R.H.), GROUND IMPACT

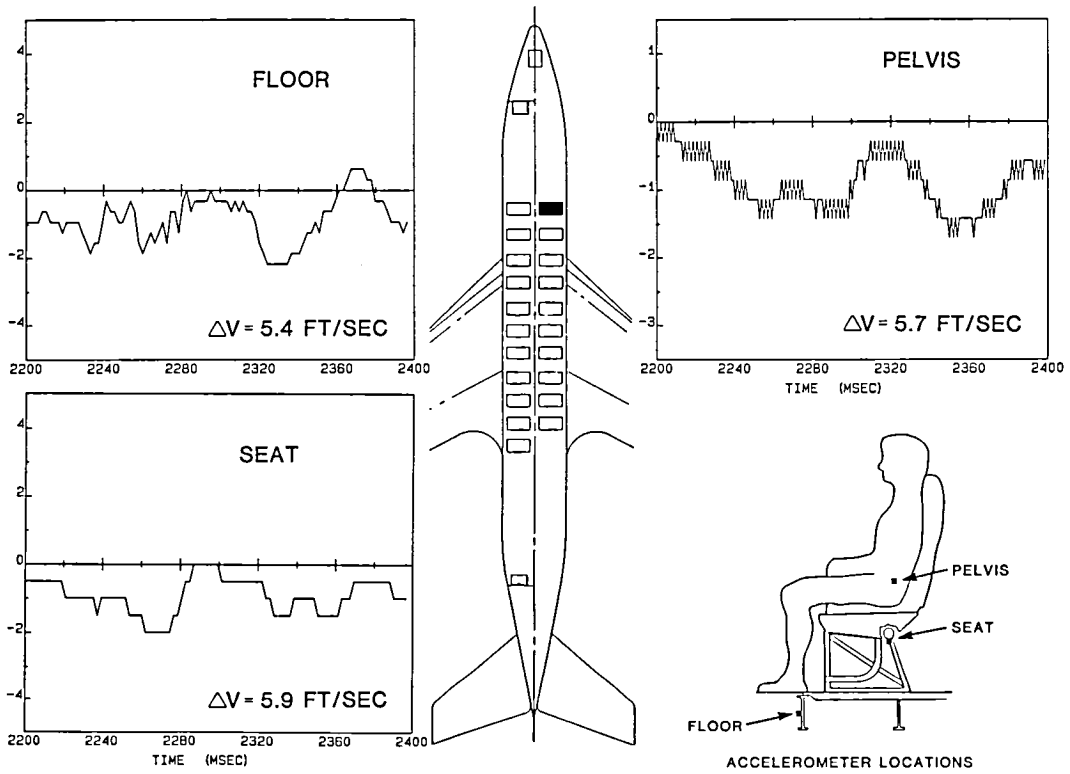
Figure 17.

LATERAL ACCELERATIONS - SEAT A (R.H.), GROUND IMPACT

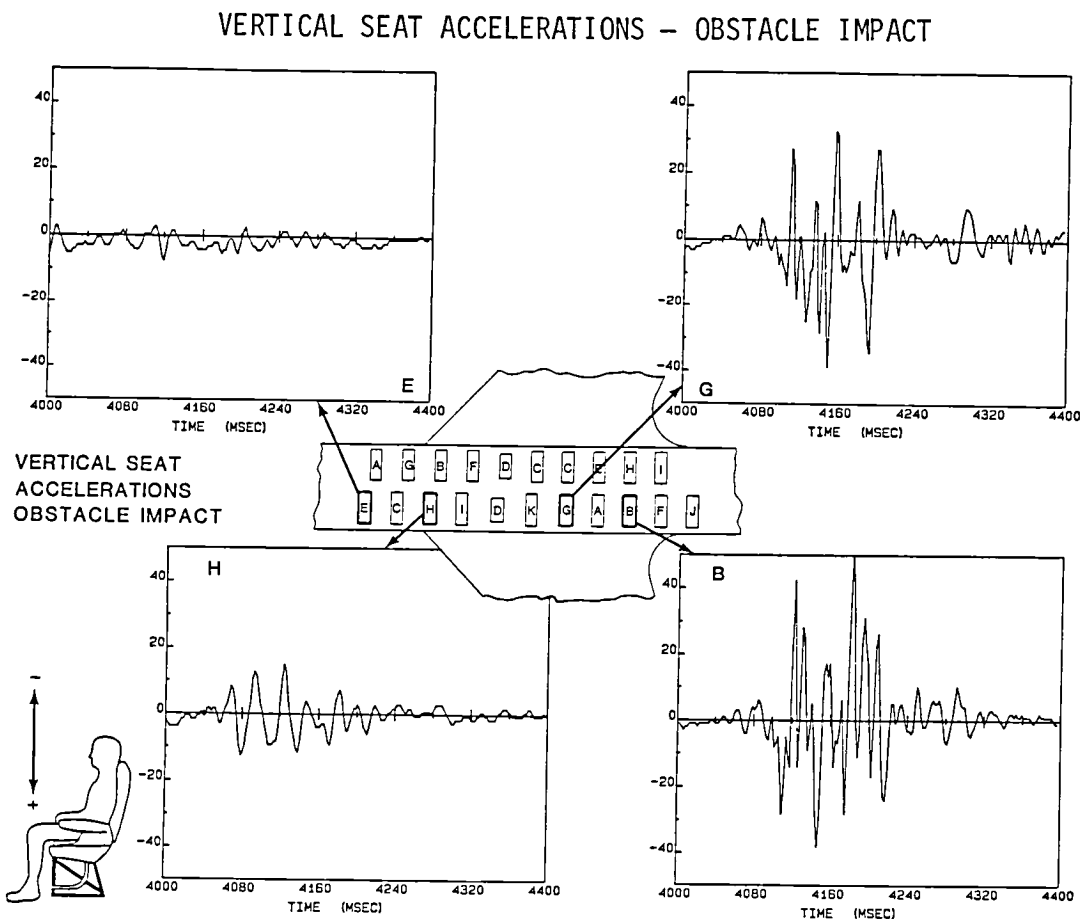
Figure 18.

The vertical seat accelerations for four seats along the length of the aircraft are shown in figure 18, which shows that the accelerations on those seat pans during obstacle impact are a function of position along the aircraft. There are some higher values than were seen on ground impact. There are very brief and occasional accelerations of over 20 G; sometimes there is a sharp spike up to 40 G. However, they are extremely steep and narrow and represent very little energy. It therefore does not appear unusual for unmodified seats to have survived this impact.

The following three figures (figures 18-20) show floor, seat, and pelvis data for obstacle impact. This includes four seat accelerations along the length of the cabin, and seat and pelvis accelerations for Seat A.

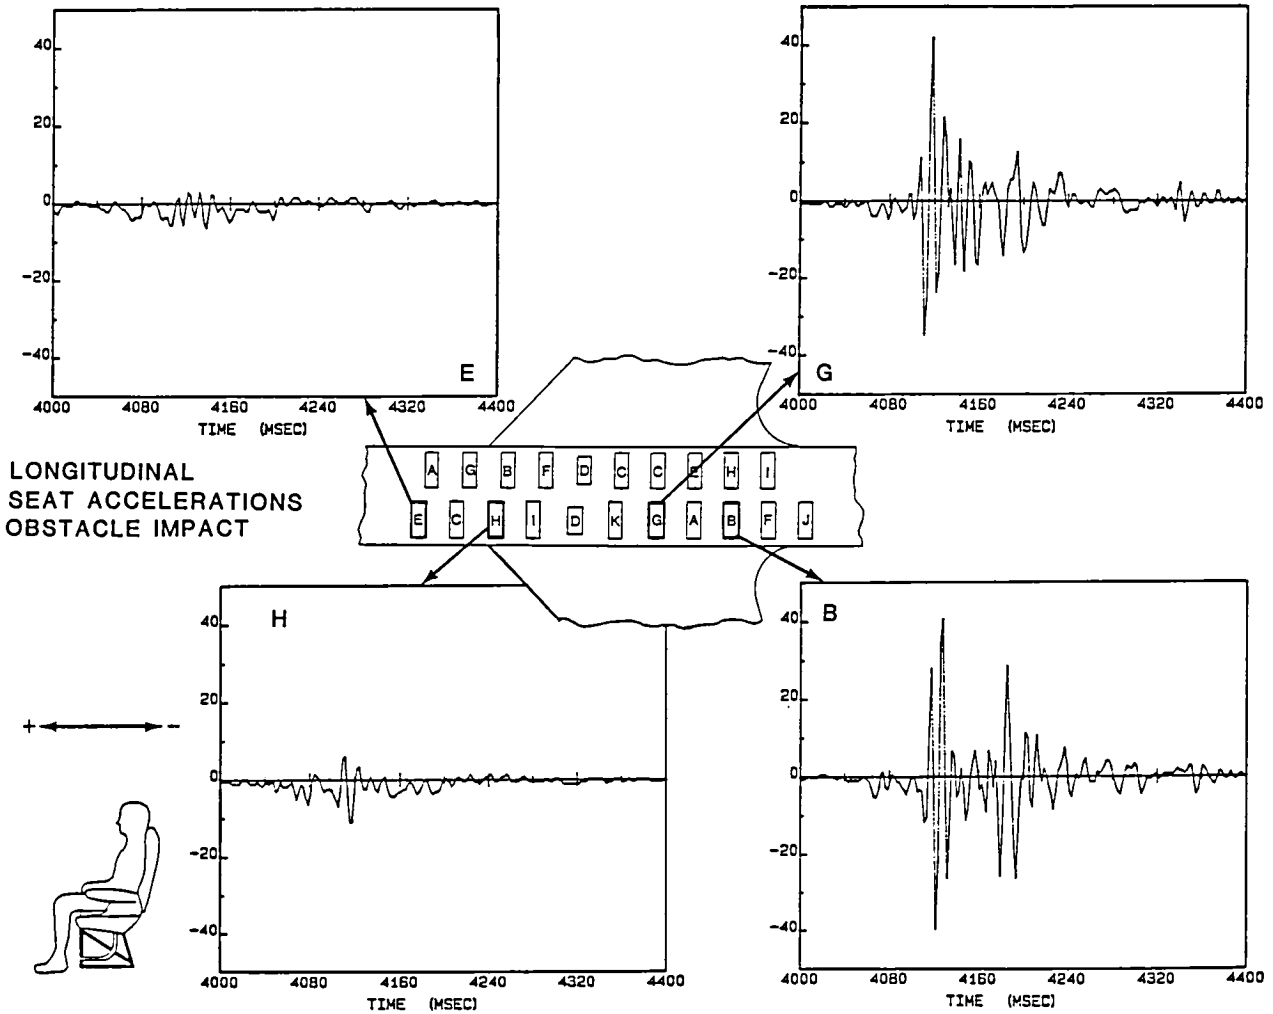
Figure 19.

Figure 19 shows the longitudinal data during obstacle impact for the same four seats. Again, the response is shown to be most severe in the aft portion of the aircraft.

LONGITUDINAL SEAT ACCELERATIONS - OBSTACLE IMPACT

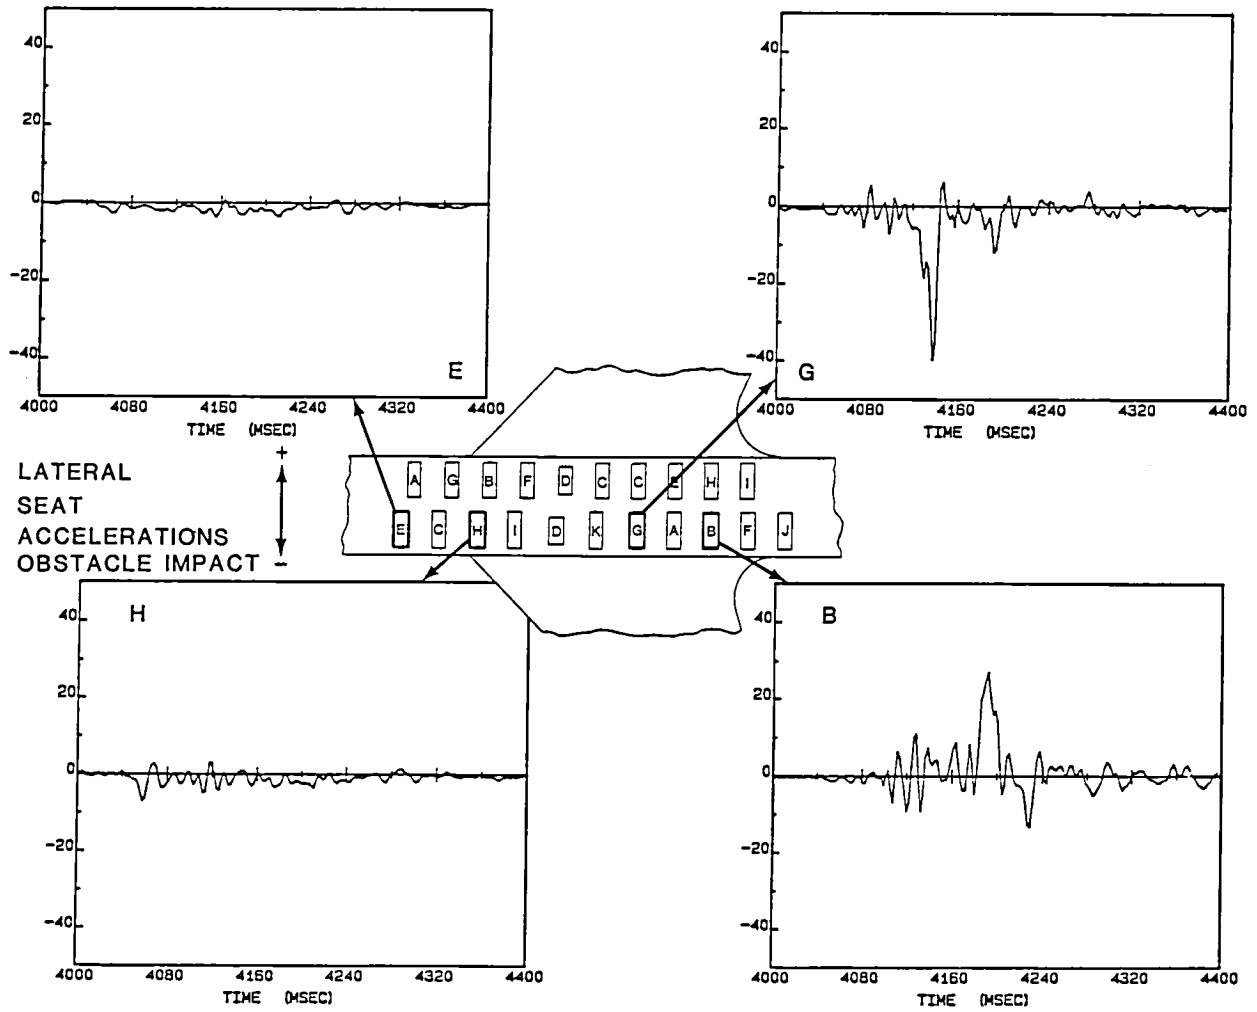
Figure 20.

Figure 20 shows the lateral acceleration component. Note that the main pulses are wider. This is probably consistent with the cutter tearing through the aircraft as it slid sideways.

LATERAL SEAT ACCELERATIONS - OBSTACLE IMPACT
