PRELIMINARY FLOOR, SEAT,
AND DUMMY DATA

Mark R. Cannon
Richard E. Zimmerman
Simula Inc.
Phoenix, Arizona

NASA/FAA Government/Industry CID Workshop
NASA Langley Research Center
April 10, 1985

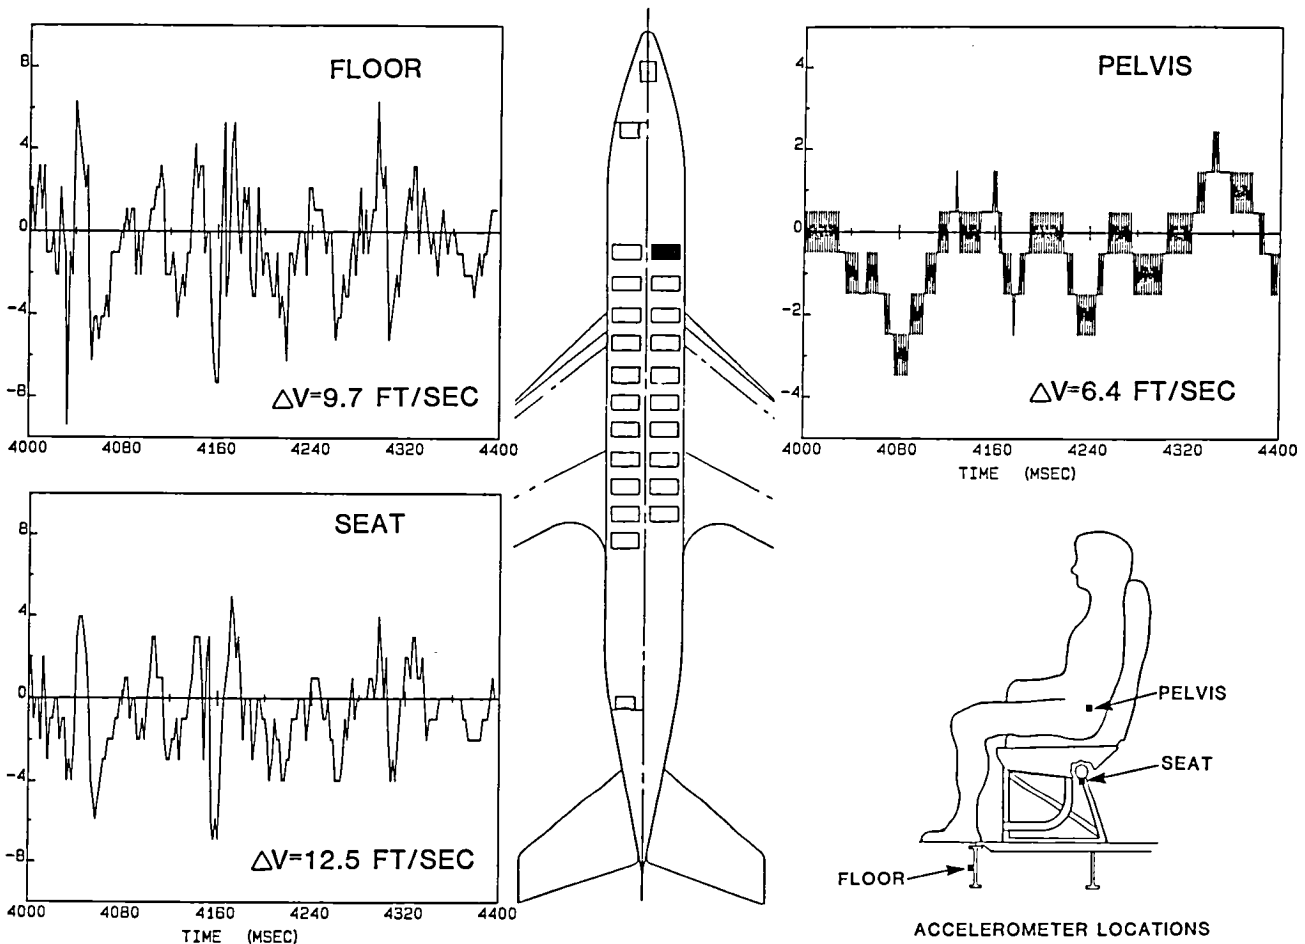
Figure 21.

VERTICAL ACCELERATIONS - SEAT A (R.H.), OBSTACLE IMPACT

The next three figures (figures 21-23) show seat and dummy response during obstacle impact. Figure 21 shows comparisons of the floor, seat, and pelvis response for Seat A. This was the most forward seat in the cabin, and similar data for this seat during ground impact has already been shown. Again, the data is consistent. The fact that the floor and seat pan accelerations matched fairly well gives confidence that the transducers were performing properly. This is particularly true of the vertical acceleration. The dummy response is quite different, as would be expected. However, the velocity change for the dummy is also quite different, and this is not so encouraging.

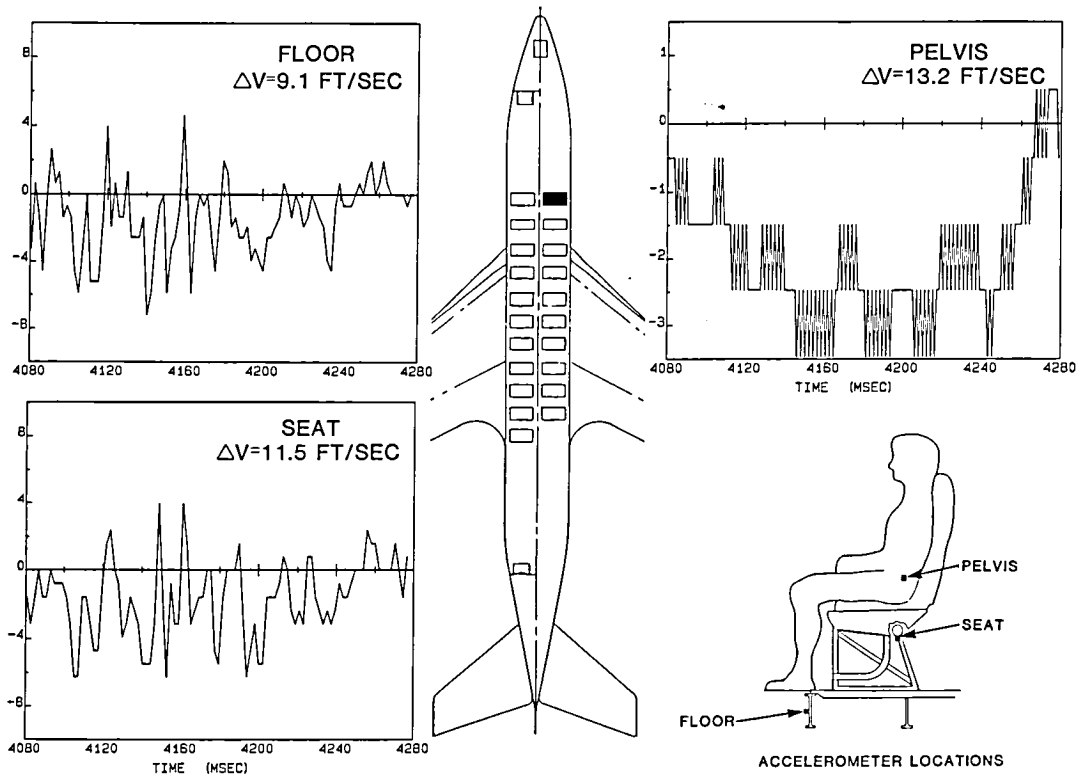
Figure 22.

The longitudinal data seen in figure 22 also shows reasonable correlation between floor and seat pan. Here, the dummy velocity change is more nearly matched to that of the seat pan.

LONGITUDINAL ACCELERATIONS - SEAT A (R.H.), OBSTACLE IMPACT

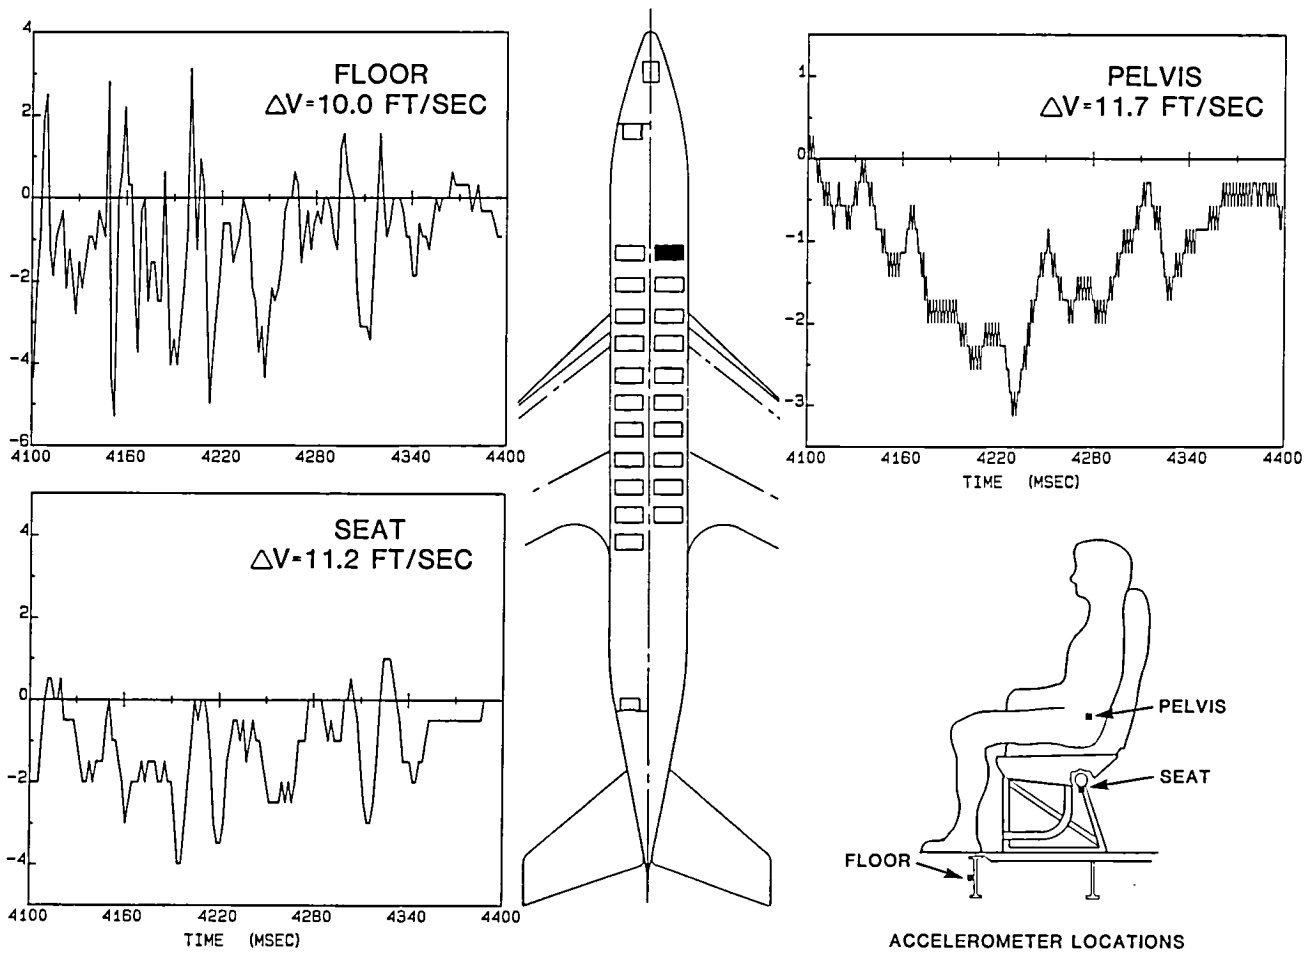
Figure 23.

Figure 23 shows the lateral component of acceleration during ground impact. The lesser stiffness of the seat in this direction causes more of a disparity between floor and seat pan accelerations.

LATERAL ACCELERATIONS - SEAT A (R.H.), OBSTACLE IMPACT

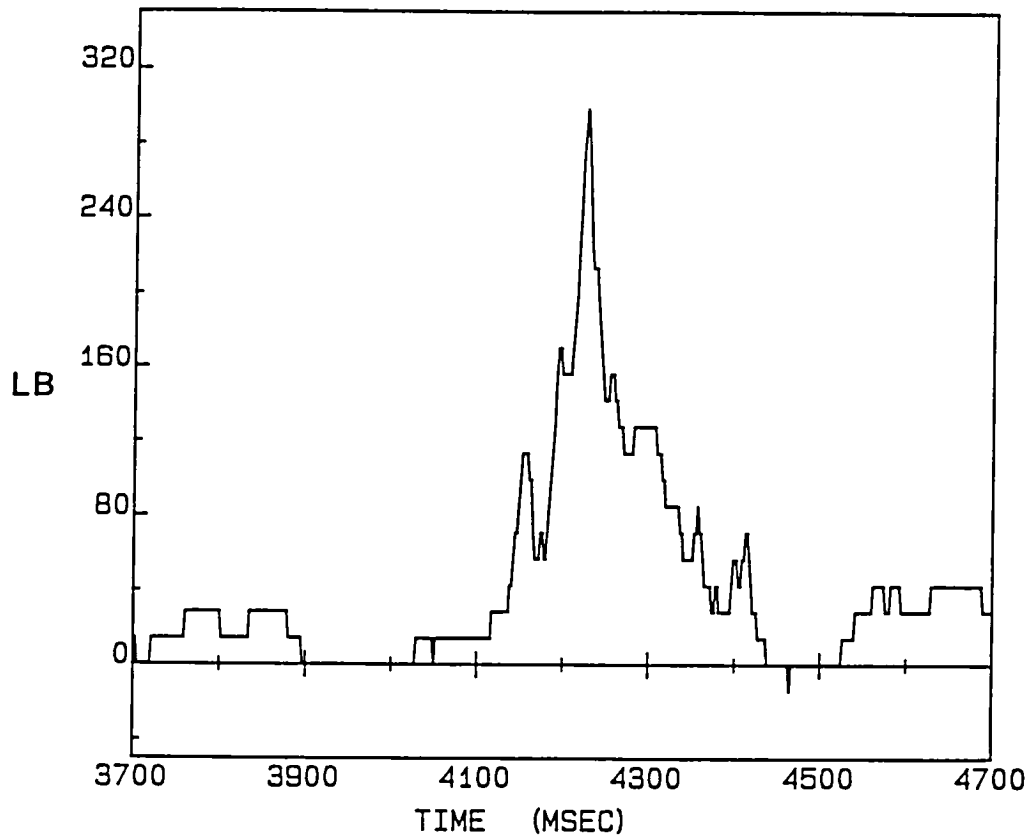
Figure 24.

TYPICAL LAP BELT LOAD

Figure 24 shows a typical lap belt tensile load, with about a 300-lb peak. This is a low load for a lap belt, and most of the lap belt data reviewed is similar. It is relatively consistent with the measured G loads and the film data which shows that the dummies did not jackknife.

OBSTACLE IMPACT

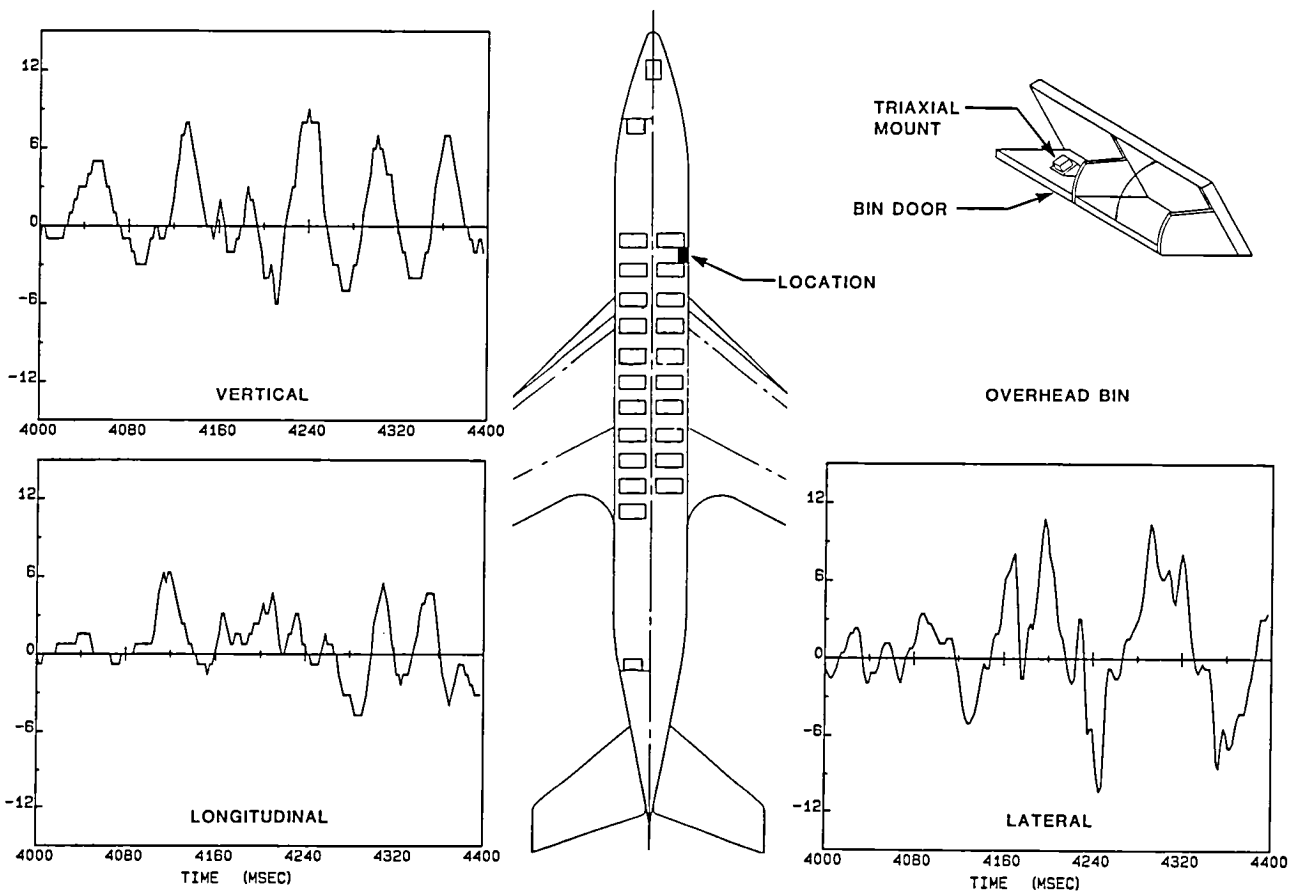
Figure 25.

OVERHEAD BIN ACCELERATIONS (G) - OBSTACLE IMPACT

Figure 25 shows overhead bin data. The FAA had a few accelerometers on an overhead bin that was placed in the aircraft. There was a mass attached to the door of the bin and the accelerometer was mounted to its back. There are peaks of 6 G or more in the vertical and longitudinal directions. Higher values are seen in the lateral direction. This data is from the time of obstacle impact.
