Effect of Hard Particle Impacts on the Atomic Oxygen Survivability of Reflector Surfaces With Transparent Protective Overcoats

Daniel A. Gulino
Lewis Research Center
Cleveland, Ohio

Prepared for the
25th Aerospace Sciences Meeting
sponsored by the American Institute of Aeronautics and Astronautics
Reno, Nevada, January 12-15, 1987

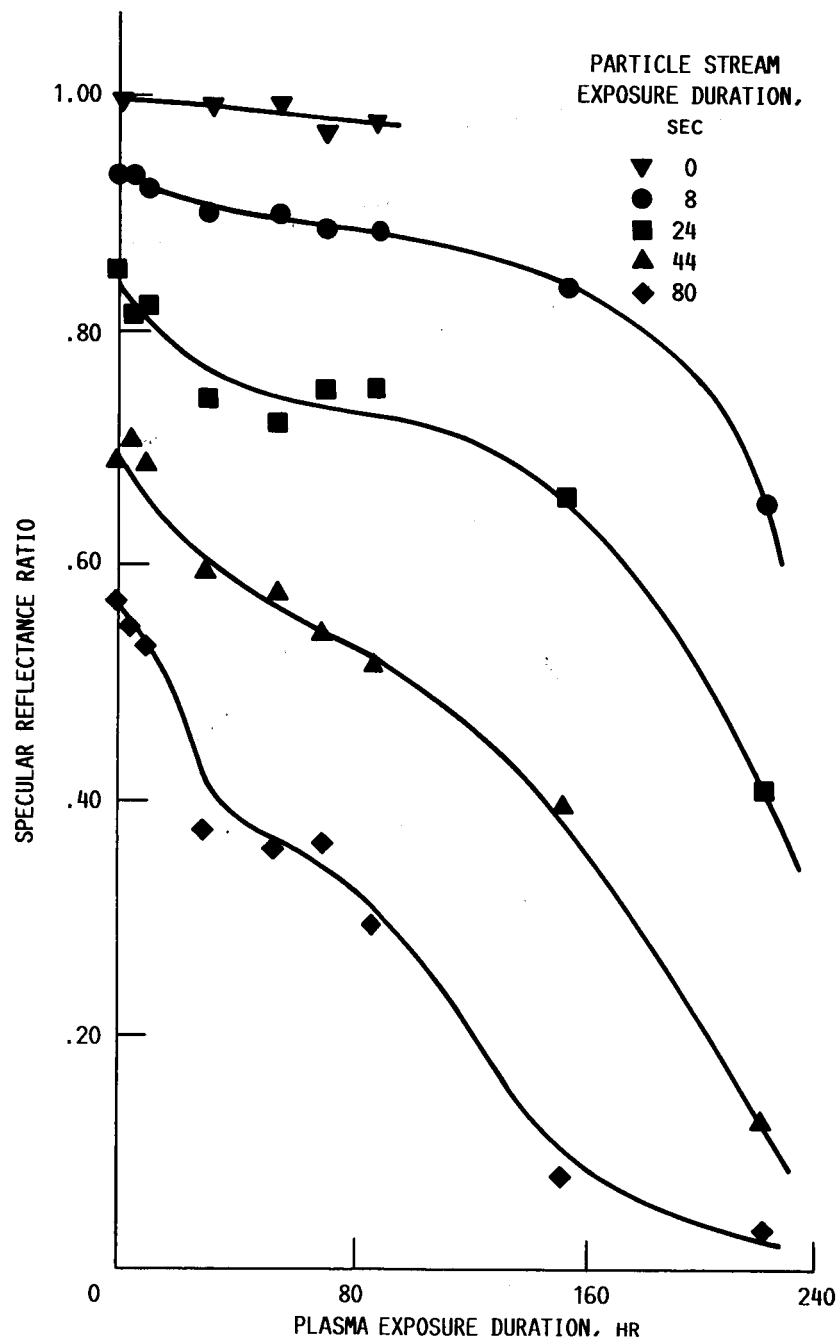
FIGURE 1.- SPECULAR REFLECTANCE RATIO VERSUS PLASMA EXPOSURE TIME FOR SEVERAL GRAPHITE-EPOXY SUBSTRATE SAMPLES FOR VARIOUS LENGTHS OF TIME OF EXPOSURE TO THE ERODIVE PARTICLE STREAM. THE RATIO IS CALCULATED BY DIVIDING THE REFLECTANCE AT A GIVEN TIME BY THE REFLECTANCE MEASURED PRIOR TO PARTICLE EXPOSURE.

In Figs. 1 and 2 are plotted, respectively, the specular and total reflectance ratios of several of the graphite-epoxy substrate samples as a function of oxygen plasma exposure duration. The reflectance ratios were obtained by dividing the reflectance at a given time by the initial, non-eroded, non-ashed reflectance. The data points at zero hours thus indicate the effect on the reflectance of only the erosive particle stream as a function of duration of exposure to the particle stream. In these plots, three rather broadly defined regions can be observed. During the first roughly 30 hr of exposure, the reflectances fell rather markedly from their initial values, with the degree of fall directly proportional to the length of time of exposure to the particle flux. For the next 60 hr, the reflectances remained roughly constant. After this, they began to decrease once again, and with a rate of decrease that increased with time. These effects were somewhat more pronounced on the specular reflectance plots.

These photos clearly show that while oxidative undercutting is a process that does not begin immediately, once it does start, its rate accelerates with increasing asher exposure time. This finding explains the shape of the reflectance versus exposure time curves shown in Figs. 1 and 2, particularly the later, rapid fall-off in reflectance. As a final observation in this series, Fig. 9 is a micrograph of the lower right portion of Fig. 8, taken at a tilt angle of 60° . This figure shows that wherever the undercutting occurred, the surface of the sample had collapsed. This is an indication that oxidation of the substrate had occurred.

The series of SEM micrographs discussed above (Figs. 3 to 9) indicates that the reflectance data (Figs. 1 to 2) may be explained by the following mechanism: the initial, rapid drop in reflectance was caused by oxidation of those parts of the silver layer directly exposed as a result of the particle-induced damage. After some time (about 30 hr in this case), this

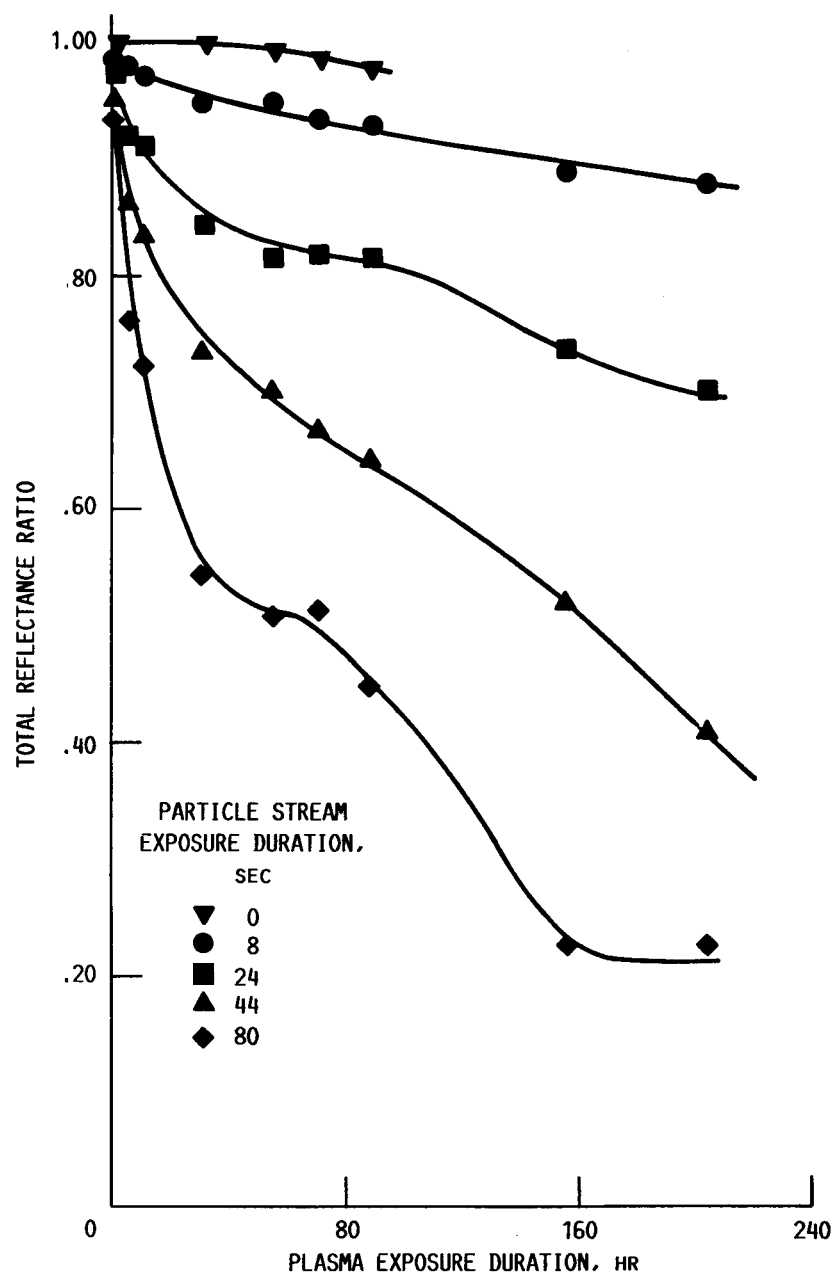
FIGURE 2.- TOTAL REFLECTANCE RATIO VERSUS PLASMA EXPOSURE TIME FOR SEVERAL GRAPHITE-EPOXY SUBSTRATE SAMPLES FOR VARIOUS LENGTHS OF TIME OF EXPOSURE TO THE EROSIIVE PARTICLE STREAM. THE METHOD OF CALCULATION IS IDENTICAL TO THAT OF FIGURE 1.

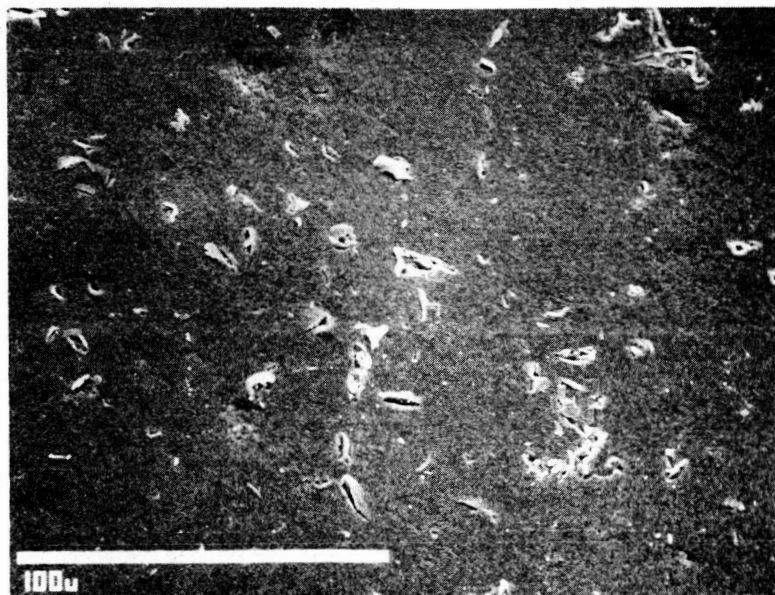
FIGURE 4. - MICROGRAPH TAKEN AT 500x SHOWING THE EFFECT OF THE EROSIIVE PARTICLE STREAM ONLY (NO PLASMA EXPOSURE) ON A GRAPHITE-EPOXY SUBSTRATE SAMPLE. A NUMBER OF DEFECT SITES ARE EVIDENT.

SEM micrographs were obtained after a variety of different treatments and exposure times. Figure 3 is a micrograph of a non-eroded, non-ashed sample on a graphite-epoxy substrate. (The white, irregularly shaped object in the lower left is a dust particle which aided in focusing.) The only feature visible is the ridged structure of the graphite-epoxy substrate. Figure 4 is a micrograph of a sample similar to that in Fig. 3, except that this sample had been exposed to the particle stream. A number of defect sites are evident.

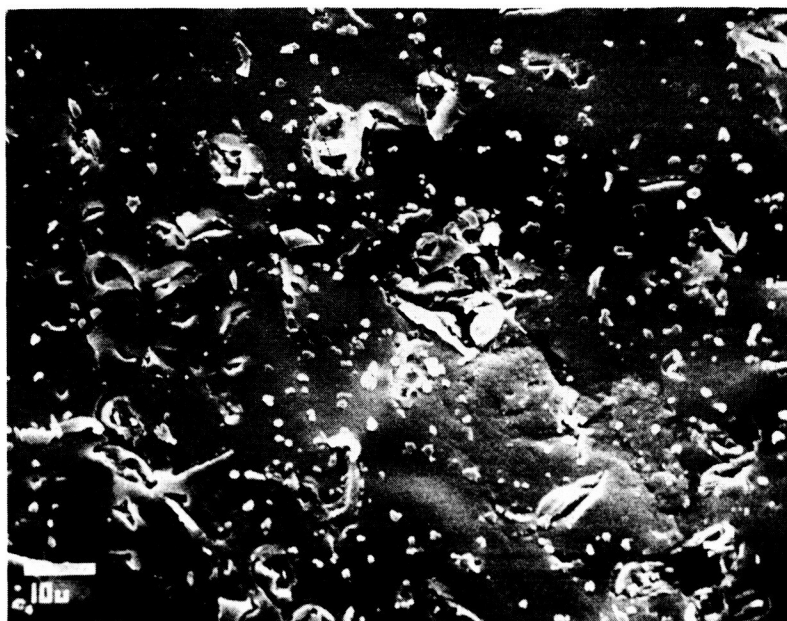
FIGURE 5. - MICROGRAPH TAKEN AT 1000X SHOWING A PARTICLE ERODED SURFACE AFTER 50 HOURS OF EXPOSURE TO THE OXYGEN PLASMA. THE APPEARANCE IS SIMILIAR TO THAT OF FIGURE 4. NO EVIDENCE OF UNDERCUTTING IS VISIBLE.

Figure 5 is a micrograph of a sample that had been exposed in the asher for 50 hr. While the region photographed is a different from that of Fig. 4, their appearance is the same: a variety of differently sized and shaped defect sites. Figure 6 is a micrograph of a sample exposed in the asher for 90 hr. The heart-shaped, darkened "rim" surrounding the defect site in the lower left of this photo is a result of oxidation of the silver and/or the substrate surrounding that defect site. The width of the rim is very roughly the diameter of the pinhole defect. Figure 7 is an enlarged view of another defect site on the same sample as Fig. 6. Oxidative undercutting (the darkened rim) is clearly evident. Figure 8 is a micrograph of a sample exposed in the asher for 240 hr. In this figure it is evident that oxidative undercutting has occurred to a large degree. The widths of the darkened rims are now nearly ten times the diameter of the defect site.

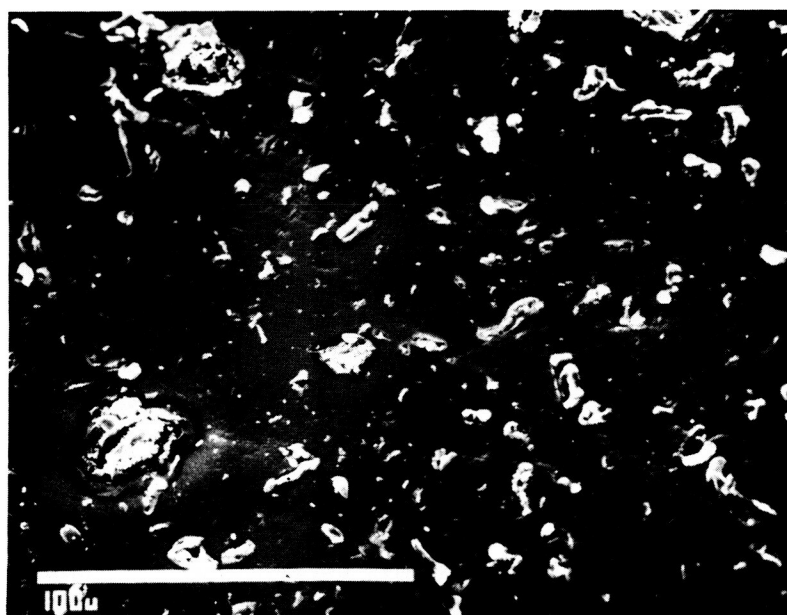
FIGURE 6. - MICROGRAPH TAKEN AT 500X SHOWING A PARTICLE ERODED SURFACE AFTER 90 HOURS OF EXPOSURE TO THE OXYGEN PLASMA. THE DARKENED "RIM" SURROUNDING THE HEART-SHAPED DEFECT IN THE LOWER LEFT IS OXIDATION OF THE SILVER LAYER AND/OR THE SUBSTRATE BENEATH THE PROTECTIVE COATING.

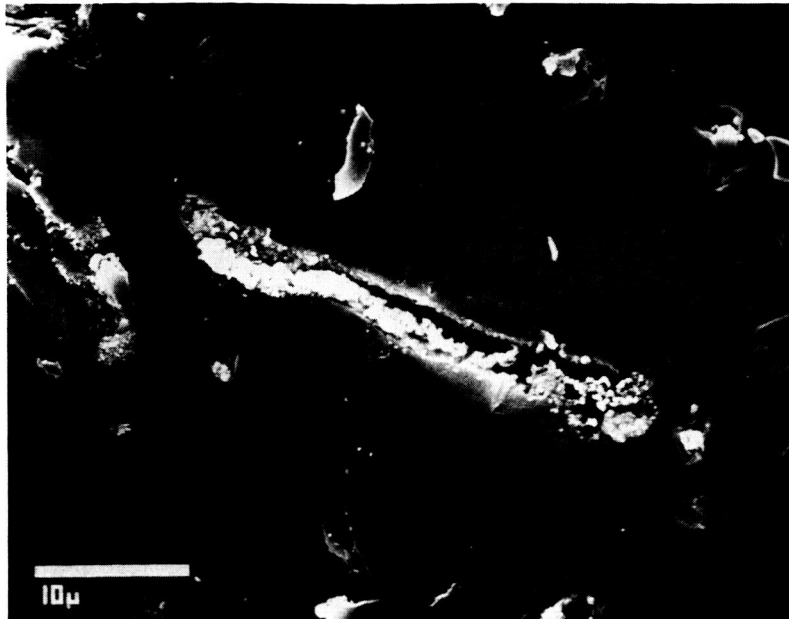
FIGURE 7. - MICROGRAPH TAKEN AT 2000X OF A FEATURE ON THE SAME SAMPLE AS DEPICTED IN FIGURE 6. OXIDATIVE UNDERCUTTING CAN BE SEEN CLEARLY AS THE DARKENED "RIM" SURROUNDING THE ELONGATED DEFECT.

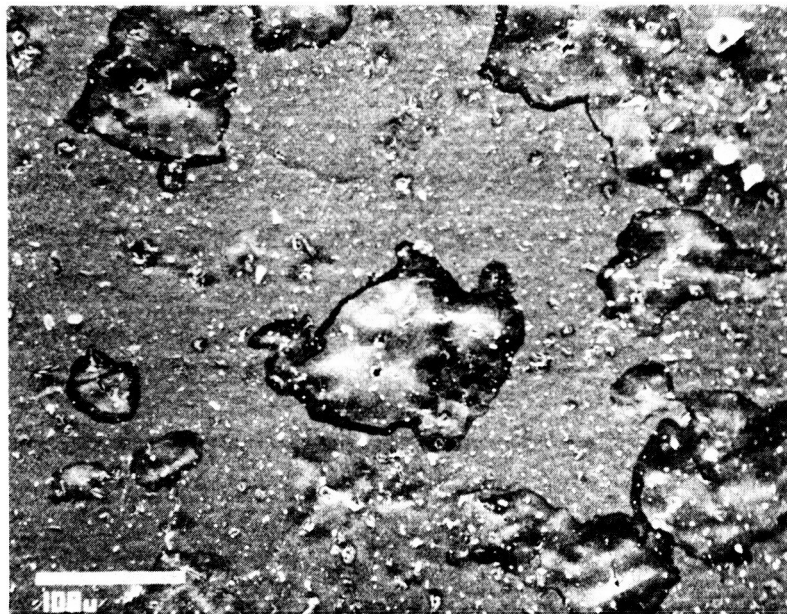
FIGURE 8. - MICROGRAPH TAKEN AT 200X SHOWING A PARTICLE ERODED SURFACE AFTER 240 HOURS OF EXPOSURE TO THE OXYGEN PLASMA. THE DARKENED AREAS SURROUNDING THE DEFECT SITES HAVE GROWN CONSIDERABLY IN SIZE RELATIVE TO THE SIZE OF THE PINHOLE, INDICATING THAT OXIDATIVE UNDERCUTTING HAS OCCURRED TO A SIGNIFICANT DEGREE.

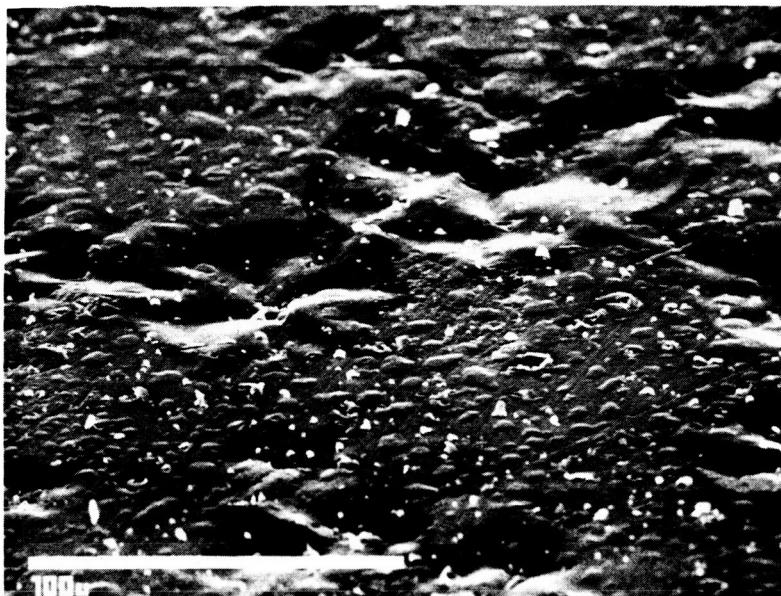
FIGURE 9. - MICROGRAPH TAKEN AT 500X OF THE LOWER RIGHT PORTION OF FIGURE 8 AT A SHARP ANGLE (60°) SHOWS THAT WHEREVER UNDERCUTTING HAD OCCURRED, THE SURFACE HAD COLLAPSED.

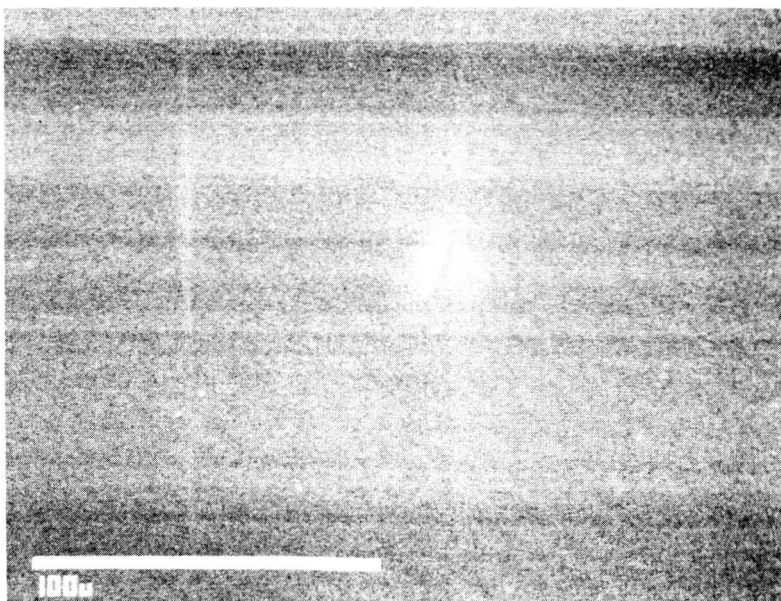
FIGURE 10. - MICROGRAPH TAKEN AT 500X SHOWING A NON-ERODED, NON-ASHED FUSED QUARTZ SUBSTRATE SAMPLE.

Figures 10 to 17 show the effects of exposure of the fused quartz substrate samples to the plasma environment for different lengths of time. For comparison purposes, Fig. 10 (like Fig. 3) shows a non-eroded, non-ashed sample. Figure 11 is a micrograph of a sample similar to that in Fig. 10, except that it has been exposed to the particle stream. As before, a number of defect sites resulting from the particle impacts is evident. Figure 12 is a micrograph of a pitted surface after 50 hr of exposure. While no undercutting (transverse oxidation of the silver, in this case) is readily observed, oxidation of the freshly exposed silver layer is evident as the puffed material protruding from the defect sites. This is more apparent in Fig. 13, which is the same surface as shown in Fig. 12, but at a higher magnification and at a sharp tilt (60°).

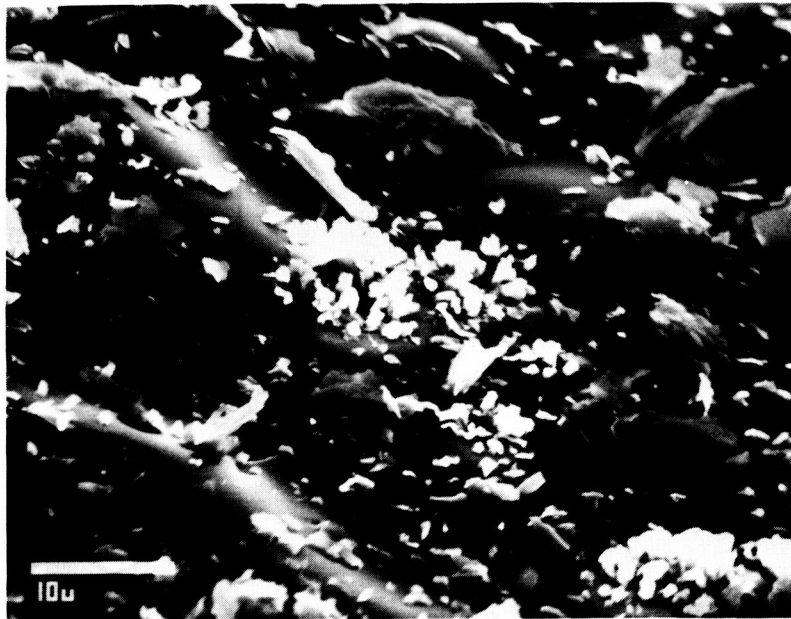
FIGURE 13. - MICROGRAPH OF THE SAME SAMPLE AS THAT OF FIGURE 12 BUT AT 2000X AND AT A 60° TILT ANGLE. THE OXIDIZED SILVER, WHICH TAKES THE FORM OF A PUFFY MATERIAL PROTRUDING THROUGH THE DEFECT SITES, IS CLEARLY EVIDENT.

samples. However, a comparison of Fig. 13 with Fig. 17 (the latter of which is an enlargement of the same surface seen in Fig. 16, but at a 60° tilt) shows that the outgrowths of silver oxide had continued unabated.

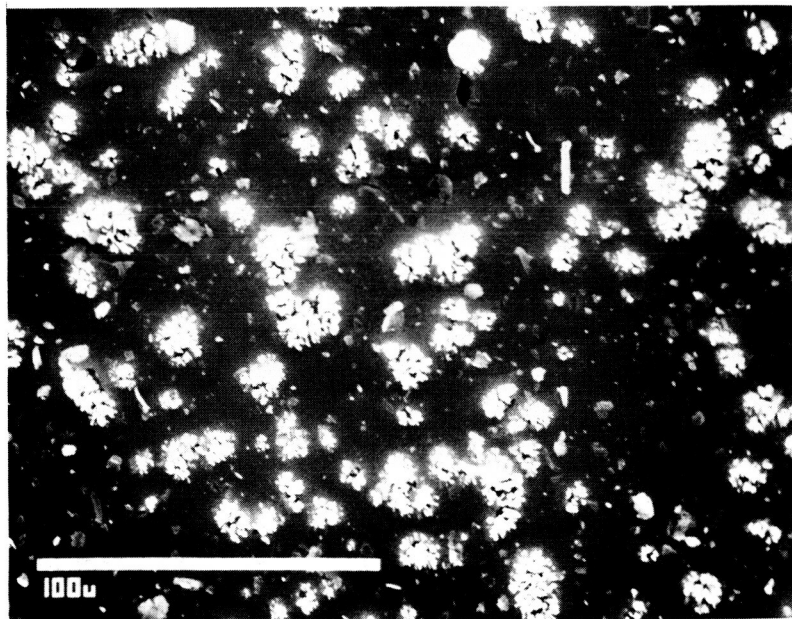
FIGURE 14. - MICROGRAPH TAKEN AT 500X SHOWING THE SURFACE OF A FUSED QUARTZ SUBSTRATE SAMPLE AFTER PARTICLE EROSION AND 90 HOURS OF EXPOSURE TO THE OXYGEN PLASMA. OXIDIZED SILVER IS SEEN PROTRUDING THROUGH THE DEFECT SITE. TRANSVERSE OXIDATION IS VISIBLE AS A BRIGHTER RIM SURROUNDING THE DEFECT SITE.

Figure 14 is a micrograph of an eroded surface after 90 hr of exposure. As before, oxidized silver protruding through the defect sites is clearly evident. Transverse oxidation of the silver after 90 hr of exposure is more clearly seen in Fig. 15, which is an enlargement of Fig. 14. As in the previous samples, the oxidative damage appears as a discolored rim surrounding the defect site. In Fig. 15, the rim appears brighter in color.

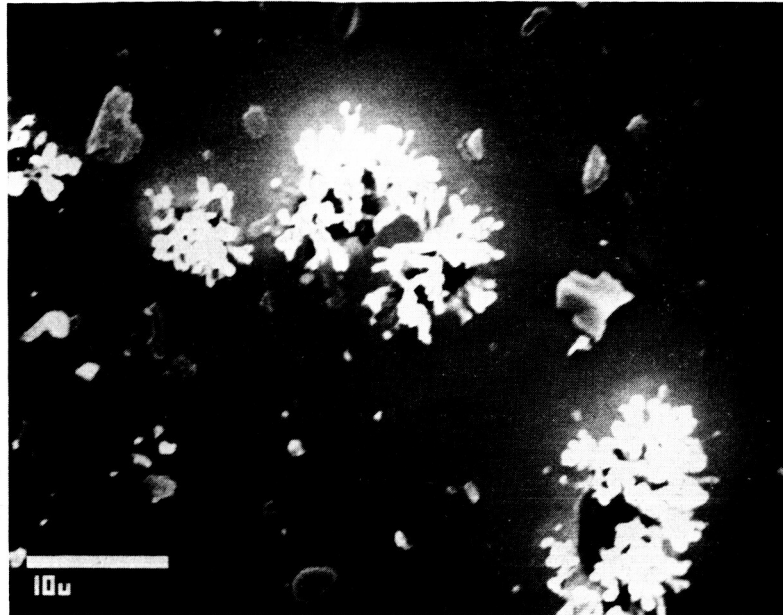
FIGURE 15. - MICROGRAPH OF THE SAME SAMPLE AS THAT OF FIGURE 14, BUT AT 2000X. TRANSVERSE OXIDATION IS CLEARLY EVIDENT AS A BRIGHTER RIM SURROUNDING THE DEFECT SITE.

Figure 16 is micrograph showing a pitted surface after 240 hr of asher exposure. As in Fig. 15, a rim lighter in color and surrounding each defect site is evident. Unlike the graphite-epoxy substrate samples, the width of the rim did not appear to increase significantly between the 90 hr and 240 hr

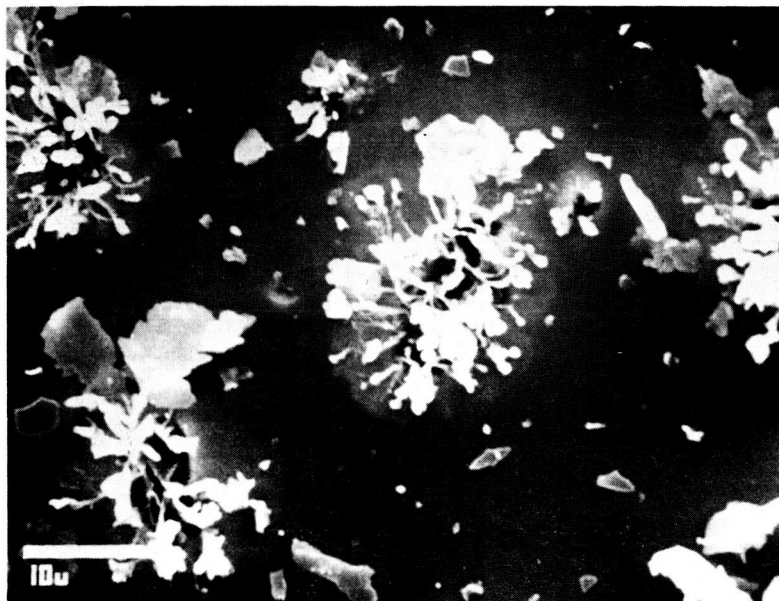
FIGURE 16. - MICROGRAPH TAKEN AT 2000X SHOWING THE SURFACE OF A FUSED QUARTZ SUBSTRATE SAMPLE AFTER PARTICLE EROSION AND 240 HOURS OF OXYGEN PLASMA EXPOSURE. TRANSVERSE OXIDATION IS EVIDENT; HOWEVER, ITS EXTENT DID NOT INCREASE SIGNIFICANTLY OVER THAT OF THE 90 HOUR SAMPLE (FIGS. 14 AND 15).

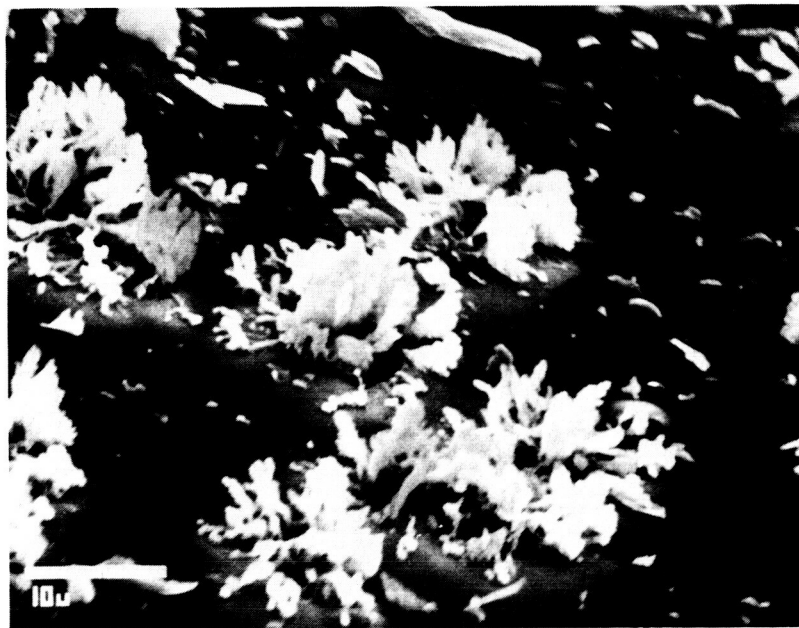
FIGURE 17. - MICROGRAPH OF THE SAME SAMPLE AS THAT OF FIGURE 16
AT THE SAME MAGNIFICATION AND A 60° TILT. OUTGROWTH OF OXIDIZED
SILVER HAD BEEN CONTINUING AS OF 240 HOURS.
