# NASA Contractor Report 3875

## Fuel Containment, Lightning Protection, and Damage Tolerance in Large Composite Primary Aircraft Structures

Charles F. Griffin and Arthur M. James

**Charles F. Griffin and Arthur M. James**  
*Lockheed-California Company*  
*Burbank, California*

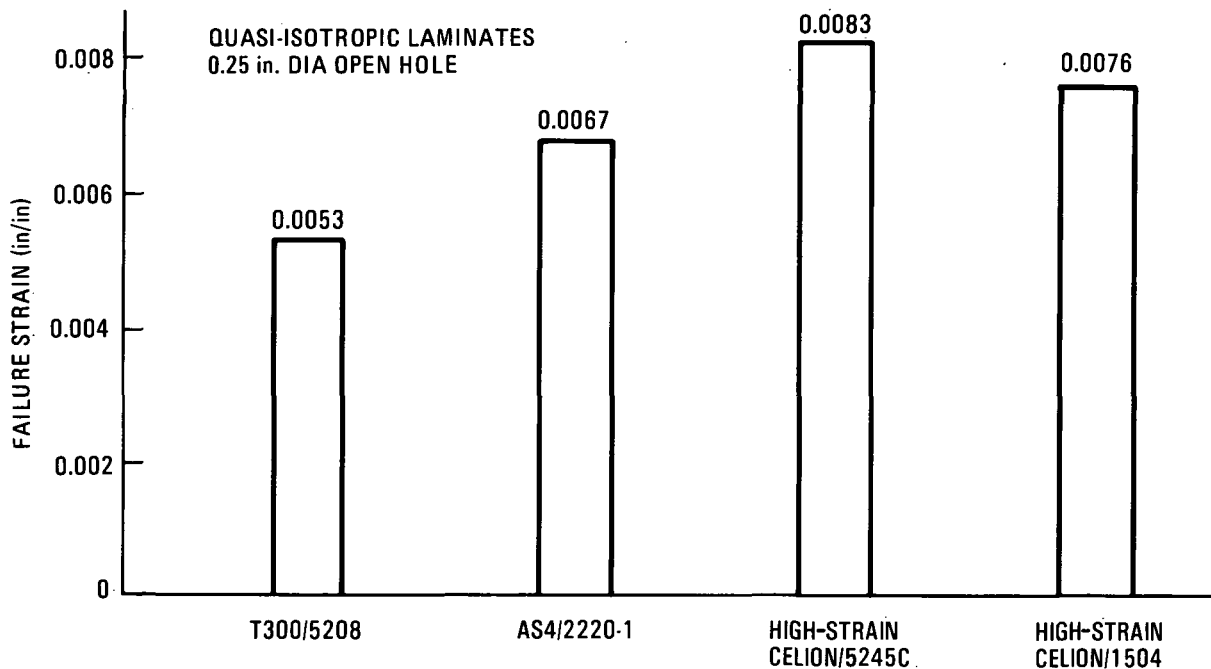
Figure 1. - Comparison of the tension failure strain of various materials.

Celion/1504 is presented in Table 2. The data indicate that the laminate fabricated with 5245C resin has better tensile properties than the laminate fabricated with 1504 resin. Both materials have much greater failure strains for the notched coupon test than either AS4/2220-1 or T300/5208, as shown in Figure 1.

The material used for the fabrication of the L-1011 composite vertical fin and ailerons (References 6 and 7) was T300/5208. The design allowable tensile strain established for this material was approximately 0.0045 in/in for the notched (0.25-inch-diameter hole) condition. The data presented in Table 2 and Figure 1 indicate that the combination of high strain to failure of graphite fibers in a toughened resin matrix could lead to a significantly higher design allowable strain for tensile loads.

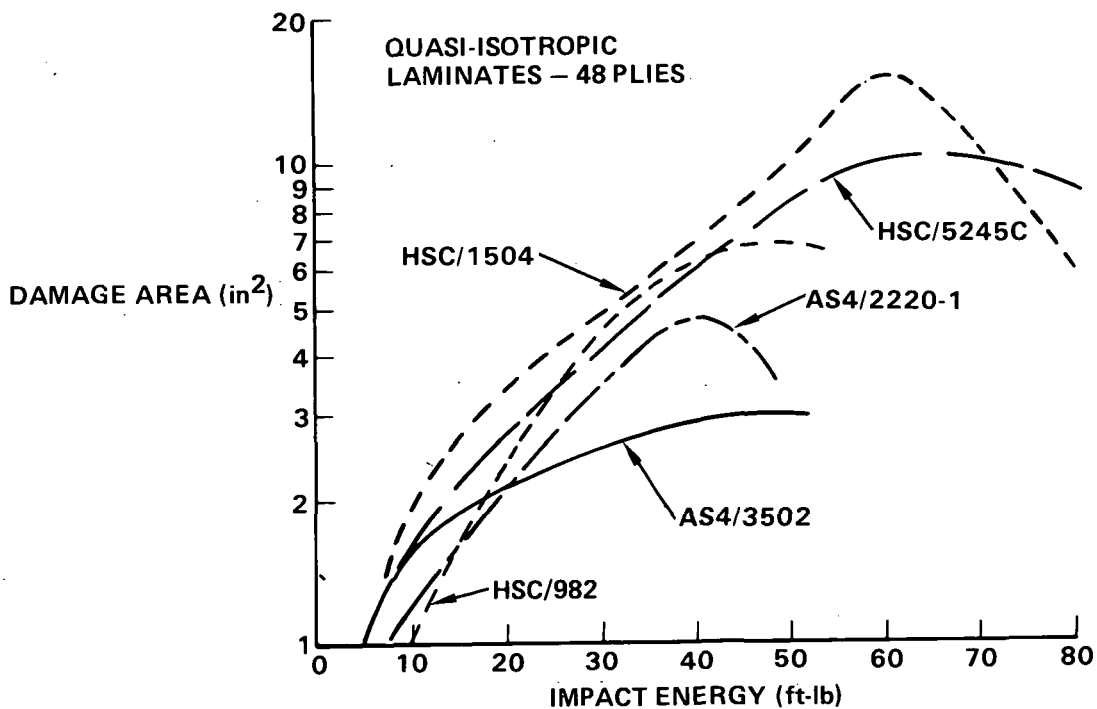
Figure 2. - Evaluation of toughened resin composites-impact response.

Quasi-isotropic panels, 48 plies thick were fabricated with each material and subjected to impact tests. For these tests, a 25- by 7-inch portion of the laminate was clamped to a steel plate with a 5- by 5-inch opening. The panel was struck in the center of the opening with a 12-pound impactor which had a 0.5-inch hemispherical diameter hardened steel tup. After impacting, the panels were inspected visually and ultrasonically to ascertain the amount of damage. Figure 2 presents the damage area versus the impact energy for several materials. In general, the panels constructed with the toughened

resins had greater damage areas than did the panel constructed with the untoughened 3502 resin. All panels displayed visual damage on the impacted side of the panel at energy levels of 20 ft-lb and greater. At energy levels of 50 to 60 ft-lb, the panels were punctured by the impactor.
