Damage Tolerant Composite Wing Panels for Transport Aircraft

Peter J. Smith and Robert D. Wilson

CONTRACT NAS1-16863
DECEMBER 1985

Peter J. Smith and Robert D. Wilson
Advanced Composite Development Program

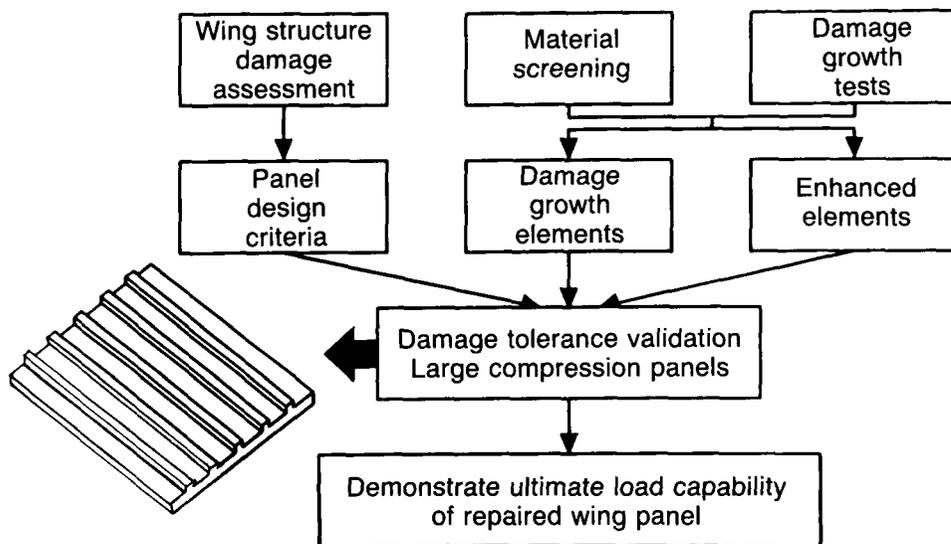
Figure 1. Damage Tolerance Panel Development Program

The results of the wing structure damage assessment study, the material screening and damage growth coupon tests, the baseline panel tests, and the enhanced panel tests were to feed into the final large compression panel damage tolerance program. Figure 1 presents a schematic of the Phase II program structure showing the progression toward the final large panel design validation tests.

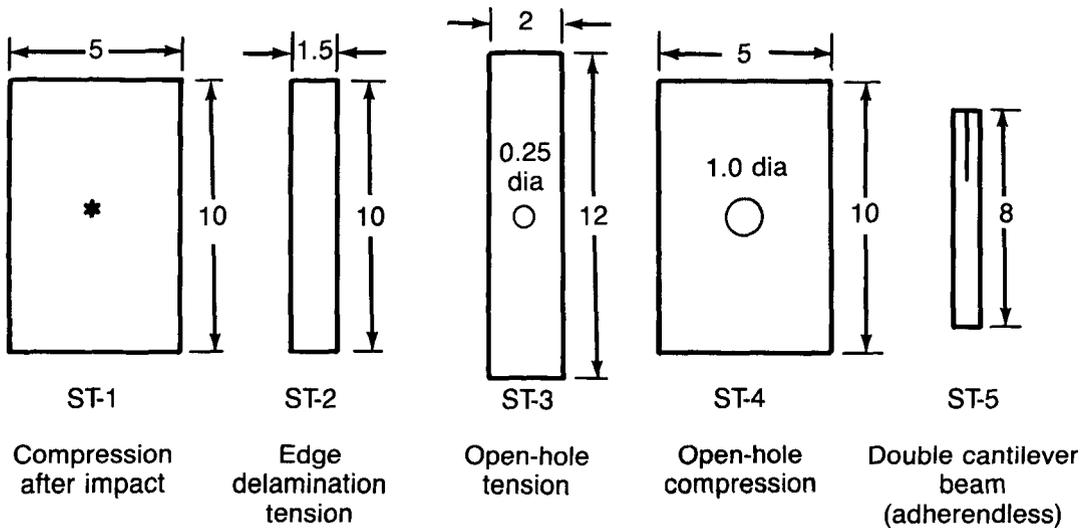
Figure 2. Standard Material Screening Tests

As a part of the development of more damage tolerant wing structure, several candidate toughened material systems were selected for evaluation in a material screening test program. NASA standard tests per reference 2 were used to evaluate these materials. These standardized tests (fig. 2) were mutually agreed upon by NASA, Boeing, Douglas, and Lockheed for use in the wing key technology contracts.

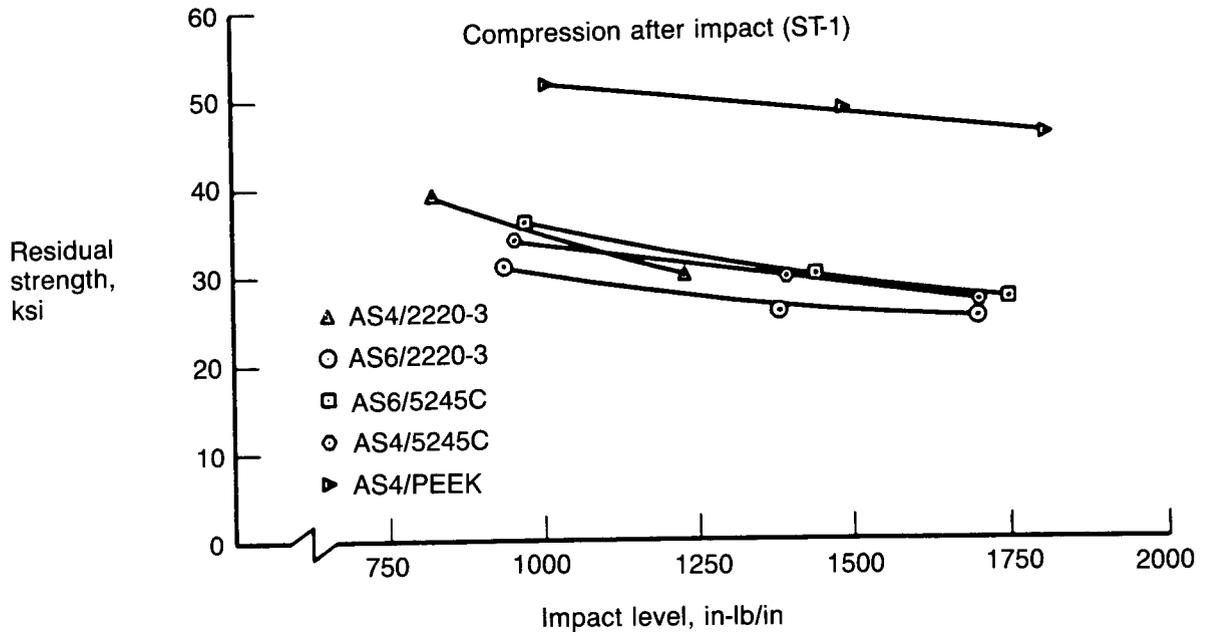
Figure 3. Compression After Impact Test Results

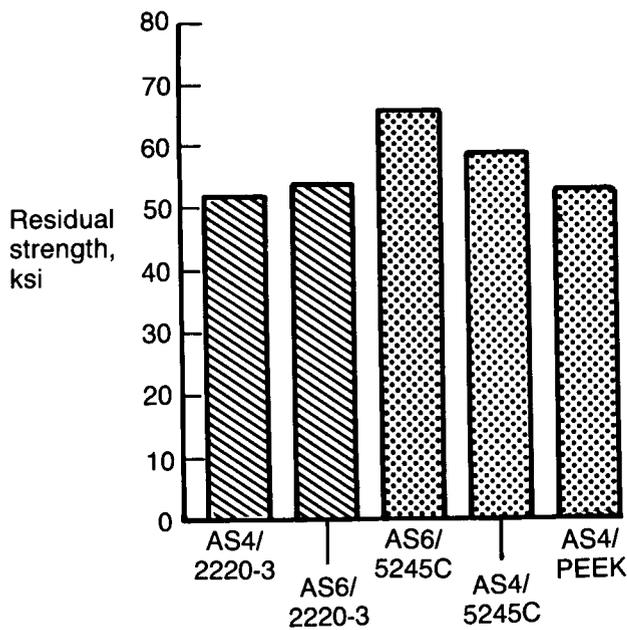
Figure 4. Open Hole Tension (ST-3) Test Results

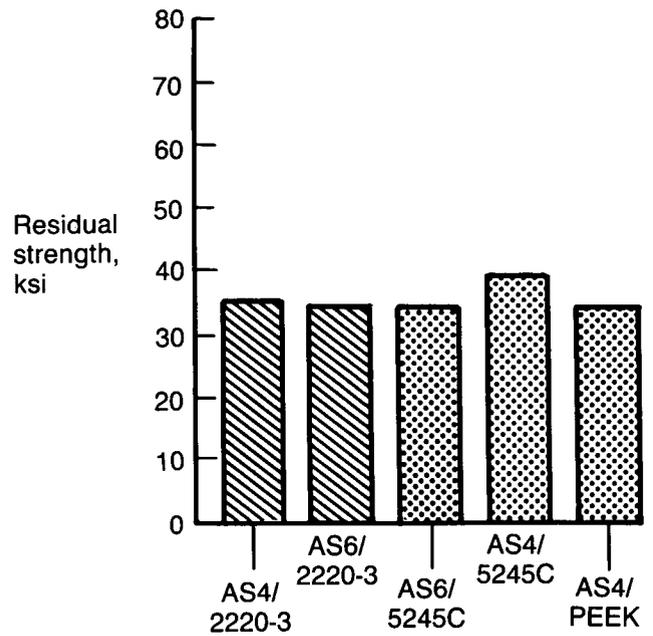
Figure 5. Open Hole Compression (ST-4) Test Results

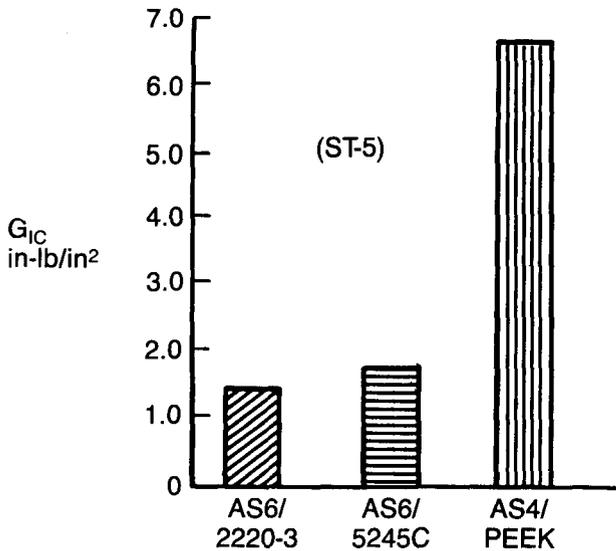
Figure 6. Mode I Fracture Toughness Test Results

Figures 6 and 7 present the results of the adherendless double cantilever beam (DCB) (ST-5) tests performed on the AS6/2220-3, AS6/5245C, and AS4/PEEK materials only.

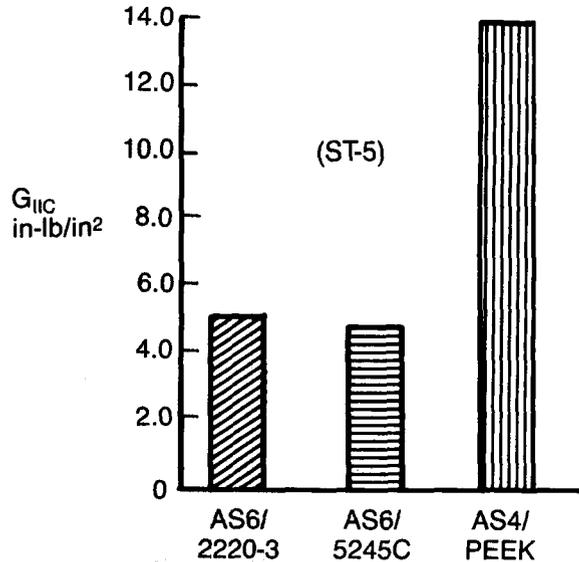
Figure 7. Mode II Fracture Toughness Test Results

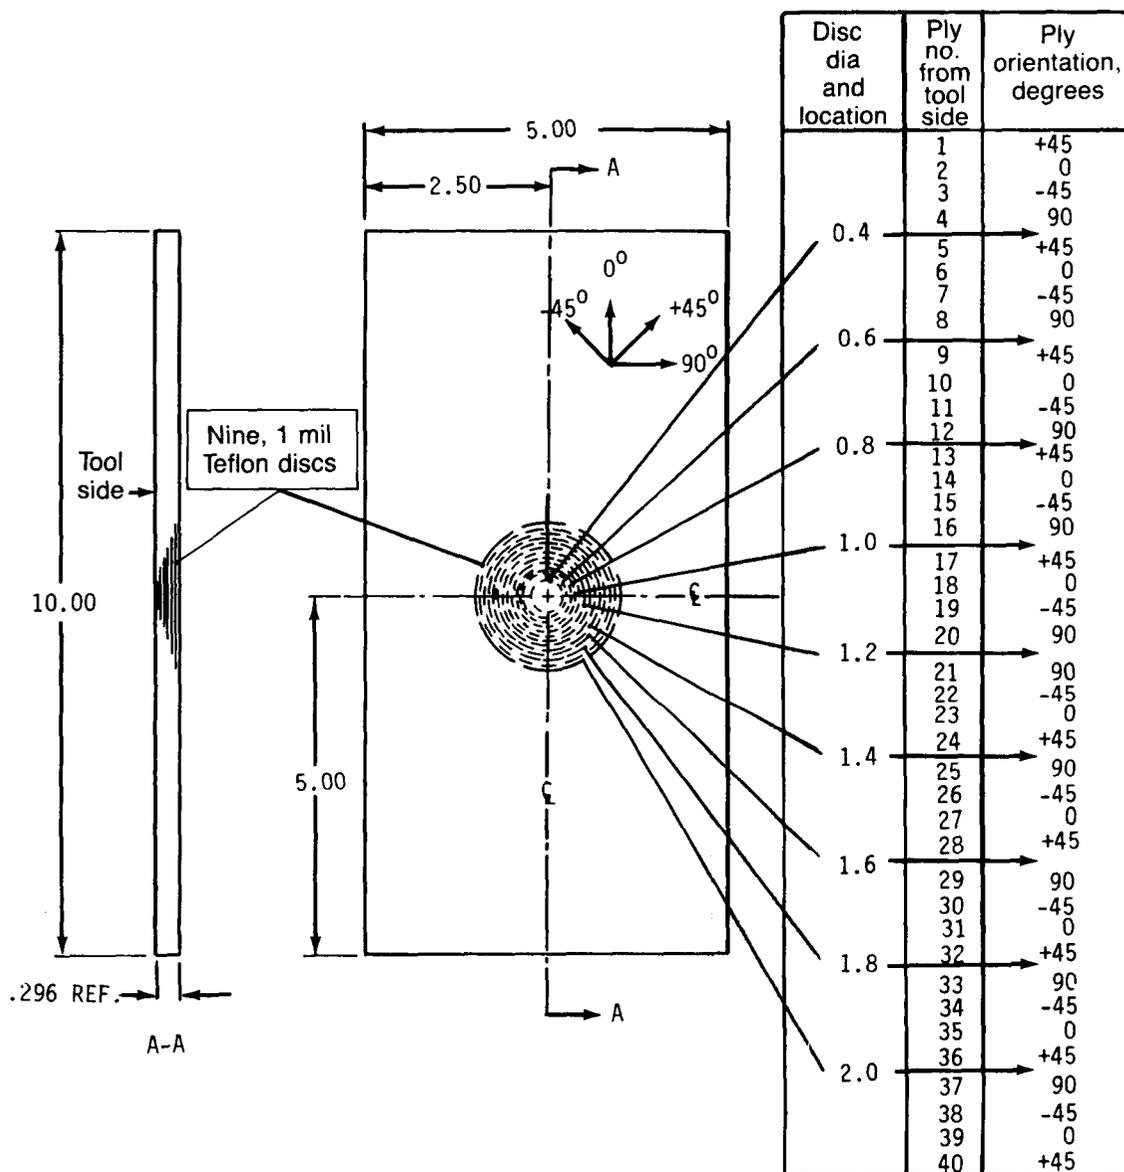
Figure 8. Simulated Impact Multidelamination Specimen Configuration

The toughened thermoset material, AS6/2220-3, was chosen as the Phase II baseline material for damage growth evaluations at both coupon and panel level. The purpose of the damage growth coupon test program was to evaluate the damage growth characteristics of low velocity impact damaged coupons after load cycling. The test program included five types of known initial damage, two fatigue environments, various different strain levels, and utilized the compression-after-impact coupon ST-4 (ref. fig. 2). The five types of known initial damage were: delaminations from 280 in-lb of impact energy; delaminations from 500 in-lb of impact energy; open hole with delamination damage; delaminations from 500 in-lb of impact energy in through-stitched laminates (Kevlar stitches in rows of four stitches/inch at both .25-in and .05-in row spacing); and multiple delamination simulation of impact damage, using nine Teflon discs of varying sizes inserted between plies in a cone-shaped arrangement through the laminate thickness. The configuration of the simulated multiple delamination specimen is presented in Figure 8.

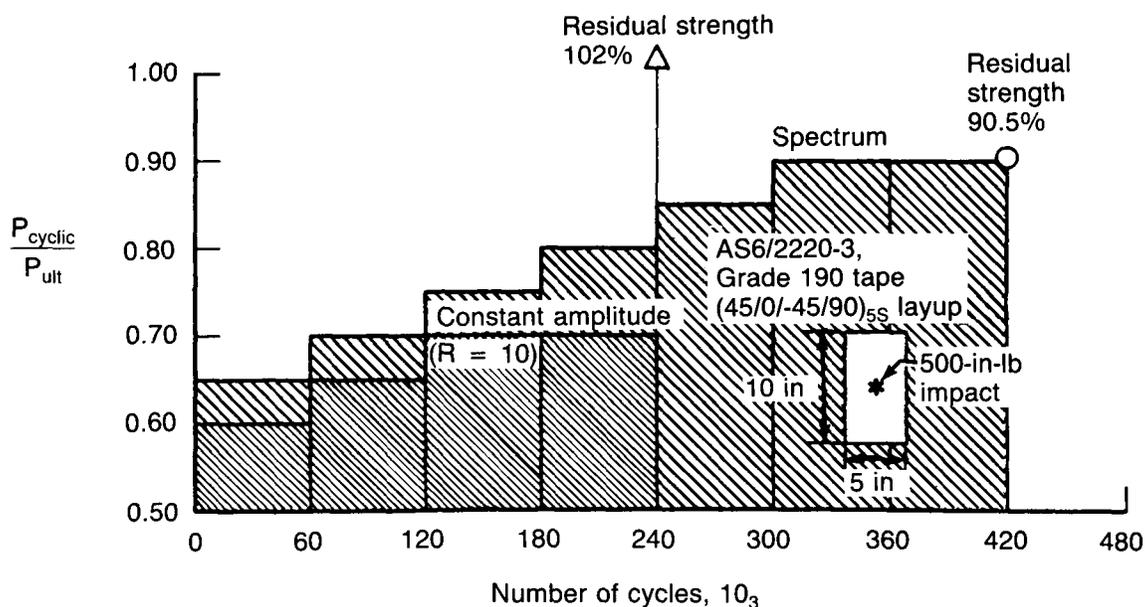
Figure 9. Fatigue Performance of 500-in-lb Impact Damaged Coupons

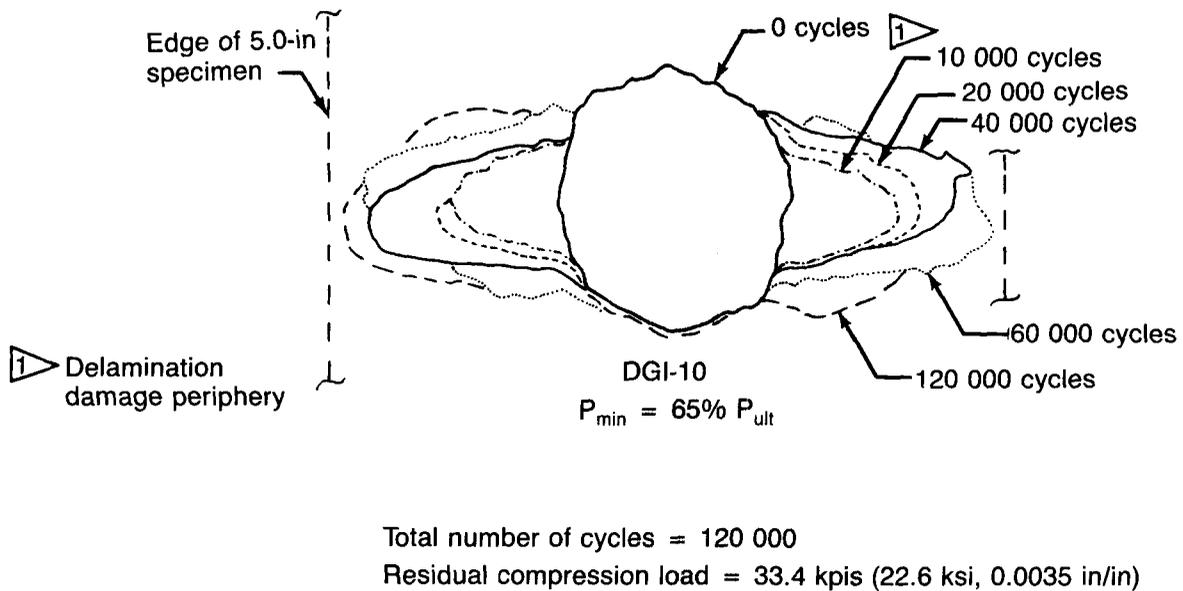
Figure 10. Damage Growth of 280-in-lb Impact-Damaged Specimen Subjected to Constant Amplitude ($R = 10.0$) Cycling

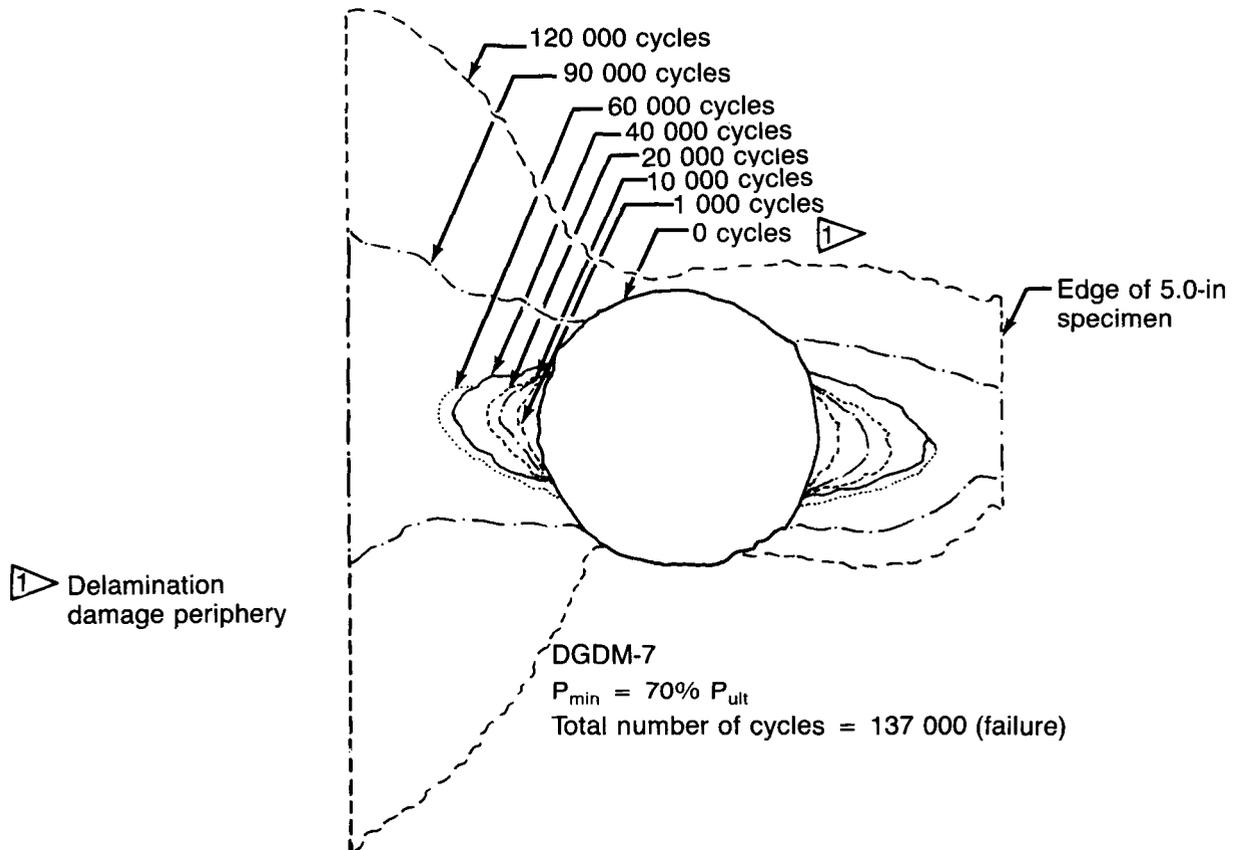
Figure 11. Damage Growth of Simulated Multiple Delamination Specimen Subjected to Constant Amplitude ($R = 10.0$) Cycling

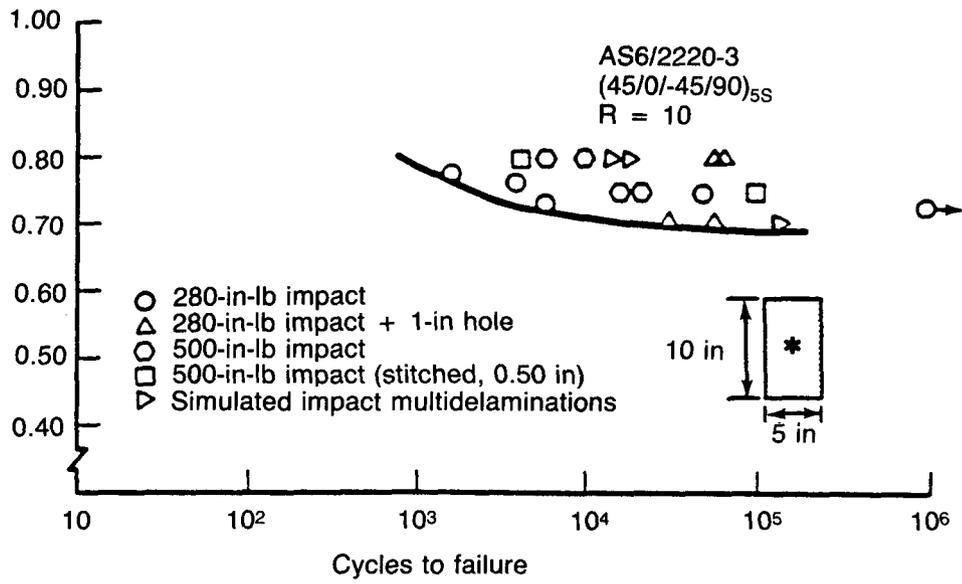
Figure 12. Fatigue Performance of Impact Damaged Coupons

Figure 12 presents the constant amplitude fatigue performance of the damage types tested showing fatigue endurance runout at about 70% of the static strengths. Figure 13 presents the residual static compression strength of all of the damage types for both uncycled and cycled specimens. The fatigue loaded specimens had all been cycled for several lifetimes and their residual compression strengths had degraded very little from the uncycled strengths. The specimens with Kevlar stitches at 0.25 row spacing which had been subjected to 500 in-lb impact damage exhibited the best static and fatigue compression after impact strength.

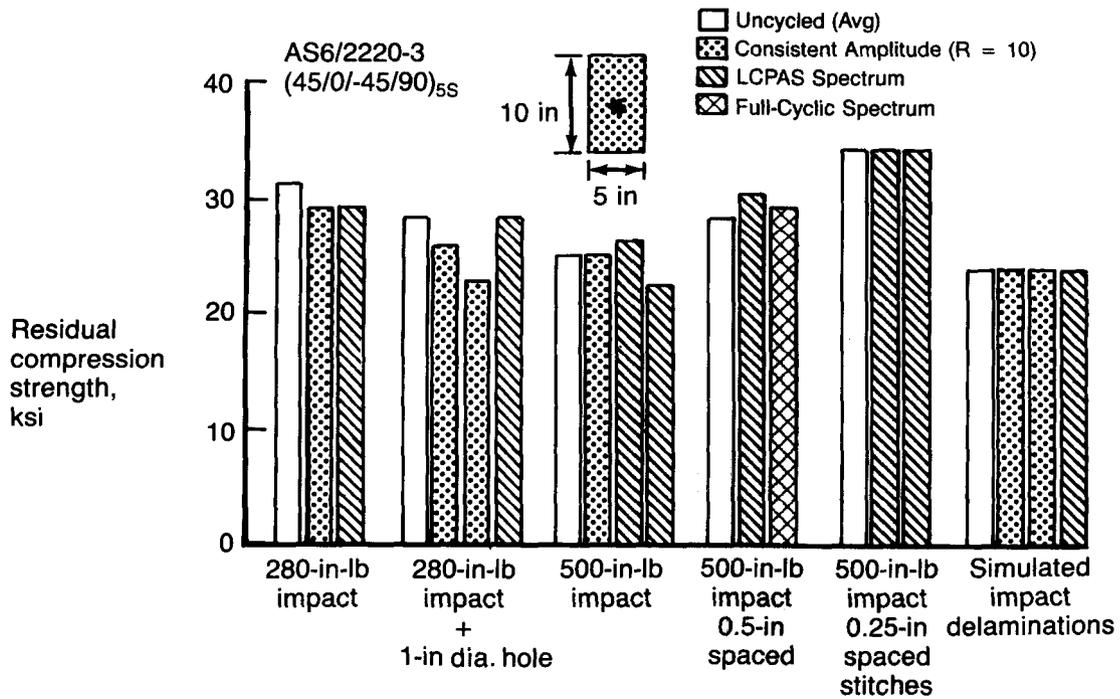
Figure 13. Residual Compression Strength of Impact Conditioned Specimens After Fatigue Cycling

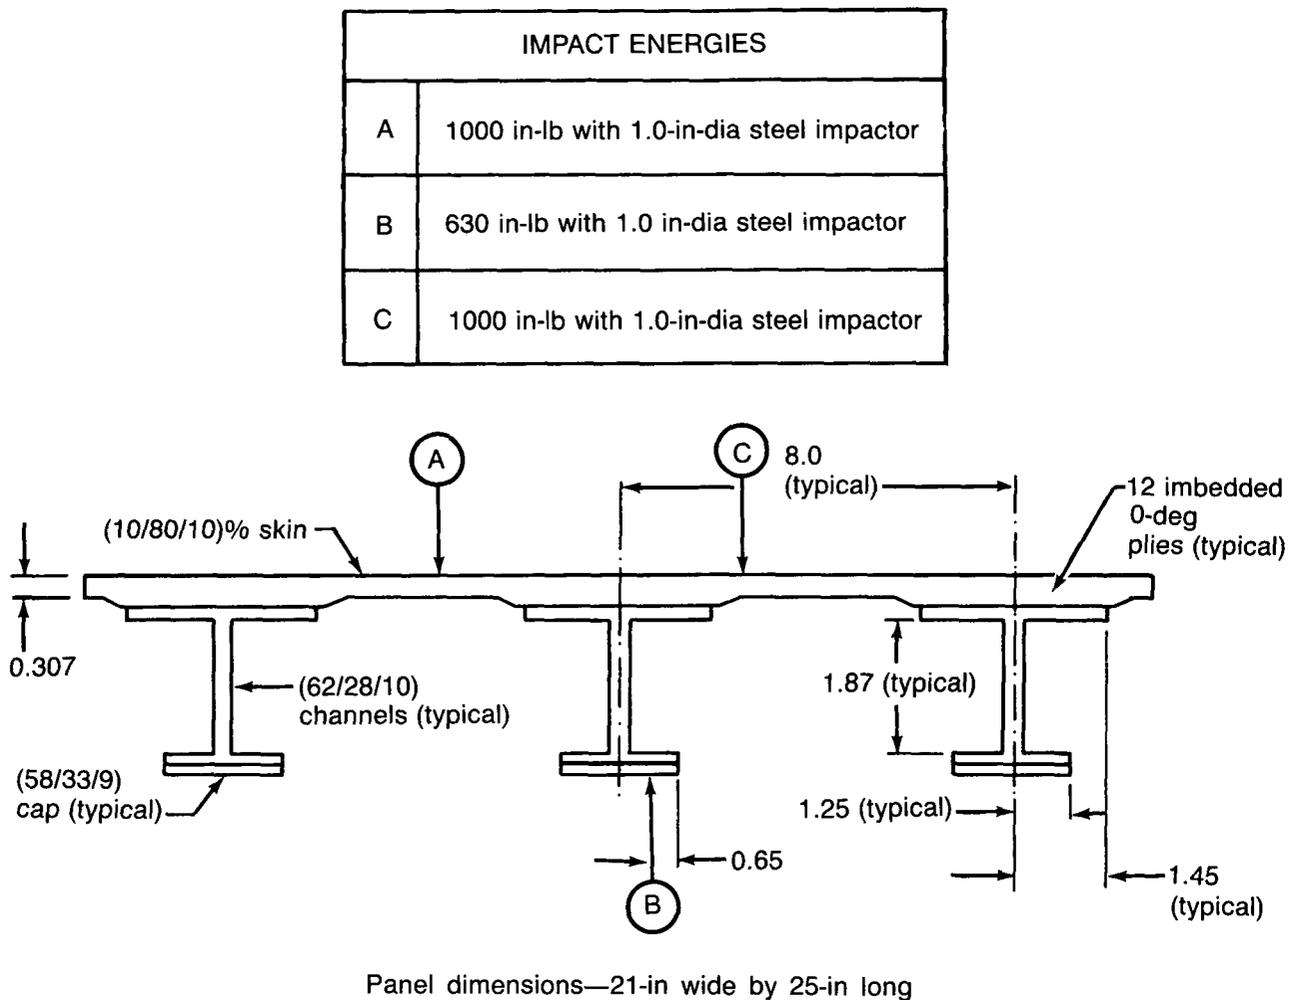
Figure 14. Baseline Panel Configuration and Impact Locations

The critical impact locations highlighted in the wing damage study were addressed in this test program. These impact locations and energy levels are presented in Figure 14. The skin impact damages (A) and (C) were not easily visible with impact dents in the laminate surfaces of approximately 0.03 inch. The stiffener cap impact (B) was more visible with a larger dent, approximately .06-in deep.

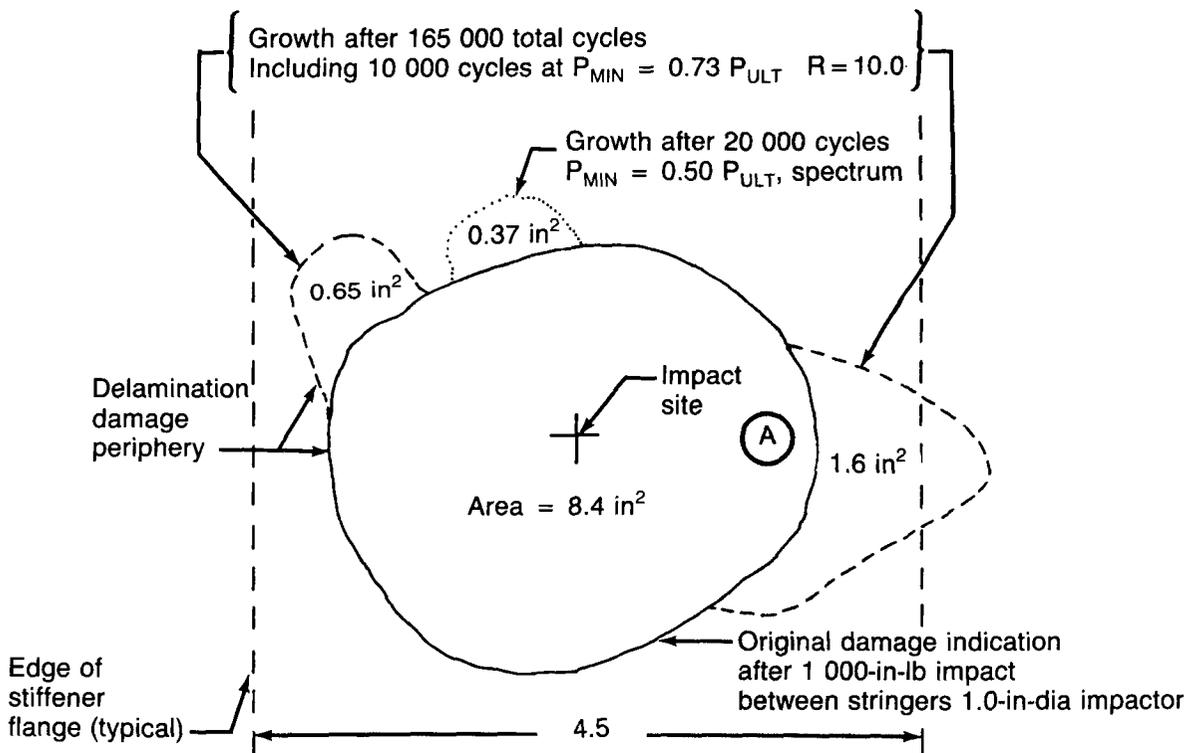
Figure 15. Damage Growth Results of Fatigue Cycling of Impact Damage Panel 65C23890-2

After 5000 cycles, the panel was reinspected and again no damage growth was detected. The maximum cyclic loading was increased to P_{min} equal to 495 kips (73% of P_{ult} and P/AE strain of .0044). This time damage growth was detected after 10,000 cycles. The load cycling was continued and another inspection performed after 10,000 additional cycles. No damage growth was detected and the cycling was continued again. The panel failed through the damage after 9660 additional cycles at $P_{min}=.73 P_{ult}$. Figure 15 presents the damage growth and initial impact damage size for this panel.

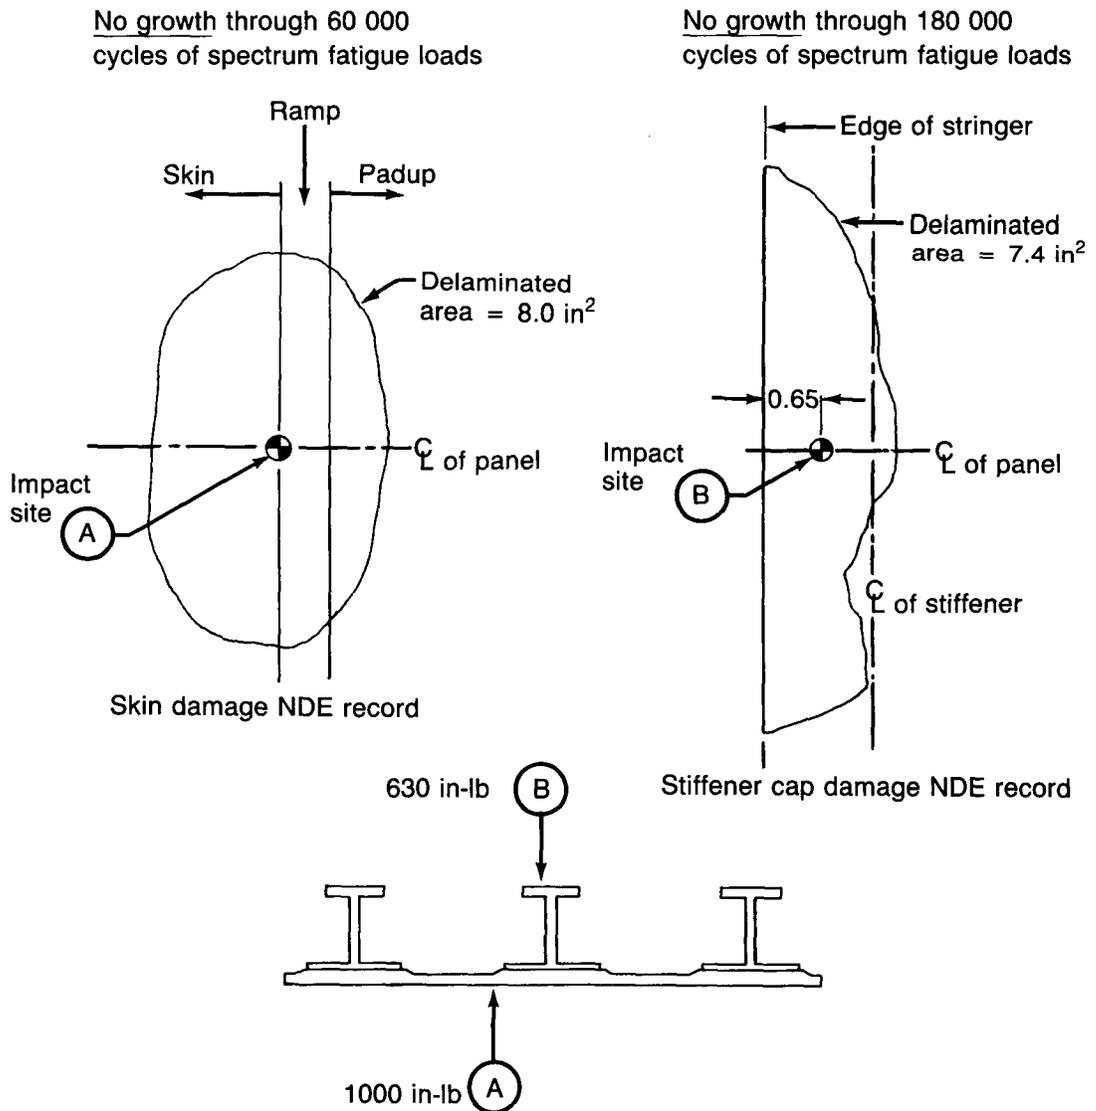
Figure 16. Damage Growth Results of Fatigue Cycling of Impact Damaged Panel 65C23890-3

The third baseline panel, 65C23890-3, was impacted on the central stiffener cap at location (B) (ref. fig. 11) with 630 in-lb of energy. This impact level had been determined to produce barely visible stiffener cap damage from the results of a Boeing IR&D studies, but the actual damage incurred was easily visible. The panel was cycled in spectrum fatigue for two lifetimes (120,000 cycles) and two limit load surveys without any damage growth detected during periodic pulse echo inspections. The maximum cyclic load (P_{min}) was 340 kips (50% of P_{ult} at P/AE strain of .0030). The panel was then removed from the test machine, impacted on the skin at the panel centerline at location (A) (ref. fig. 14) with 1000 in-lb of energy. The panel was then spectrum cycled to one more lifetime with P_{min} equal to 50% of P_{ult} . No damage growth at either damage site was observed during the periodic pulse echo inspections. The panel was then being loaded to limit load (450 kips) when two-piece failure occurred at 430 kips (96% of design limit load and P/AE strain of 0.0038). The failure occurred at the center of the panel through both damage sites. The NDE history for panel 65C23890-3 is presented in Figure 16.

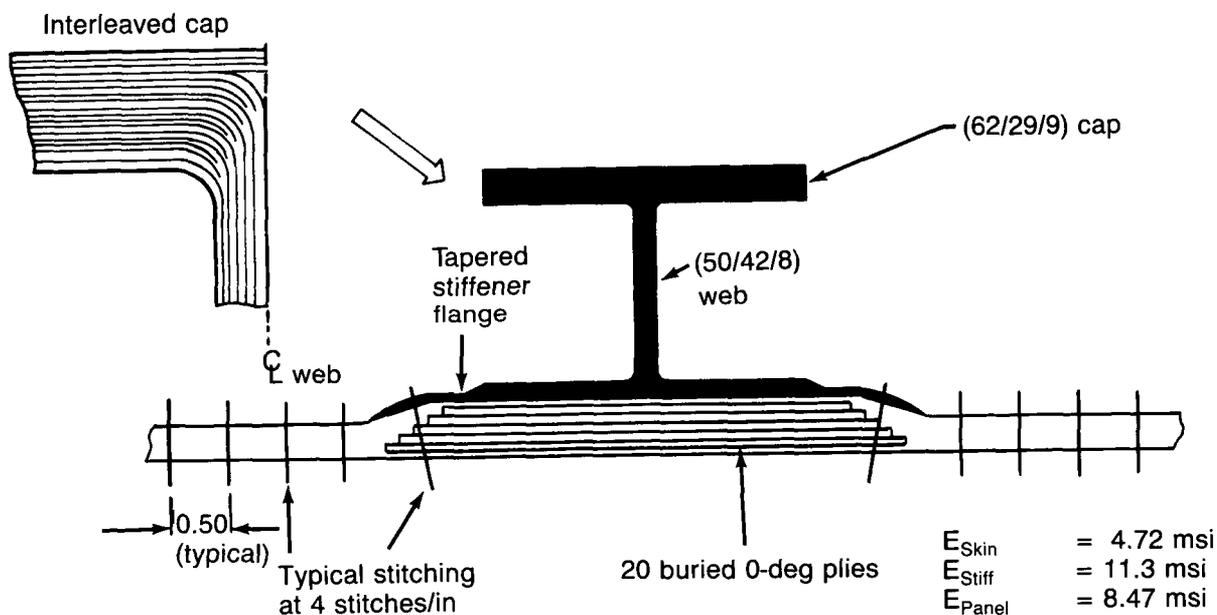
Figure 17. Enhanced Stiffened Panel Design Features

The enhanced panel design was developed from the experience gained from the Phase 1 panel tests, the Phase II damage growth coupon study, and state-of-the-art damage containment concepts. The design features are shown in Figures 17 and 18. The soft skin had continued to demonstrate good damage tolerance, and the damage growth coupon tests demonstrated improved damage containment and residual compression strength from through-stitching of prepreg laminates. The wing structure damage assessment study highlighted the criticality of the stiffener cap, and therefore, interleaving of the 0-deg plies with 45-deg plies was accomplished to increase the damage tolerance of the stiffener cap. The interleaved stiffener cap allowed for a slimmer stiffener web and for more 0-deg planks to be buried in the skin for greater damage containment. Ply layouts for the various panel elements are shown in Table 7.

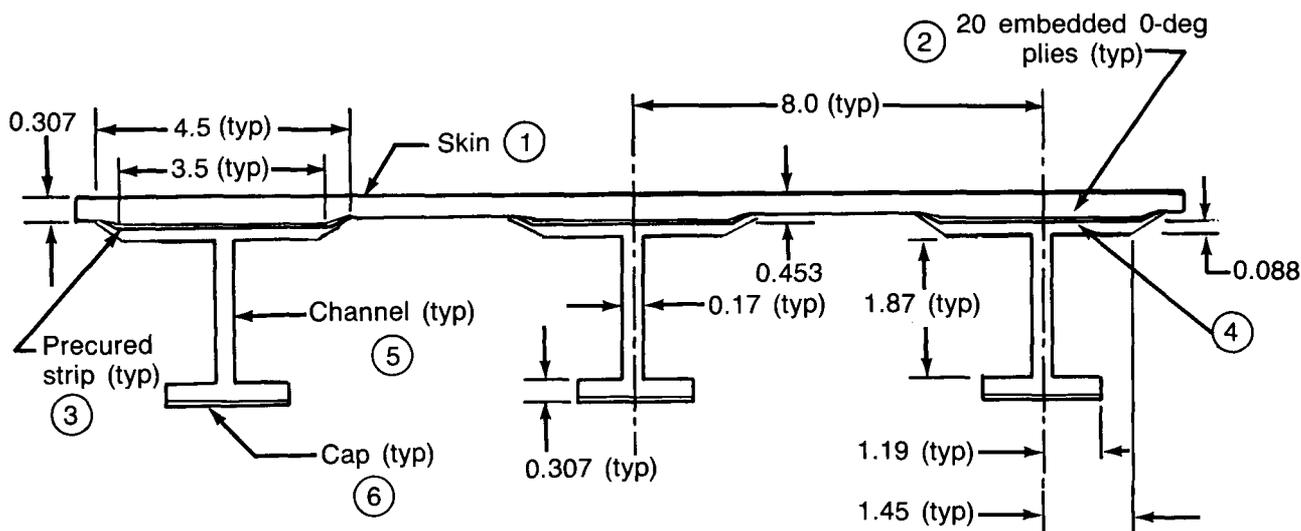
Figure 18. Enhanced Panel Configuration

The skin-stiffener interface, which is cocured and contains a precured strip (fig. 18), is a critical location for panel failure initiation. Through-stitching of this detail with Kevlar yarn was done to enhance this interface. The skin flanges of the stiffener were tapered down in thickness and lengthened to drape over the skin pad-up ramps in order to allow skin-stiffener flange stitching while stiffener tools were in place. This feature was also judged to provide for greater durability than the conventional nontapered stiffener skin flange of the baseline design. Because of manufacturing constraints, the skin through-stitching was performed in rows 0.50-in apart rather than the optimum 0.25-in spacing of the damage growth coupon tests.

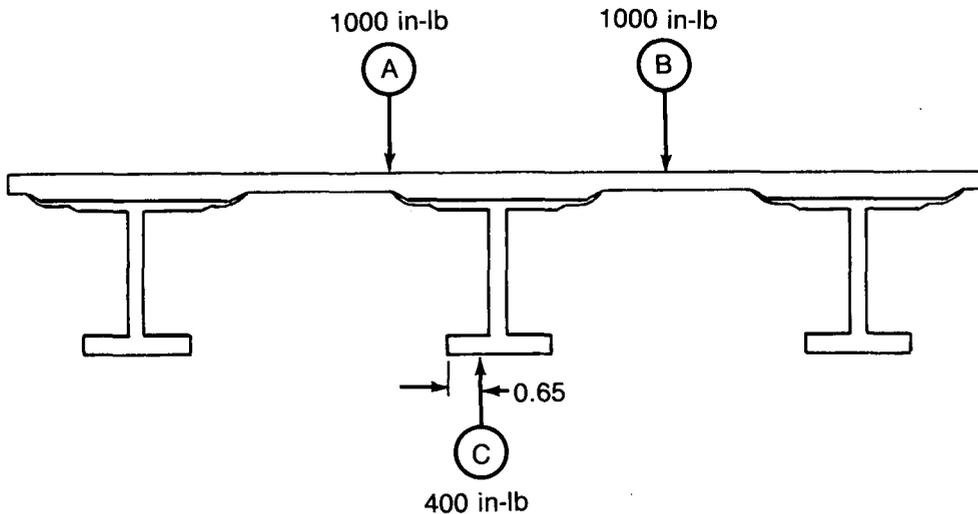
Figure 19. Enhanced Test Program Impact Locations and Energy Levels

Three-stiffener test panels were fabricated from AS6/2220-3 material to provide a direct design comparison with the baseline three-stiffener panel tests. Stiffener spacing and panel dimensions were identical. The test program included three panels tested in static compression to determine the damage tolerance of the enhanced design. The baseline damage growth panel test program had shown that durability was not as critical as damage tolerance. The Phase 1 panel tests had demonstrated that the ultimate load case with barely visible damage was the most critical design case. Figure 19 presents the enhanced panel impact damage locations and energy levels.

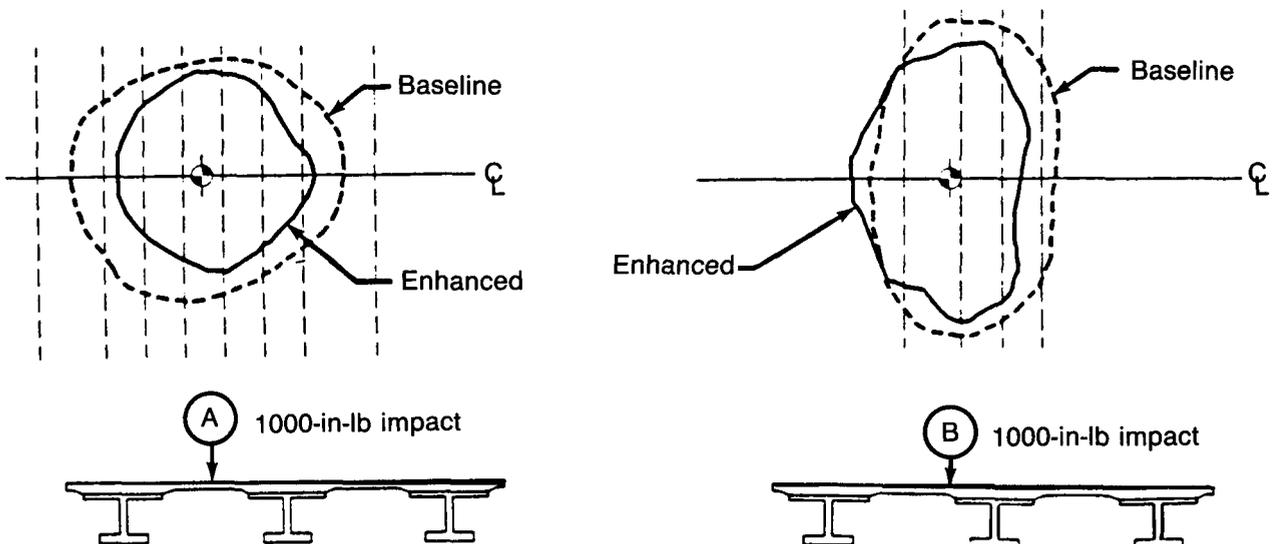
Figure 20. NDE Records of Impact Delaminations, Baseline Versus Enhanced Designs

The 1000 in-lb impacts to the skins were similar to those of the baseline panel tests. The 650 in-lb impact to the baseline panel stiffener cap had produced damage which was considered greater than barely visible; therefore, the enhanced panel stiffener cap damage was reduced to 400 in-lb. The results of the pulse echo NDE inspections of the skin impacts at location (A) on panel 65C23891-1 and location (B) on panel 65C23891-2 are presented and compared to the results of the baseline panel skin impact inspections in Figure 20. It can be seen that the 0.50-in row spaced grid stitching of the skins significantly reduces the area of delaminations caused by the impacts. Each of the impacts caused barely visible damage and the associated dents were less than 0.05-in deep.

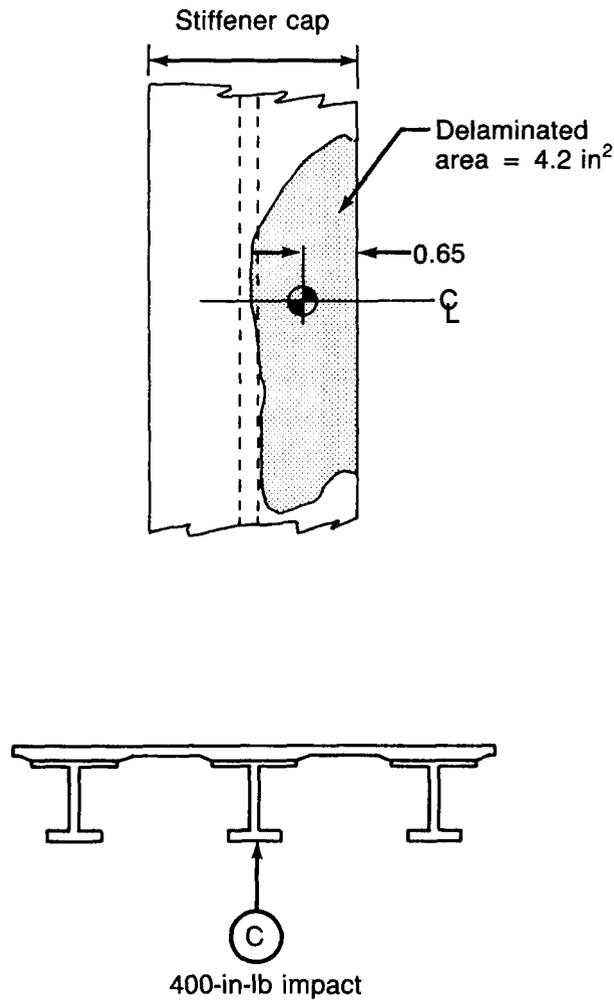
Figure 21. NDE Record of Impact Delaminations in Center Stiffener Cap of Panel 65C23891-3

Figure 21 presents the results of the NDE inspection of the stiffener cap damage of panel 65C23891-3. It can be seen that even the reduced level of impact energy still caused a large area of delaminations in the cap, 4.2 in² compared to 7.4 in² of the baseline 630 in-lb of impact energy.

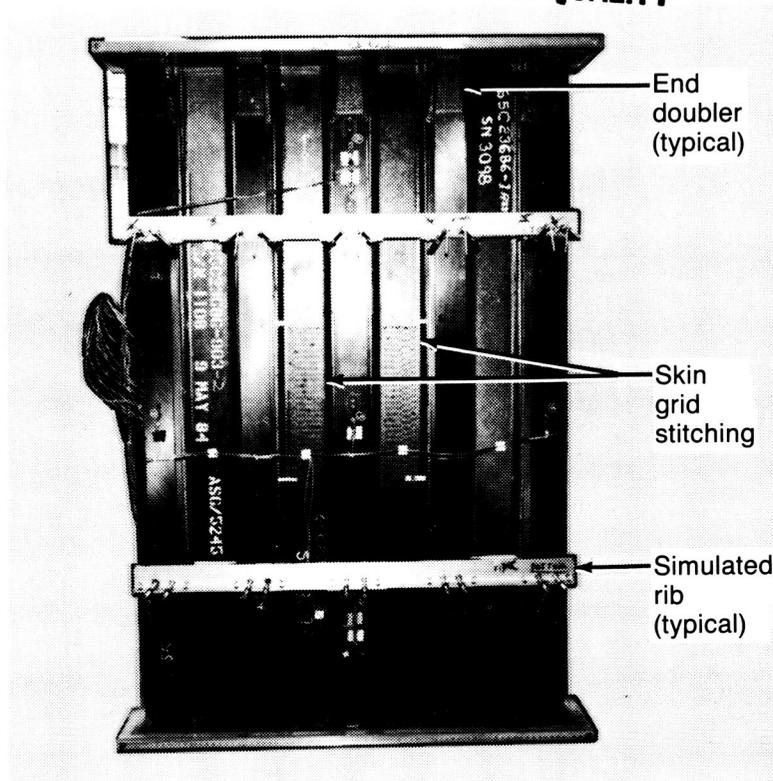
Figure 22. Five-Stiffener Test Panel

The five-stiffener panel test configuration is presented in Figure 22. The end-potting, cobonded doublers, and simulated ribs are shown together with installed test instrumentation. The instrumentation consisted of axial strain gages to record panel strains, deflectometers to record out-of-plane deflections, and acoustic emission transducers to monitor damage growth. The skin side of the panels was painted with Moire fringe material in order to provide a record of any skin deflections and buckles.

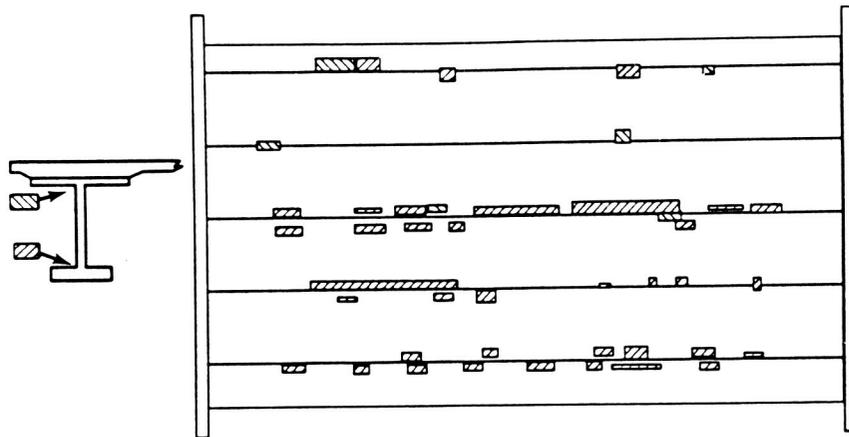
Figure 23. Pulse Echo Indications of Anomalies in Panel ①

Each of the panels was tested to two-piece static compression failure. All panels failed through their damage sites. The results of the enhanced panel tests are presented in Table 8. The two panels with the impact damage in the skin yielded an average of 15% greater residual compression strength than the stiffener damaged panel. All three stiffeners were completely detached from the skin after failure of the stiffener damaged panel. The panels with the skin damage did not exhibit this interface failure. Panels 65C23891-2 and 65C23891-3 had NDE indications of voids or cracks and delaminations in the skin flanges of the stiffener adjacent to the precured strips in the skin-stiffener interfaces. Panel 65C23891-3, with the stiffener cap damage, had more of these indications than panel 65C23891-2. The effect of these anomalies on the structural integrity of the panel skin-stiffener interface is not known. The NDE inspections of the five-stiffener panels (ref. fig. 23) revealed considerably more of these anomalies.

During the fabrication of the five-stiffener panels, a number of material processing problems arose. The AS6/5245C material was difficult to use because of lack of tack and boardiness. These material problems made stiffener ply lay-down on the tools extremely difficult. Each ply was compacted after lay-down as standard practice, but the complete compaction of the stiffeners and skin-stiffener interfaces containing the cobonded precured strip was in doubt. The pulse echo inspection results of the completed panel ① are shown in Figure 23. Panels ②, ③, and ④ had similar, but fewer, pulse echo indications.

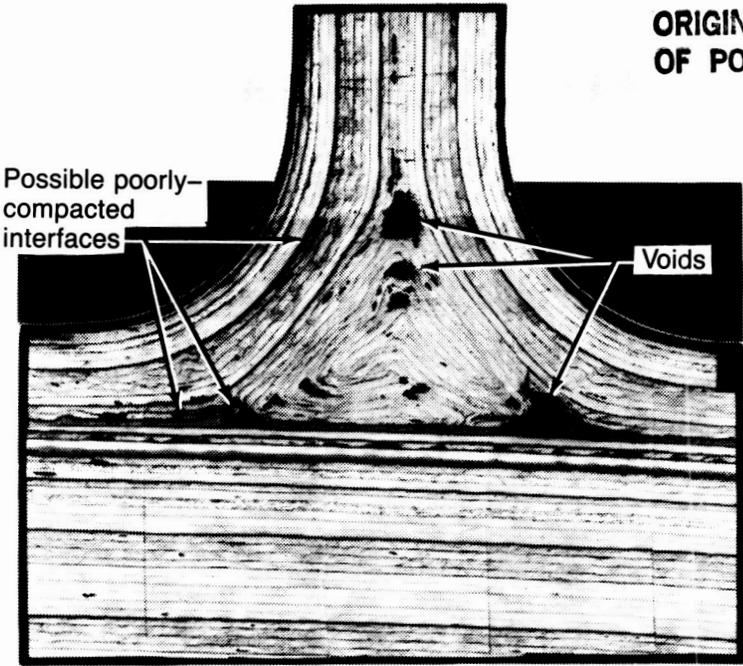
Figure 24. Photomicrograph of Sectioned Stiffener and Skin Area

End trim from panel ① was sectioned through a number of the pulse echo indicated areas, and photomicrographs were taken. Figure 24 presents a photomicrograph of one of these sections. A number of voids and suspect compaction areas can be clearly noted in the stiffener radius and stiffener-skin interface.

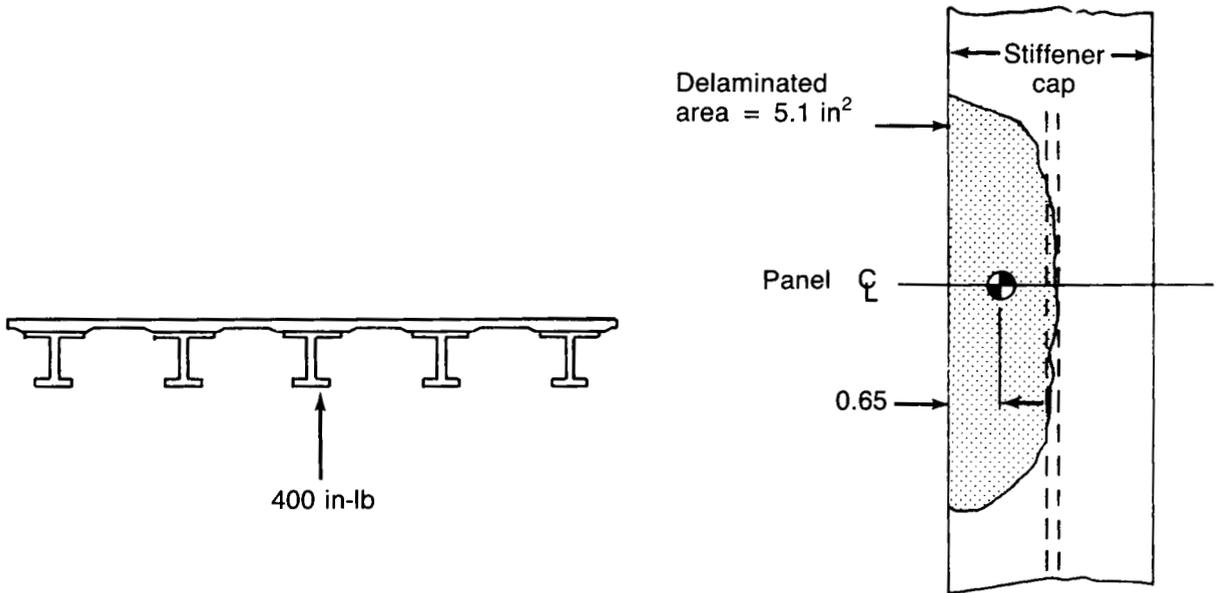
Figure 25. Stiffener Cap Damage to Panel ①

The results of the pulse echo inspections of the impact sites for the 400 in-lb stiffener damage of panel ① and the 2000 in-lb skin damages of panels ② and ③ are presented in Figures 25 and 26. The total area of delamination discovered in the stiffener cap of panel ① after a 400 in-lb impact with a 1.0 diameter steel impactor was larger than of the three-stiffener enhanced stiffener cap after a similar impact (ref. fig. 21). The damage was also more visible with some evidence of the stiffener cap being bent at the impact site.

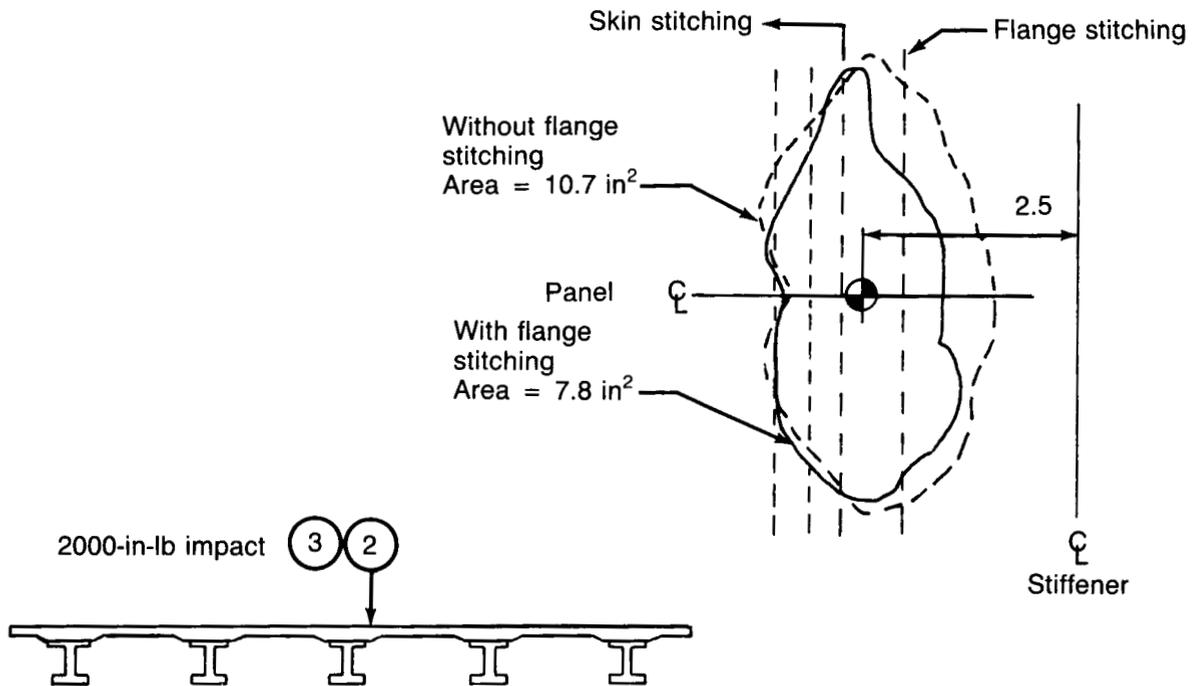
Figure 26. Inspection Results of Impacted Skins of Panels ② and ③

The 2000 in-lb impacts, with a 0.5-in diameter impactor, on the skins of panels ② and ③ produced visible surface damage. The dents were in excess of .07-in with some fiber breakage, and fiber break-out on the backside of the skin. Panel ②, which featured the skin-stiffener flange stitching, was found to have less total delaminated area than the non-flange-stitched panel ③.
