Damage Tolerant Composite Wing Panels for Transport Aircraft

Peter J. Smith and Robert D. Wilson

CONTRACT NAS1-16863
DECEMBER 1985

Peter J. Smith and Robert D. Wilson
Advanced Composite Development Program

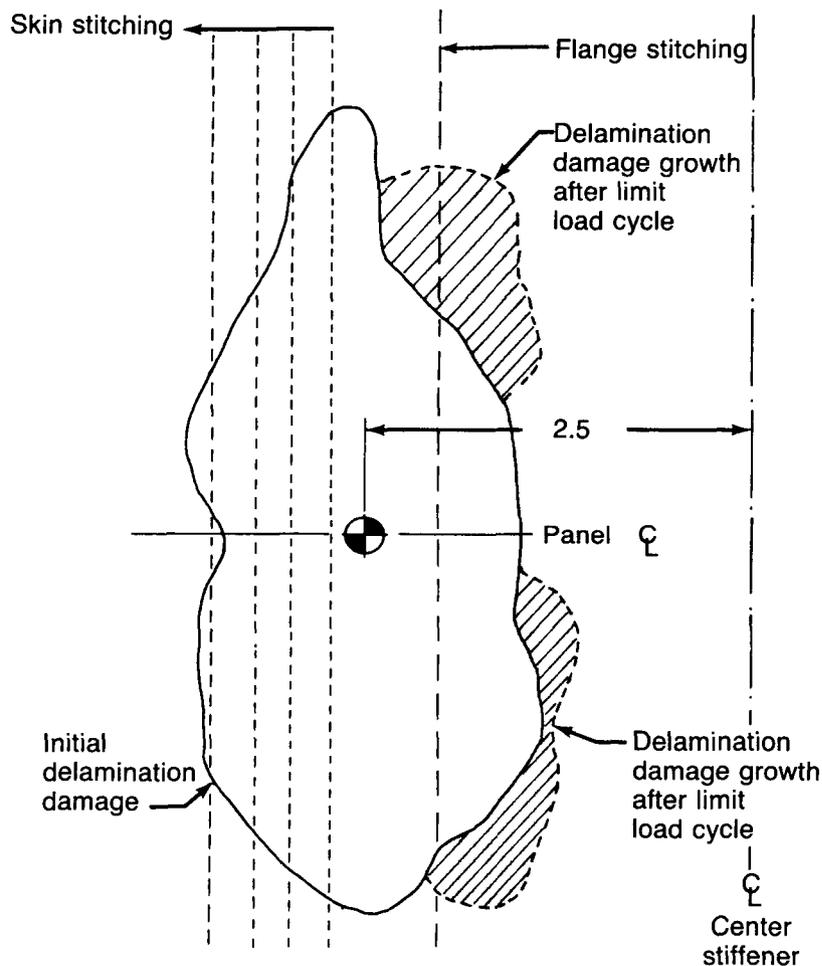
Figure 27. Pulse Echo Indications of Damage Growth After Limit Load Cycle of Panel ②

Panel ②, with the 2000 in-lb impact damage to the skin, was initially tested to the design limit load of 785 kips. Some delamination growth occurred (ref. fig. 27) due to this load which represents 20 kips/inch end load and a P/AE strain of .0041. The damage was increased incrementally by sawcut as shown in Figure 28. The panel was loaded to the continued safe flight load of 470 kips after each sawcut increment. There was no further evidence of growth due to these load cycles. After the third sawcut extension with the skin, central skin pad-up and stiffener flange completely severed with the 0.25-in wide sawcut for a length of 6.4 in, the panel was tested to determine the residual compression strength with this severe damage. The panel failed at a load of 573 kips which represents 122% of the continued safe flight load and a P/AE gross area strain of .0030. The failure, shown in Figure 29, was through the damage site with the skin and stiffeners fractured. There was no evidence of skin-stiffener separation except locally adjacent to the failure.

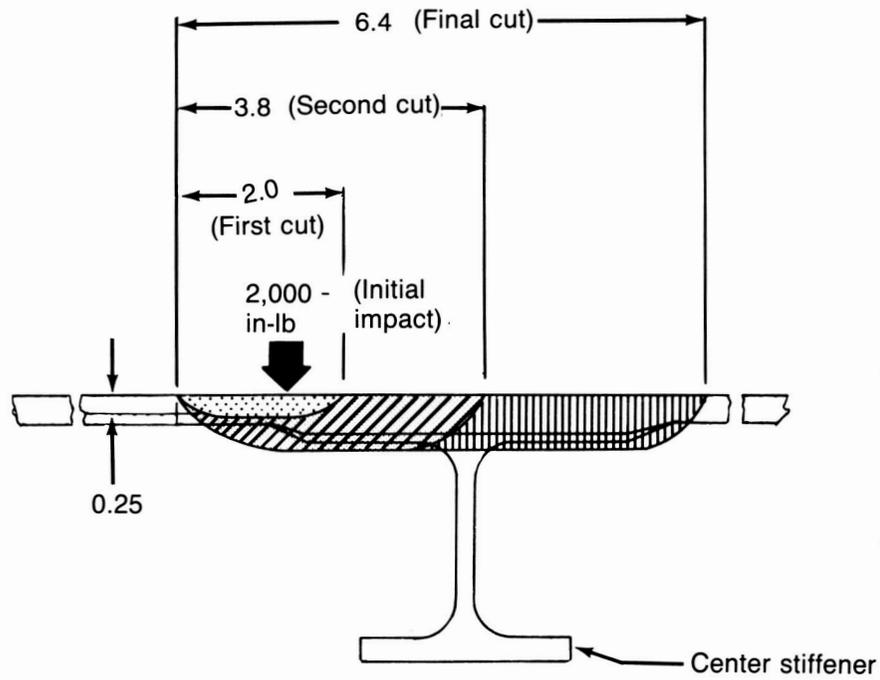
Figure 28. Sawcut Damage Increments of Panel ②

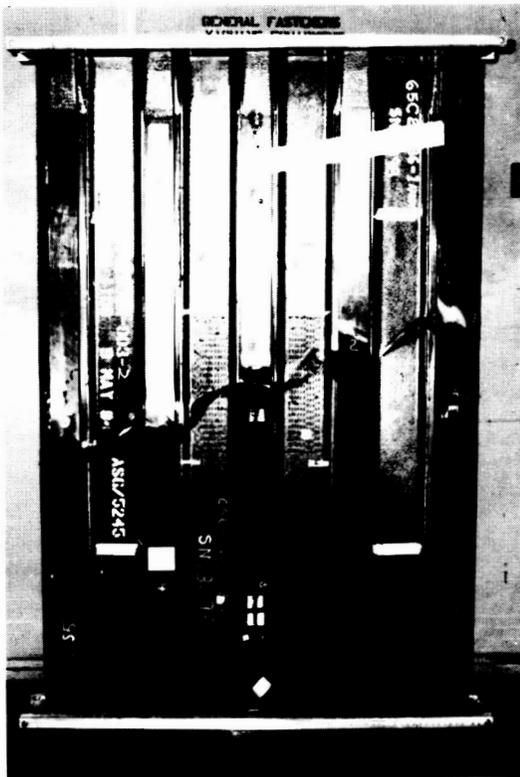
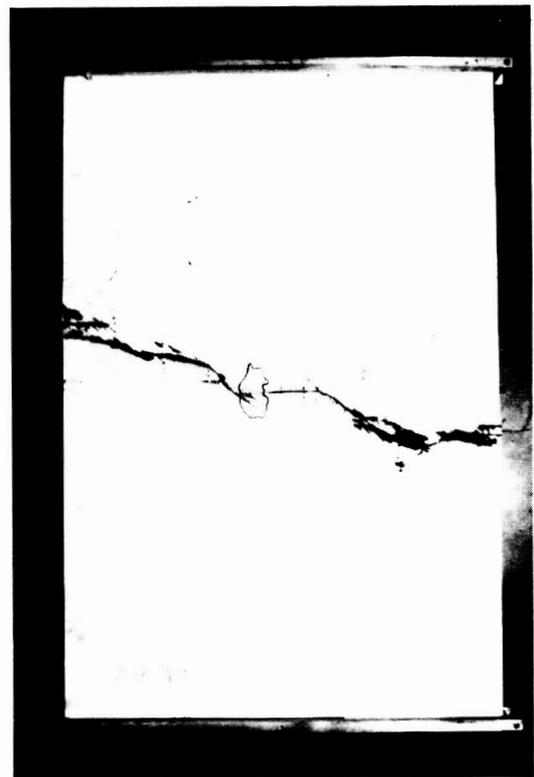
Figure 29. Failure of Panel ② After Sawcut Damage

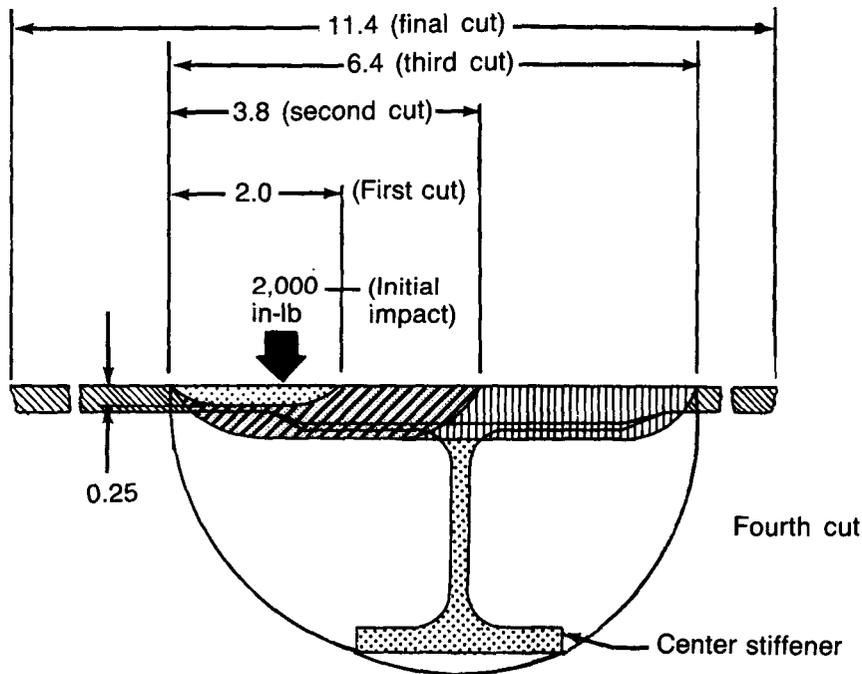
Figure 30. Sawcut Increments of Panel ③

The loading sequence for panel ③ was similar to that of panel ②. The panel did not contain the skin-stiffener-flange stitching of panel ② and the area of delamination damage due to the initial impact of 2000 in-lb was larger than that of panel ②. The panel was initially tested to limit load and no damage growth was recorded due to this load cycle. The damage was then increased incrementally by sawcutting as shown in Figure 30.

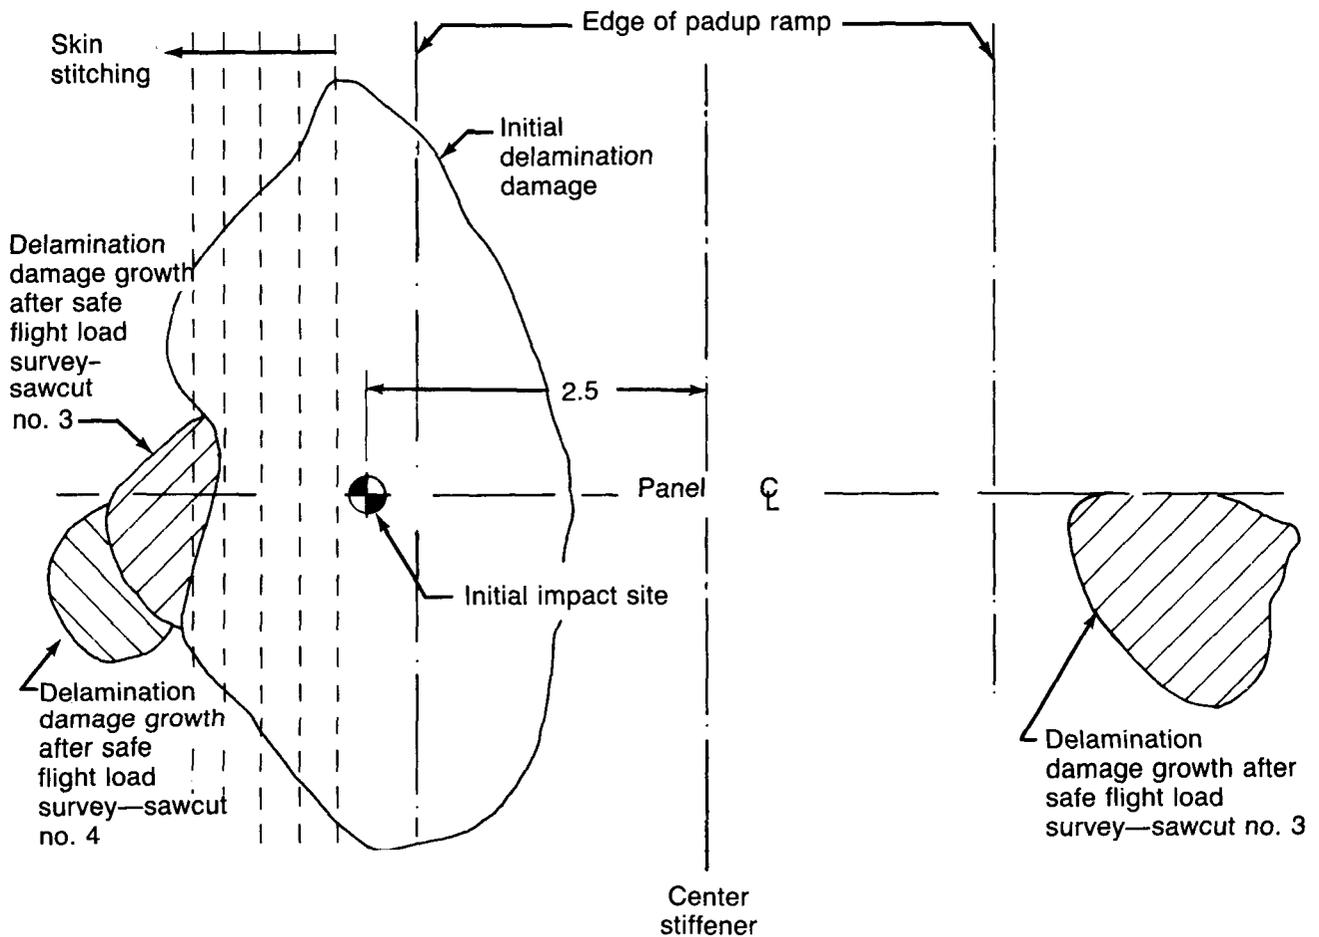
Figure 31. Pulse Echo Indications of Damage Growth in Panel ③

The panel was loaded to the continued safe flight load after each sawcut increment. There was damage growth discovered after the safe flight load surveys of the third and fourth sawcut increments as shown in Figure 31. After the fifth sawcut extension with the center stiffener, skin pad-up, and skin completely severed for a total of 11.4 inches, the panel failed at a load of 460 kips. This load represented 98% of the continued safe flight load and a gross P/AE strain of 0.0024. The failure, similar to that of panel ②, was through the damage site with skins and stiffeners fractured.

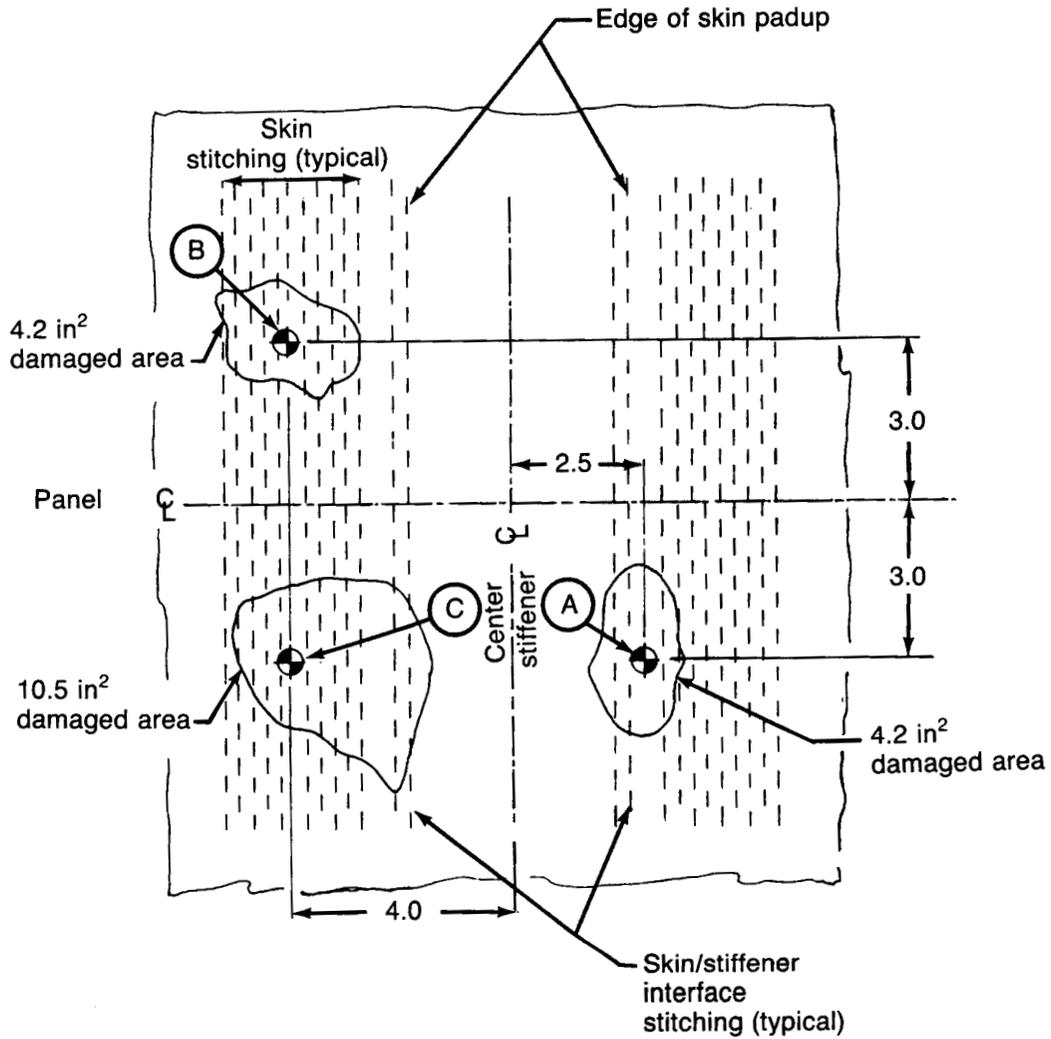
- Ⓐ 1000 in-lb (1-in-dia impactor) on skin at edge of ramp
- Ⓑ 1000 in-lb (1-in-dia impactor) on skin between stiffeners
- Ⓒ 2000 in-lb (0.5-in dia impactor) on skin between stiffeners

Figure 32. Impact Sites and Pulse Echo Inspection Results of Panel ④

Panel ④ was tested to the ultimate compression load condition with multiple impact damage. The panel was initially impacted with 1000 in-lb of energy, using the 1.0-in diameter steel impactor, on the skin at the edge of the pad-up ramp at site (A) as shown in Figure 32. The damage was barely visible with a dent of less than .04-in. The panel was loaded to the ultimate load of 1178 kips without failure. This load represents 52 KSI stress and a P/AE strain of 0.0062. The post-test pulse echo inspection indicated no damage growth.

The panel was again impacted with 1000 in-lb of energy at site (B) on the skin between stiffeners. The damage was again barely visible with similar delaminated area indications to the impact at site (A). The panel was again loaded to ultimate load without failure. The post-test pulse echo inspection indicated no damage growth at either damage site.

The panel was finally impacted with 2000 in-lb of energy, using a 0.5-in diameter impactor, on the skin between stiffeners at site (C). The damage was easily visible with a dent similar in depth to those of panels (2) and (3) with some fiber breakage on the impact surface and fiber breakout on the inner skin surface. The panel was loaded to limit load of 782 kips without failure. This load represents a P/AE strain of 0.0041. The post-test pulse echo inspection did not detect any damage growth at any of the three impact sites.

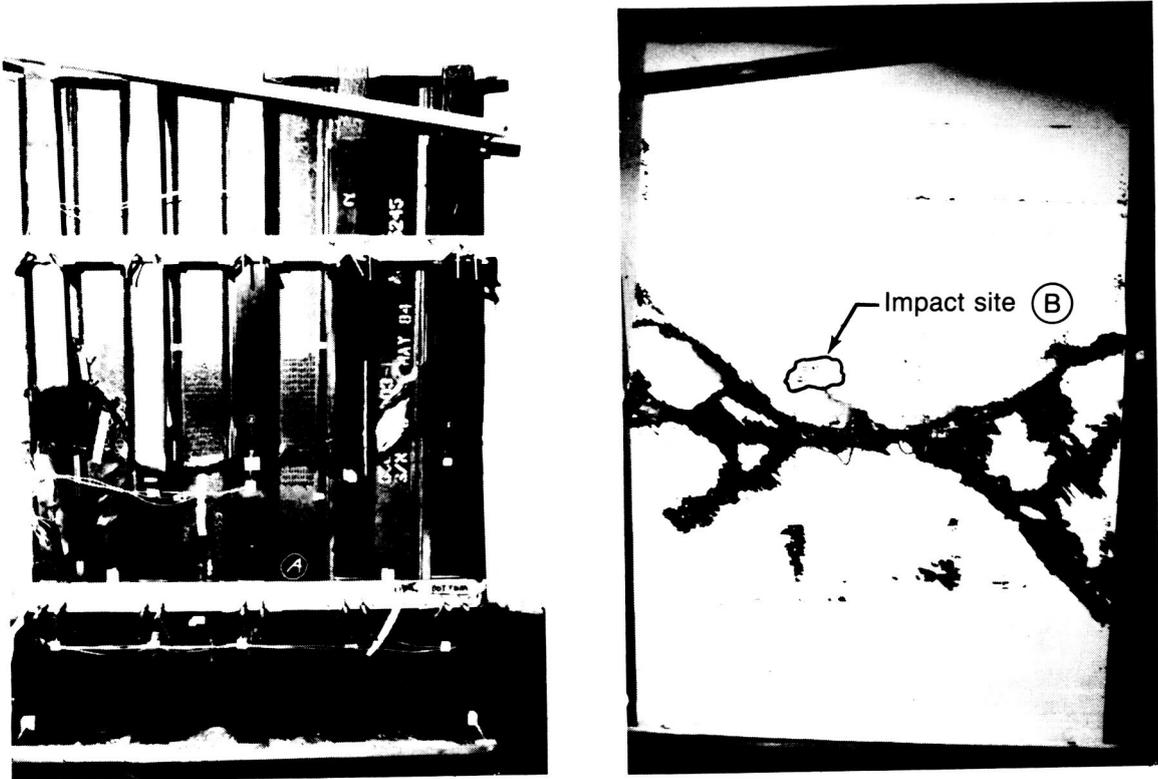
Figure 33. Failure of Panel (4) After Multiple Impact Skin Damage

The panel was finally loaded to failure to determine the residual compression strength. The panel failed through damage sites (A) and (C) at 1197 kips. This represents 102% of the design ultimate load and a P/AE strain of 0.0063. Figure 33 presents the failed panel with the failure running through the 2000 in-lb damage site.

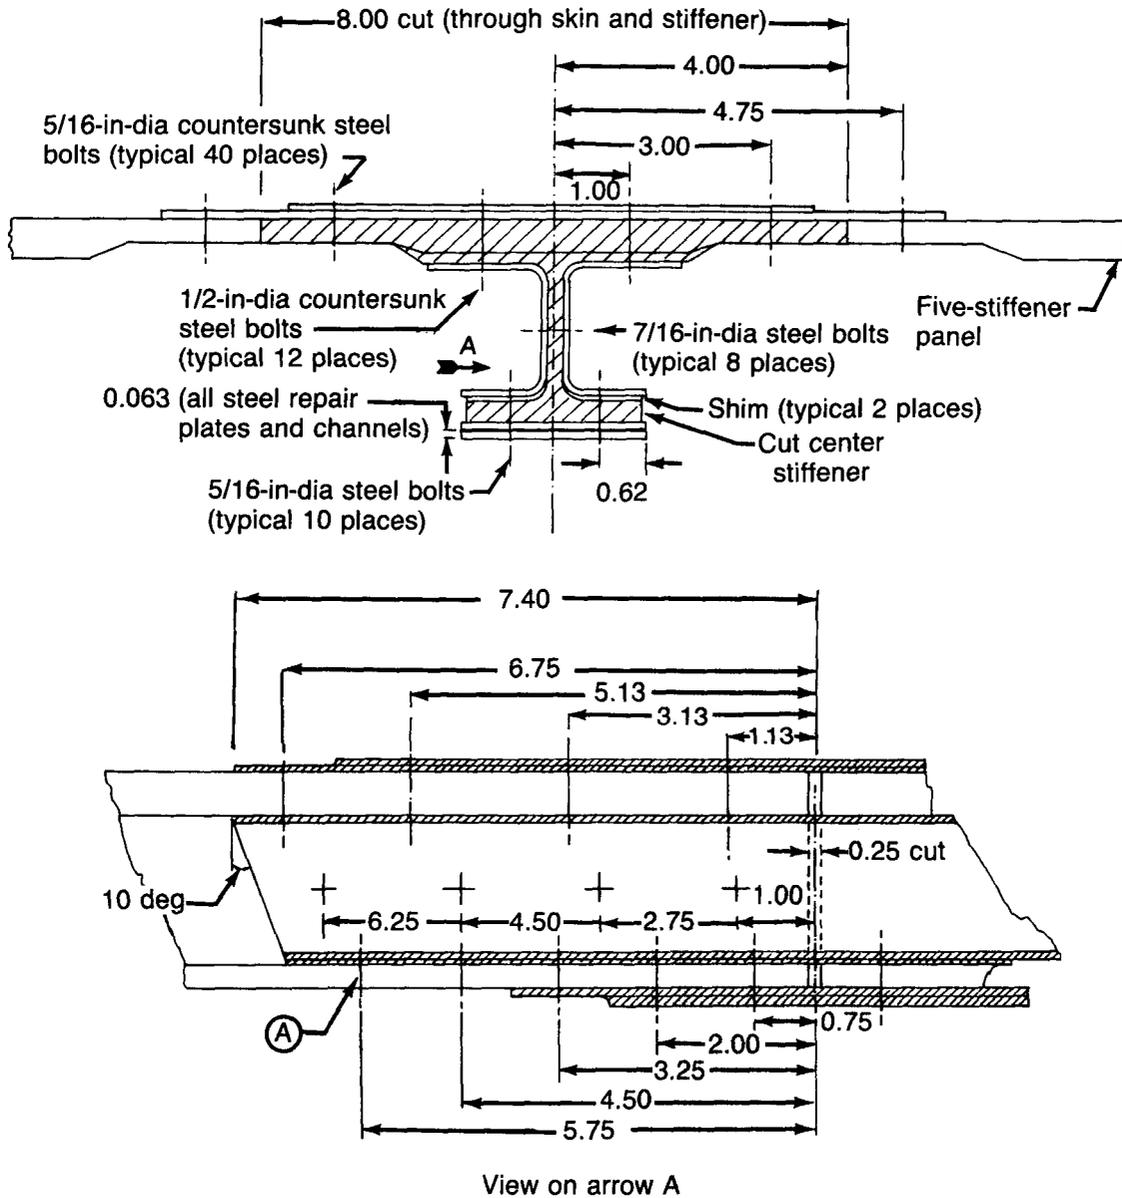
Figure 34. Initial Repair Configuration

A five-stiffener panel of the same configuration as used in the large panel damage tolerance validation test program was damaged with a sawcut. The sawcut severed the center stiffener, skin pad-up and skin for a total length of 8.0 in. The basic repair philosophy was to use a typical service repair that requires no special equipment. The repair was made using steel plates and channels assembled to the panel with steel bolts. Figure 34 presents a cross-section through the repair. The repair design

matched proportional element stiffnesses (AE) while replacing the cut AE with 125% of that lost. Bending strains were kept to a minimum by tailoring the load paths, and where possible, the fasteners were sized to develop the repair element capabilities. The steel plates and channels were all fabricated from 0.063-in 4130 steel sheet heat treated to 180 ksi ultimate tension strength. The fasteners were 180 ksi steel Hi-Loks installed wet with fuel tank sealant in close tolerance holes. The fasteners in the skin repair had countersunk heads typical of wing panel structure.

The failure originated at the first fastener in the stiffener cap repair (ref. point A in fig. 34) and propagated across the panel outside of the repair plates. All five stiffeners failed and were separated from the skin in a manner similar to that of the five-stiffener panel with the center stiffener cap impact damage. The strain in the skin, .05-in from the end of the sawcut, was .008 at failure. There was no evidence of damage emanating from either end of the sawcut. The failure location and strain values are presented in Figure 37. Figure 38 shows the panel at failure with the skin separated intact from the stiffeners.

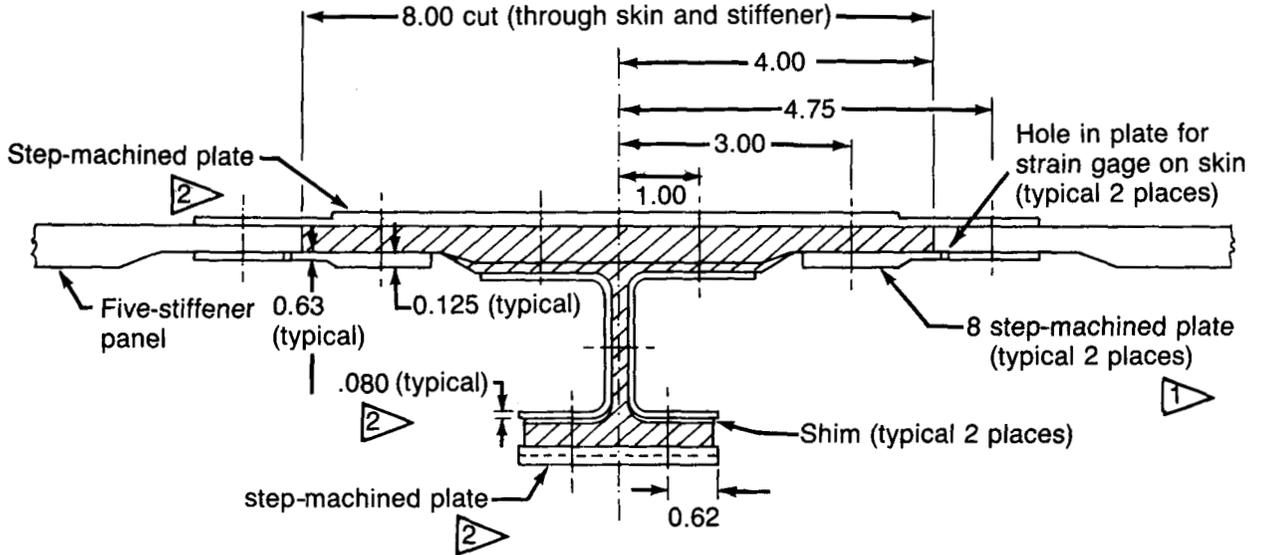
- 1 Additional repair hardware
- 2 Modified repair hardware
- All fastener protruding head oversized up to 1/32 in from original repair

Figure 35. Modified Repair

The above modifications were made to the repair. Also, the stacked 0.063-in steel plates replaced with stepped machined plates with the gage of the steel channels increased from 0.063-in to .080-in to minimize load line shift due to the increase in skin repair plate AE. Figures 35 and 36 present the modified repair configuration.

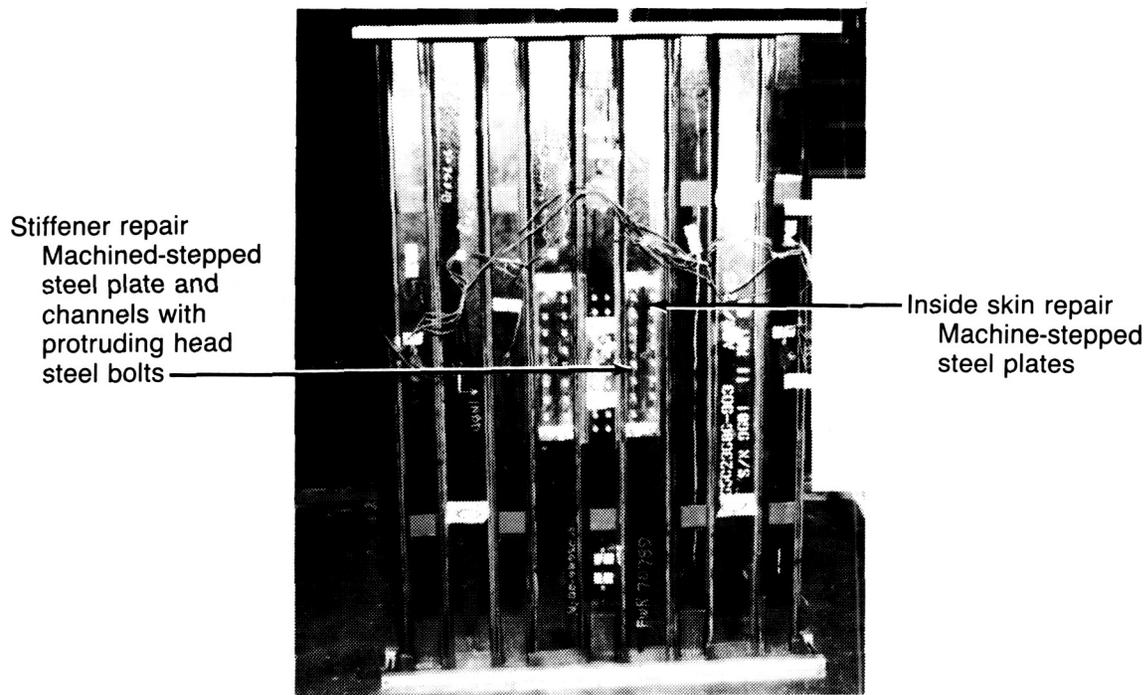
Figure 36. Modified Repair Panel

One additional change was made to reduce the tolerance between the fasteners and the fastener holes to obtain more consistent load transfer. The holes were reamed to size so the oversize fasteners were almost a net fit and the fasteners were matched to the holes. Some fasteners, particularly at the skin pad-up and stiffener flanges, had to be installed by cooling them in liquid nitrogen to reduce the shank diameter during installation. After the panel had been reinstrumented, the outside skin repair was faired-in with aerodynamic "Bondo" to smooth out the effect of the plates and protruding head fasteners.

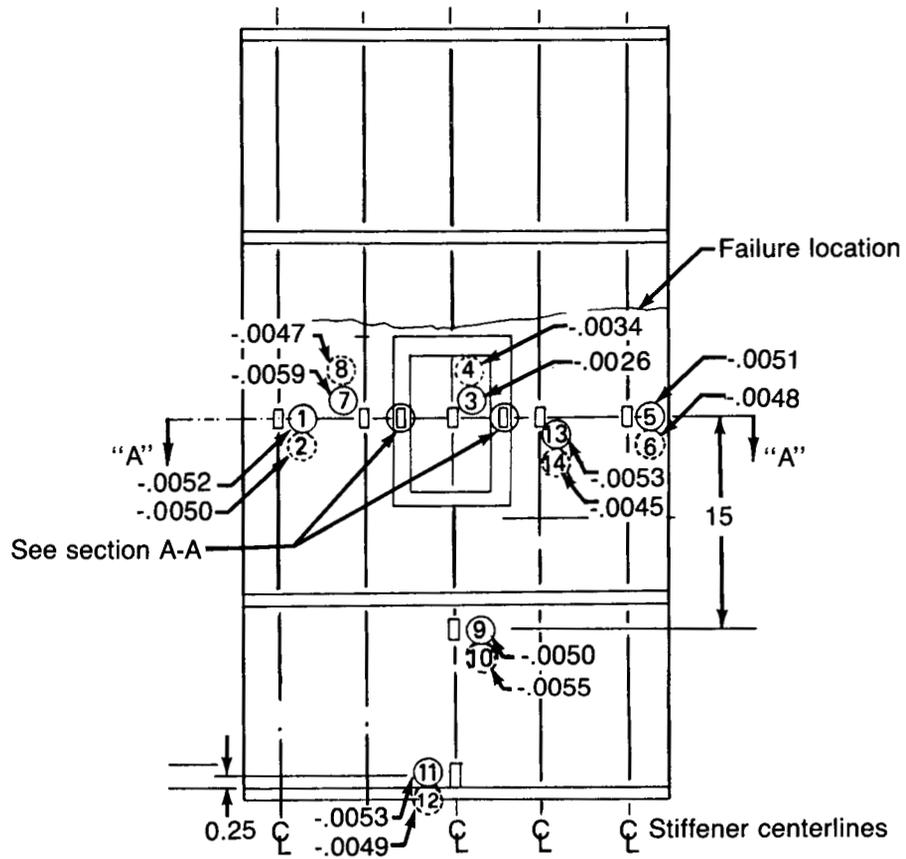
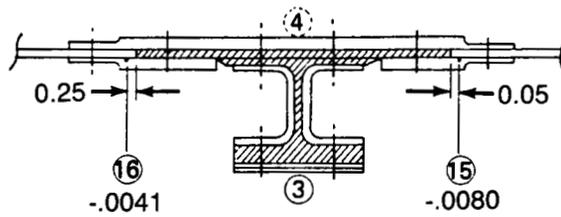
Section "A-A" — through repair

Figure 37. Repair Panel Failure Location and Strains

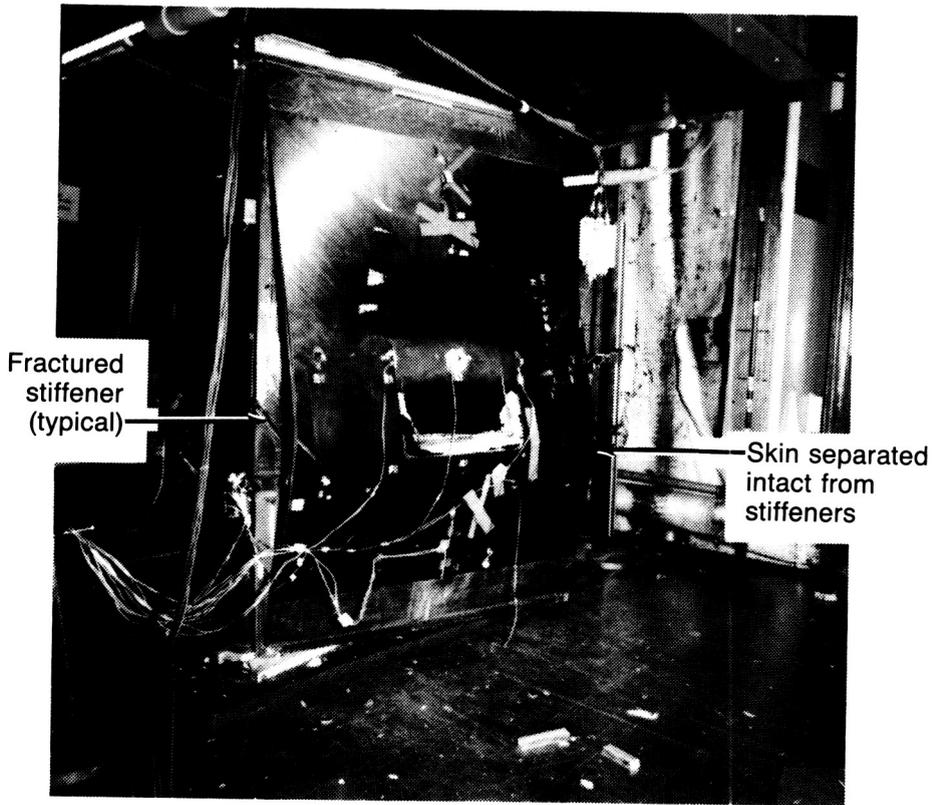
Figure 38. Repair Panel Failure

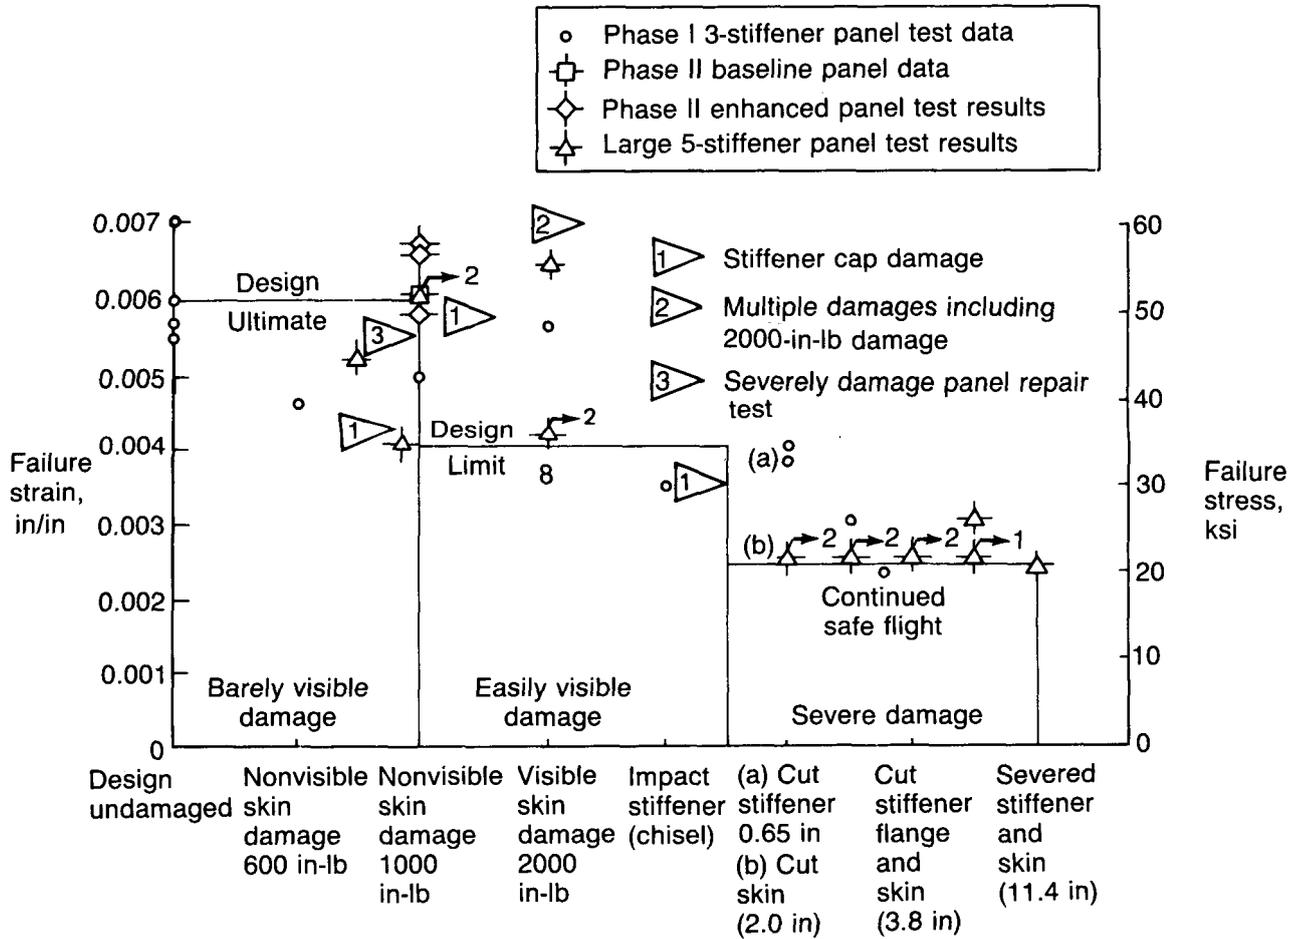
Figure 39. Damage Tolerance Validation Test Results

Figure 39 summarizes the results of the Phase I and Phase II panel tests. All of the panel test data for both Phase I and Phase II are shown relative to the design strains and corresponding stresses. The stresses were normalized for full skin bays, assuming the skins were fully effective. This assumption was validated by the strain gage data which in all cases indicated no skin buckling prior to failure. The strains are gross area P/AE strains using moduli gained from basic material property coupon tests.

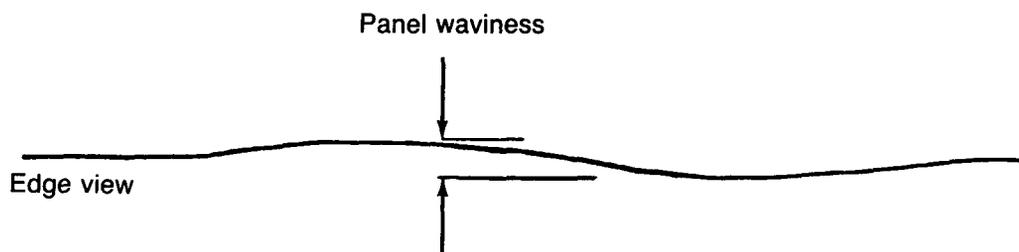
Figure 1. Contour Deviation Defect

Panel Waviness, Warpage, Contour Deviation—These defects (Figure 1) are usually caused by warped tools or thermal expansion mismatch between the part and the tooling, and primarily affect assembly and aerodynamic requirements.

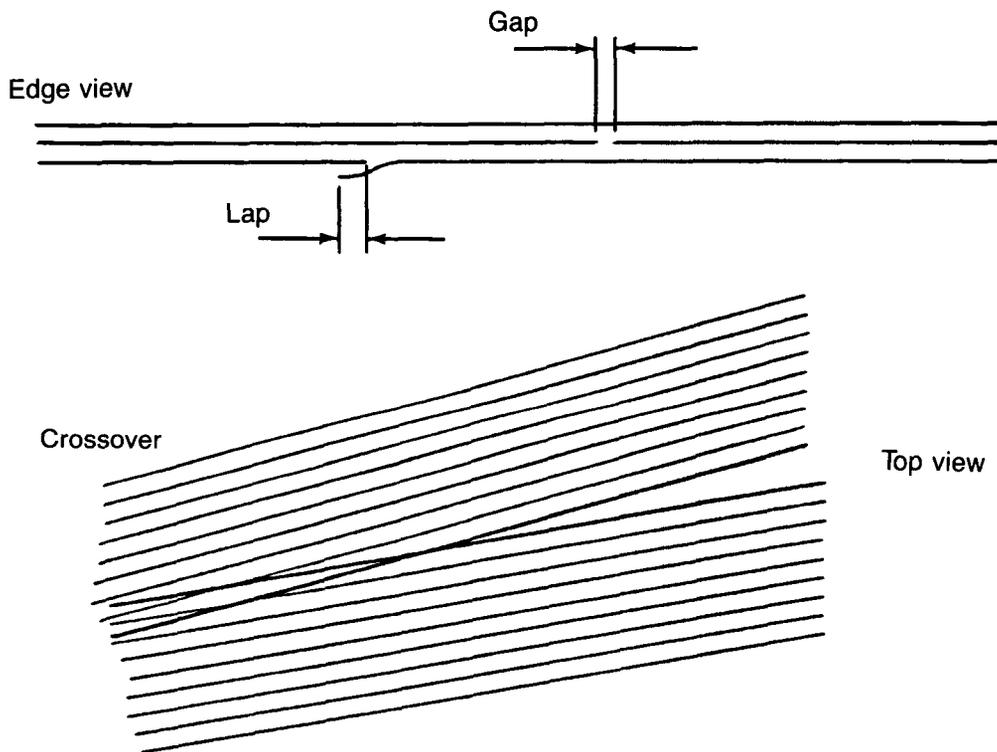
Figure 2. Ply Layup Defects

Laps, Gaps, Crossovers—These defects (Figure 2) are caused by poor manual layup methods and automatic ply layup and are nearly impossible to detect without a cross-sectional view of the laminate. Current tolerances allow a 0.1-in maximum overlap or gap. Some testing indicates that these defects can cause approximately a 10% strength reduction.

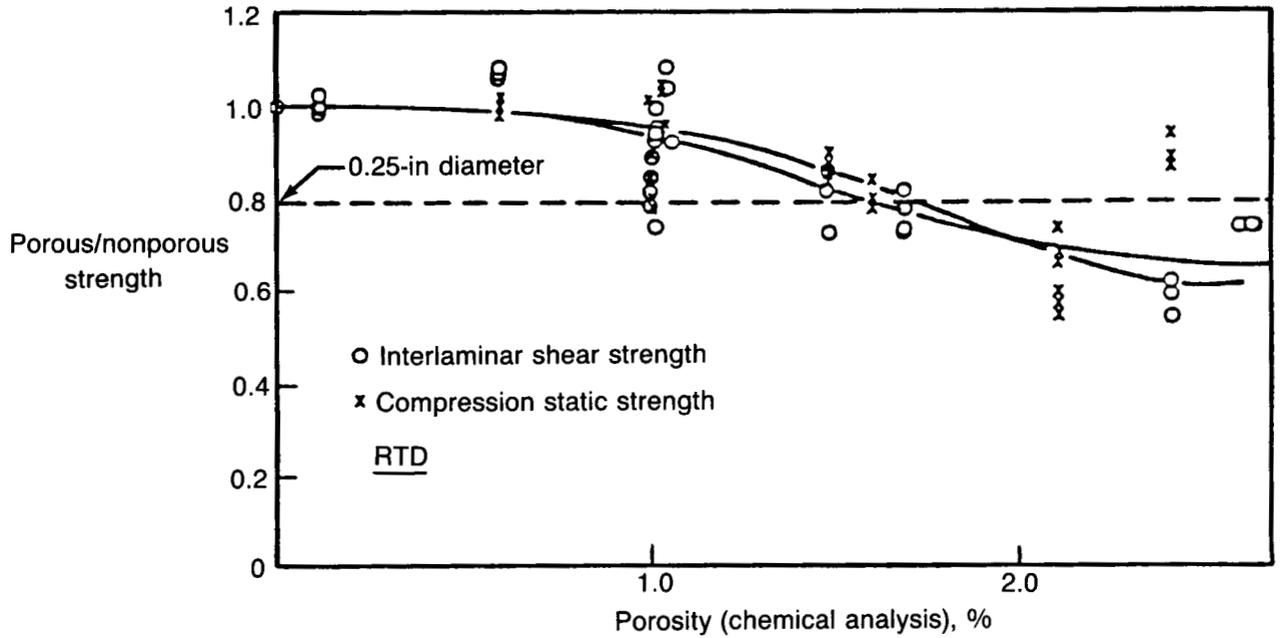
Figure 3. Influence of Porosity Level on Room Temperature Dry Interlaminar Shear and Compression Static Strength

Severe porosity (greater than 1% by volume) can reduce interlaminar and compression strength, as shown in Figure 3, although strength loss may not occur for Boeing's current porosity tolerance limit of 0.5%. It should be noted that obtaining consistent porosity measurements is difficult and results may depend on the technique used. Figure 3 also shows that in terms of strength, a .25-in diameter hole will overshadow porosity above the tolerance limit.

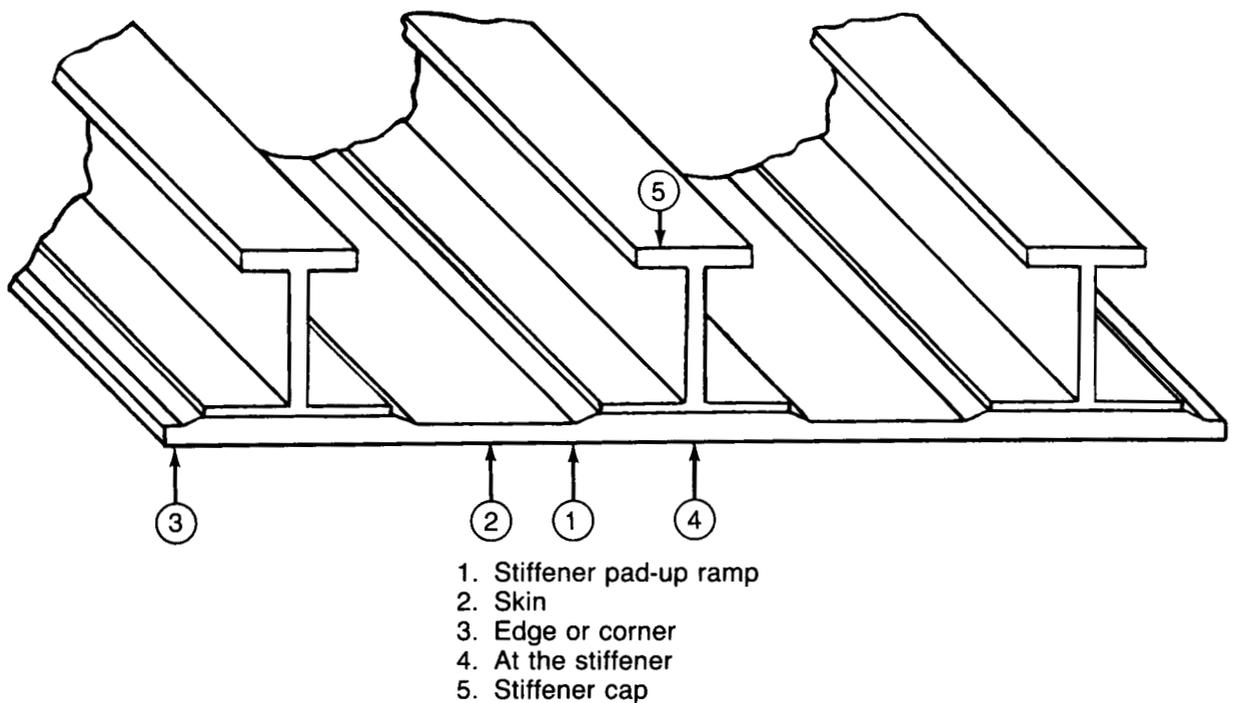
Figure 4. Critical Impact Damage Locations

Because compression members are more sensitive to damage, the locations to be considered here are primarily the wing upper surface. The general exterior areas of the wing differentiated for impact criticality (fig. 4) are as follows:

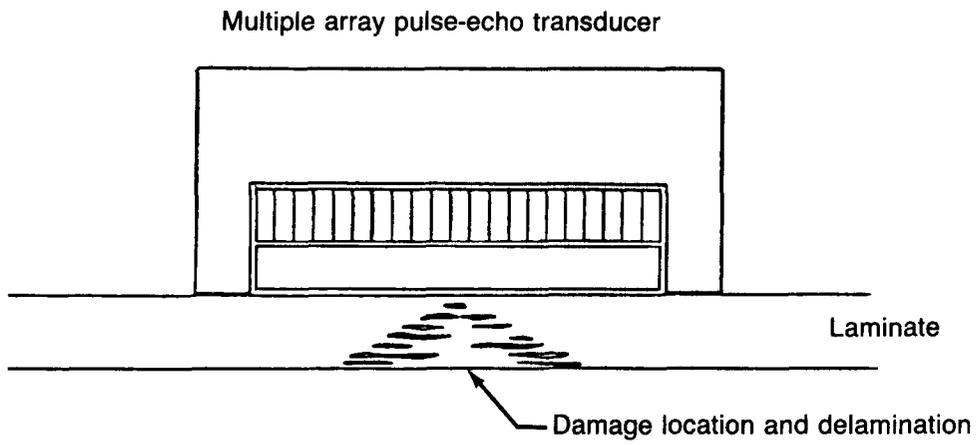
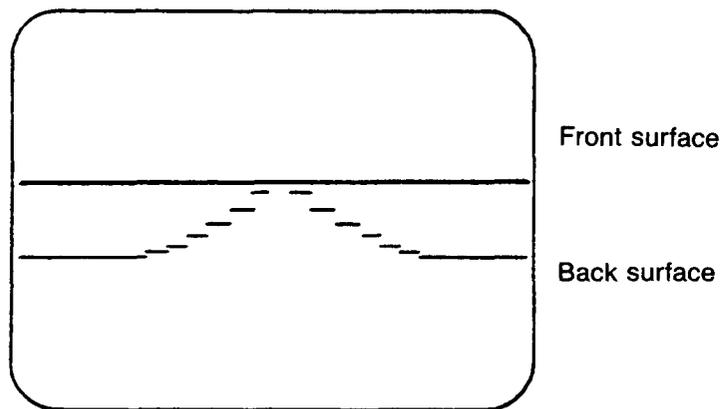
Oscilloscope view

Figure 5. Multiple Array Pulse-Echo Transducer

Boeing has constructed an experimental multiple array pulse echo transducer with its associated monitoring electronics using principles taken from a similarly operating medical device. Specifically, the transducer consists of 32 closely spaced elements (as shown in Figure 5), each 0.050-in wide, for a total width of 1.6 in. The design frequency of this prototype is 5 MHz, optimum for laminates up to 0.3-in thick with a practical limit of 0.5-in thick. Thicker laminates (1-in or more) could be scanned with a transducer designed to operate at lower frequencies.

This system is useful for creating images of disbonds, delaminations, impact damage and porosity. Figure 5 shows an oscilloscope view of a panel cross-section containing a flaw under the stiffener and a view of the sectioned area revealing the small delamination. These diagrams were taken from an original micrograph and photograph of the oscilloscope screen.

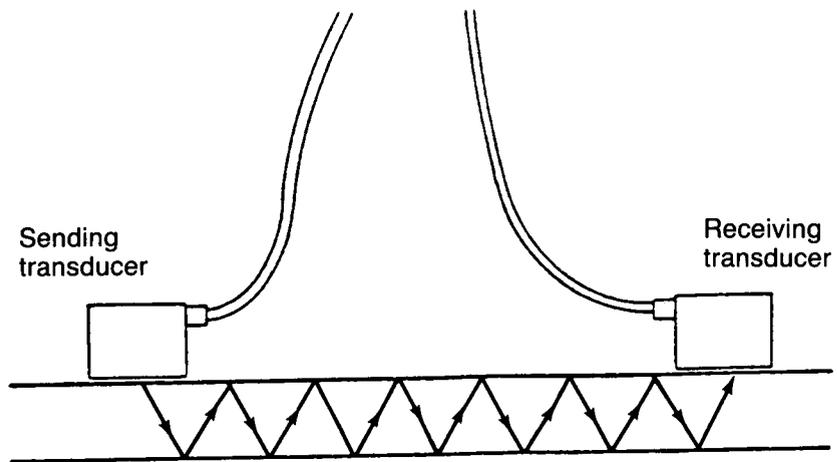
Figure 6. Two Ultrasonic Transducers

One method uses two ultrasonic transducers, one transmitting and one receiving, on the same side of the laminate (Figure 6). The system measures a stress wave factor or the number of reflected acoustic wave peaks received from a specified transmitted wave form. The stress wave factor depends on the input signal characteristics, transducer characteristics, system gain, reset time, threshold voltage, repetition rate, distance between transducers, etc.; therefore, results are generally comparable only when these factors are consistent. Experimenters have obtained good correlation between the stress wave factor and the number of impact events, and between the stress wave factor and tensile strength of graphite/epoxy coupons.

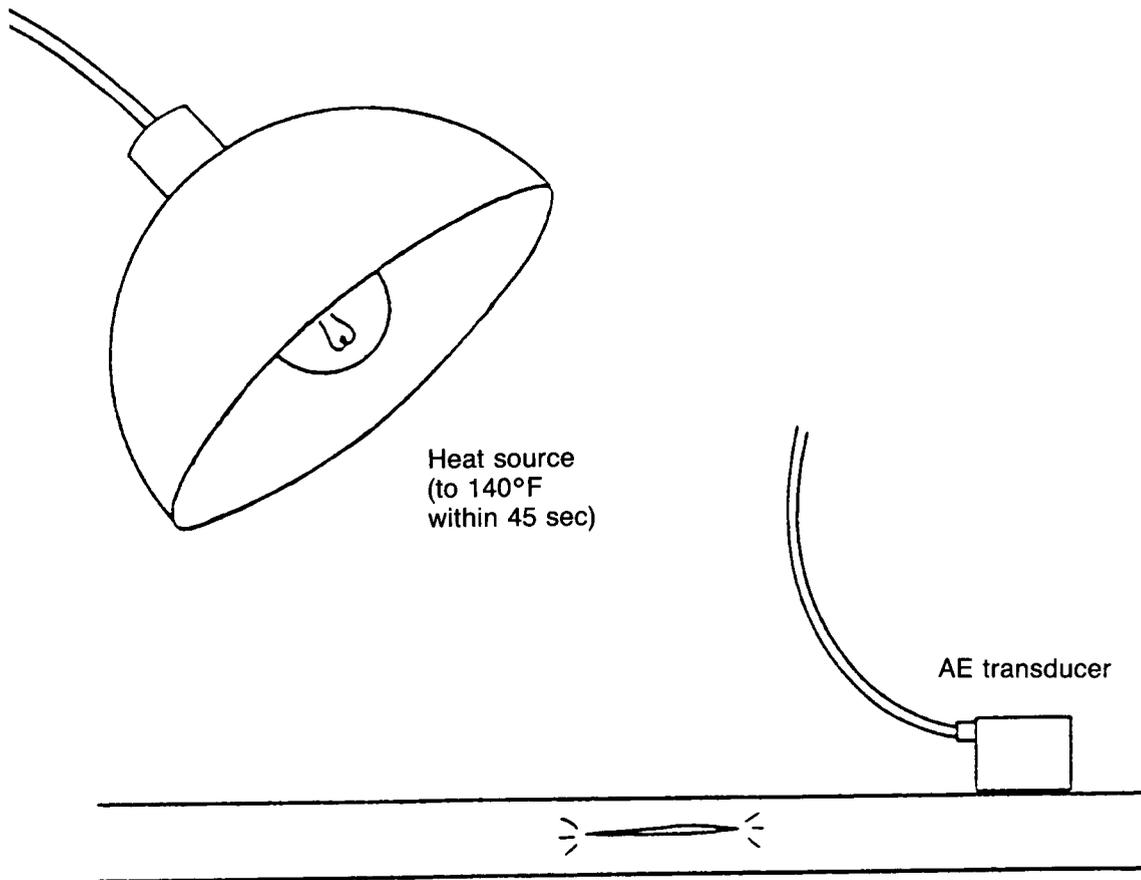
Figure 7. AE Response to Thermal Shock

Another technique involves exciting an AE response from a structure using a thermal shock (Figure 7). This method has been informally tested on small panels before and after impact damage. Experimenters propose that a system could be devised for rapid scanning of large structures incorporating two roller transducers in a fixture with an attached heat lamp for the thermal shock input. A two transducer system could geometrically locate damaged or anomalous areas. A computerized AE data system could aid in developing the thermal AE technique as well as the more traditional AE methods.

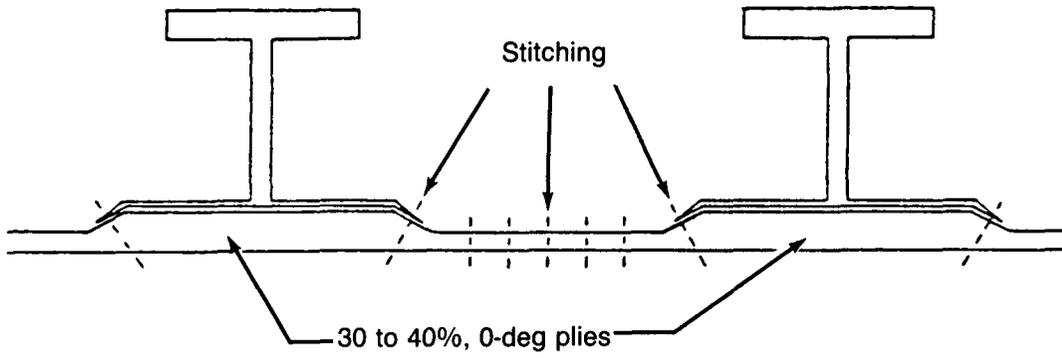
Figure 8. Structural Design Details for Impact Damage Tolerance

Skin Design—Design criteria affecting skin design include variations in the skin directional fiber%ages. Panels with skins consisting primarily of 45-deg plies are damage tolerant due to the low load level in the skin. In this design, the primary load carrying member is the stiffener. Grid stitching with Kevlar yarn in the area between the stiffeners has potential to restrict impact damage and inhibit growth (fig. 8). This has been demonstrated in both Phase II coupon level and three-stringer panel testing.

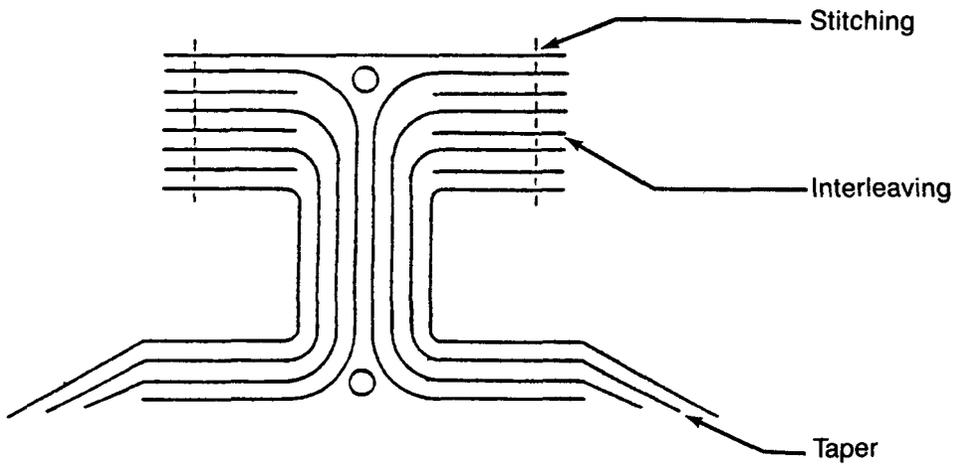
Figure 9. Structural Design Details for Impact Damage Tolerance—Stiffener
