DOE/NASA/50111-2  
NASA TM-101439

# Hot Corrosion of Ceramic Engine Materials

Prepared for the  
Twenty-sixth Automotive Technology Development  
Contractors' Coordination Meeting  
sponsored by the U.S. Department of Energy  
Dearborn, Michigan, October 24-27, 1988

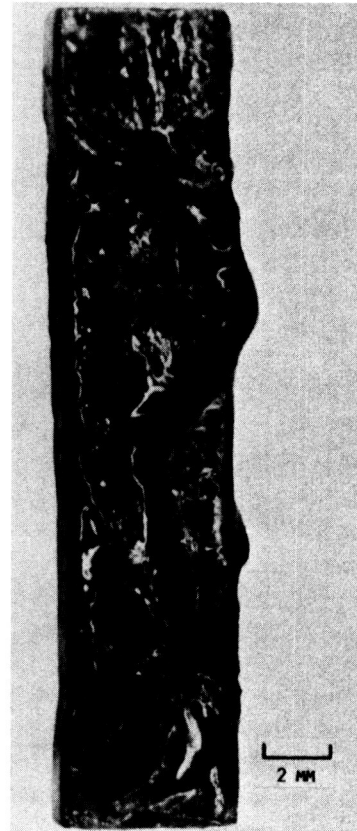
FIGURE 3. - CARBORUNDUM HEXOLOYS SINTERED  $\alpha$ - $\text{SiC}$  EXPOSED FOR 40 H AT  $1000^\circ\text{C}$ , 2 PPM Na, 400 KPA (AIR FLOW LEFT TO RIGHT).

The corrosion of the four types of SiC was very similar. The analysis of just one material, Carborundum Hexoloy sintered  $\alpha$ -SiC, is therefore presented in detail. When this material is exposed in the burner rig with out adding sodium, it is unattacked according to visual examination. Figure 3 illustrates the result of a burner test on Hexoloy sintered  $\alpha$ -SiC with 2 ppm sodium added. A substantial glassy corrosion product was formed after 40 hr at 1000 °C and 400 kPa pressure. The subsonic burner gases drive the corrosion product toward the trailing (or downstream) edge of the sample. This suggests that the corrosion product is liquid at 1000 °C. The glass was quite friable and spalled easily. Bubbles that are evolved and lead to the fragile nature of the corrosion product are seen macroscopically. A similar type of corrosion involving the formation of a friable, glassy corrosion product occurred with the three other SiC materials.
