NASA Technical Memorandum 102332

Fatigue Crack Growth Study of SCS₆/Ti-15-3 Composite

FATIGUE CRACK GROWTH STUDY OF SCS₆/Ti-15-3 COMPOSITE

SUMMARY

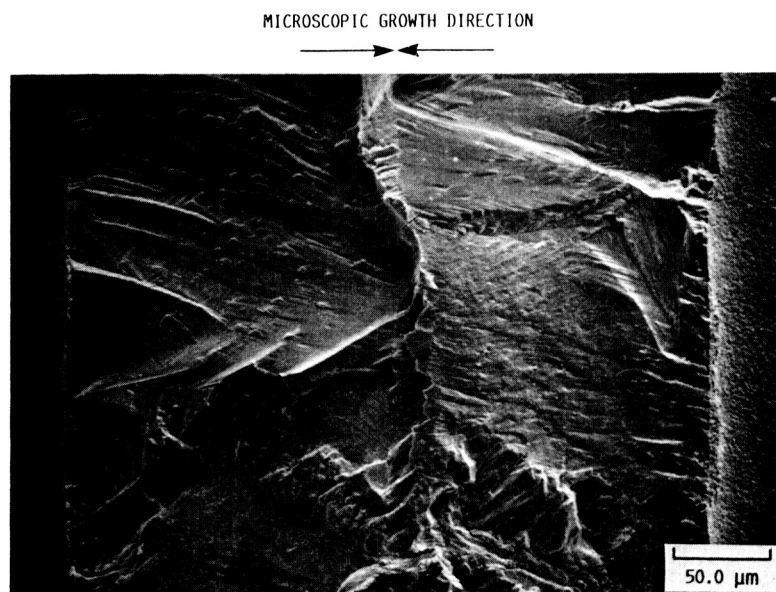
(a) LOW da/dN $[0]_g$.

(b) HIGH da/dN $[0]_g$.

FIGURE 9. - MICROSCOPIC CRACK GROWTH DIRECTION FROM THE INTERFACE INTO THE MATRIX LIGAMENT IN THE $[0]_g$ SPECIMENS.

crack growth process consisted of the continuous cracking of the interface region at or ahead of the crack tip, followed by crack growth into the matrix ligaments and crack coalescence. This phenomena is illustrated in figure 9. In particular, note in the fractograph (fig. 9(b)) of a high da/dN region just prior to final failure, that stable crack growth has occurred in the areas adjacent to the interface. However, the remaining part of the matrix ligament failed through void coalescence during the catastrophic failure. This fractograph clearly shows the direction of localized crack growth to be from the interface region to the matrix ligament.

The crack propagation within the matrix was transgranular in nature (fig. 9). The active fatigue failure mechanisms in the matrix were dependent on grain orientation, and included evidence of striation formation, slip decohesion and some cleavage. Some secondary cracking was present in the matrix foil laminate boundaries perpendicular to the main crack front.

One of the major findings of the study was the close similarity of the fatigue failure processes for the two different composite orientations (compare figs. 9 and 12). The most important event which lead to this similarity in the fatigue behavior was the preferential cracking of the interface region, in particular the carbon coatings surrounding the fibers. The cracking of the interface region occurred for both orientations tested, and promoted crack growth being confined to the fiber direction. While crack growth in the fiber direction is not to surprising in the [90]g oriented specimens, it is somewhat surprising in the [0]g specimens. For the [90]g specimens, cracking of the weak interface region normal to the applied tensile load apparently occurred first. These microcracks later propagated into the matrix and linked up resulting in a dominant crack growing in the fiber direction. For the [0]g specimens, with the main crack growing in the direction of the applied load, one would expect the shear stresses to control the FCG behavior. However, calculations of the simple shear and bending stresses, shown in table II and figure 14, reveal that the bending stress σ_{xx} perpendicular to the fiber direction, is initially twice that of the shear stress τ_{xy} parallel to the fibers, with the ratio increasing as the crack grows further in the fiber direction. These relatively high bending stresses must have been high enough to initiate cracking of the interface region perpendicular to the σ_{xx} direction (fig. 7(a)). The cracking in the interface region was followed by propagation and linkage of the cracks in the matrix ligaments. The relatively high shear stresses in the [0]g specimens might have further contributed to keeping the crack front in the fiber direction by weakening the fiber/matrix interface. However, from the fractographic evidence, as well as the above mentioned analysis, it appears that tensile loads perpendicular to the fiber direction played the major role in controlling the FCG behavior of this composite system by preferentially cracking the interface region.

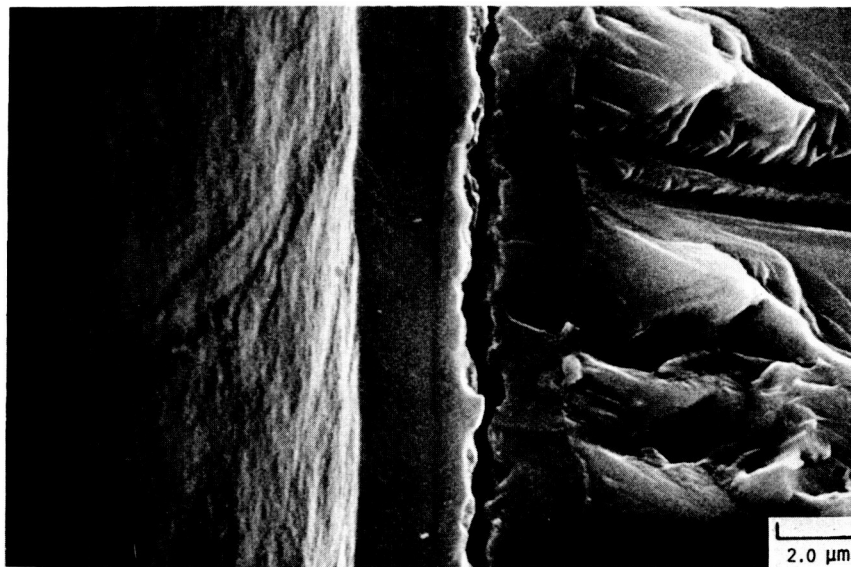
(a) REMNANTS OF THE CARBON COATING ADHERING TO THE MATRIX AFTER ITS SEPARATION FROM THE FIBER IN THE $[90]_8$ COMPOSITE.

(b) CARBON COATING REMAINING IN THE FIBER GROOVE. IN THE CENTER OF THE FRACTOGRAPH NOTE A CRACK BETWEEN CARBON COATING AND THE INTERFACE.

FIGURE 11. - SEPARATION OF THE CARBON COATING FROM THE FIBER IN THE $[90]_8$ SPECIMENS.
