NASA Contractor Report 4330

Current Emergency Locator Transmitter (ELT) Deficiencies and Potential Improvements Utilizing TSO-C91a ELTs

Bernard J. Trudell and Ryland R. Dreibelbis Atlantic Research Corporation Landover, Maryland

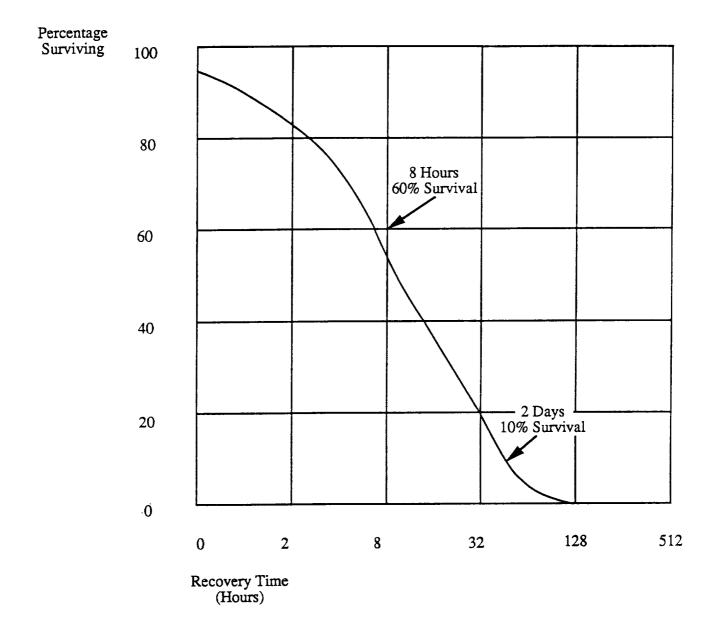
Figure 1 SURVIVAL AS A FUNCTION OF RECOVERY TIME

REF: <u>Final Report ICSAR Ad Hoc Working Group Report on Satellites for Distress Alerting and Locating.</u> Oct. 1976, pg. 6-15.

DOD & NSC data given in C. Mundo, L. Tarni & G. Larson, <u>Final Report Program Plan for Search & Rescue Electronics Alerting and Locating System.</u> DOT-TSC-OST-73-42, February 1974.

A large percentage of general aviation accidents result in some survivors. Review of the data from Block 213 of the NTSB accident records revealed that 85% of general aviation accidents result in some survivors categorized as : Seriously Injured; Minor Injuries or No Injuries. The time between a serious aircraft accident and when potential survivors can be found by rescue forces can have a dramatic impact on the probability of accident victims surviving the accident. This general time/survivability relationship is shown in Figure 1 developed by DOT, Mundo, et al. This time factor is particularly crucial when a search is required to locate the crash site.

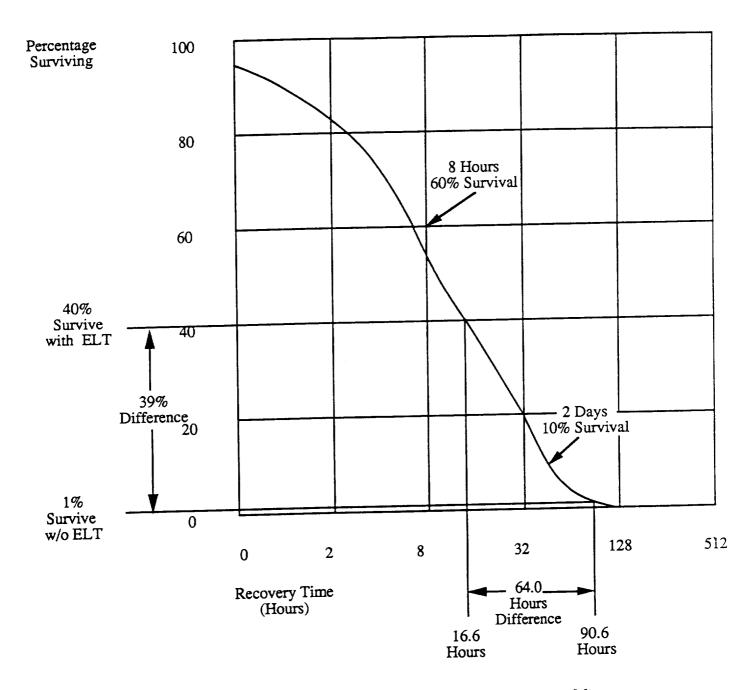
Figure 2 SURVIVAL AS A FUNCTION OF RECOVERY TIME

From NTSB Form 6120.4, Factual Report Aviation Accident/Incident, Supplement M, Search/Rescue/Firefighting/Medical Treatment Section and AFRCC data (See Tables 9 and 10).

REF: Final Report ICSAR Ad Hoc Working Group Report on Satellites for Distress Alerting and Locating. Oct. 1976, pg. 6-15.

The above data can be used to project the expected improvement in survivability when an ELT is used during a search for a missing aircraft. If we average the difference in time from the two data sources (NTSB and AFRCC records) a projection of improved survivability can be derived from the DOT survival curve as shown in Figure 2.
