AN EVALUATION OF THE INTERFACIAL BOND PROPERTIES BETWEEN CARBON PHENOLIC AND GLASS PHENOLIC COMPOSITES*

Kelvin Jordan Hughes Aircraft Company Tucson, Arizona

Raymond Clinton
NASA - Marshall Space Flight Center
Huntsville, Alabama

Shaik Jeelani Materials Research Laboratory Tuskegee University, Tuskegee, Alabama

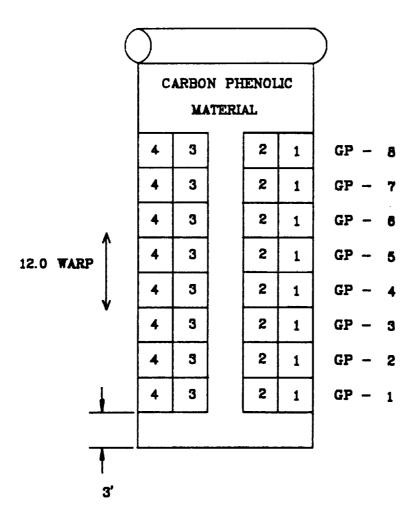
- 1. CUT 3 FOOT SWATCHES AT THE BEGINNING AND AFTER EVERY 168 PLIES UNTIL 504 PLIES ARE CUT.
- 2. CUT 504 [10 IN BY 12 IN (WARP)] PLIES OF C/P MATERIAL. MAKE 6 STACKS (84 PLIES PER STACK), BY STACKING THE FIRST 4 PLIES, SMOOTH SIDE UP, IN STACK CP 1, THE NEXT 4 IN STACK CP 2, ETC. UNTIL EACH STACK CONTAINS 84 PLIES.

Figure 1. Cutting and stacking plan for carbon phenolic material (Roll 1B).

Three C/P laminates were assembled using the six debulked stacks CP-1 thru CP-6 (figure 1) as follows: (a) Panel A consisted of stacks CP-1 and CP-2, (b) Panel B consisted of stacks CP-3 and CP-4, and (c) Panel C consisted of stacks CP-5 and CP-6. The three panels were assembled and bagged on a trilateral cure tool. The hydroclave trilateral tool was designed to simultaneously cure three flat panel laminates with cured thickness of 2.5 inches each. The laminates were cured according to the hydroclave cure cycle designed by MTI [15].

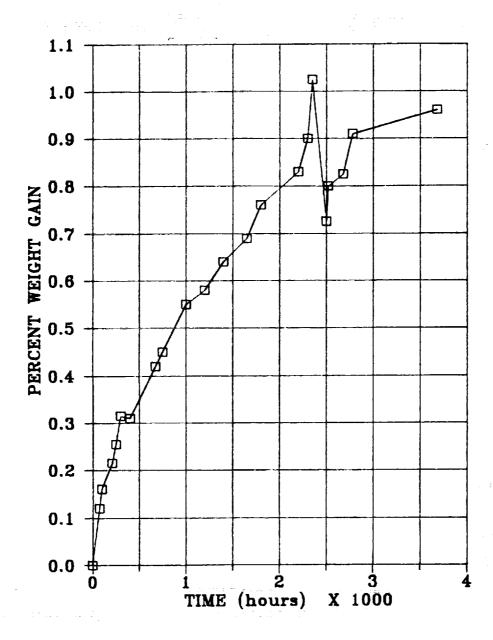
Figure 2. Percent weight gain for wet panel.

Percent weight gain versus time data were plotted as shown in Figure 2. The conditioning resulted in a 0.96 percent weight gain.

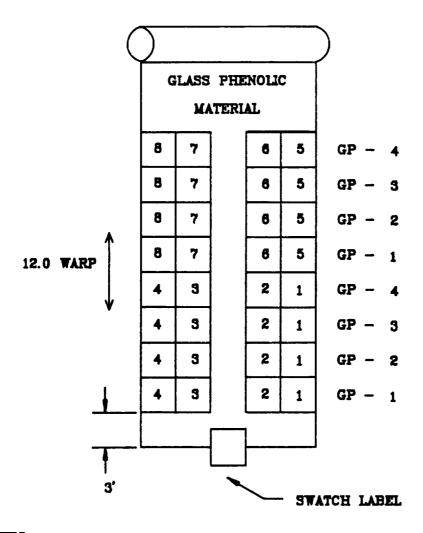
- 1. CUT 160 10 IN BY 12 IN (WARP) PLIES.
- 2. MAKE 4 STACKS BY STACKING THE FIRST 4 PLIES IN STACK GP 1, THE NEXT 4 IN GP 2, ETC., UNTIL EACH STACK CONTAINS 40 PLIES.

Figure 3. Cutting and stacking plan for glass phenolic material (Roll 1).

Lay-up and cure of the G/P immediately followed the conditioning of the C/P laminates. Prior to the lay-up of the G/P debulked stacks, the stacks GP-1 thru GP-3 (Figure 3) were machined to equal the dimensions of their respective C/P laminates. The lay-up and bagging sequences for cure may be found in reference [14]. The composite laminates were machined and test sections removed.

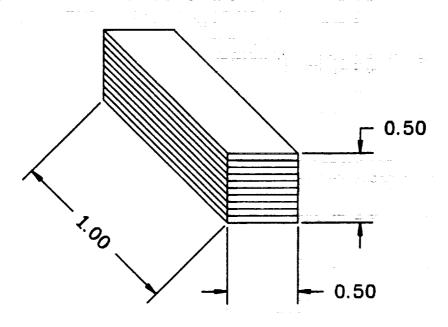
Figure 4. Specimen geometry of specific gravity, residual volatile, and resin content tests.

sisted of residual volatile content, specific gravity and resin content [19]. The MTI specifications require that resin content tests be performed using the tested residual volatile specimens. The same test geometry was used for each of the above three tests. The specimen geometry is shown in Figure 4.

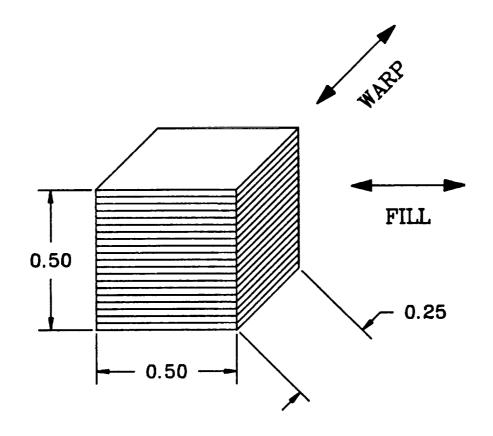
Figure 5. Specimen geometry for photomicroscopy evaluation.

Optical photomicroscopy examinations were conducted on specimens taken from the C/P, G/P and at the interfaces of each laminate. The objectives were to: (a) observe material for possible microstructural damage; (b) characterize the appearance of the microstructure of the C/P and G/P materials; and (c) characterize the appearance of the different interfaces between the C/P and G/P laminates. A typical final machined specimen is presented in Figure 5. Prior to the examination, each specimen was mounted in epoxy and then polished. Photomicrographs were taken of each specimen at several magnifications.

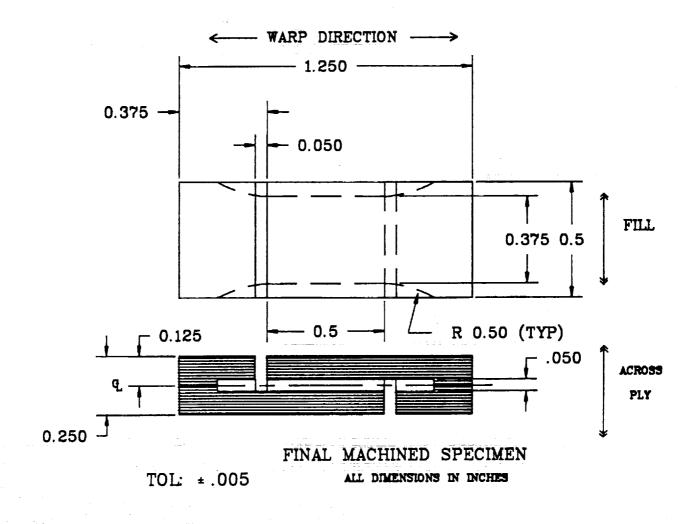
Figure 6. Specimen geometry for DNS test.

The basic cutting plans for the specimen removal may be found elsewhere [14]. Specimens were first excised as blanks, then machined to the specified dimensions shown in the schematic presented in Figure 6. The gage section was maintained at 0.375 inches (fill) by 0.300 inches (warp) by 0.050 inches (A/P), allowing four plies to be isolated in the gage section for the C/P specimens and two plies in the gage section for the G/P specimens. The number of plies isolated in the gage section was determined by dividing the A/P dimension of the gage section by the cured ply thickness of each material. For the interface specimens, approximately 2 plies of C/P and 1 ply of G/P were isolated in the gage section with the bondline centered in the gage section. The specimens were loaded in axial compression to provide pure shear at the gage section. Each specimen was loaded at a rate of 10,000 pounds per minute [21]. The load versus time plot obtained from the Instron for each specimen was transformed into a stress versus time plot by dividing load values by the shear (gage) area. The data obtained from the linear stress versus time plot were used to determine the ultimate interlaminar shear strength.

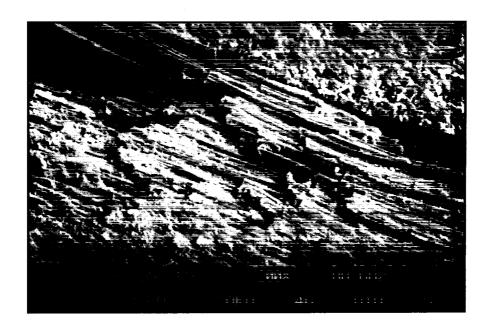
Figure 7b. SEM photomicrograph at 200X of fracture surface depicting interlaminar failure.

Interlaminar failure (presented in Figure 7) was characterized by a fracture surface exhibiting one or more of the following features: (a) large areas of exposed denuded fibers, (b) thin cracks between the fibers and matrix, and (c) clear imprints in the matrix where fibers were removed. This type of failure was characteristic of the interface specimens of the wet laminate and the glass phenolic material of all laminates.

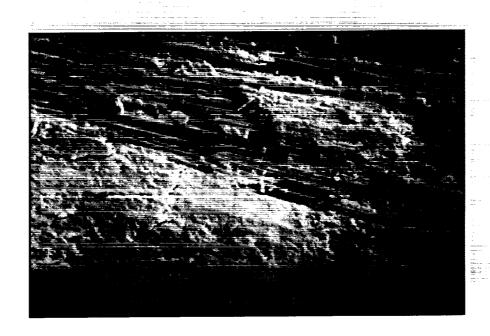
Figure 7c. SEM photomicrograph at 200X of fracture surface depicting interlaminar failure.

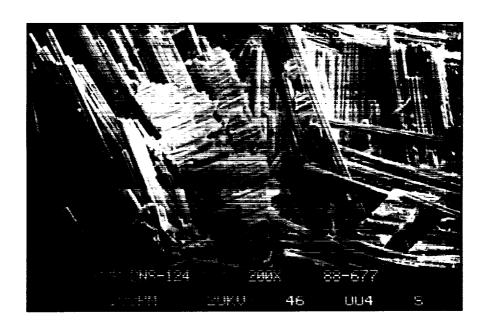
Figure 8b. SEM photomicrograph at 200X of fracture surface depicting across-laminar failure.

Across-laminar failure (presented in Figure 8) was characterized by a fracture surface exhibiting similar features on interlaminar failure with the addition of some extensive fiber breakage across individual plies of material. This type of failure was common to all carbon phenolic material and the bondline specimens of the dry, as-received and the cocure laminates. From analysis of fracture surfaces of failed DNS C/P specimens by SRI, it was found that the predominate mode of failure was interlaminar although the presence of across-laminar failure was observed [21].

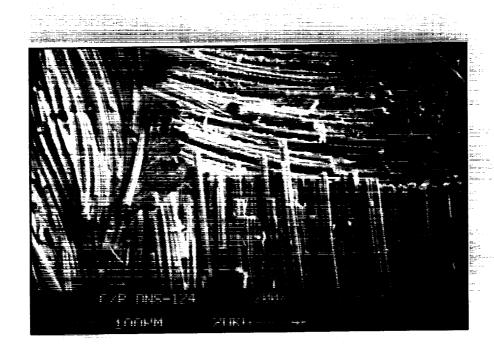
Figure 8c. SEM photomicrograph at 200X of fracture surface depicting across-laminar failure.
