PERFORMANCE OF FUSELAGE PRESSURE STRUCTURE

James R. Maclin
Boeing Commercial Airplane Group

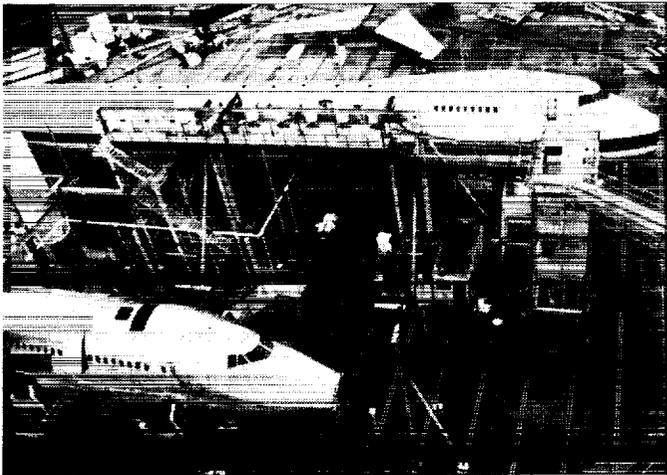
Figure 14. Retired and New Model 747 Fuselage Test Articles.

For this test, a 747-100SR with an equivalent of 20,000 full-pressure cycles (flights) was obtained from service and monitored as it was extended to 40,000 cycles (Figure 14). The minimum gage lap splices are shown in Figure 15.

Sections 41 and 42 from the 747-400 production line were pressure cycled to determine some of the fatigue and damage tolerance characteristics of the latest production configurations (Figure 14). The minimum gage lap splices are shown in Figure 17.
