TECHNICAL NOTE

No. 1203

A FLIGHT INVESTIGATION TO INCREASE  
THE SAFETY OF A LIGHT AIRPLANE

By P. A. Hunter and J. R. Vensel

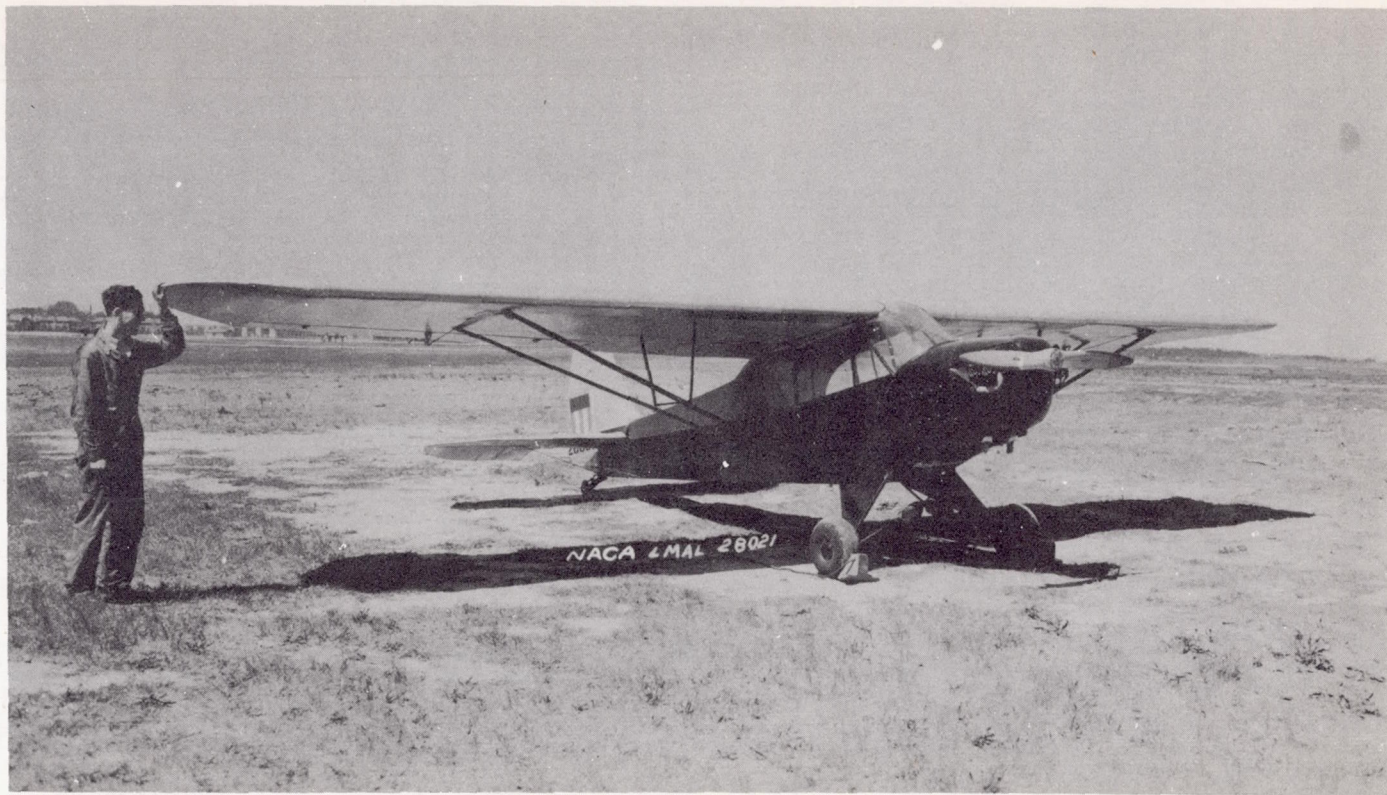
(a) Three-quarter front view.

Figure 1.- Airplane used in tests.
