STABILITY RESULTS OBTAINED WITH DOUGLAS D-558-1 AIRPLANE

(BuAero No. 37971) IN FLIGHT UP

TO A MACH NUMBER OF 0.89

William H. Barlow and Howard C. Lilly

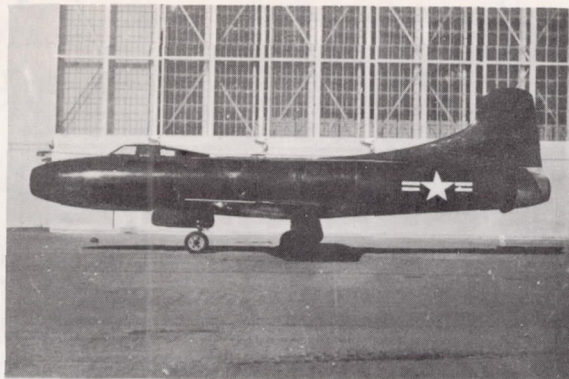
(a) Side view.

Figure 1.- Photographs of D-558-1 airplane.

The Douglas D-558-1 airplane is a single-place low-wing monoplane powered by a General Electric TG-180 turbojet engine. General views of the airplane are given in figures 1(a), 1(b), and 1(c). A three-view drawing of the airplane is given in figure 2. Detailed specifications of the airplane are given in reference 1.

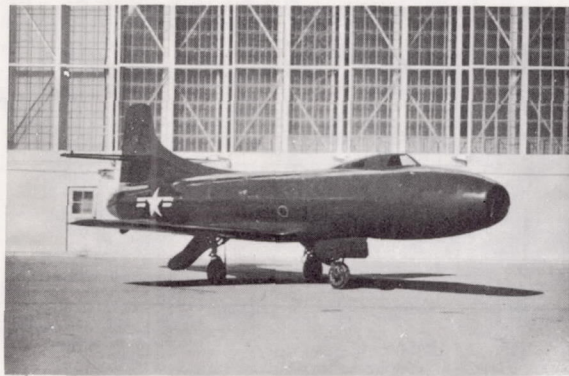
(b) Three-quarter front view.

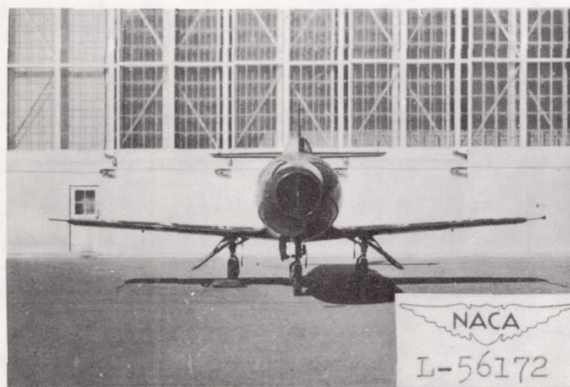
(c) Front view.

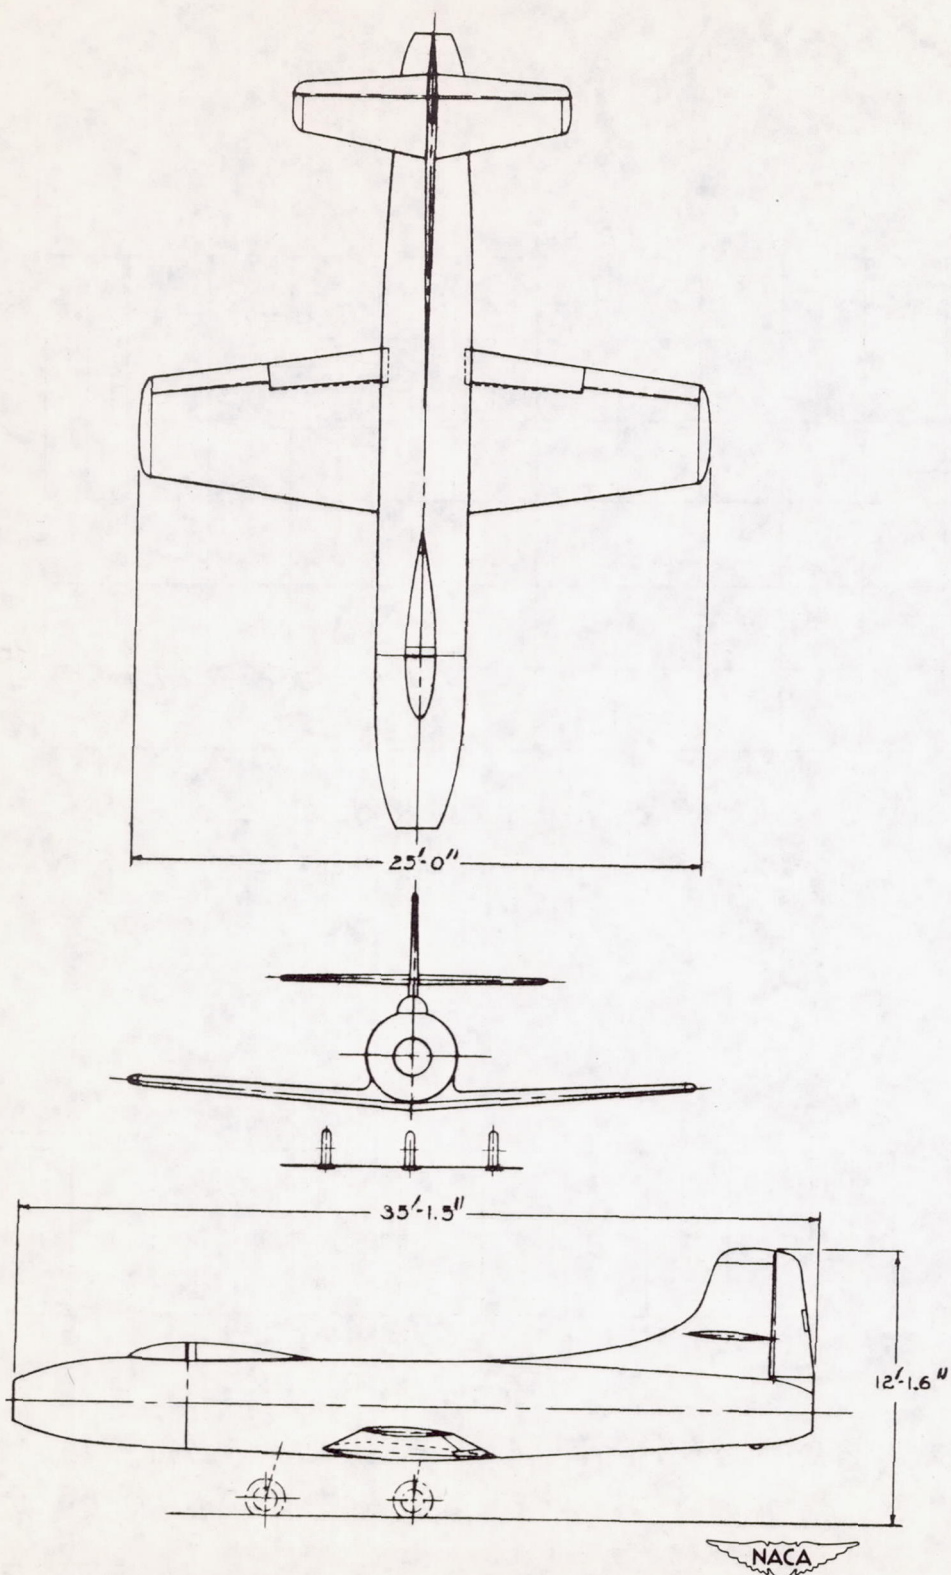
Figure 2.- Three-view drawing of D-558-1 airplane.

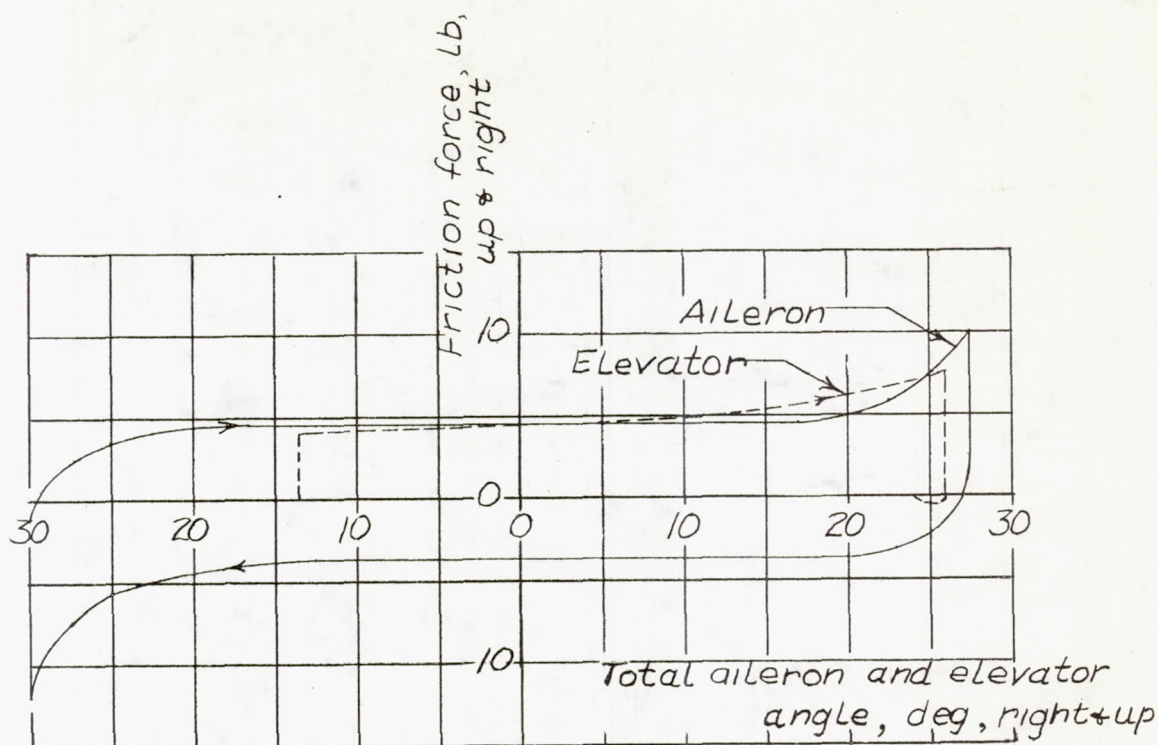
Figure 3.— Control friction forces obtained by moving controls slowly in direction shown. D-558-1 airplane.

The force required to move the wheel controls slowly under static airplane conditions is shown in figure 3. The rudder friction is of the order of 7 pounds near neutral position. The elevator control has a bungee tending to return the elevator to the down position. All controls have hydraulic dampers at the control surface which necessitate high control force for rapid motion of control.

of acceleration. With the  $1.4^\circ$  stabilizer setting in figure 6 the airplane became increasingly tail heavy above a Mach number of 0.83. During the recovery in this run (65 to 89 sec and  $M = 0.88$  to  $0.834$ ) the pilot merely decreased the push force and a normal recovery was effected. The pilot reported that in both runs, there was buffeting which began at about a Mach number of 0.85. It is also interesting to note that above a Mach number of 0.84, the airplane becomes very right-wing heavy and the pilot applied control to correct it. The pilot reported that this wing heaviness was not continuous and it was difficult to determine the lateral control required for trim. As a consequence, the airplane felt uncertain laterally at the highest speeds as can be seen by the control motions used by the pilot, and the lateral oscillations which resulted. Some of this uncertainty in lateral trim may arise from aileron friction. (See fig. 3.)

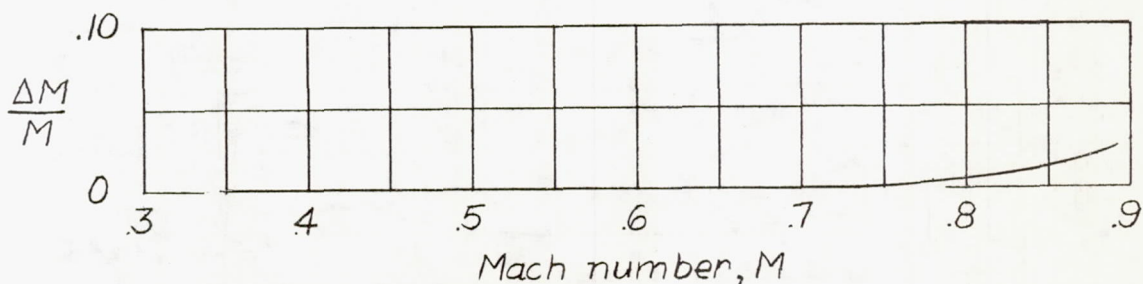
Figure 4.— Variation of percentage error in Mach number,  $\frac{\Delta M}{M}$ , with corrected Mach number.

A calibration of the airspeed system was made using the fly-by and radar tracking methods of reference 3. The results of the calibration are presented in figure 4 as a variation of percentage error in Mach number  $\frac{\Delta M}{M}$ , with corrected Mach number. The error increases above  $M = 0.75$  due to blocking effects of the wing on static pressure at the airspeed head. These results are in general agreement with data obtained from a similar airspeed installation on the Bell XS-1 airplane, reference 4.

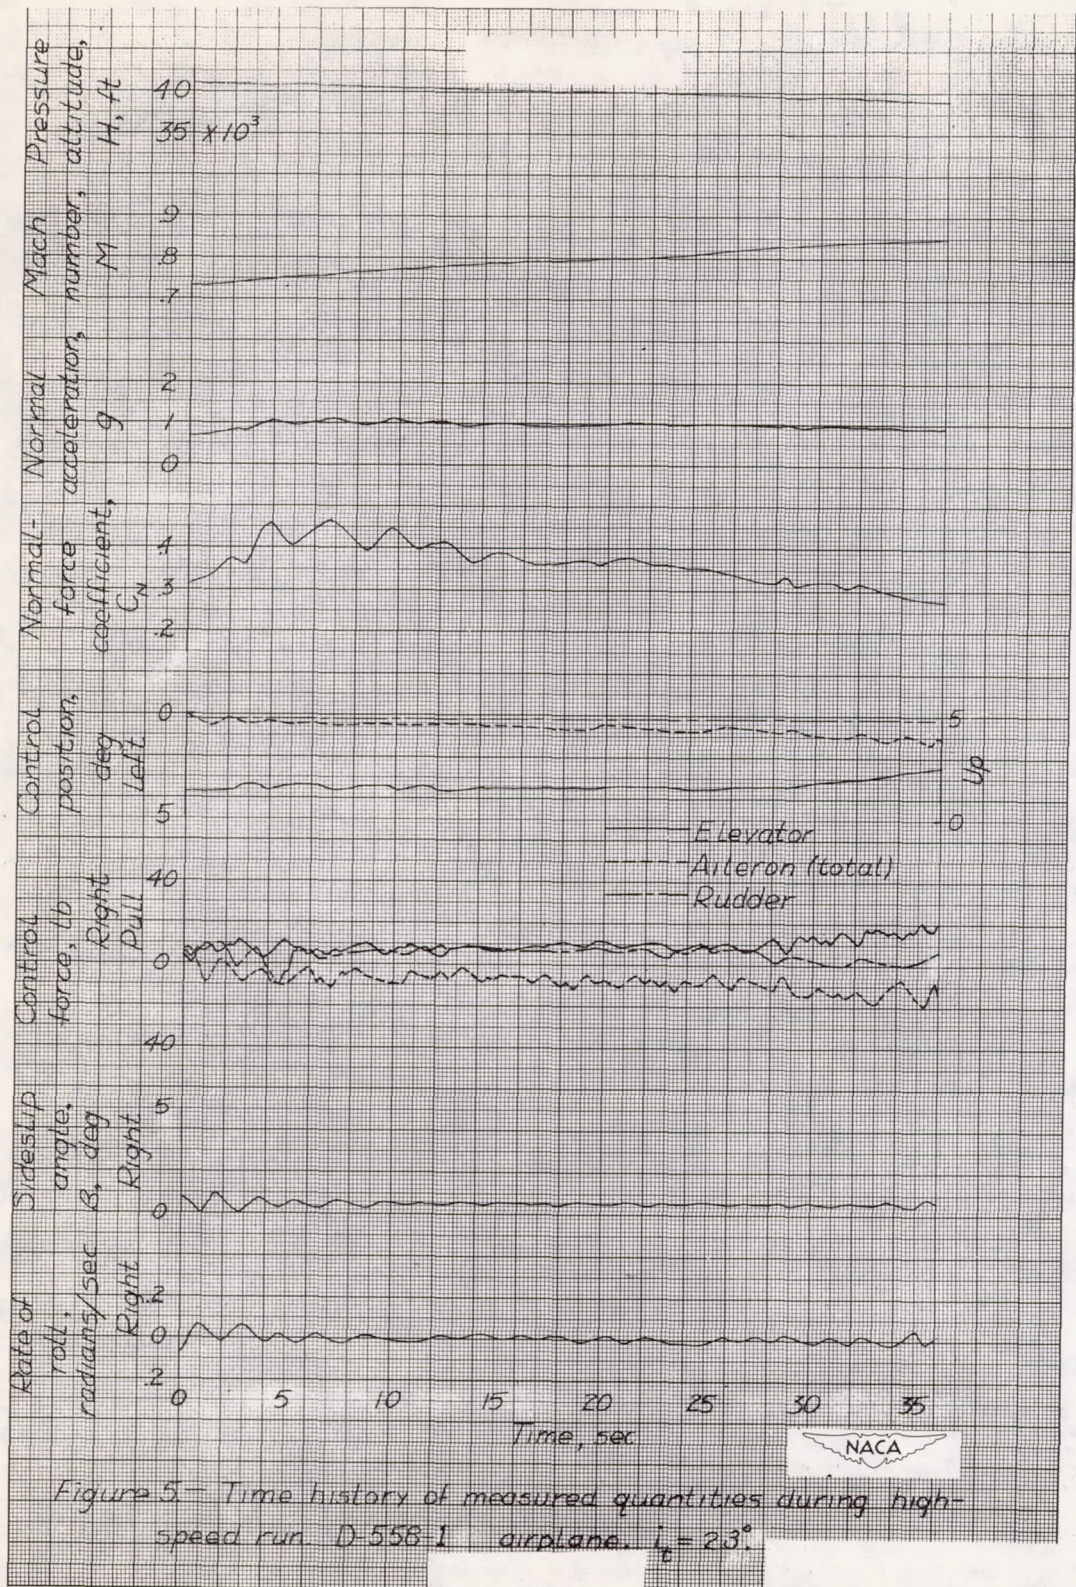
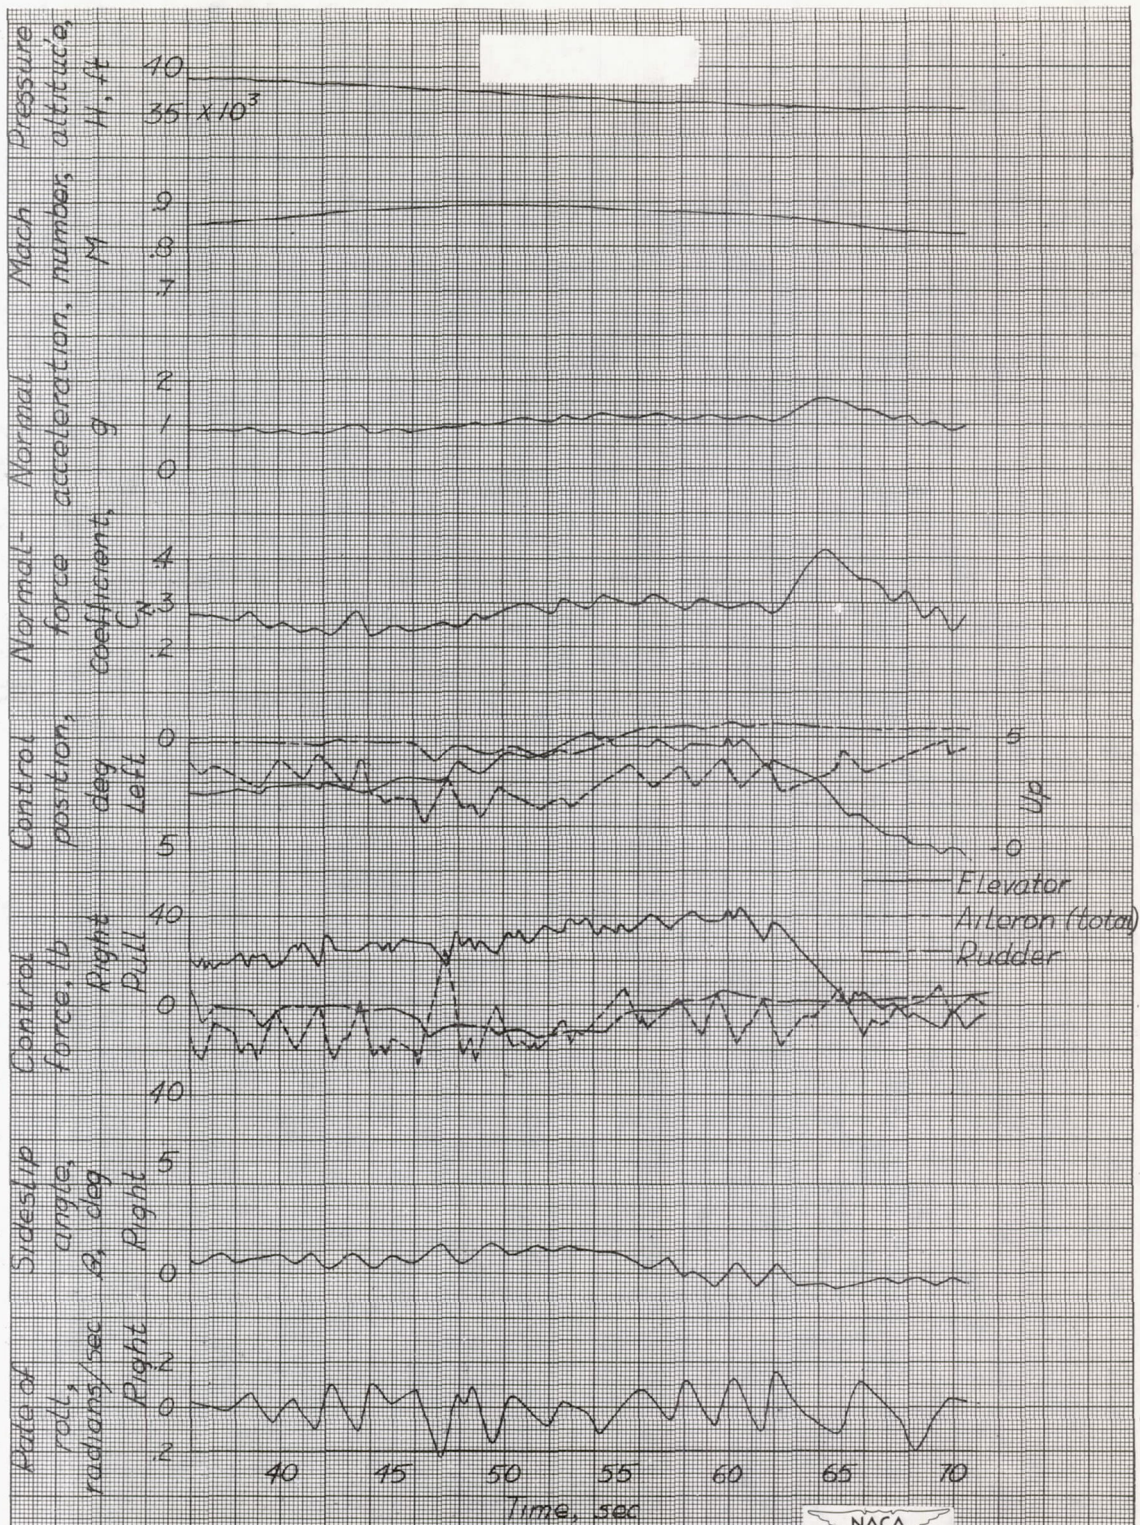
Figure 5—Time history of measured quantities during high-speed run D-558-I airplane.  $i_e = 23^\circ$ .

Figure 5.-Concluded.

The stability measurements reported here were obtained for the most part from two high-speed runs to a Mach number of approximately 0.89 and several turns made at various Mach numbers up to 0.81. Time histories of the two high-speed runs made at altitudes of about 40,000 feet are given in figures 5 and 6. In the run shown in figure 5, the pilot used a stabilizer setting of  $2.3^\circ$ ; in the run shown in figure 6, a stabilizer setting of  $1.4^\circ$  was used. As shown in figure 5, the airplane with a  $2.3^\circ$  stabilizer setting became increasingly nose heavy as the Mach number was increased above 0.80. During the initial phase of the recovery, (after 50 sec) an appreciable pull force was required to increase the normal-force coefficient and decrease the Mach number. As the Mach number decreased (time, 60 sec), the nose heaviness also decreased and the pilot was required to relieve the pull force to prevent reaching high values

In order to illustrate further the control required by the pilot to trim the airplane, control positions and forces and sideslip angle for steady flight were selected from figures 5 and 6 and plotted in figure 7 as functions of Mach number. In this figure, the difference in control required for trim caused by the two stabilizer settings is clearly shown. These trim changes, from the standpoint of pilot's forces, are large in that approximately 30 pounds force was required in either the pull or push direction, depending on the stabilizer setting. In the case of the Bell XS-1, data for two stabilizer settings showed no difference in the direction of the trim change as the airplane becomes nose heavy in both cases (reference 4) for this Mach number range. The right-wing heaviness is illustrated in this figure by the increased left aileron for trim required at the higher speeds. There was no appreciable change in rudder position or sideslip angle. (A similar phenomenon of wing heaviness was noted with the XS-1 airplane (reference 4).)

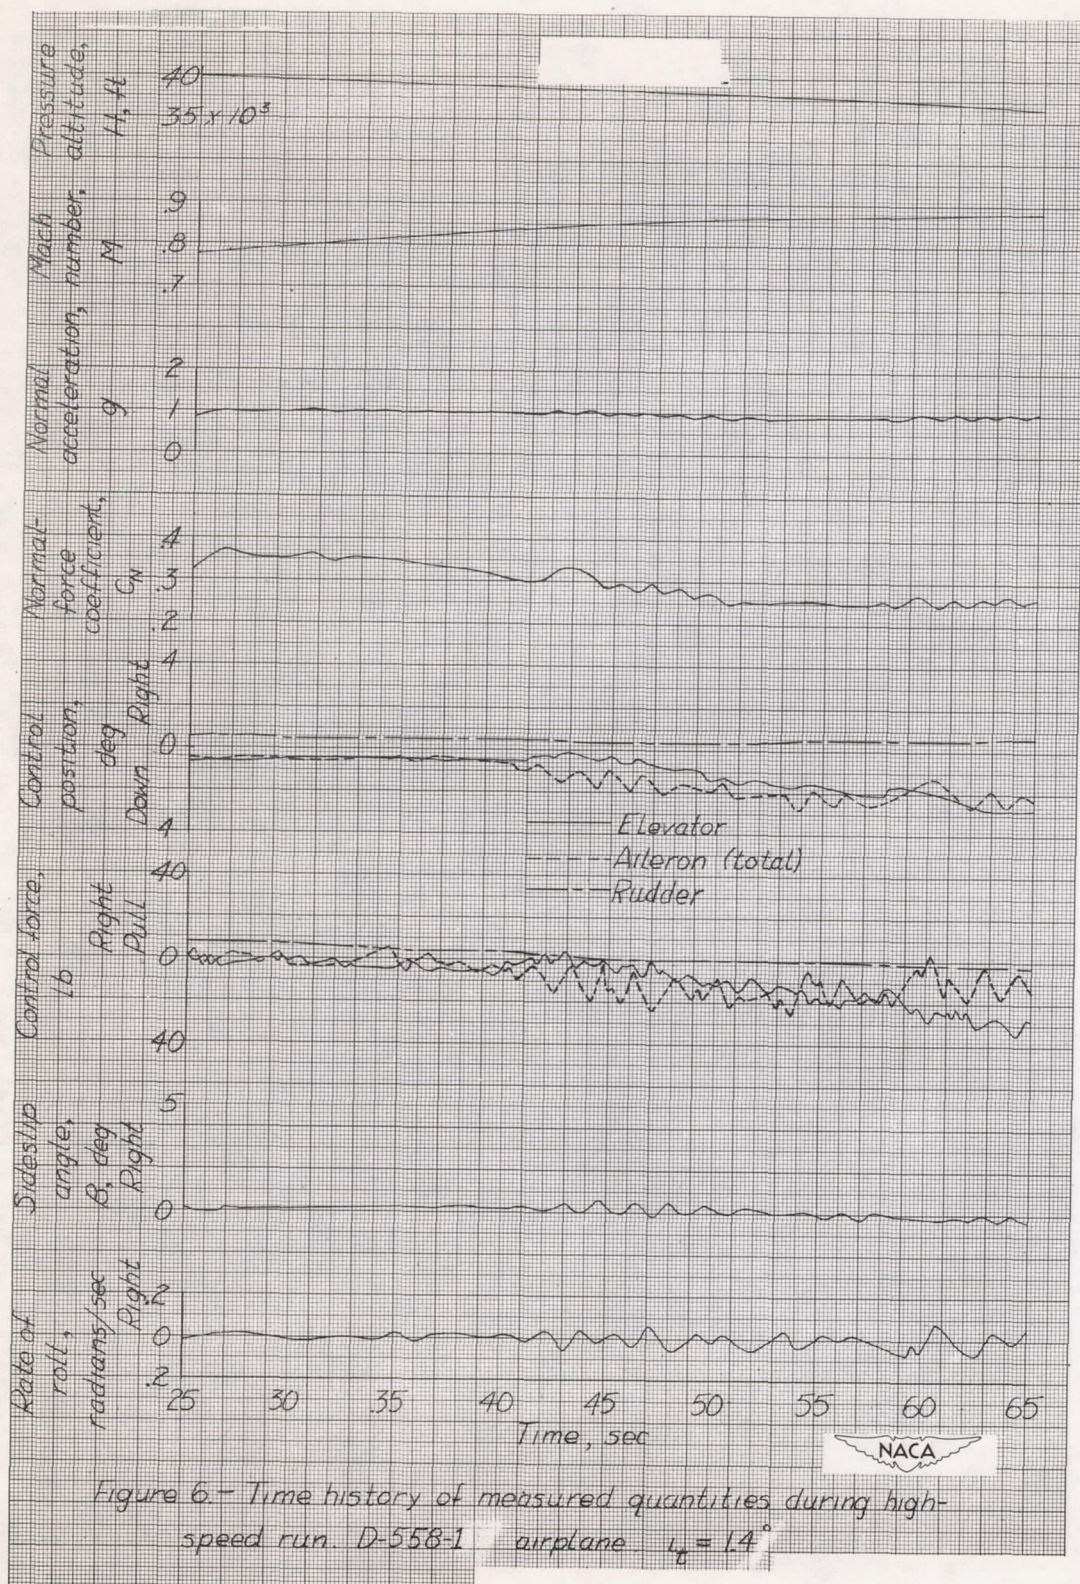
Figure 6.- Time history of measured quantities during high-speed run. D-558-1 airplane  $\alpha = 1.4^\circ$

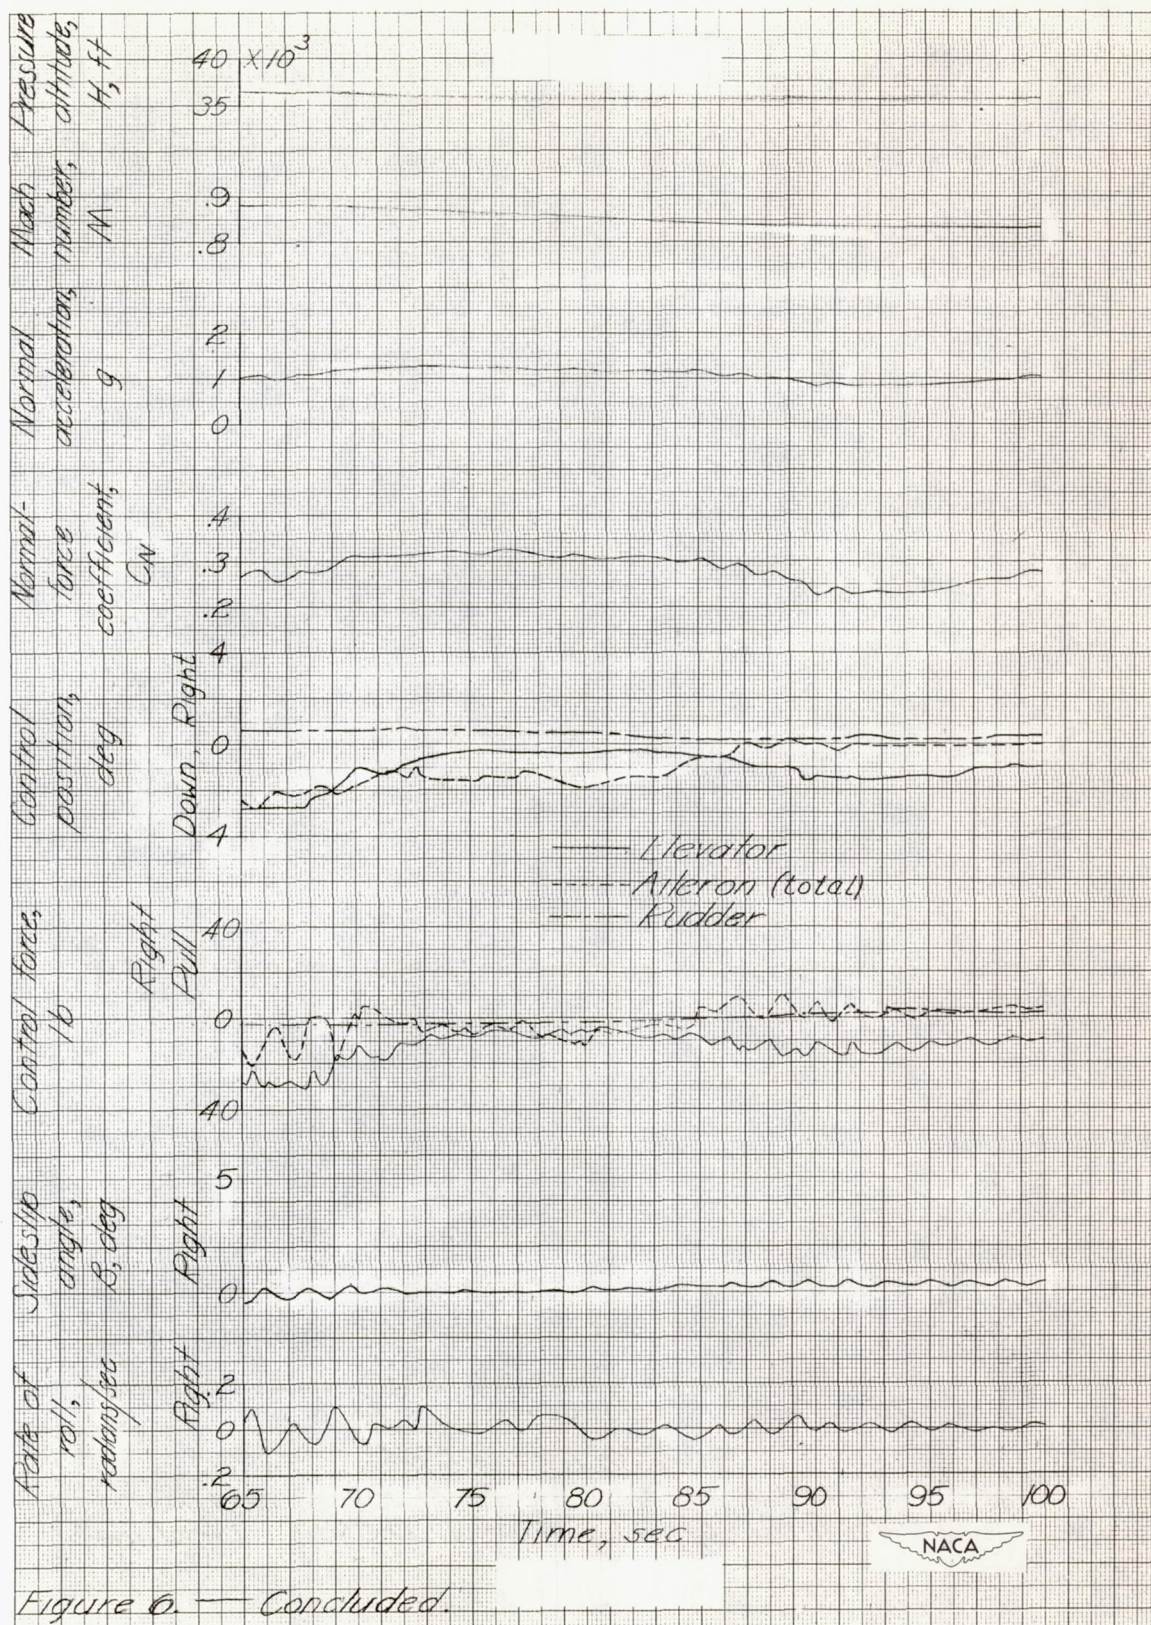
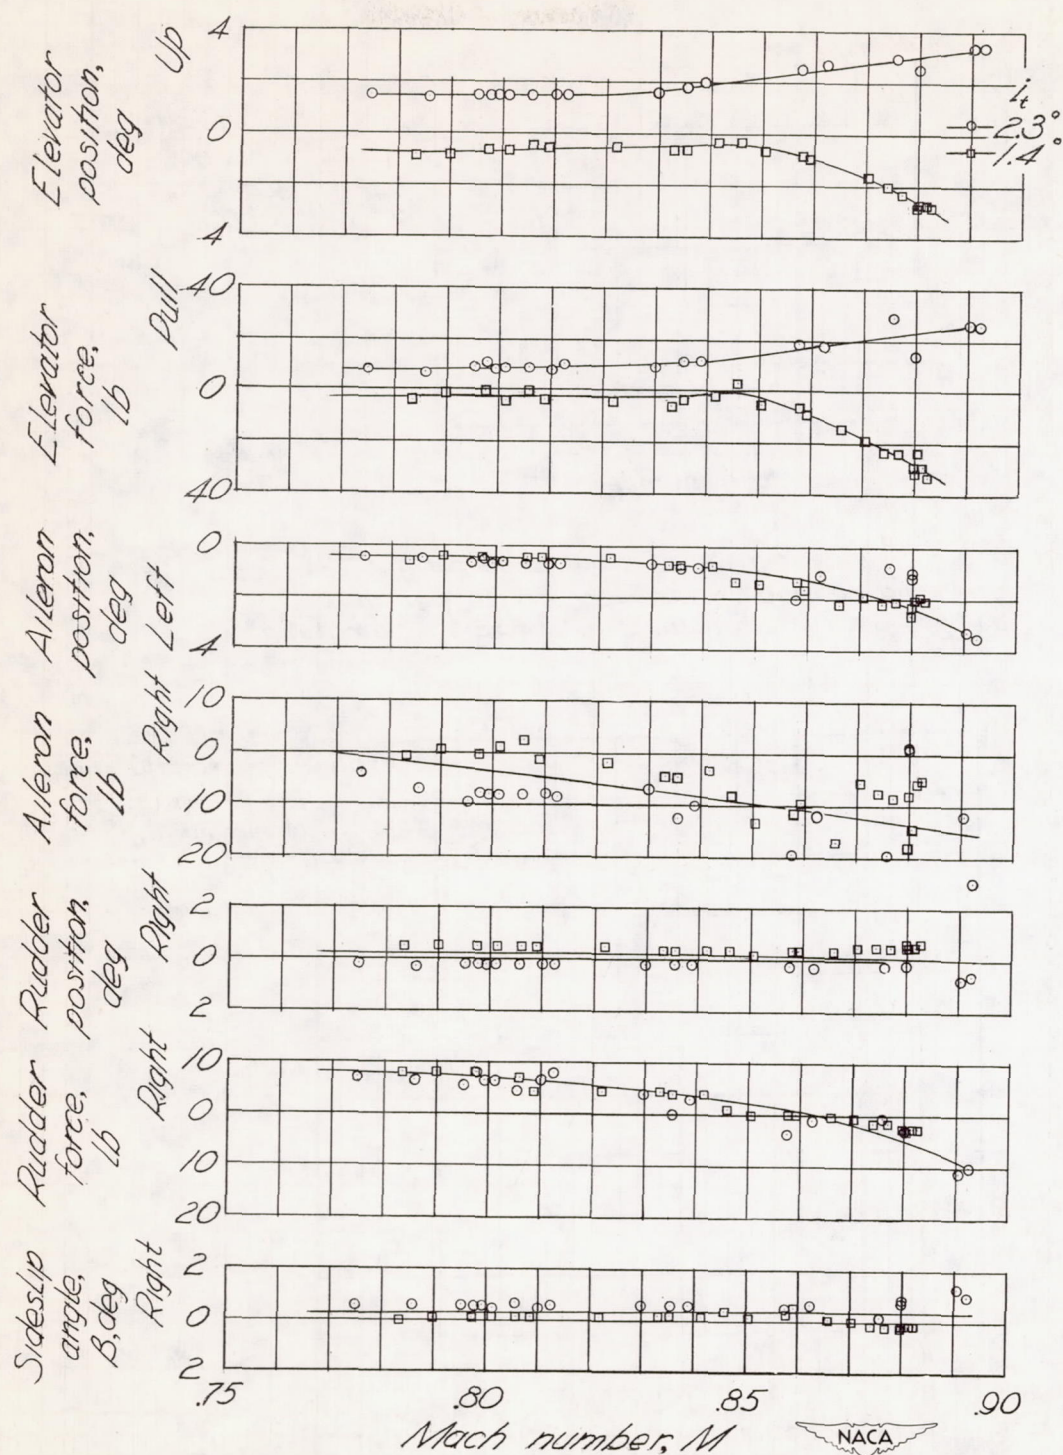
Figure 7.-Variation of airplane trim forces and positions with Mach number. ( $C_N \approx 23$  to  $43$ ) D-558-1 airplane.

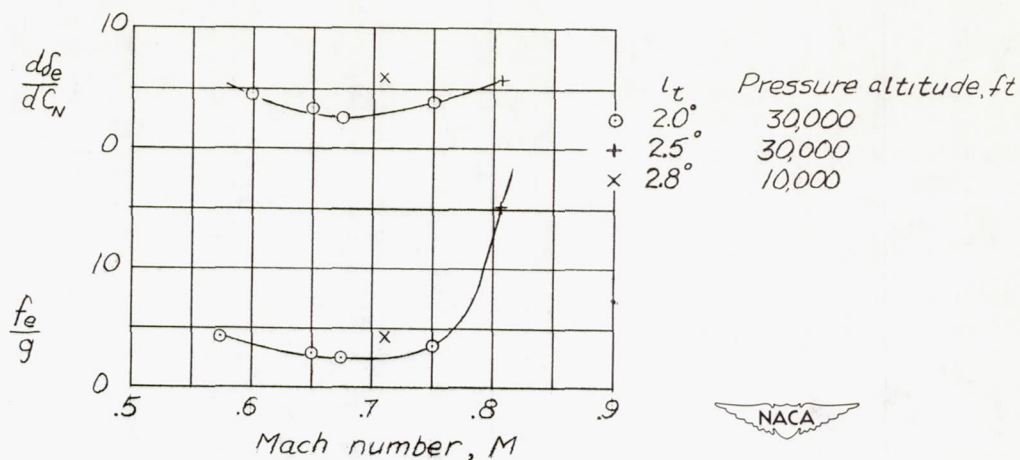
Figure 8.- The variation of stick force per g,  $f_e/g$ , and the change in elevator angle per unit  $C_N$ ,  $d\delta_e/dC_N$ , with Mach number. D-558-1 airplane.

Some stability and control data in accelerated flight were obtained from steadily increasing turns made at an altitude of 30,000 feet in a Mach number range from 0.50 to 0.80 and one turn made at 10,000 feet at a Mach number of 0.71. The results of these measurements are given in figure 8 where the stick force per  $g$  and elevator angle required per unit  $C_N$  are plotted as functions of Mach number. These data show that the longitudinal stability is positive throughout the speed range and is lowest at about a Mach number of 0.675. Above a Mach number of 0.675, the stability increases with increasing Mach number. These results are in general agreement with the data obtained on the Bell XS-1 airplane (reference 5). Although data were available only at one speed for an altitude of 10,000 feet, it is interesting to note that the apparent stability is higher at 10,000 feet than at 30,000 feet. Some of this difference can be accounted for by the effect of altitude but it is also possible that, because of the higher dynamic pressure at the lower altitudes, the apparent stability is altered by distortion effects.

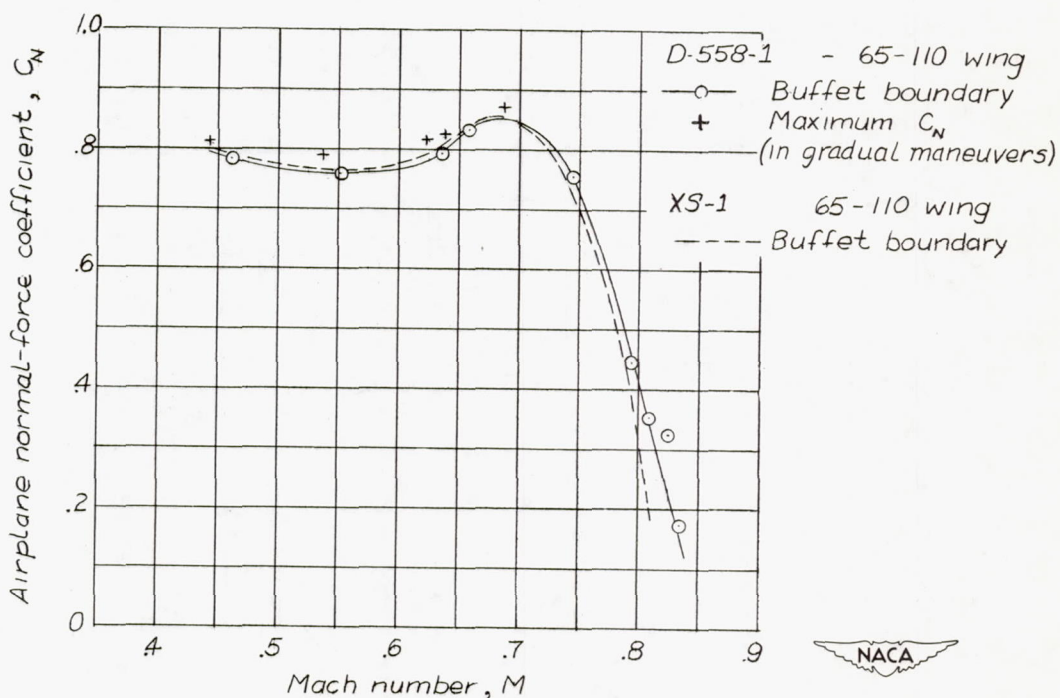
Figure 9.- Buffet boundary of D-558-1 airplane compared with buffet boundary of X5-1 airplane.

measurements are given in figure 9 where the normal-force coefficients necessary for buffeting are plotted as functions of Mach number. The buffet boundary as presented in this figure defines the combination of Mach number and normal-force coefficient where buffeting begins. Below a Mach number of 0.70, the airplane was flown into the buffet boundary and the test points shown beyond the boundary represent maximum lift for a gradual maneuver at the test speed. Above a Mach number of 0.70, the airplane was flown into the buffet region but peak lift was not obtained during the tests. For comparison, the buffet boundary for the Bell XS-1 airplane with the same wing section 65-110 (references 4 and 6) is also shown in this figure. As might be expected, the buffet boundaries for the two airplanes are quite similar.
