RESEARCH MEMORANDUM

FACILITIES AND METHODS USED IN FULL-SCALE
AIRPLANE CRASH-FIRE INVESTIGATION

By Dugald O. Black

Lewis Flight Propulsion Laboratory
Cleveland, Ohio

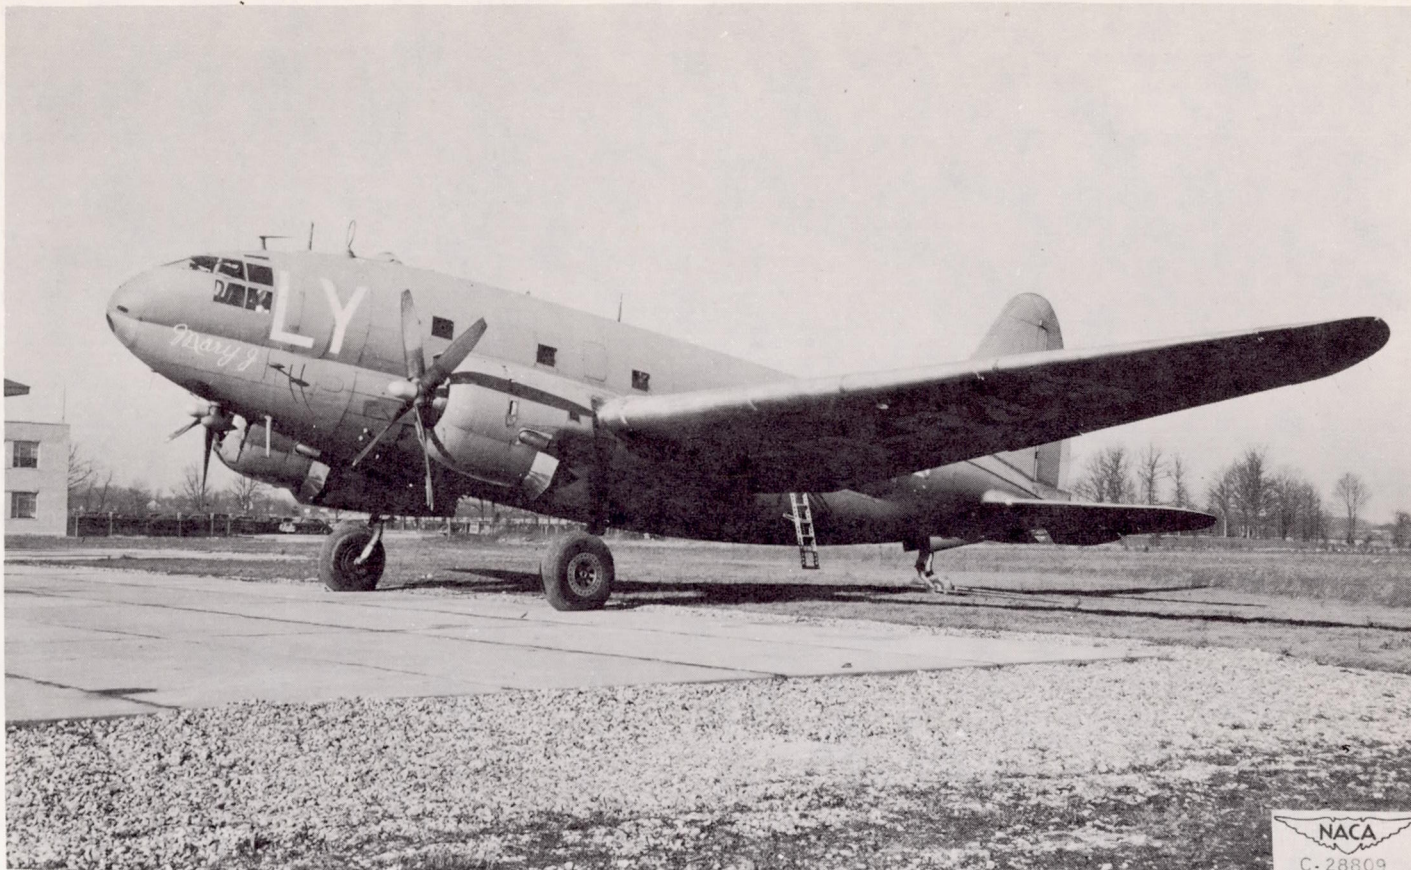
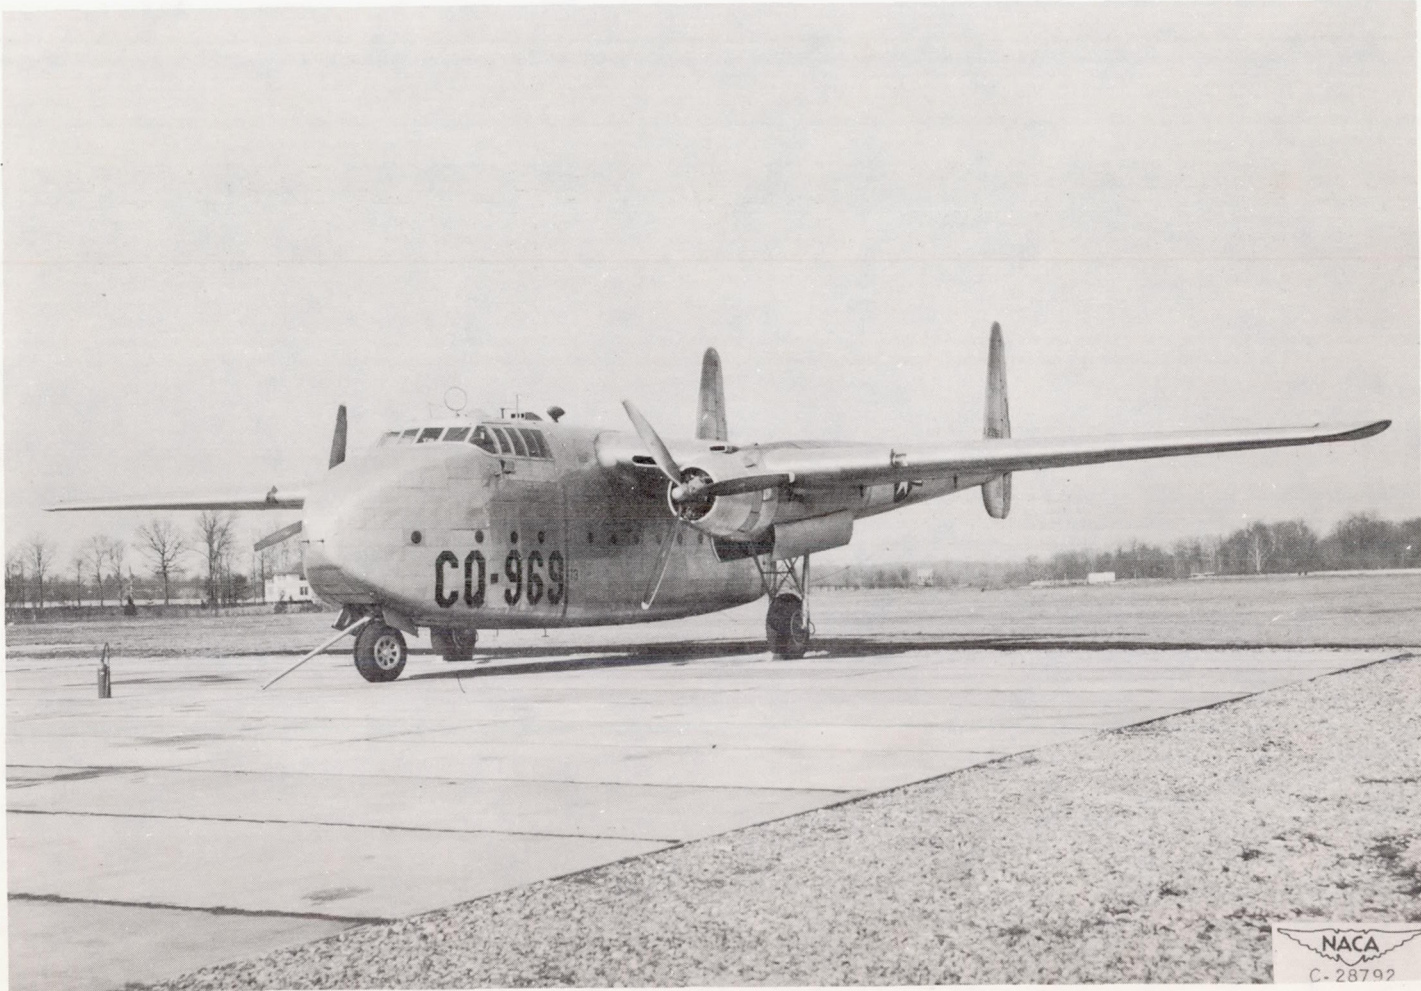
Figure 1. - Airplanes used in full-scale crash-fire investigation.

Figure 1. - Concluded. Airplanes used in full-scale crash-fire investigation.

The NACA full-scale crash-fire investigation was conducted on C-46 and C-82 airplanes of the type shown in figure 1. The United States Air Force provided valuable assistance in conducting the investigation by supplying the war-weary and obsolete test airplanes.

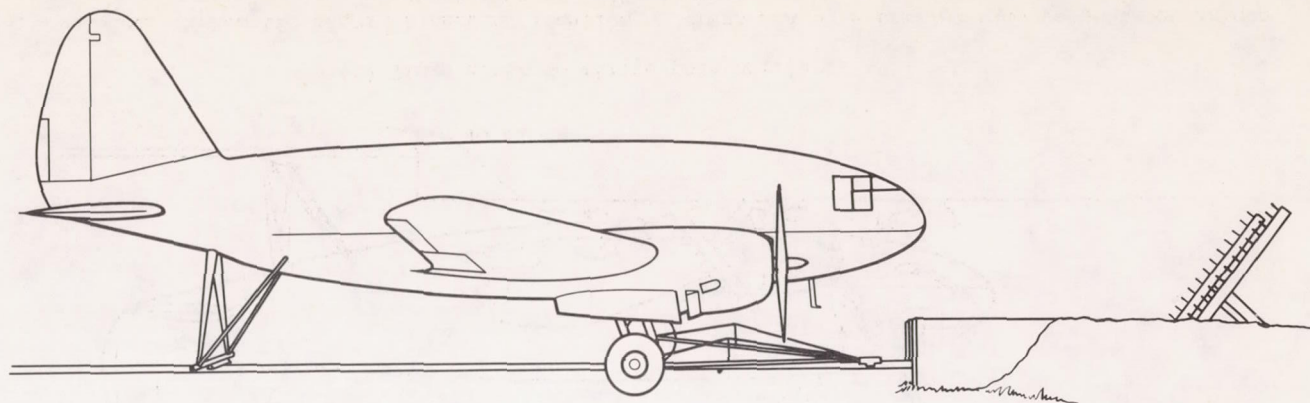
(a) Airplane approaching crash barrier.

Figure 2. - Schematic diagrams showing location of crash and pole barrier with respect to various components of C-46 airplane.

The diagrams presented in figure 2 show how the barriers on the crash site produced the type of crash desired. The airplane as it approaches the crash barrier is shown in figure 2(a). First, the propellers of the airplane contact the crash barrier (fig. 2(b)); second, the main landing-gear wheels come in contact with the crash barrier (fig. 2(c)); and third, the leading edge of the wings come in contact with the pole barrier (fig. 2(d)).

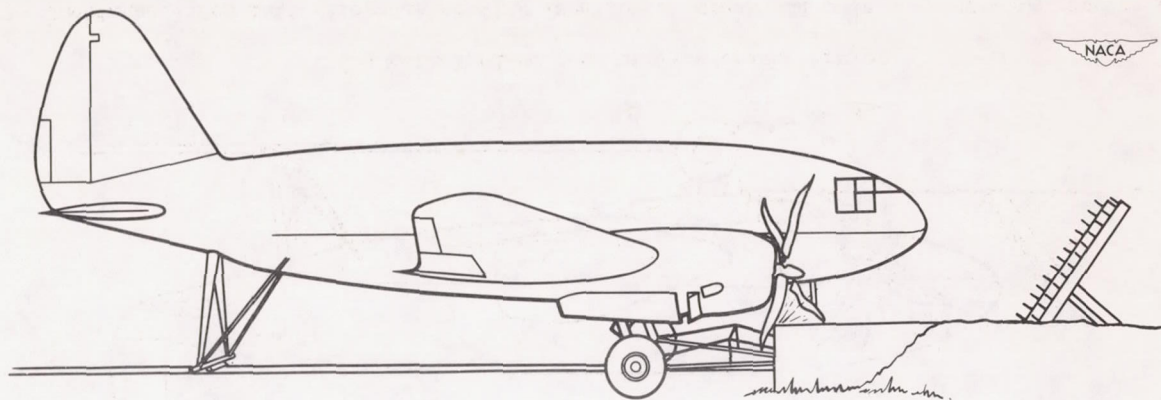
(b) Propeller strikes crash barrier.

Figure 2. - Continued. Schematic diagrams showing location of crash and pole barrier with respect to various components of C-46 airplane.

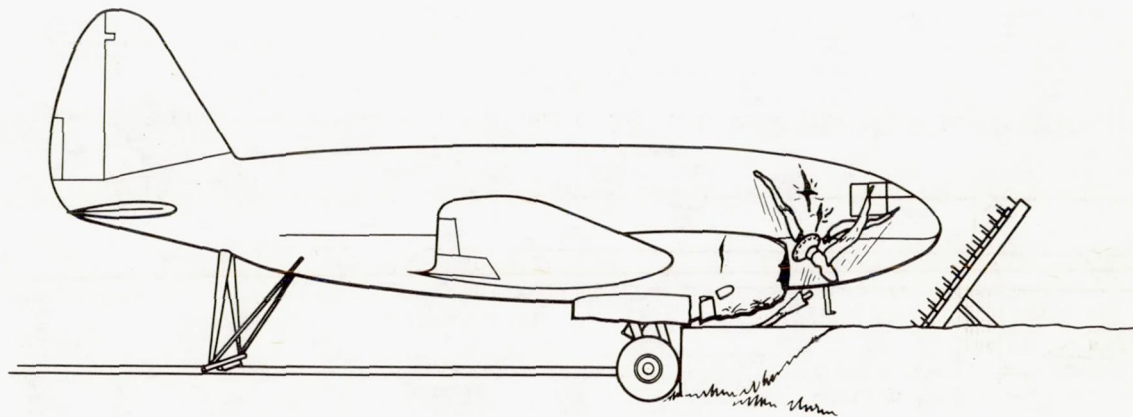
(c) Main landing gear strikes crash barrier.

Figure 2. - Continued. Schematic diagrams showing location of crash and pole barrier with respect to various components of C-46 airplane.

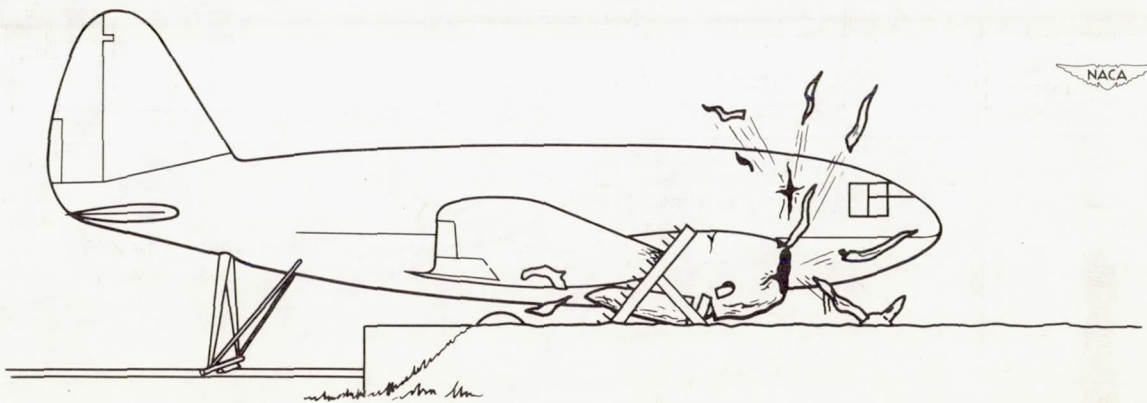
(d) Wings about to strike pole barrier.

Figure 2. - Concluded. Schematic diagrams showing location of crash and pole barrier with respect to various components of C-46 airplane.

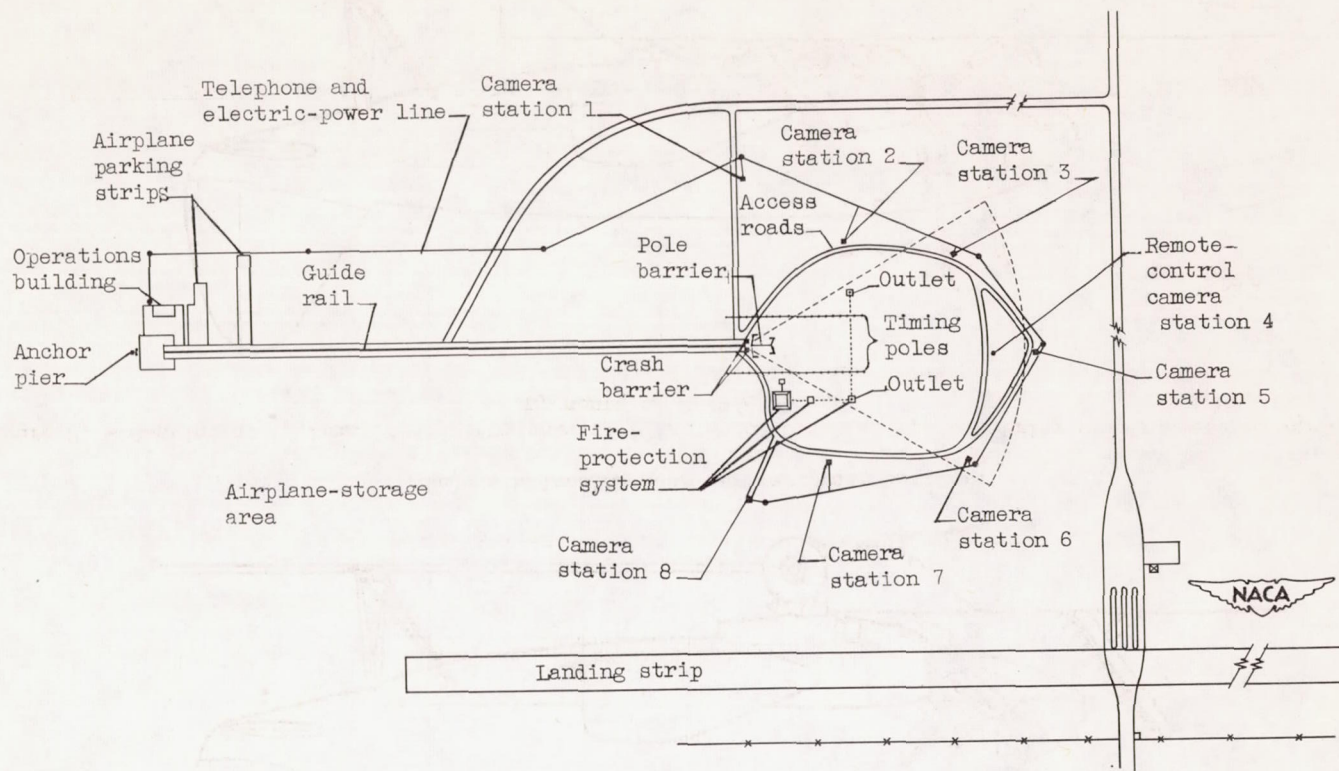
Figure 3. - Plan view of test site for conducting full-scale crash-fire investigation.

The crash tests were conducted on a portion of the United States Army Ravenna Arsenal. A plan view of the test site is shown in figure 3. The preparation or launching area includes operations building, airplane parking strips, and storage area. A runway for guiding the unmanned airplanes is located between the launching area and the crash area. The crash area includes the crash barrier, the pole barrier, the fire-protection system and the camera platforms. Electric and telephone lines connected each platform with the operations building. Located on the southern edge of the test site is an unpaved strip for landing the airplanes that were used in the crash-fire investigation. The airplanes were towed from the landing strip over the connecting roads to the airplane-storage area.

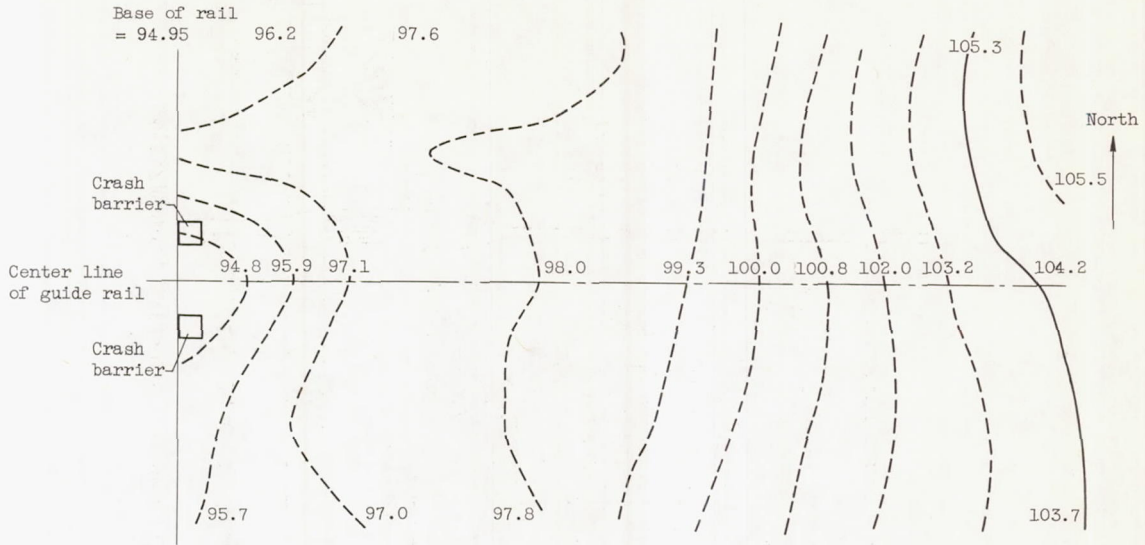
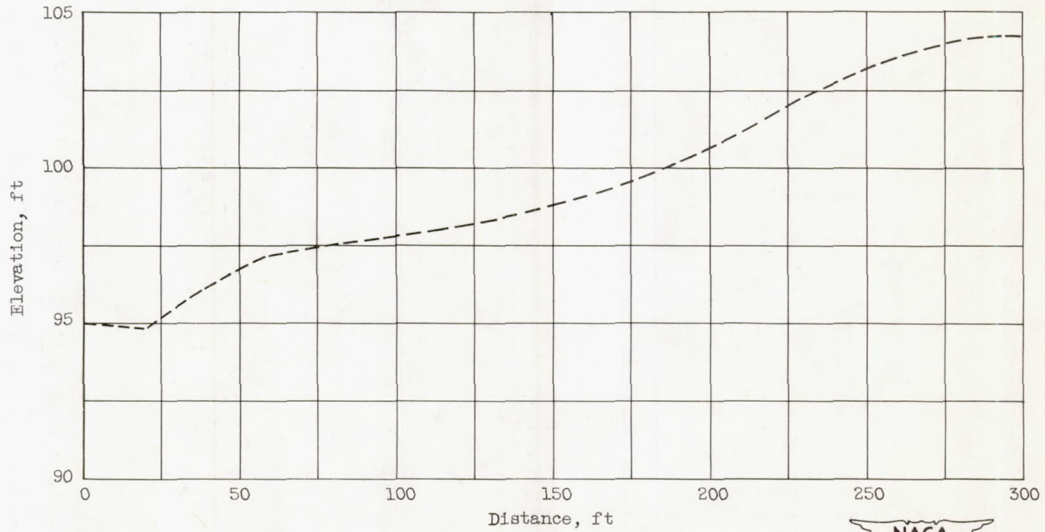
(a) Plan view.

(b) Profile view.

Figure 4. - Crash area in which the crash-fire investigation was conducted.

Plan and profile views of the crash area in which the crash-fire investigation was conducted are shown in figure 4. Photographs showing the side and front views of a C-82 airplane being prepared for a crash test are presented in figures 5(a) and 5(b), respectively.

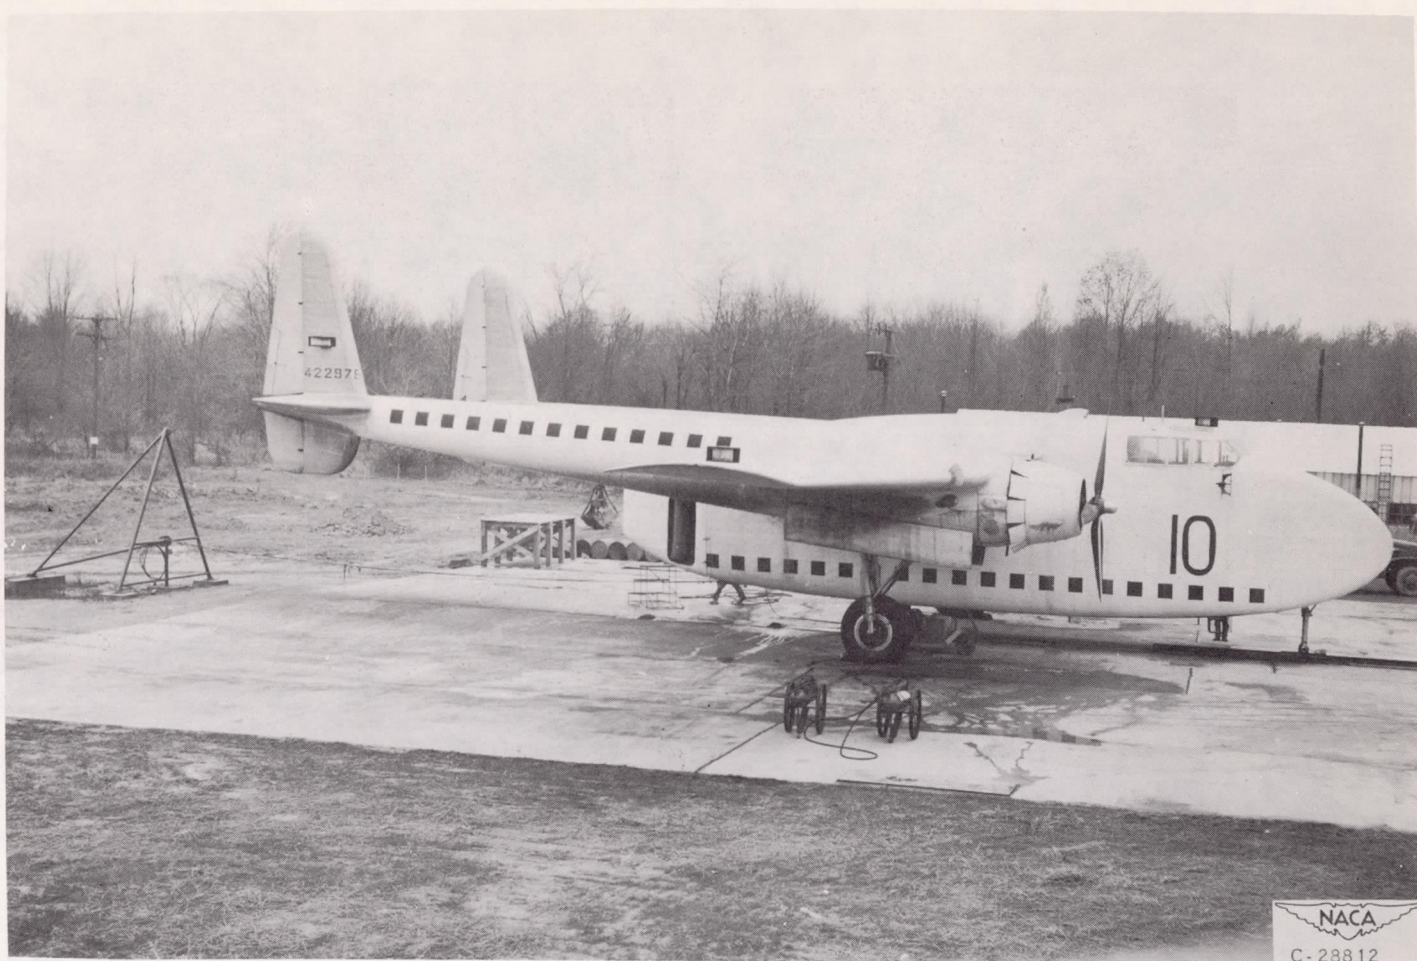
(a) Side view.

Figure 5. - C-82 Airplane being readied in preparation area for test.

An anchor pier (fig. 10) was erected at the end of the guide rail in the preparation area to retain the airplane under take-off power without brakes just before release. It was constructed of four separate concrete piers set in the ground with heavy iron framework connecting them. The restraining cable attached between the anchor pier and the glider tow mechanism of the C-82 airplane is shown in figure 5(a).

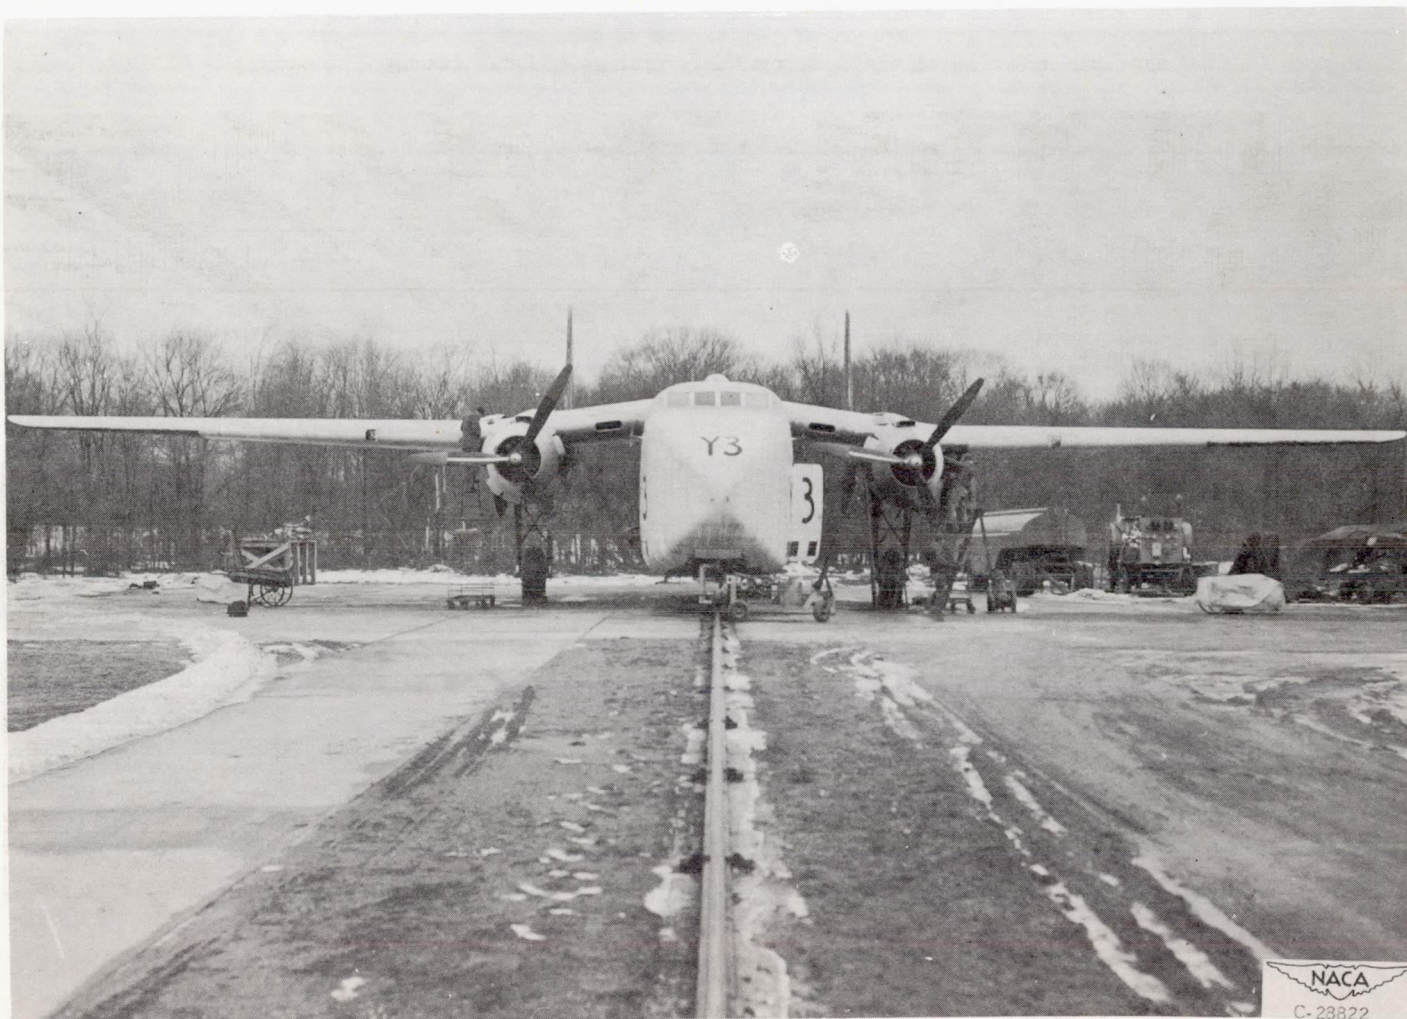
(b) Front view.

Figure 5. - Concluded. C-82 airplane being readied in preparation area for test.

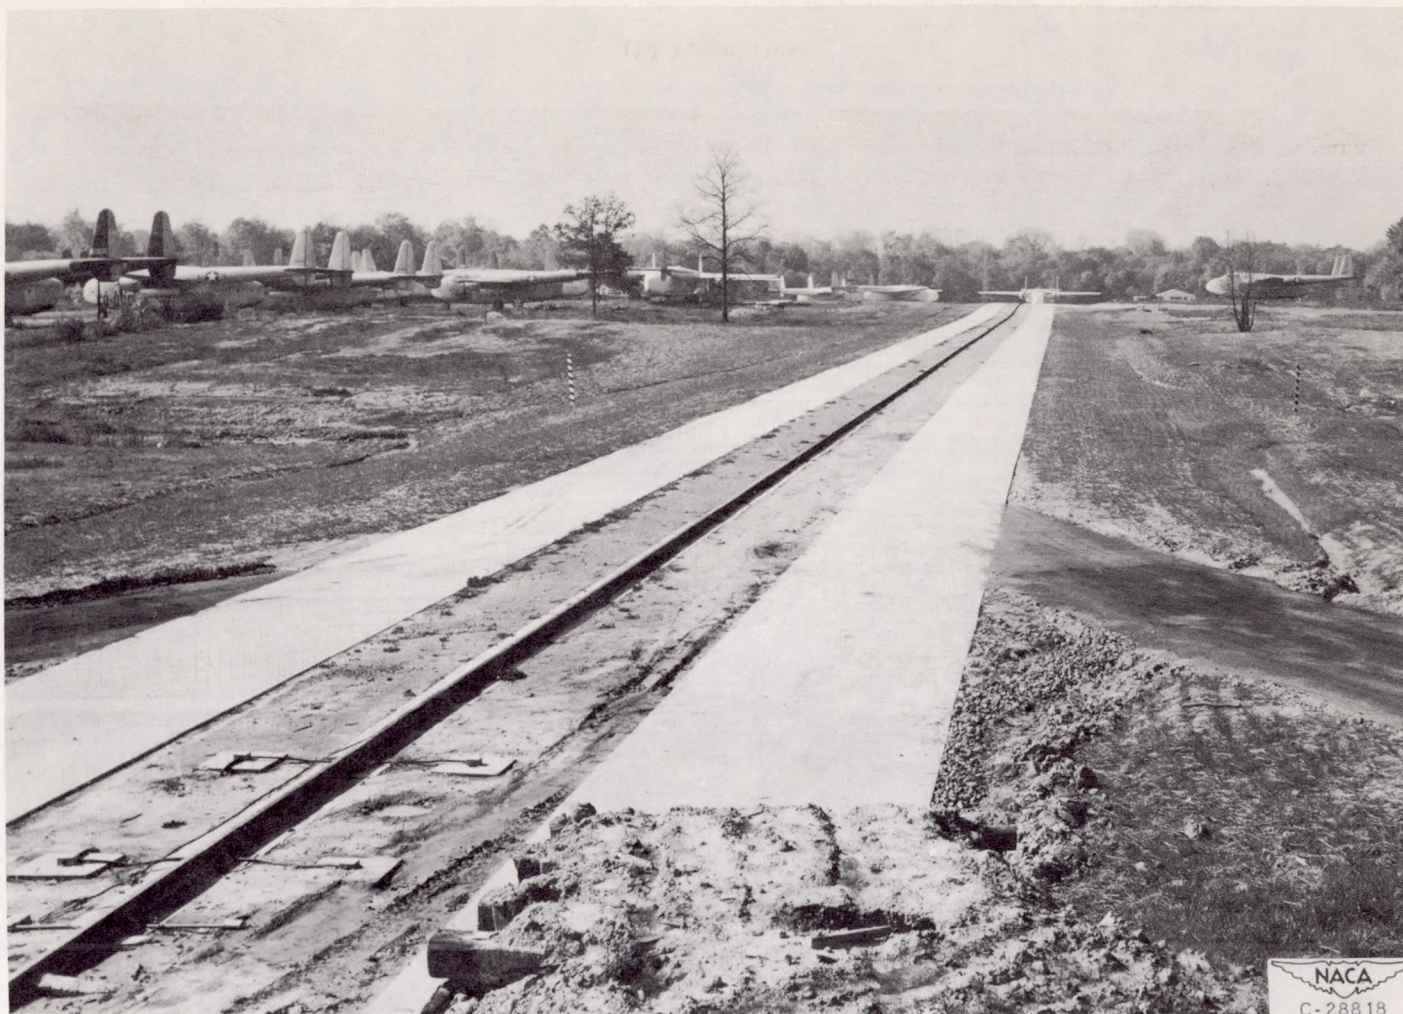
Figure 6. - Runway and center rail for guiding airplane to crash barrier.

The specially prepared runway and the center rail used to guide the test airplanes to the crash barrier are shown in figure 6. The rail and the runway were 1700 feet long. The runway was constructed of two concrete strips 10 feet wide separated by 15 feet. Between these two concrete strips one 80-pound rail was installed.

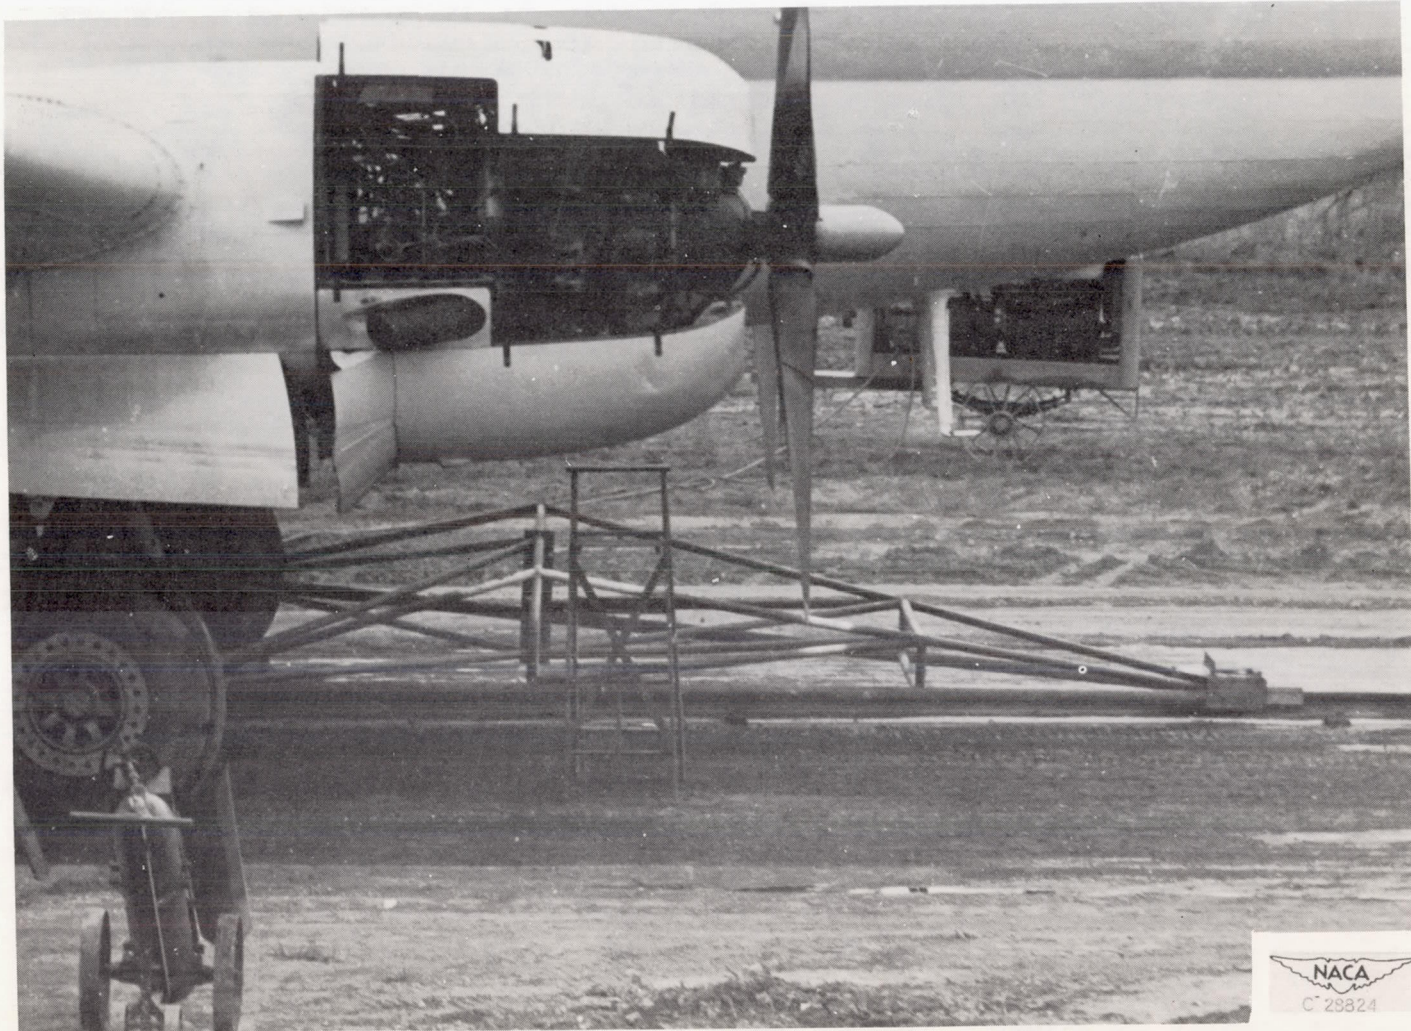
Figure 7. - Guiding truss attached to main landing wheel of C-46 airplane.

Two methods were used for guiding the unmanned test airplanes down the runway to the crash barrier. The C-46 airplanes, which have a conventional landing gear, were guided by a truss attached to the axles of the main landing gear and a slipper attached to the center rail (fig. 7). The 2-foot-long guide slipper was designed to fit around the top flange of the rail in such a manner that it would be impossible for the slipper to leave the rail in either a vertical or lateral direction.

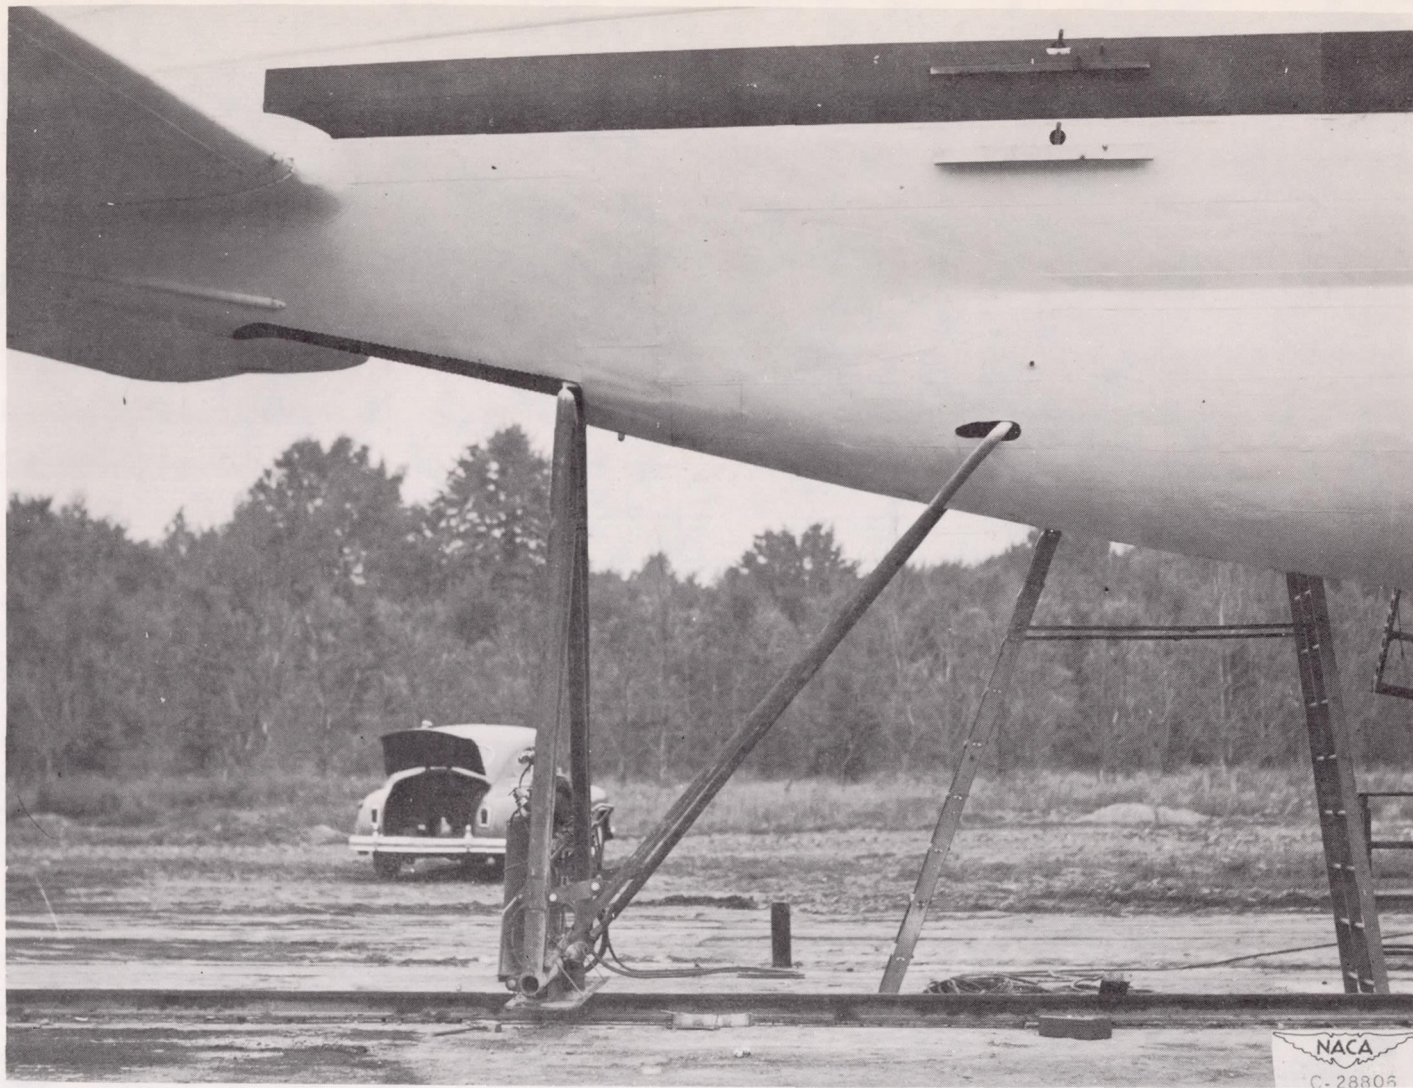
Figure 8. - Extended tail-truss support for holding C-46 airplane in flight attitude.

In order to support the C-46 airplane in flight attitude as it proceeded down the runway, a tail truss was bolted to the lugs on the tail-wheel bulkhead (fig. 8), the tail-wheel assembly having been removed. Welded to the bottom of the tail truss was a 4-inch I-beam which was attached to a 1/2-inch-thick steel plate that slid along the top of the center rail (fig. 8).

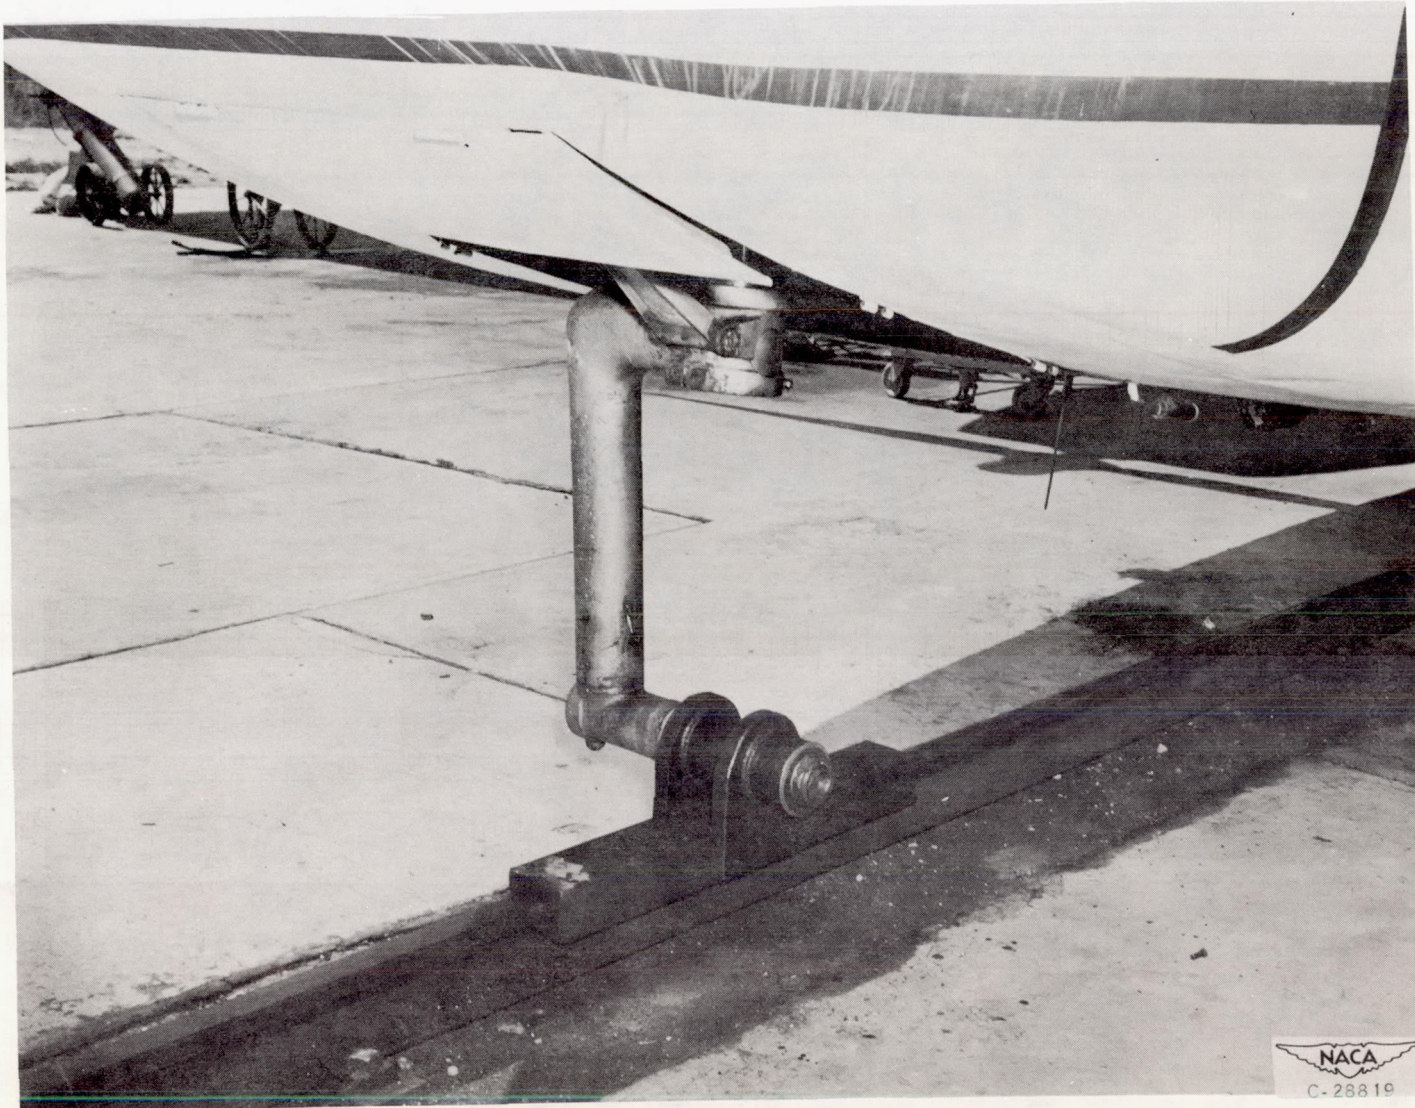
Figure 9. - Guide slipper attached to nose-gear axle of C-82 airplane.

For tricycle-type landing-gear airplanes, such as the C-82, the guide slipper was attached to the axle of the nose gear as shown in figure 9. The guide slipper on the C-82 airplanes was the same as those used on the C-46 airplanes.

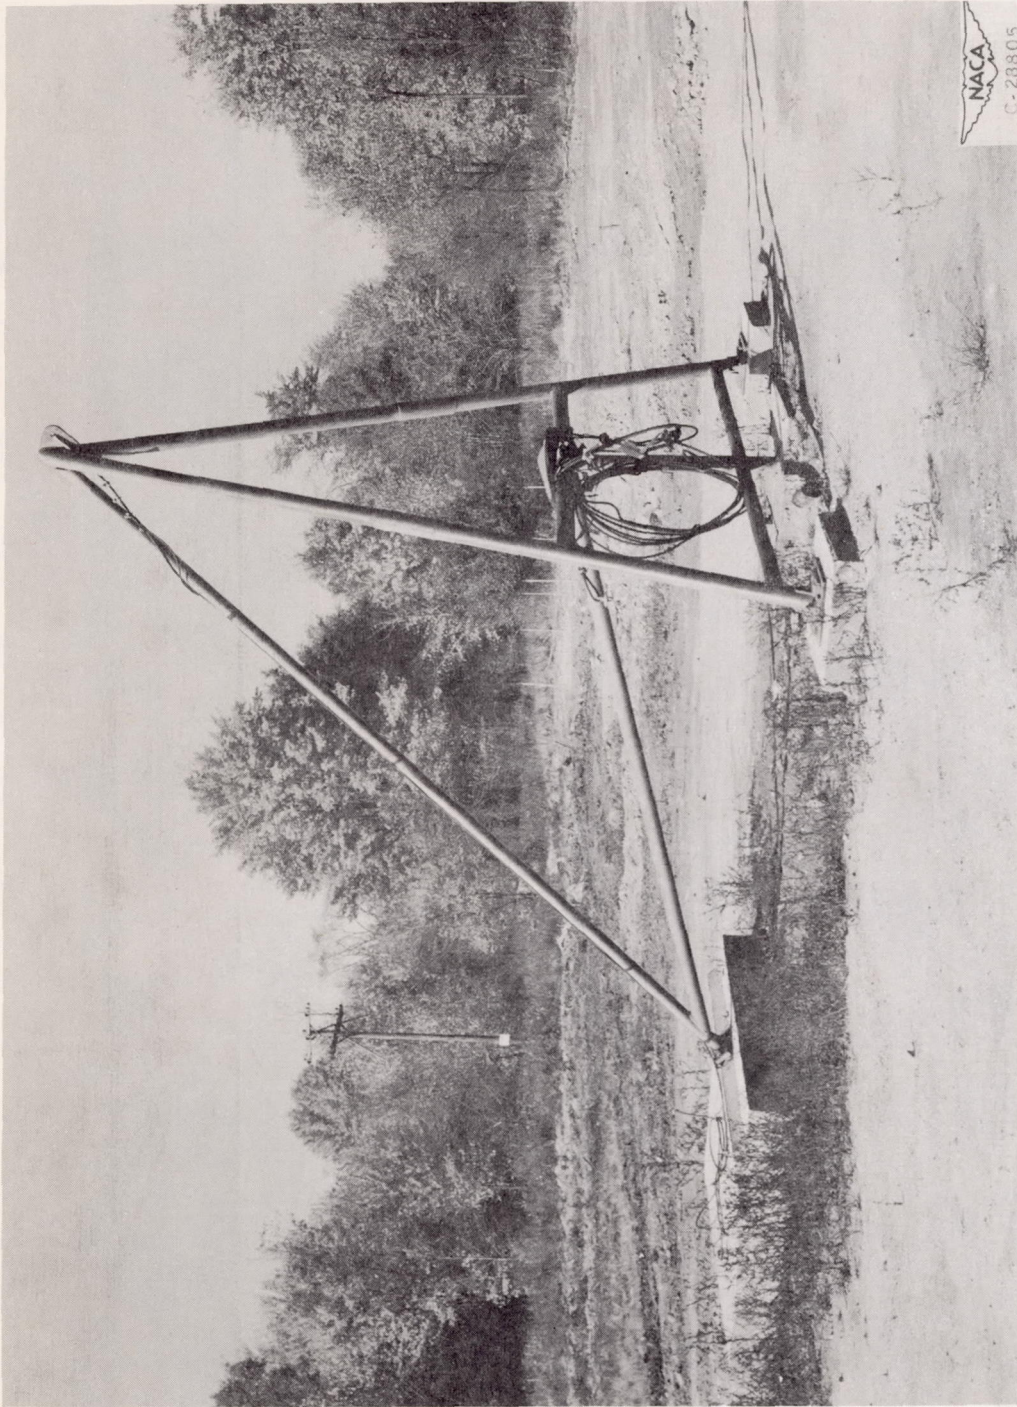
Figure 10. - Anchor pier for retaining airplane before release.

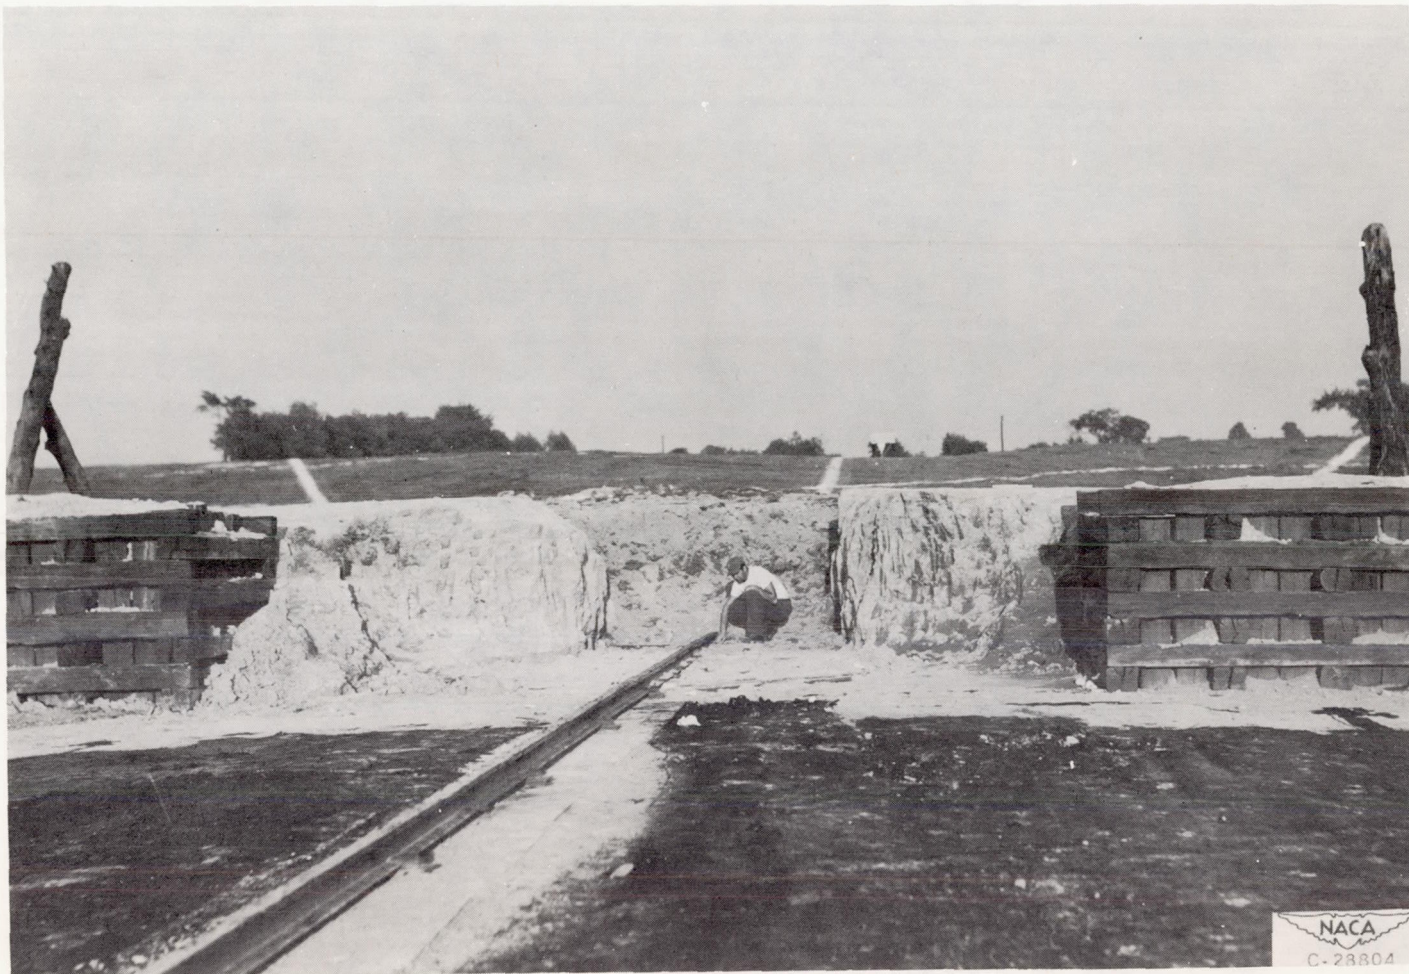
(a) For C-46 airplanes.

Figure 11. - Crash and pole barriers.

The crash barrier used to disrupt the engine propeller and to remove the main landing gear of the C-46 airplane is shown in figure 11(a). It was constructed of 8-foot-long wooden railroad ties interlocked and spiked together to form a hollow cube approximately the height of the main landing-gear wheels. This hollow cube was then filled and packed with dirt. Dirt was removed from between the abutments when tests were made with the C-82 airplanes to allow the low fuselage of the airplane to slide between the abutments as shown in figure 11(b).

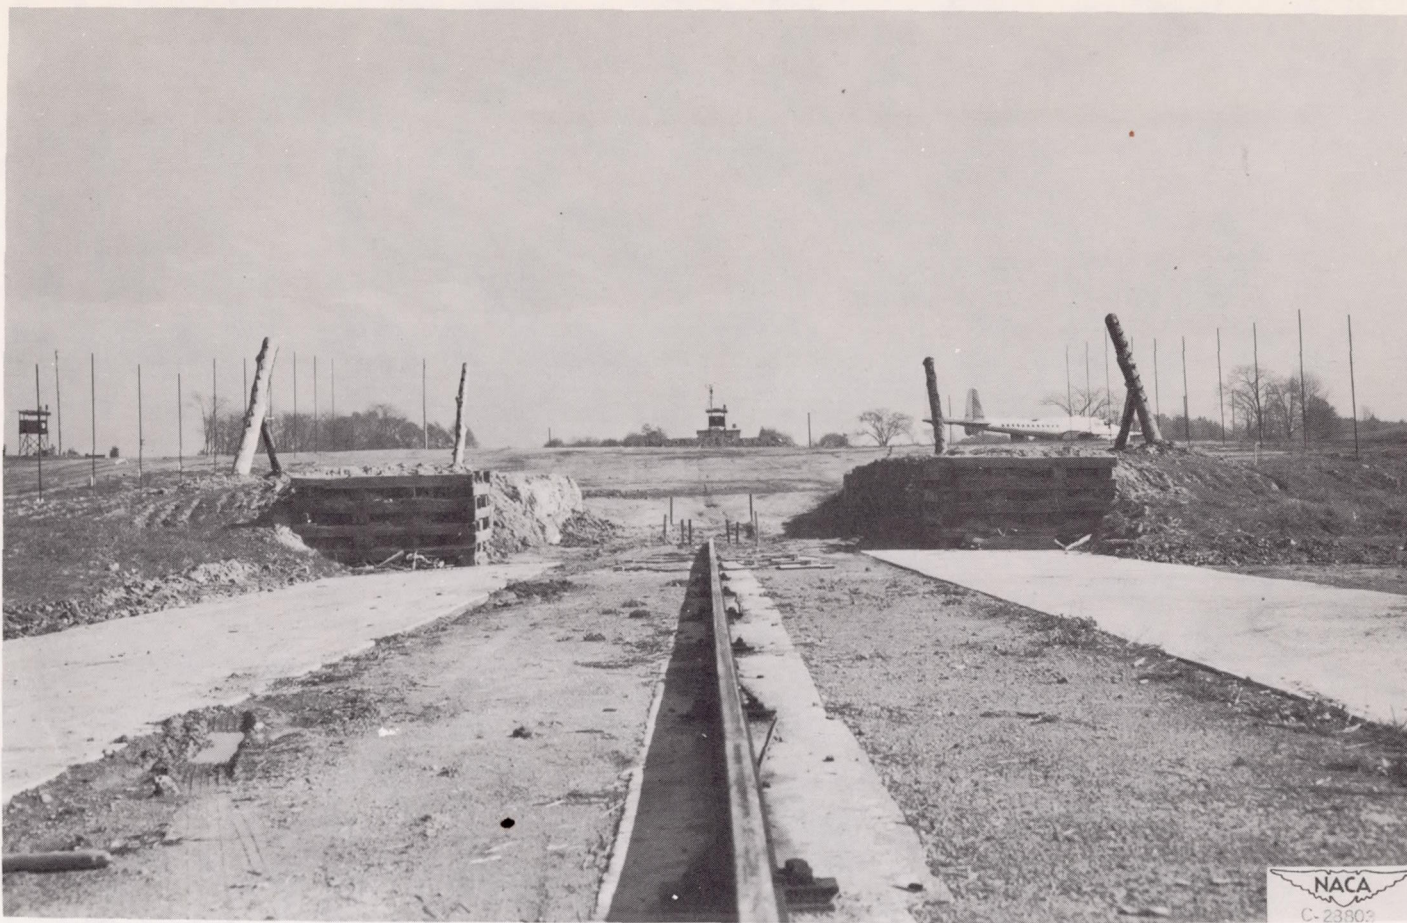
(b) For C-82 airplanes.

Figure 11. - Concluded. Crash and pole barriers.

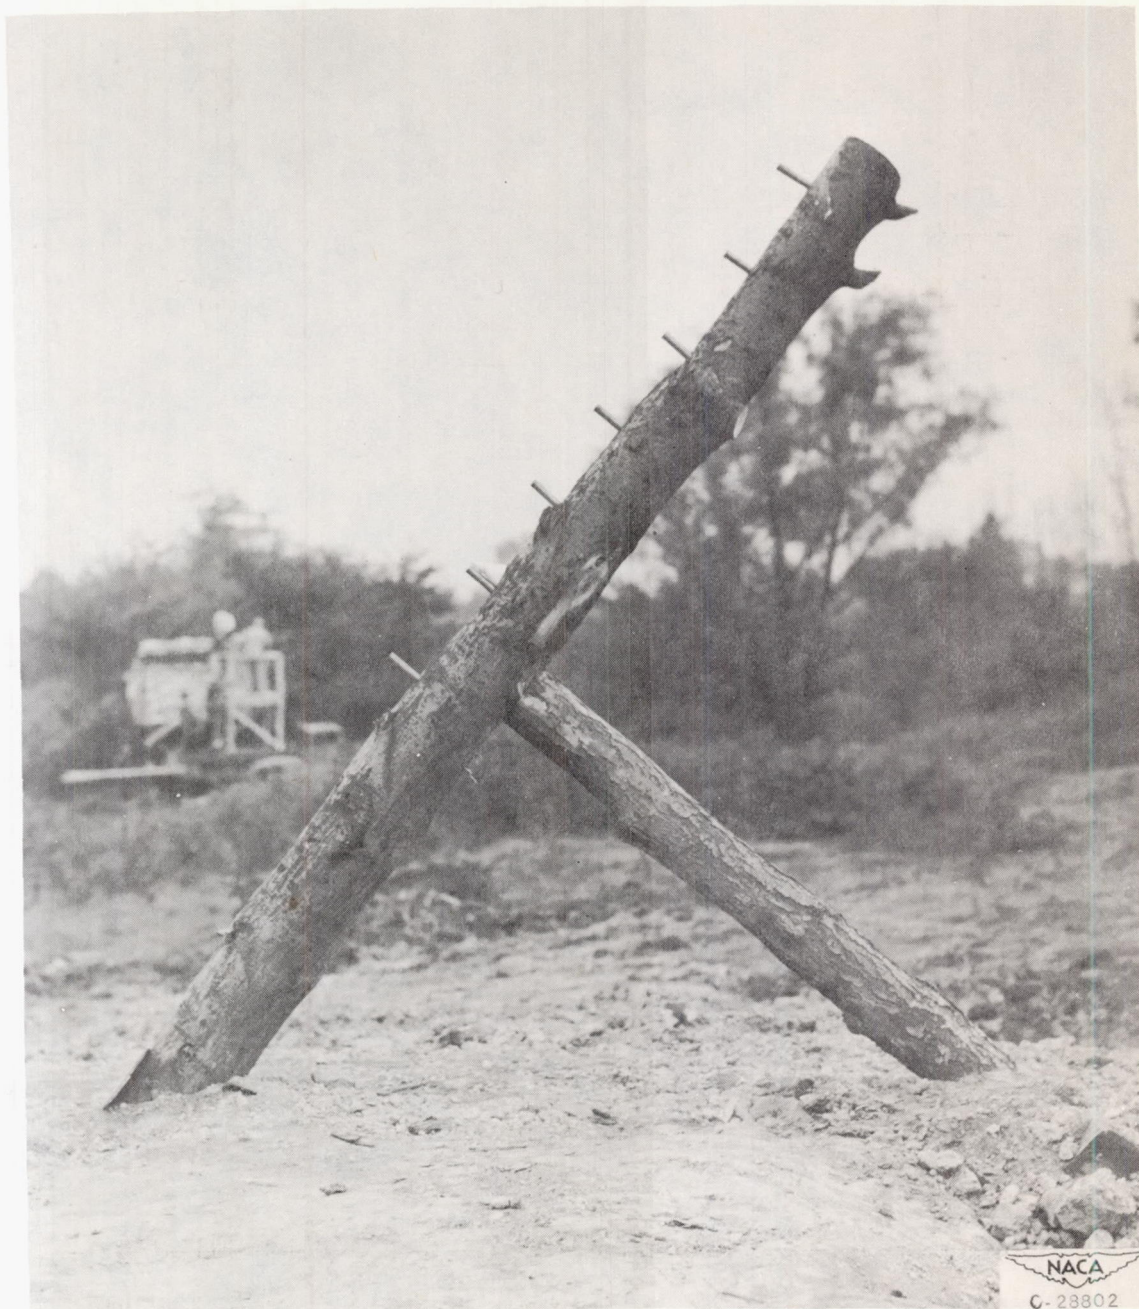
Figure 12. - Close-up of pole barrier showing steel spikes.

The poles installed behind the crash barrier simulated trees which ruptured the wings and fuel tanks of the airplanes. These poles, which had a minimum diameter of 10 inches, were buried 5 feet below the surface of the ground at a 45° angle. Each pole had seven 1-inch-diameter steel spikes 9 inches long protruding 4 inches above the upper surface and spaced 12 inches apart as shown in figure 12. The location of the two poles used in the tests with the C-46 airplane are shown in the sketch on figure 13. The location of the four poles used in the tests with the C-82 airplane are shown in figure 14. Because of differences in construction of the fuel tanks in these airplanes, four poles were required in the C-82 crash tests to duplicate the rate of fuel spillage obtained with two poles in the C-46 crash tests. A photograph showing the damage to the left wing and the fuel tanks of a C-82 airplane produced by the pole barriers is presented in figure 15.
