RESEARCH MEMORANDUM

FACILITIES AND METHODS USED IN FULL-SCALE
AIRPLANE CRASH-FIRE INVESTIGATION

By Dugald O. Black

Lewis Flight Propulsion Laboratory
Cleveland, Ohio

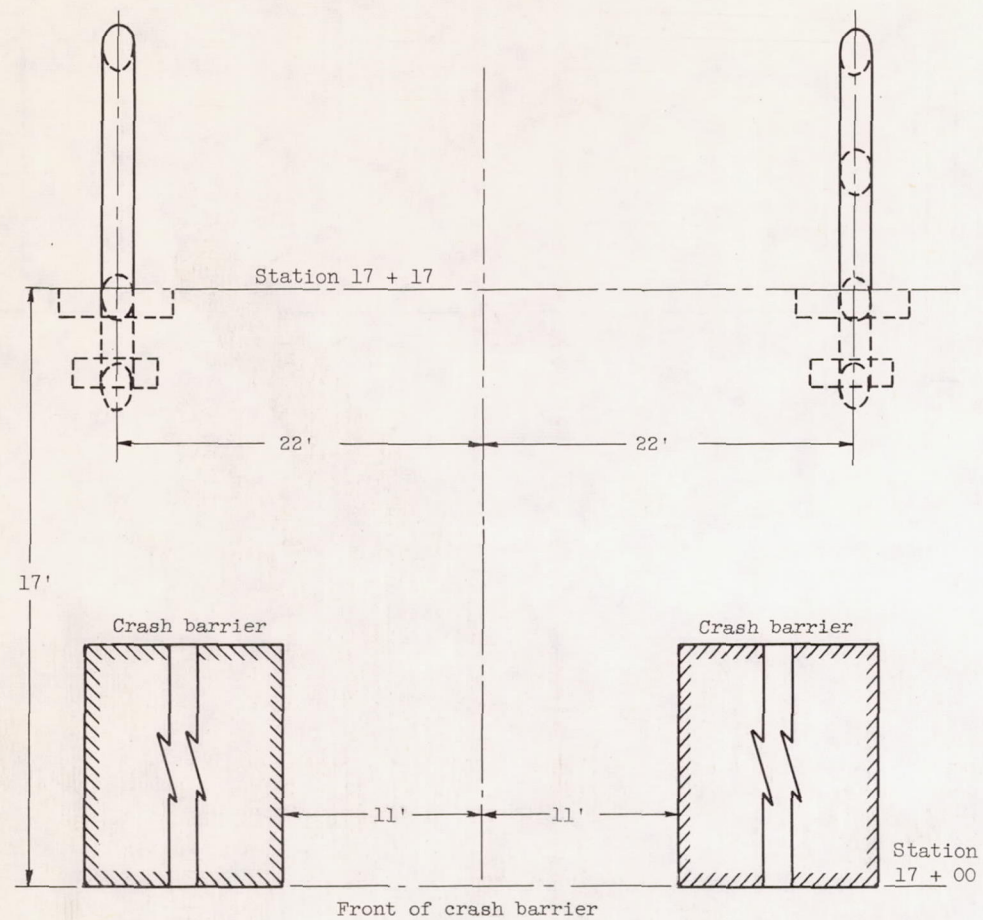
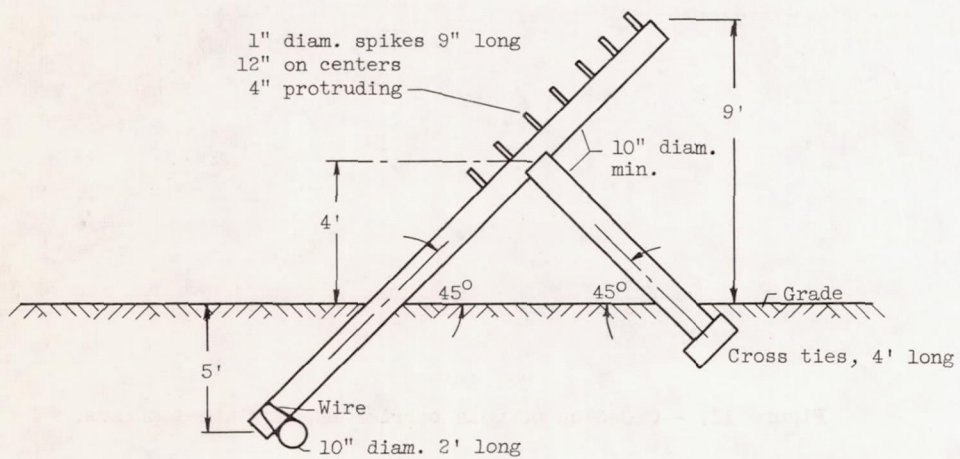
(a) Plan view of crash barrier.

(b) Side view of pole barrier.

Figure 13. - Sketch showing location of pole barrier for C-46 airplane crash tests.

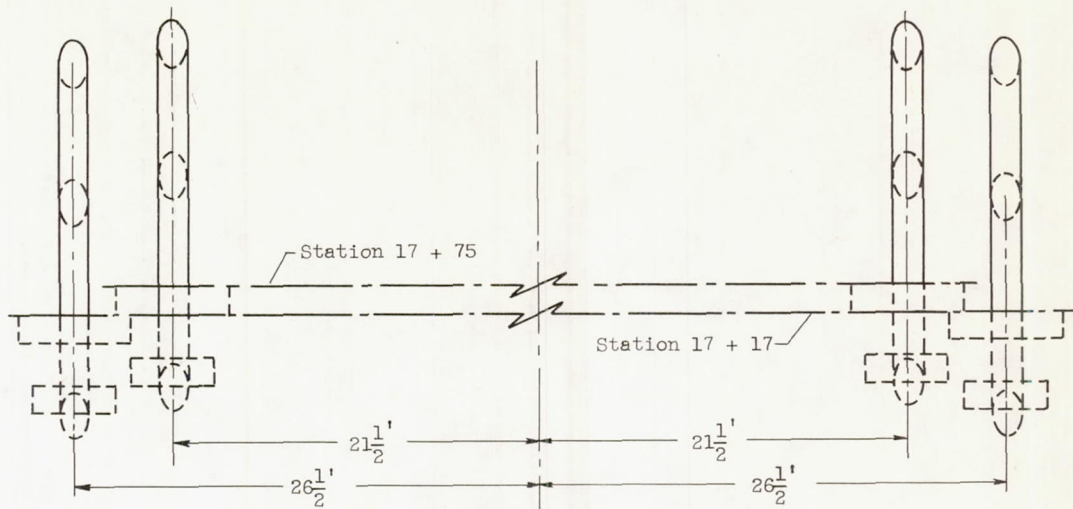
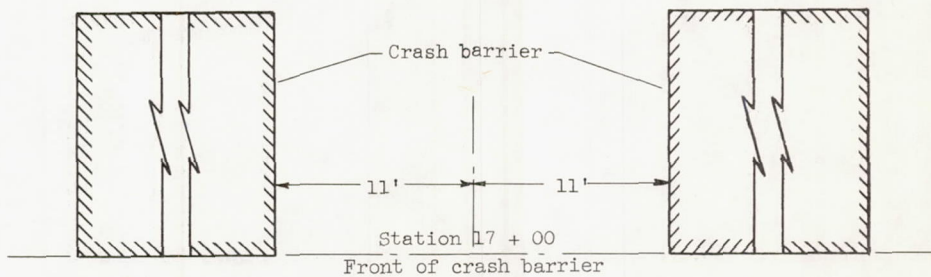
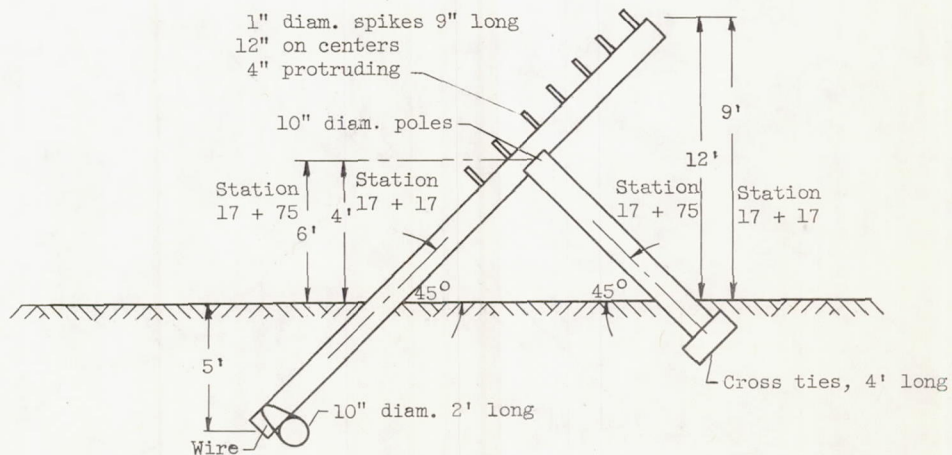
(a) Plan view of crash barrier.

(b) Side view of pole barrier.

Figure 14. - Sketch showing location of pole barrier for C-32 airplane crash tests.

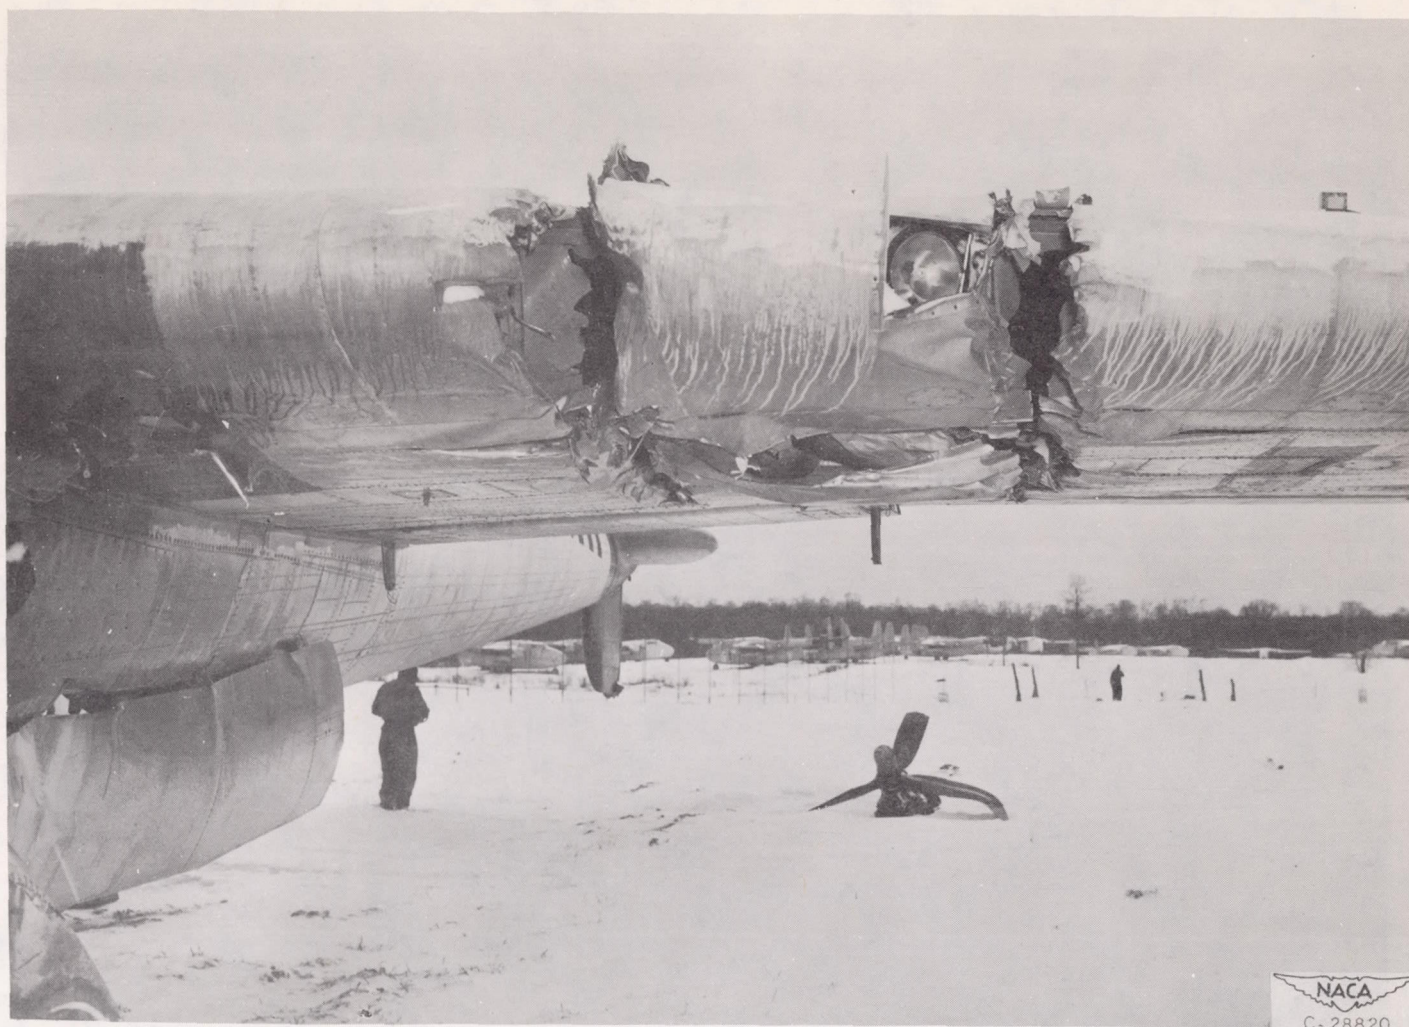
Figure 15. - Damage to left wing and fuel tanks of C-82 airplane produced by pole barriers.

The poles installed behind the crash barrier simulated trees which ruptured the wings and fuel tanks of the airplanes. These poles, which had a minimum diameter of 10 inches, were buried 5 feet below the surface of the ground at a 45° angle. Each pole had seven 1-inch-diameter steel spikes 9 inches long protruding 4 inches above the upper surface and spaced 12 inches apart as shown in figure 12. The location of the two poles used in the tests with the C-46 airplane are shown in the sketch on figure 13. The location of the four poles used in the tests with the C-82 airplane are shown in figure 14. Because of differences in construction of the fuel tanks in these airplanes, four poles were required in the C-82 crash tests to duplicate the rate of fuel spillage obtained with two poles in the C-46 crash tests. A photograph showing the damage to the left wing and the fuel tanks of a C-82 airplane produced by the pole barriers is presented in figure 15.

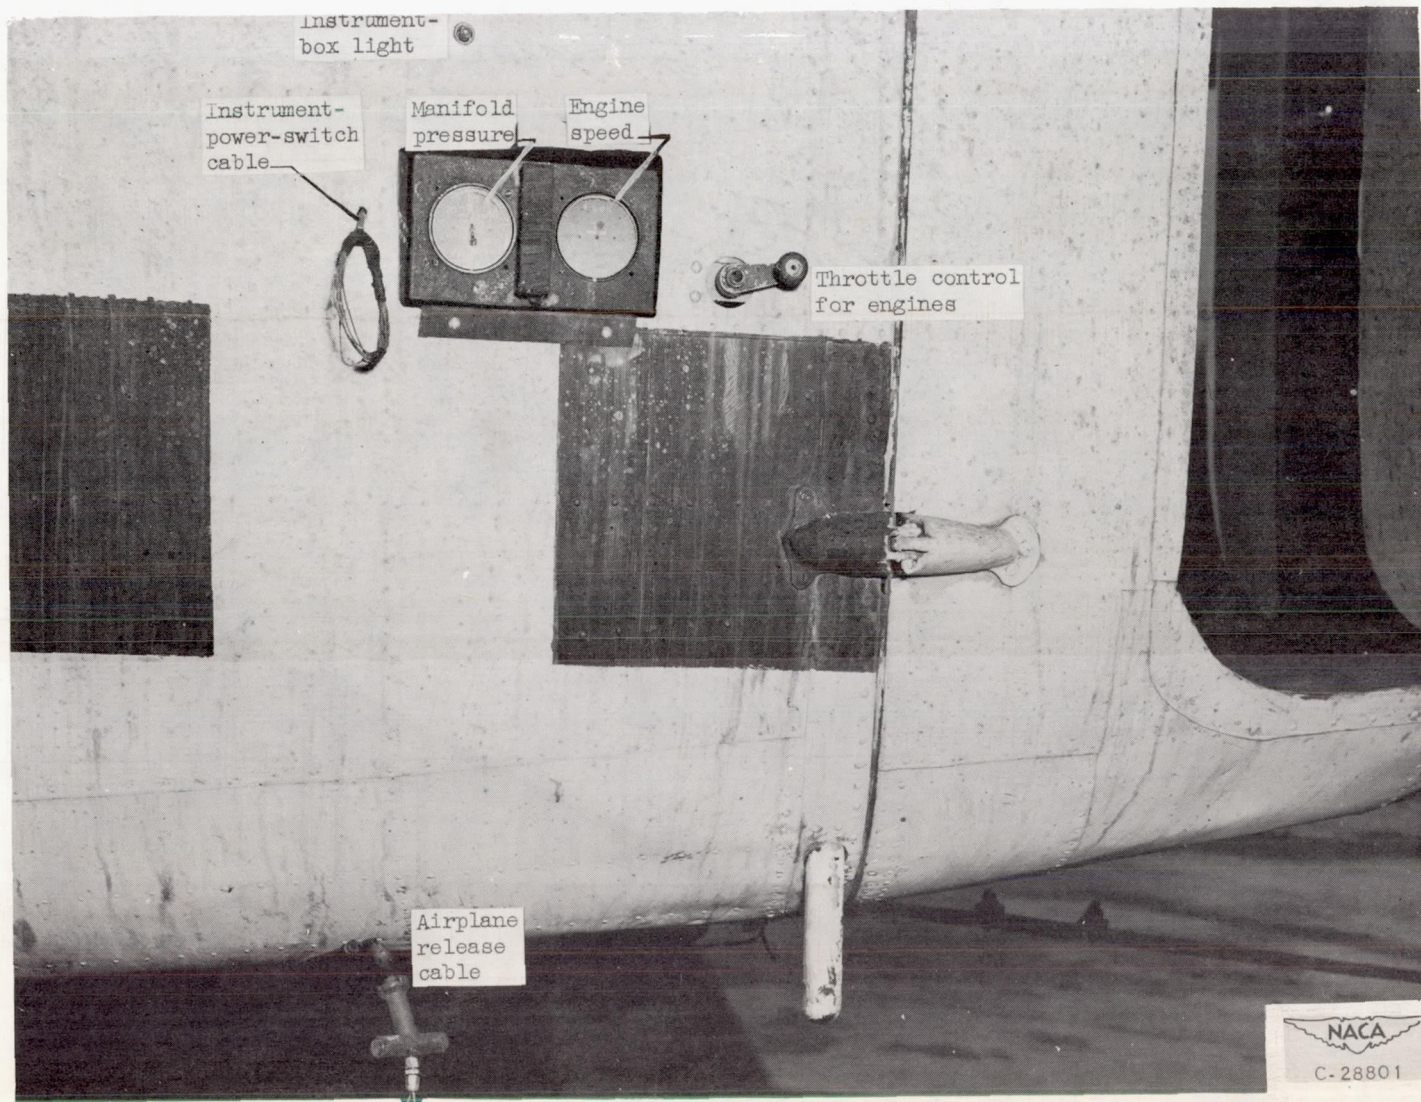
Figure 16. - Controls for operating engines, instrument box power, and airplane release located at rear of fuselage in C-82 airplane.

Operation of the engines from outside the airplane was accomplished by installing a hydraulic remote-control mechanism that was attached to the throttles in the cockpit and actuated by a control installed on the outside of the fuselage at the rear. The control for operating throttles, instrument-box light, airplane release cable, engine speed, and manifold-pressure indicators were located on the left side of the fuselage at the rear door (fig. 16). The instrument box cable was attached to a switch which provided power to the instruments inside the fireproof box and the light indicated that all instruments were energized.

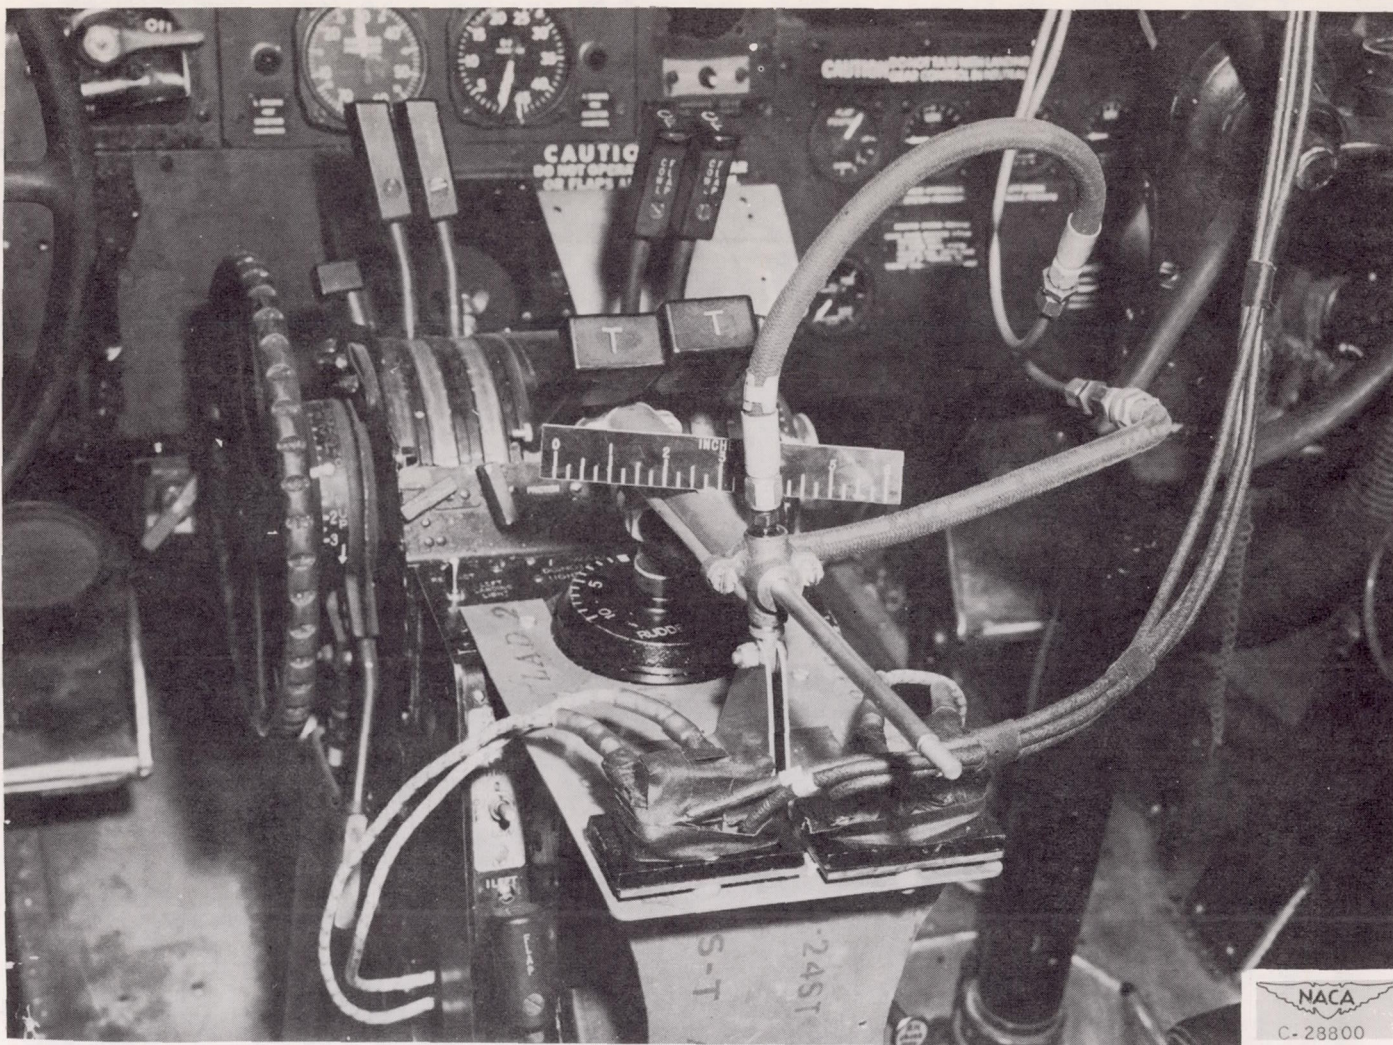
Figure 17. - Remote-control throttle mechanism located in cockpit of C-82 airplane.

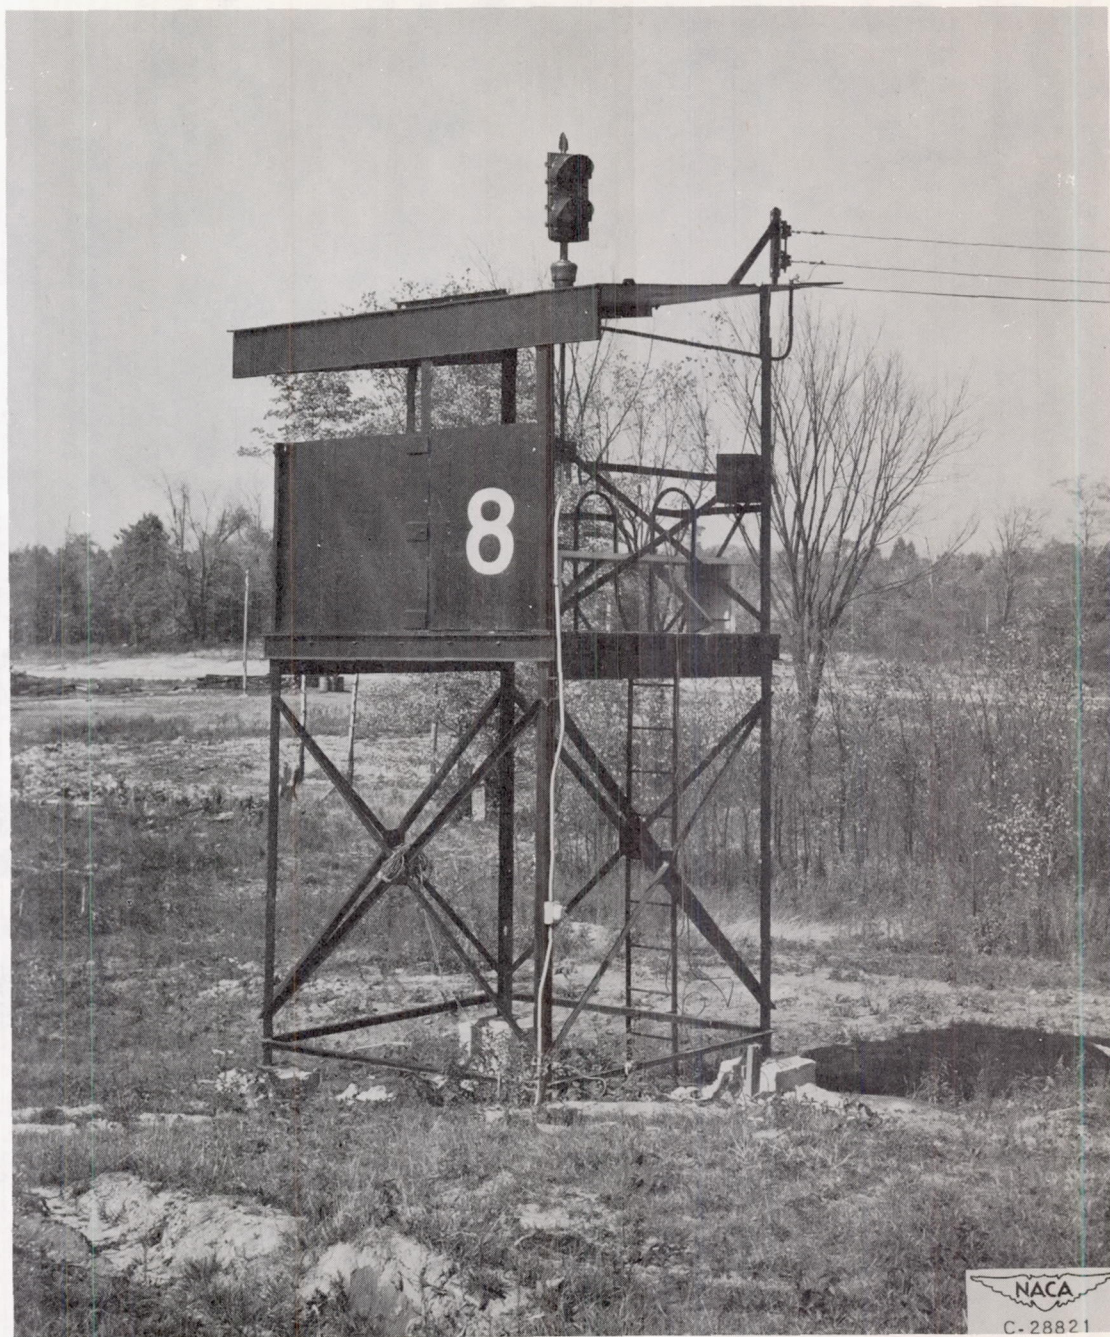
Figure 18. - Typical camera platform installation in crash area.

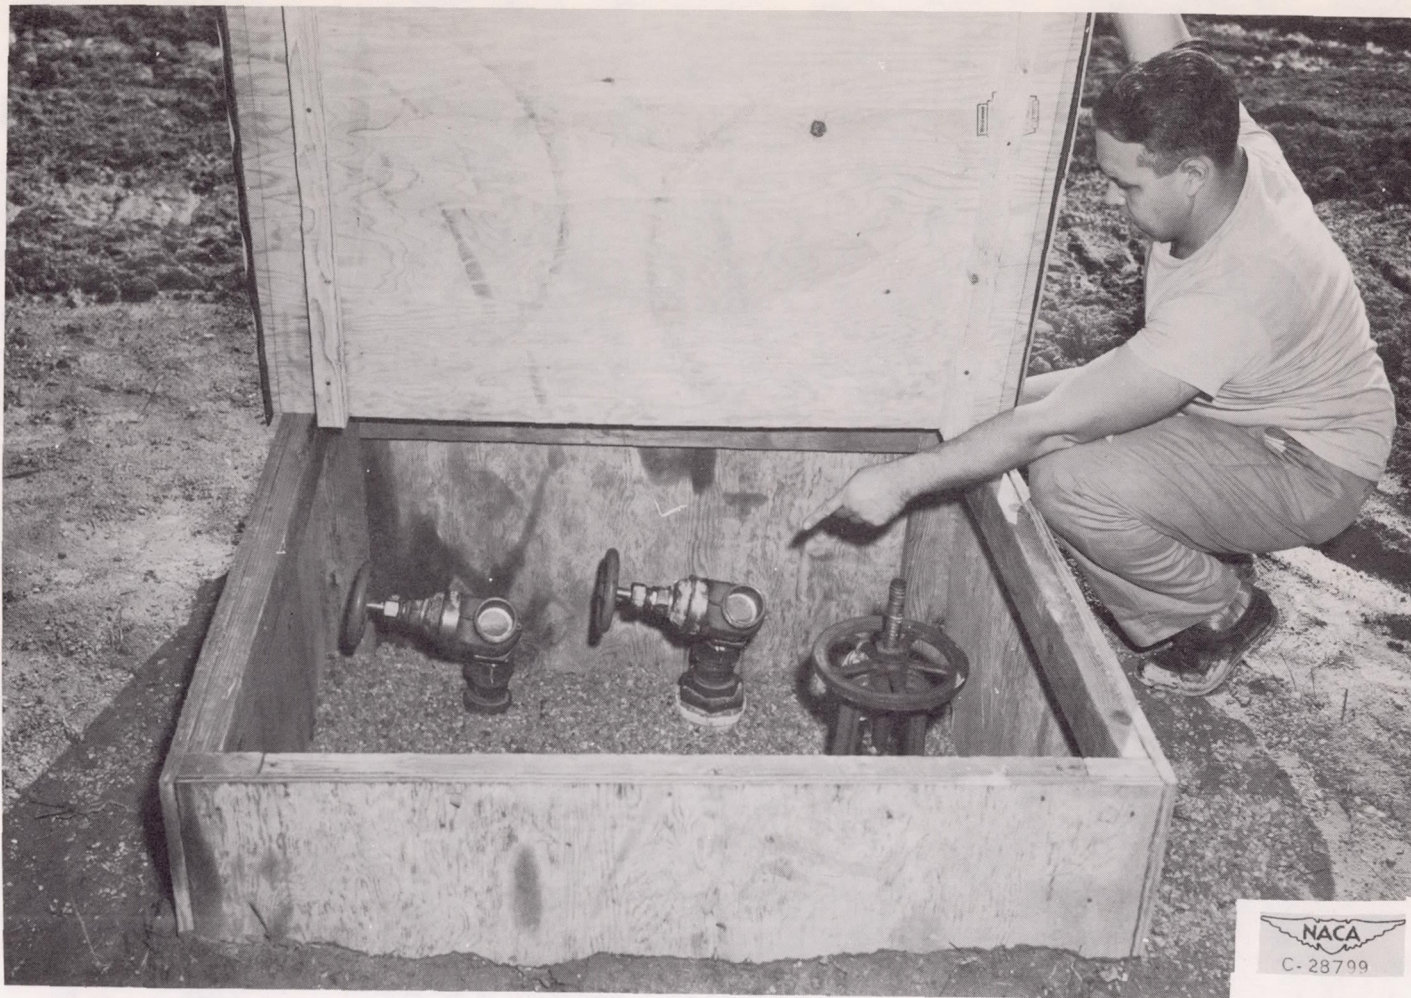
Figure 19. - Fire protection outlet located on each side of crash area.

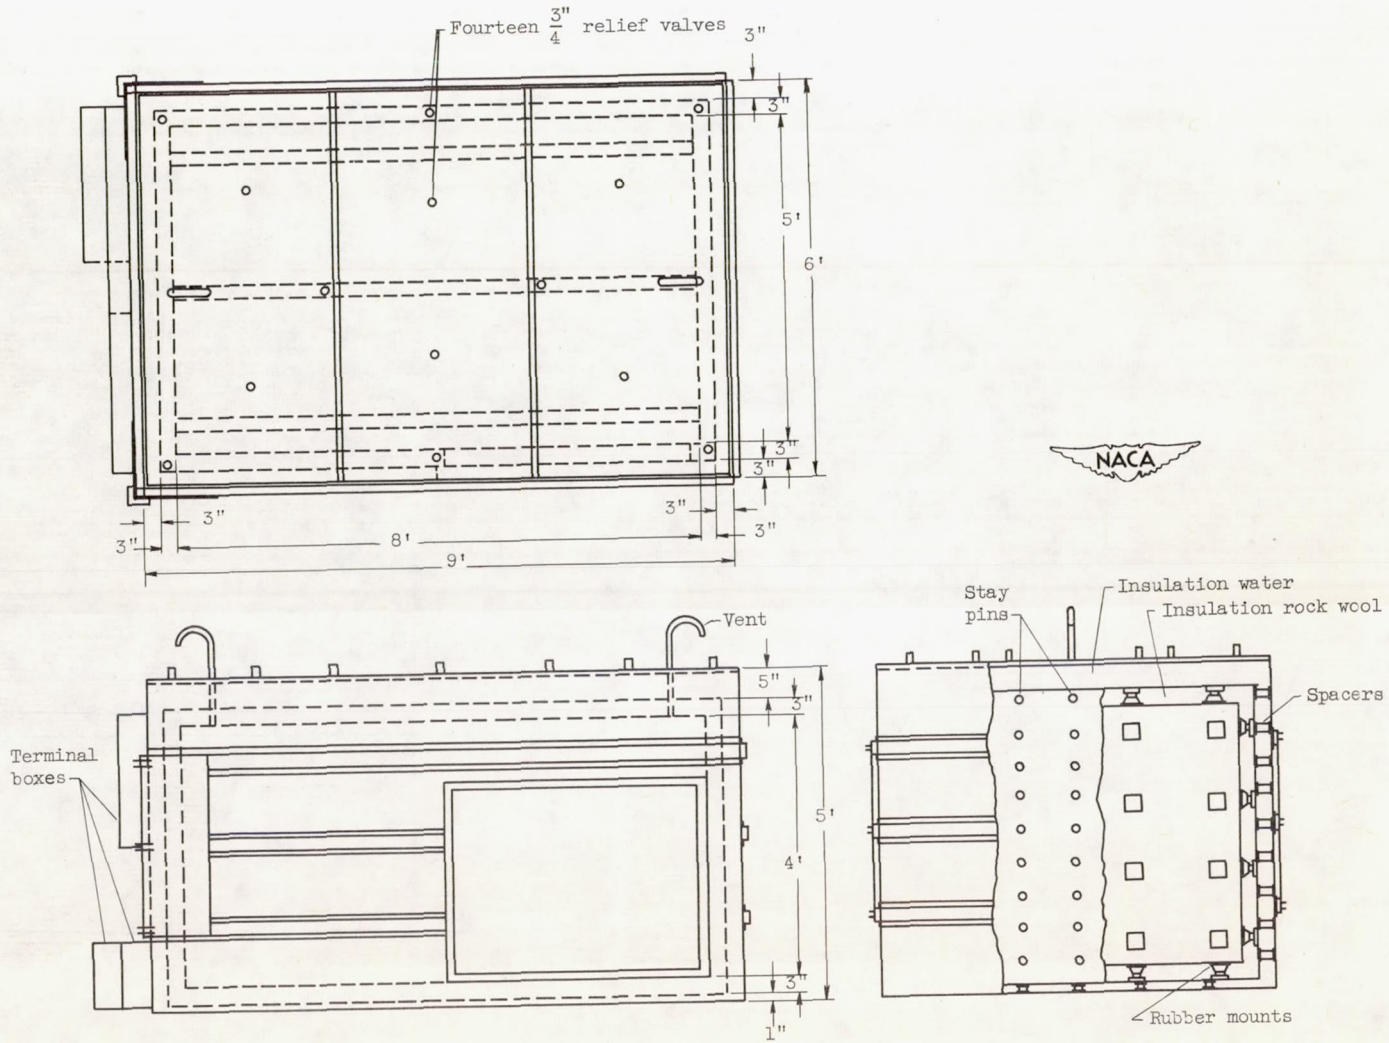
Figure 20. - Sketch showing construction of fireproof instrument box. Material, 1/16-inch black iron; water capacity, 310 gallons; total weight, 6575 pounds.

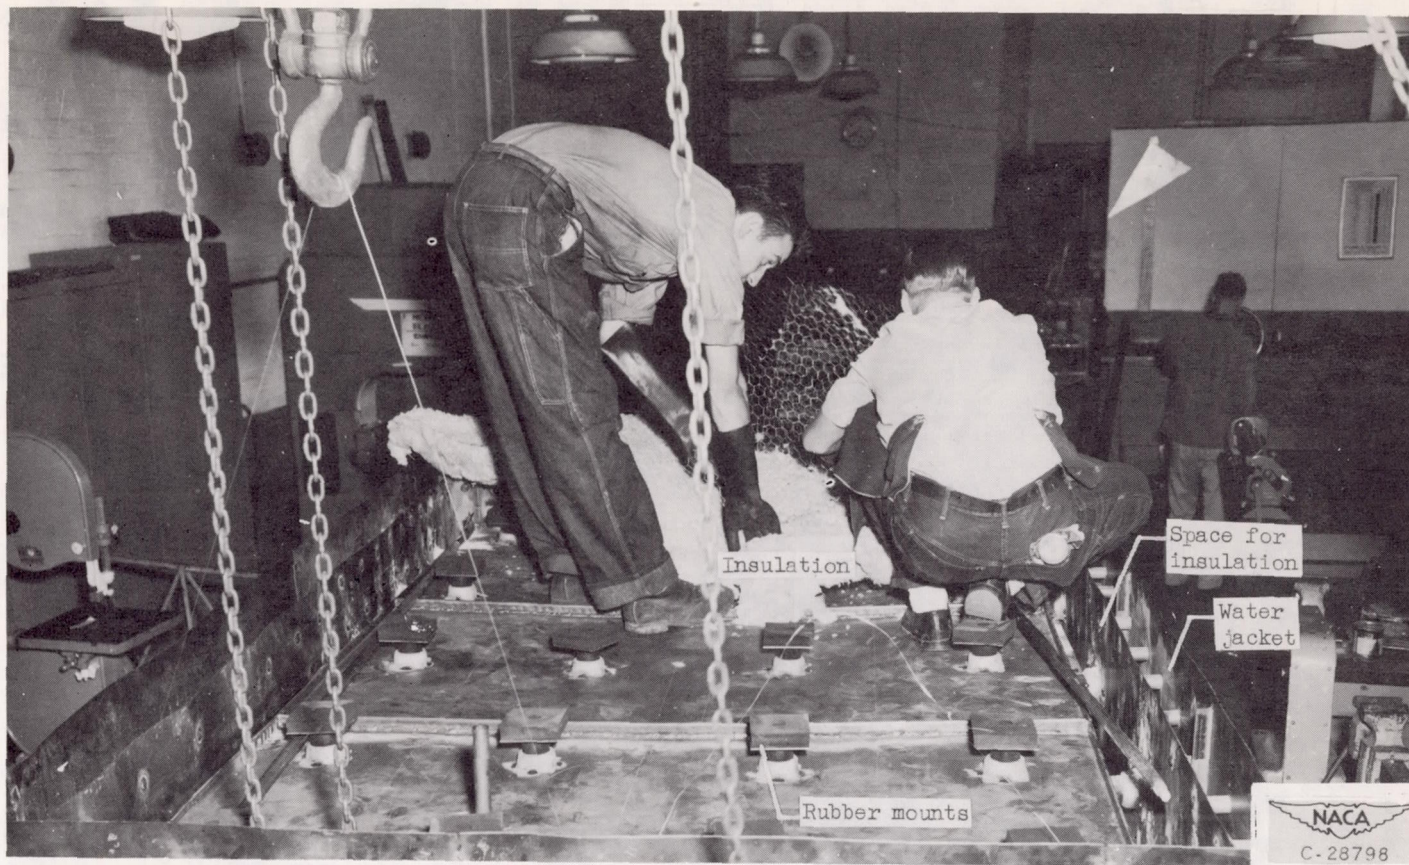
Figure 21. - Three-quarter top view showing construction of fireproof instrument box before top was installed.

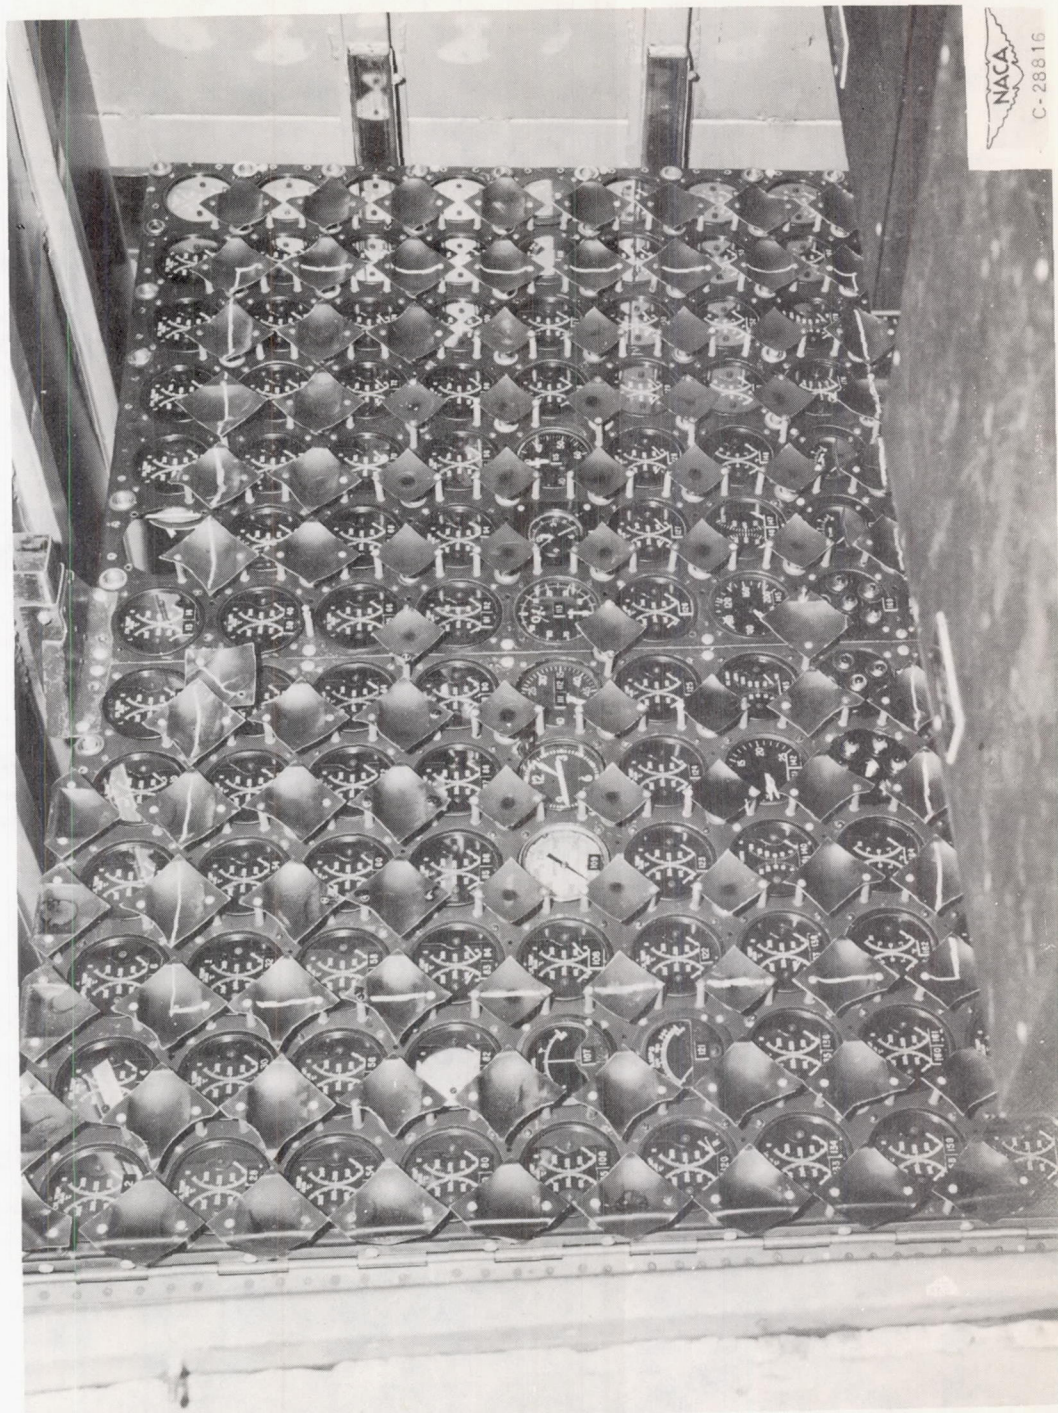
Figure 22. - Instrument panel located at one end of fireproof instrument box.

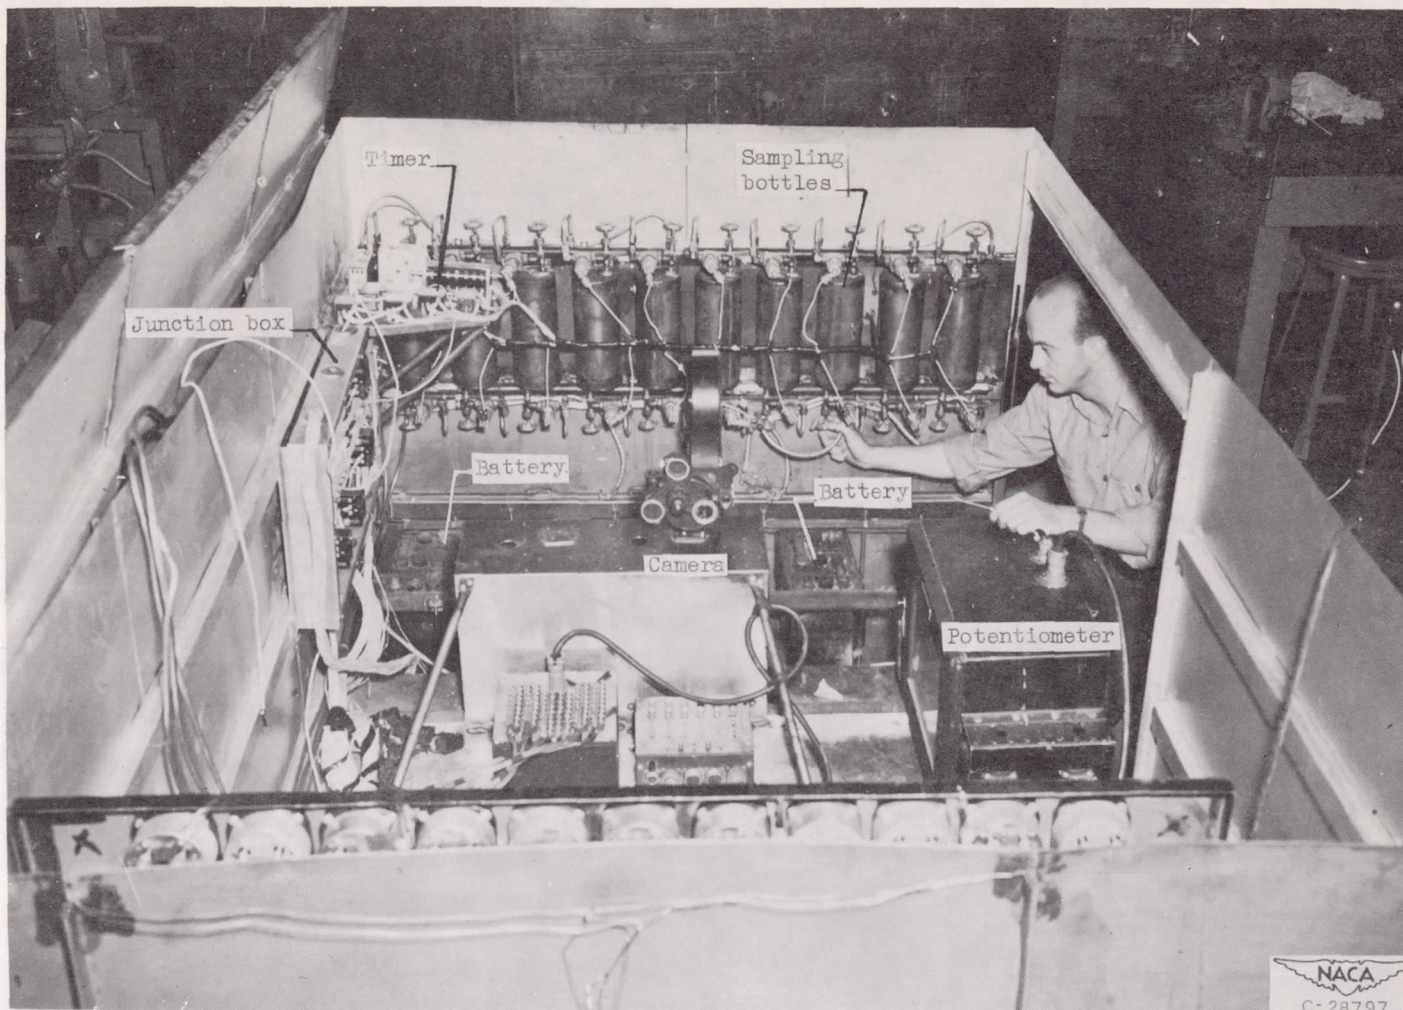
Figure 23. - Installation of cabin-air sampling bottles, camera, junction box, batteries, potentiometer, and timer in fireproof instrument box.

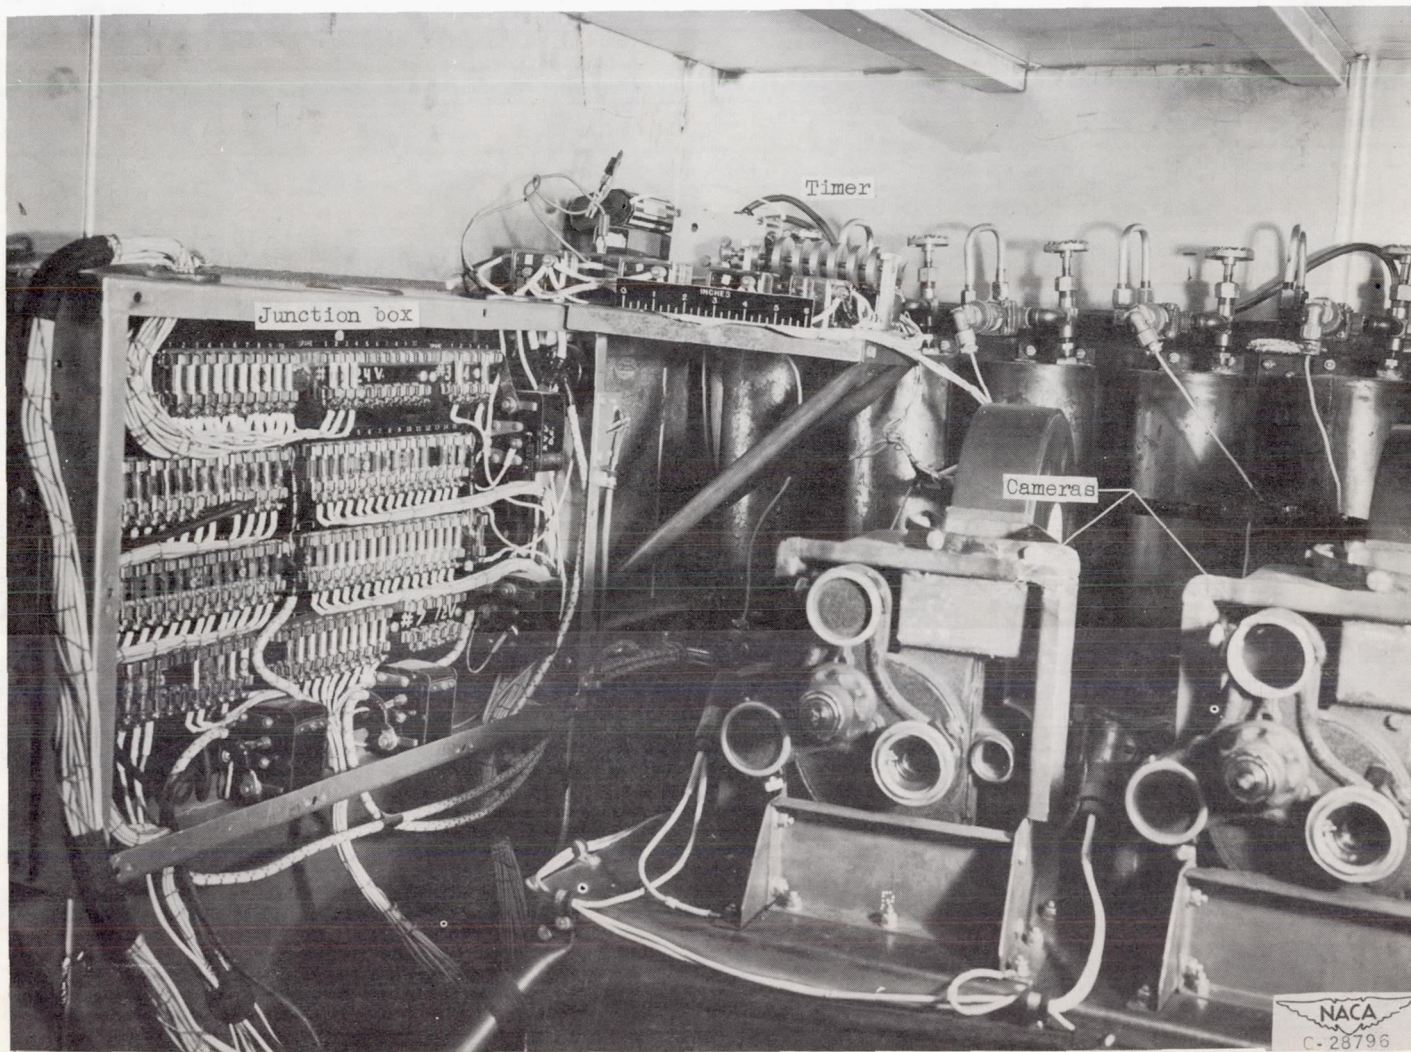
Figure 24. - Closeup view of installation of cameras, junction box, and timer in fireproof instrument box.

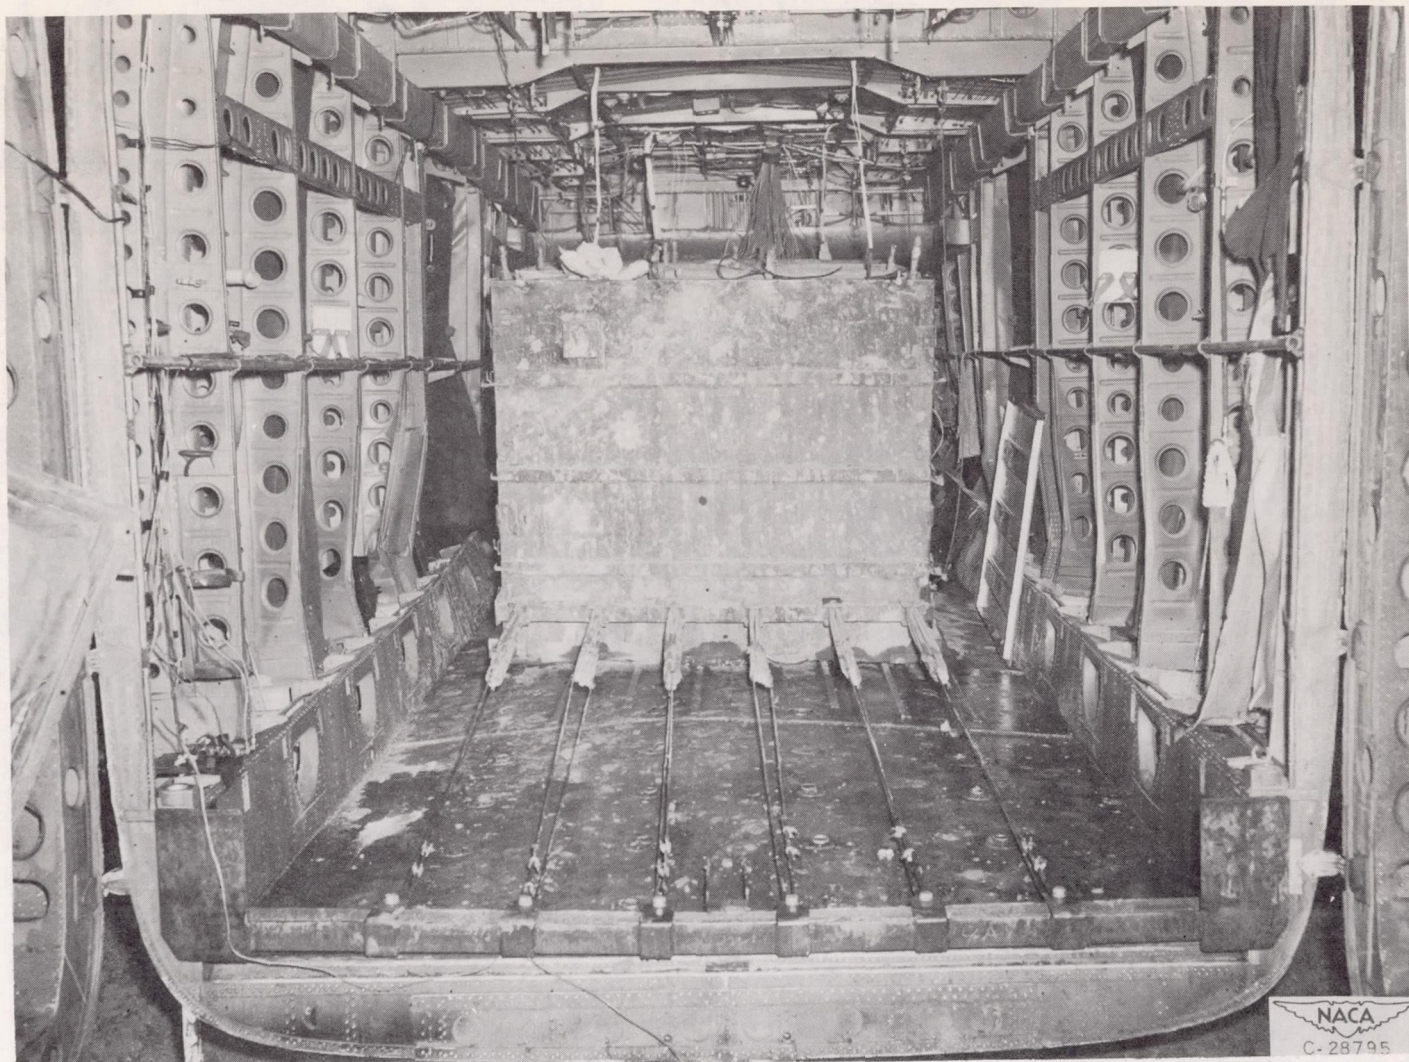
Figure 25. - Rear view of instrument box and shock absorbing system installed in rear of fuselage of a C-82 airplane

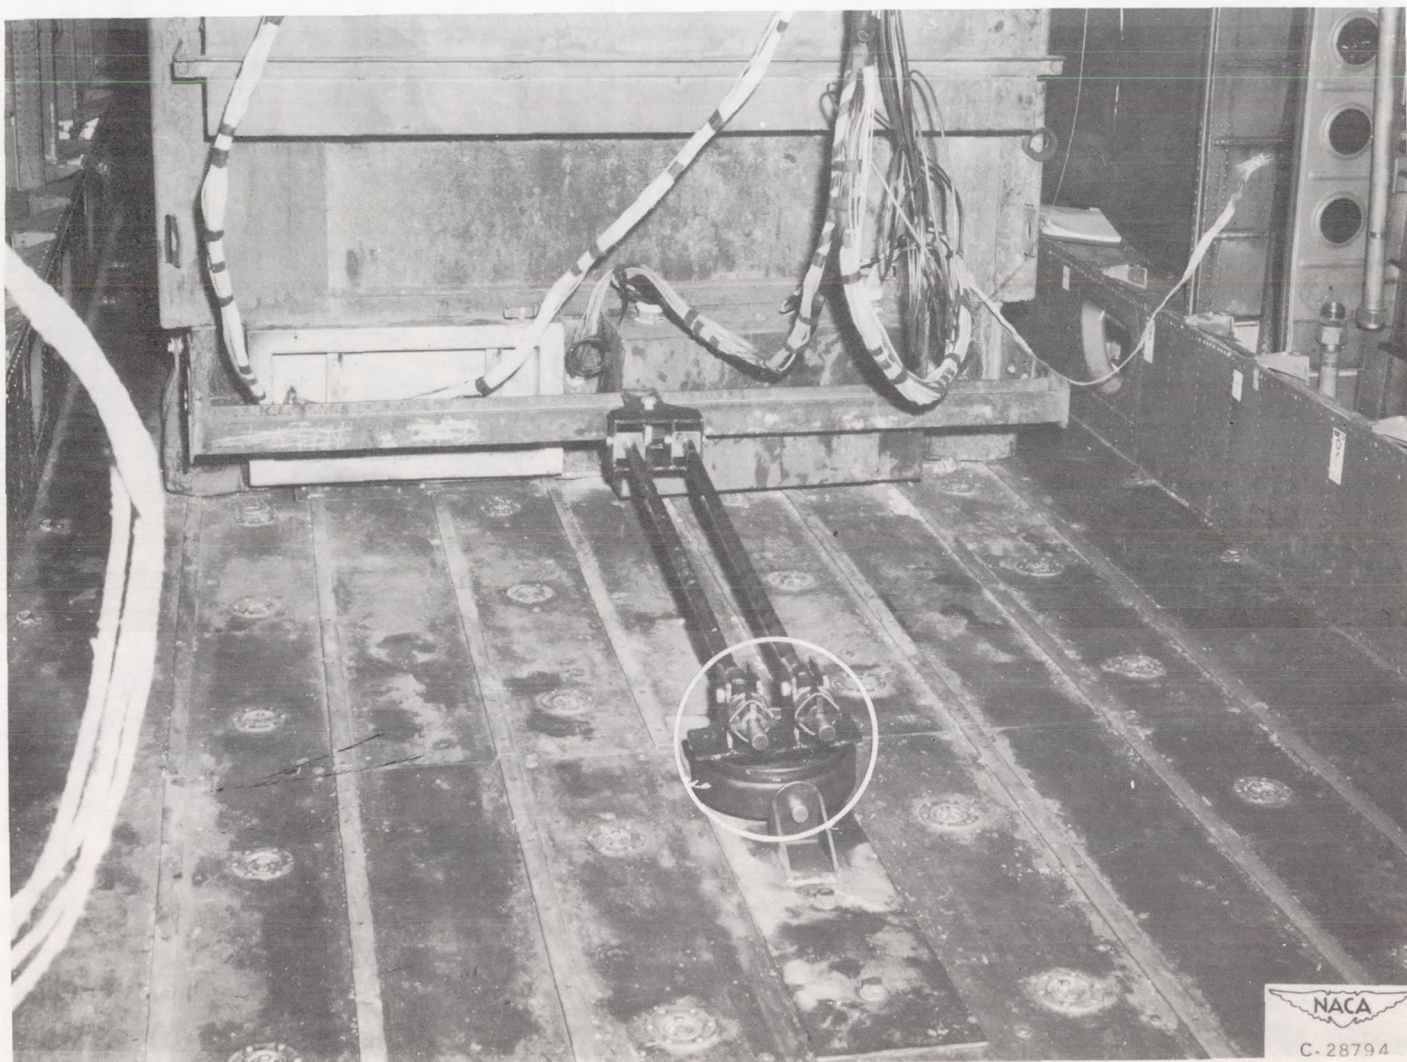
Figure 26. - Installation of restraining mechanism in front of fireproof instrument box in C-82 airplane.

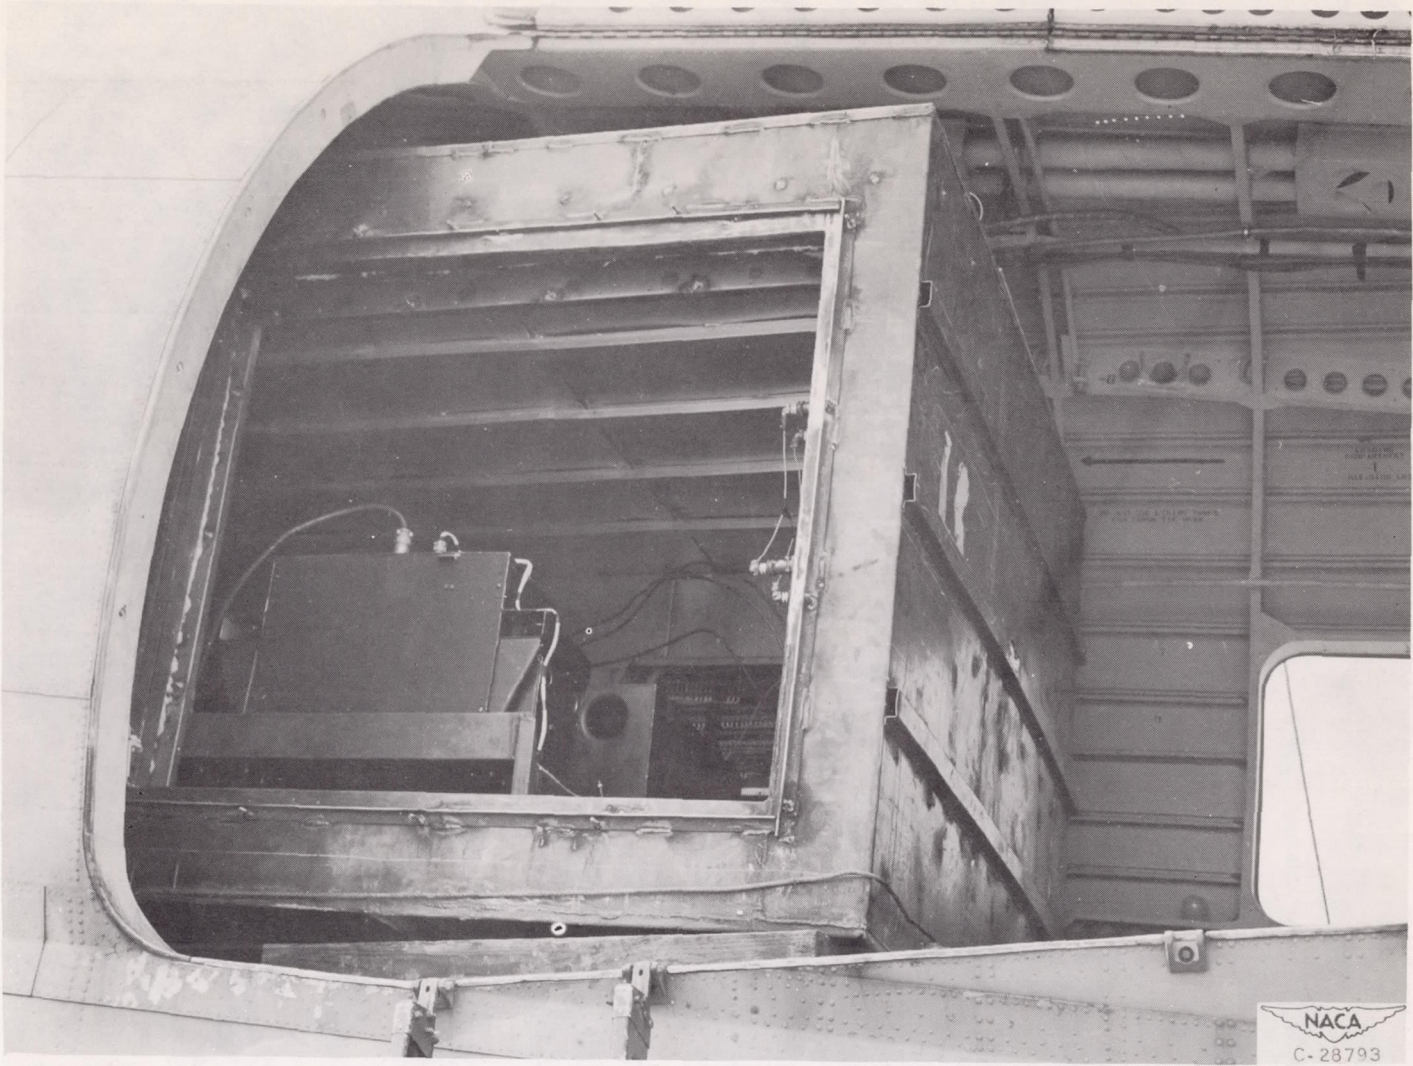
Figure 27. - Fireproof instrument box installation in C-46 airplane; side view.
