RESEARCH MEMORANDUM

FACILITIES AND METHODS USED IN FULL-SCALE
AIRPLANE CRASH-FIRE INVESTIGATION

By Dugald O. Black

Lewis Flight Propulsion Laboratory
Cleveland, Ohio

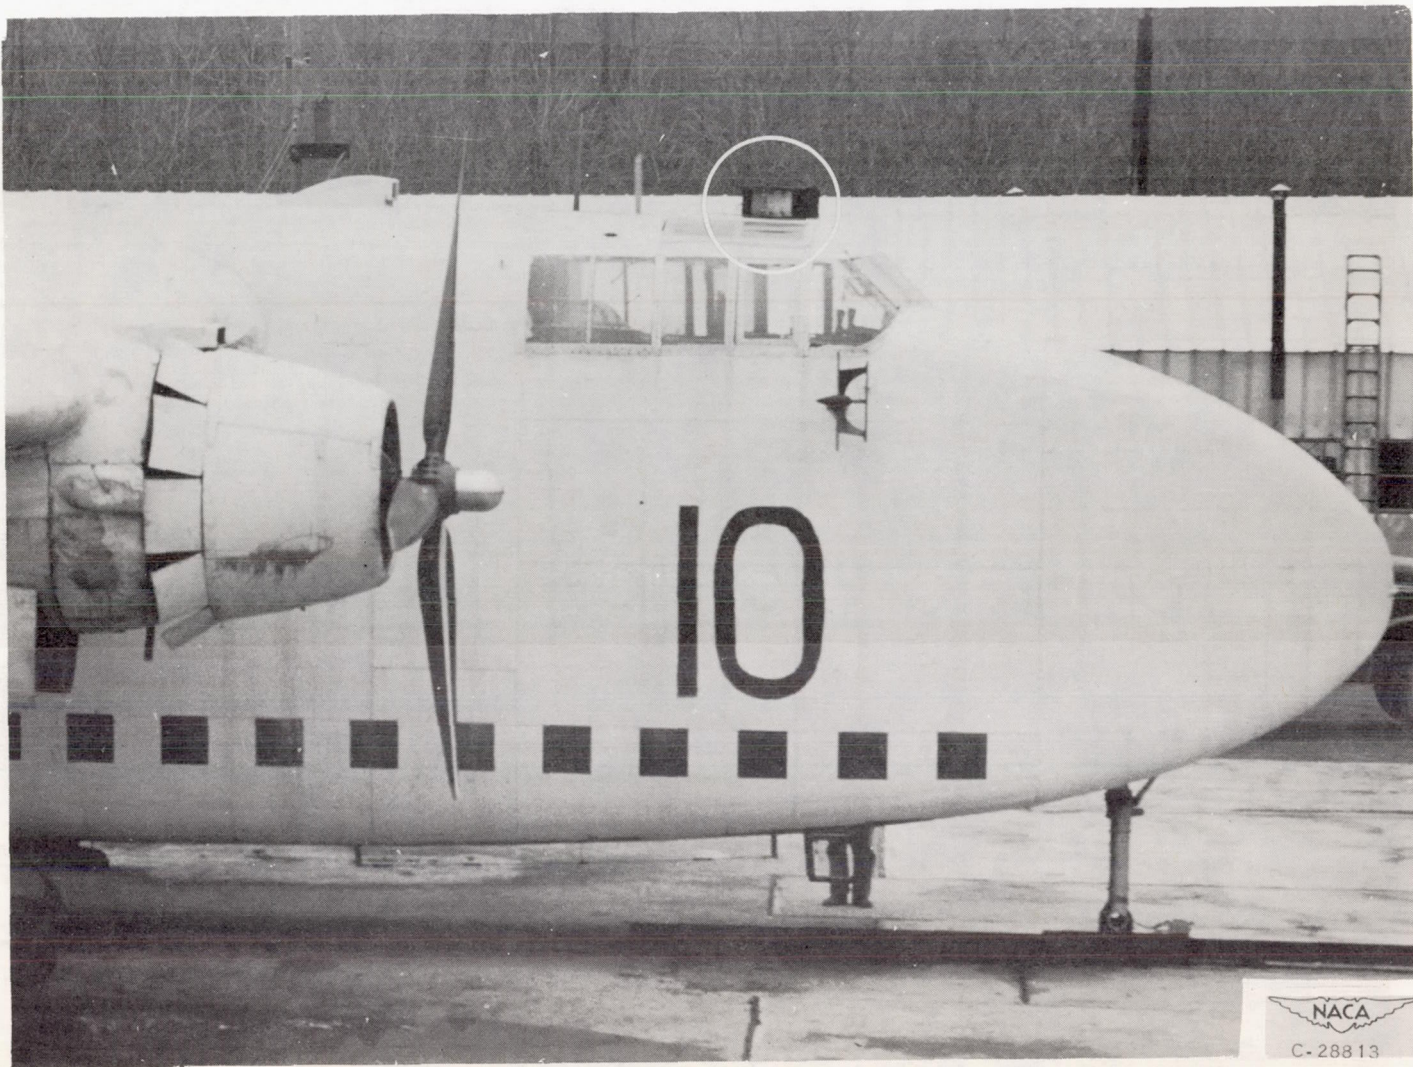
(a) On top of fuselage.

Figure 28. - Timing lights installed on C-82 airplane.

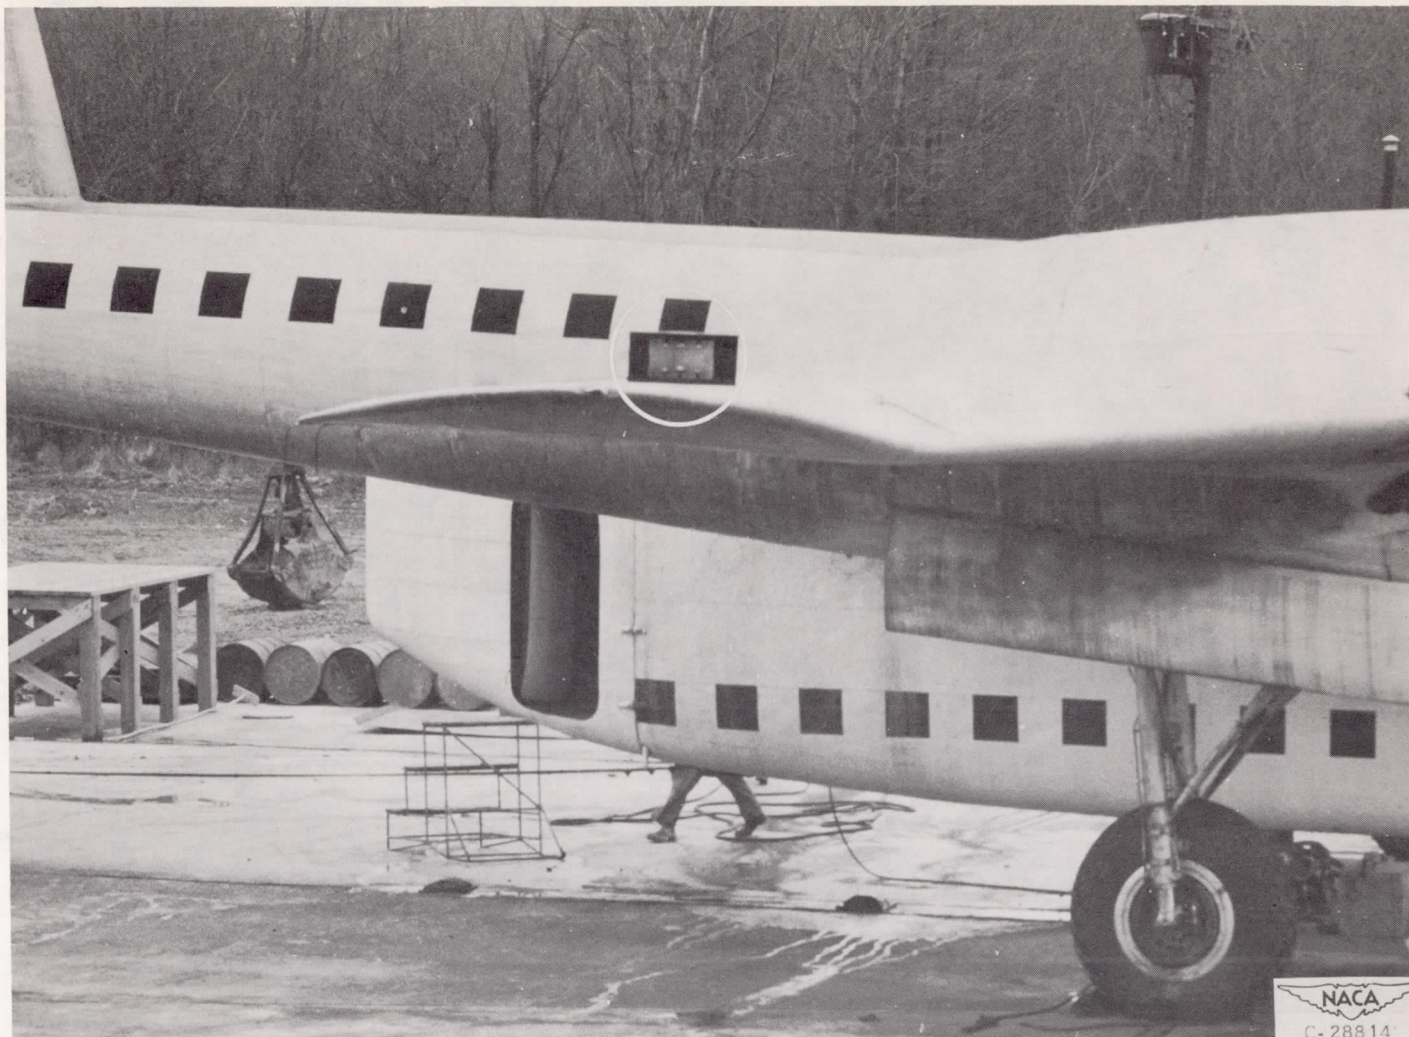
(b) On right wing tip.

Figure 28 - Continued. Timing lights installed on C-82 airplane.

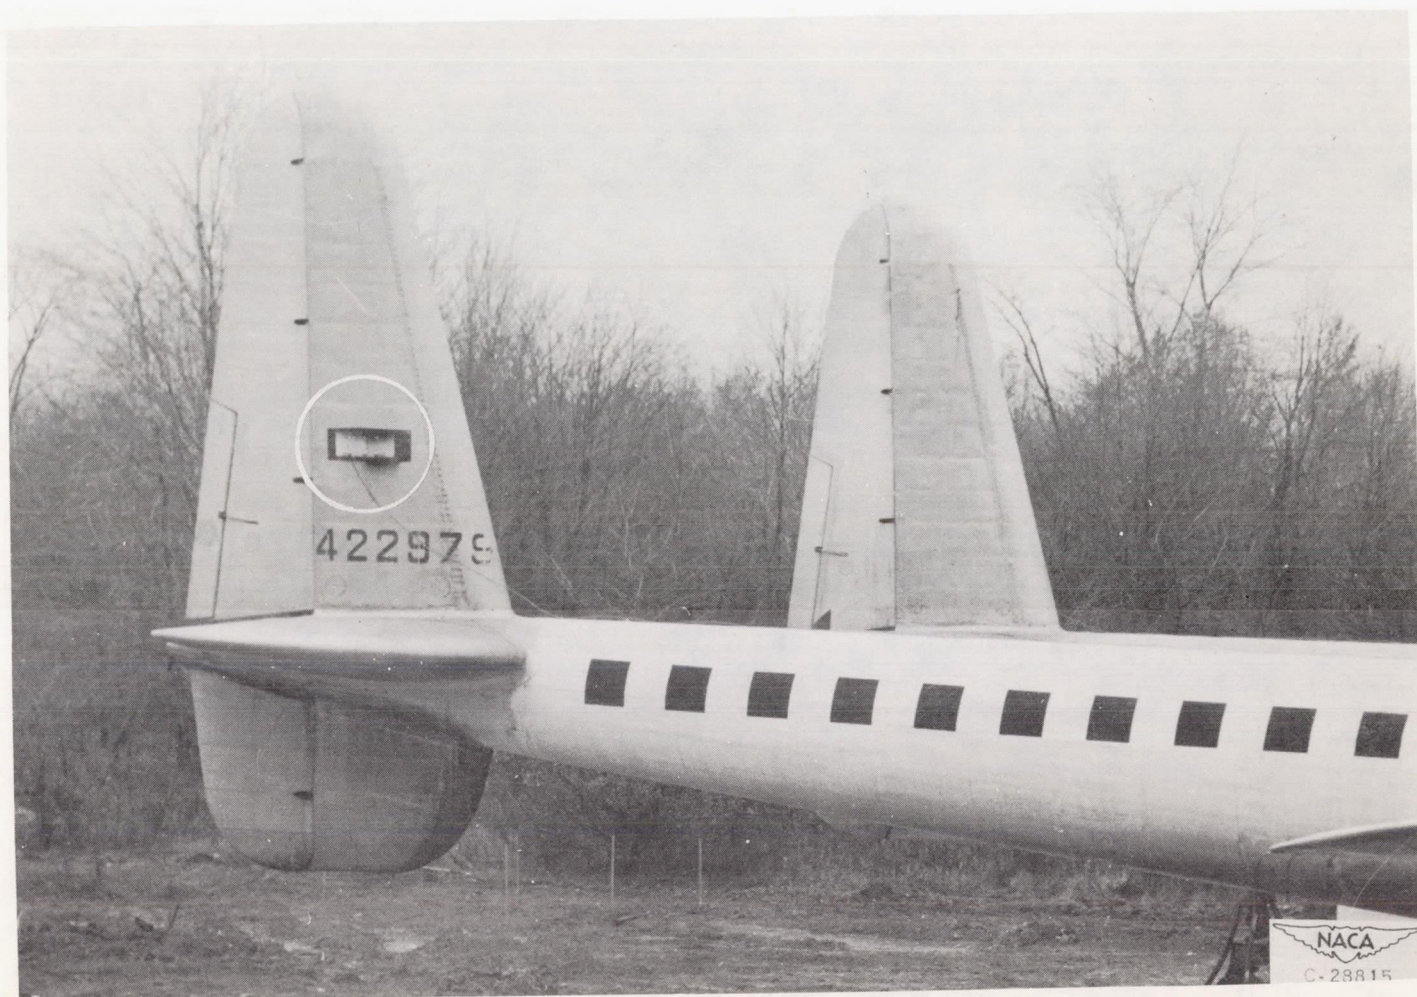
(c) On right vertical wing tip.

Figure 28. - Concluded. Timing lights installed on C-82 airplane.

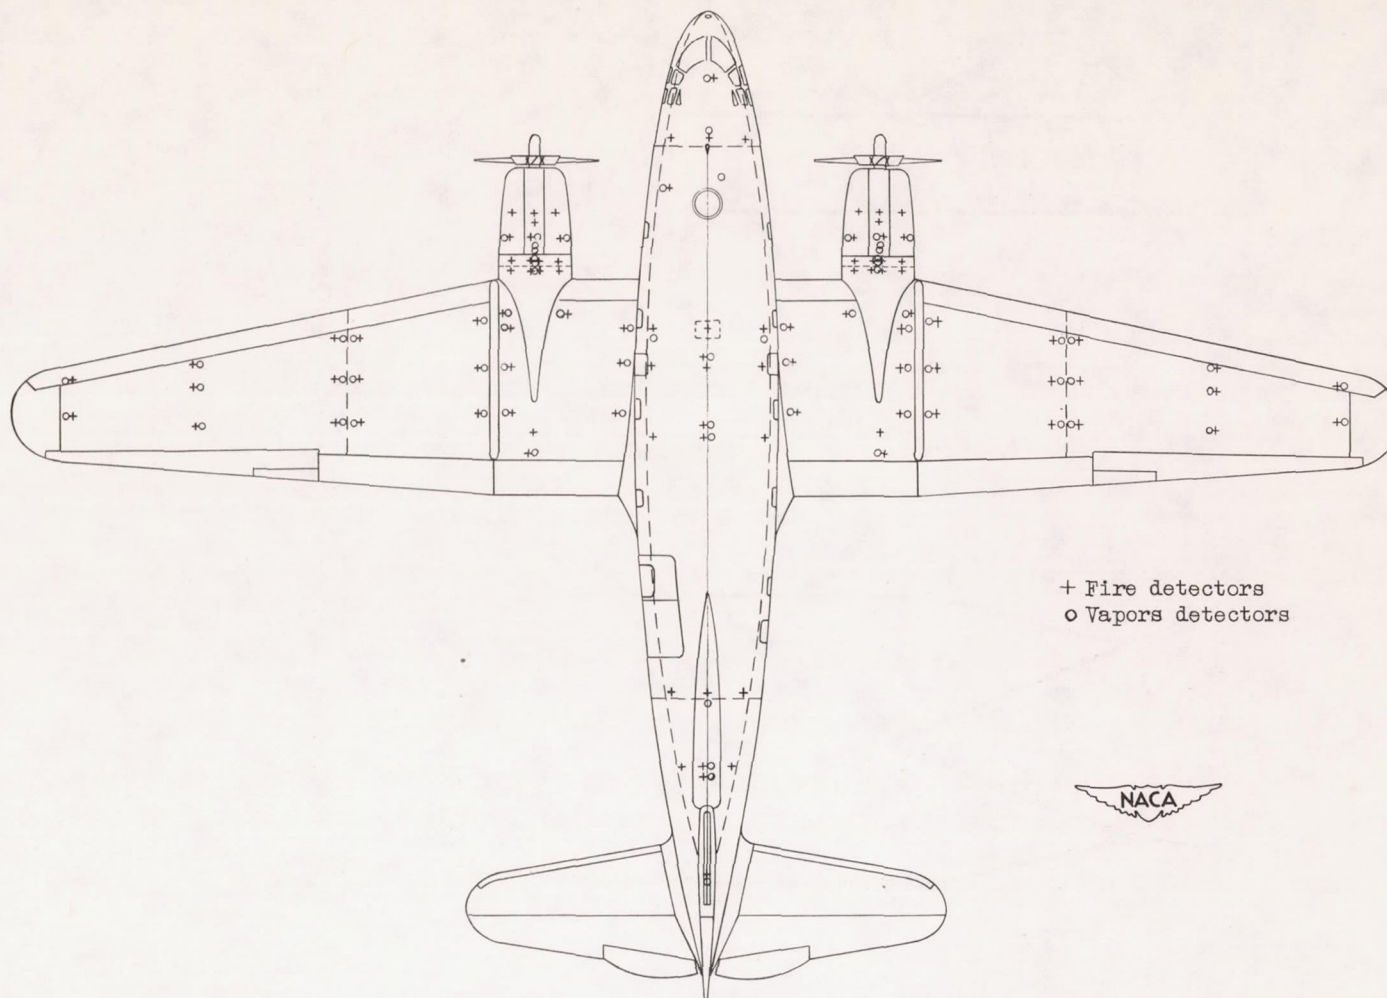
Figure 29. - Location of fire and vapor detectors installed in C-46 airplane.

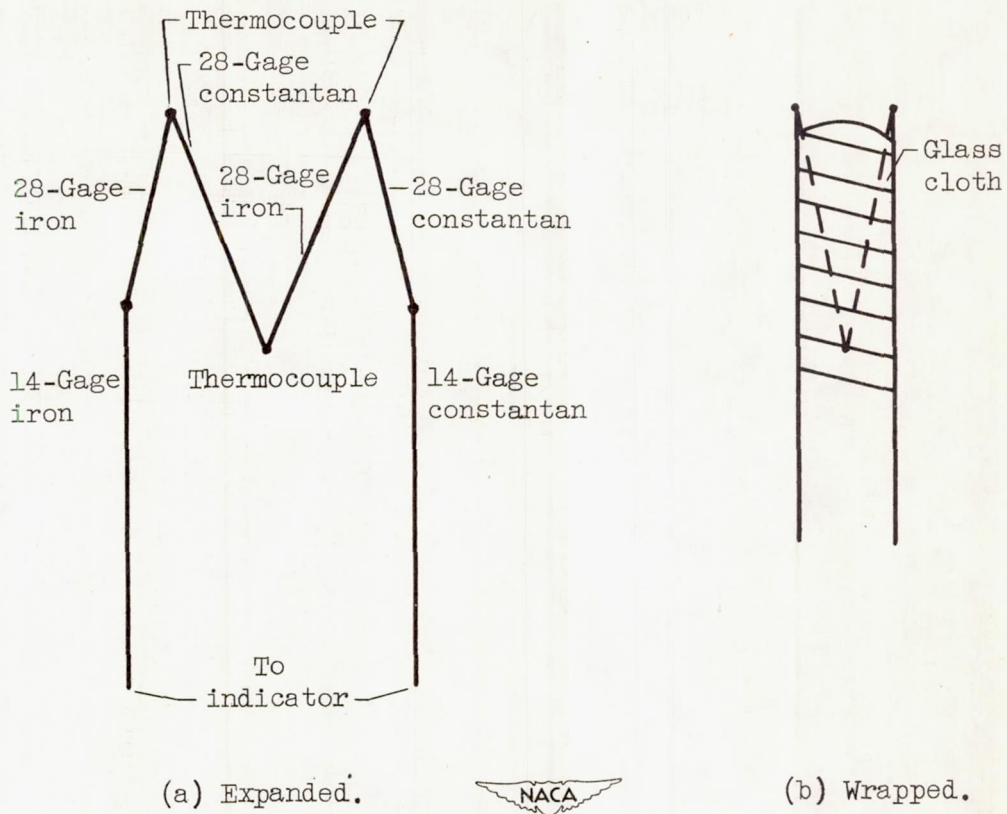
Figure 30. - Construction of thermopiles.

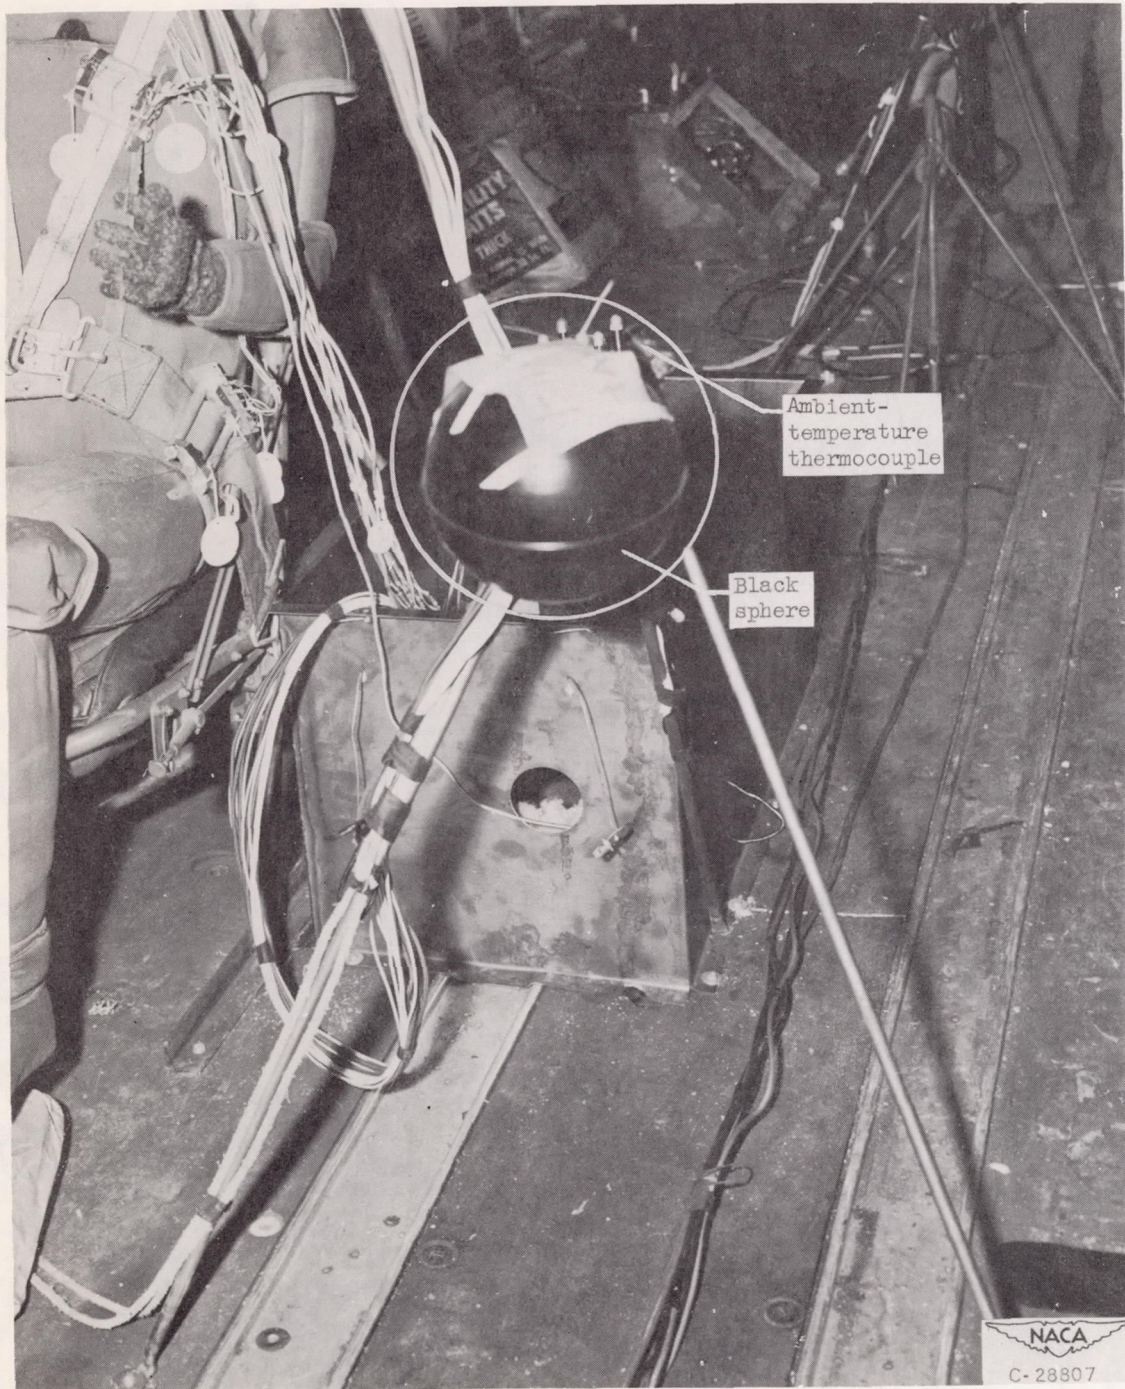
Figure 31. - Installation of radiant and ambient temperature thermocouples in fuselage of C-46 airplane.

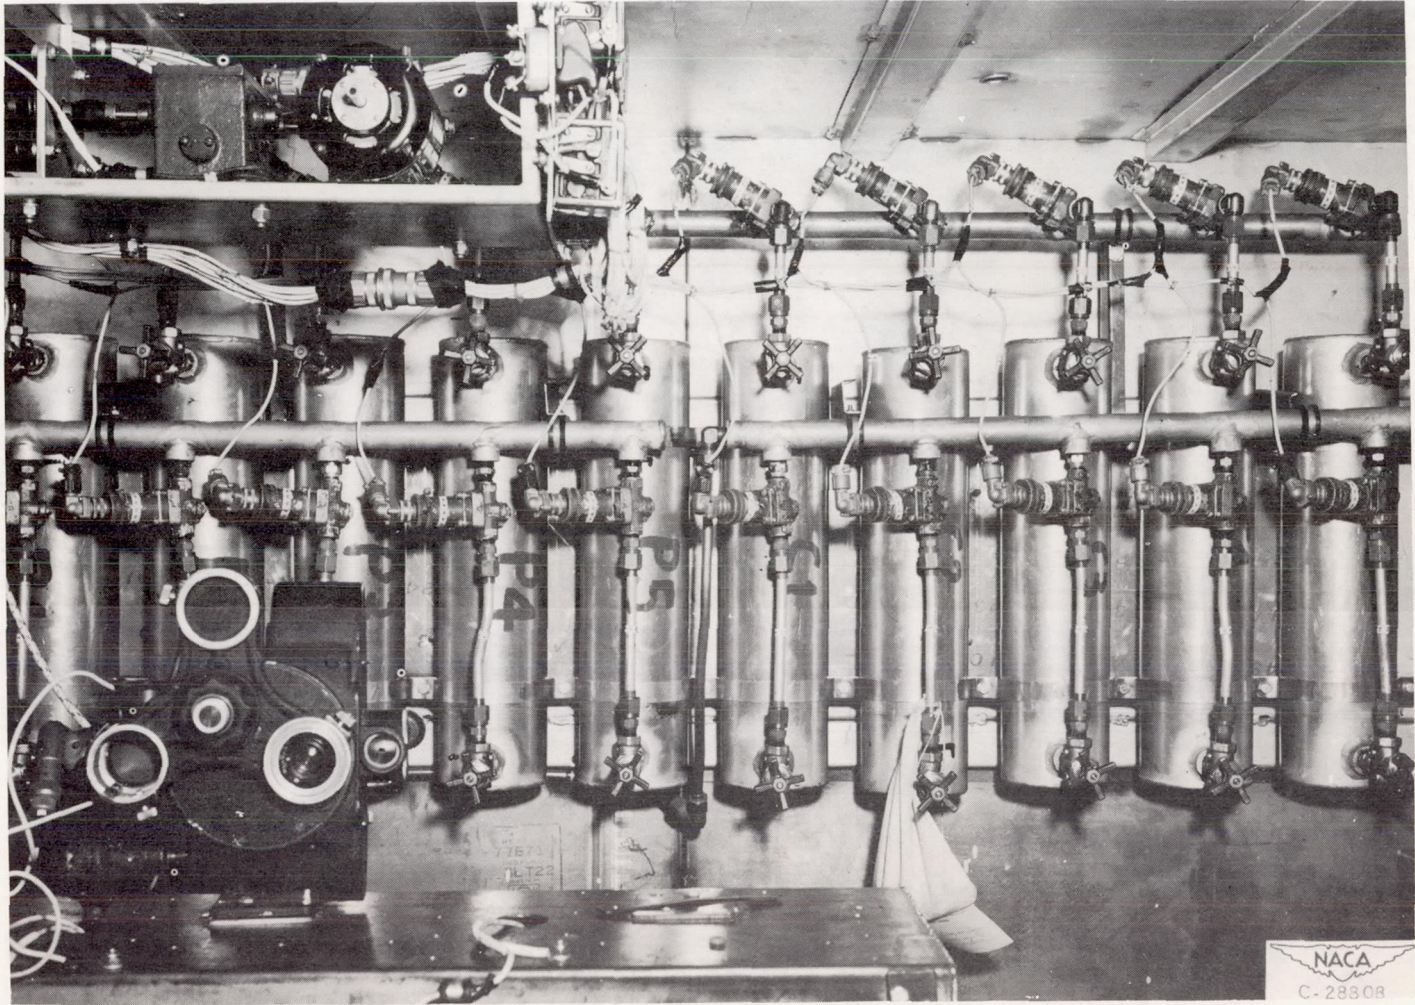
Figure 32. - Cabin-air sampling system installed in fireproof instrument box.

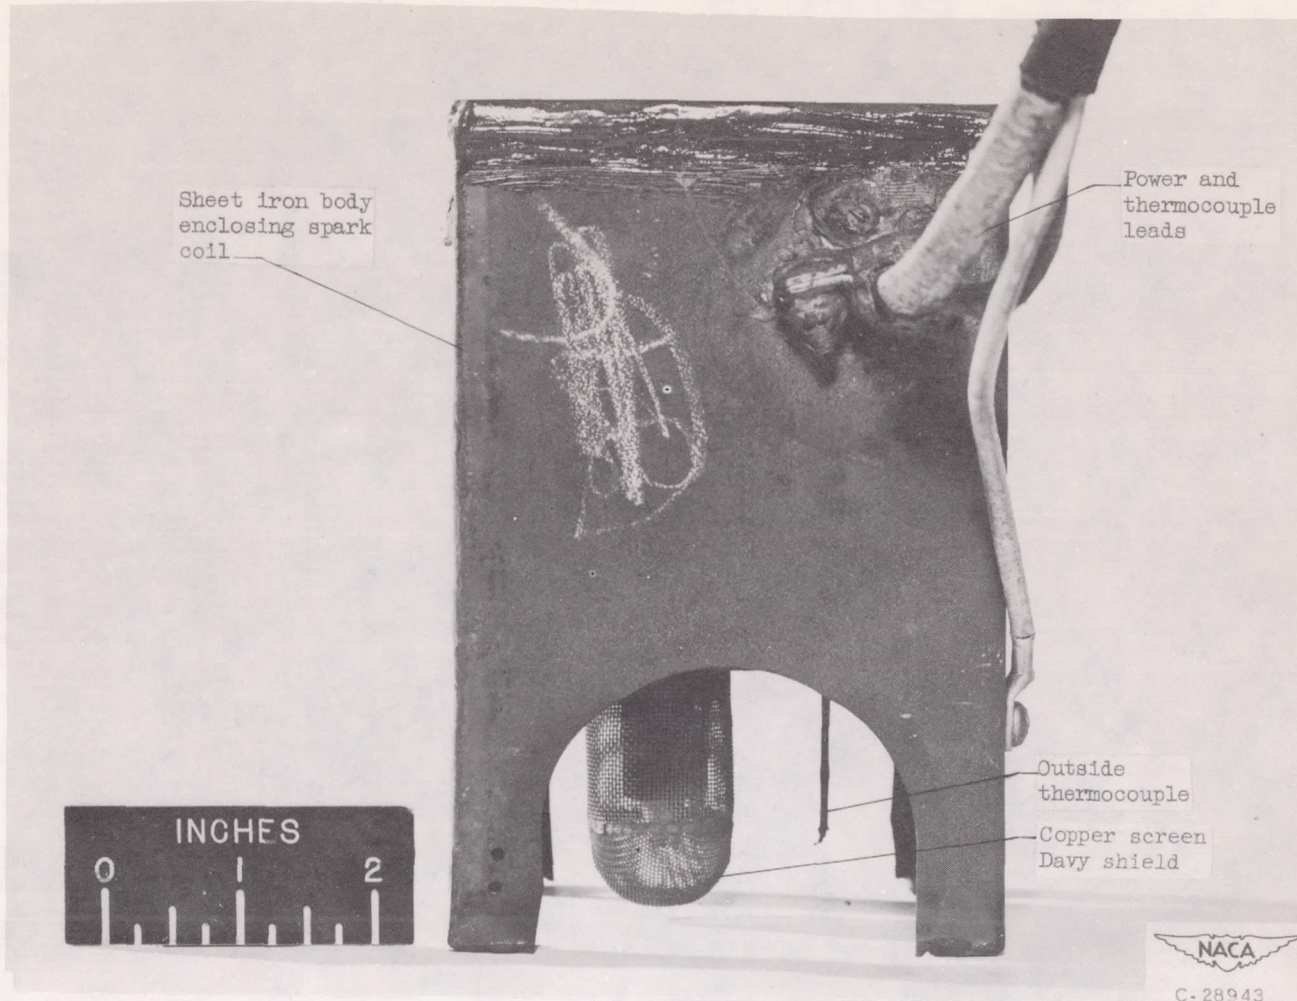
Figure 33. - Vapor Detector.
