STALLING CHARACTERISTICS OF THE SUPERMARINE

SPIRITFIRE VA AIRPLANE

ADVANCE CONFIDENTIAL REPORT

SPITFIRE VA AIRPLANE

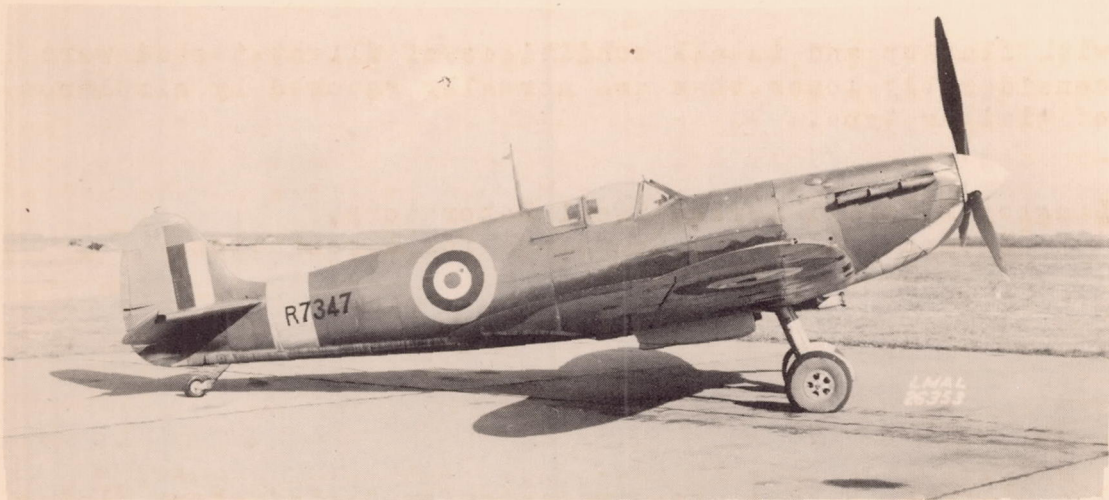
Figure 1.- Side view of the Supermarine Spitfire airplane.

The Supermarine Spitfire is a single-engine, single-place, low-wing cantilever monoplane with retractable landing gear and partial-span split flaps. (See figs. 1, 2, 3, and 4.)

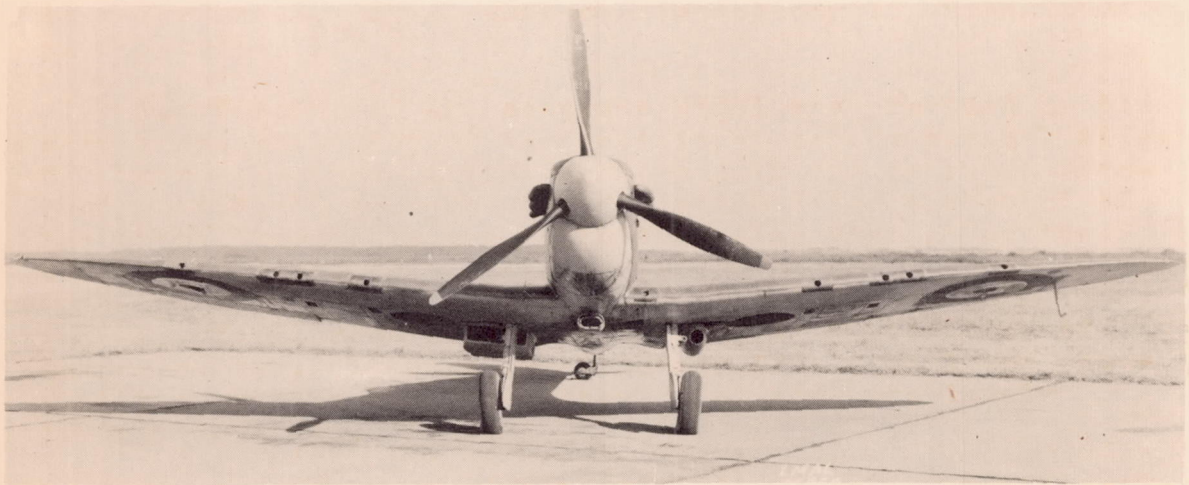
Figure 2.- Front view of the Supermarine Spitfire airplane.

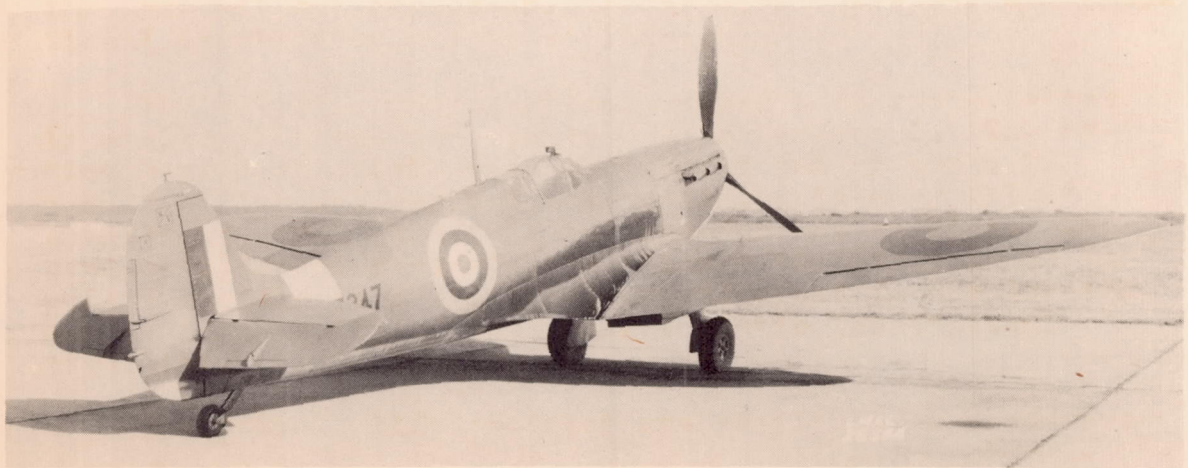
Figure 3.- Three-quarter rear view of the Supermarine airplane.

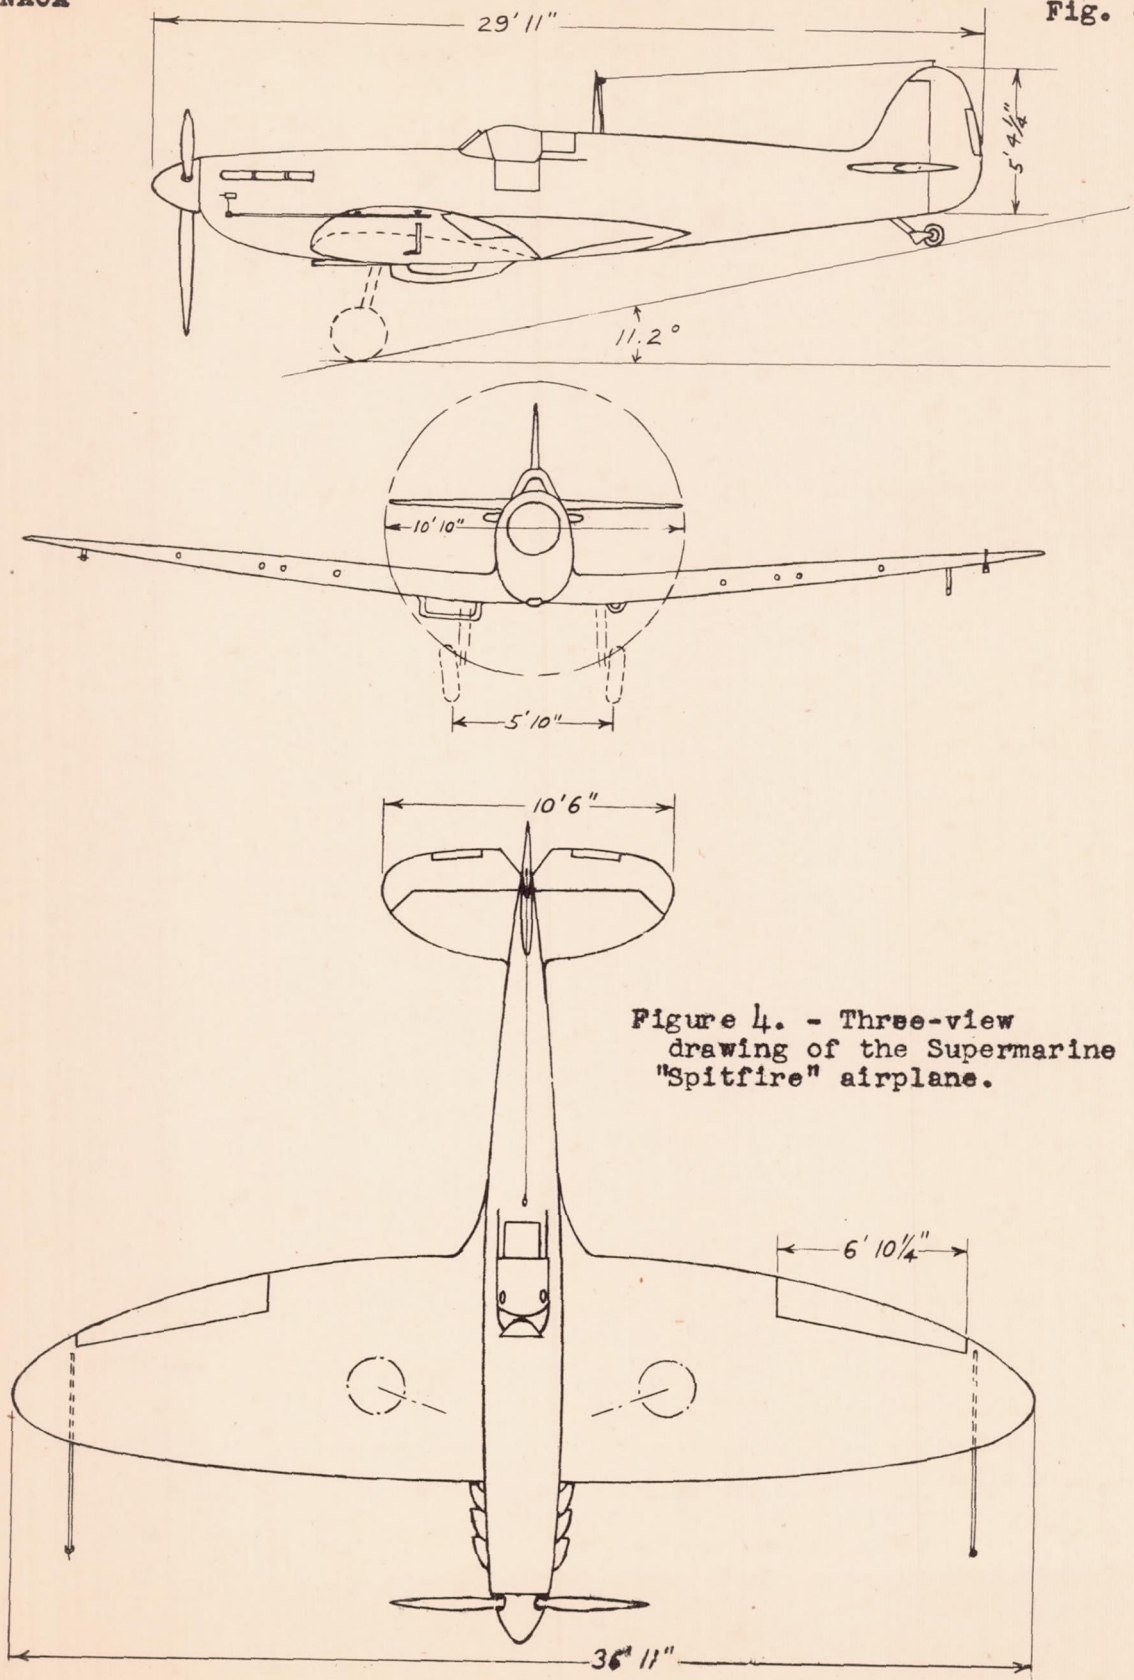
Fig. 4

Figure 4. - Three-view drawing of the Supermarine "Spitfire" airplane.

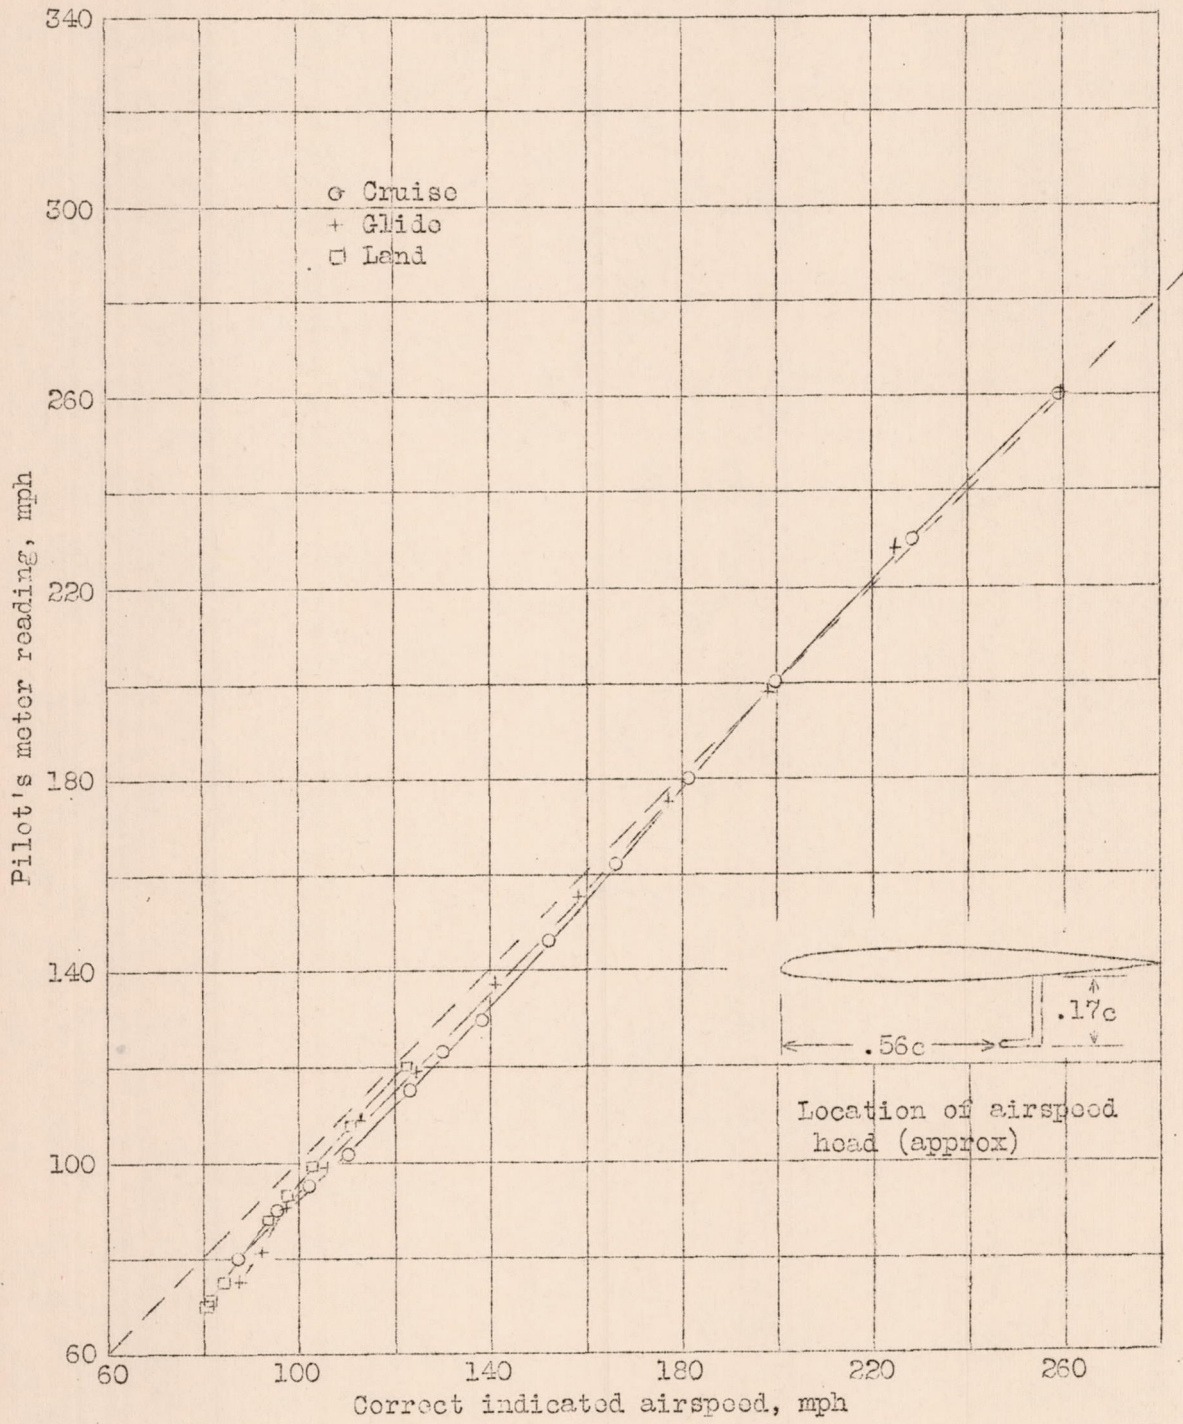
Figure 5.- Calibration of the pilot's airspeed indicator in the Supermarine Spitfire airplane.

The airspeed recorder in the Spitfire was calibrated by flying in formation with another airplane. The airspeed recorder in the other airplane was calibrated by means of a trailing airspeed head. The calibration of the pilot's airspeed meter is shown in figure 5.

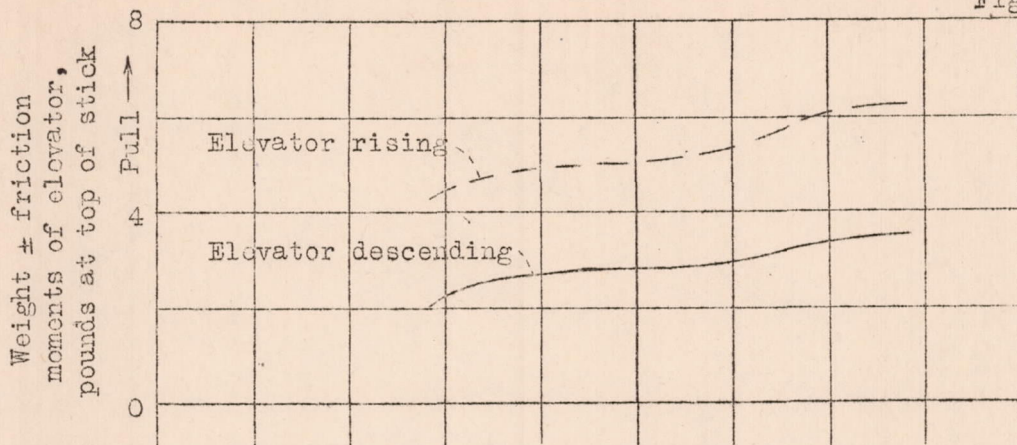
Figure 6.- Variation with control-stick angle of elevator angle and stick force caused by elevator friction and unbalance. Supermarine Spitfire airplane.

The variation of elevator angle with control-stick position is shown in figure 6 and the variation of aileron angle with control-stick position is shown in figure 7.

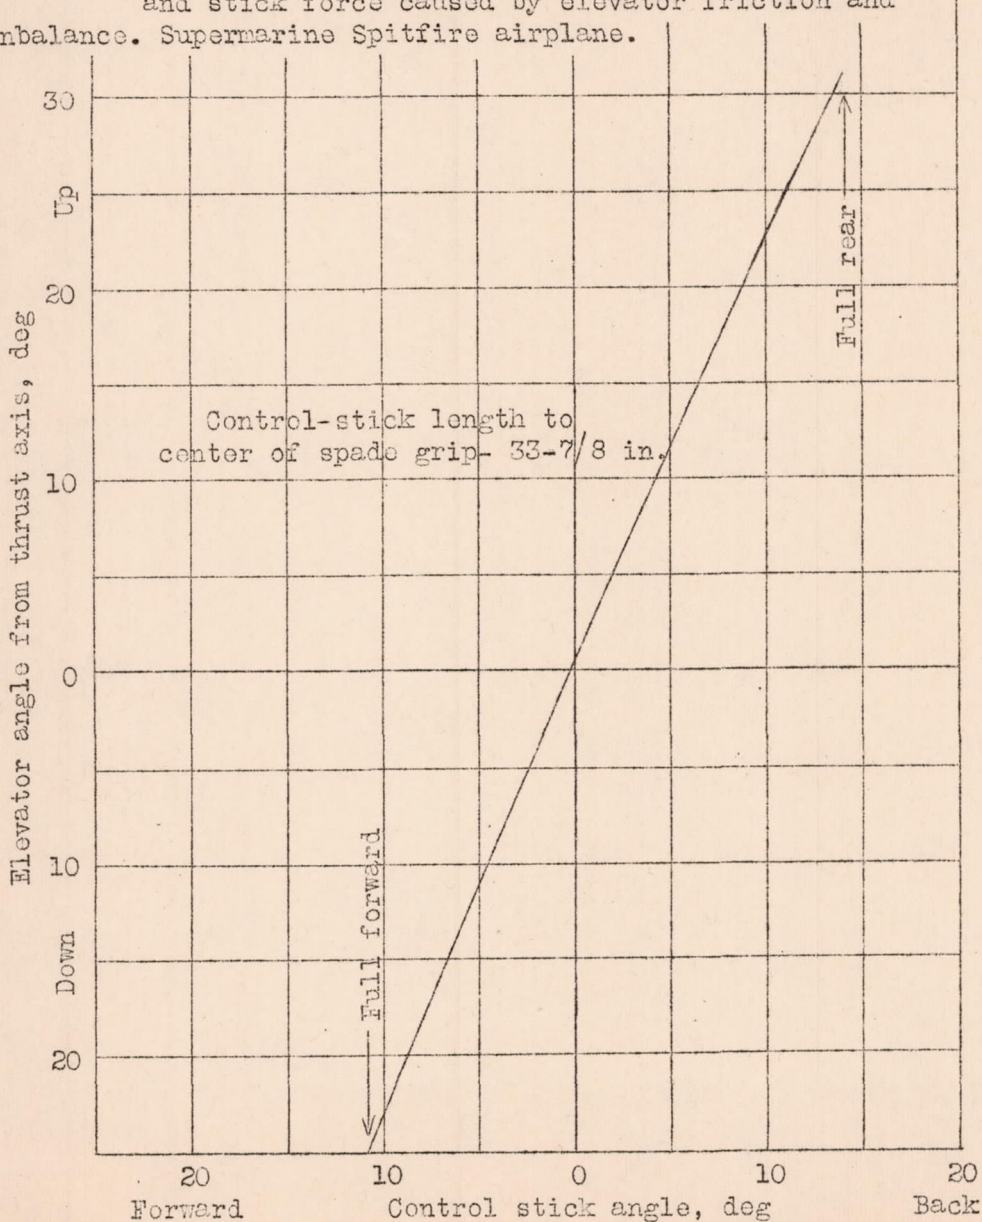
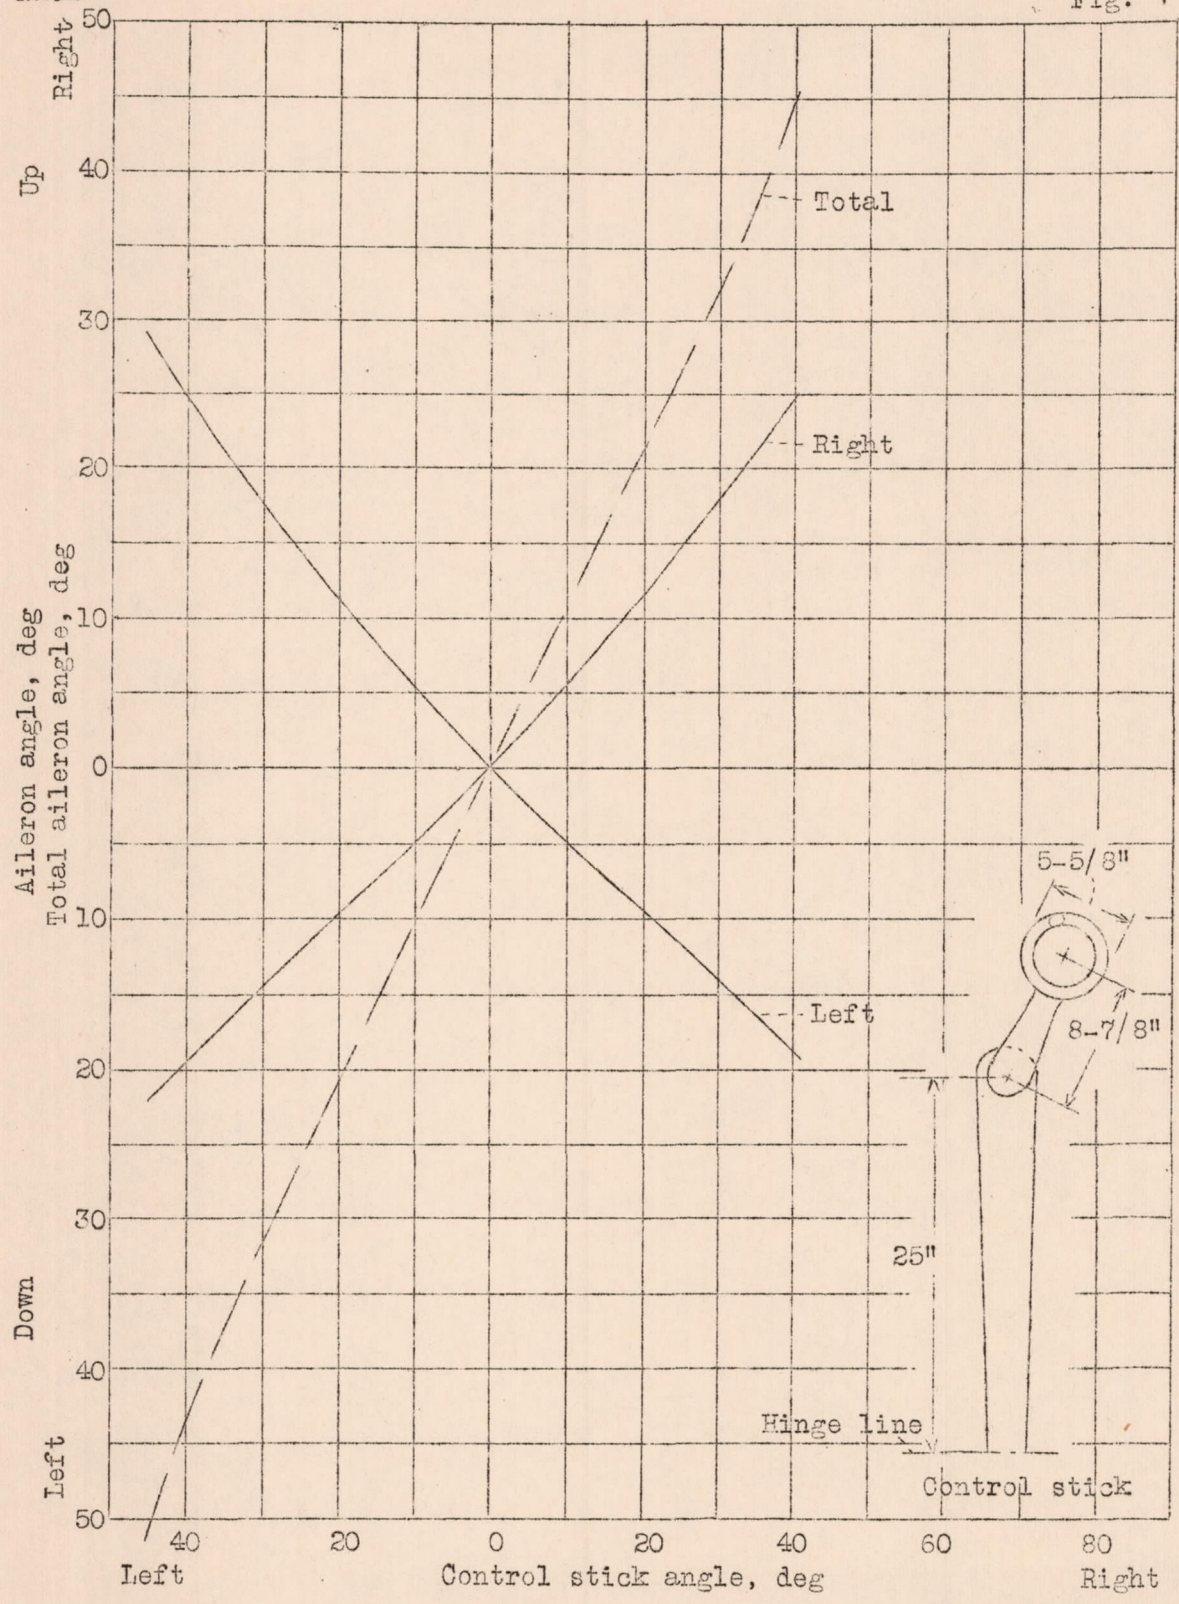
Figure 7.- Variation of left, right, and total-aileron angles with control stick angle. Supermarine Spitfire airplane.

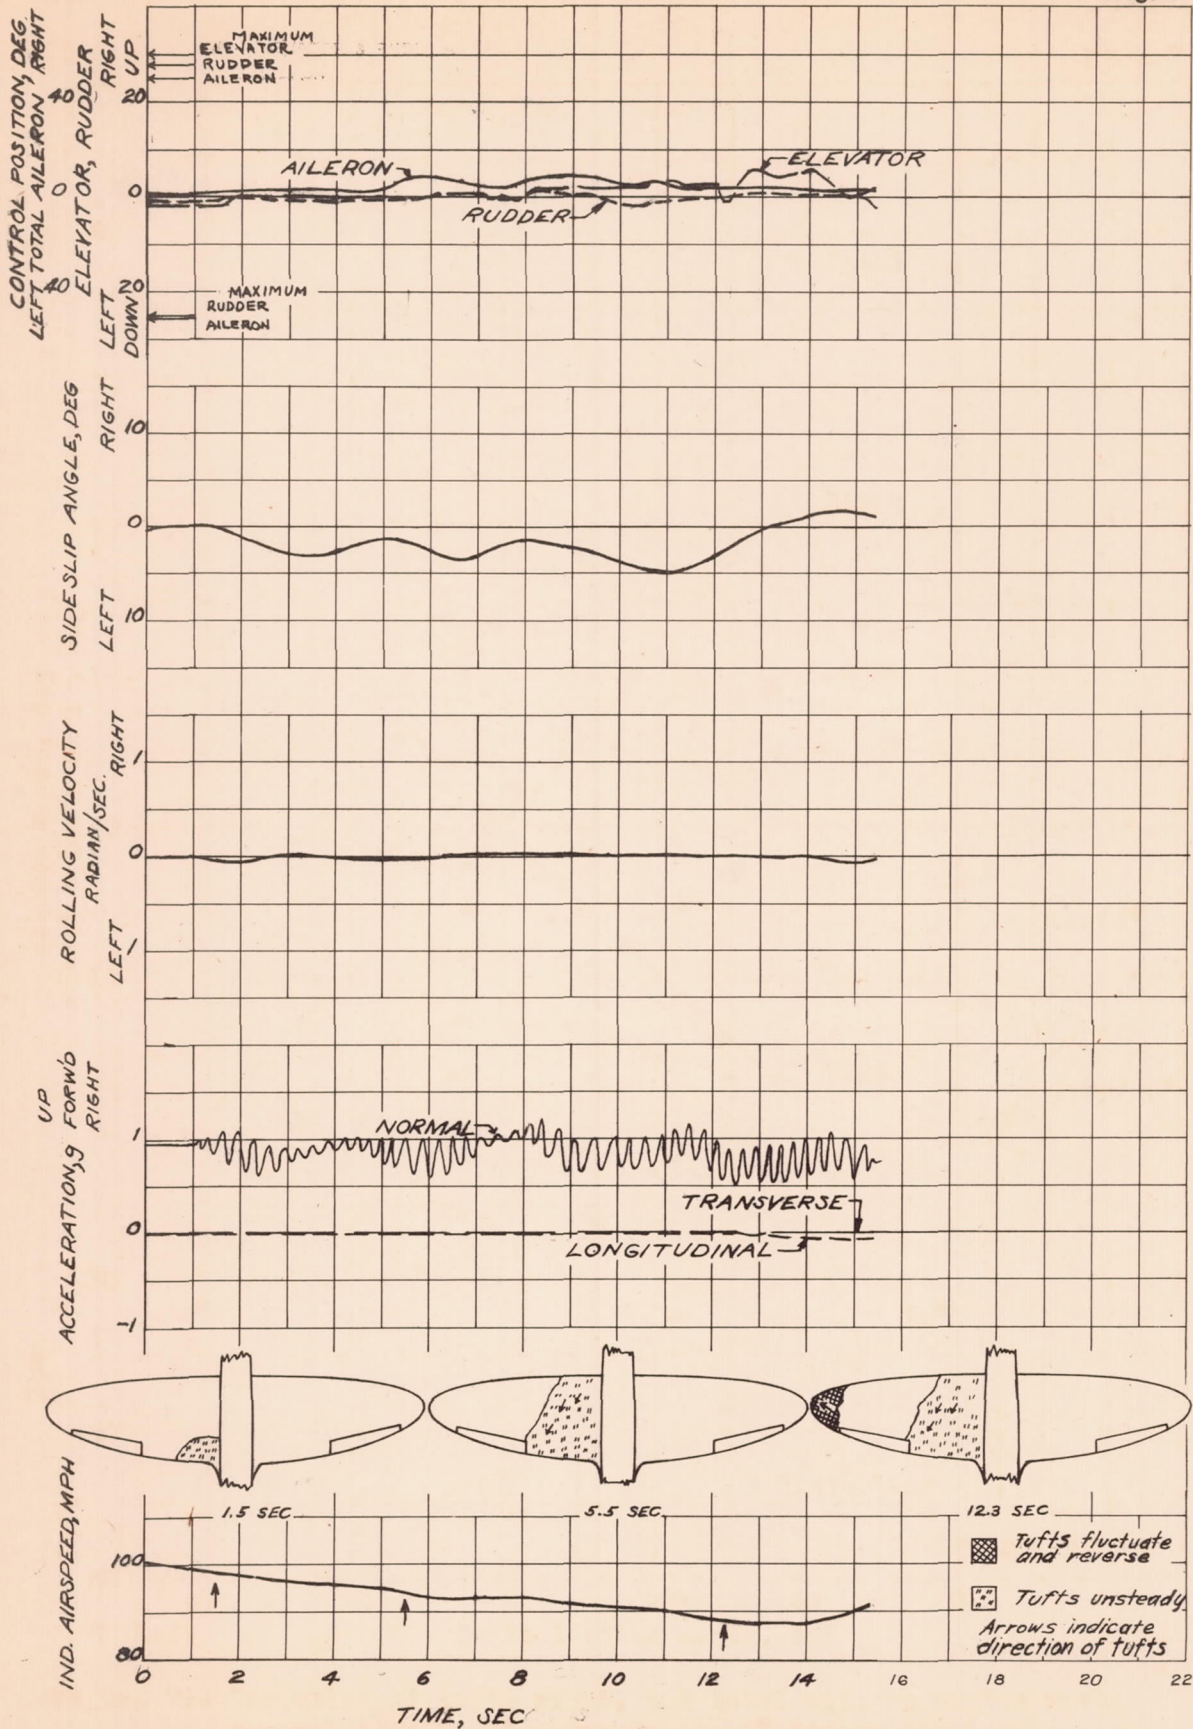
Fig. 8

Figure 8. - Time history of a stall in the gliding condition, gun ports covered. Controls were held approximately in the positions required at the start of the stall. Supermarine Spitfire airplane.

Stalling characteristics in the gliding condition of flight.- In the gliding condition with the gun ports covered, the airplane showed no tendency to roll off. Figure 8 shows a stall in which the controls were held approximately in the positions required at the first sign of the stall. At speeds of about 10 miles per hour above the minimum speed, the tufts at the trailing edge of the left wing root were observed to reverse and buffeting was felt in the elevator and rudder controls. This buffeting caused a fairly violent and unmistakable shaking of the airplane. In figure 8 and the following time histories, the buffeting is indicated on the figure by an oscillation of the normal acceleration record. Actually all the instrument records showed vibrations, but it was thought unnecessary to indicate this fact on the time histories. The approximate amplitude of the variation in normal acceleration is shown by the plotted curve, but no attempt has been made to reproduce the frequency of the oscillation that was recorded.

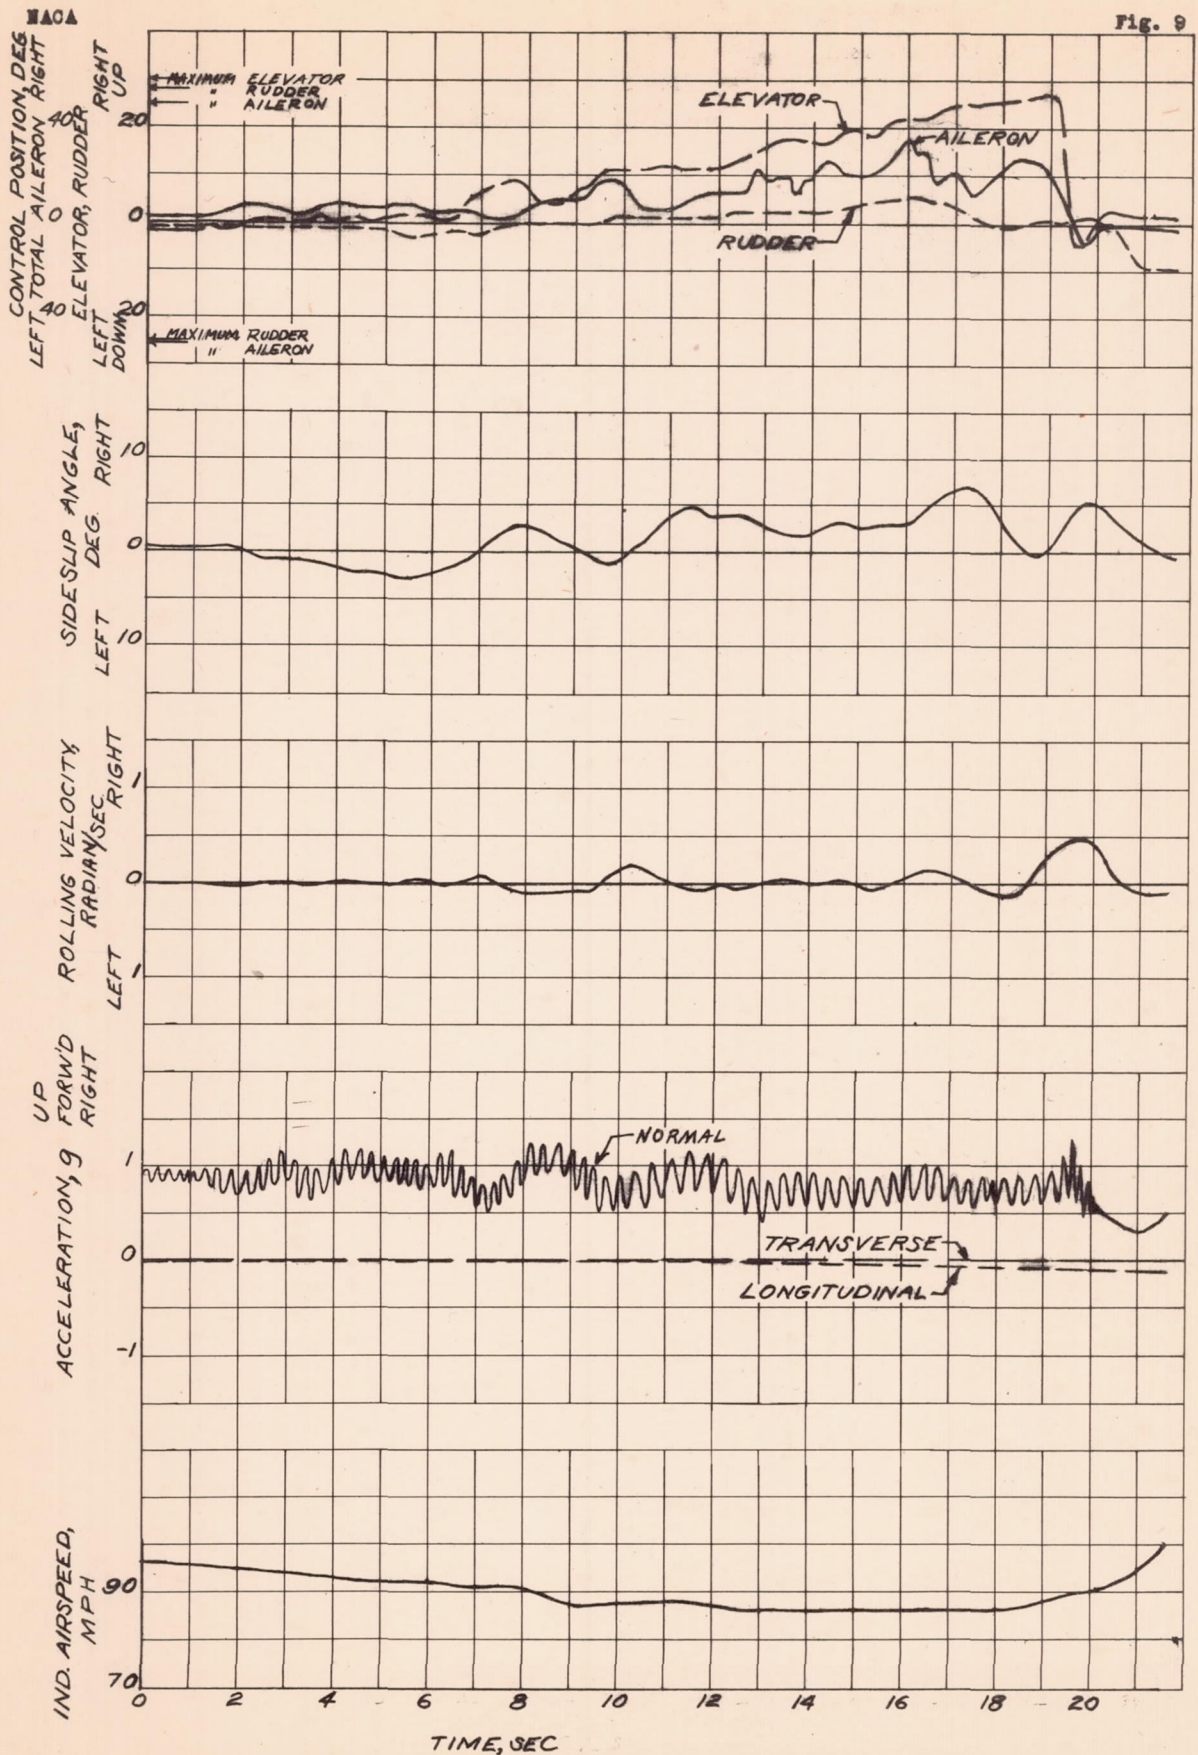
Fig. 9

Figure 9. - Time history of a stall in the gliding condition with gun ports covered. Nearly full up elevator was applied and control was maintained with ailerons and rudder. Supermarine Spitfire airplane.

Figure 9 shows a gliding stall with the gun ports covered in which the stick was moved far back after minimum speed was reached. Use of the ailerons finally re-

The effect of uncovering the gun ports in the gliding condition is shown in figures 9 and 10. In this case, the stall progressed symmetrically outward from each side of the fuselage at the wing root; a very mild lateral and pitching oscillation was observed to accompany the fairly violent buffeting. If the stick were held all the way back, a lateral oscillation would develop which eventually led to a complete loss of lateral control.

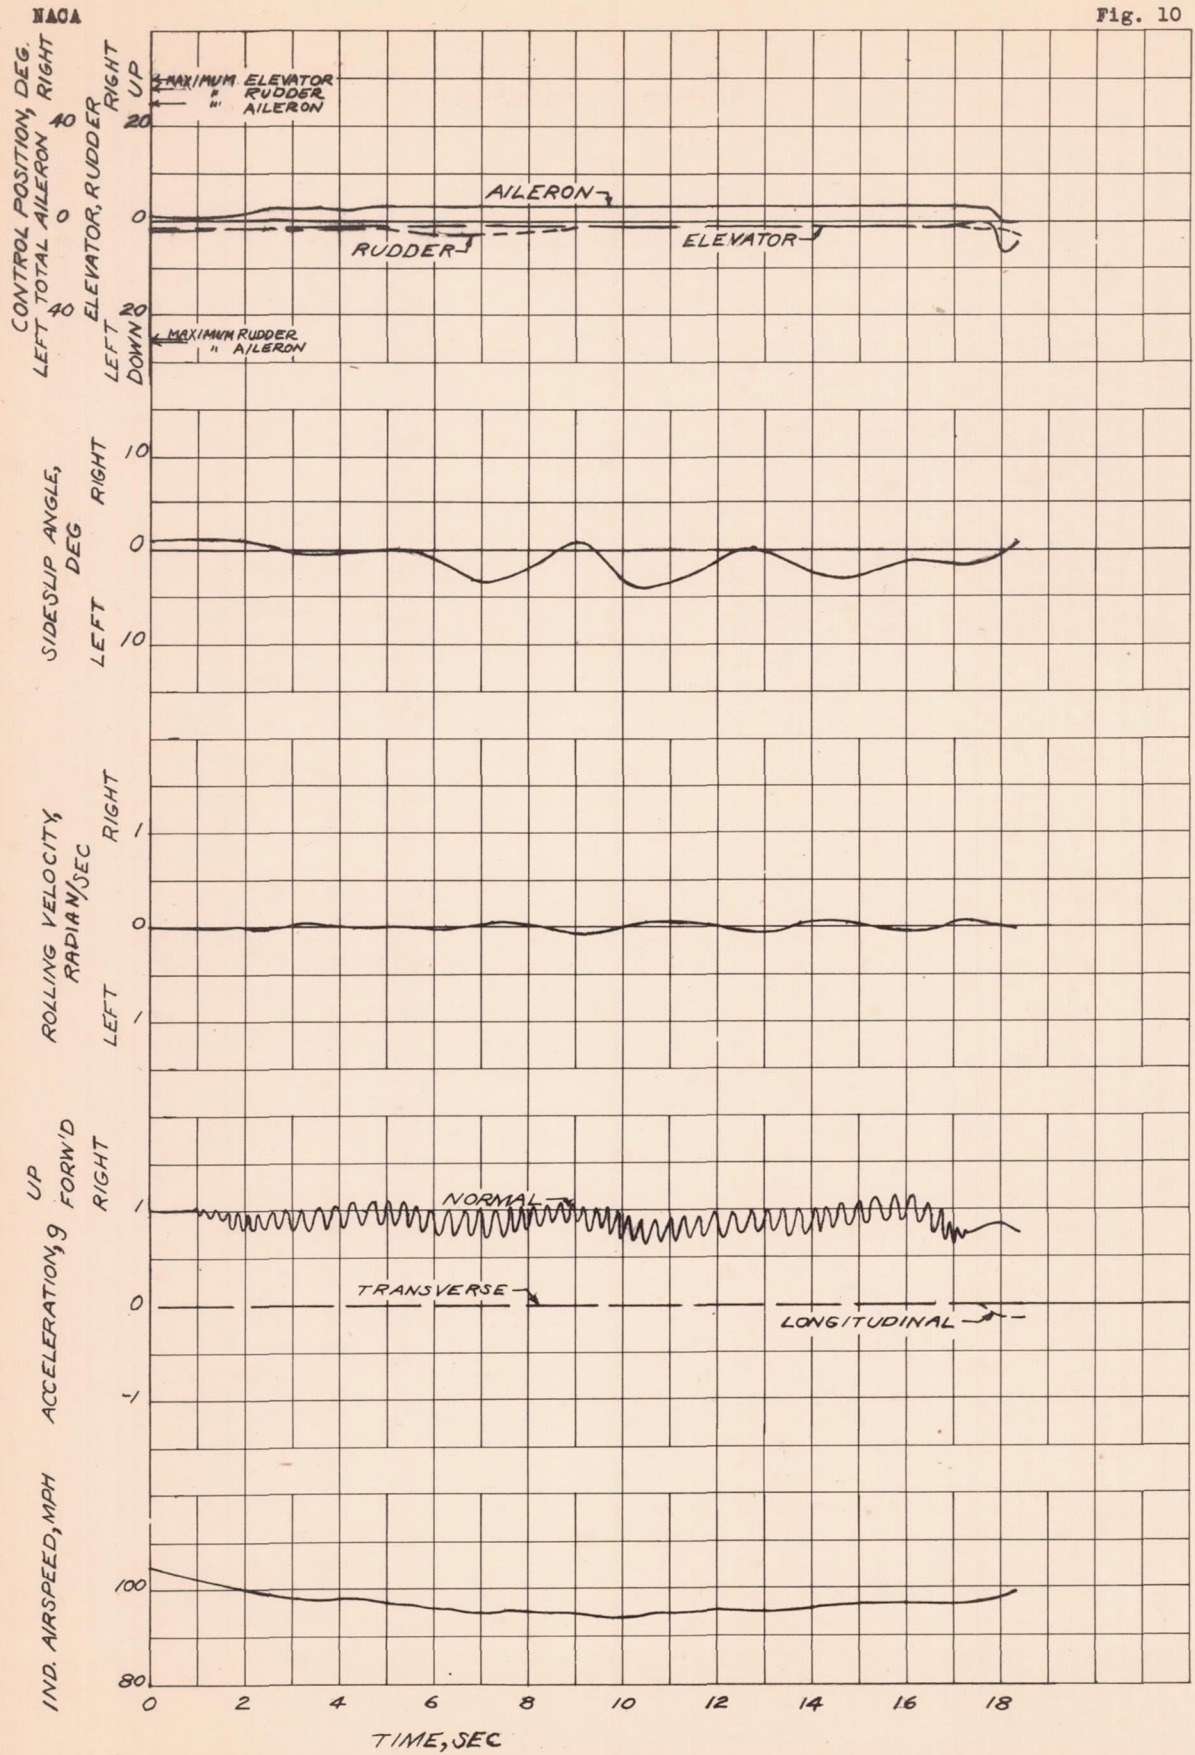
Fig. 10

Figure 10. - Time history of a stall in the gliding condition with gun ports open. Controls were held in the positions required at the start of the stall. Supermarine Spitfire airplane.

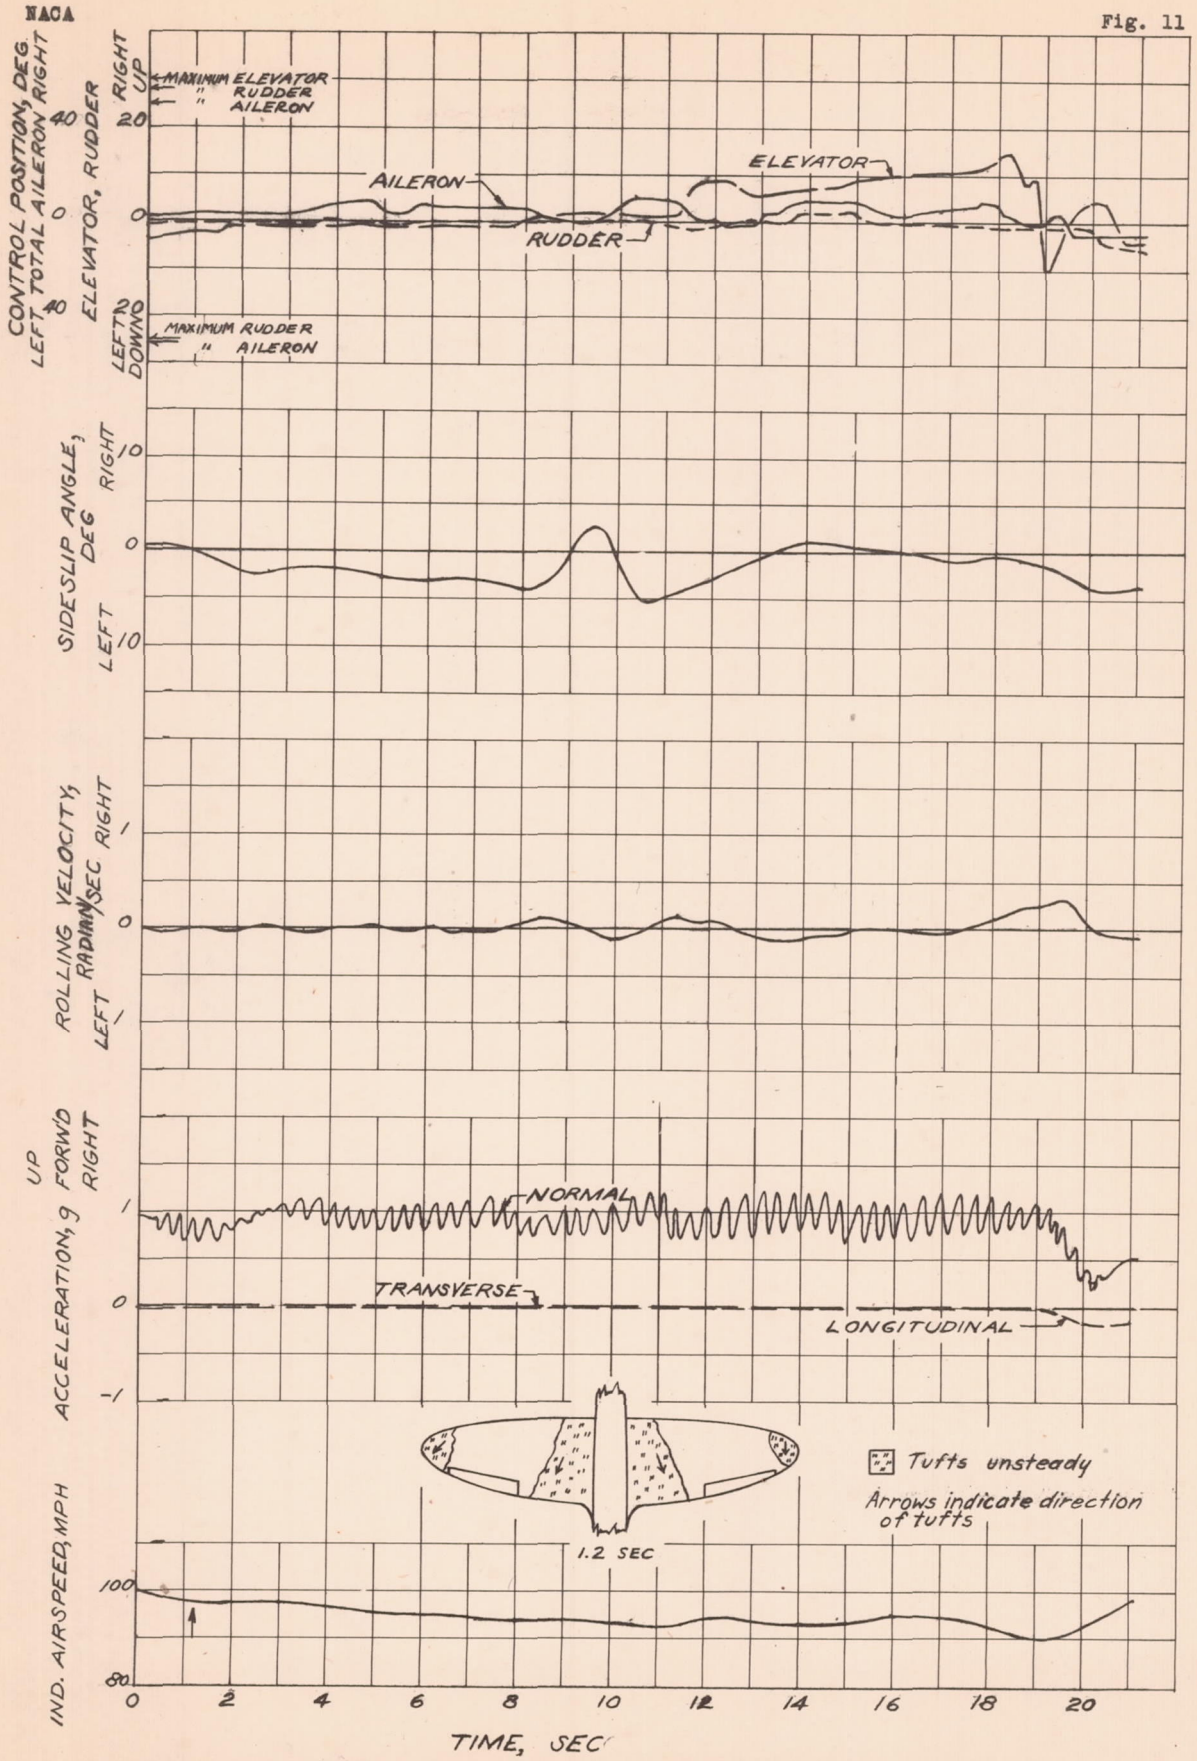
Fig. 11

Figure 11. - Time history of a stall in the gliding condition with gun ports open. Airplane was controlled by ailerons and rudder beyond the stall. Supermarine Spitfire airplane.

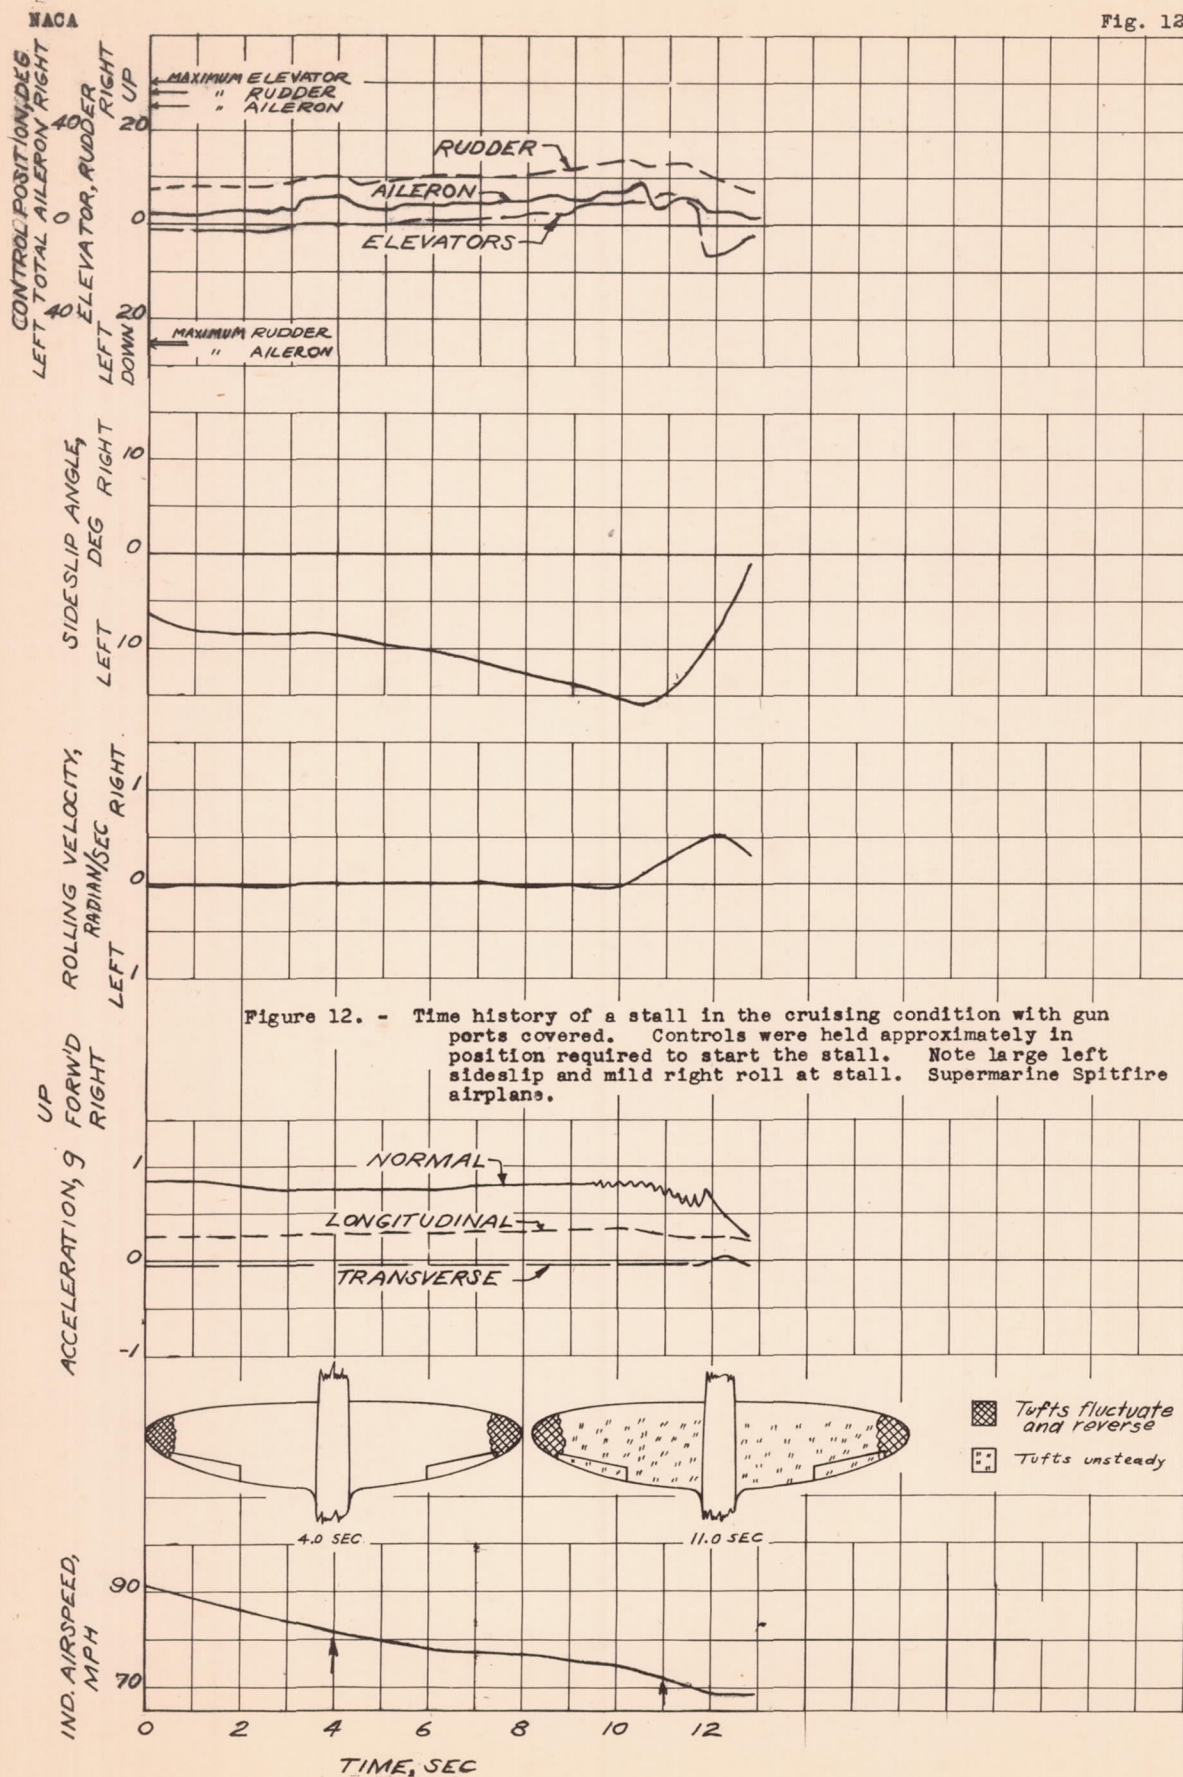
Figure 12. - Time history of a stall in the cruising condition with gun ports covered. Controls were held approximately in position required to start the stall. Note large left sideslip and mild right roll at stall. Supermarine Spitfire airplanes.

Stalling characteristics in the cruising condition of flight.- In the cruising condition, there was essentially no difference in the types of stall that occurred with gun ports open or covered, as shown on figures 12 and 13. The wing tips beyond the ailerons stalled first, apparently because the slipstream prevented separation of flow from the center section. Slight buffeting and rearward motion of the stick started about 5 miles per hour above minimum speed, though the tufts at the center section did not reverse. A considerable amount of left sideslip was necessary to hold the wings level near the stall. This sideslip did not occur in the power-off condition. When the minimum

Figures 12 and 13 show that the rolling velocity was not checked until approximately one-half second had elapsed after the application of down elevator. This time interval is longer than has been measured in tests on other airplanes.

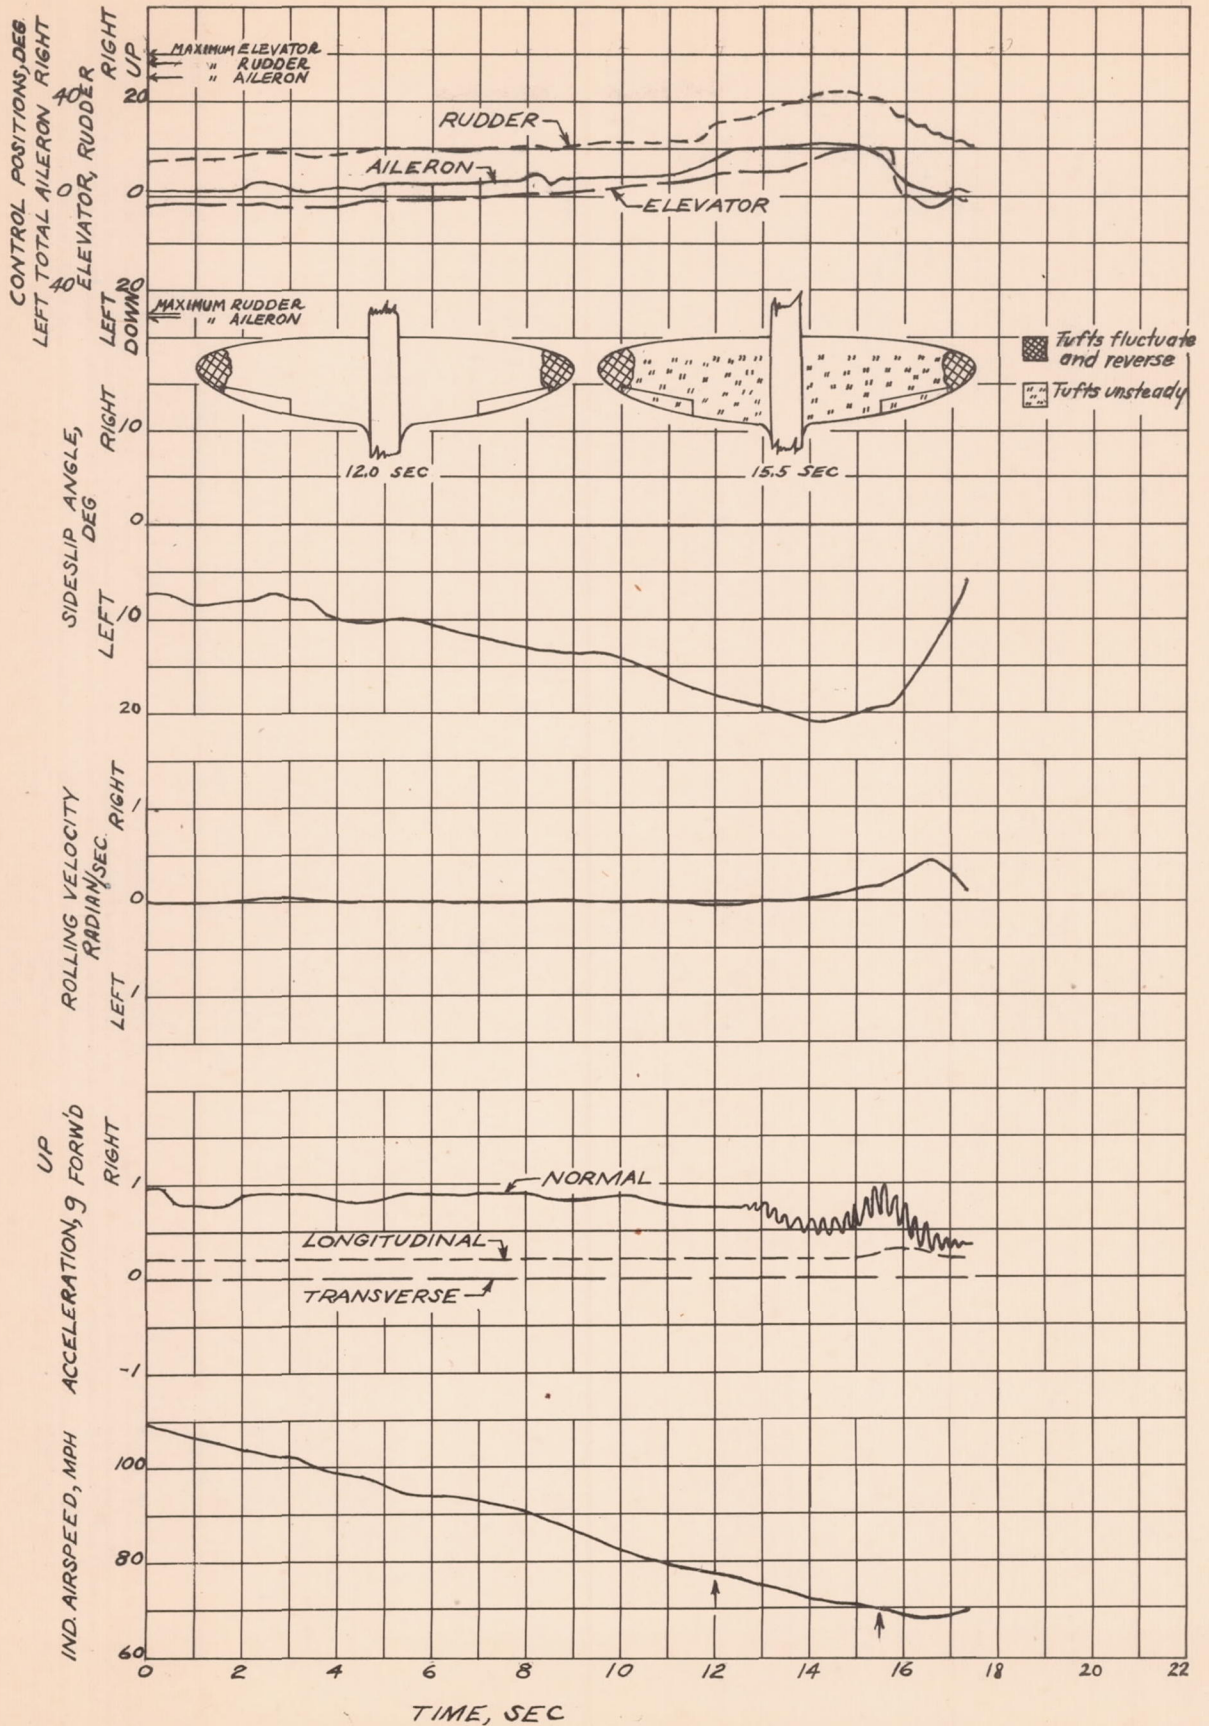
Figure 13. - Time history of a stall in the cruising condition with gun ports open. Note similarity to stall with gun ports closed (fig. 11). Supermarine Spitfire airplane.
