STALLING CHARACTERISTICS OF THE SUPERMARINE

SPIRITFIRE VA AIRPLANE

ADVANCE CONFIDENTIAL REPORT

SPITFIRE VA AIRPLANE

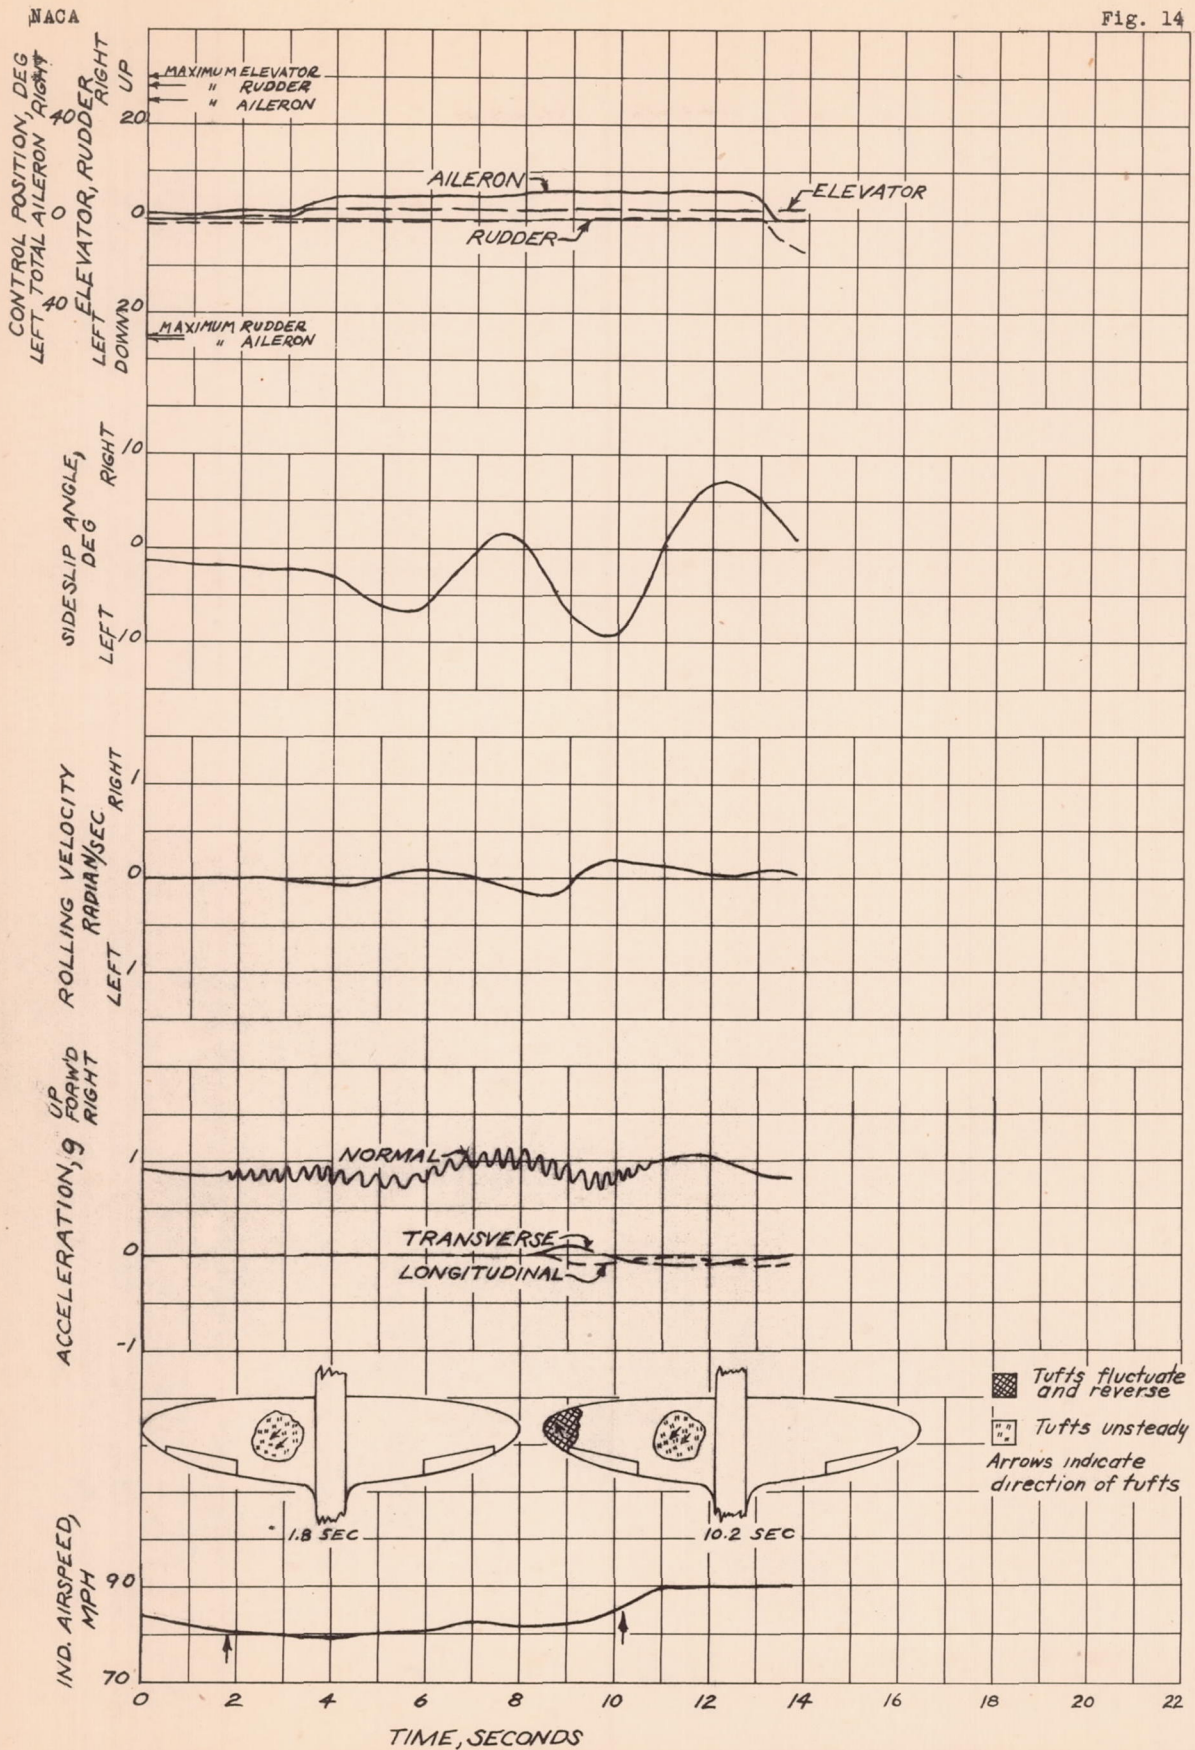
Figure 14. - Time history of a stall in the landing condition with gun ports covered. Controls were held in the positions required to start the stall. Note lateral and pitching oscillation. Supermarine Spitfire airplane.

Stalling characteristics in the landing condition of flight.-- A time history of a stall in the landing condition is shown on figure 14. The development of the stall was the same with gun ports open or covered. At a speed of about 10 miles per hour above the minimum speed, the tufts reversed in a region on the left side of the center section near the leading edge, but the tufts at the trailing edge did not reverse.

Buffeting set in when this separation took place. Figure 14 shows that a lateral and pitching oscillation of increasing amplitude developed if the controls were held fixed. With elevator full up, however, some measure of lateral control could be maintained by means of the rudder and ailerons.

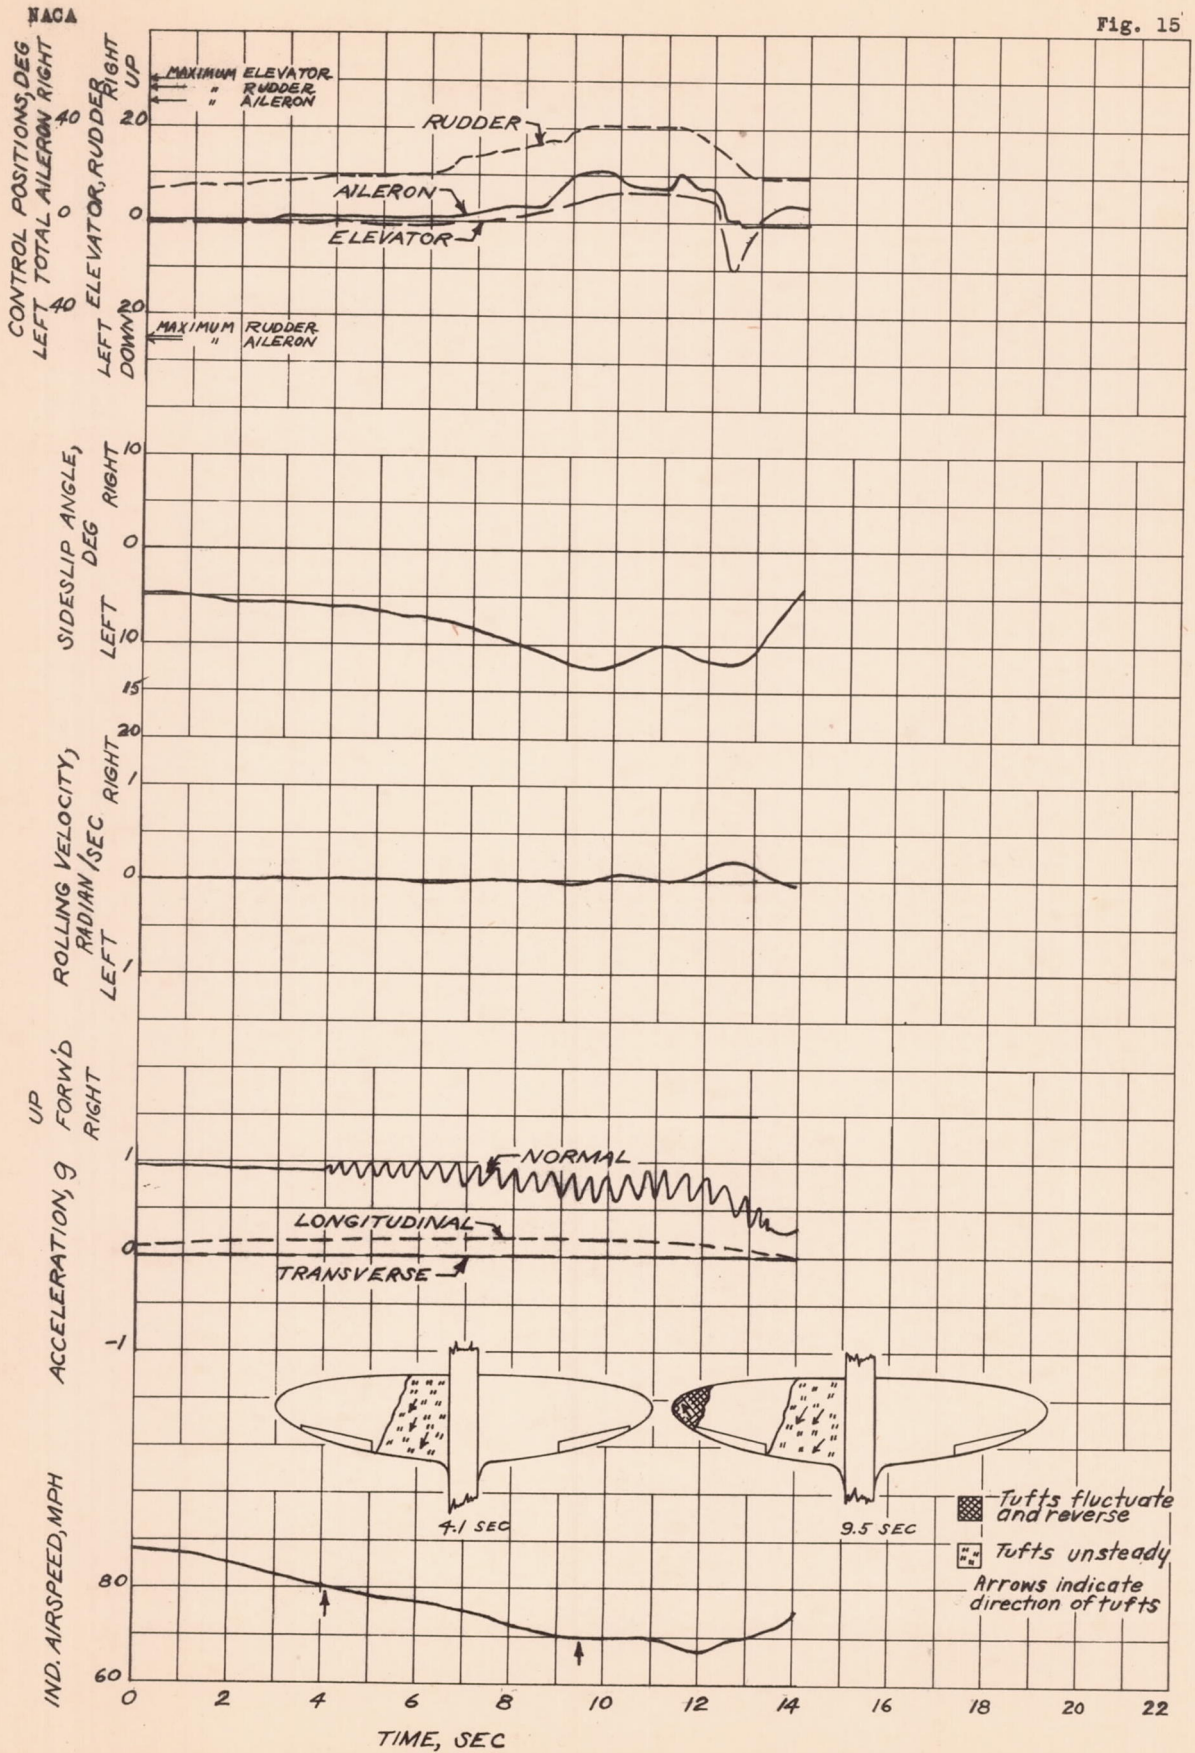
Fig. 15

Figure 15. - Time history of a stall in the landing-approach condition with gun ports covered. Supermarine Spitfire airplane.

In the landing-approach condition, with gun ports covered, the stall was similar to that in the landing condition, with the exception that considerable rudder and aileron deflections were required to maintain trim near minimum speed. Figure 15 shows the time history of a stall in this condition.

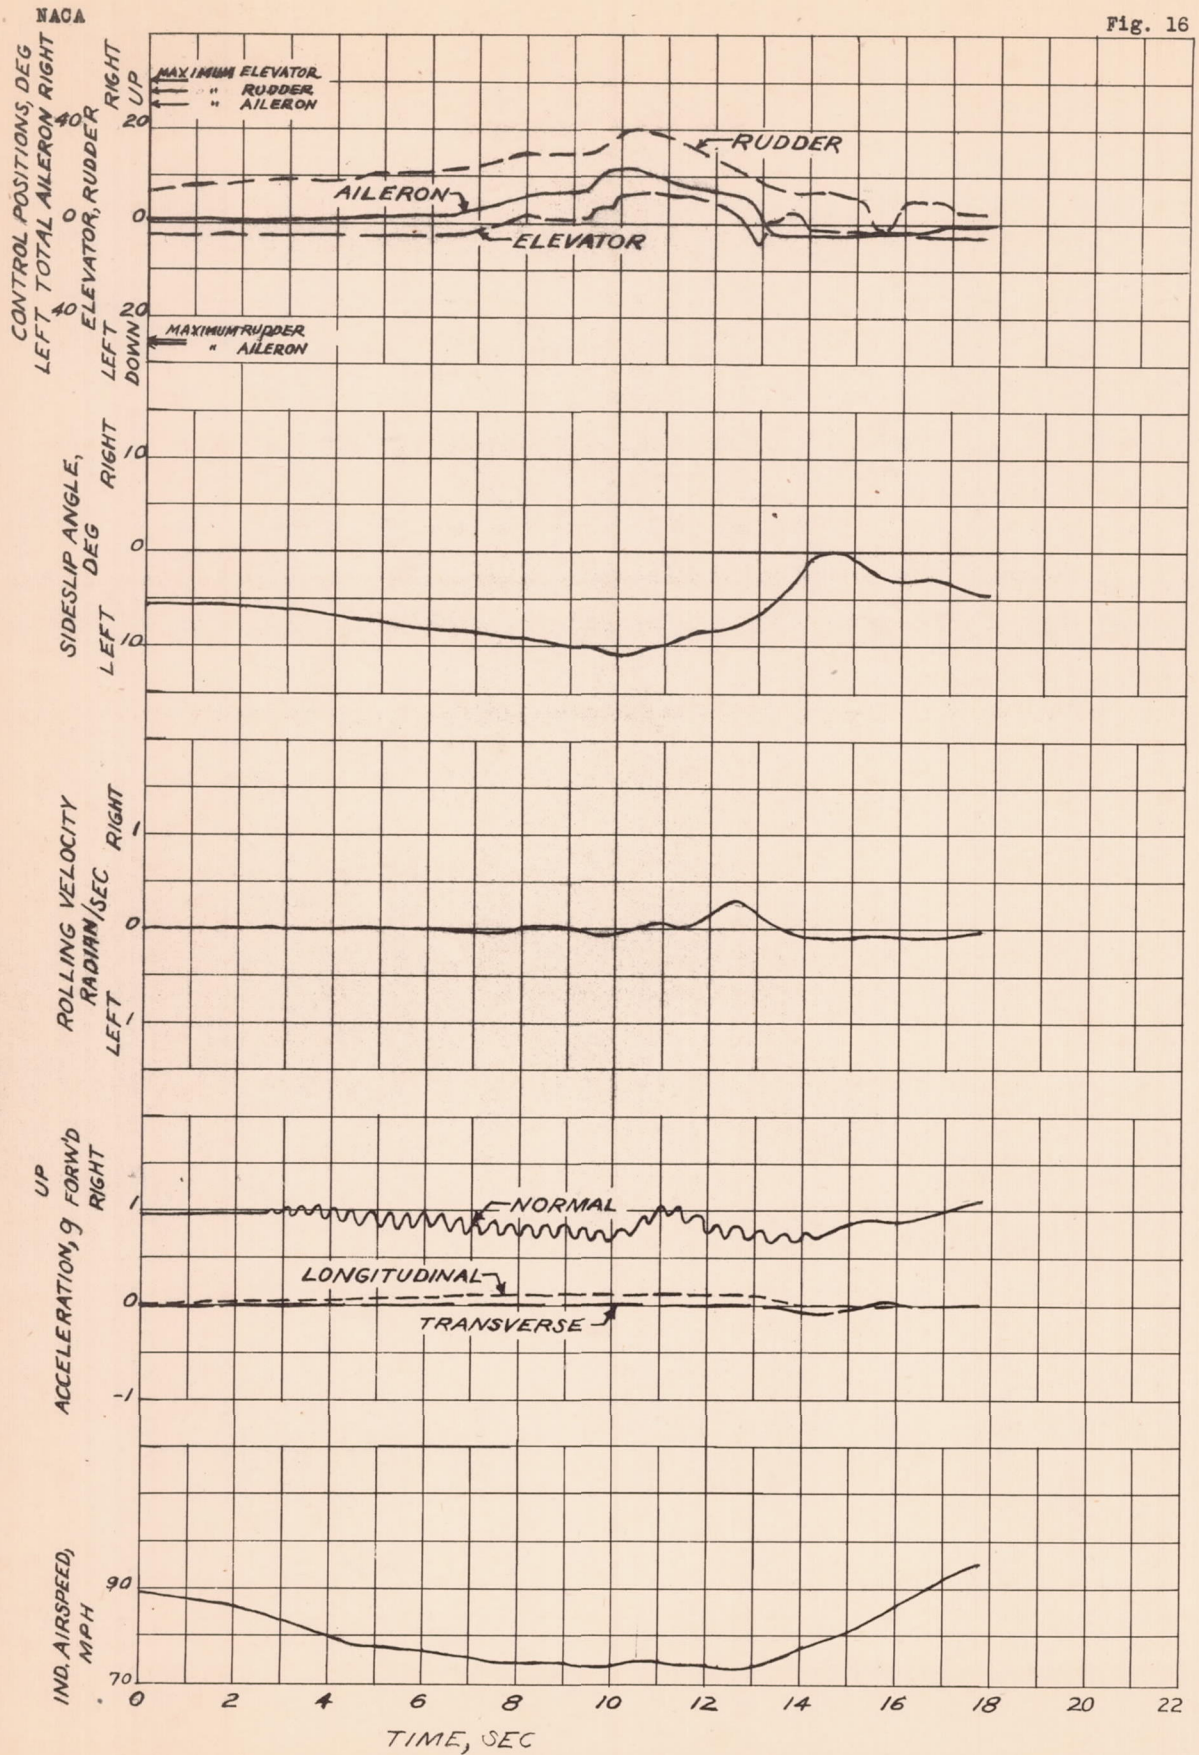
Figure 16. - Time history of a stall in the landing approach condition with gun ports open. Note slight right roll. Supermarine Spitfire airplane.

With gun ports open, the flow separated from the outboard wing panels before the center section stalled. Figure 16 shows that control was maintained in this condition for several seconds after the stall, but a mild right roll eventually occurred.

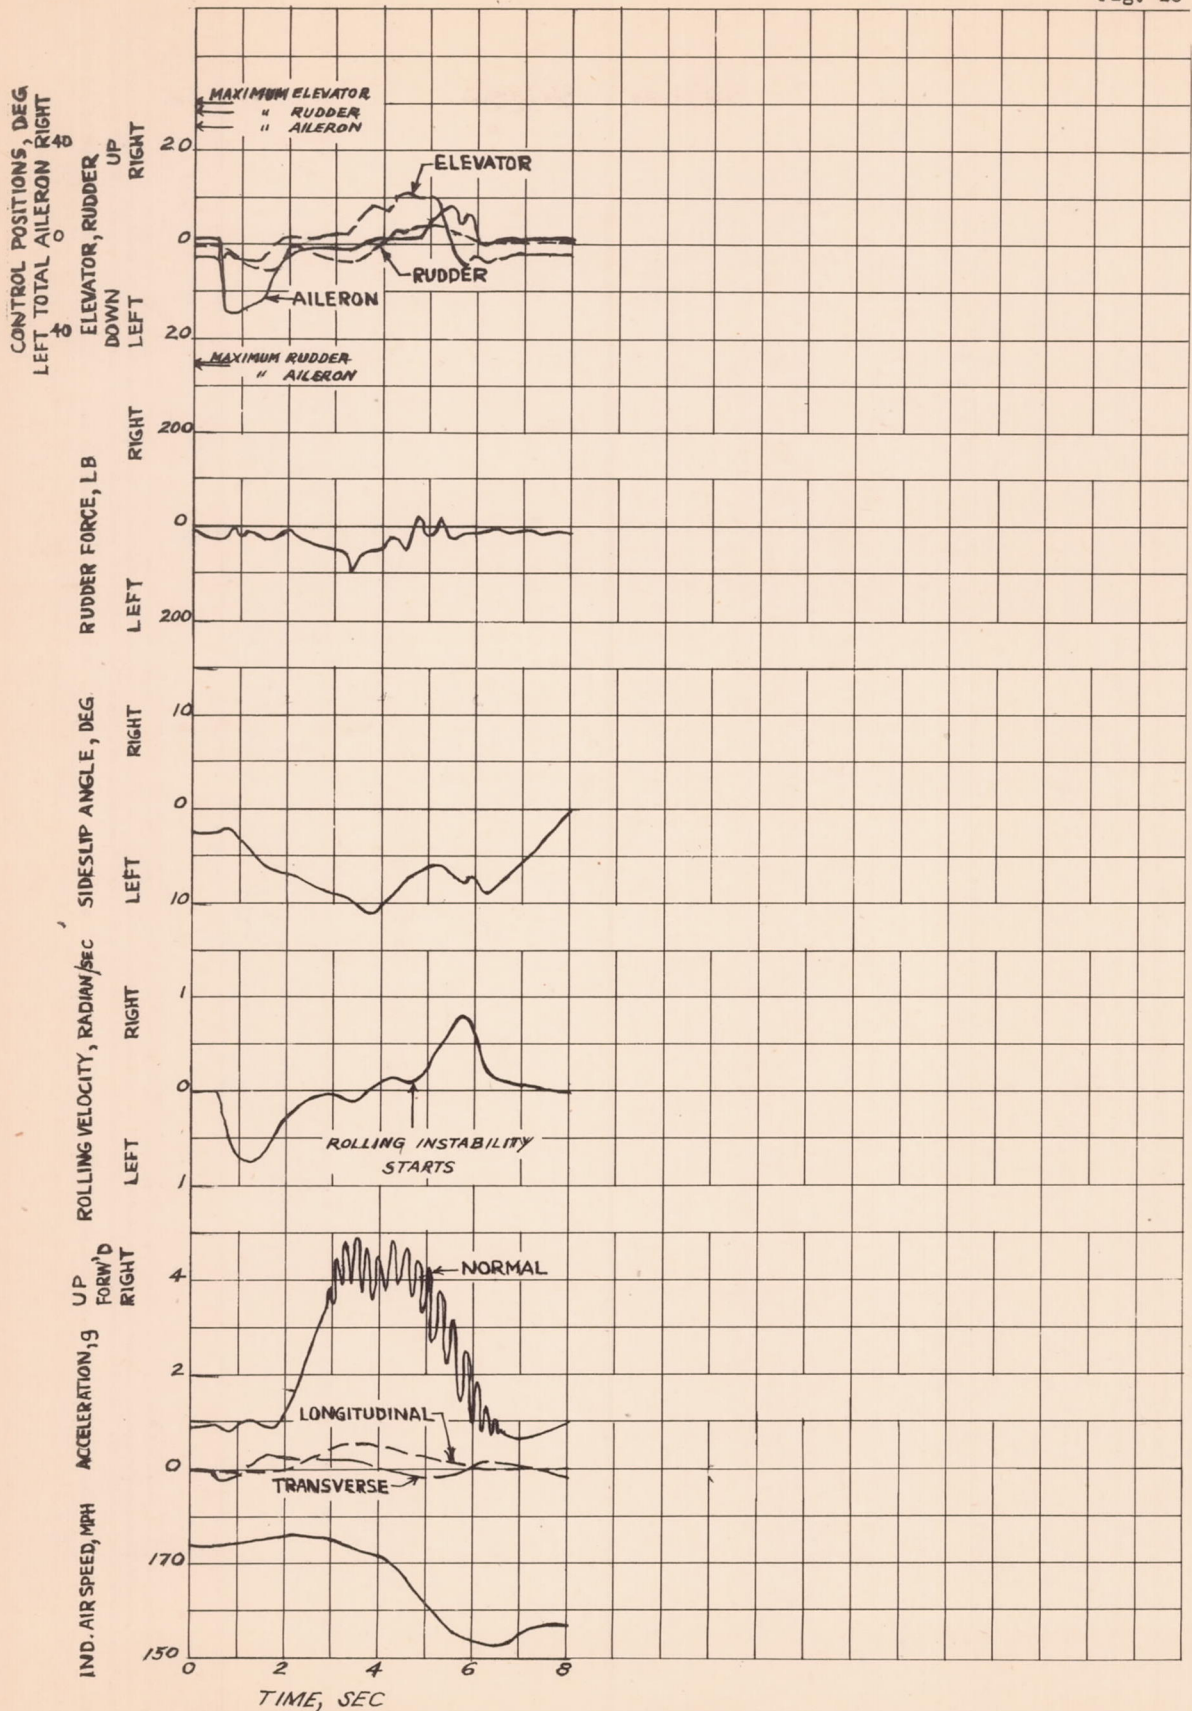
Figure 18. - Time history of a rapid turn to the left started from level flight at 174 miles per hour in which the stall was reached followed by a roll out of the turn. The aileron motion that occurred during the roll resulted from the floating tendency of the ailerons. Supermarine Spitfire airplane with gun ports open.

With gun ports open, a right roll occurred if more than about 10° up elevator were applied. This reaction caused the airplane to roll out of a left turn and into a right turn. Time histories of these maneuvers are shown on figures 18 and 19. In spite of the lateral instability that occurred in turns with gun ports open, the pilot was able to approach maximum lift coefficient closely because of the desirable stall warning. The maximum lift coefficient reached in turns from level flight with flaps up was 1.22. The airplane could be flown beyond the stall at even lower lift coefficients.

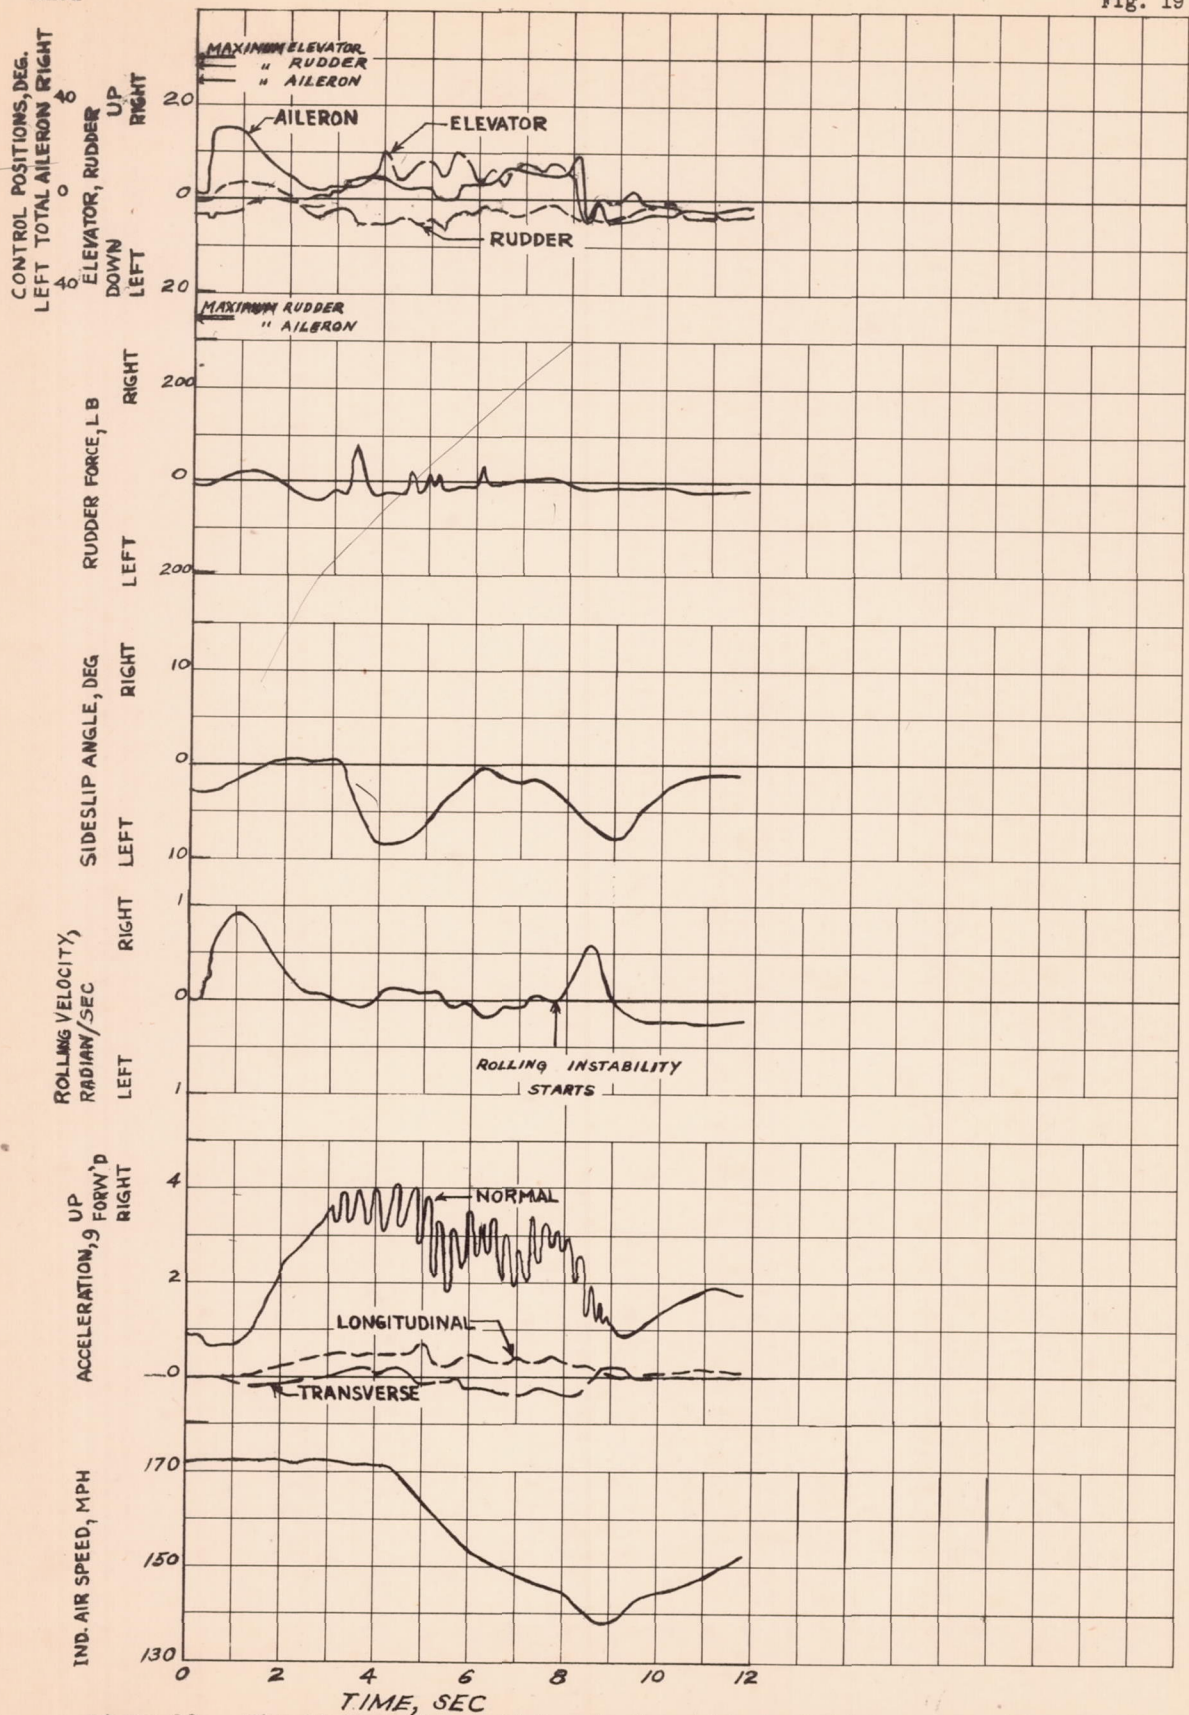
Figure 19. - Time history of a rapid turn to the right started from level flight at 172 miles per hour in which the stall was reached. The airplane subsequently rolled into the turn. The aileron motion that occurred at the start of this roll resulted from the floating tendency of the aileron. Supermarine Spitfire airplane with gun ports open.
